YOUR INSPECTION REPORT

**637 Tiffany Court
Chula Vista, CA 91990**

Inspected Date: 5/16/2026

Report ID: 1138963

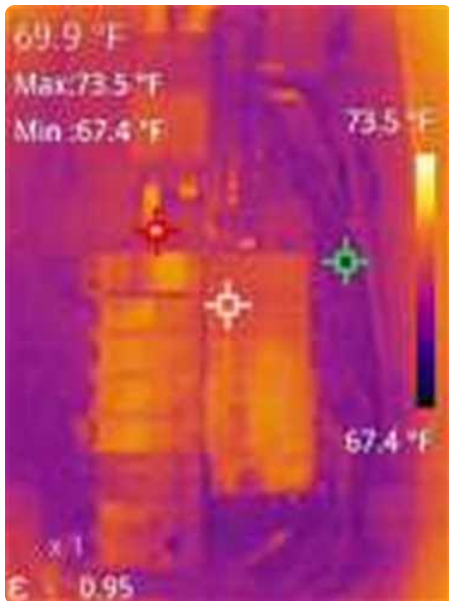
no heat abnormalities in main panel

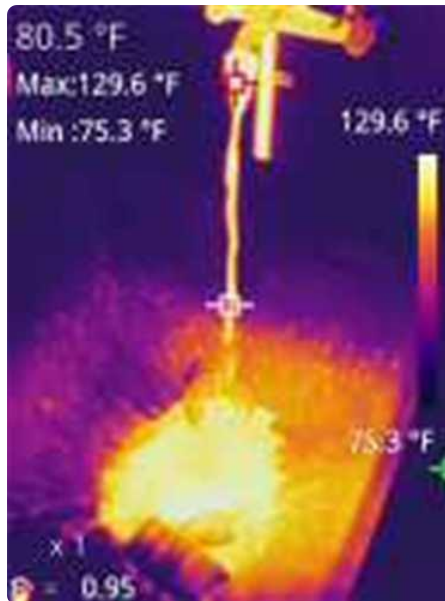
Hot water noted in home

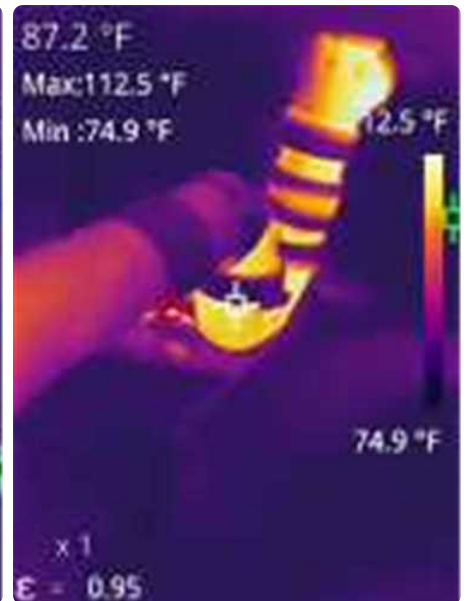
No leaks detected under sinks

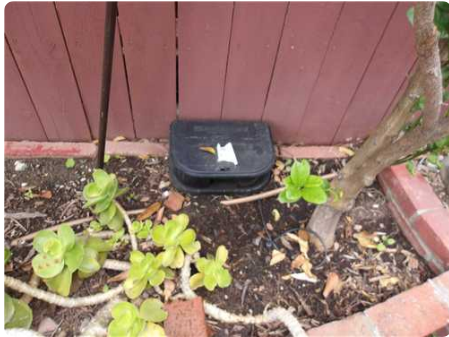
- There is evidence of rodent droppings and/or activity in several areas. This could be a potential health and safety concern. Have a pest control contractor locate the vermin entrance point and make repairs, and remove all waste and debris.

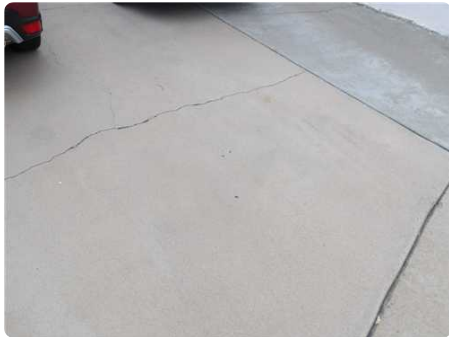
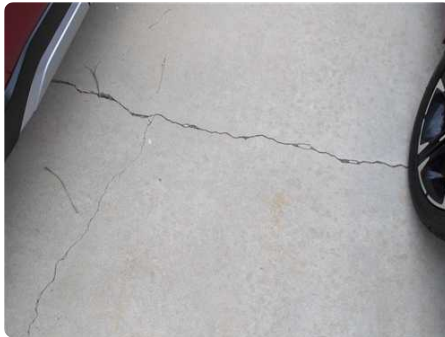
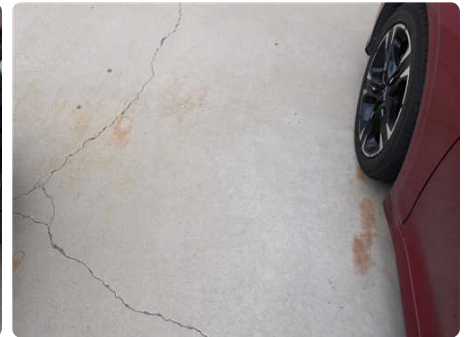
- We observed cracking of the driveway. Have a qualified technician repair or replace as needed.

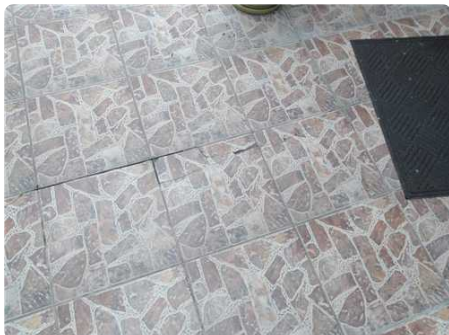
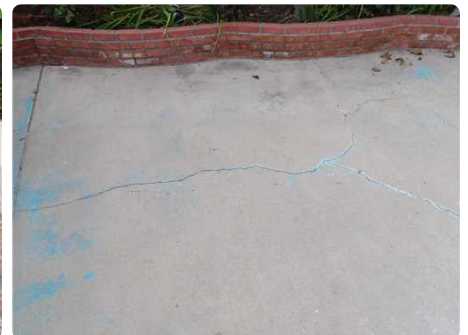
- We observed cracking of the walkways around the building. The damaged areas should be evaluated and repaired as needed.

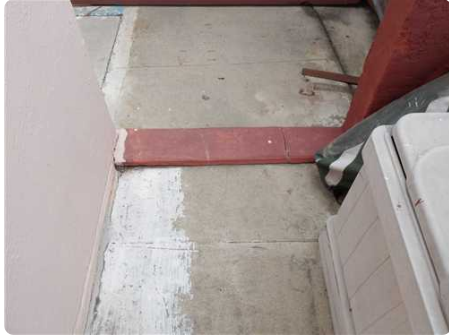
- Trip hazards exist. Correcting/marking the condition is recommended for safety reasons.

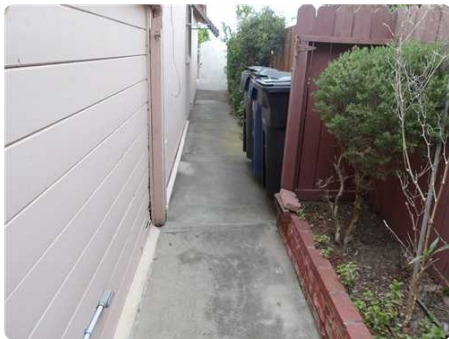
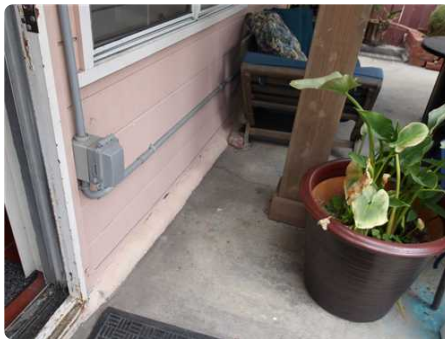
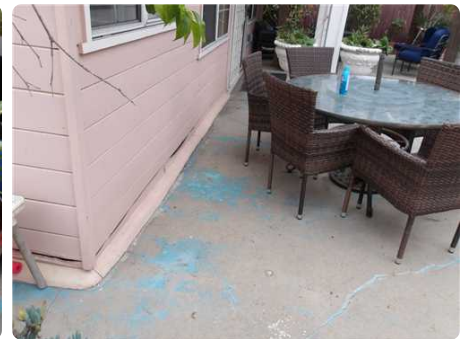
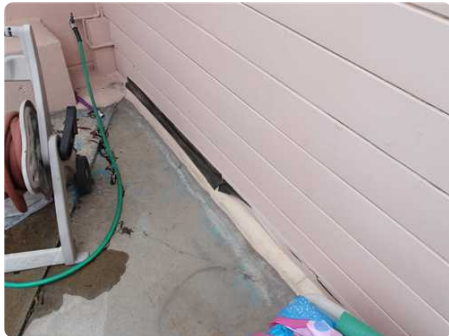
- There is a negative or flat slope at the Left and rear of the home which promotes water intrusion and potential deterioration or damage to the structure. We recommend regrading of the landscaping as needed to drain water away from home.

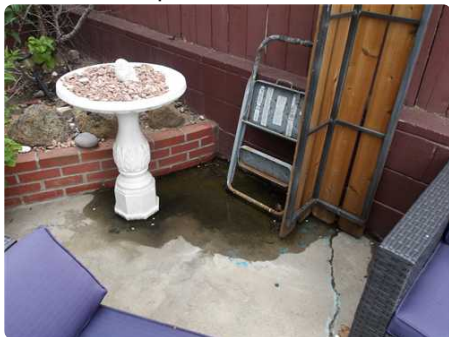
- The landscape at the back of the home may require a trench or drain if water ponds after heavy rains.

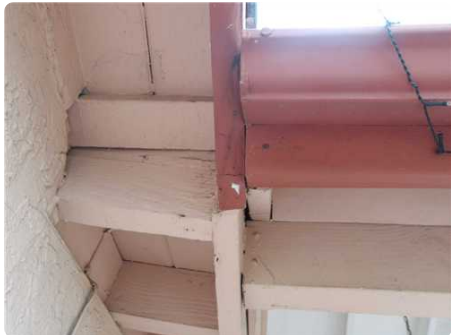
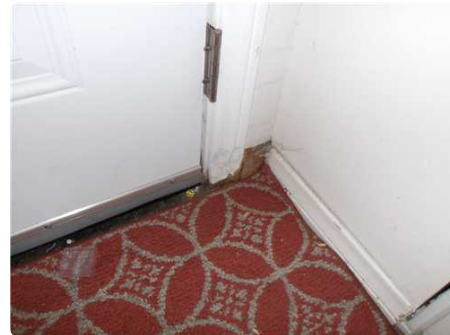
- 🔑 • Some of the exterior trim is damaged in several areas.
 - A qualified technician should examine all exterior trim for damage or deterioration and repair or replace material as necessary. Refer to the termite inspection report for repairs of all wood.

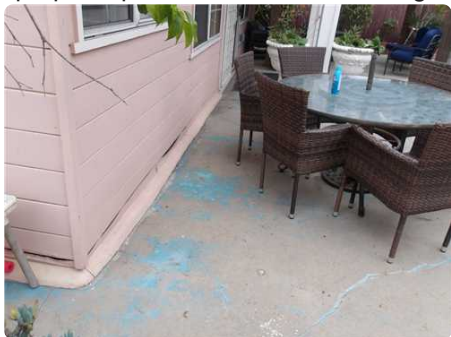
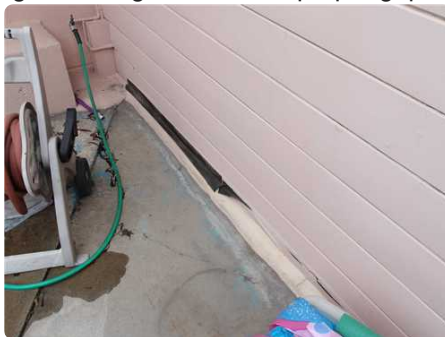
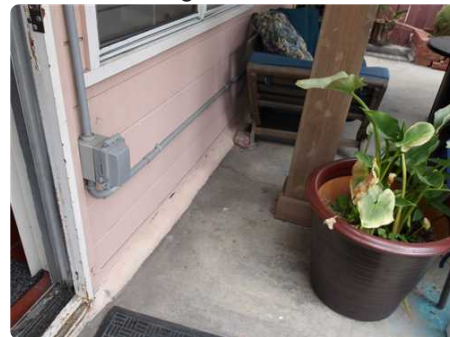
- 🔑 • The wood siding is in contact with the concrete. This is not in accordance with industry standards. Such an installation usually results in the siding being damaged by moisture and/or wood destroying organisms.
 - As preventative maintenance, the area could be flooded with a wood preservative from time to time. However, a proper repair would involve reconfiguring the siding, to ensure a proper gap between the siding and the concrete.

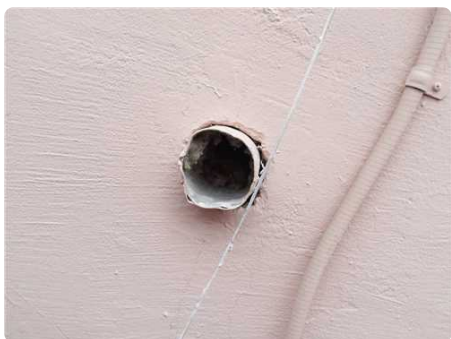
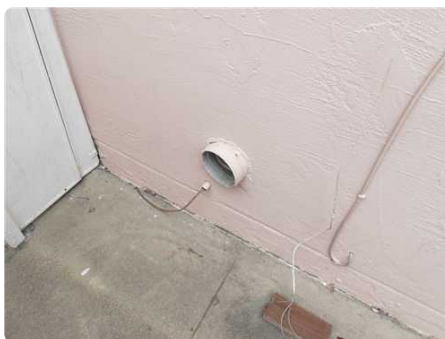
- 🔑 • Two vents on the right side of home should have a louver vent screen. A technician should perform the repairs as needed.

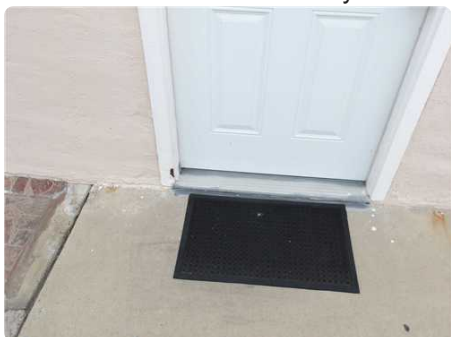
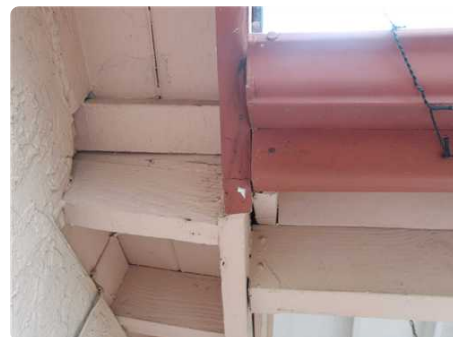
- Conditions associated with wood-destroying organism activity are present in several areas.
 - A qualified, licensed pest control operator should evaluate these conditions, and determine what further steps are necessary.
 - NOTE: Observations by a building inspector, who is not otherwise specially qualified to inspect for evidence of pests, is not a substitute for inspection by a licensed Pest Inspector or exterminator. This report includes comments on current visible conditions only.

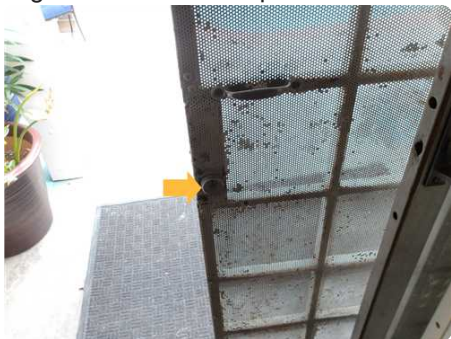
- The door at the *IDENTIFY(door/exterior)* has a double keyed dead bolt. This configuration is not allowed under fire egress standards. A qualified technician should make any repairs or modifications as needed.

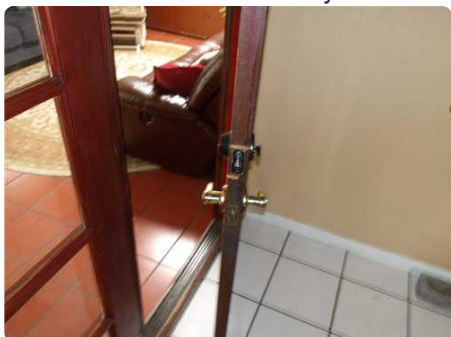
- The door locks and hardware at several areas need to be adjusted so they properly latch and lock. A qualified technician should make any needed repairs or modifications.

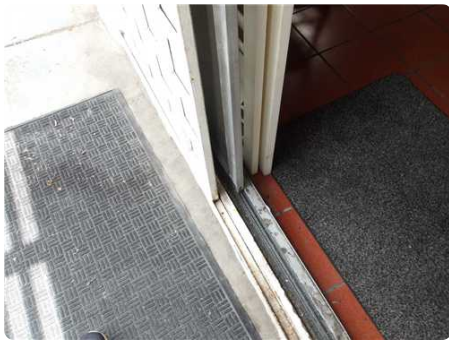
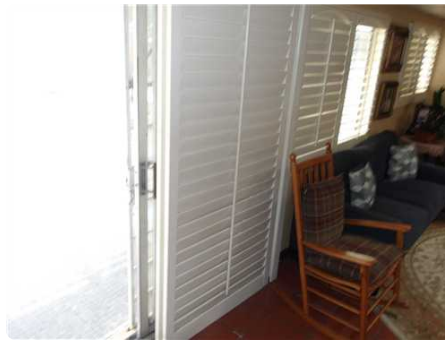
- Several sliding exterior doors are damaged and are no longer reliable.
 - A qualified technician should repair or replace the doors as necessary.

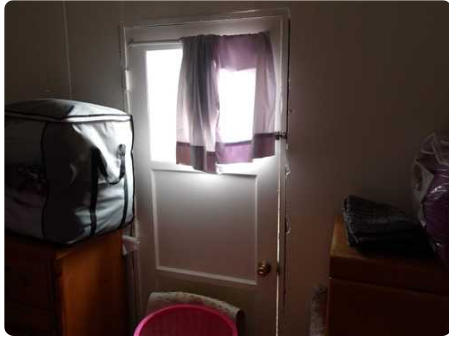
- The door at the right side of the home does not have a tempered glass label visible. A qualified technician should make any needed repairs or modifications.

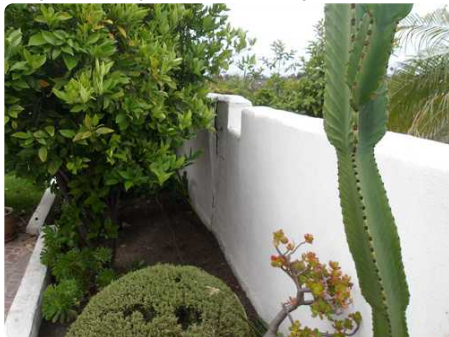
- The masonry block fencing at the Front left of the property is settled and cracked.- Damaged fence elements should be repaired if possible, or replaced as necessary.

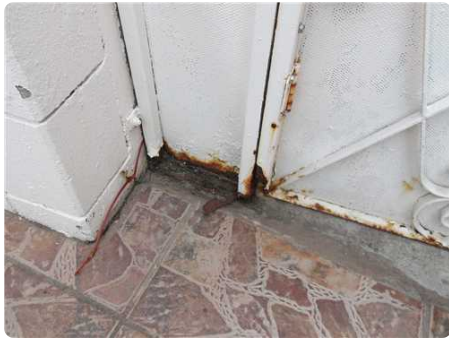
- The metal fencing at the sides of the property is rusting, and deteriorated. - Damaged fence elements should be repaired if possible or replaced as necessary.

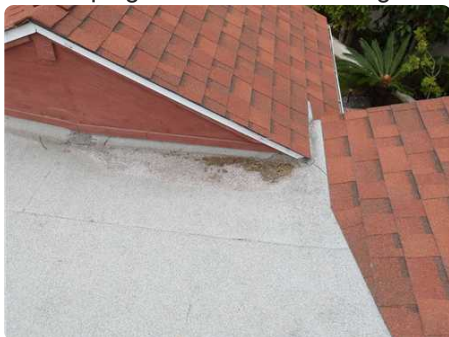
- 🔑 There is evidence of ponding in one area on the low slope roof. The presence of shallow ponds of water in some areas after rains is not unusual.
 - Regular maintenance of the areas is vital to avoid a build-up of rotting vegetation and possible damage to the roof. Re-sloping of these areas during the next re-roof may be necessary.

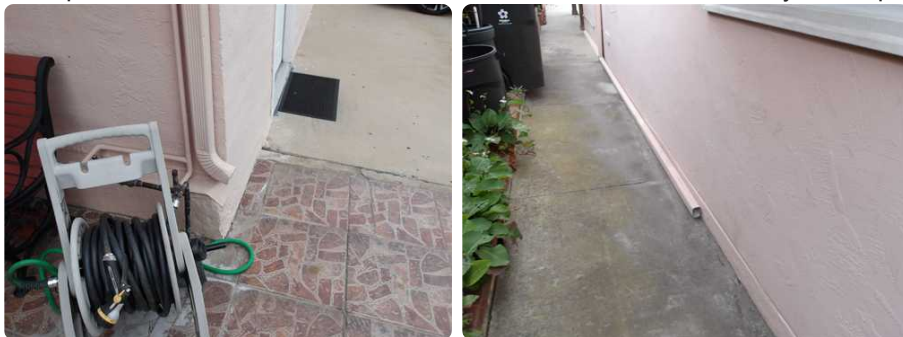
- The downspouts have no splashblock or lack an extension. Splashblocks and extensions help divert water away from the foundation.
- A splashblock or extension should be installed at the base of every downspout.

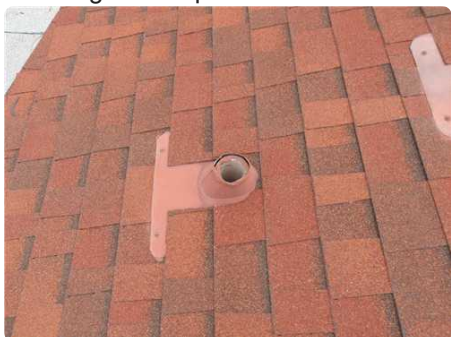
- The vent cap for the exhaust from the water heater is missing. A damaged or missing vent cap can allow water into the vent pipe, and could create unsafe conditions. - Have a qualified trades person repair or replace all damaged and/or missing vent caps.

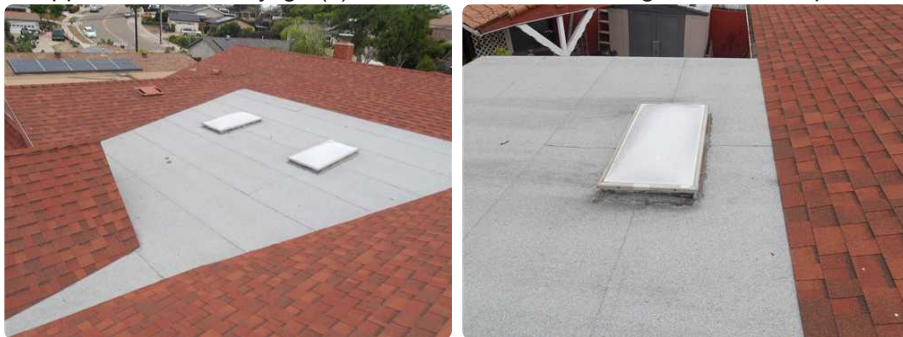
- It appears that the skylight(s) was added to this building after the completion of the original construction.

- Skylights are common leak sources. Monitor the area around the skylight(s) for any moisture intrusion and have repairs made if necessary.

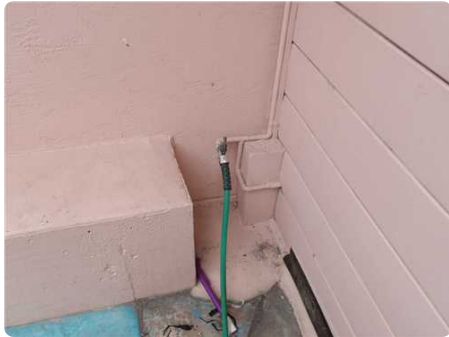
- Water pressure could not be tested at time of inspection due to hoses at hose bib not being able to be removed. (The water pressure should be between 40 - 80 psi.)

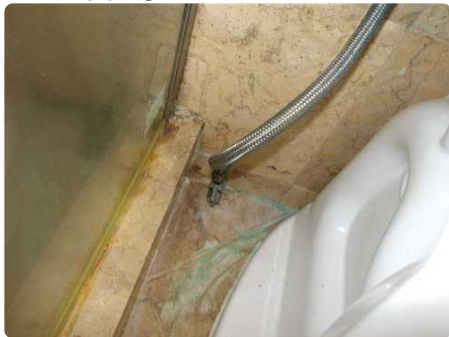
- There is surface corrosion in the visible supply and/or waste piping at several valves, fixture and drains in the home. We observed no signs of active leaks at the time of the inspection but leaks can develop anytime without warning. All valves and fixtures should be evaluated during your final walk through and before close of escrow to verify that no new leaks have developed.
 - This piping should be evaluated for leaks on a regular basis and repaired by a qualified technician when necessary.

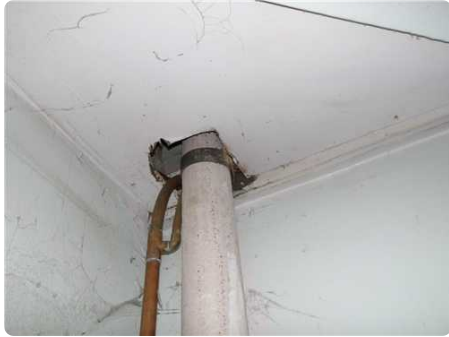
- The vent connector terminates in a Transite (asbestos cement) flue pipe, which does not meet modern industry standards. The local building department may require the flue to be upgraded when the water heater is replaced.

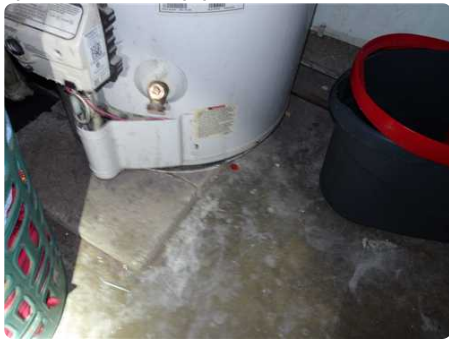
- This water heater does not have a "Thermal Expansion tank" installed to prevent a possible leak at the T&P or "Pop-off" valve. Changes in the building standards may require one when a new water heater is installed. This change is not retroactive on older previously installed Gas/LP water heaters. Check with your local building department as to their requirements. There were no leaks or drips at the T&P valve during inspection. If your water heater does begin to drip or leak, then a Thermal Expansion tank may be needed.
- There is no metal pan installed under the water heater. A pan is required by some jurisdictions when the appliance is located in certain areas of the structure. If the water heater leaks, the water will flood the floor. Consider installing a pan and drain pipe.

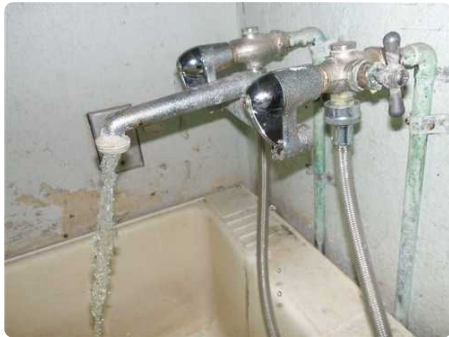
- The laundry sink faucet is leaking or dripping at the valve stem. All leaking or dripping faucets should be repaired or replaced as needed by a qualified plumber.

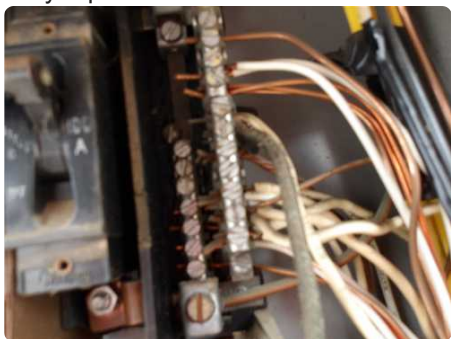
- Multiple breakers of a different brand than panel manufacturer. The manufacturer requires that in order for the panel to be safe, only their brand is allowed to be used inside the panel. Even though these circuit breakers are all "UL approved," they are not approved to be used in panels of different manufacturers unless so indicated on the panel label. --- A qualified electrician should replace all non-matching breakers with breakers of the same brand as the panel.
- The panel has "double-tapped neutrals," or two or more neutral wires connected under one buss lug. Current standards do not allow this configuration. We recommend further evaluation by a qualified technician who can make any repairs as needed.

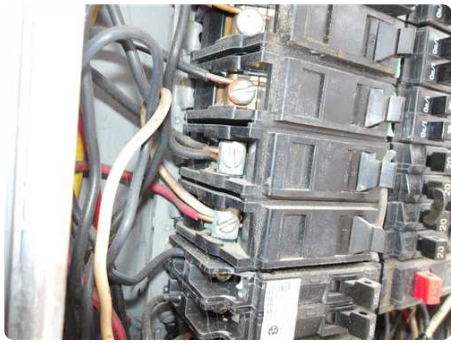
- Multiple wires are installed on one or more circuit terminals. The connectors do not appear to be designed to accommodate two circuits. This "double tapping" can be a safety hazard. A licensed electrician should correct all improper double taps.

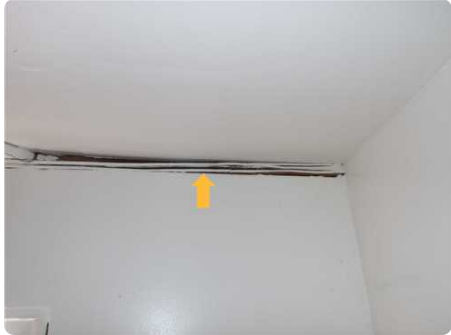
- There is exposed wiring. The wiring is susceptible to physical damage and not well protected.
- A licensed electrician should properly install any exposed wiring.

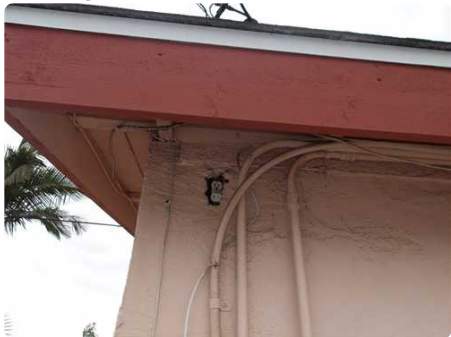
- No GFCI (ground fault circuit interrupter) protection is present at all locations per current industry standards. This may not have been required at the time of construction but current industry standards requires GFCI protection in all bathrooms, garages, exteriors, laundry rooms, basements and kitchens. **As a safety upgrade, consider installing GFCI protection at all recommended locations.**

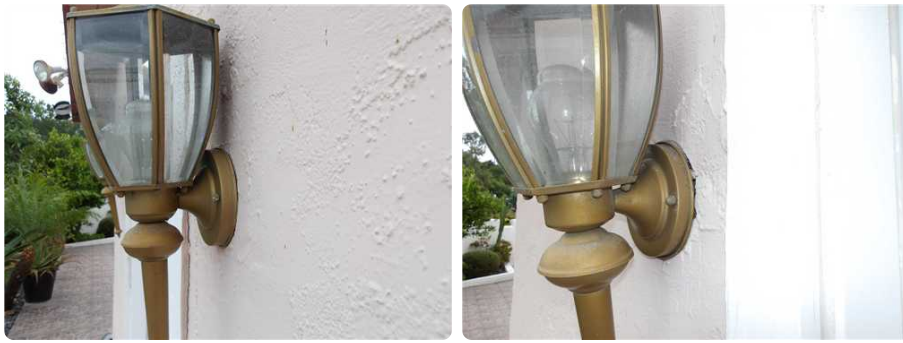
- One or more light fixtures are loose and/or not sealed at the exterior walls. A qualified licensed electrician should make any needed corrections.

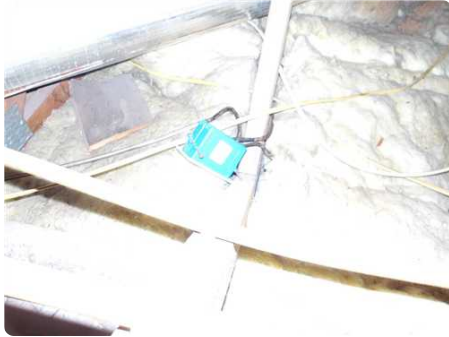
- An electrical box is loose and/or not properly secured to the wall or framing. We recommend a licensed contractor and/or specialist evaluate and perform repairs.

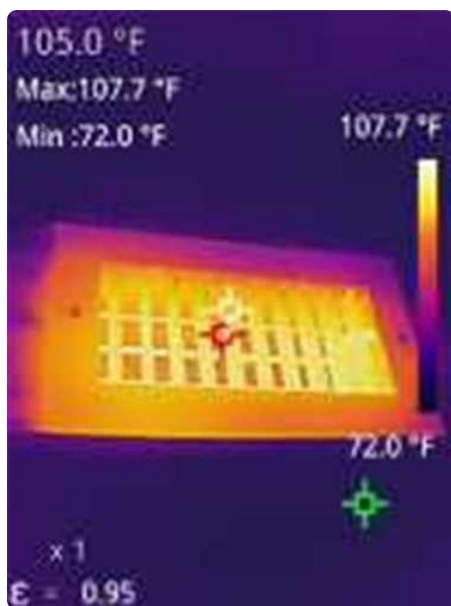
- All HVAC (heating, ventilation and air conditioning) systems would benefit from a yearly check up and cleaning by an HVAC technician. The older a unit is, the more important this becomes. The heater was operational at the time of the inspection.

107 degrees

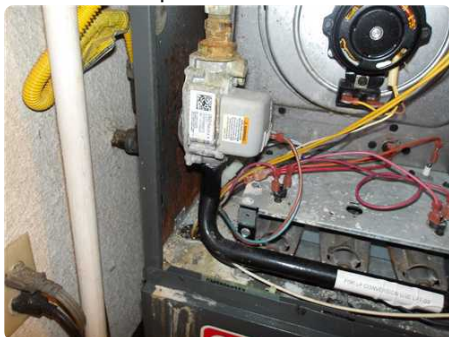
- The heater unit showed signs of aging and wear, but were in otherwise functional condition. The system is approximately 20 years old and the average life expectancy is approximately 20 years for this type of unit. Routine service will assist in the longevity of the unit. We recommend you have the unit serviced by a licensed HVAC technician prior to close of escrow.
- The heating system shows evidence of water intrusion or damage. A qualified technician should evaluate the system and effect repairs as needed.

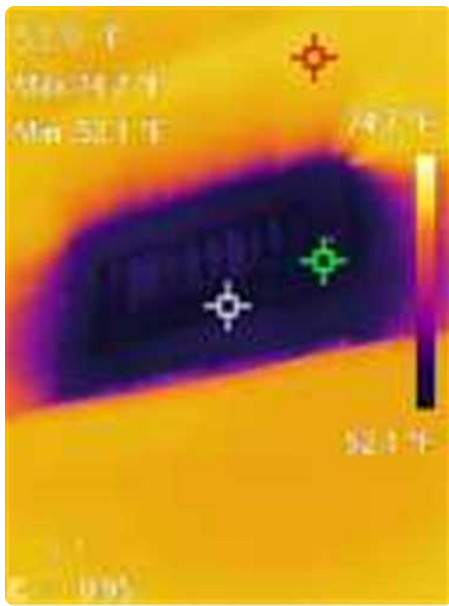
- AC cooling temperature. The temperature drop was within cooling limits and the system was functional at time of inspection. This is FYI.

52 degrees

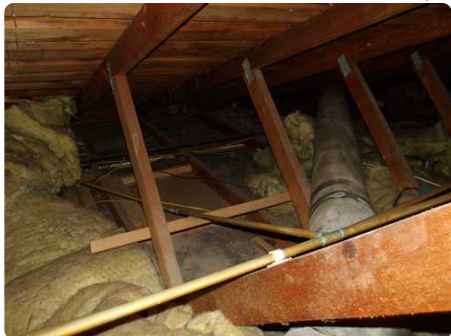
- Some of the insulation in the attic is missing, or is out of place. Where insulation is missing, new insulation should be installed. Where insulation is out of place, it should be put back into place. A qualified technician should do the work.

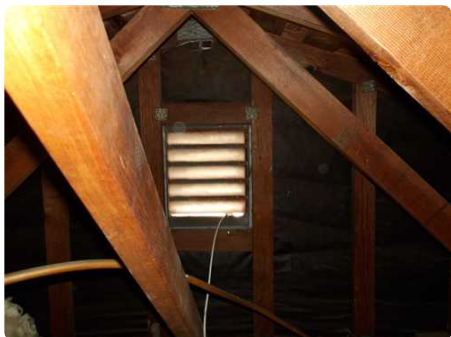
- One or more gable vent screens are damaged at the exterior gables. A qualified technician should repair or replace as needed.

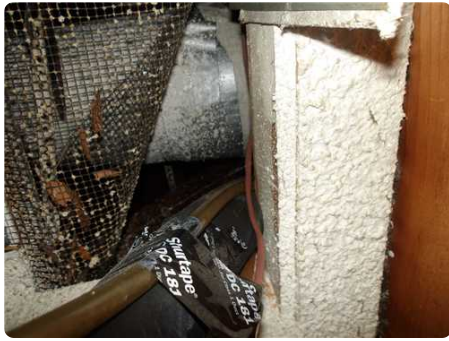
- The utility closet for furnace screen is damaged. A qualified technician should repair or replace as needed.

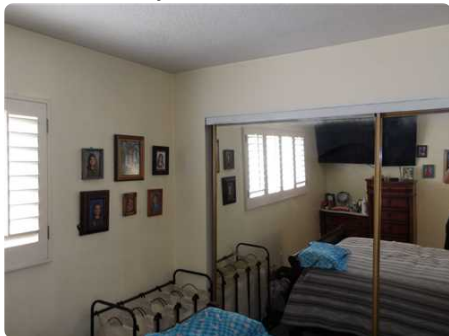
- One or more bedroom closet doors are rough in operation. A qualified technician should make repairs or modifications as necessary.

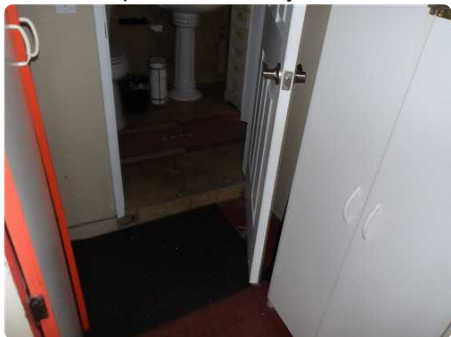
- The passage door swings outward over a downward step. For safety, all passage doors should have adequate landings under the arc of the door for safe egress. Changing the swing of the door or installing a platform would enhance personal safety.

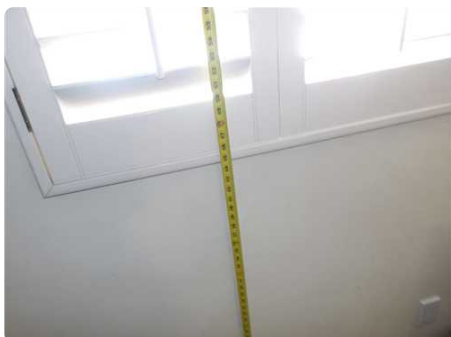
- Dirty windows/screens makes dual pane windows more difficult to inspect for broken seals. It is not uncommon for homes to have one or more windows with a broken seal. We recommend all dirty windows be cleaned and further evaluated prior to close of escrow to determine if their are any broken window seals.
- The bottom of the bedroom window sills are more than forty-four inches above the floor. Windows this high above the floor may not allow adequate egress. This appears to be the original window height installation and was likely allowed at the time of construction. Although no upgrading is required for fire safety at sale, the client should consider installing windows meeting the maximum height requirements. At that time, sills may need to be lowered. A qualified technician should do the work.

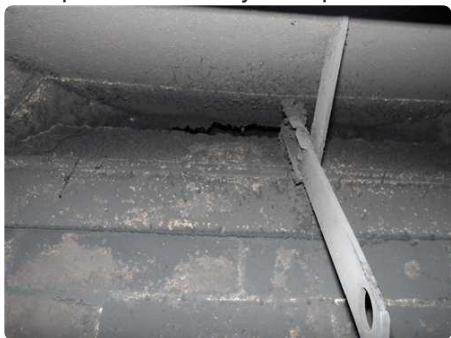
- The dinning room fireplace flue and firebox has a build-up of soot and/or debris. The condition of the flue and firebox could not be fully determined.
- A qualified chimney sweep should clean & evaluate the flue and chimney.

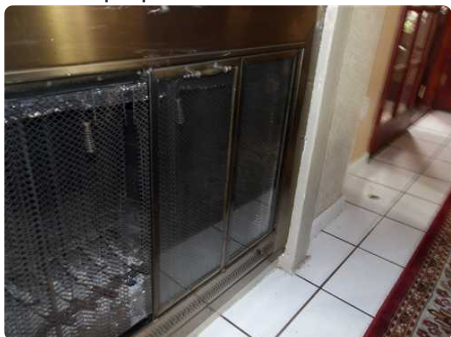
- The glass doors for the fireplace(s) in this area was damaged or not operating properly. All damaged, poorly operating or non-operating glass doors and their associated hardware should be cleaned, lubricated, adjusted, or replaced to restore proper function.

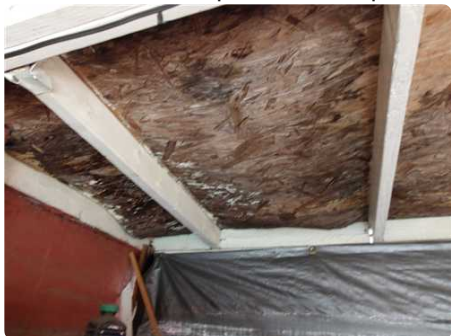
- There are some dips or sags in the roof in areas. The roof sheathing shows signs of deterioration. We recommend a licensed roofer repair and or replace as necessary.
