## HOME INSPECTION REPORT

**PROPERTY ADDRESS**  
36305 Colbert Place, Newark

**REPORT NUMBER**  
668218

**DATE OF INSPECTION**  
December 6, 2025

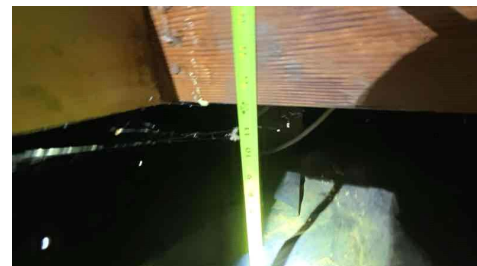
Photo 31

1. Due to the lack of clearance between the ground and ducting, plumbing, and/or floor joist/girders, portions of the crawl space were not inspected. With access and an opportunity for a complete inspection, conditions in need of attention may be discovered. We recommend further inspection when a minimum of 16 inches between the ground and any obstructions is provided. (See Photo 31)

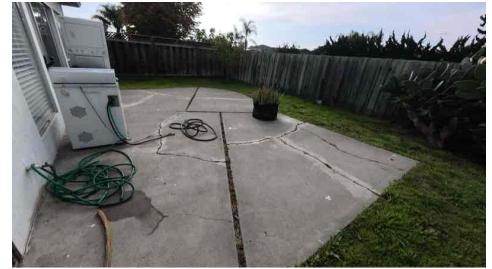
Photo 04

4. The patio surface has cracked, heaved, or uneven sections that create a potential trip hazard. We recommend addressing these conditions to improve safety and prevent potential injuries. (See Photo 4)

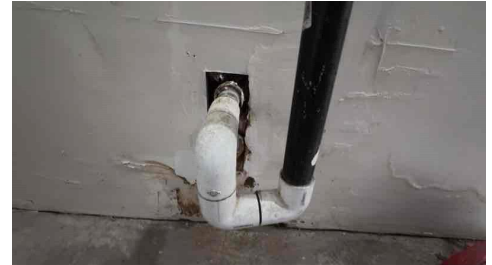
Photo 18

5. Damaged, open or missing wall and/or ceiling finishes of attached garages should be repaired and sealed where they abut the interior of a house. This reduces the potential of toxic automobile gases entering the house and serves as a fire break. Current standards require all walls/ceilings common to the finished living spaces be covered with 5/8" fire resistant sheetrock double taped at all seams. (See Illustration 3A) (See Photo 18)

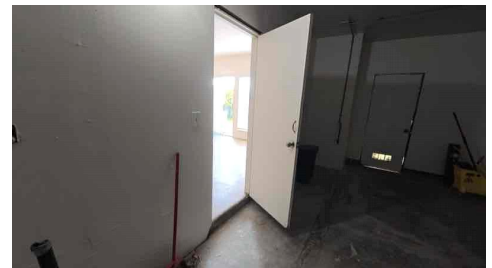
Photo 15

6. The door between the garage and the house did not have an automatic closing mechanism. The door between the garage and the interior of the house should be fitted with an automatic closing mechanism. This will reduce the potential of toxic automobile gases entering the house and serves as a fire break. (See Illustration 3G) (See Photo 15)

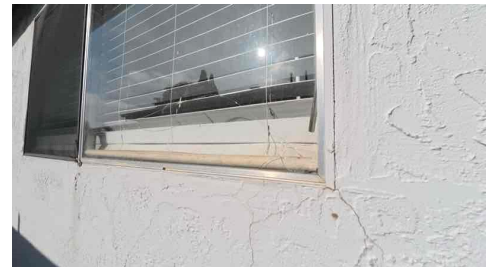
Photo 08

7. Cracked or broken exterior window glass at the left side should be replaced. (See Photo 8)

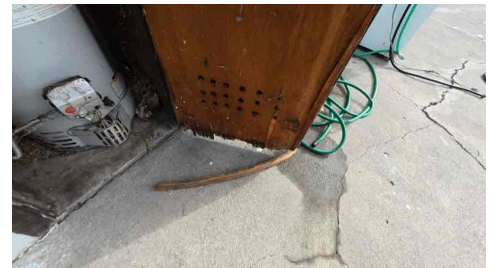
Photo 05

8. Water damage was noted at the rear door. We recommend the services of a licensed general contractor and/or structural pest control company regarding repairs. (See Photo 5)

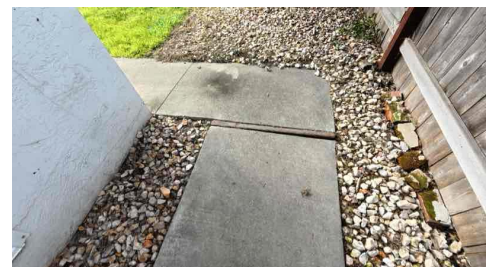
Photo 03

9. The cracked, heaved, or uneven walkway sections at the right side pose a potential trip hazard. We recommend corrective action to improve safety and reduce the risk of injury. A qualified contractor should assess the affected areas and perform necessary repairs to ensure a level walking surface. (See Photo 3)

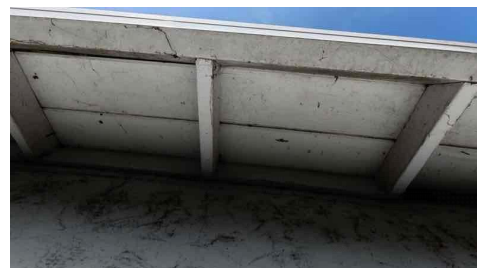
Photo 12

10. Water damage was observed to the roof eaves/sheathing at the left side. We recommend the services of a licensed general contractor and/or structural pest control company. (See Photo 12)

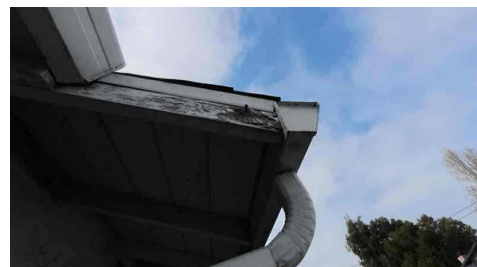
Photo 02

11. Water damage was observed to the rafters at the front and various areas. We recommend the services of a licensed general contractor and/or structural pest control company. (See Photo 2) (See Photo 9) (See Photo 14)

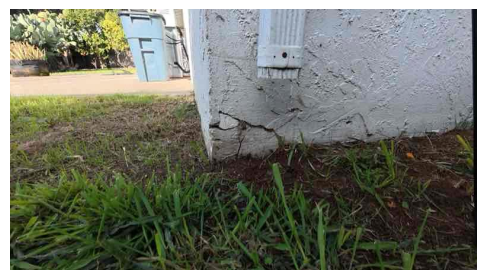
Photo 10

12. Localized damage and/or large stucco cracks at the rear corner should be further evaluated by the appropriate tradesperson to determine if any moisture intrusion has occurred and to repair the stucco in this area. (See Photo 10)

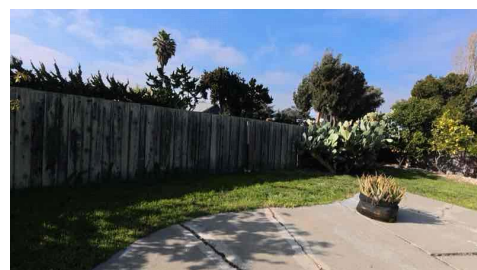
Photo 13

13. The fence is in satisfactory condition, however one or more fence posts are loose at the rear. We recommend all loose, damaged or deteriorated posts be reinforced or replaced as necessary. (See Photo 13)

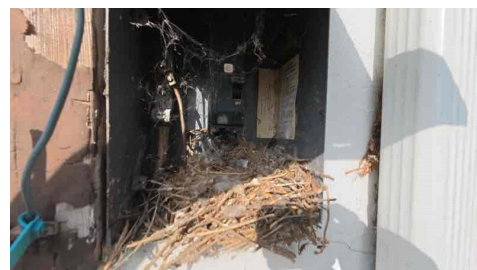
Photo 06

14. The main electric panel cover plate sometimes called the "Dead Front" is missing. It should be replaced. (See Illustration 4S) (See Photo 6)

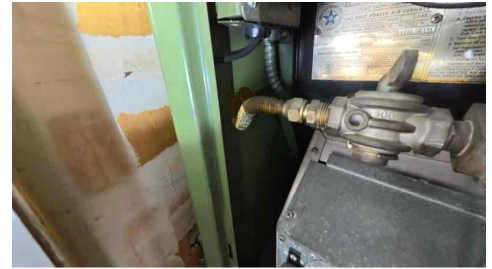
Photo 24

15. We noted a flexible gas line running through the furnace metal housing. We recommend consideration be given to installing rigid piping at the penetration of the housing and the installation of flexible supply piping at the exterior of the furnace. (See Photo 24)

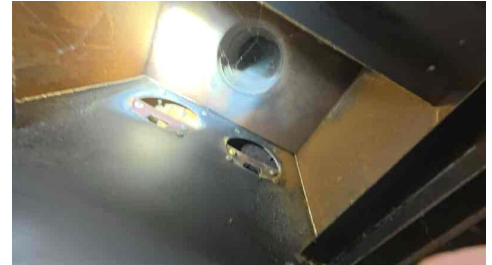
Photo 23

16. The heat exchanger is rusted, streaked and worn where visible from the exterior. These conditions indicate that it is at or near the end of its service life. We recommend inspections of the unit by the local utility company or a licensed heating contractor, to determine if repairs or replacement is necessary. (See Photo 23)

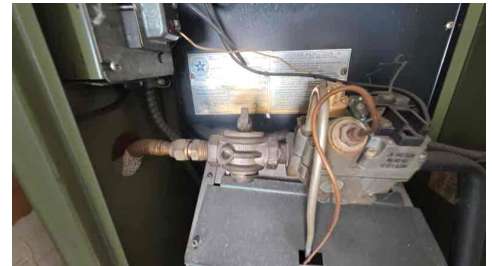
Photo 25

17. The heating systems energy source was shut off and the system was not operational at the time of our inspection. We cannot offer opinions about system performance or general state or repair. We recommend inspection by a licensed HVAC contractor when service has been restored. (See Photo 25)

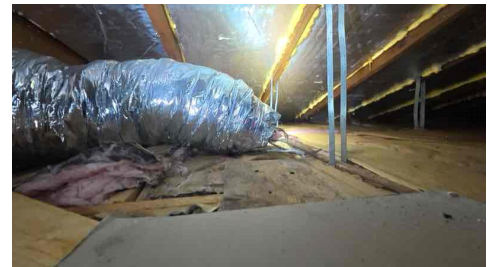
Photo 34

18. One or more of the heating ducts have come apart at the attic. This will allow conditioned air into surrounding area. We recommend they be repaired and secured. (See Photo 34)

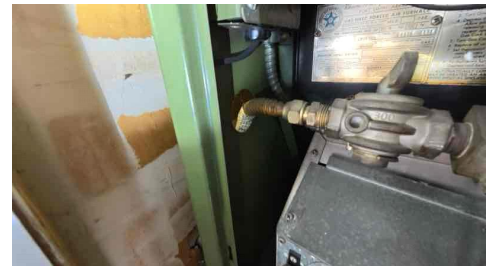
Photo 24

19. The gas line/connector at the furnace is flexible and made of brass. Brass is no longer approved for this use because it is prone to deterioration. We recommend the gas line/connectors be replaced with a line/connector meeting present standards. (See Photo 24)

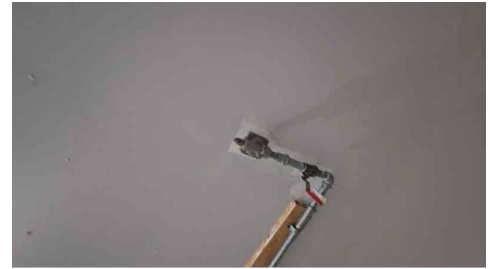
Photo 19

20. There was an uncapped gas line noted at the garage. If it is not going to be used we recommend the line be capped. (See Photo 19)

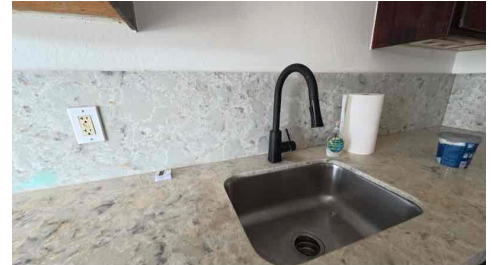
Photo 20

21. Leakage was noted at the kitchen faucet and/or handle. We recommend all leaks be repaired. (See Photo 20)

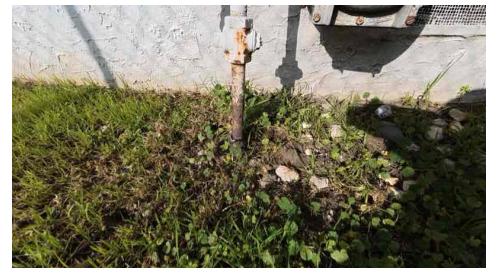
Photo 07

22. There is evidence of heavy corrosion and rust on the exterior of the exposed and accessible metal gas supply piping at the left side. This section of piping should be replaced as necessary. (See Photo 7)

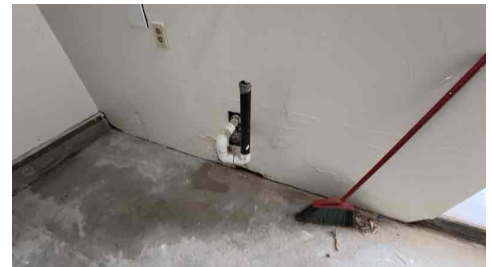
Photo 16

23. The laundry standpipe and/or trap is configured improperly or is missing. This is not an approved configuration and is considered a significant defect and potential safety hazard. We recommend an approved standpipe that is two inches in diameter and drain trap be installed. (See Illustration 8D) (See Photo 16)

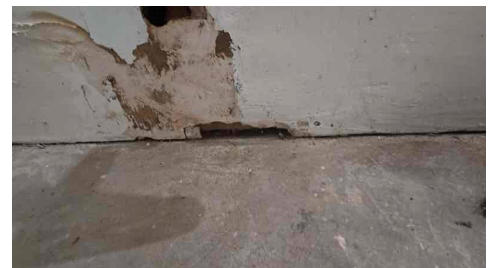
Photo 17

24. The wall at the garage shows evidence of water damage. We recommend the services of a licensed structural pest control company for investigation. (See Photo 17)

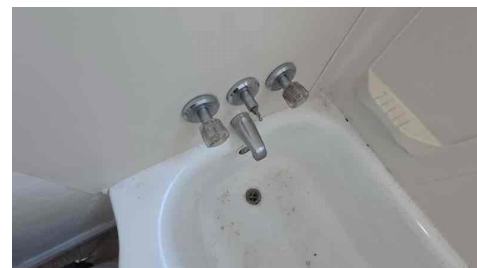
Photo 28

25. The faucet handles at the hall bathtub are damaged or missing. We recommend the handles be repaired or replaced for full use of the faucet. (See Photo 28)

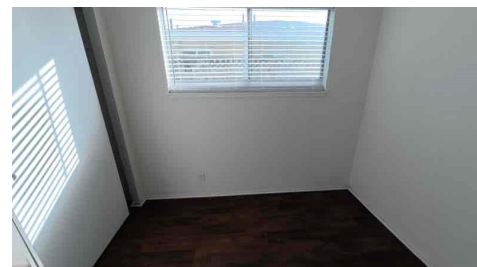
Photo 21

26. The height or size of the window in the bedroom does not conform to proper standards for egress. We recommend contacting the local building department to confirm if this installation conforms to specifications for escape openings in bedrooms. (See Photo 21)

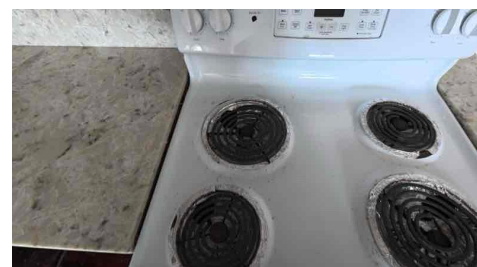
Photo 35

27. The burner of the oven was inoperable or missing at the rear left. All missing, damaged or inoperable burner elements should be repaired or replaced as necessary by a qualified appliance technician. (See Photo 35)

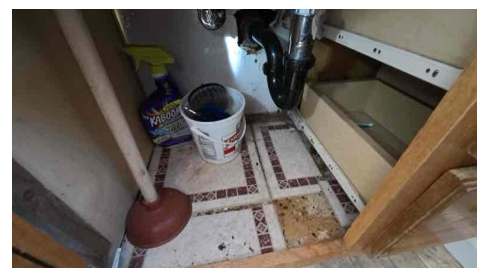
Photo 30

28. The base and/or side of the master bathroom cabinet sink shelf is deteriorated. We recommend the advice and services of a licensed pest control operator for investigation and possible repair of this condition. (See Photo 30)

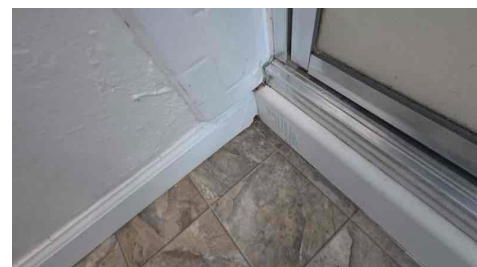
Photo 29

29. Evidence of water damage at the master bathroom floor was observed. The extent of the damage is difficult to predict without removing floor coverings. We recommend the services of a licensed structural pest control operator for investigation of this condition. (See Photo 29)

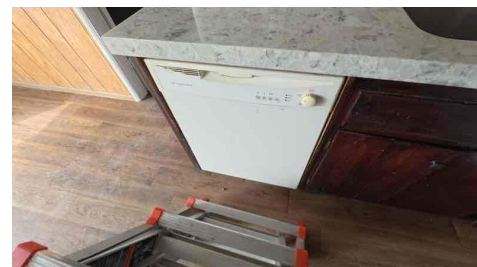
Photo 36

30. At the time of our inspection the dishwasher was inoperative or did not respond to normal operating controls. For attention to the conditions noted and/or cost estimates, if necessary, we recommend the advice of a qualified appliance technician. (See Photo 36)

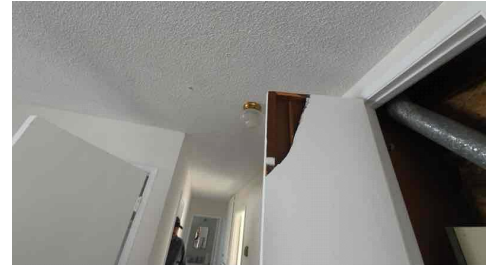
Photo 22

32. Damaged, splitting or cracking was noted at the furnace closet door. We recommend it be repaired or replaced for cosmetic consideration and ease of use. (See Photo 22)

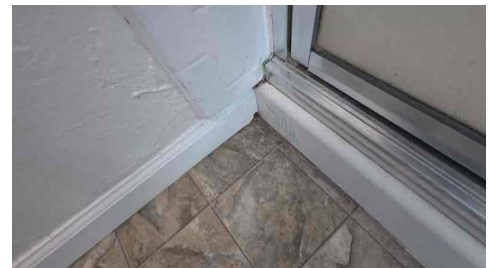
Photo 29

33. The wall trim and/or baseboard at the master bathroom was observed to be water damaged. We recommend the services of a licensed general contractor and/or structural pest control company. (See Photo 29)

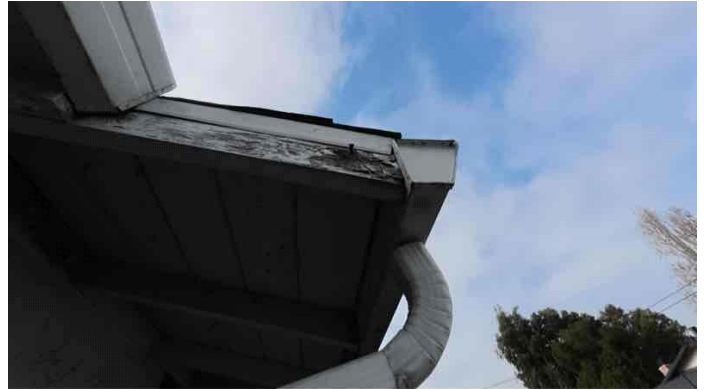
Photo 02

- ! 8. Water damage was observed to the rafters at the front and various areas. We recommend the services of a licensed general contractor and/or structural pest control company. (See Photo 2) (See Photo 9) (See Photo 14)

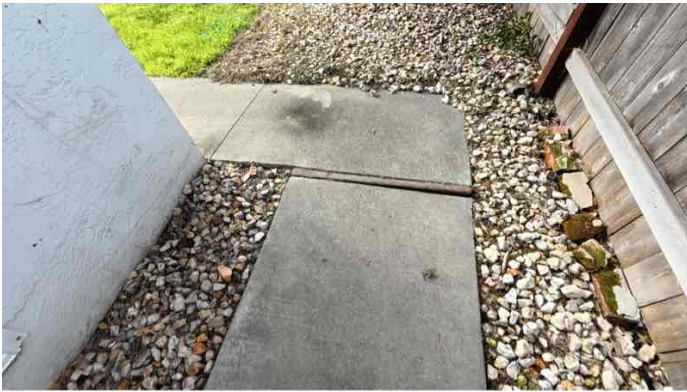
Photo 03

- ! 6. The cracked, heaved, or uneven walkway sections at the right side pose a potential trip hazard. We recommend corrective action to improve safety and reduce the risk of injury. A qualified contractor should assess the affected areas and perform necessary repairs to ensure a level walking surface. (See Photo 3)

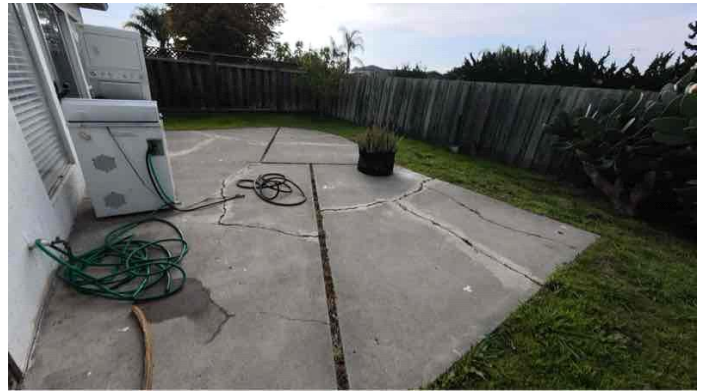
Photo 04

- ! 1. The patio surface has cracked, heaved, or uneven sections that create a potential trip hazard. We recommend addressing these conditions to improve safety and prevent potential injuries. (See Photo 4)

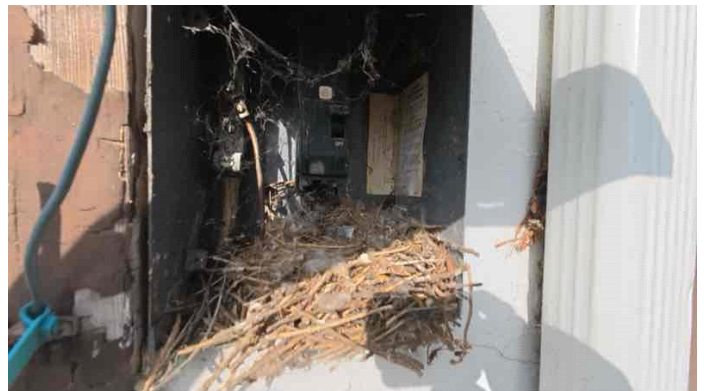
Photo 06

- ! 1. The main electric panel cover plate sometimes called the "Dead Front" is missing. It should be replaced. (See Illustration 4S) (See Photo 6)
2. The light at the hallway appears to flicker or malfunction when in operation. We recommend the services of a licensed electrician. (See Photo 26)
3. The main electrical panel was noted to have a birds nest inside. This is a potential safety issue. We recommend the services of the appropriate trades. (See Photo 6)
4. The water heater cold and hot water lines do not appear to be bonded to the gas lines. The local building department may presently require that the lines be bonded. We recommend consulting the local building authority regarding this condition.

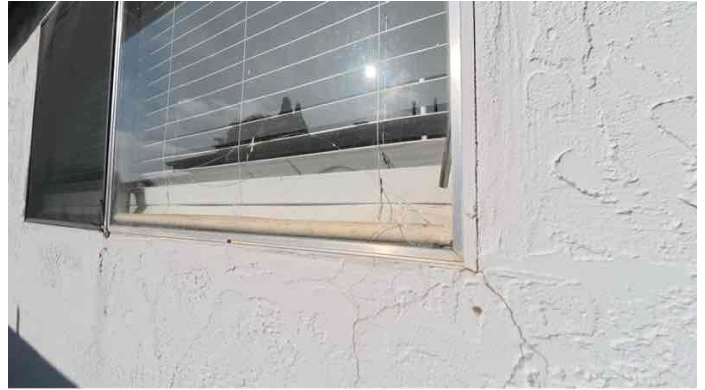
Photo 08

- ! 4. Cracked or broken exterior window glass at the left side should be replaced. (See Photo 8)
- ! 5. Water damage was noted at the rear door. We recommend the services of a licensed general contractor and/or structural pest control company regarding repairs. (See Photo 5)

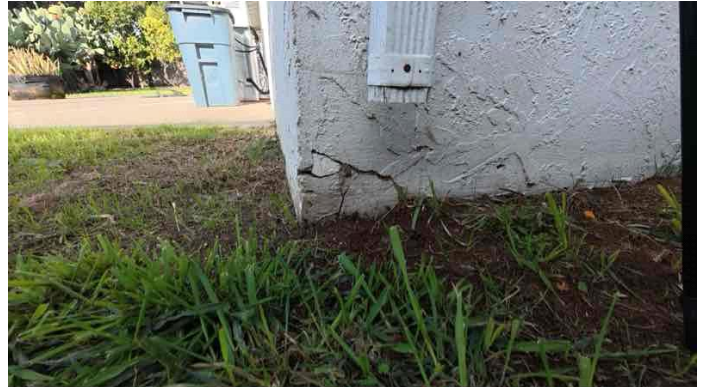
Photo 10

- ! 9. Localized damage and/or large stucco cracks at the rear corner should be further evaluated by the appropriate tradesperson to determine if any moisture intrusion has occurred and to repair the stucco in this area. (See Photo 10)

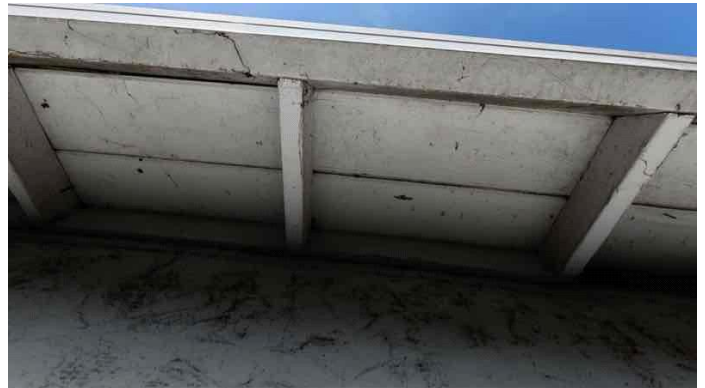
Photo 12

- ! 7. Water damage was observed to the roof eaves/sheathing at the left side. We recommend the services of a licensed general contractor and/or structural pest control company. (See Photo 12)

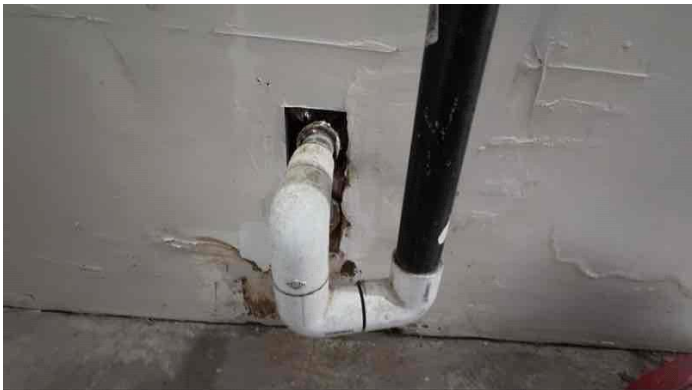
Photo 18

- ! 2. Damaged, open or missing wall and/or ceiling finishes of attached garages should be repaired and sealed where they abut the interior of a house. This reduces the potential of toxic automobile gases entering the house and serves as a fire break. Current standards require all walls/ceilings common to the finished living spaces be covered with 5/8" fire resistant sheetrock double taped at all seams. (See Illustration 3A) (See Photo 18)

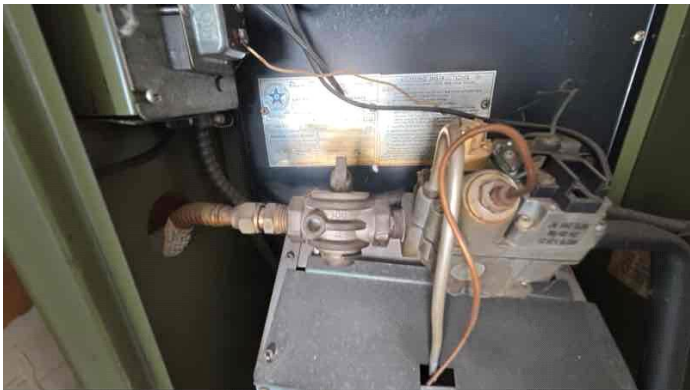
Photo 25

The heating systems energy source was shut off and the system was not operational at the time of our inspection. We cannot offer opinions about system performance or general state or repair. We recommend inspection by a licensed HVAC contractor when service has been restored. (See Photo 25)

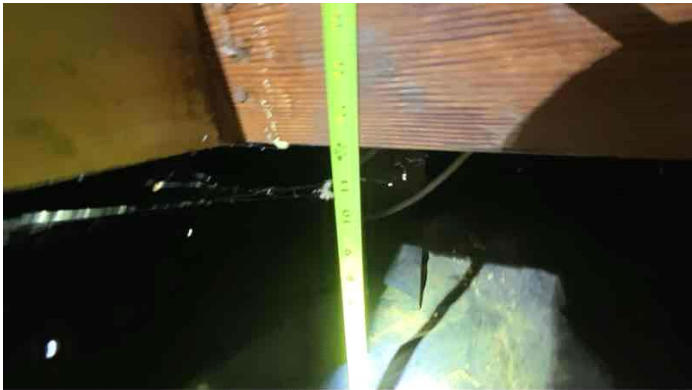
Photo 31

Due to the lack of clearance between the ground and ducting, plumbing, and/or floor joist/girders, portions of the crawl space were not inspected. With access and an opportunity for a complete inspection, conditions in need of attention may be discovered. We recommend further inspection when a minimum of 16 inches between the ground and any obstructions is provided. (See Photo 31)
