ANDERSON INSPECTIONS

Inspection Report

25482 Westborne Dr
Dana Point CA 92629

061126RA2

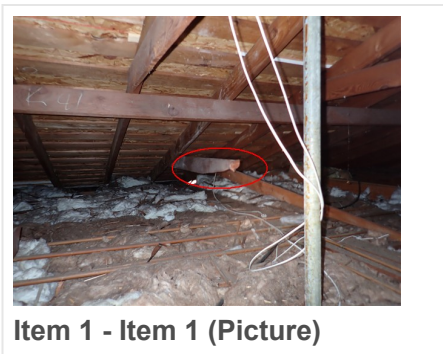
Item 1 - Item 1 (Picture)

There is a damaged rafter tie at of the attic. Rafter ties are important structural members that connect opposing paired rafters to help prevent the roof from sagging.

1. There is a damaged rafter tie at of the attic. Rafter ties are important structural members that connect opposing paired rafters to help prevent the roof from sagging.
- A qualified contractor should repair or replace the broken rafter tie.

- A qualified contractor should repair or replace the broken rafter tie.

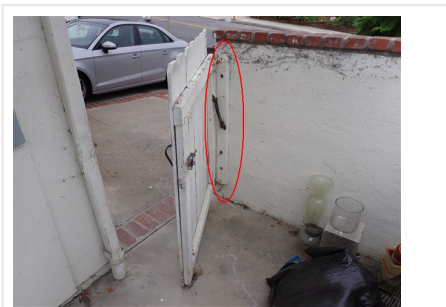
Item 4 - Item 1 (Picture)

(1) The gate at the front of the property is loose.
 - The gate should be repaired or replaced as needed.
-

4. (1) The gate at the front of the property is loose.
- The gate should be repaired or replaced as needed.

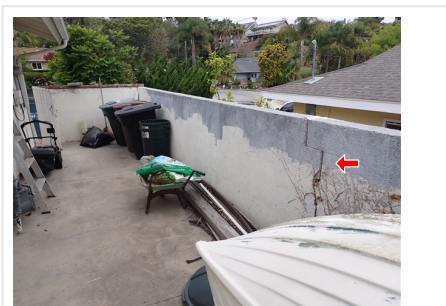
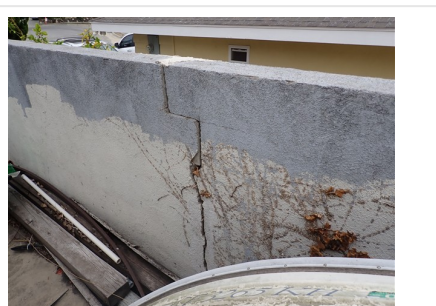
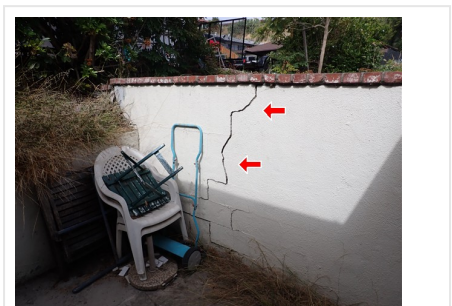
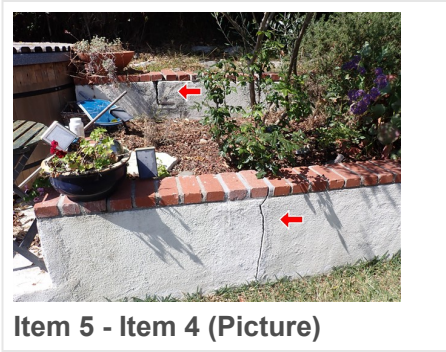
(2) Cracking and/or separations were present in the masonry garden fencing. This appears to be a result of movement in the supporting soils. An evaluation of the soil conditions is beyond the scope of this inspection. - The masonry fencing can be patched and repaired as part of typical maintenance. However, the cracks may reappear over time. If needed, further evaluation of these conditions by a qualified fencing and/or soils specialist is recommended.

5. (2) Cracking and/or separations were present in the masonry garden fencing. This appears to be a result of movement in the supporting soils. An evaluation of the soil conditions is beyond the scope of this inspection. -The masonry fencing can be patched and repaired as part of typical maintenance. However, the cracks may reappear over time. If needed, further evaluation of these conditions by a qualified fencing and/or soils specialist is recommended.

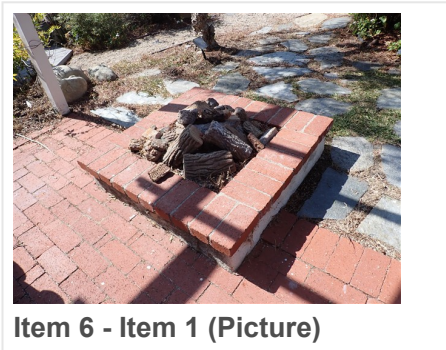
Item 6 - Item 1 (Picture)

The gas valve at the patio firepit was operational, however the gas was not lit. - We recommend having the seller demonstrate the operation of the firepit.

- The gas valve at the patio firepit was operational, however the gas was not lit. - We recommend having the seller demonstrate the operation of the firepit.

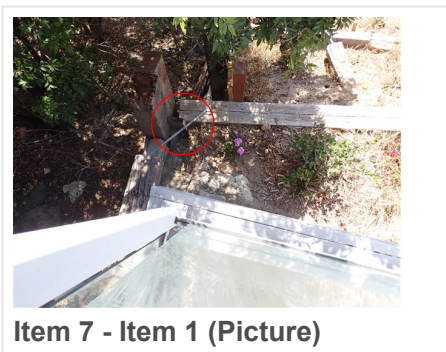
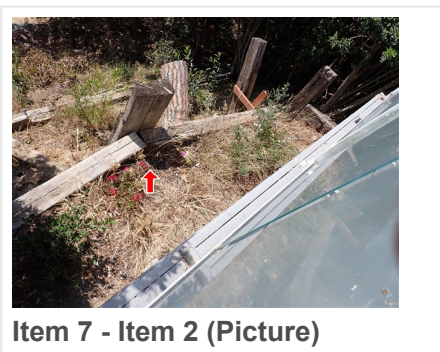
The wooden retaining wall is leaning and there are gaps at some connections. - Repairs should be made as needed to stabilize the wall.

- The wooden retaining wall is leaning and there are gaps at some connections. - Repairs should be made as needed to stabilize the wall.

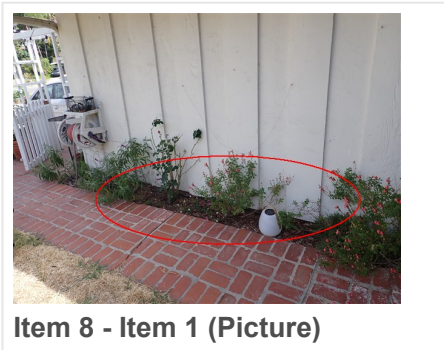
Item 8 - Item 1 (Picture)

- 🌊 (1) There is earth-to-wood contact on the right front side of the building. This condition promotes infestation by wood destroying organisms and deterioration.
 - All earth/wood contact should be eliminated and proper clearances to soil should be provided. Any damaged material discovered in the course of repairs should be removed and replaced.
 - 🌊 (2) Soil is at or above the weep screed at some locations. The weep screed is designed to allow the water absorbed by the stucco to drain at the base of the wall. When soil block the weep screed, this can promote water retention in the wall and potential damage.
 - We recommend adequate clearances be provided in accordance with current standards. The stucco areas should be monitored for any moisture related conditions and repaired or modified by a qualified technician if problems are noted.
-

8. (1) There is earth-to-wood contact on the right front side of the building. This condition promotes infestation by wood destroying organisms and deterioration.
- All earth/wood contact should be eliminated and proper clearances to soil should be provided. Any damaged material discovered in the course of repairs should be removed and replaced.

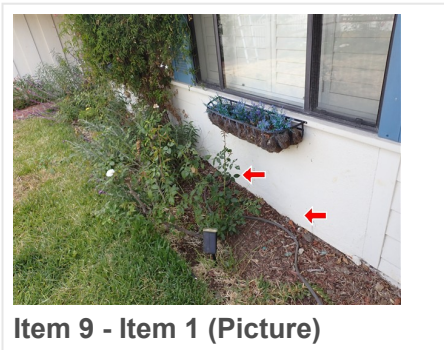
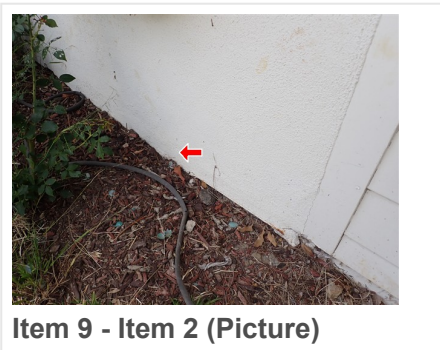
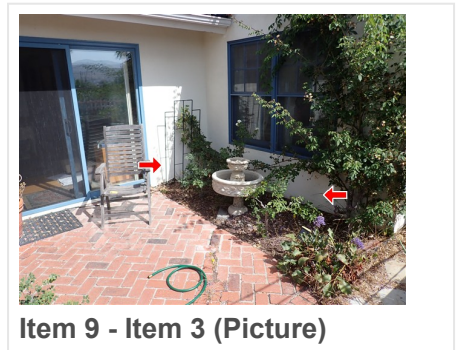
9. (2) Soil is at or above the weep screed at some locations. The weep screed is designed to allow the water absorbed by the stucco to drain at the base of the wall. When soil block the weep screed, this can promote water retention in the wall and potential damage.
- We recommend adequate clearances be provided in accordance with current standards. The stucco areas should be monitored for any moisture related conditions and repaired or modified by a qualified technician if problems are noted.

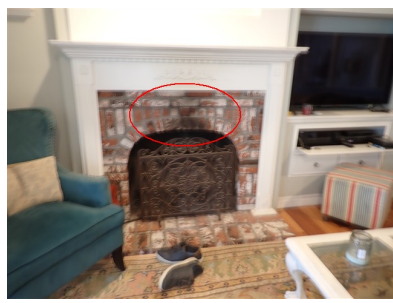
Item 11 - Item 1 (Picture)

🌊 (1) Smoke stains were present at the fireplace. This may be an indication of poor drafting of the chimney. - We recommend further review by a qualified fireplace specialist.

11. (1) Smoke stains were present at the fireplace. This may be an indication of poor drafting of the chimney. - We recommend further review by a qualified fireplace specialist.

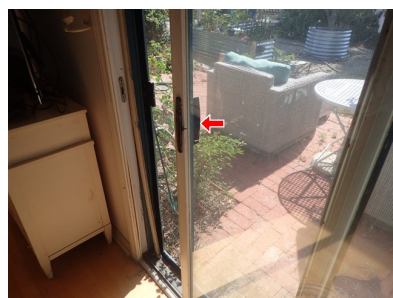
Item 12 - Item 1 (Picture)

12. (2) The exterior door at the rear patio does not latch properly. - The hardware on all non-latching doors should be repaired or replaced to restore full operation.

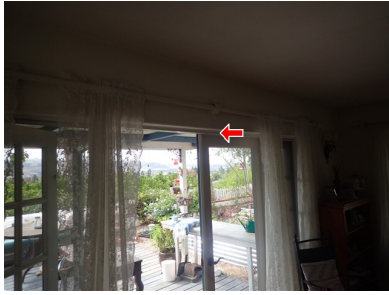
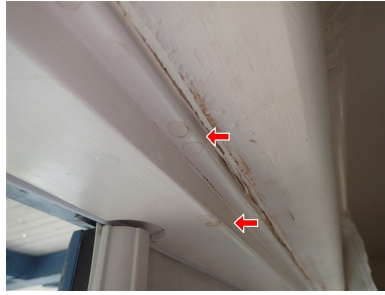
- + There is evidence of water intrusion at the living room exterior doors. - We recommend further review by a qualified specialist. Repairs should be made as needed to prevent any future water intrusion.

13. There is evidence of water intrusion at the living room exterior doors. - We recommend further review by a qualified specialist. Repairs should be made as needed to prevent any future water intrusion.

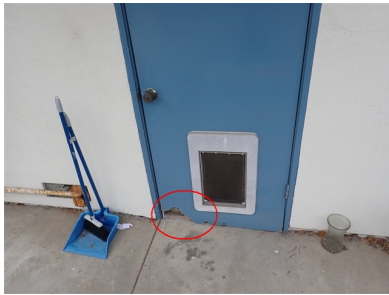
Item 14 - Item 1 (Picture)

14. (1) The garage service door is deteriorated/ damaged. - The deteriorated door should be repaired or replaced as necessary.

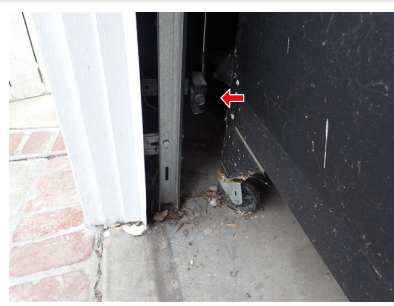
Item 15 - Item 1 (Picture)

15. The optical sensor for the garage door opener(s) (which activates the safety reverse system) was installed too high. This is a child safety concern. - The optical sensors should be installed no more than six inches above the floor of the garage or in accordance with the manufacturer's specifications.

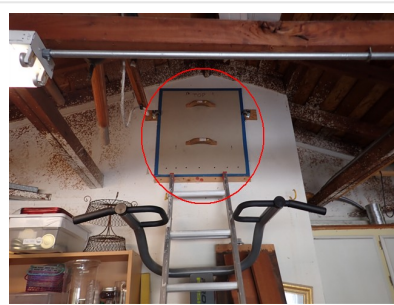
Item 16 - Item 1 (Picture)

- + The attic access in the garage is not a fire-rated assembly. In the event of a fire, this could lead to rapid spread of smoke and flames into the attic and the living space.
 - We recommend properly sealing the access with drywall or the installation of an approved fire rated access for fire safety.

16. The attic access in the garage is not a fire-rated assembly. In the event of a fire, this could lead to rapid spread of smoke and flames into the attic and the living space.
- We recommend properly sealing the access with drywall or the installation of an approved fire rated access for fire safety.

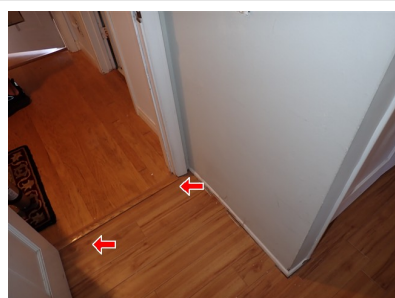
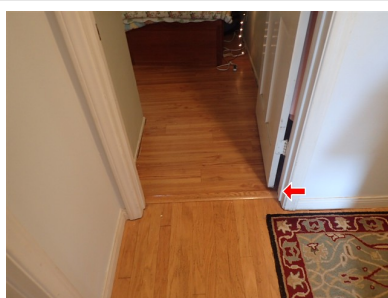
- 18. (1) A door threshold strip is loose. This creates a potential trip hazard. A qualified technician should make repairs or modifications as necessary.

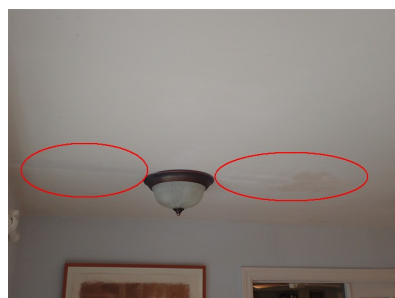
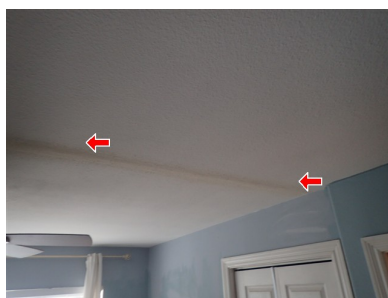
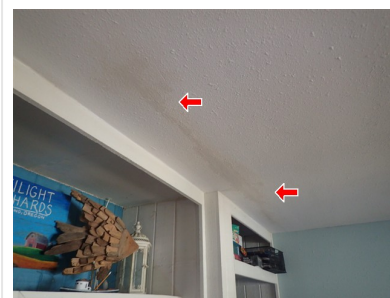
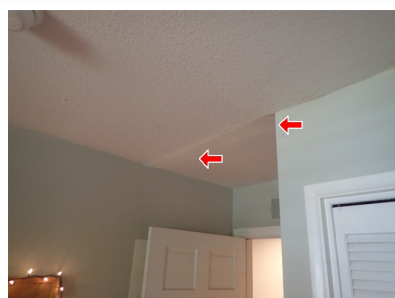
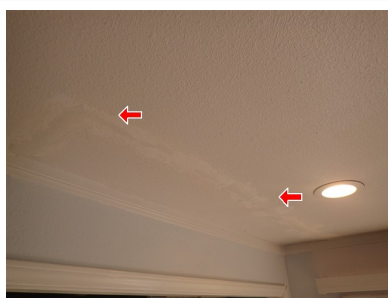
There is evidence of previous patching at various locations ceiling. The reason for the patching was not determined. - We recommend asking the seller for information about this condition.

- 20. There is evidence of previous patching at various locations ceiling. The reason for the patching was not determined. - We recommend asking the seller for information about this condition.

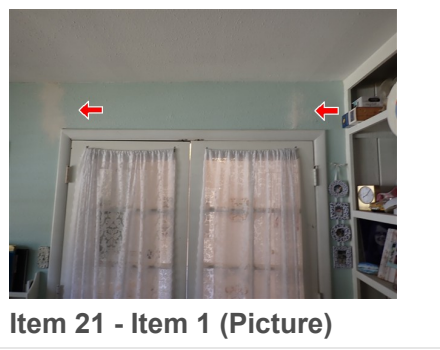
Item 21 - Item 1 (Picture)

There is evidence of previous patching and/or repairs to the finished wall surface at various locations. - Ask the seller the reason for the repairs. If necessary, have a qualified technician further evaluate this condition.

21. There is evidence of previous patching and/or repairs to the finished wall surface at various locations. - Ask the seller the reason for the repairs. If necessary, have a qualified technician further evaluate this condition.

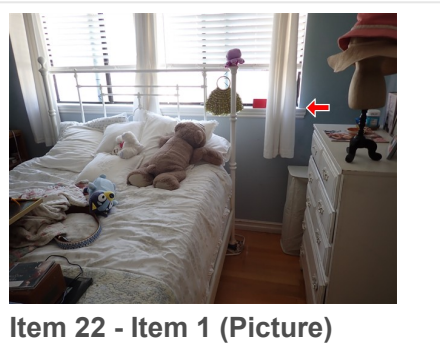
Item 22 - Item 1 (Picture)

One or more of the bedroom window sills are more than forty-four inches above the floor. This was likely allowed at the time of construction but no longer meets current standards for fire safety. - Although no upgrading is required, we recommend modifying the windows to meet present safety standards.

22. One or more of the bedroom window sills are more than forty-four inches above the floor. This was likely allowed at the time of construction but no longer meets current standards for fire safety. - Although no upgrading is required, we recommend modifying the windows to meet present safety standards.

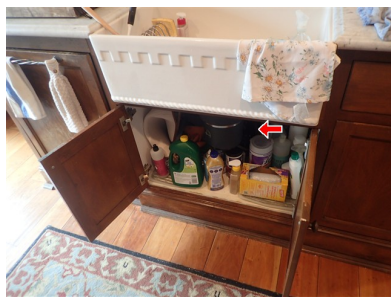
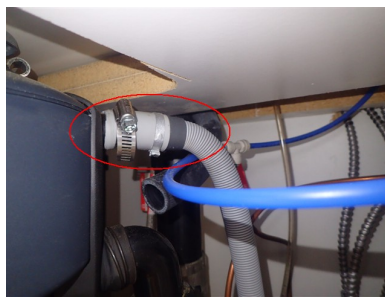
**The dishwasher drain has no air gap. This can allow dirty sink water (from a clogged sink) to siphon back into the dishwasher.**
- Consider having an air gap installed when the dishwasher is replaced, or when other plumbing work is done. In the meantime, the dishwasher drain hose should be secured as high as possible under the sink (in a "high loop" configuration), to prevent siphoning of the drain water back into the dishwasher.

24. The dishwasher drain has no air gap. This can allow dirty sink water (from a clogged sink) to siphon back into the dishwasher.
- Consider having an air gap installed when the dishwasher is replaced, or when other plumbing work is done. In

the meantime, the dishwasher drain hose should be secured as high as possible under the sink (in a "high loop" configuration), to prevent siphoning of the drain water back into the dishwasher.

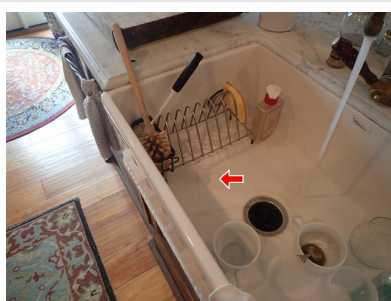
Item 25 - Item 1 (Picture)

**The kitchen sink is cracked, but not leaking. - Repairs should be made as needed.**

25. The kitchen sink is cracked, but not leaking. - Repairs should be made as needed.

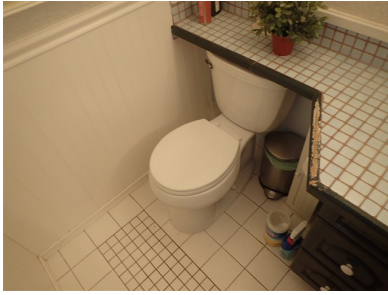
Item 27 - Item 1 (Picture)

**The Hall Bathroom toilet is not securely attached at the floor. This could allow leaks at the wax ring seal. No leaks were noted at the time of the inspection. - A qualified technician should secure the toilet as needed.**

27. The Hall Bathroom toilet is not securely attached at the floor. This could allow leaks at the wax ring seal. No leaks were noted at the time of the inspection. - A qualified technician should secure the toilet as needed.

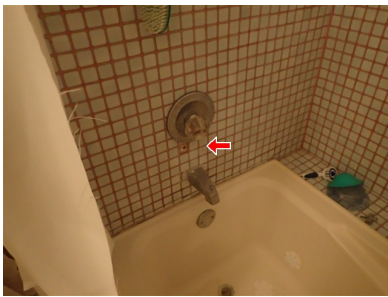
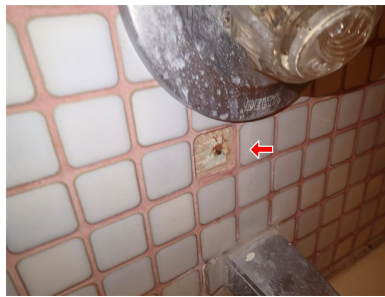
28. There are loose or missing tiles at the shower walls. - Have a qualified tile contractor make repairs as needed.

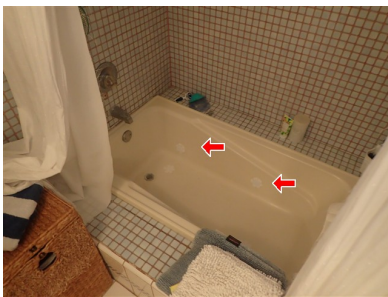
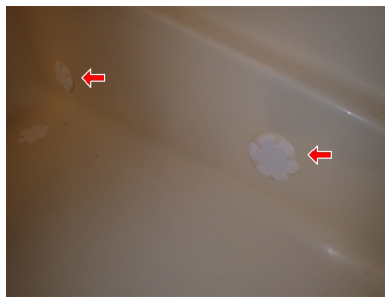
29. The hydrotherapy tub jets are sealed.
The hydrotherapy tub pump was not tested. - A qualified technician should make repairs as desired.

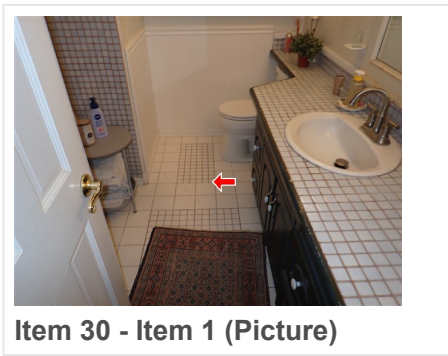
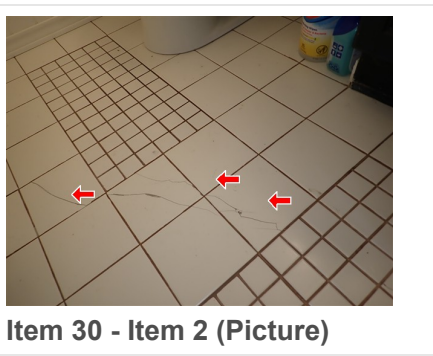
30. Some floor tiles were cracked in the Bathroom. - Repairs should be made as needed by a qualified flooring specialist.

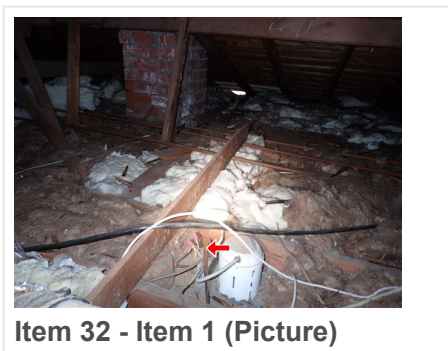
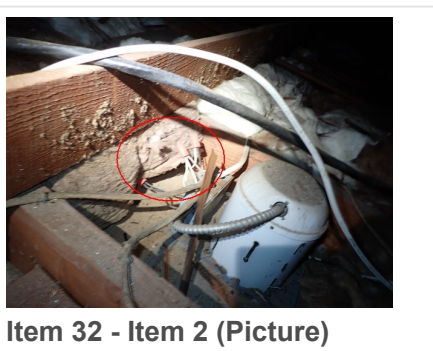
32. (1) There are open wire splices (wiring connections outside of a junction box) at the attic. Open splices can be a shock or fire hazard. - A qualified technician should properly enclose all wiring splices inside covered junction boxes.

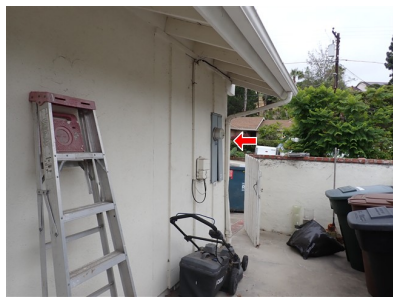
Item 33 - Item 1 (Picture)

33. Some circuits in the main service panel are labeled, some are not. We did not verify the accuracy of the labels.
- Each circuit should be identified and labeled by a qualified electrician for safe operation of the circuit breakers.

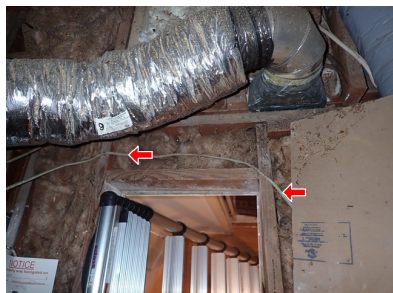
Item 34 - Item 1 (Picture)

34. (2) There is unsecured wiring exposed to physical damage near the attic access. No wiring should be within 6' of the access to prevent damage to the wiring. - A qualified technician should make repairs or modifications as necessary.

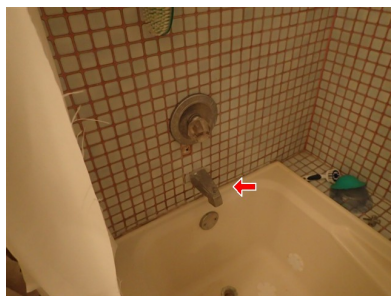
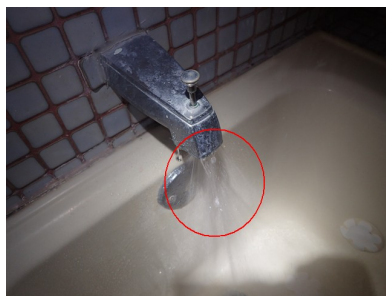
37. A shower diverter valve leaks. This is preventing the water from being completely diverted to the shower from the tub spout. - Repair of the diverter valve is usually not practical. We recommend replacing the tub spout for water conservation

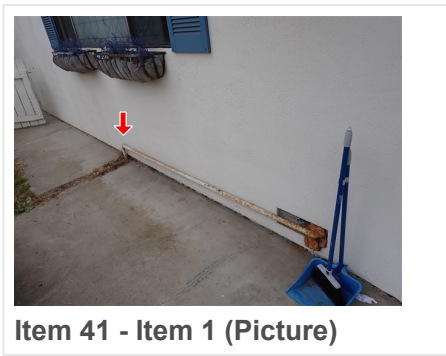
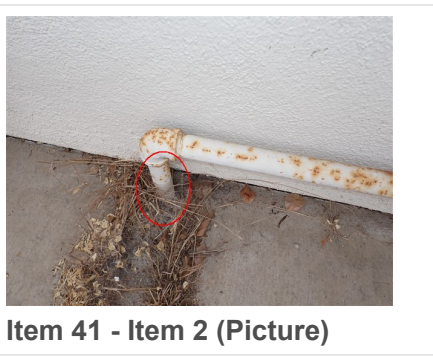
41. (1) The gas piping at the right side exterior was not verified to be approved for underground installation by current standards. The pipe is subject to corrosion and leakage if it is not the proper pipe.
- Consult a qualified plumbing contractor for evaluation of this condition and any required repairs.

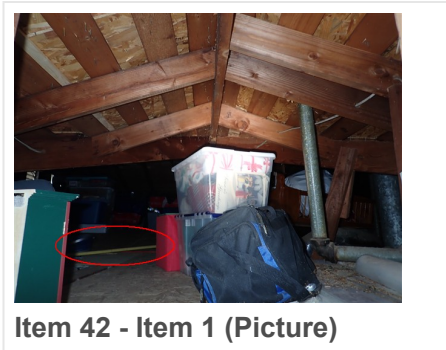
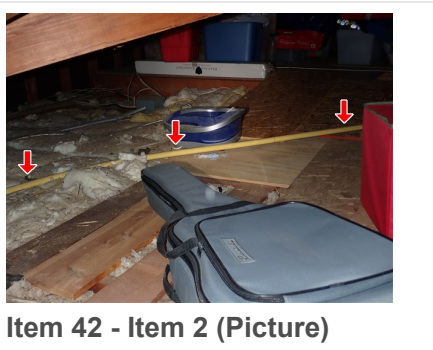
42. (2) There is CSST (Corrugated Stainless Steel) gas pipe located in the attic with no visible bonding. This type of gas piping is required (since 2009) to be bonded to prevent fires from happening when lightning strikes. Lightning strikes have resulted in ruptures of this type of gas piping, which then leads to fires. Proper bonding provides a path for the energy from a lightning strike to be dissipated to ground. - A qualified electrician should bond the gas pipe where needed. (See CSSTsafety.com for further information.)

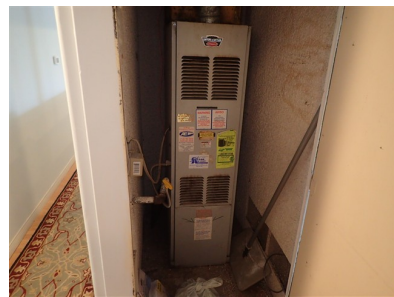
Item 45 - Item 1 (Picture)

45. The heating system failed to respond to normal operating controls.
- A qualified technician should evaluate the system and make repairs or modifications as necessary

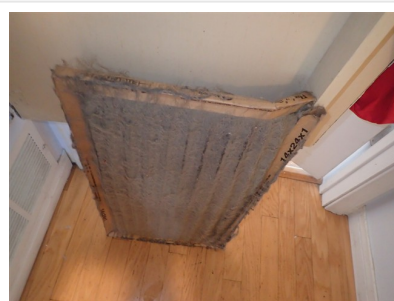
Item 46 - Item 1 (Picture)

46. (2) The filter(s) were dirty. This decreases the effectiveness of the filter and blocks airflow, making the blower work harder. -Replace (or clean washable) filters now, and at regular intervals thereafter.

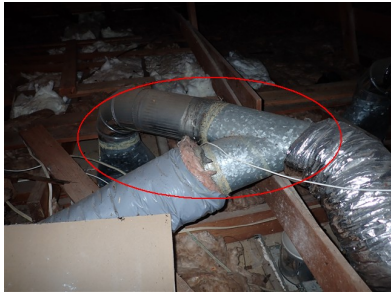
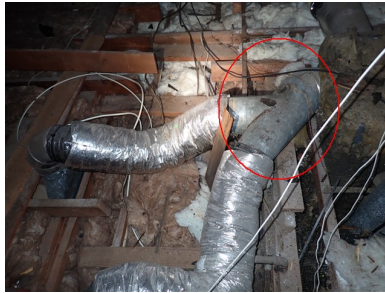
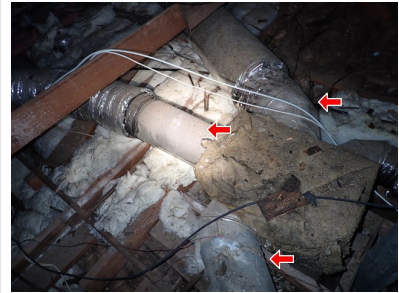
47. (1) There is no insulation on some of the duct connections. This is energy inefficient.
 - As an energy conservation upgrade, insulation should be installed to meet current industry standards.

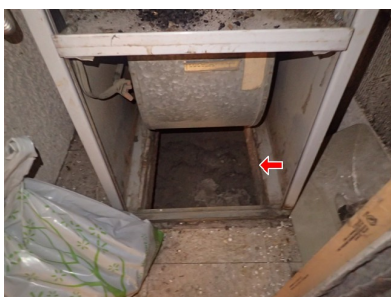
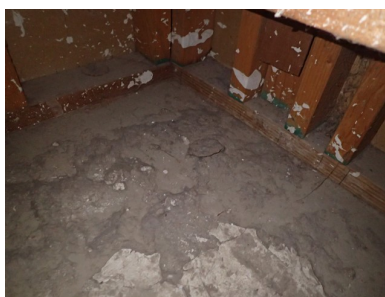
48. (3) Dust and debris have collected in the bottom of the return air plenum.
 - We recommend that these areas be thoroughly vacuumed for improved health safety.

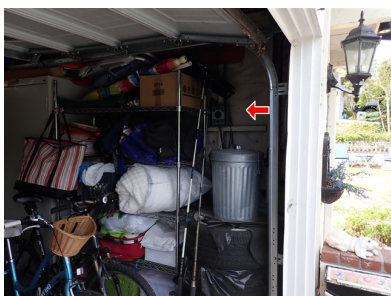
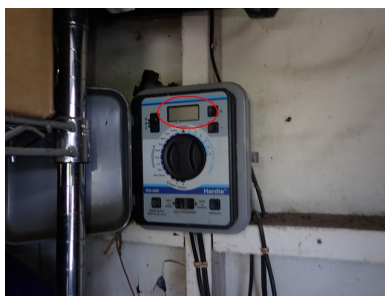
49. Operation and evaluation of irrigation (sprinkler) systems is outside of the scope of this inspection. However, it was noted the sprinkler timer was in the Off position or has been unplugged.
 - We suggest that you have the owner or a sprinkler technician demonstrate the irrigation system and any related equipment before closing.
