# Inspection Report

**Jeff Wall**  
1480 Madonna Road  
San Luis Obispo, CA 93405

Report Date: 6/15/2026

Customer File # 21379

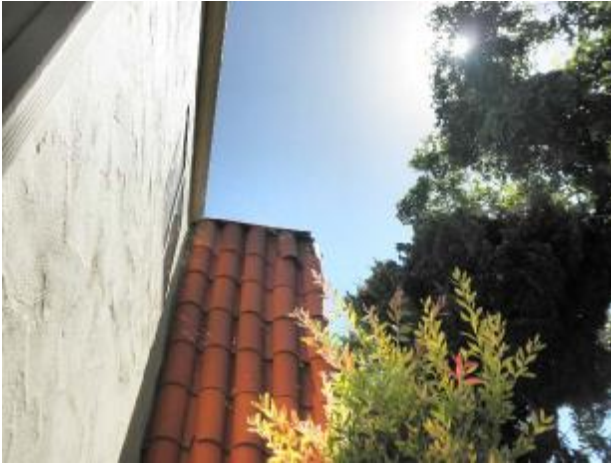
2.) There are some damaged/missing clay tiles at the SW corner of the roof.

Damaged clay tiles at the SW corner of the roof.

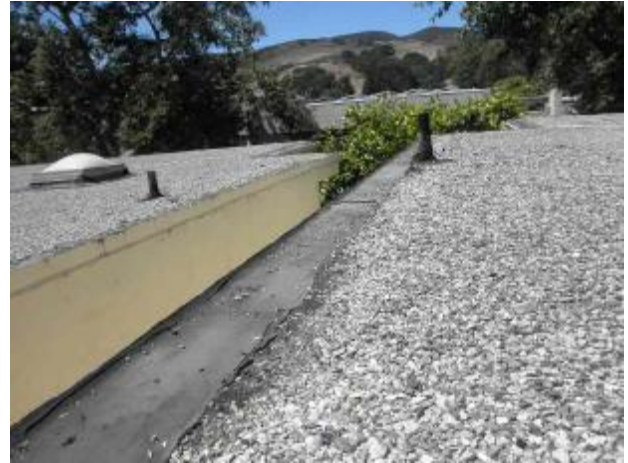
1.) The tar & gravel low slope roofing is deteriorated due to age. Multiple patches were observed along the perimeter edges of the roof. This portion of the roof appears to need complete replacement.

Patching along the perimeter of the tar & gravel roofing.

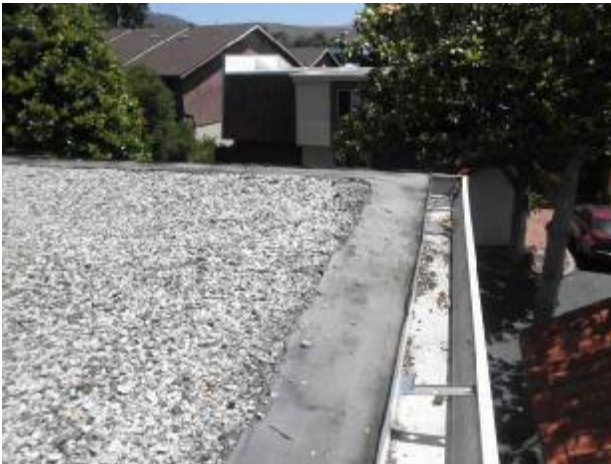
Patching along the perimeter of the tar & gravel roofing.

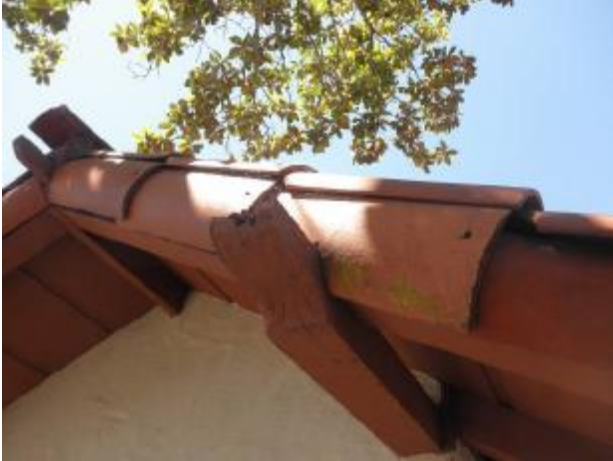
**Moisture damage to the barge rafter at the community laundry room.**

- 4.) There is moisture damage to the barge rafter at the NE corner of the community laundry.
- 5.) The lock set sticks at the front entry door to unit 3.
- 6.) The screen doors are missing at both of the sliding glass doors in unit 3.
- 7.) There is moisture damage to parts of the exterior wood siding and trim. Refer to the Pest Control Report for a full accounting of this damage.
- 8.) There are four damaged window screens.

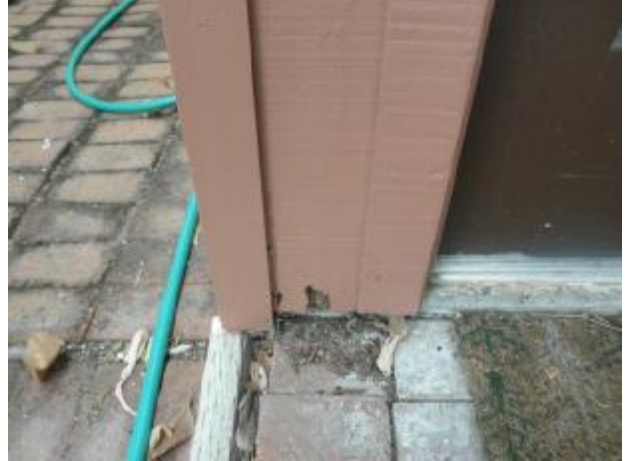
**Example of some of the moisture damage at the exterior of the building.**

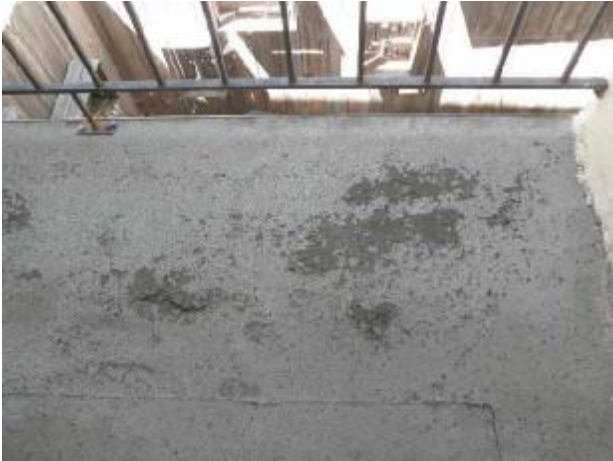
1.) The water proof decks at all four of the dwelling units are improperly installed with Modified Bitumen roofing material and not a proper water proofing material. Additionally, there is no visible flashing at the interface with the exterior stucco walls which may result in leaks. All of the water proof decks are recommended to be evaluated by a qualified and licensed tradesman that specializes in water proof deck construction prior to close of escrow.

**Example of wrong material for water proof decks and no flashings installed.**

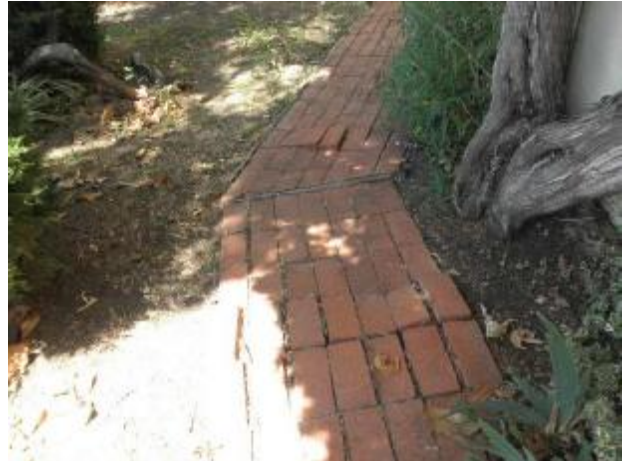
**Safety Hazard Note: There are uplifted and dislodged bricks at the walkways in the breezeway, the backyard in unit 3 and the south lawn area. This has created multiple tripping hazards.**

**Uplifted and dislodged bricks at the walkway in the south lawn.**

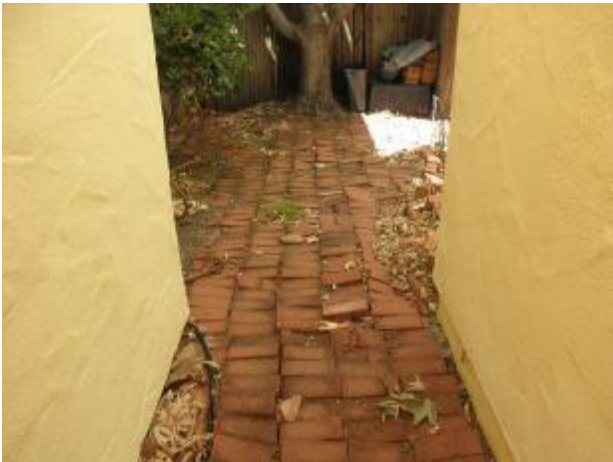
**Uplifted and dislodged bricks at the walkway in the breezeway.**

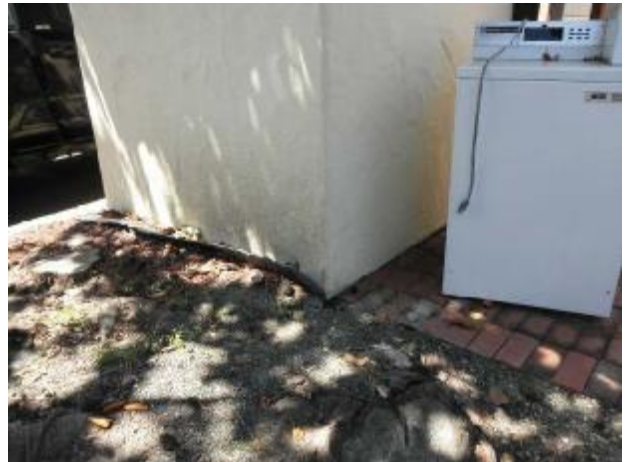
**Drainage Note: There is a faulty grade at the east wall of the community laundry room. (This is where the soil elevation against the exterior wall is higher than the elevation of the interior slab.) This can be a moisture intrusion condition. Recommend corrective grading as needed.**

**Faulty grade along the east wall of the community laundry building.**

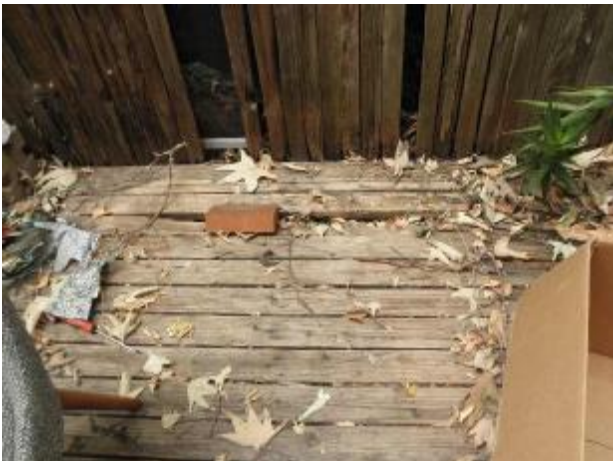
**2.) There is general moisture damage to the wood decks in the backyards at all four dwelling units.**

**Example of the moisture damage at the wood decks.**

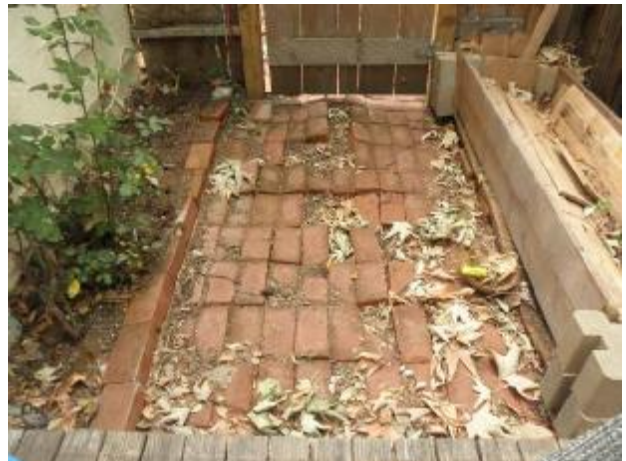
**Uplifted and dislodged bricks at the walkway in the backyard at unit 3.**

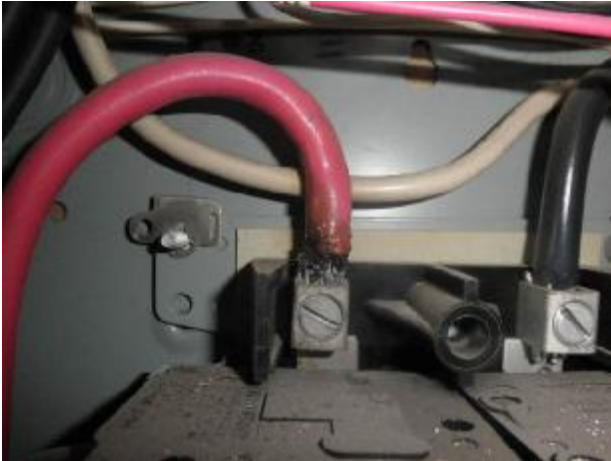
**Fire Safety Hazard:** There is scorching at the electrical wires at the main lug inside the subpanel in unit 1.

Scorched/melted wire at the at the electrical subpanel in unit 1.

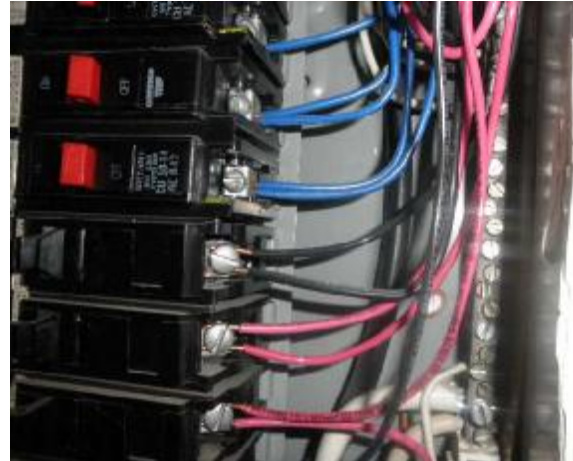
**Fire Safety Hazard Note:** There is double tapping in the electrical subpanels in all four units and at the subpanel in the community laundry room. (This is where two conductors are connected to a single circuit breaker.) This is advised to be corrected by a qualified and licensed Electrical Contractor.

Example of double tapping in the electrical subpanels.

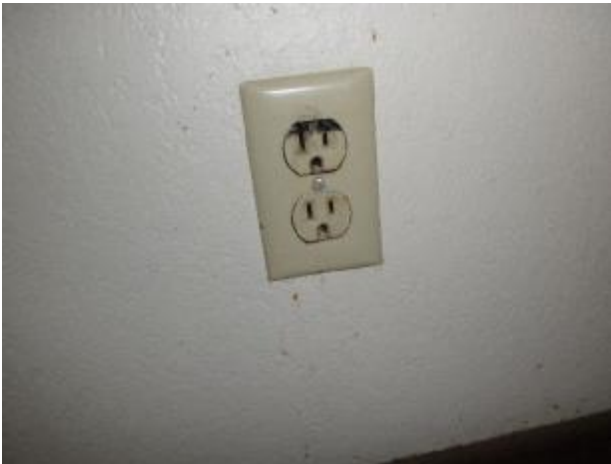
**Fire Safety Hazard Note:** There is a scorched outlet in the west bedroom in unit 3.

Scorched outlet in the bedroom in unit 3.

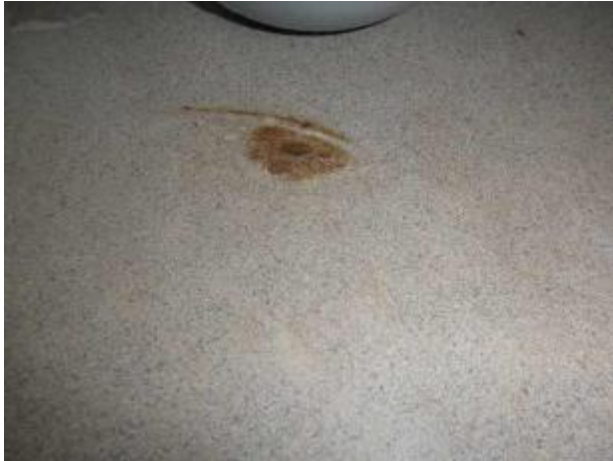
**Burn mark in the kitchen counter in unit 4.**

1.) There are burn marks on the counter to the left of the range in unit 4.

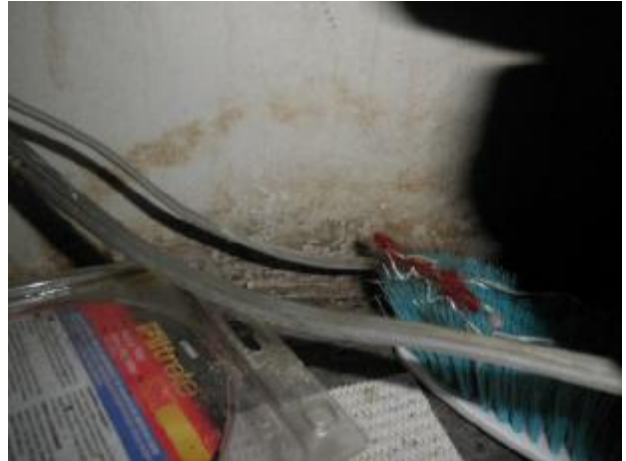
**Black mildew like substance on the drywall below the kitchen sink in unit 3.**

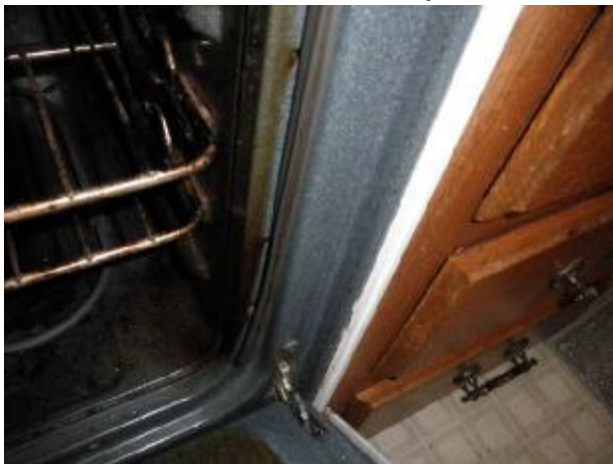
**Damaged door gasket at the oven in unit 3.**

2.) The gasket is damaged at the oven door in unit 3.

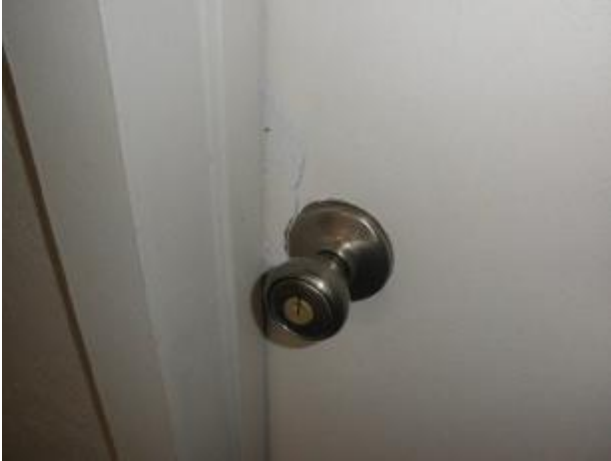
**Damage to the center bedroom door in unit 4.**

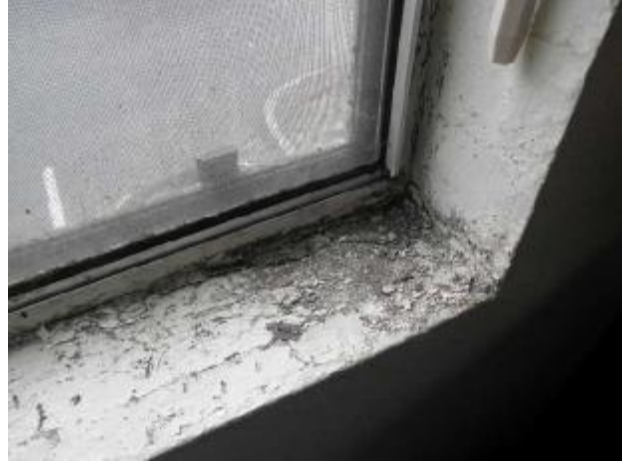
**Moisture damage to the window sills in the bedrooms in unit 3.**
