# Inspection Report

8975 Alcosta Blvd

San Ramon CA 94583

20250826-8975-Alcosta-Blvd

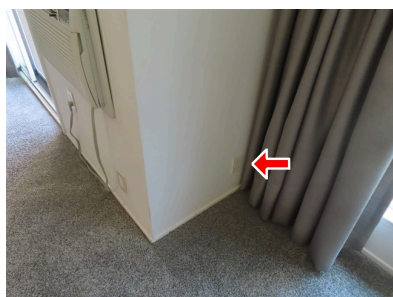
**3.5 Item 1(Picture)**  
dining room

One outlet is dead (not functional). Consulting with a licensed electrician for further evaluation and repair is recommended.

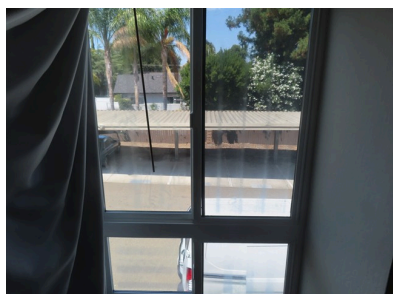
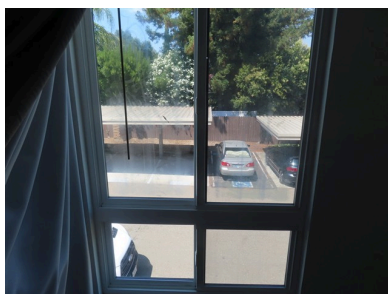
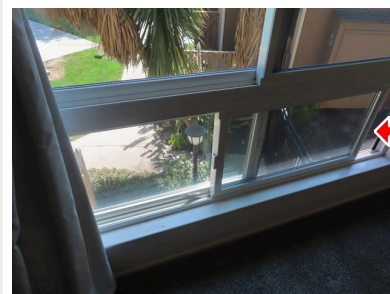
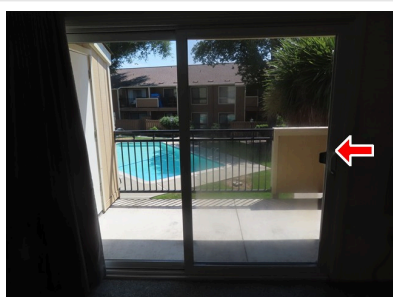
Some windows have discoloration and/or evidence of fogging between the dual panes. Consulting with a window installation professional for further evaluation of all windows and replacement of the affected panes is recommended.

**6.5 Item 1(Picture)**  
bedroom 1

**6.5 Item 2(Picture)**  
bedroom 2

**6.5 Item 3(Picture)**  
dining room

**6.5 Item 4(Picture)**  
slider door

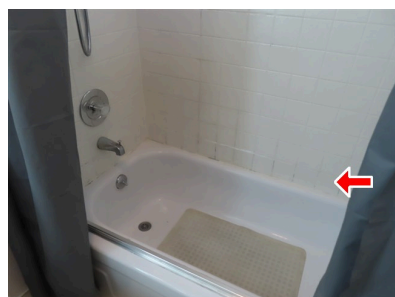
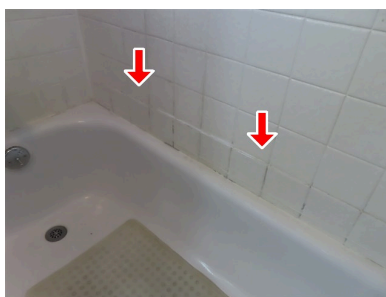
There are loose bathroom tiles. This may indicate moisture penetration behind the tiles. Consulting with a tile installation professional for further evaluation and repair is recommended.

**6.7 Item 1(Picture)**  
hall bathroom

**6.7 Item 2(Picture)**  
hall bathroom

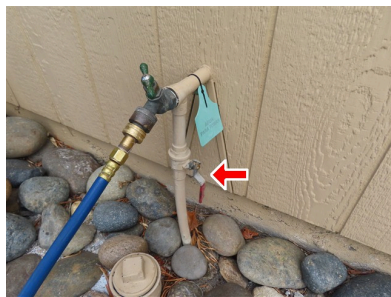
**1.0 Item 1(Picture)**  
lower front of building

Included is a photo of a main water shut-off valve.

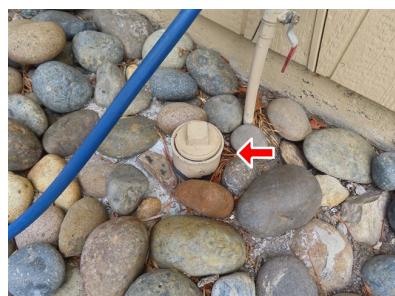
**1.1 Item 1(Picture)**  
lower front of building

Included is a photo of a sewer clean-out. Consulting with a plumbing professional for an invasive, video camera inspection of the sewer piping to insure proper slope, structure, and flow is recommended. This procedure is not included under the scope of this inspection.

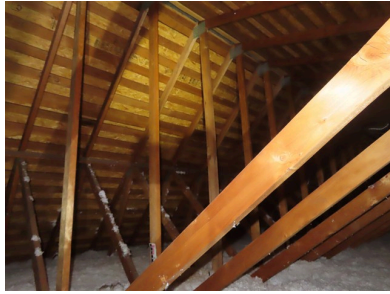
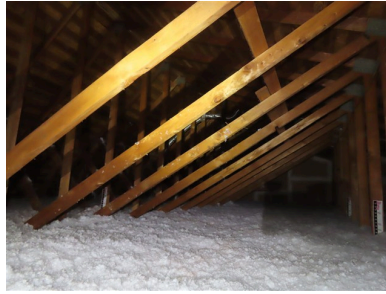
The attic entrance is located at the exterior entry ceiling. Included are general photos inside the visible attic areas. FYI

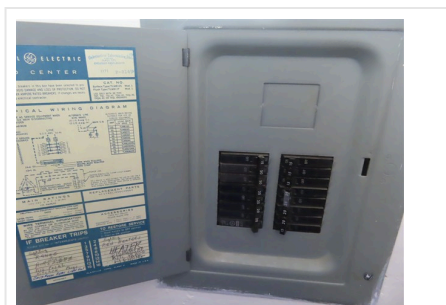
**3.1 Item 1(Picture)**  
entry closet

Subpanel photo(s)

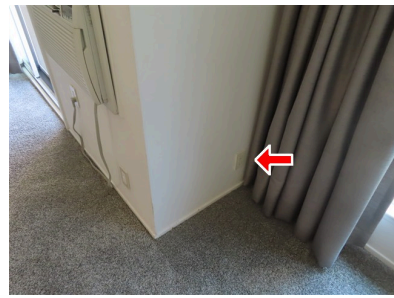
3.5 Item 1(Picture)  
dining room

One outlet is dead (not functional). Consulting with a licensed electrician for further evaluation and repair is recommended.

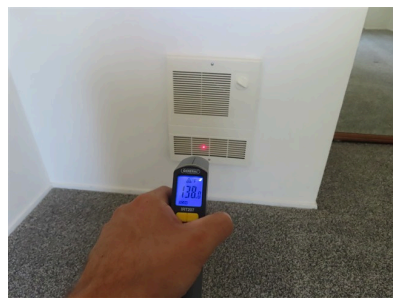
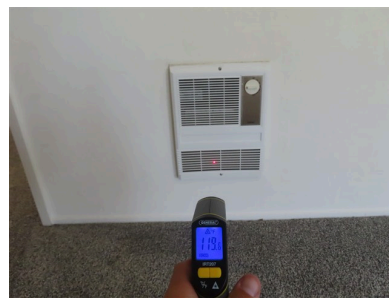
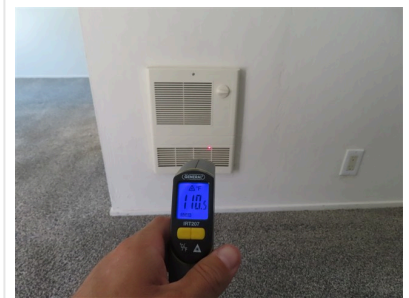
The heating system appeared to function properly. Regular professional service of the heating system is recommended as a safety precaution.

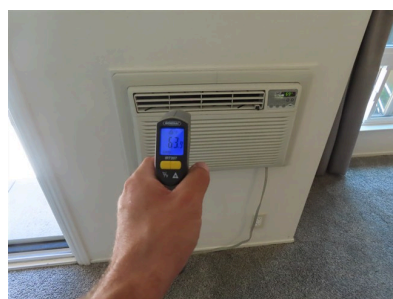
**5.1 Item 1(Picture)**  
living room

The AC system appeared to function properly. Air produced at the registers dropped at least 15 degrees relative to ambient air when operating in the cooling mode.

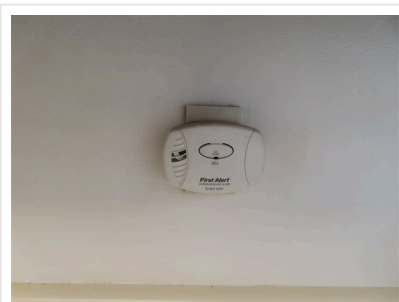
6.1 Item 1(Picture)

A Carbon Monoxide detector is installed. SAFETY NOTE: CO detectors should be inspected, tested, and replaced according to the manufacturer's instructions.

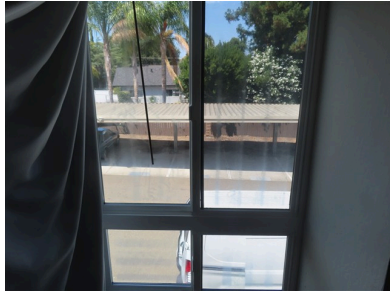
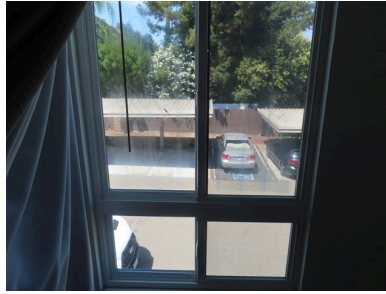
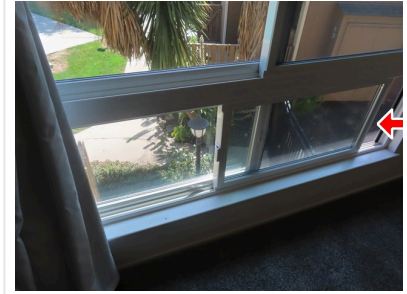
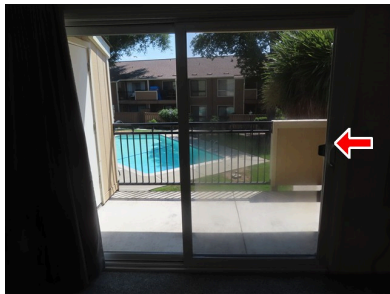
Some windows have discoloration and/or evidence of fogging between the dual panes. Consulting with a

window installation professional for further evaluation of all windows and replacement of the affected panes is recommended.

6.5 Item 1(Picture)  
bedroom 1

6.5 Item 2(Picture)  
bedroom 2

6.5 Item 3(Picture)  
dining room

6.5 Item 4(Picture)  
slider door

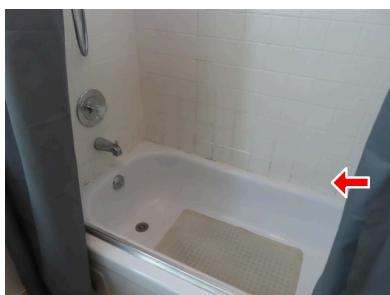
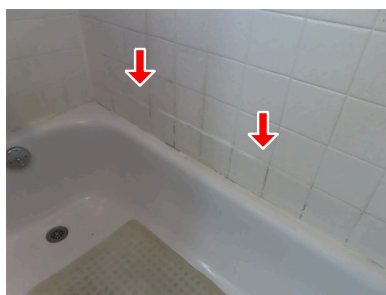
There are loose bathroom tiles. This may indicate moisture penetration behind the tiles. Consulting with a tile installation professional for further evaluation and repair is recommended.

6.7 Item 1(Picture)  
hall bathroom

6.7 Item 2(Picture)  
hall bathroom
