## WOOD DESTROYING PESTS AND ORGANISMS INSPECTION REPORT

Building Address: <b>2310 Poinsettia St., Santa Ana, CA 92706</b>		Date of Inspection 06/12/2026	Number of Pages 6
<h1 style="margin: 0;">BUGMASTERS</h1> <p style="margin: 0;">Termite Control Services since 1974!</p>		<b>350 E. Orangethorpe #8</b> Placentia, CA 92870 Office: 800-982-2131 www.bugmasters.com	
		Report # W56479	
		Lic. Registration # PR 0894	
Escrow #			
Ordered by: Seven Gables Real Estate Phil Schaefer 12651 Newport Ave Tustin, CA 92867	Property Owner and/or Party of Interest: Seven Gables Real Estate Phil Schaefer 12651 Newport Ave Tustin, CA 92867	Report Sent to: Seven Gables Real Estate Phil Schaefer 12651 Newport Ave Tustin, CA 92867	
COMPLETE REPORT <input checked="" type="checkbox"/> LIMITED REPORT <input type="checkbox"/> SUPPLEMENTAL REPORT <input type="checkbox"/> REINSPECTION REPORT <input type="checkbox"/>			
General Description: Single story stucco/wood siding single family residence with a detached garage		Inspection Tag Posted:    Sub Area

Address 2310 Poinsettia St., Santa Ana, CA 92706

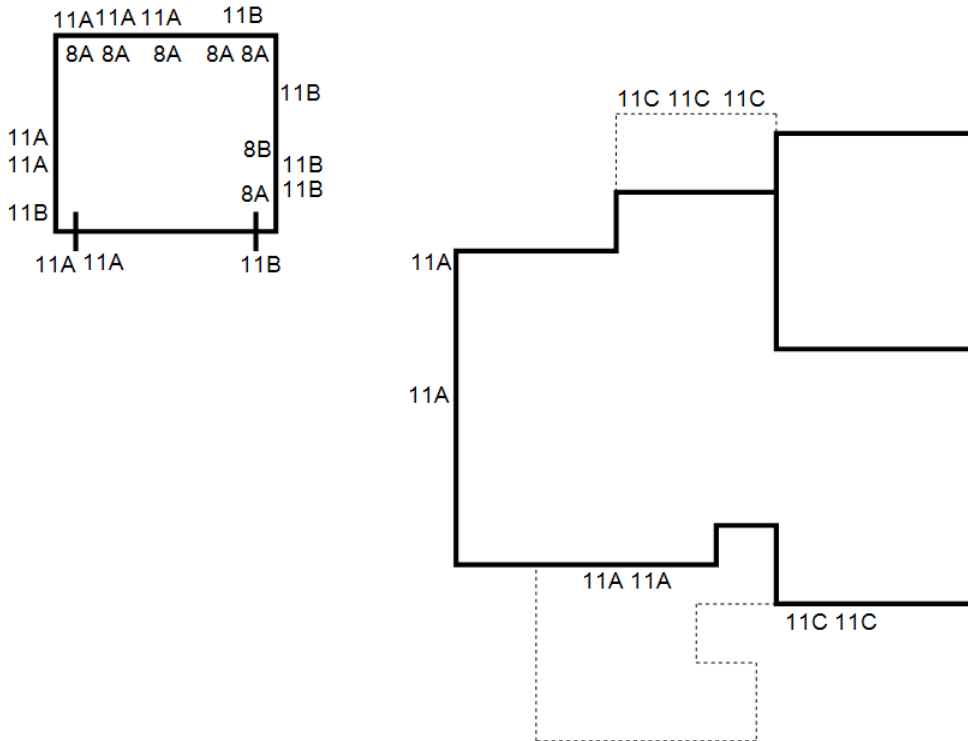
This Diagram is not to scale

- 8A PRICE: \$1,287.00 (Section I)  
 FINDINGS: Evidence of drywood termite infestation noted at time of inspection.  
 RECOMMENDATION: Chemically treat visible and accessible infestations. Remove or cover accessible pellets.

- 8B PRICE: \$300.00 (Section I)  
 FINDINGS: Evidence of subterranean termite infestation noted at time of inspection.  
 RECOMMENDATION: Pressure "ROD" treat, trench application or low pressure spot spray as necessary. Break accessible sub tubes. Note: Bugmasters is not responsible for damage to hidden plumbing under concrete slab floors and/or damage to tile or linoleum during drilling.

- 11A PRICE: See 8A (Section I)  
 FINDINGS: Evidence of drywood termite infestation noted at time of inspection.  
 RECOMMENDATION: Chemically treat visible and accessible infestations. Remove or cover accessible pellets.

11B PRICE: \$670.00 (Section I)  
FINDINGS: Evidence of termite damaged wood members noted at time of inspection.  
RECOMMENDATION: Repair or replace termite damaged wood members as required. Bugmasters is not responsible for any damage to roofing materials that may occur during repairs made to roof members.

11C PRICE: \$230.00 (Section I)  
FINDINGS: Wood Fungus condition visible noted at time of inspection.

RECOMMENDATION: Scrape and remove fungus condition, chemically treat with wood preservative, and fill with a hard wood filler
