**HaslerHomes Inc. DBA**  
**National Property Inspections**

**Ed & Jennifer Gildea, 335 W Avenida De Las Flores, Thousand Oaks, CA, 91360**

Inspection Date:  
06/23/2026

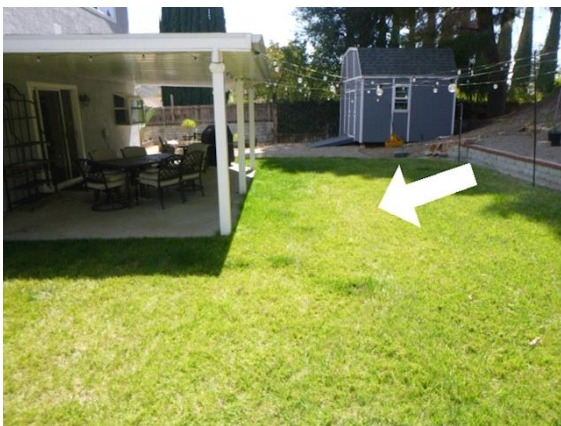
Grading / Drainage:

Negative slope noted at the rear of the home. May cause drainage problems/water intrusion during rainfall.

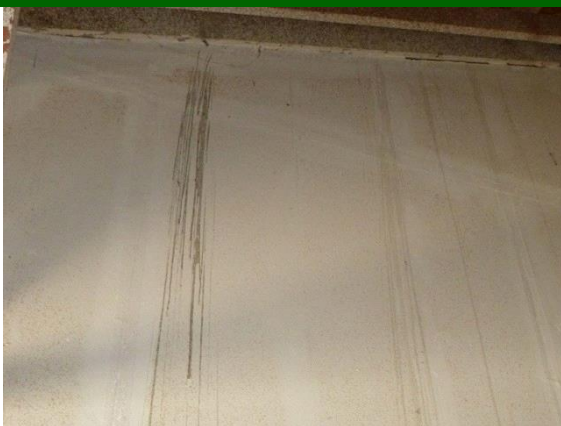
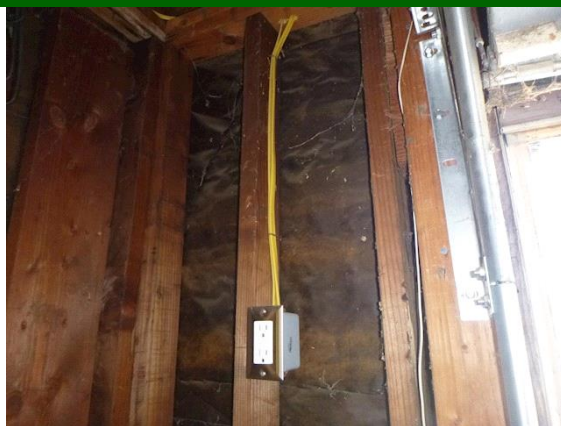
Garage/Carport:

1. Wall stains noted.
2. All electrical circuits are required to be encased within conduit or be installed behind wall board.  
We recommend repair by a qualified electrician.

1. Wall stains noted.
  2. All electrical circuits are required to be encased within conduit or be installed behind wall board.
- We recommend repair by a qualified electrician.

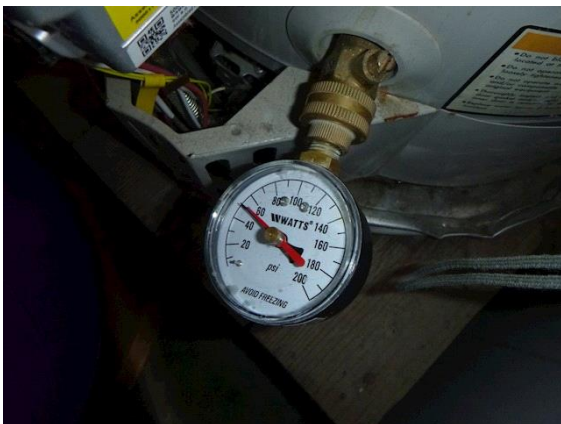
Plumbing:

Water pressure tested at 50 PSI (pounds per square inch). Readings of 40-80 PSI are considered normal.

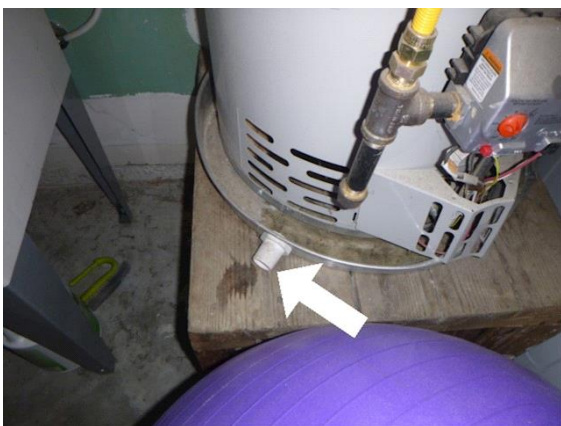
Water Heater:

The water heater catch basin is required to terminate the dwellings' exterior or to a waste pipe. We recommend repair by a qualified plumbing contractor.

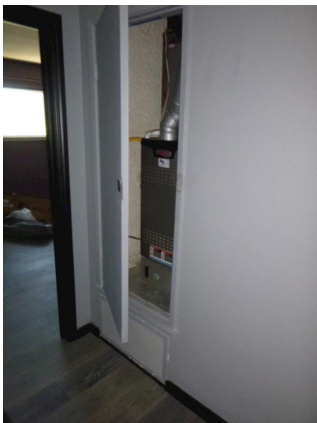
Heating:

1. The furnace operates as designed reaching a 39 degree temperature increase within 15 minutes of operation.
2. The furnace closet door is required to properly latch and make a complete seal to prevent fumes of combustion from mixing with recirculating air.

Heat Exchanger - Unable to detect cracks/holes without dismantling unit.

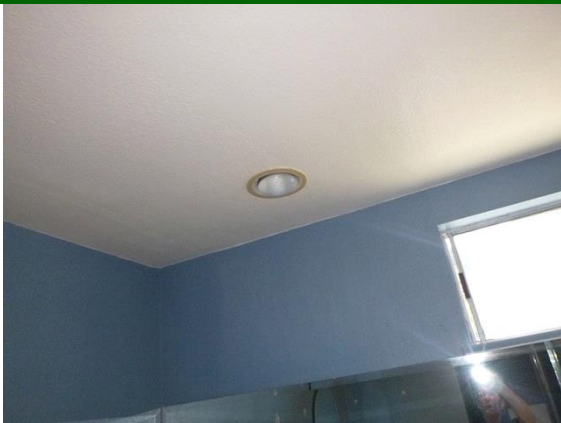
2nd Floor Bathroom:

We recommend repair by a qualified electrician.
