June 8, 2026
SGI# 2102145

Subject: Limited Geologic Investigation and Opinion Summary, Distressed Retaining Wall, 3661 North Sunswept Drive, APN 2376-003-005, Studio City, City of Los Angeles, California

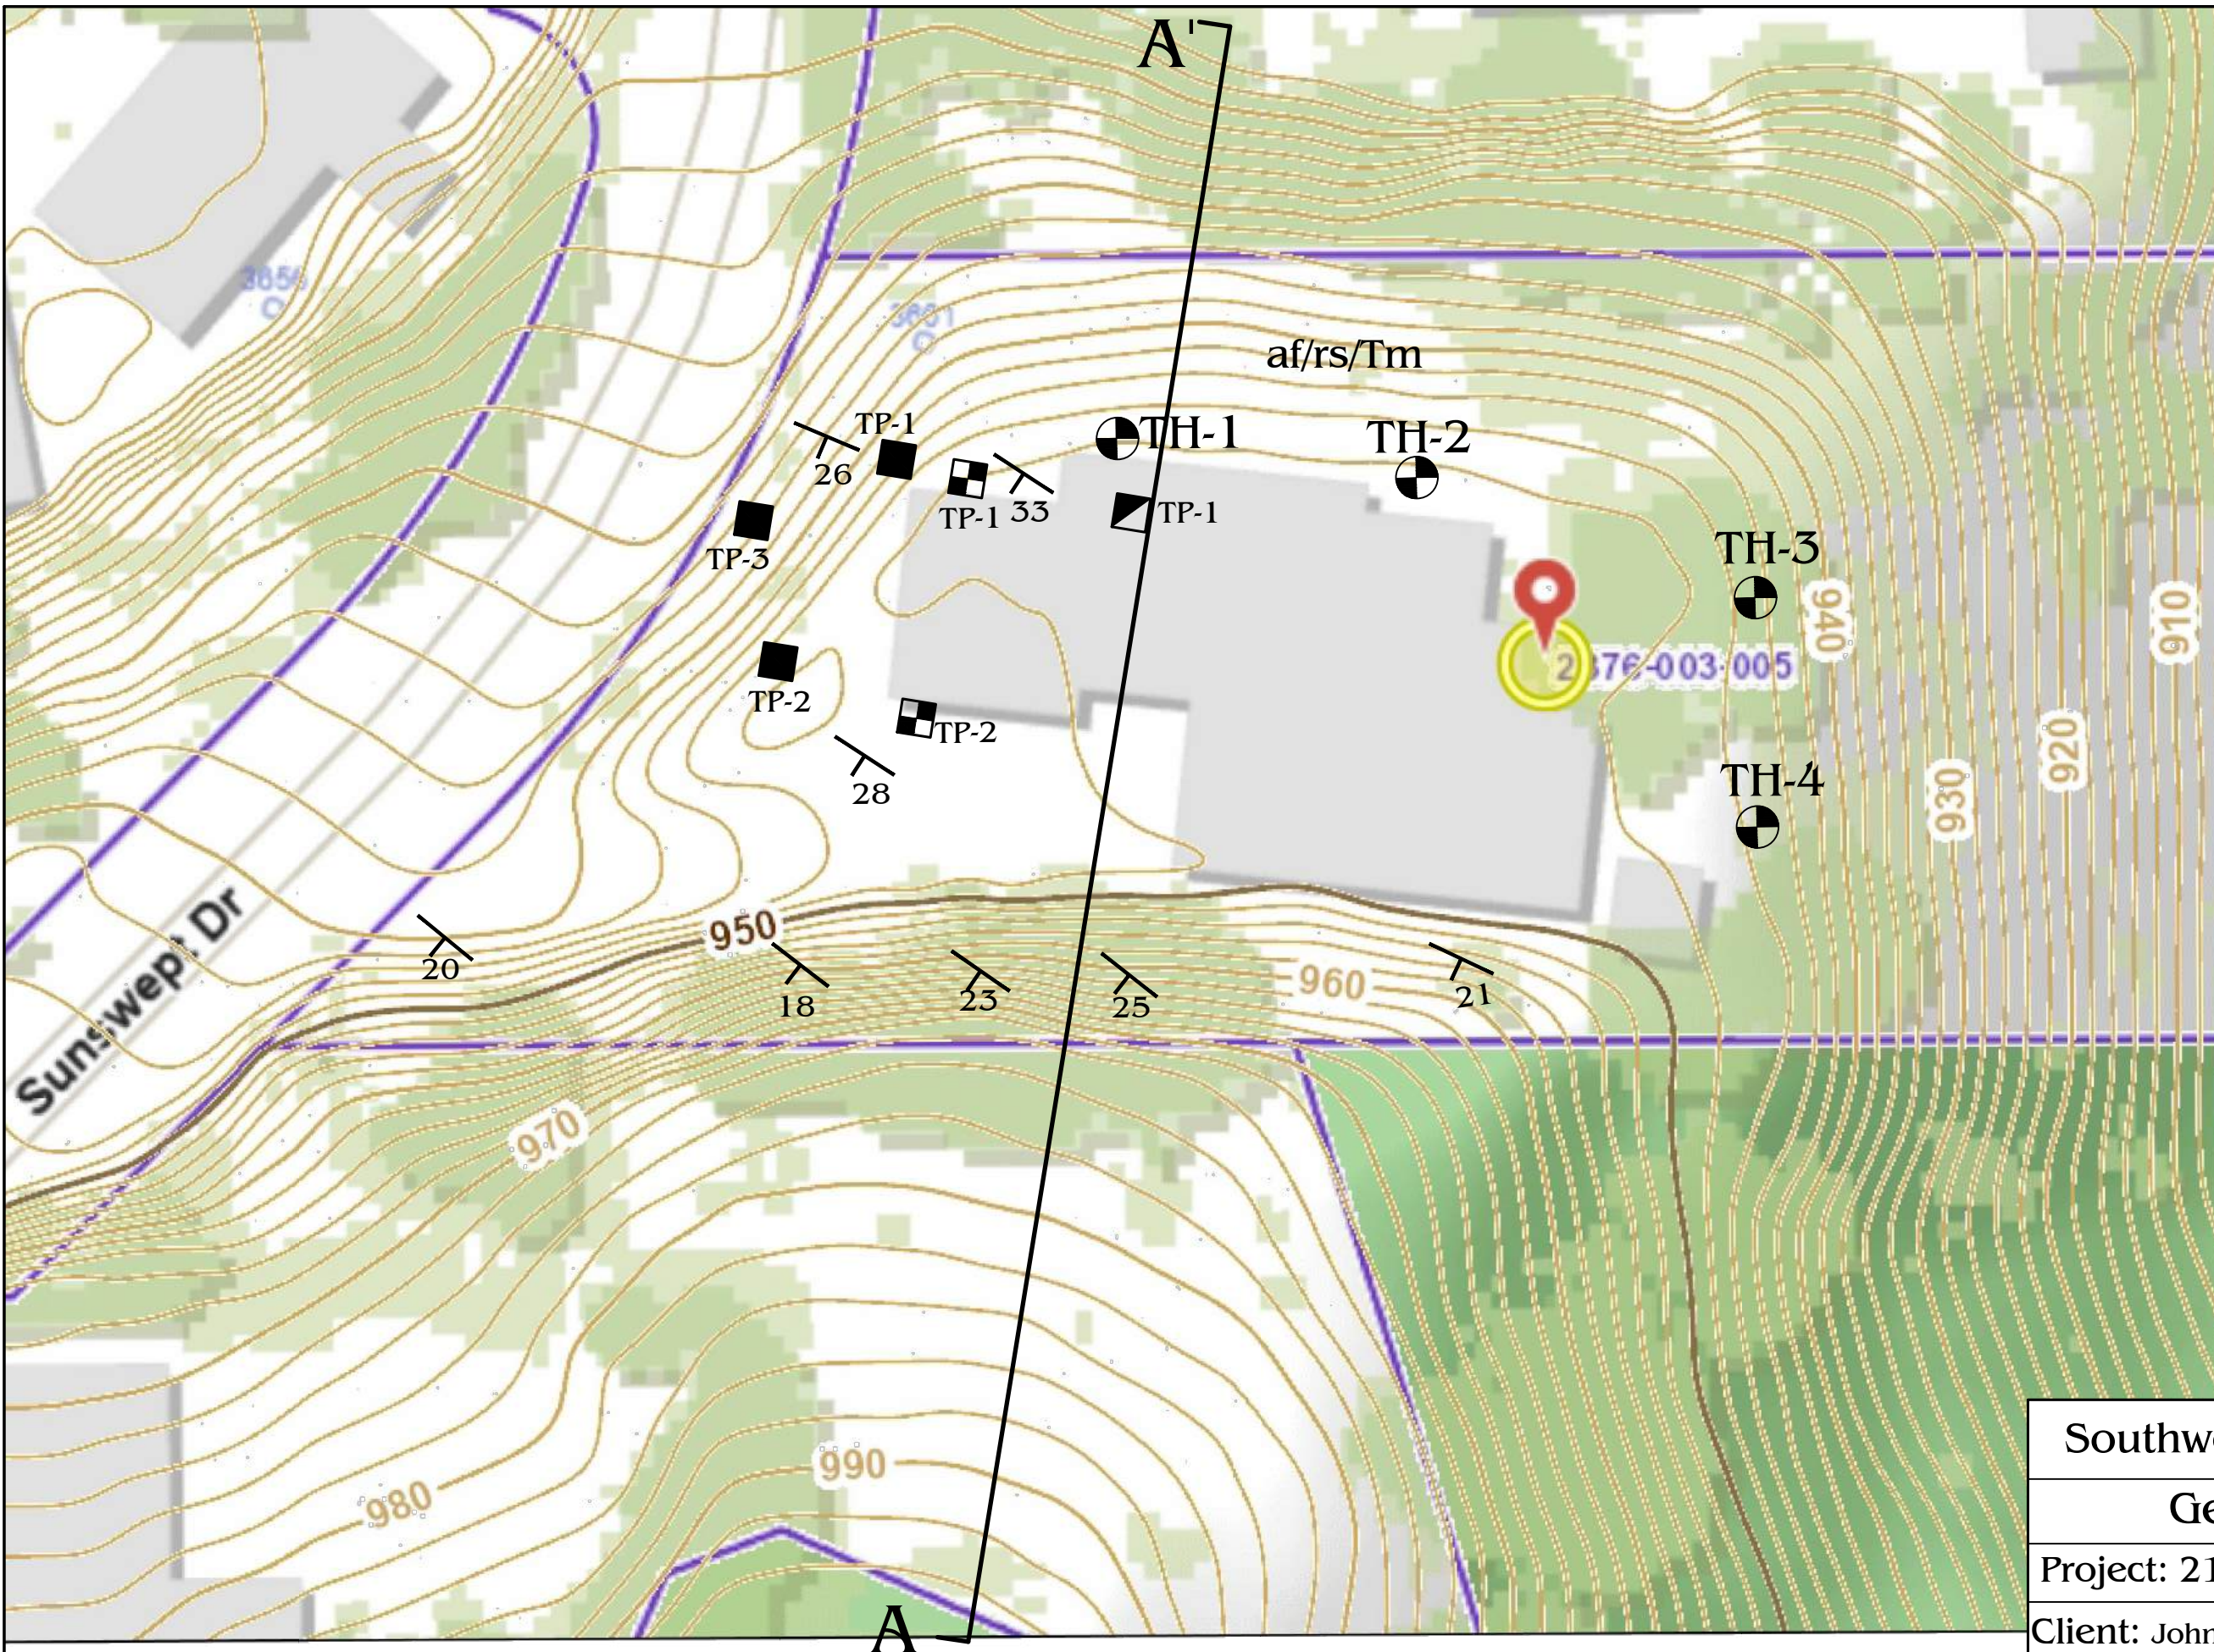
Southwest Geotechnical, Inc.	
Geotechnical Map	
Project: 2102145	Scale: 1"=20'
Client: Johnson-Minnix	Date: 6/2026
Site: 3661 Sunswept Drive

Bedding measurements were taken on the outcrops and within the test holes and have been shown on the attached Geotechnical Map by SGI. The bedding exhibits a northwesterly strike and southwesterly dip. This orientation is deemed to be favorable to overall site stability. The test holes exposed artificial fill over natural soil underlain by siltstone, sandstone and shale bedrock. They attribute the distress to the garage as being caused by the Northridge earthquake but also due to creep and settlement, and that expansive soils may also be influencing the site.

Bedding plane measurements taken by SGI and by other geotechnical professionals discussed in the Research section of this Report, indicate that bedding has a northwesterly strike and southwesterly dip of approximately 18-35 degrees. This bedding plane orientation is favorable with respect to overall stability of the site.

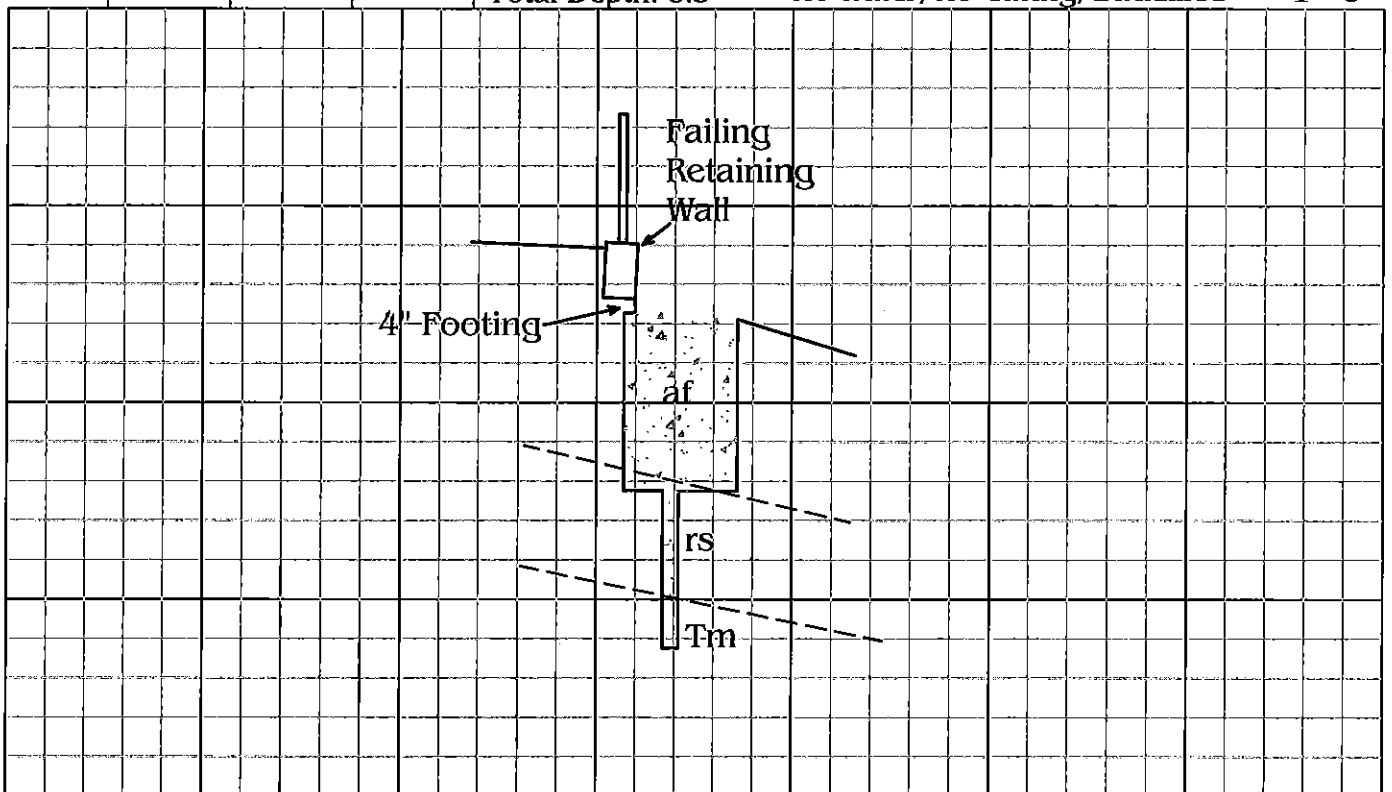
Test Hole TH-2

Sample Depth	Dry Density (pcf)	Insitu Moisture (%)	USCS
			<p>0'-4' Artificial Fill (af): 0'-2': Very loose fill, brown with yellowish brown mottling, bedrock fragments, highly porous, some construction debris. 2'-4': Silty clay, dark brown with tan to yellowish brown mottling, moderately stiff, slightly moist, bedrock fragments.</p> <p>4.0'-6.5' Residual Soil (rs): Silty clay with some sand, dark brown with common tan bedrock fragments, stiff, slightly moist.</p> <p>6.5'-8' Monterey Formation Bedrock (Tm): Siltstone and shale, yellowish brown, weathered in upper 8"-12".</p>

Total Depth: 5' No Water, No Caving, Backfilled 1"=5'

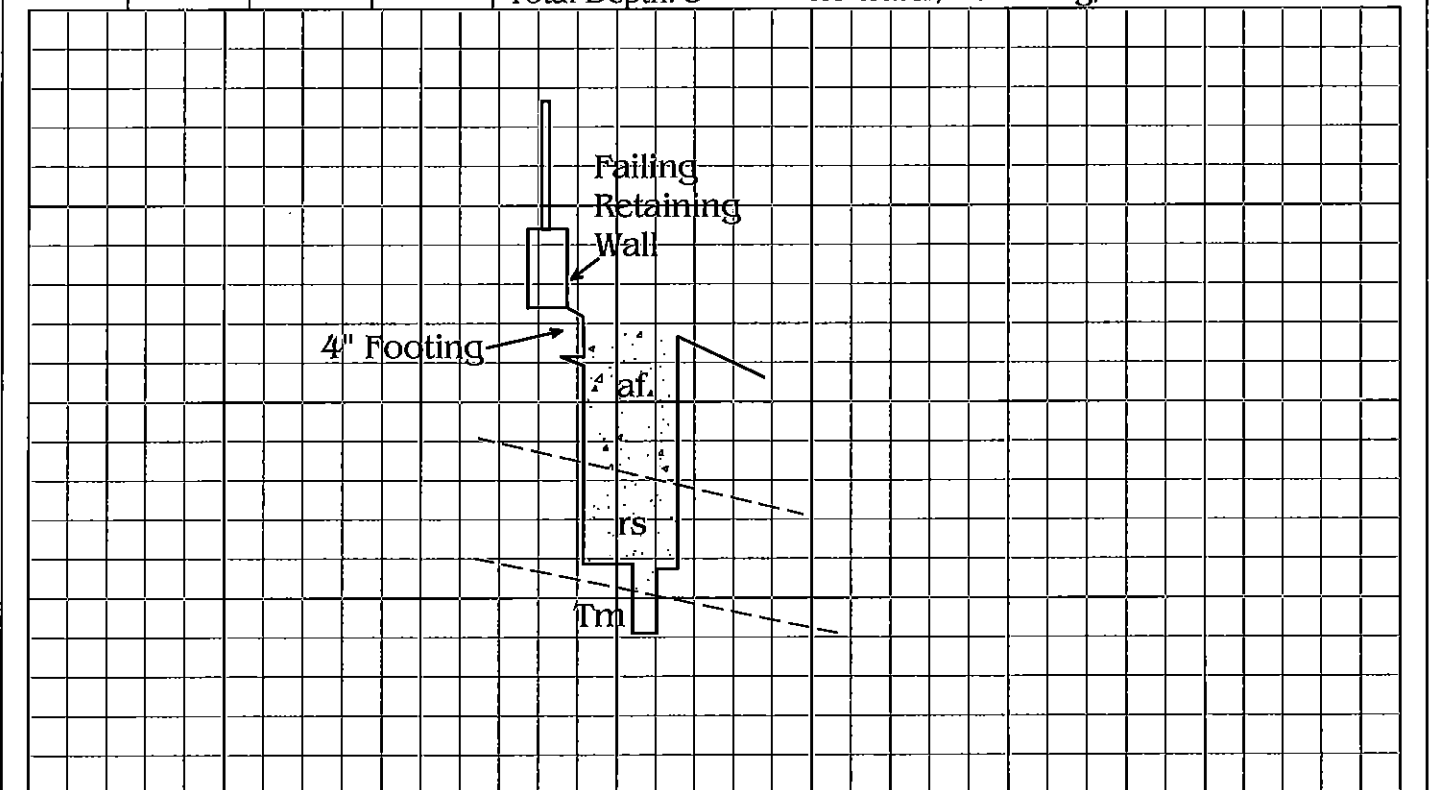
Test Hole TH-4

Sample Depth	Dry Density (pcf)	Insitu Moisture (%)	USCS
			<p>0'-4.5' Artificial Fill (af): Clayey silt to silty clay with some sand, angular bedrock fragments, light brown to brown.</p> <p>4.5'-8.5' Residual Soil (rs): silty clay to clayey silt with some sand and common angular bedrock fragments, brown to dark brown with tan mottling, dense, slightly moist.</p>

Total Depth: 8.5' No Water, No Caving, Backfilled 1"=5'

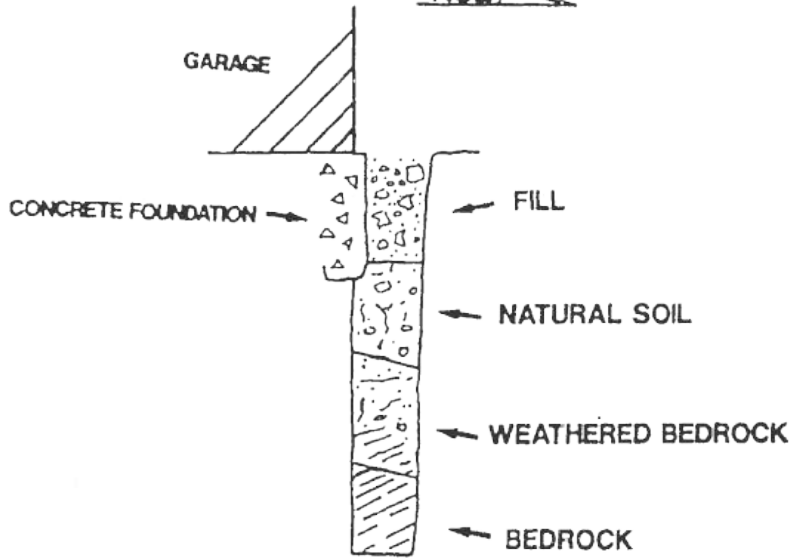
LOG OF TEST PIT 1

Depth (ft)	Description
0 - 3	Fill: Brown clayey silt, relatively dry, loose, abundant rock fragments, scattered roots.
3 - 6	Natural Soil: Dark brown clayey silt, porous, abundant roots, scattered rock fragments.
6 - 11	Bedrock: Light brown siltstone, upper three feet is weathered with no bedding observed, firm, clayey, tight. Lower two feet is well bedded with attitudes of N62W 33S and N70W 26S. Bedrock is slightly sandy siltstone, hard, tight, moderately jointed.

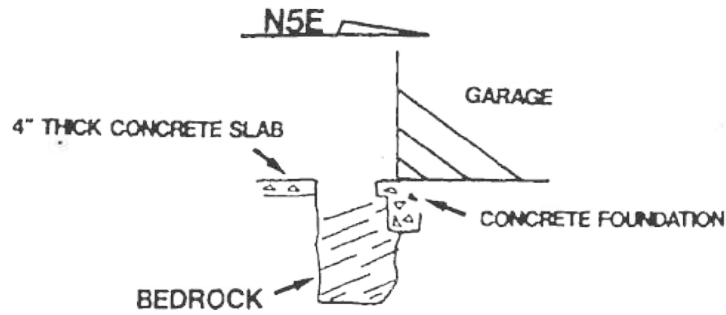
LOG OF TEST PIT 2

Bedrock: Light brown siltstone, well bedded with attitudes of N56W 26S and N63W 26S. Bedrock is slightly sandy siltstone, hard, tight, moderately jointed.
