# Summary Report, prepared exclusively for:

952 Seaside Ct. Ventura (Main Report - Upstairs) - Paul & Suzanne Guthrie 06 10 2026 By

June 10, 2026

RE: 952 Seaside Ct. (Main Report - Upstairs)  
Ventura, CA

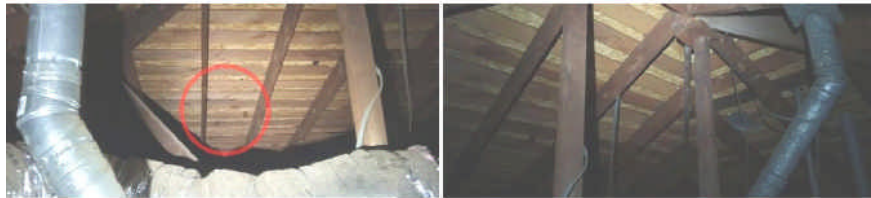
Attic is full size over the house. Conventional roof framing is present. Attic ventilation vents are provided. EXCEPT: Signs of past / present water leakage is noted in attic space. Unable to determine the status of the stains. Inquiry should be made with seller to determine present condition, prior to close of escrow. (see photo, detailed report page - )

### Water stains

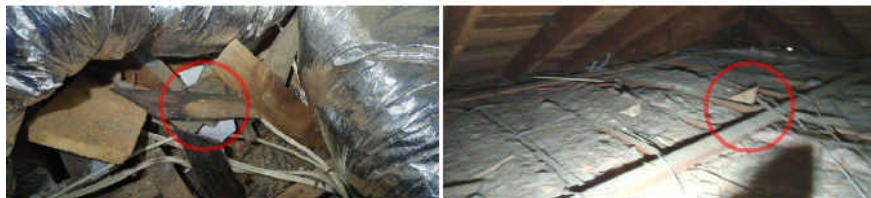
6-6 1/2 inches, approx. R-19 insulation value. NOTE: Some trash was noted on insulation. Recommend removing. (see photo, detailed report page - )

### Roof trash from last roof replacement

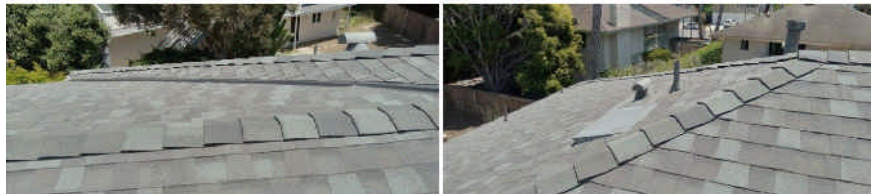
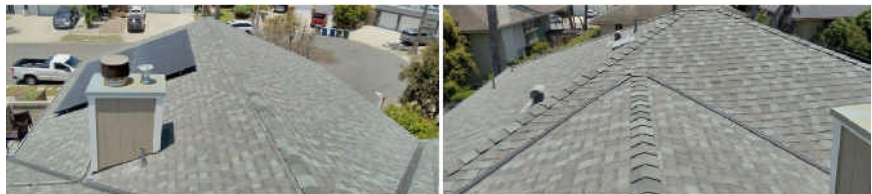
### Roof areas/newer roof materials

Newer roof is installed. Roof appears serviceable. Normal wear and tear is noted. Determining if active leakage, without a rain in progress, is beyond the scope of this inspection.

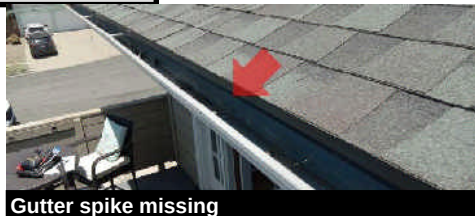
Full house gutters are installed, were observed by the inspector and found they are wearing well, durable and capable of being used. EXCEPT: Missing gutter spike. Recommend proper repairs by a qualified tradesperson. (see photo, detailed report page - )

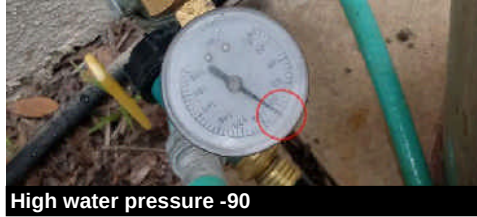
An in-line pressure regular is installed to regulate the main street water pressure down to within the recommended 40 to 80 PSI for house use. EXCEPT: Water pressure tested was above the recommended 40 to 80 PSI maximum for house use. PSI is approximately - 90. High water pressure will cause faucets, valves, etc. to quickly wear out, and may cause leaks in interior water lines. Recommend adjusting / replacing or installing an in-line regulator. Recommend proper repairs by a licensed plumber. House water shut off valve was not tested, because these valves oftentimes malfunction as they are in the on / open position all the time. Care should be taken in operating this valve if the water should ever need to be turned-off and on. (see photo, detailed report page - )

High water pressure -90

An in-line pressure regular is installed to regulate the main street water pressure down to within the recommended 40 to 80 PSI for house use. EXCEPT: Water pressure tested was above the recommended 40 to 80 PSI maximum for house use. PSI is approximately - 90. High water pressure will cause faucets, valves,

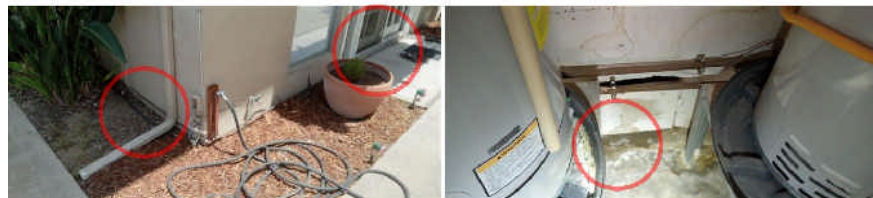
Interior water pipes were observed by the inspector and found they are wearing well, durable and capable of being used. EXCEPT: Viewing of plumbing system is limited. Loose and exposed water line on the ground. Leak in water supply line is noted. Recommend proper repairs be made. Call a licensed plumbing contractor for further evaluation of the system and for improvements and repairs, as needed. (see photo, detailed report page - )

### Expose water line/leaking water lines

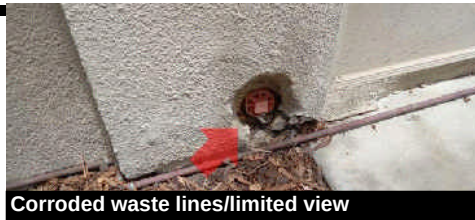
Waste drainage lines are not fully visible, but those observed appear serviceable. Unable to fully view waste vent pipes, but those observed appear serviceable and are properly venting. EXCEPT: Rust / corrosion is noted. Repair or replacement will be needed. Recommend proper repairs by a qualified tradesperson. (see photo, detailed report page - )

Corroded waste lines/limited view

waste drainage lines are not fully visible, but those observed appear serviceable. Unable to fully view waste vent pipes, but those observed appear serviceable and are properly venting. EXCEPT: Rust / corrosion is noted. Repair or replacement will be needed. Recommend proper repairs by a qualified tradesperson. (see

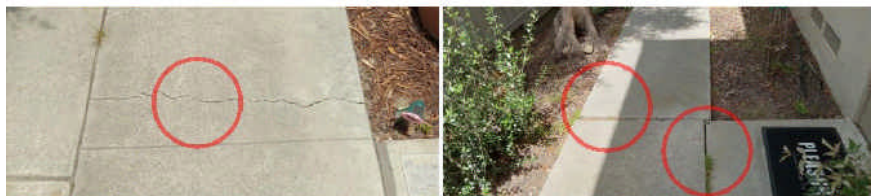
Concrete sidewalks and walkways. NOTE: Cracks noted are large in size, and should be repaired / sealed to keep water from penetrating into the soil below and causing more problems. **Surface of sidewalk / walkway has raised / settled, causing tripping hazards. This is a safety liability.** Leveling repairs should be made by a qualified tradesperson. (see photo, detailed report page - )

## **Cracks and tripping hazards**

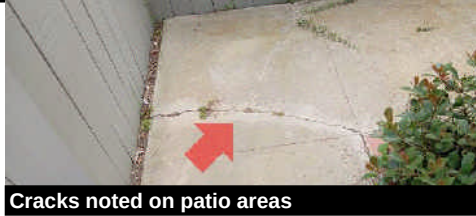
Concrete patio. EXCEPT: Displacement / cracks are large in size. Repair should be made to prevent water intrusion. Recommend proper repairs by a qualified tradesperson. (see photo, detailed report page - )

Cracks noted on patio areas

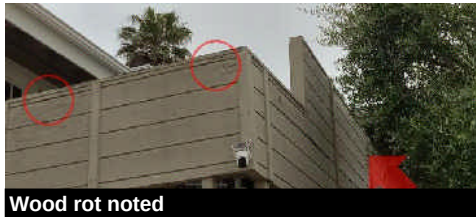
Deck was observed by the inspector and found it is wearing well, is durable and capable of being used. EXCEPT: Tall deck walls are loose. Fungus damage (wood rot) is noted in some of the exterior wood walls. A fungus growth will continue to rot the wood. Replacement of parts or whole boards will be needed to affected areas. Recommend referring to the present-in-effect Termite Report conducted on this property for findings / recommendations, or arrange for further evaluation by a licensed Pest Control Operator. Recommend proper repairs by a qualified tradesperson. (see photo, detailed report page - )

Wood rot noted

Deck was observed by the inspector and found it is wearing well, is durable and capable of being used. EXCEPT: Tall deck walls are loose. Fungus damage (wood rot) is noted in some of the exterior wood walls. A fungus growth will continue to rot the wood. Replacement of parts or whole boards will be needed to affected areas.

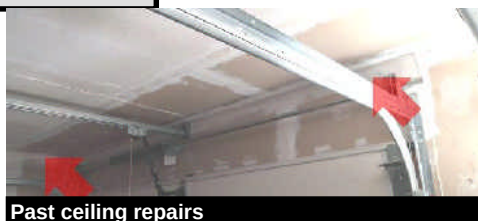
Above garage ceiling area has been previously repaired / patched. Recommend inquiring with seller. (see photo, detailed report page - )

Past ceiling repairs

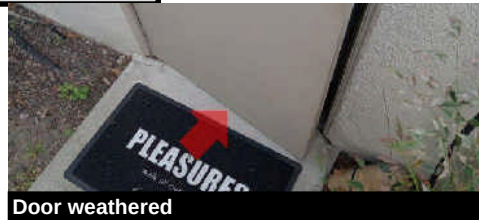
Garage passage door is weathered, door has water damage at bottom and is delaminating. Repairs or replacement is needed. (see photo, detailed report page - )

Door weathered

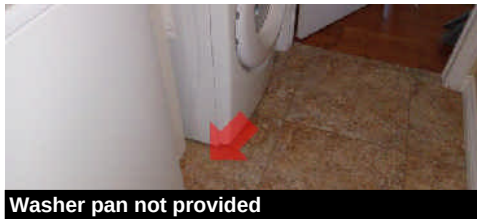
Plumbing appears serviceable. Electrical outlet is grounded and appears serviceable. Gas service pipe is provided and appears serviceable. Dryer venting to outside is provided and was observed by the inspector and found it is wearing well, is durable and capable of being used. Waste drain line clean-out is located near laundry area. EXCEPT: Recommend installation of a washer drain pan system, to prevent interior damage from future washer or plumbing leaks. Recommend proper repairs by a qualified tradesperson. (see photo, detailed report page - )

Washer pan not provided

Plumbing appears serviceable. Electrical outlet is grounded and appears serviceable. Gas service pipe is provided and appears serviceable. Dryer venting to outside is provided and was observed by the inspector and found it is wearing well, is durable and capable of being used. Waste drain line clean-out is located

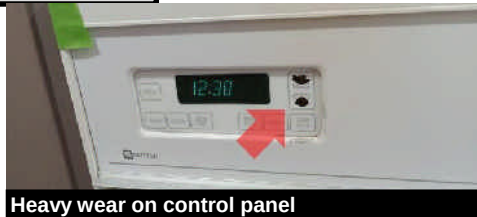
Gas. Electric ignition. Oven light(s) - OK. Oven / broiler was tested or observed by the inspector and found it is wearing well, is durable and capable of being used. EXCEPT: Control panel has heavy wear, repairs or replacement needed. Recommend proper repairs by a qualified tradesperson. (see photo, detailed report page - )

Gas. Electric ignition. Oven light(s) - OK. Oven / broiler was tested or observed by the inspector and found it is wearing well, is durable and capable of being used. EXCEPT: Control panel has heavy wear, repairs or replacement needed. Recommend proper repairs by a qualified tradesperson. (see photo, detailed

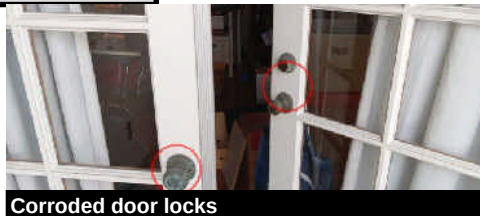
French type door(s) present. Exterior doors were tested or observed by the inspector and found they are wearing well, durable and capable of being used. EXCEPT: Corroded locks on doors. Recommend proper repairs by a qualified tradesperson. (see photo, detailed report page - )

Corroded door locks

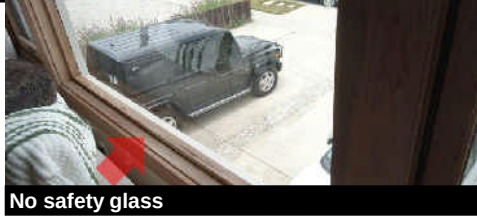
Wood double hung type. Wood sliding type. Vinyl sliding type. Some windows have double insulated glass. A representative sampling was taken. Windows as a grouping are generally operational. Window screens were observed by the inspector and found they are wearing well, durable and capable of being used. NOTE: **Inspector could not determine if low window glass is of safety glass type. Did not see a safety type sticker on the glass.** Recommend installing safety glass. Recommend proper repairs by a qualified tradesperson. (see photo, detailed report page - )

No safety glass

Wood double hung type. Wood sliding type. Vinyl sliding type. Some windows have double insulated glass. A representative sampling was taken. Windows as a grouping are generally operational. Window screens were observed by the inspector and found they are wearing well, durable and capable of being used. NOTE:

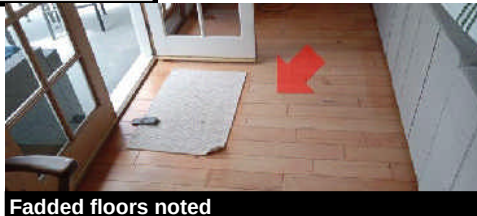
Tile. Wood. General condition appears serviceable. EXCEPT: Discolored wood flooring near french doors. Recommend proper repairs by a qualified tradesperson. (see photo, detailed report page - )

Faded floors noted
