# PROPERTY INSPECTION REPORT

**995 Jacqueline Pl**  
**Inspection Prepared For: Terry Robert's**  
**Agent: -**

**Date of Inspection: 5/27/2026**

**Year Built: 2007 Size: 2110**

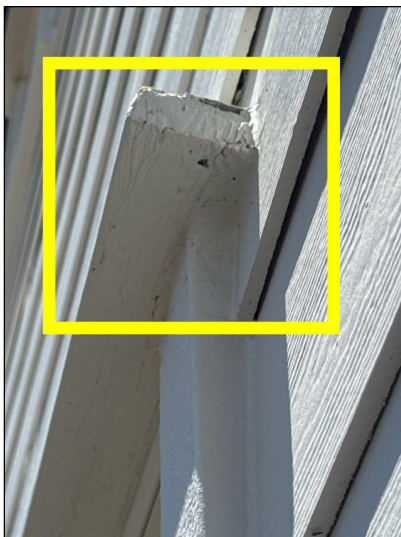
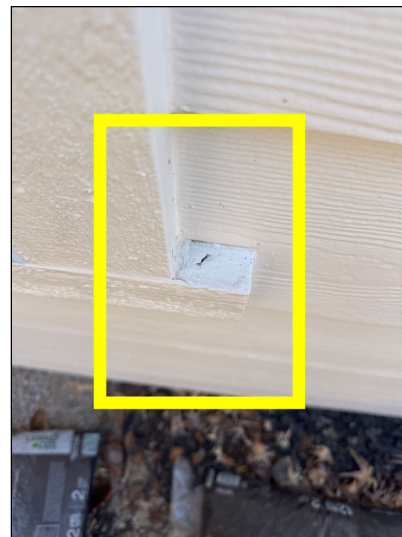
- **Moisture damage, wood rot, observed.** Refer to pest report for further details and repair damage as needed.

Moisture damage, wood rot, observed.

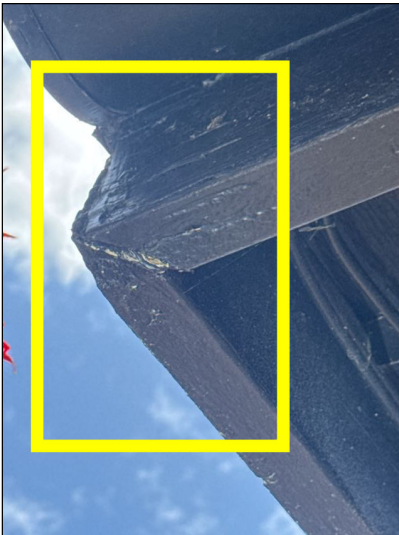
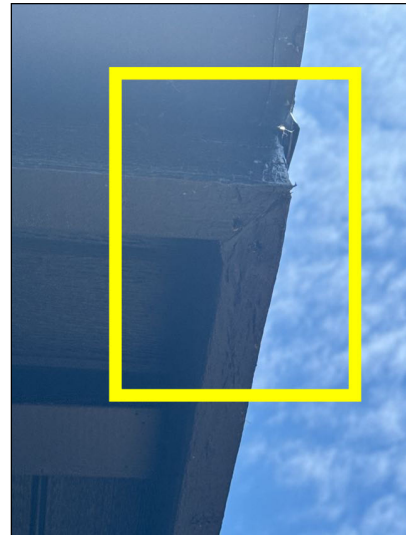
Moisture damage, wood rot, observed. Refer to pest report for further details and repair damage as needed.

Moisture damage, wood rot, observed.

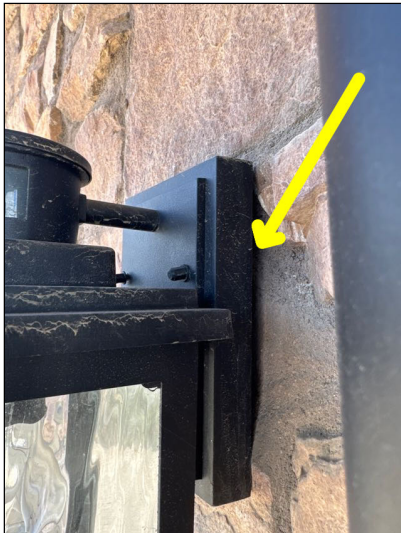
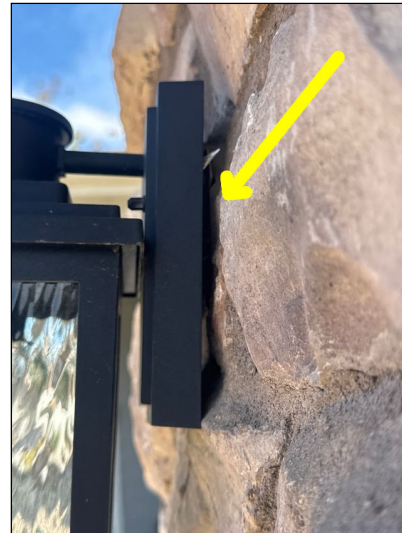
Exterior lighting was loose/not flush to the wall and could expose electrical components to moisture intrusion. front of garage

Some exterior lighting was loose to the wall and could expose electrical components to moisture intrusion. The inspector recommends all fixtures are properly fastened and sealed to the wall by a qualified electrical contractor.

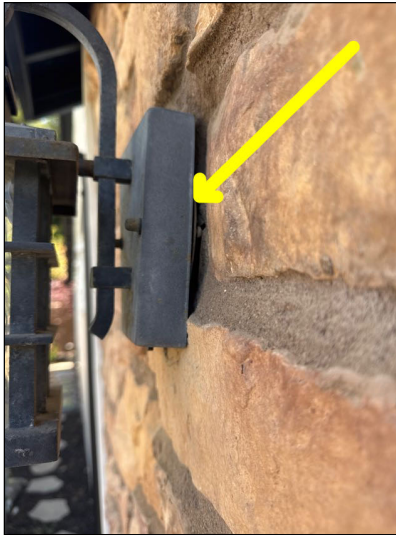
Exterior lighting was loose/not flush to the wall and could expose electrical components to moisture intrusion. garage exterior exit door

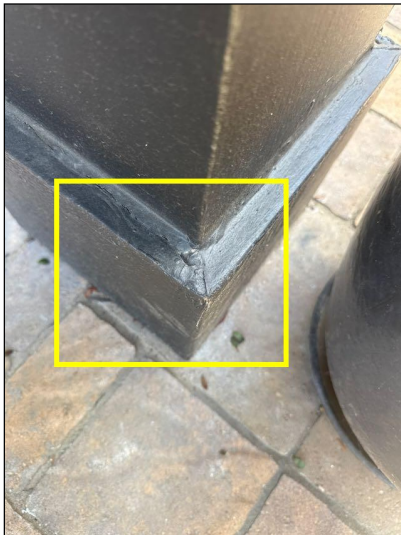
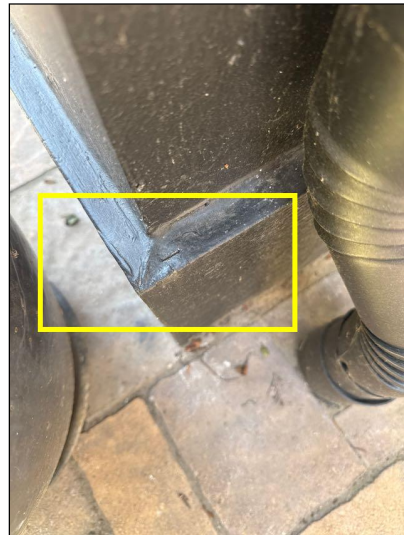
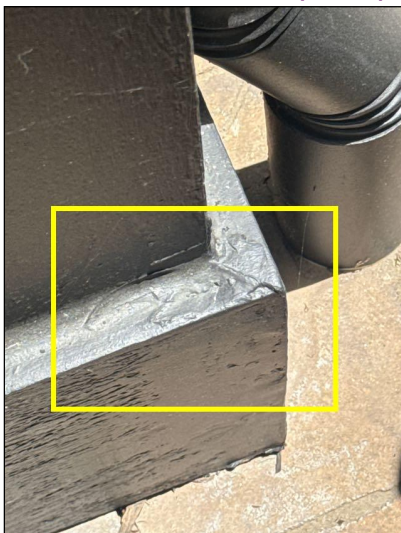
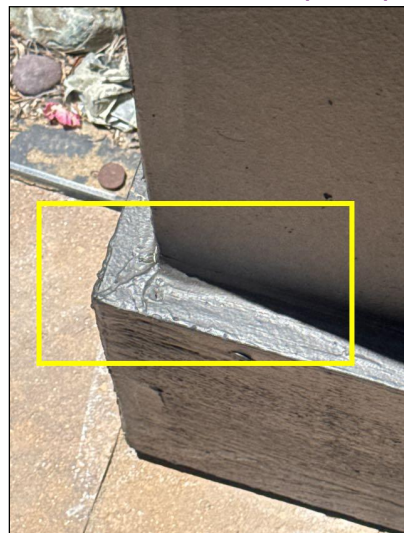
Minor moisture damage, wood rot, observed at the trim around the back patio posts. Refer to pest report for further details and repair damage as needed.

Minor moisture damage, wood rot, observed at the trim around the back patio posts.

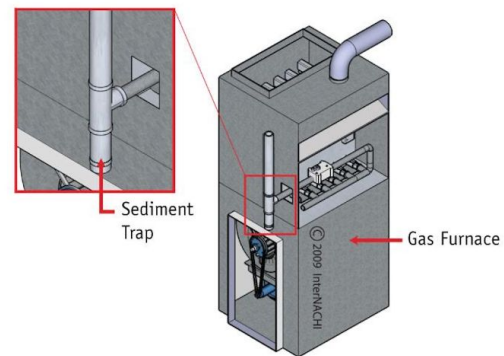
**Improvement:** The gas supply pipe contained no sediment trap.

The purpose of a sediment trap is to prevent sediment or debris particulates from entering and clogging the heaters gas valve.

**Recommended Improvement:** The gas supply pipe contained no sediment trap. A sediment trap is generally recommended but not always required, depending on the local Authority Having Jurisdiction (AHJ). The purpose of a sediment trap is to prevent sediment or debris particulates from entering and clogging the heaters gas valve, which can cause the heater to shut down. You may wish to consult with local contractor concerning the advisability of installing a sediment trap in the gas line.

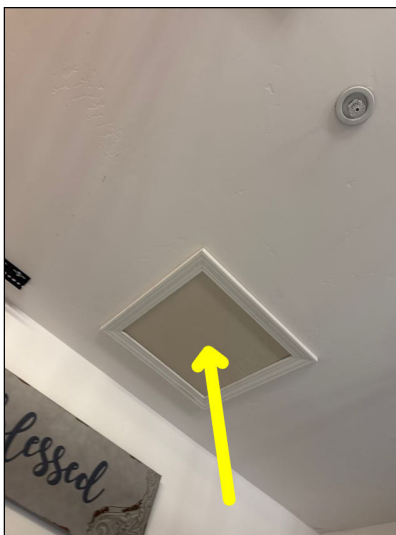
Attic access in garage is considered a breach in the fire wall. Fire walls are fundamental to the integrity of fire barriers which provide resistance to the spread of fire, smoke, and toxic gasses. This means that should a fire occur in the garage, this door does not afford protection until fire-rescue people arrive. A fire rated access panel should be installed to complete the fire wall.

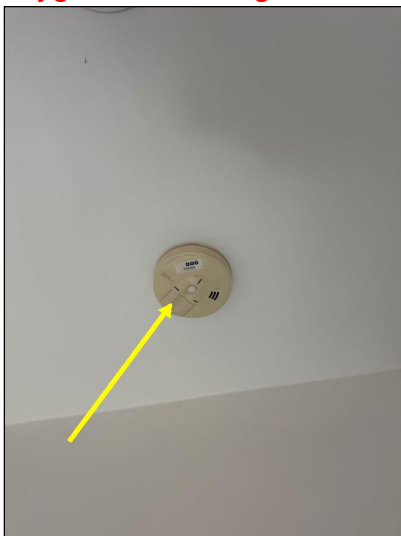
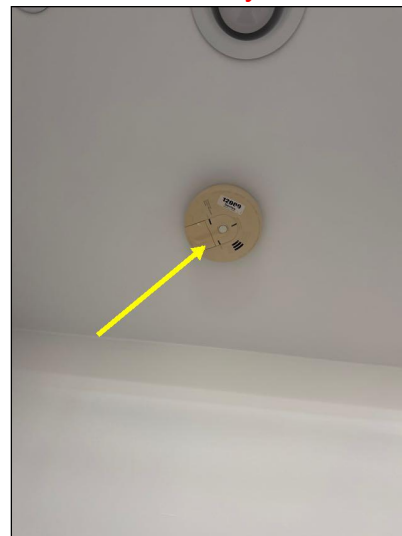
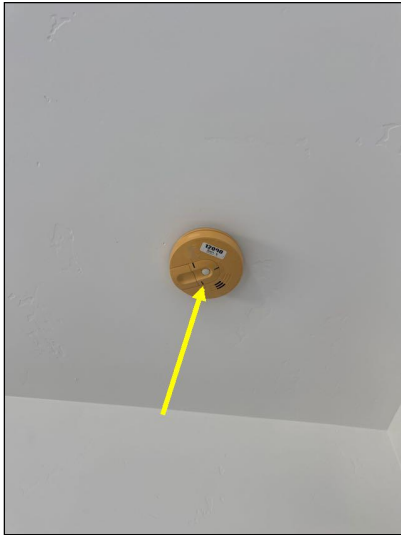
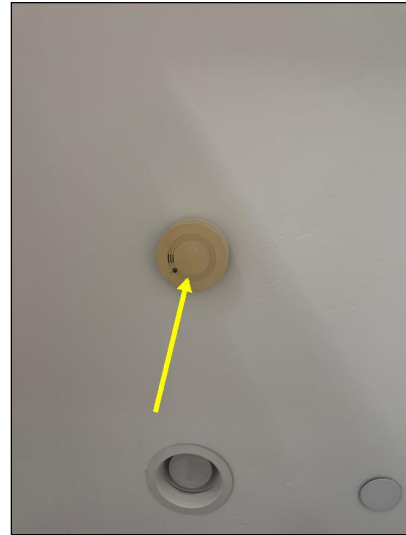
**Safety:** Yellowing of a smoke detector and smoke/carbon monoxide dual detector is an indication of age and most likely should be replaced regardless if it is functional. Most Smoke detector manufacturers inject a fire retardant bromine into the plastic of residential smoke detectors, as a side effect, this additive turns the polymer yellow over time as it is exposed to heat, oxygen, and UV light. Average lifespan of a smoke detector is 8-10 years.

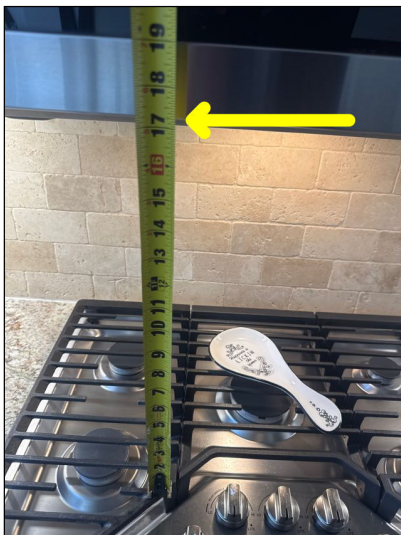
**Safety Improvement:** The exhaust fan is only recirculating so no exhaust duct is vented to the exterior.

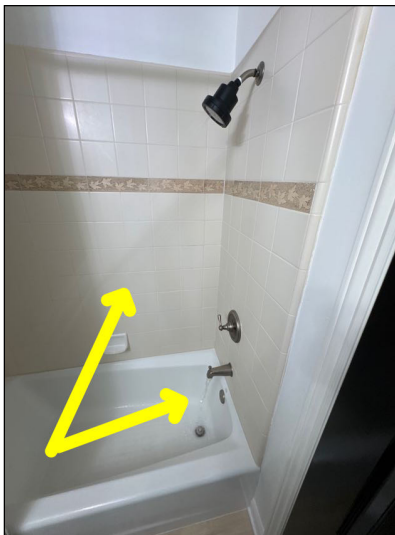
The diverter valve was leaking during operation or did not operate correctly (the diverter is the valve which diverts water from the tub faucet to the shower head). At the time of inspection water continued to flow from the tub spout when the shower was on. This is most commonly caused by a deteriorated diverter valve seal in the tub spout. The Inspector recommends maintenance/repair be performed by a qualified contractor.

The diverter valve was leaking during operation or did not operate correctly (the diverter is the valve which diverts water from the tub faucet to the shower head).

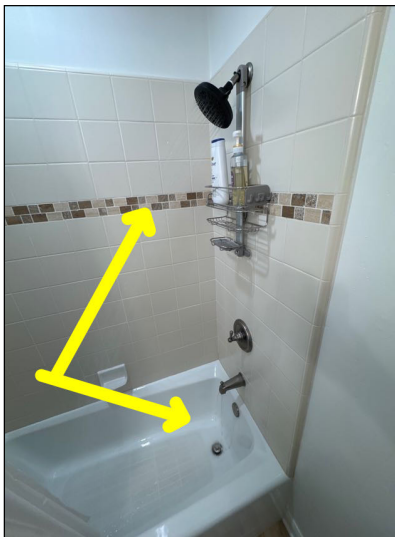
The diverter valve was leaking during operation or did not operate correctly (the diverter is the valve which diverts water from the tub faucet to the shower head). At the time of inspection water continued to flow from the tub spout when the shower was on. This is most commonly caused by a deteriorated diverter valve seal in the tub spout. The Inspector recommends maintenance/repair be performed by a qualified contractor.
