## Inspection Services

### *Inspection Report*

Address: 2315 Autumn Pl Arroyo Grande, CA 93420

06/08/2026

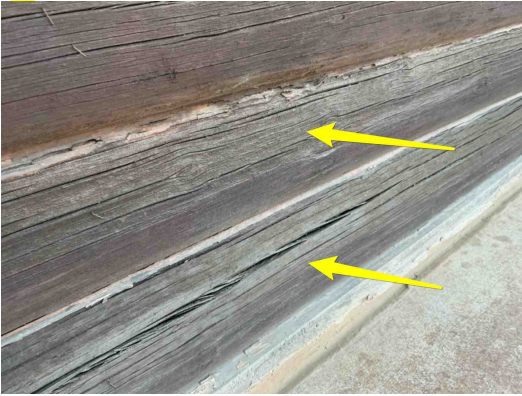
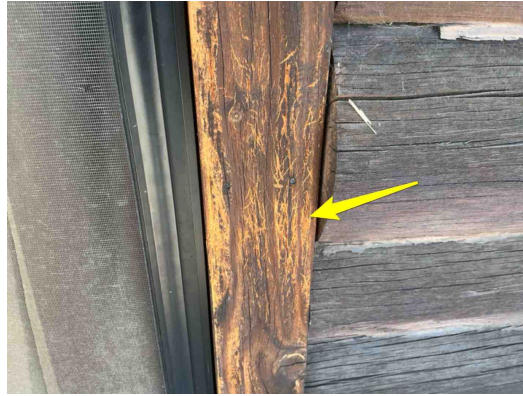
**MR 31:** Deteriorated finish at areas of the exterior.

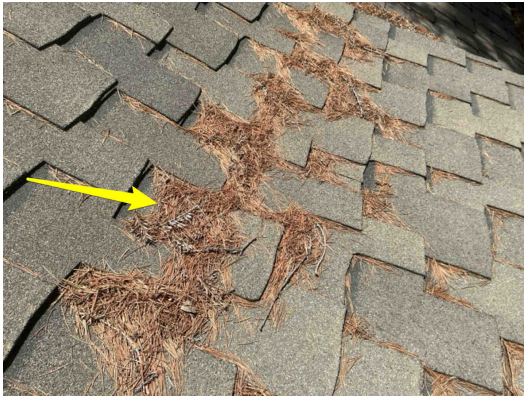
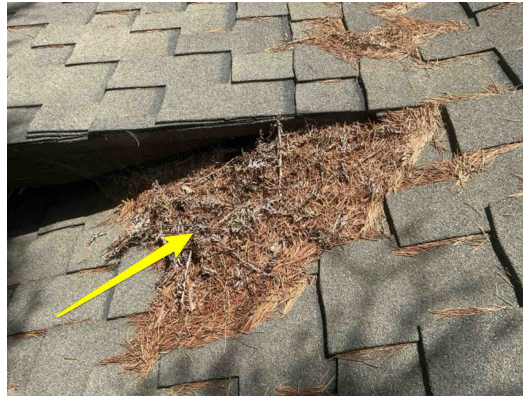
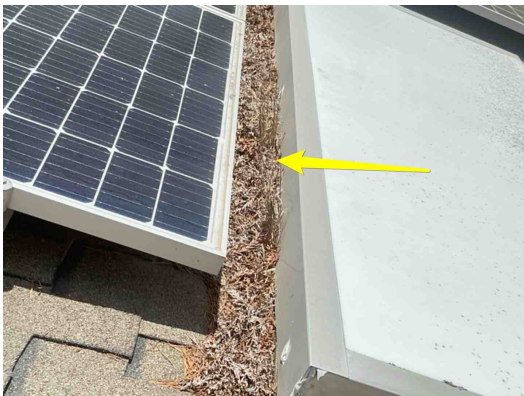
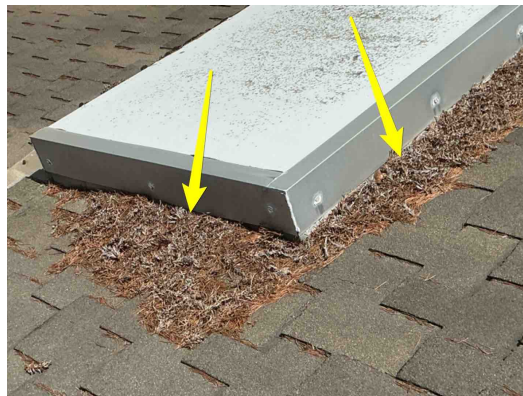
**MR 54:** Debris covers portions of the roof and/or roof flashings. This may cause deterioration and/or a roof leak. Areas of the roof are not fully visible. Clean and inspect regularly.

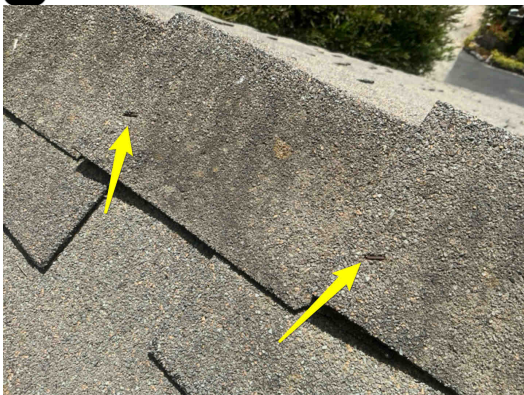
**DS 55: Disclosure:** Exposed fasteners noted at areas of the roof and/ or roof flashings.

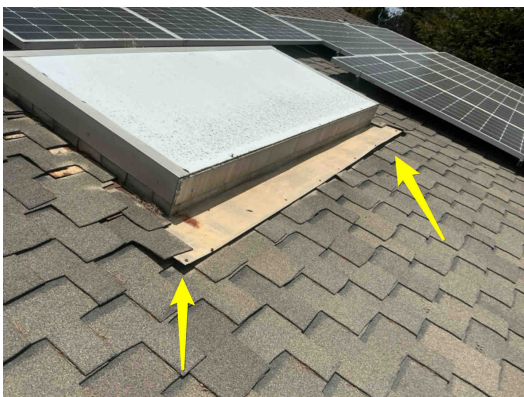
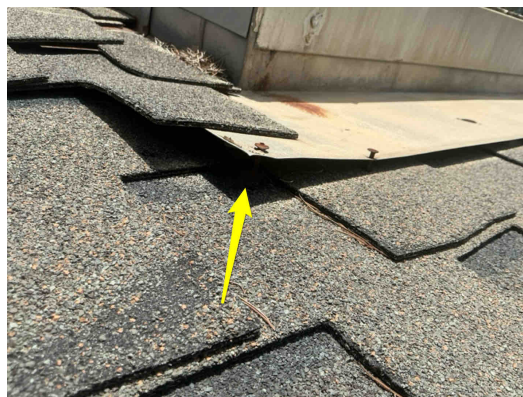
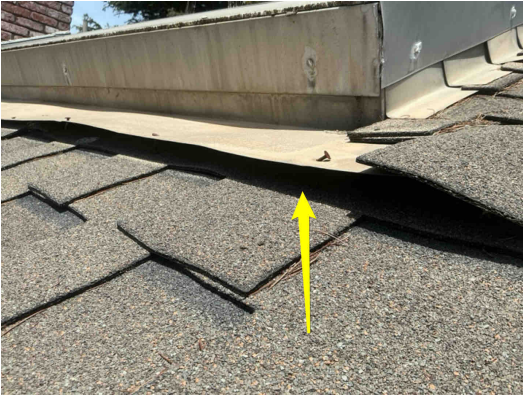
**E&C MR 58:** Some lifting roof flashings. Corrections, maintenance or repairs are recommended to help prevent water intrusion and/or roof leakage from windy, wet weather.

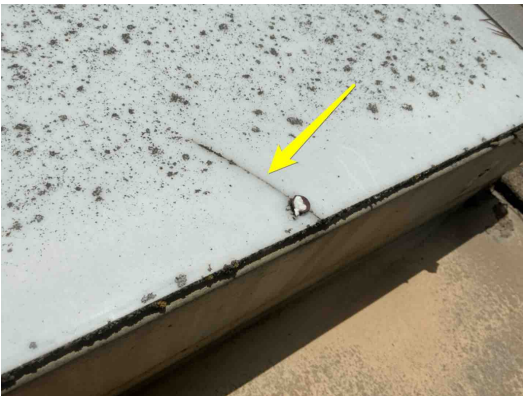
**E&C 60:** The SOUTH plastic roof skylight is cracked. Contact a qualified roofer to evaluate and replace damaged skylight.

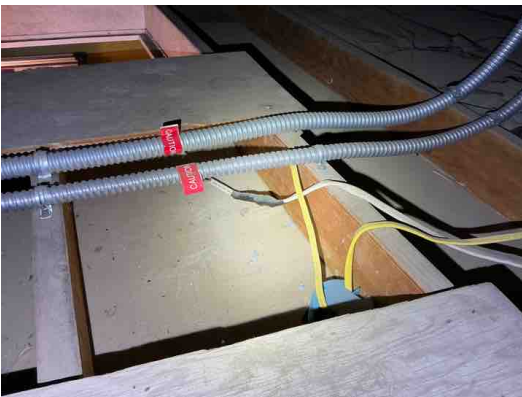
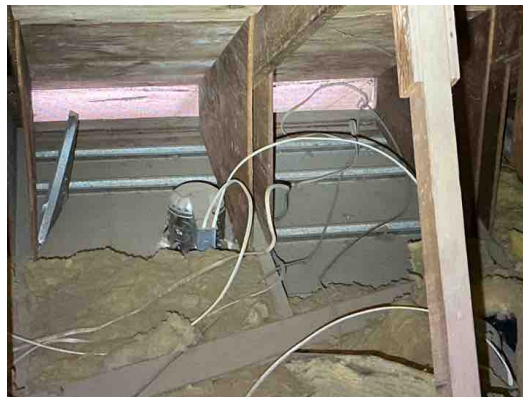
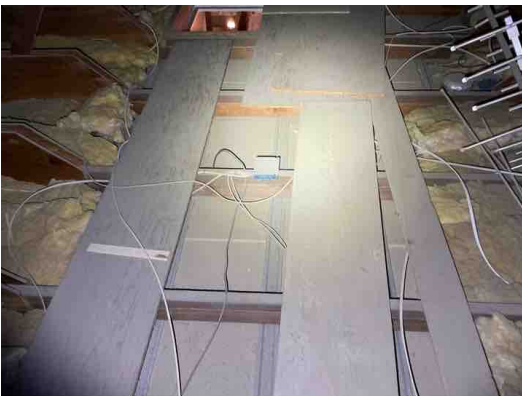
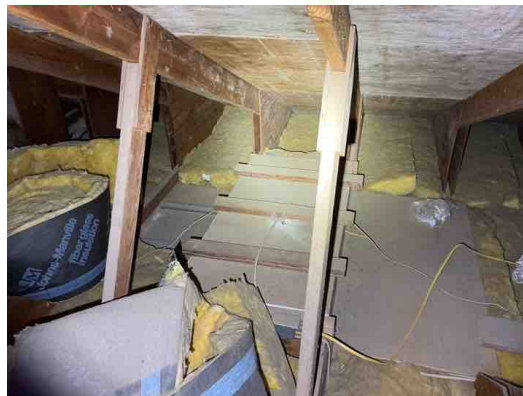
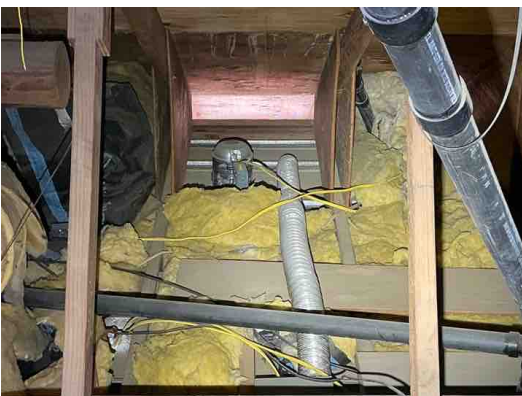
**E&C 73:** Missing insulation in the areas attic. Some of the attic Insulation in has been moved, displaced or was not originally installed for reasons unknown.

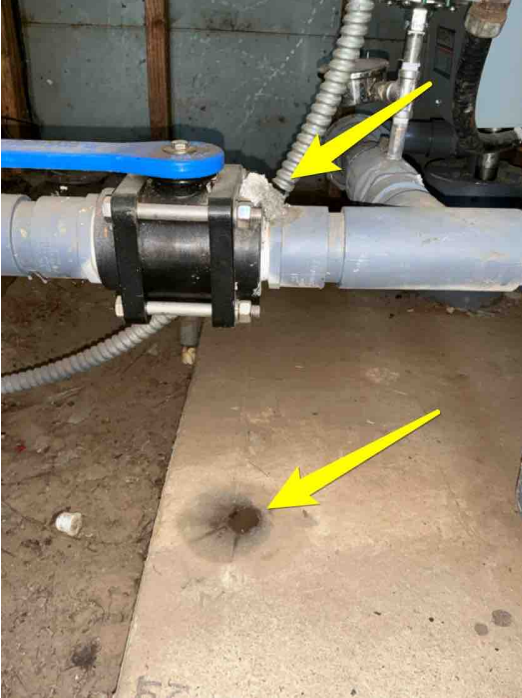
**E&C** 77: A small active water leak noted at the main water supply pipe or valve. Contact the qualified professional for repairs.

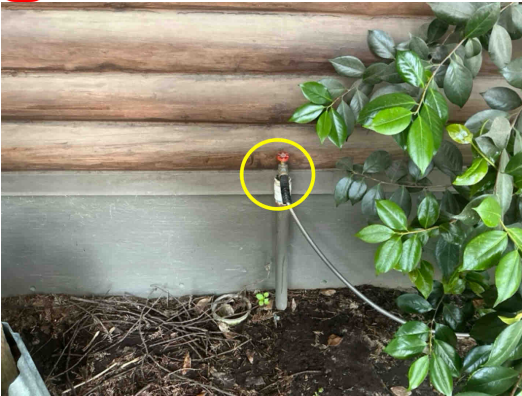
**E&C 84:** A small active water leak found at the exterior NORTHWEST HOSE BIB. Corrections recommended.

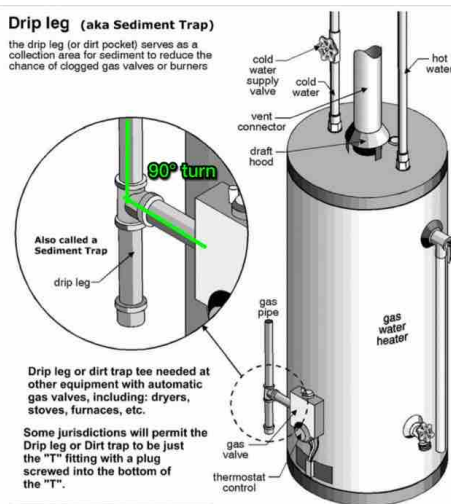
**SU 106:** Recommend the installation of the missing sediment trap / drip leg at the WATER HEATER gas piping at flex connection by a certified or licensed plumbing professional familiar with minimum requirements. [CPC 1212.8]

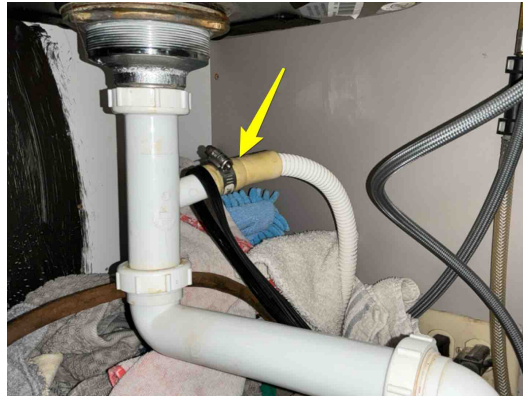
**SU 120:** Improper installation of the dishwasher drain hose. Missing the Air Gap Device at the dishwasher drain per minimum codes and standards (California does not allow for high-loop methods or direct waste connections). {CPC 801.2}

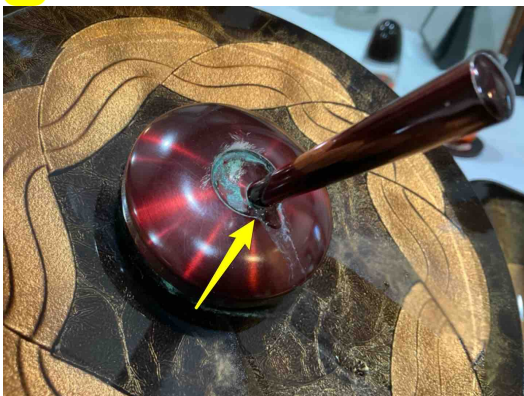
**MR 146:** Sink faucet found corroded/ deteriorated: PRIMARY BEDROOM BATHROOM

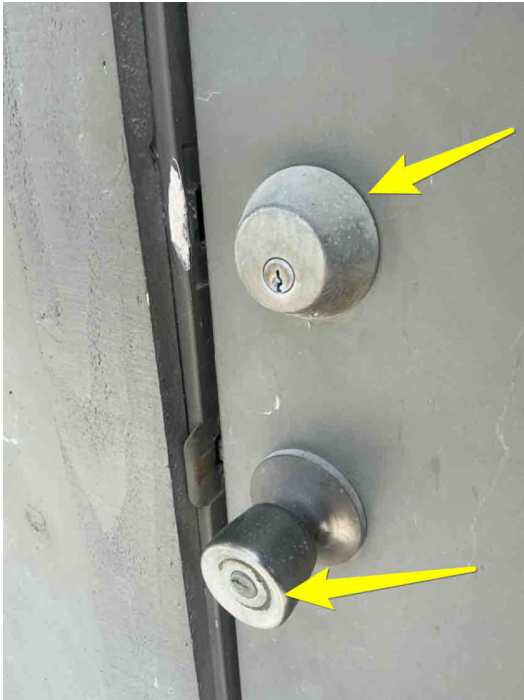
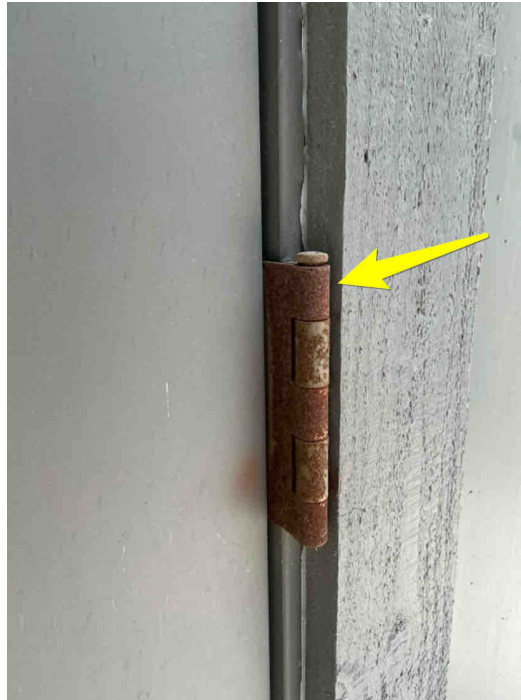
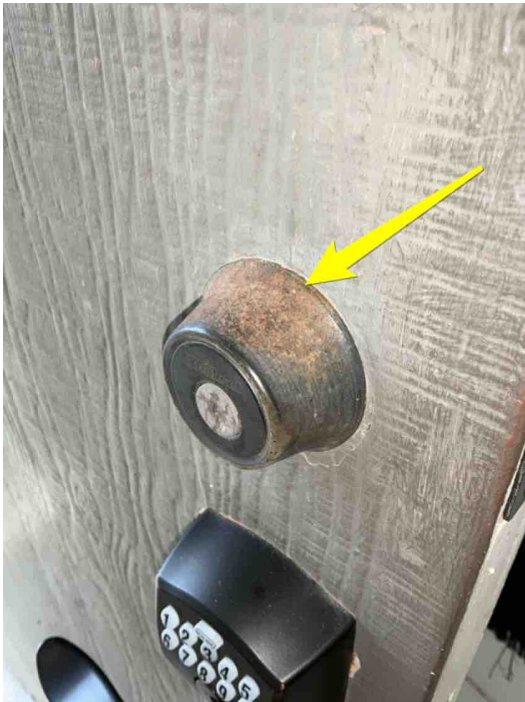
**MR 165:** Deteriorated / corroded door latching hardware and/ or hinges noted at exterior doors. Maintenance recommended.

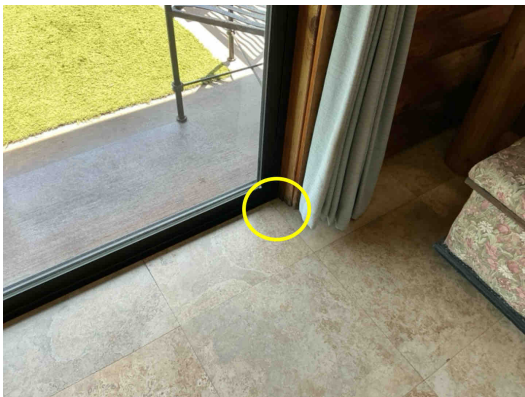
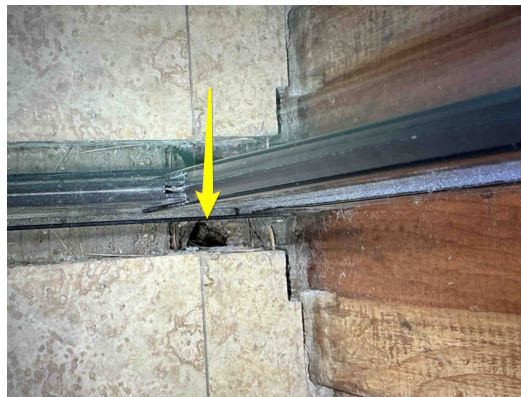
**FI 166:** Evidence of past water intrusion from around threshold area from exterior sliding glass door with stains and/or damage: DINING AREA

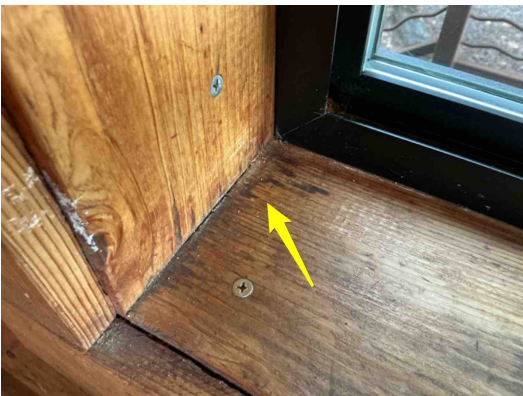
**FI 174:** Minor moisture stains noted on the inside at some window sills. Refer to the termite report for additional comments and recommendations.

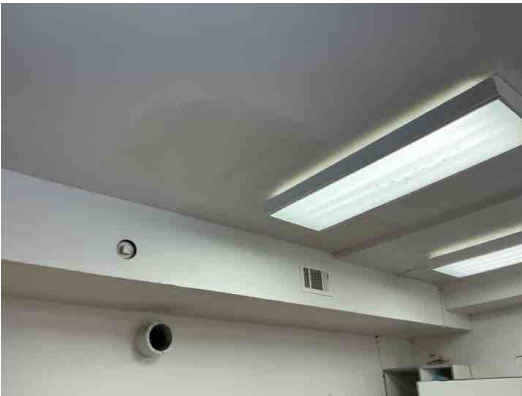
**FI DS 186:** Evidence of past ceiling and wall repairs found throughout. Client should investigate further to satisfy themselves as to the cause and current conditions.

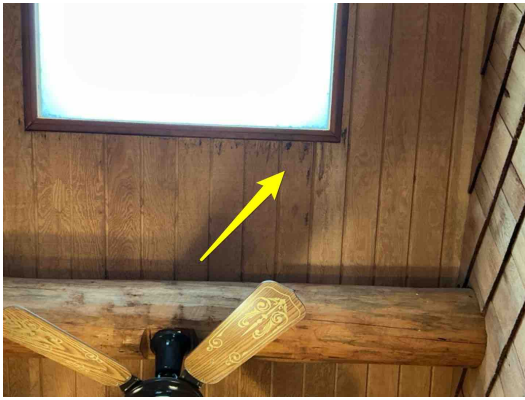
**FI 187:** Evidence of past moisture stains & damage at ceiling area in the LIVING ROOM and ENTRY AREA. Recommend further review of the water stains to determine the cause, the current condition and if repairs are needed.

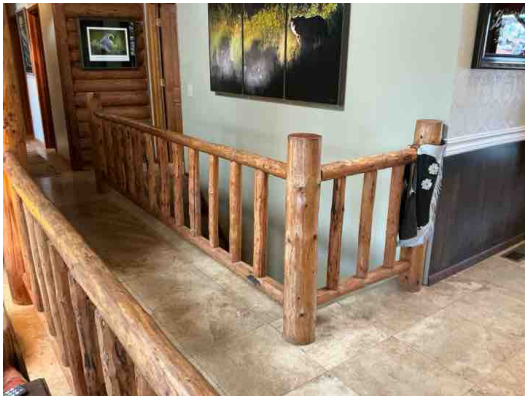
**SU 191:** Height and openings of stairway and/ or loft railings at the interior do not meet current standards. Upgrades recommended for safety.

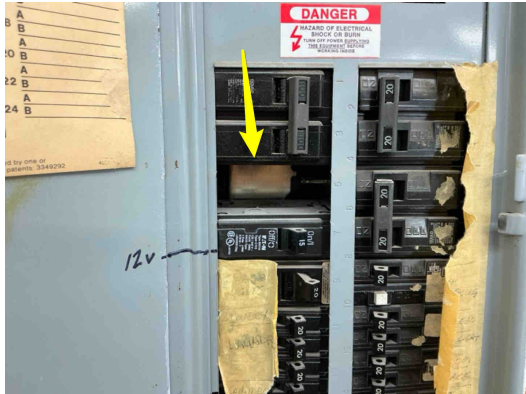
**SC 210:** Improper and unsafe openings in the dead front cover inside the GARAGE MAIN ELECTRICAL PANEL. Openings are needing to be plugged or sealed for safety per standards.

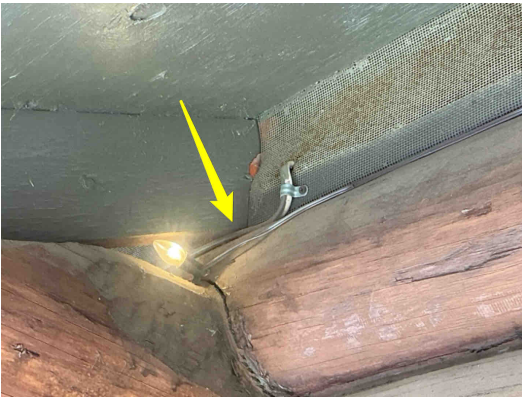
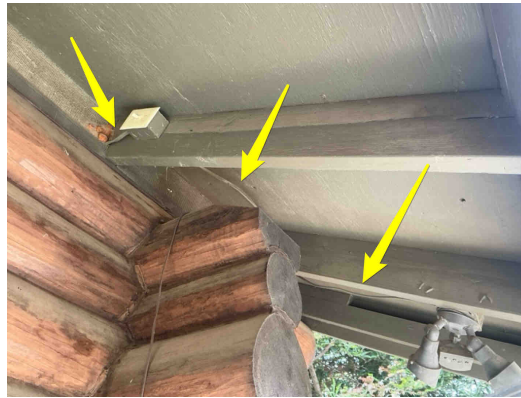
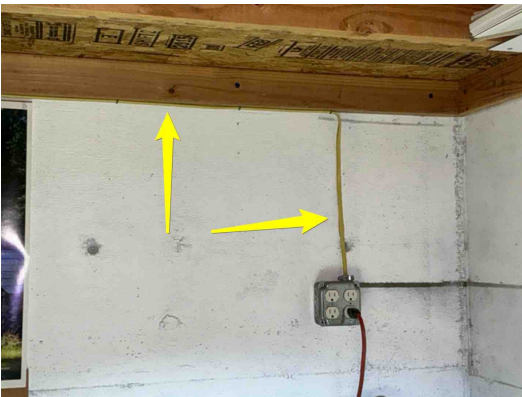
**SC 214:** Improper exposed electrical wiring, "Romex" improperly installed subject to physical damage, not in a conduit or raceway per standards: SOUTH EXTERIOR AT EAVES and SHOP DESIGN STUDIO STORAGE ROOM  
NEC 334.15(B)  
NEC 300.4

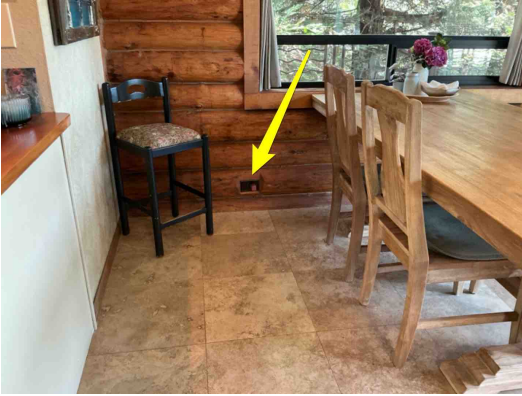
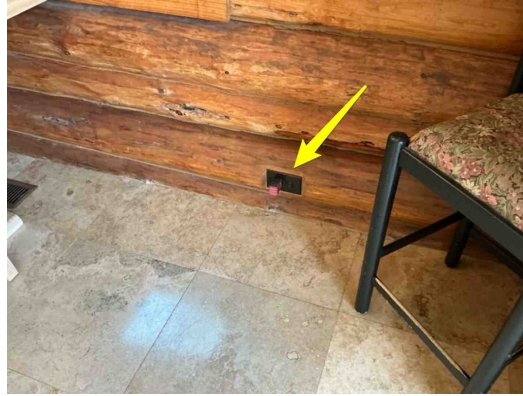
**SC FI 218:** Electrical outlet found non-operational: DINING AREA

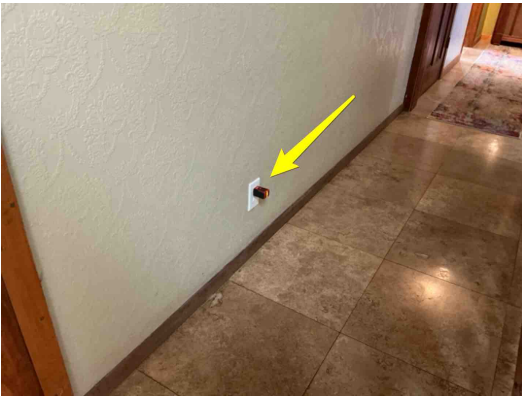
**SC 219:** Three-prong electrical outlets did not test properly grounded: BEDROOM HALLWAY. Contact a licensed electrical contractor for evaluation and repairs.

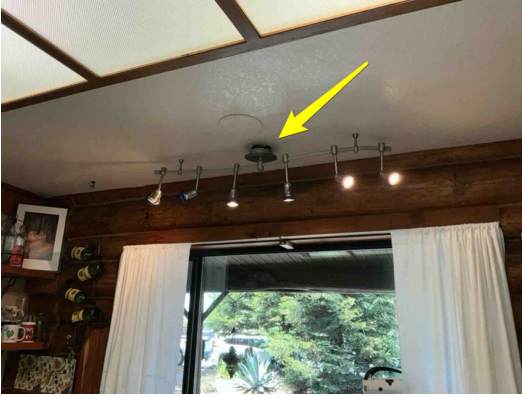
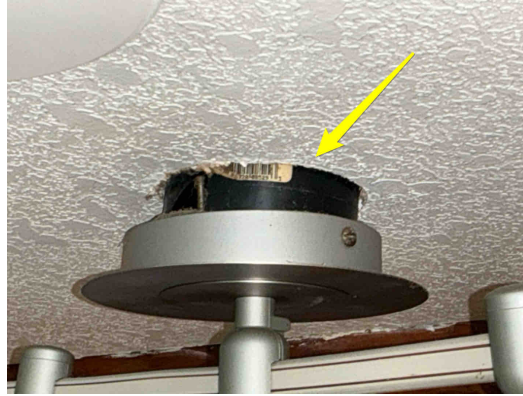
**SC 222:** Light fixture is hanging loose/ hanging at ceiling: KITCHEN

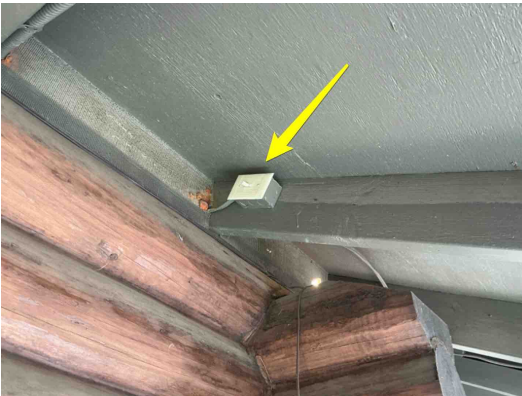
**SC 223:** Exterior electrical switch found without a proper exterior rated cover plate: SOUTHEAST EXTERIOR AT EAVES

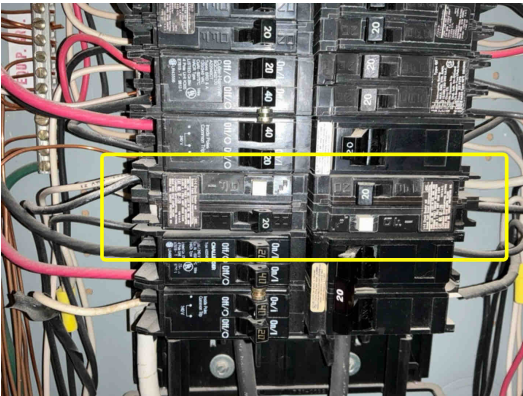
**SC 231:** TWO GFCI breakers found non-operational / Defective in the ELECTRICAL SUB PANEL. Replacement warranted.

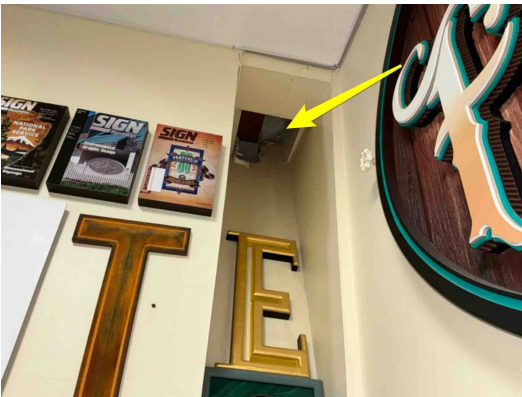
**SC FI 244:** Some holes or openings found in the garage firewall. Corrections are warranted for fire safety. Contact an appropriate contractor to review the entire garage repair as needed.

Former laundry chute

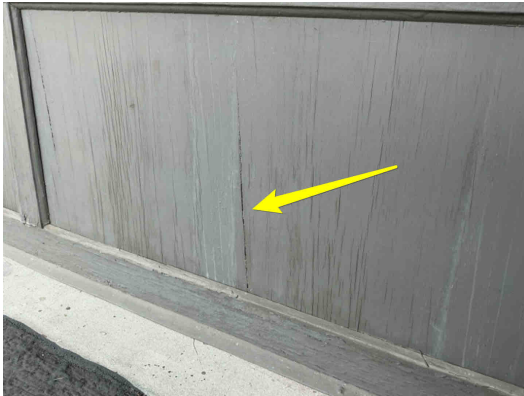
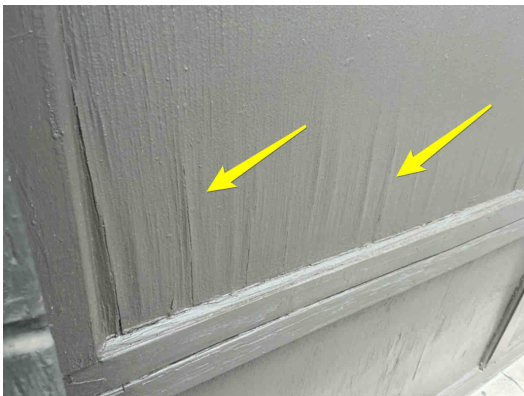
**E&C 252:** Some moisture stains & damage at garage vehicle door, door jam and/or trim. Refer to the termite report for additional comments and recommendations.

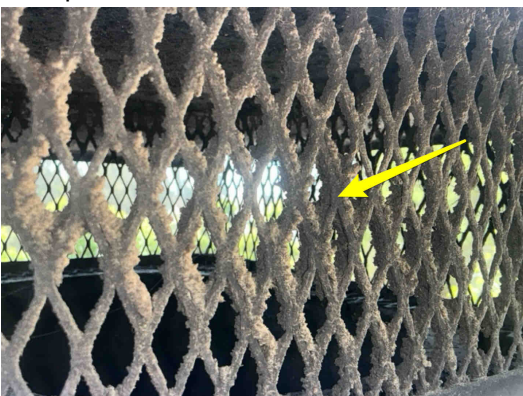
Heavy creosote buildup

**E&C 262:** Recommend cleaning & sweeping the LIVING ROOM fireplace and chimney by a qualified chimney sweep.
