# Inspection Report

**Property Address:**  
126 Flag Way B  
Paso Robles CA 93446

6/16/2026

**Harper Homes: Home Inspection Services**

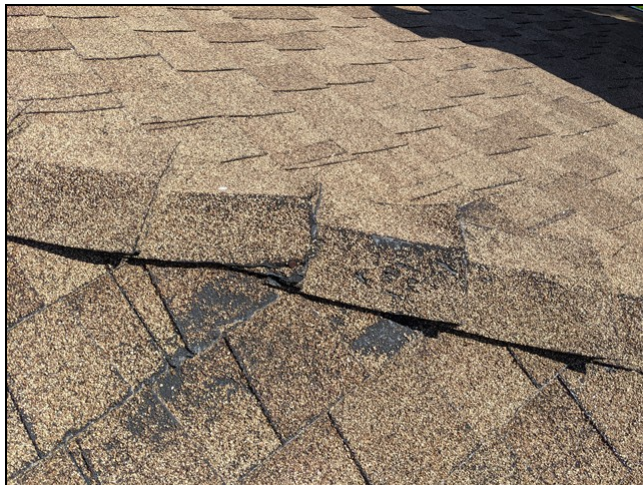
2.0 Item 1(Picture)

Damaged shingles noted at the ridge and need repaired to prevent weather exposure to the roofing materials and further deterioration in this area.

Areas of the roofing material are weathered and showing signs of age. No leaks were noted in the attic or interior. Recommend further evaluation with cost to replace and remaining life determined by a licensed roofing contractor.

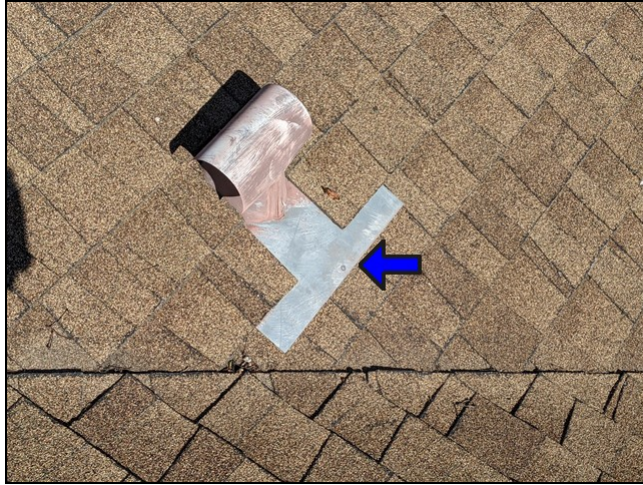
2.1 Item 1(Picture)

Exposed nails improperly "face nailed" into the bottom of the metal flashings and need sealed with roof repair

caulk. Proper installation at the next roof replacement interval will help prevent the need for caulking maintenance.

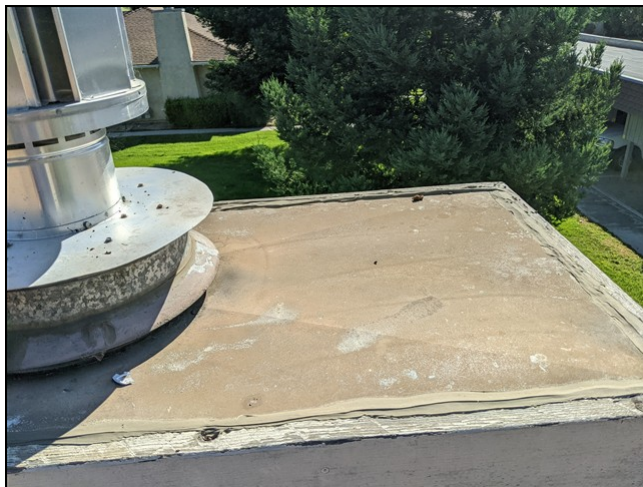
2.2 Item 1(Picture)

Plumbing vents need resealed at the roof.

The chimney chase cap is concaved slightly and will hold water, creating a probable moisture leak over time. Recommend alteration or replacement of the chimney chase cap, as needed.

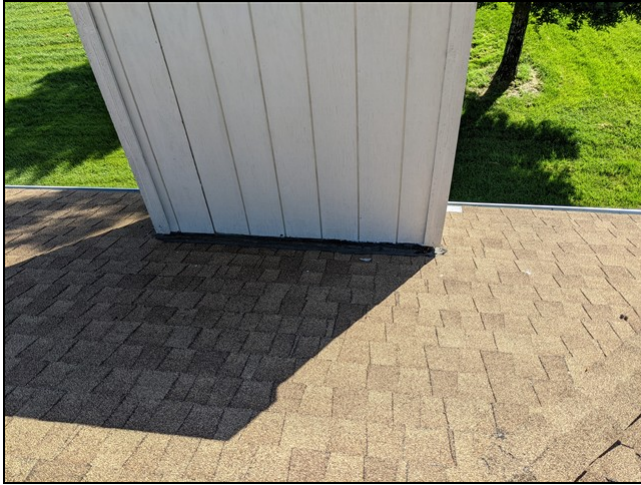
2.2 Item 2(Picture)

Proper chimney "cricket" metal flashing is not installed. While this may not have been required at the time of construction, installation of this component is recommended to prevent excessive debris build up and pooling moisture that may enter the building.

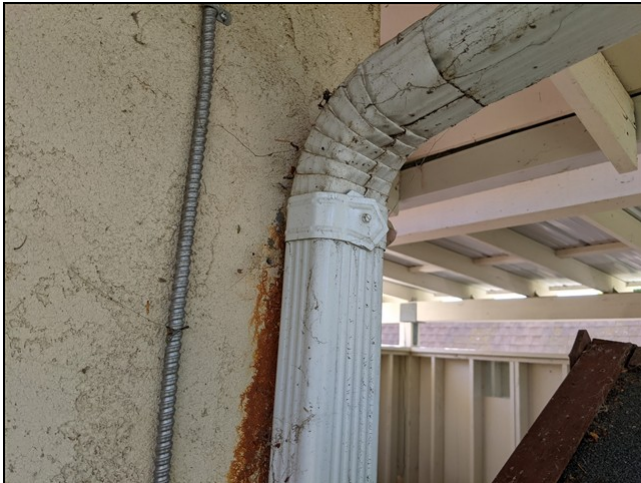
2.3 Item 1(Picture)

The gutters contain debris in areas and need cleaned and an annual maintenance schedule established to allow intended drainage of roof runoff water away from the home.

Gutter seams show signs of leaking. Recommend cleaning and sealing the seams with gutter sealant to prevent continued moisture exposure at the fascia.

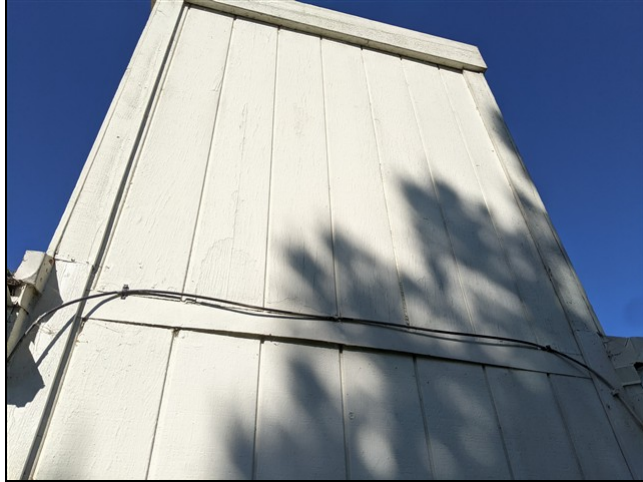
2.7 Item 1(Picture)

Peeling paint was noted at a few areas of the wood siding, fascia, and trim, and paint maintenance is needed.

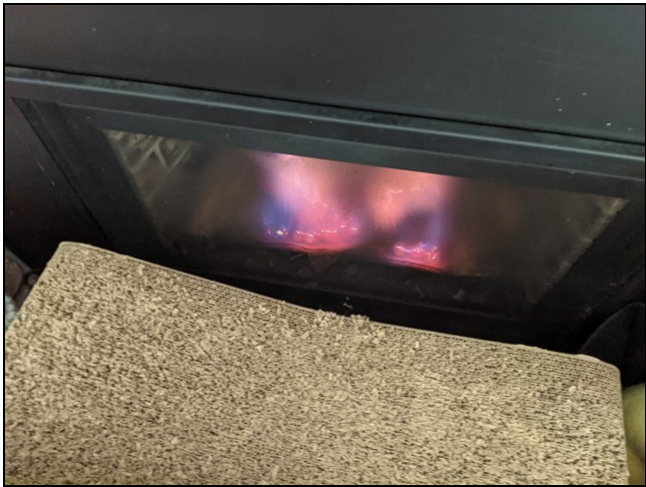
3.1 Item 1(Picture)

The fireplace was tested and functional at the time of the inspection.

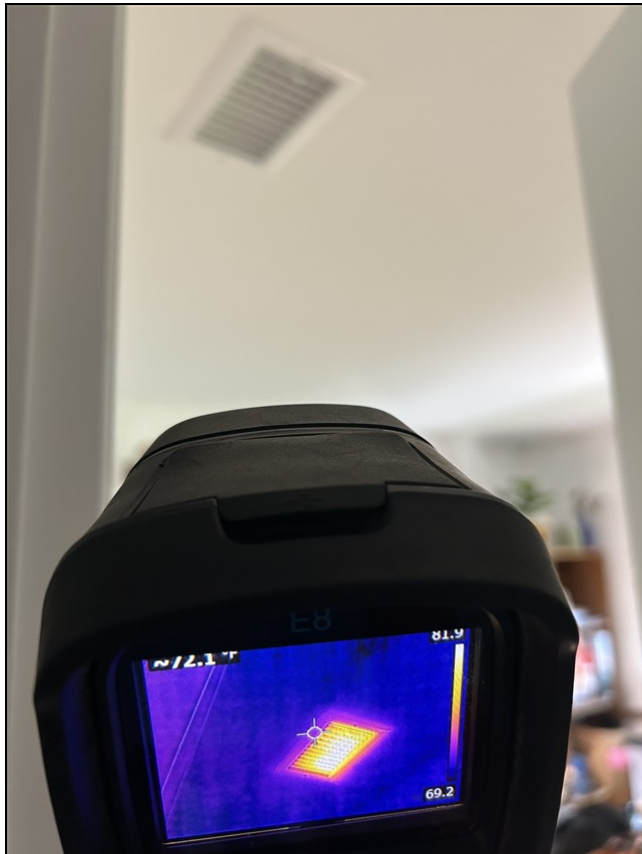
4.0 Item 1(Picture)

The furnace was tested and functional at the time of the inspection.

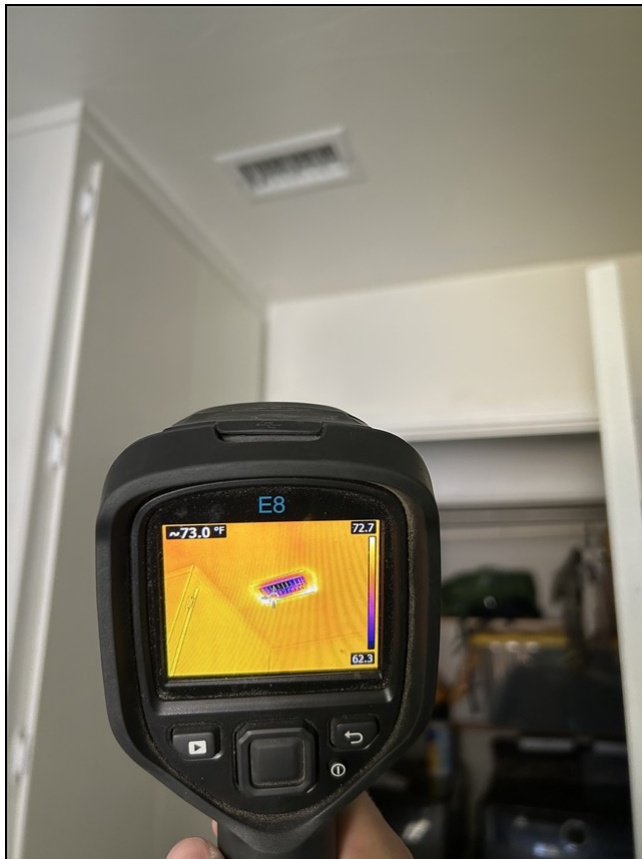
4.4 Item 1(Picture)

The AC was tested and functional at the time of the inspection.

Recommend a secondary drain pan or shut off switch installed in the air conditioner condensation removal system. While this may not have been required at the time of construction, the addition of this simple mechanism can help prevent a moisture leak within the home if the condensation drain system were not fail.

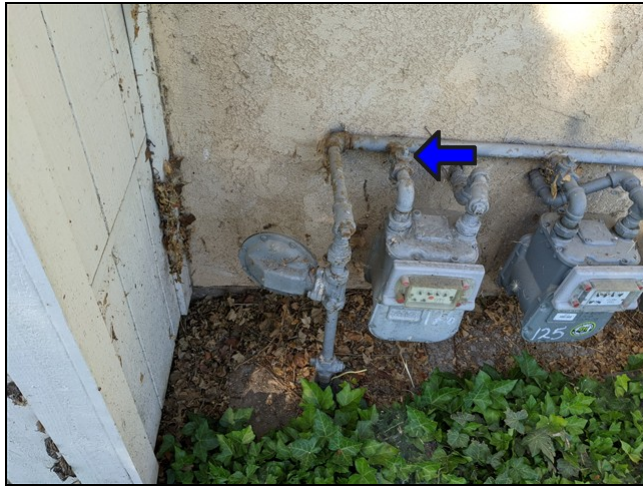
5.3 Item 1(Picture)

The gas shutoff is located at the right exterior of the home. To turn the gas off turn the valve perpendicular to the piping.

Recommend gas meter wrench permanently located near the gas meter. This upgrade will improve safety in the event of an emergency.

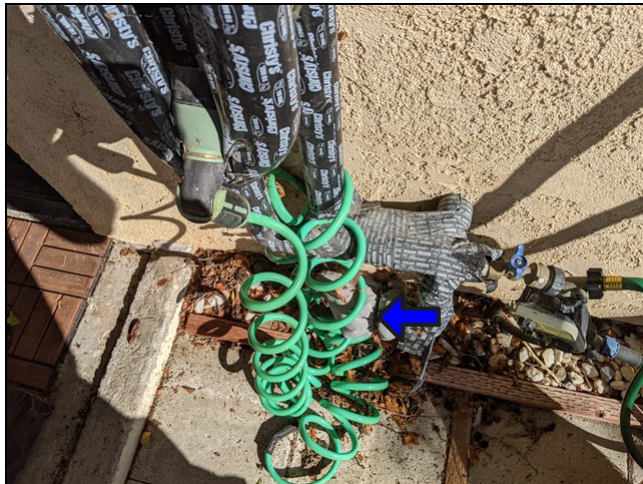
5.4 Item 1(Picture)

The front water shutoff is located at the front exterior of the home. To turn the water off turn the handle perpendicular to the piping.

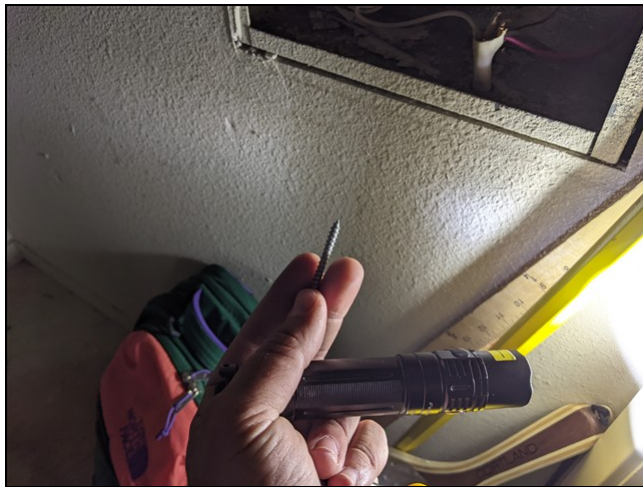
6.1 Item 1(Picture)

Sub panel front cover screws have pointed ends and are improper. Recommend proper non-pointed fasteners utilized to prevent damage to the wires and a possible unsafe condition.

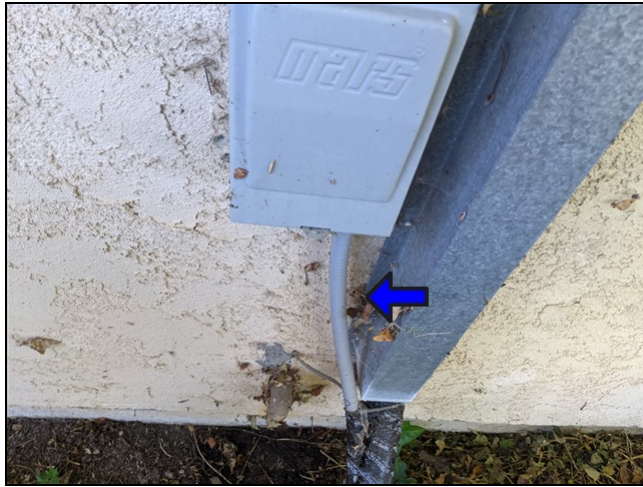
6.4 Item 1(Picture)

Conduit needs properly secured at the air conditioner power supply.

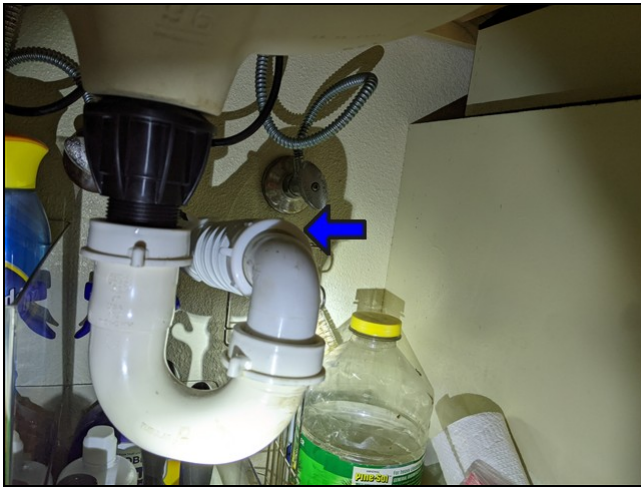
7.2.A Item 1(Picture)

Flex drain line utilized in the drain system under the sink. Recommend proper drain parts and methods utilized to prevent unnecessary clogging or displacement and leaks in the drain line.
