## Home Inspection Report

**Address: 16670 Moorpark St, Los Angeles, CA  
91436**

**Inspector: Tyler Molloy**  
**Agent: Michael Mehdizadeh**  
**Report Number: TM02081826**  
**Date of Inspection: 8/18/2026**

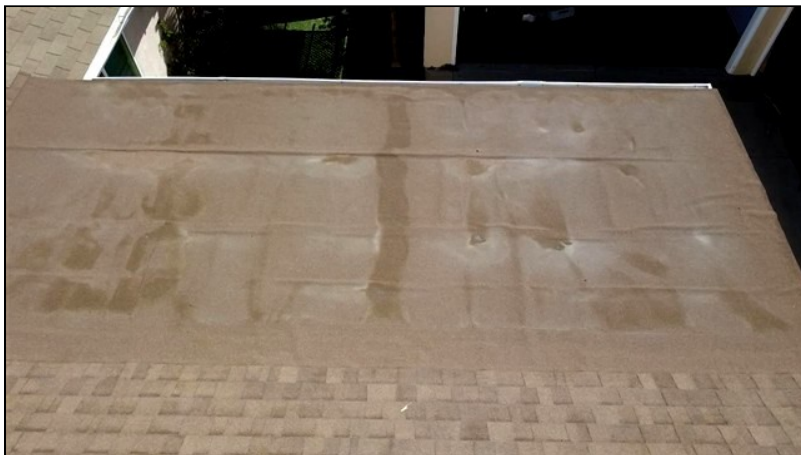
1.0.A Item 1(Picture)

(1) Blistering observed. We recommend further review of the entire roofing system by a qualified roofer, prior to the release of contingencies.

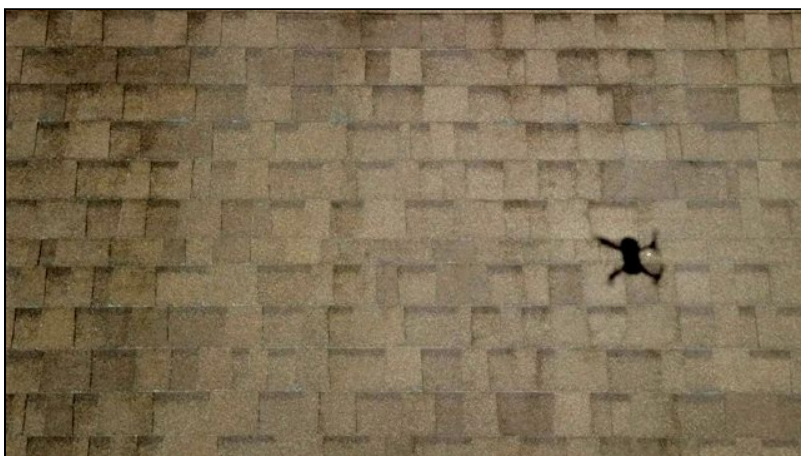
1.0.A Item 2(Picture)

(3) Roof coverings are degranulating in areas. Recommend maintenance.

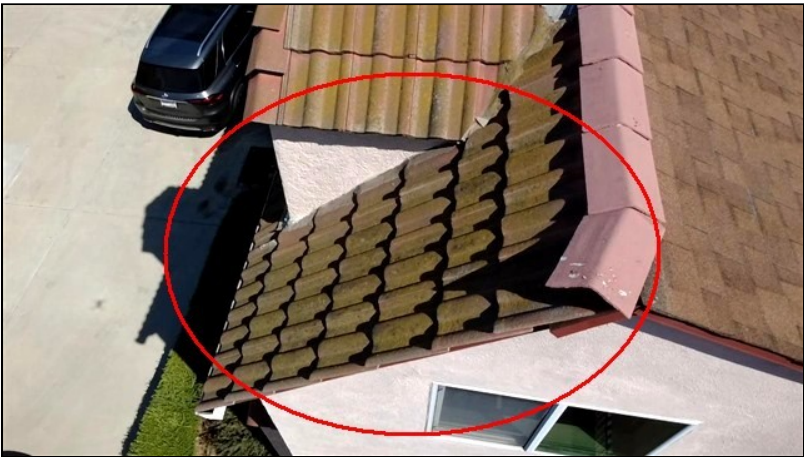
1.0.A Item 3(Picture)

(4) Green material observed on coverings. Recommend correcting.

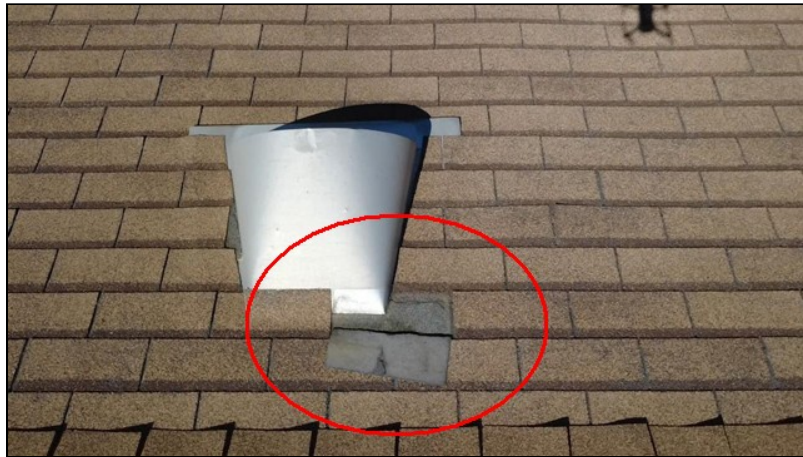
1.0.B Item 1(Picture)

(1) Roofing material is beyond its estimated service life. We recommend further review of the entire roofing system by a qualified roofer, prior to the release of contingencies.

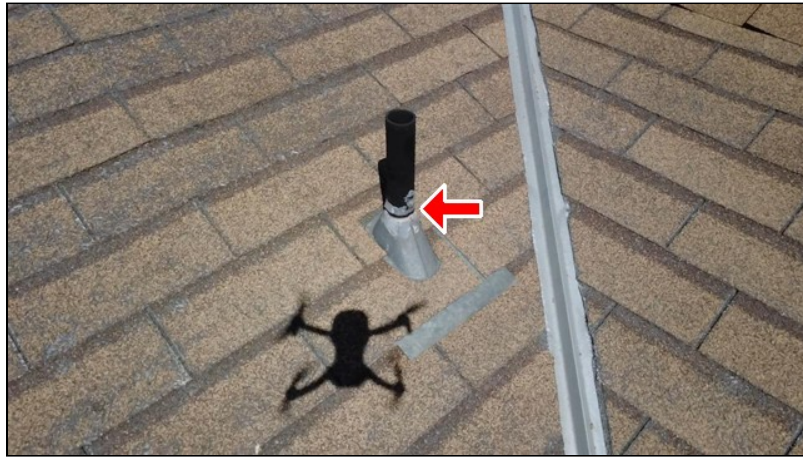
1.1.B Item 1(Picture)

Deteriorated sealant observed at a number of roof penetrations. Suggest re-sealing.

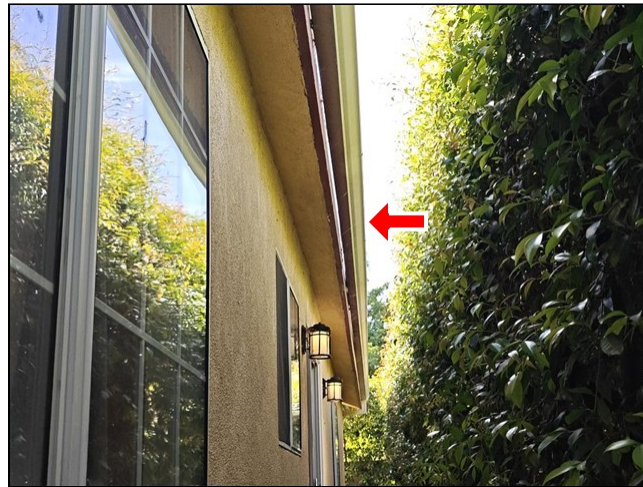
1.3.B Item 1(Picture)

Loose gutter observed at rear house. Recommend repair.

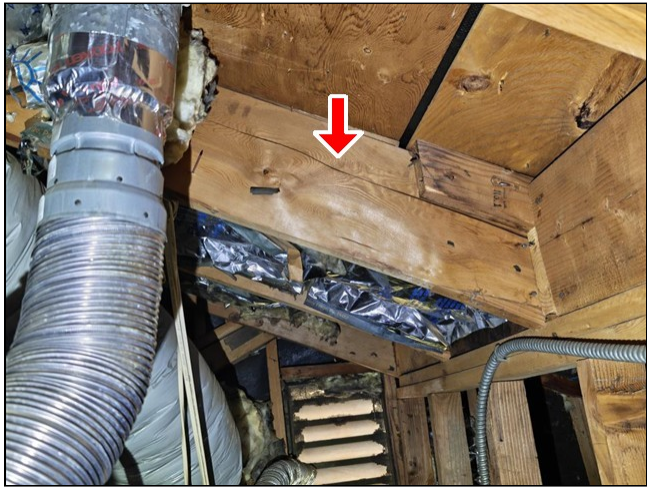
2.1.A Item 1(Picture)

Split rafter observed. Recommend repair.

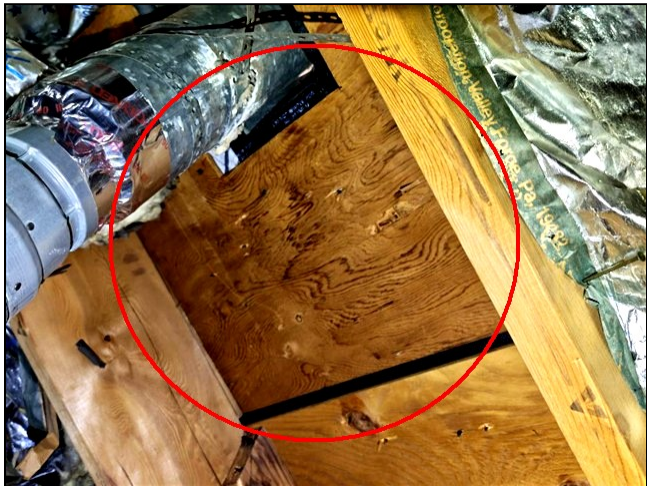
2.2.A Item 1(Picture)

Water staining observed at the sheathing. We are unable to determine if this is from active leaking or older water staining. We recommend further review of the entire roofing system by a qualified roofer, prior to the release of contingencies.

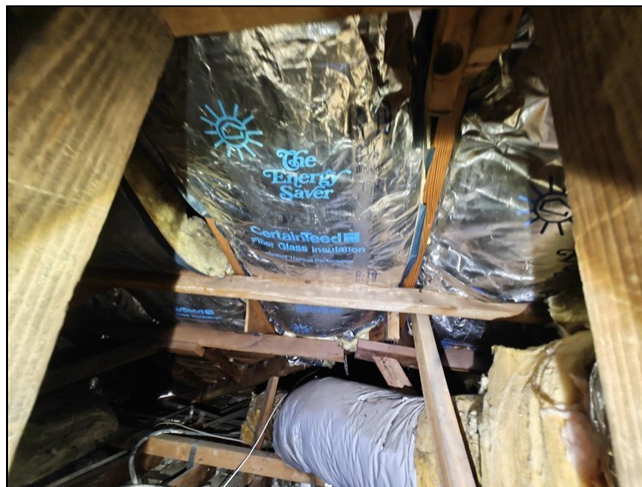
2.3.A Item 1(Picture)

(1) The insulation is installed with paper side exposed - safety concern. Recommend correcting.

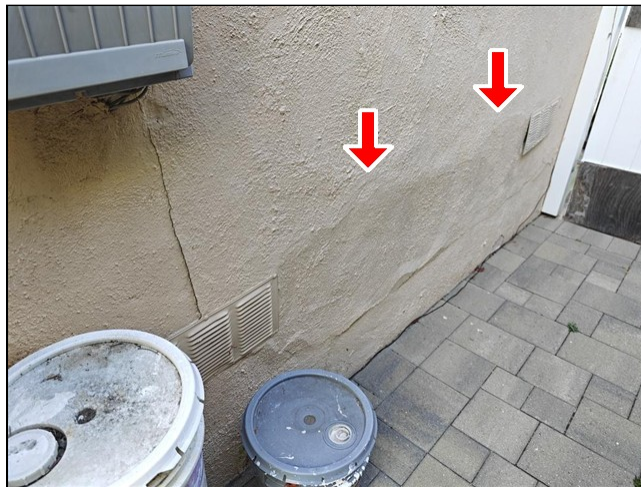
3.2 Item 2(Picture)

(4) Cracks observed at the wall cladding in a number of areas. Suggest repair.

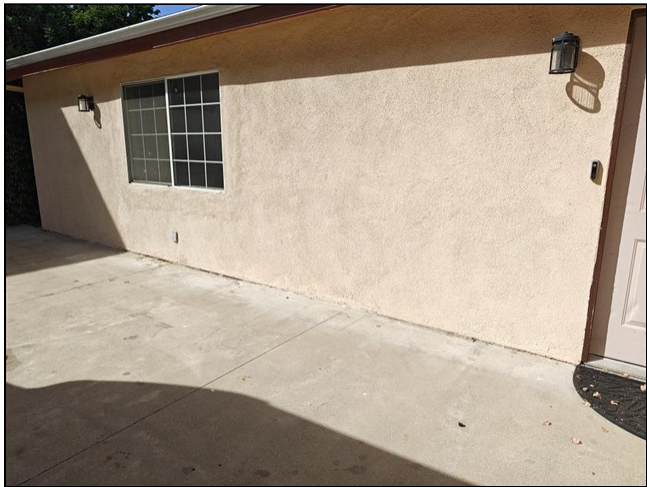
3.2 Item 3(Picture)

(5) Bulging observed at the left side. Recommend further review by a qualified contractor, prior to the end of the contingency period.

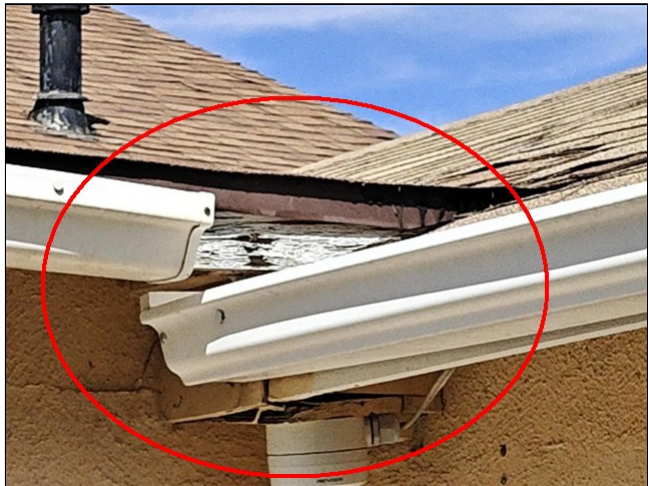
3.3 Item 1(Picture)

Deterioration observed in areas. We recommend further evaluation by a qualified termite specialist, prior to the release of contingencies.

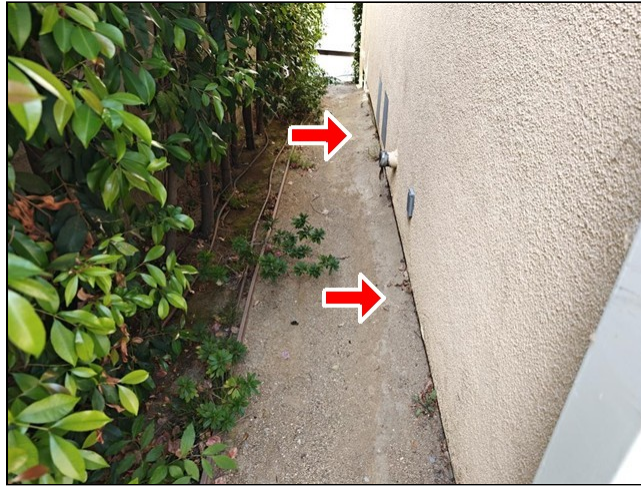
3.4 Item 1(Picture)

(1) Insufficient clearance observed between planters and the exterior wall. A two inch space between the planter and exterior wall is recommended to prevent moisture intrusion. Recommend correcting.

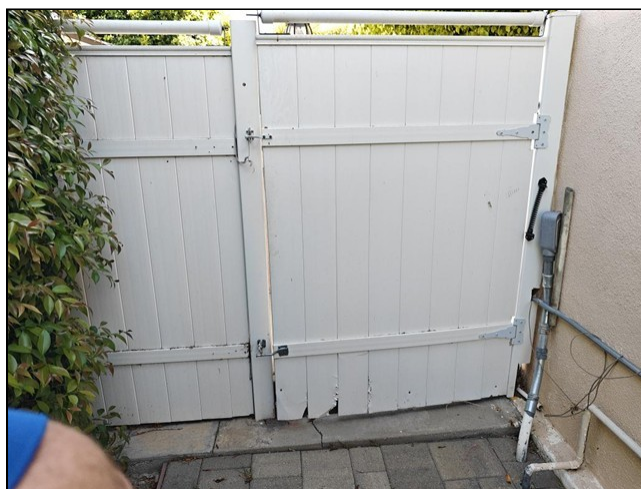
3.8 Item 1(Picture)

Loose and damaged gate at left side of home. Suggest repair.

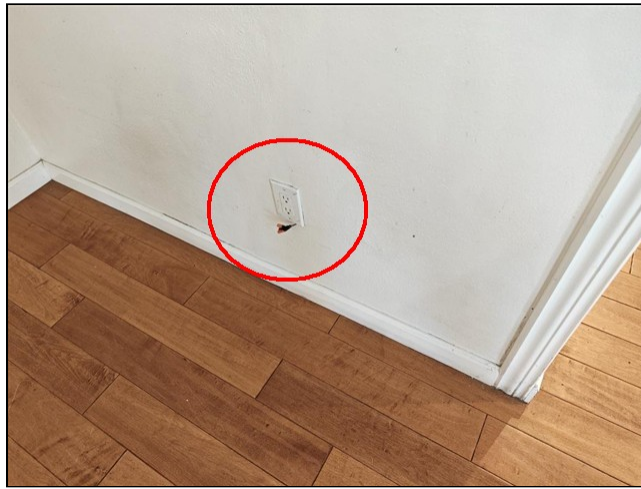
4.3 Item 1(Picture)

(1) Open splices observed at front house living room - safety concern. Recommend correcting.

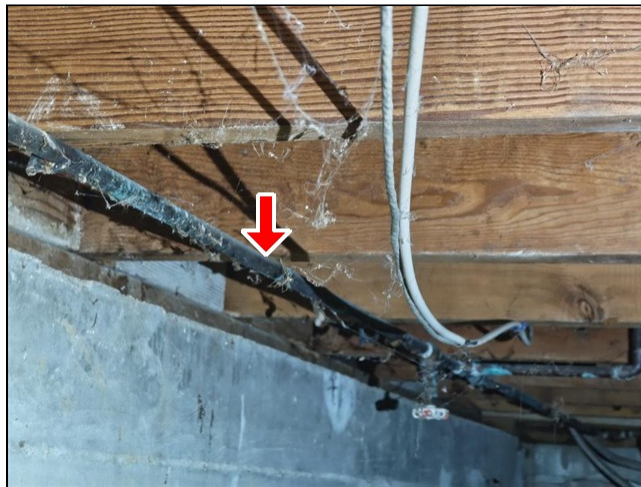
5.1 Item 2(Picture)

(1) Leaking observed at supply piping to sprinkler line at back house. Recommend repair.

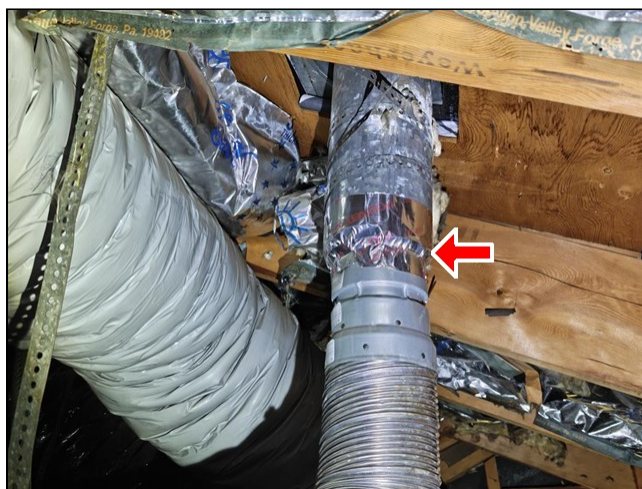
6.0.A Item 2(Picture)

(1) Exhaust vent pipe is in contact with combustible material. Recommend correcting.

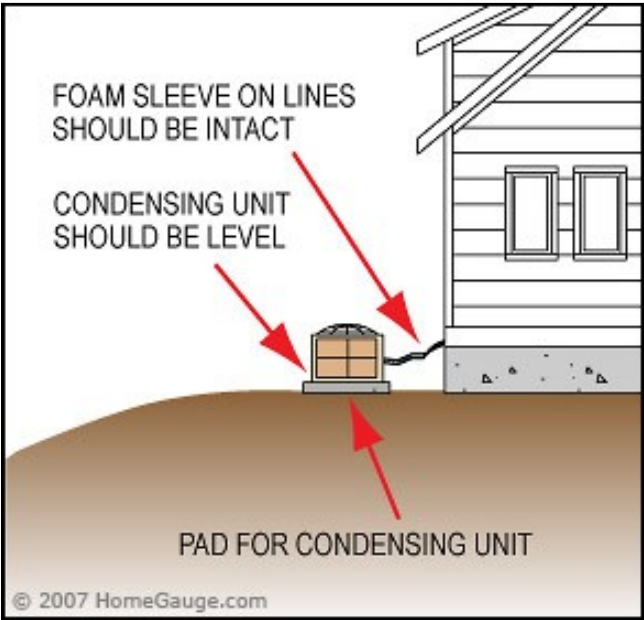
6.2.A Item 1(Picture) Condenser

(1) Deterioration or missing insulation at refrigeration line. Recommend replacement.

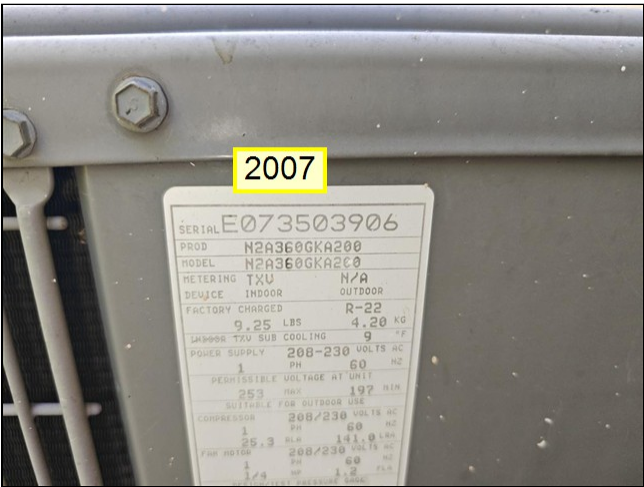
6.2.A Item 2(Picture)

(2) Condenser is not elevated 3 inches above the surrounding grade. Suggest elevating.

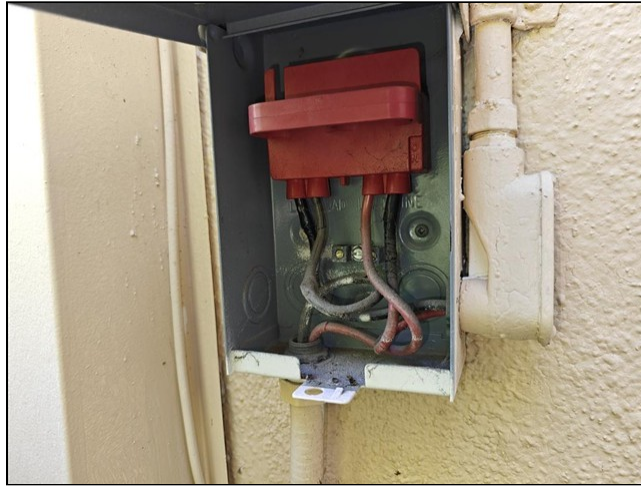
6.2.A Item 3(Picture)

(3) Air conditioner is beyond its estimated service life.

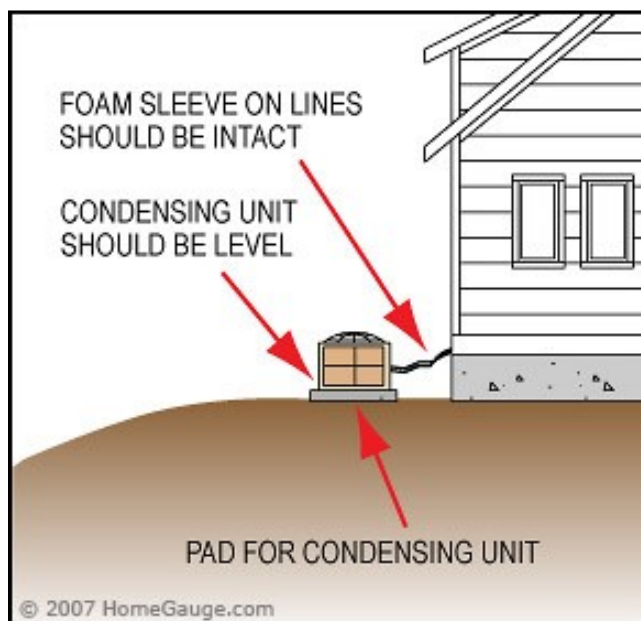
6.2.B Item 2(Picture) Condenser

(1) Deterioration or missing insulation at refrigeration line. Recommend replacement.

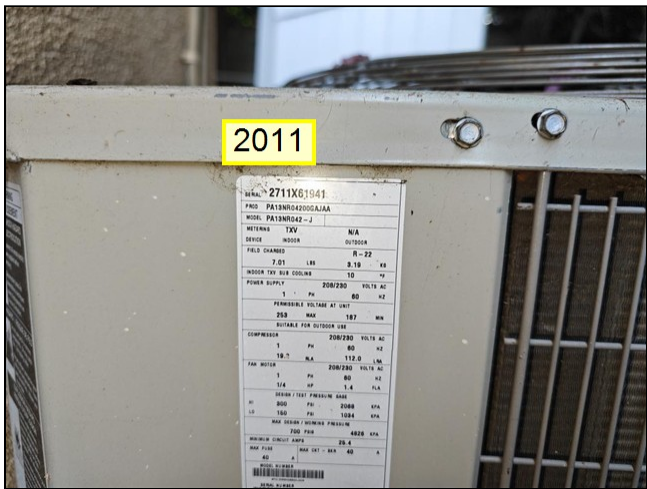
6.2.B Item 3(Picture)

(2) Condenser is not elevated 3 inches above the surrounding grade. Suggest elevating.

(3) Condenser is not strapped down/secured. Suggest correcting.

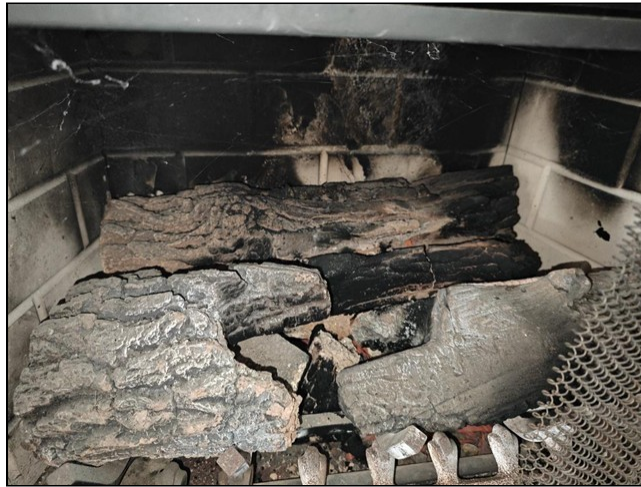
7.3 Item 1(Picture)

(1) Glass doors and a protective screen surround are not installed at living room. Recommend installing.

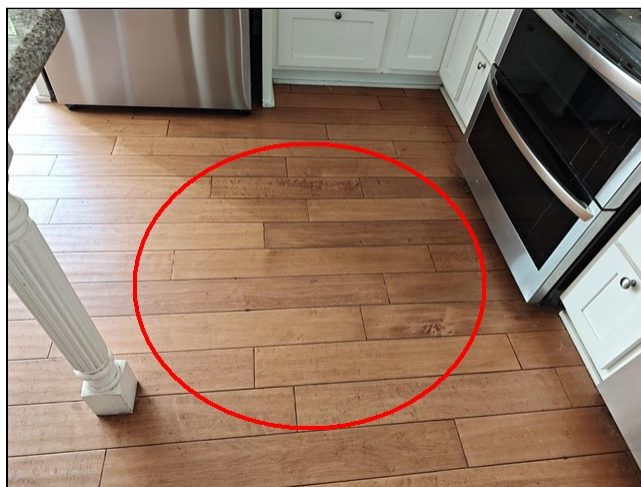
11.0.A Item 2(Picture)

(1) Sloping or even floors observed throughout the home. Recommend further review by a qualified structural engineer, prior to the end of continency period.

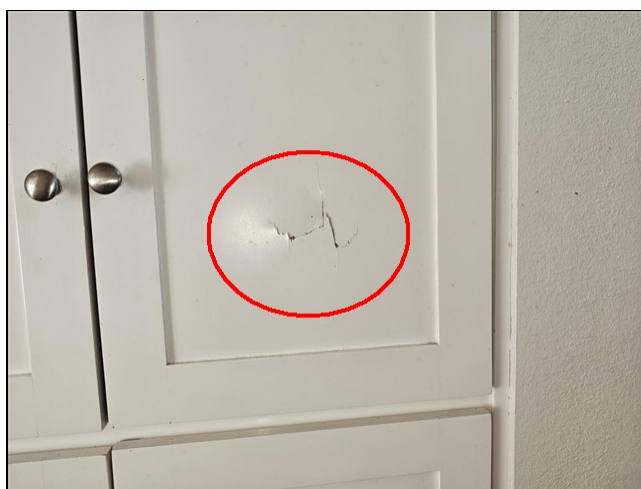
11.4.A Item 2(Picture)

(1) Moisture damage observed at kitchen cabinetry. Hidden damage may not be observable. We recommend further review by a qualified mold specialist, prior to the release of contingencies.

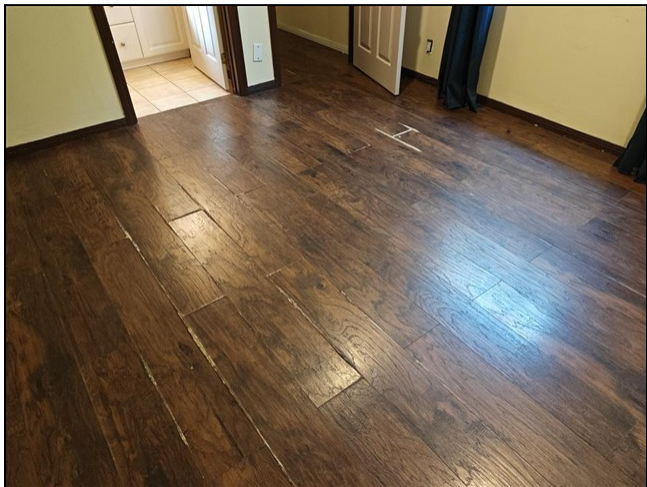
11.0.B Item 1(Picture)

(1) Sloping or even floors observed throughout the home. Recommend further review by a qualified structural engineer, prior to the end of continency period.

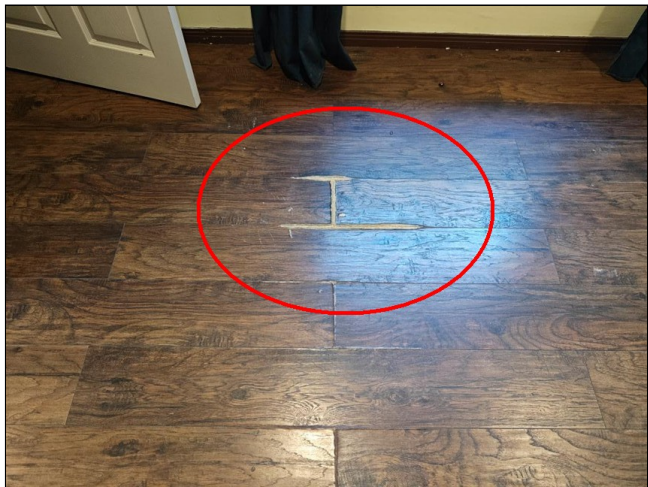
11.0.B Item 2(Picture)

(2) Excessive wear and tear observed at flooring material throughout unit. Recommend replacement.

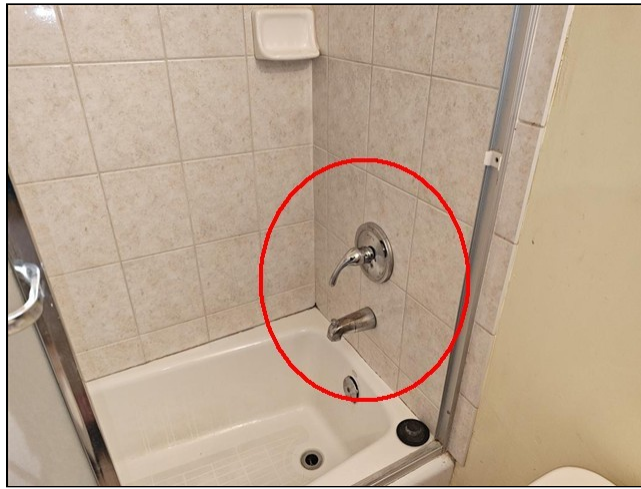
11.8.B Item 1(Picture)

(1) Faucet to tub is not functioning correctly and made unusual noise when in operation in ensuite bathroom. We recommend further review on the entire supply system by a qualified plumber, prior to the release of contingencies.

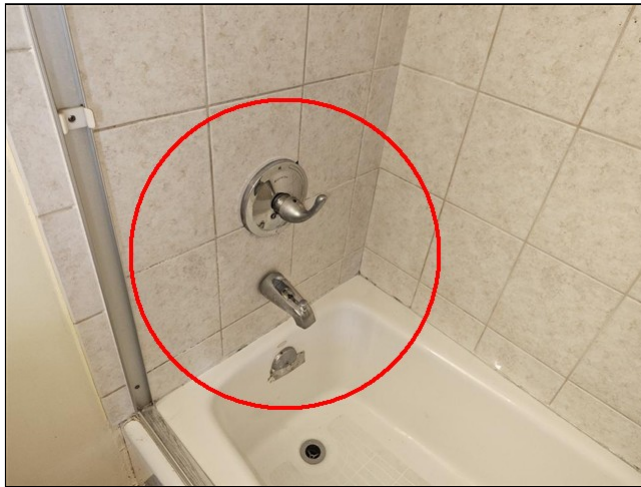
11.8.B Item 2(Picture)

(2) Missing shower head observed at ensuite bathroom shower. Suggest correcting.
