920 11<sup>th</sup> Street, Huntington Beach Ca

Inspection Date: 6/16/2026      Client: Don Archer  
 Inspector: Brian Spain      Address : 920 11<sup>th</sup> Street, Huntington Beach Ca

The home is a single family, two story structure built on a flat lot. Estimated age is approximately 35 to 40 years. Weather at time of inspection was cool and cloudy.

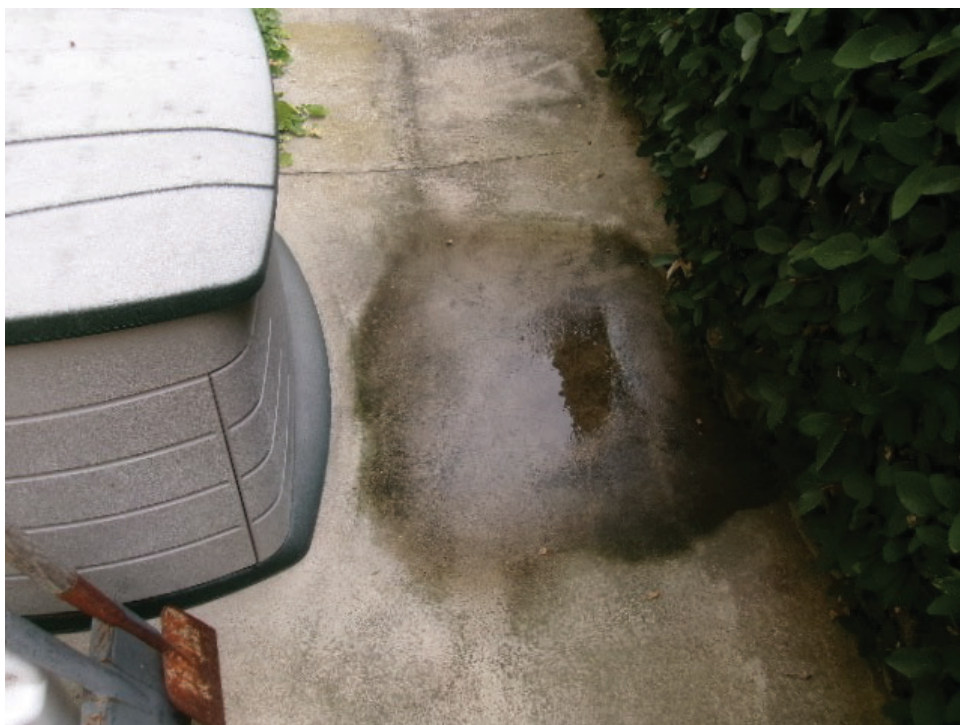
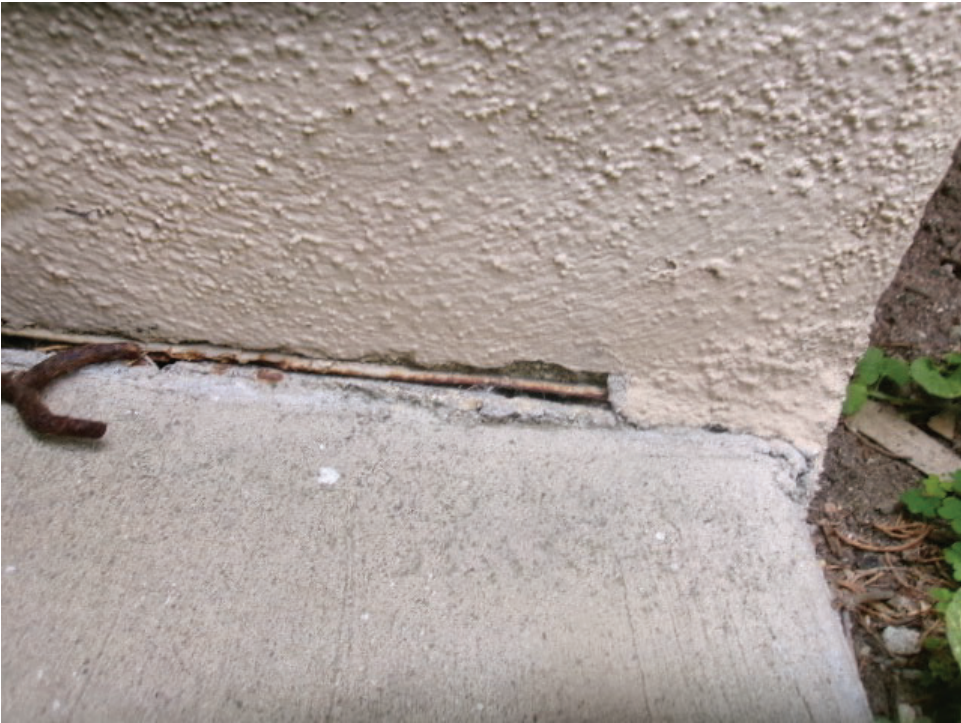
- 101 Driveway: Concrete. Cracks noted.
- 102 Walkways: Concrete, brick and stone. Water ponds at the left walk and the left walk is poured up to the weep screed, improper. See photos. Cracks noted.

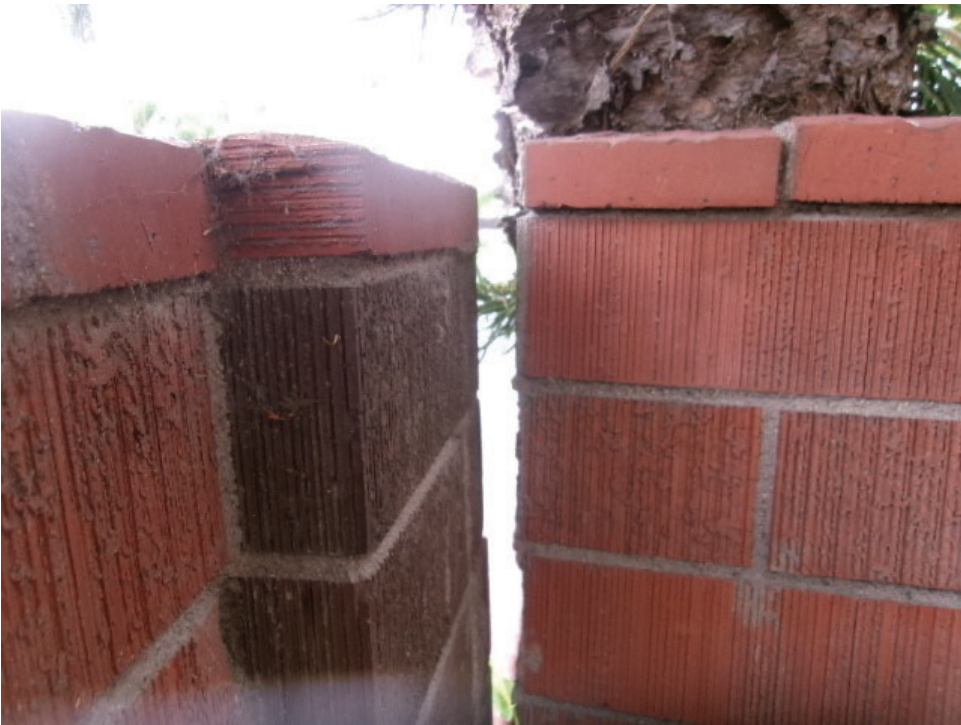
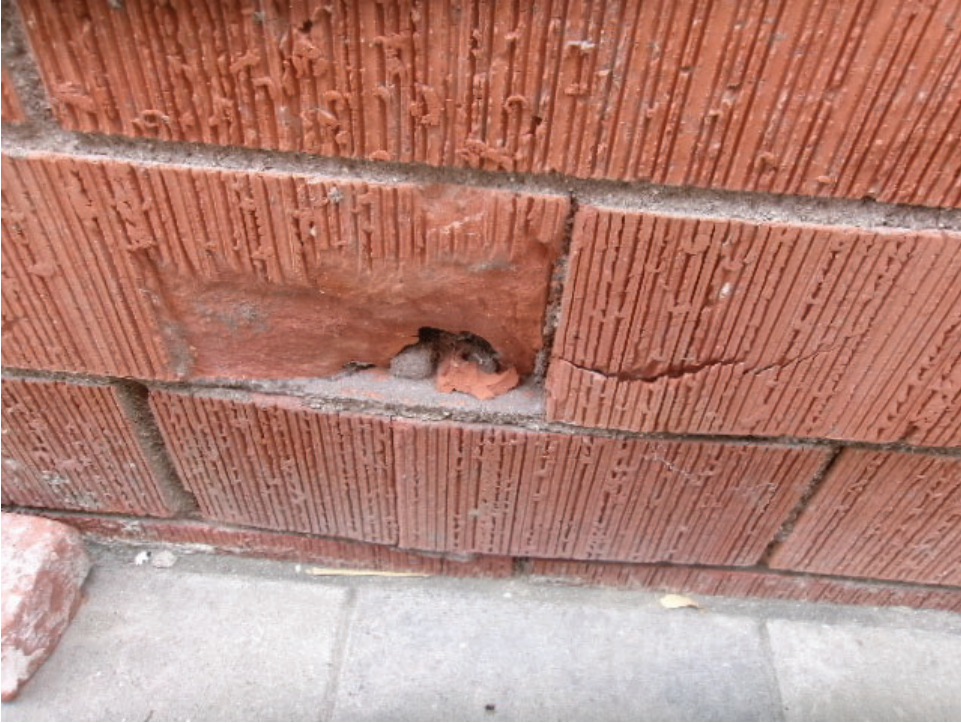
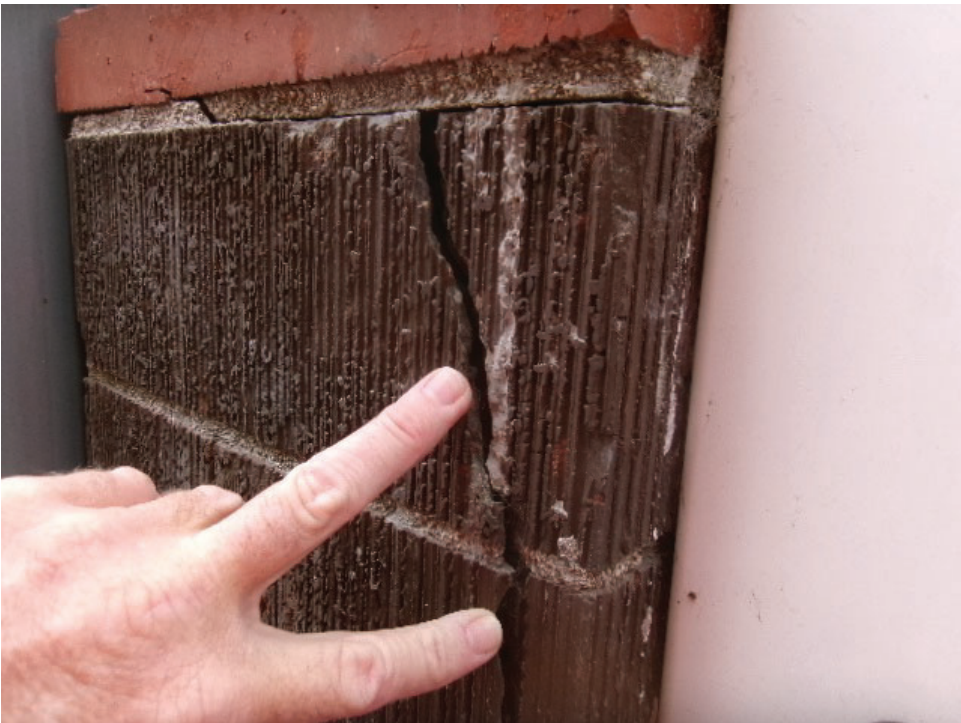
- 103 Fence/Gates: Block and vinyl. Separation at the right front wall. See photo. Cracked bricks at the right wall. See photos.
- 104 Siding: Stucco and brick. Paint is peeling at the rear wall. See photo.

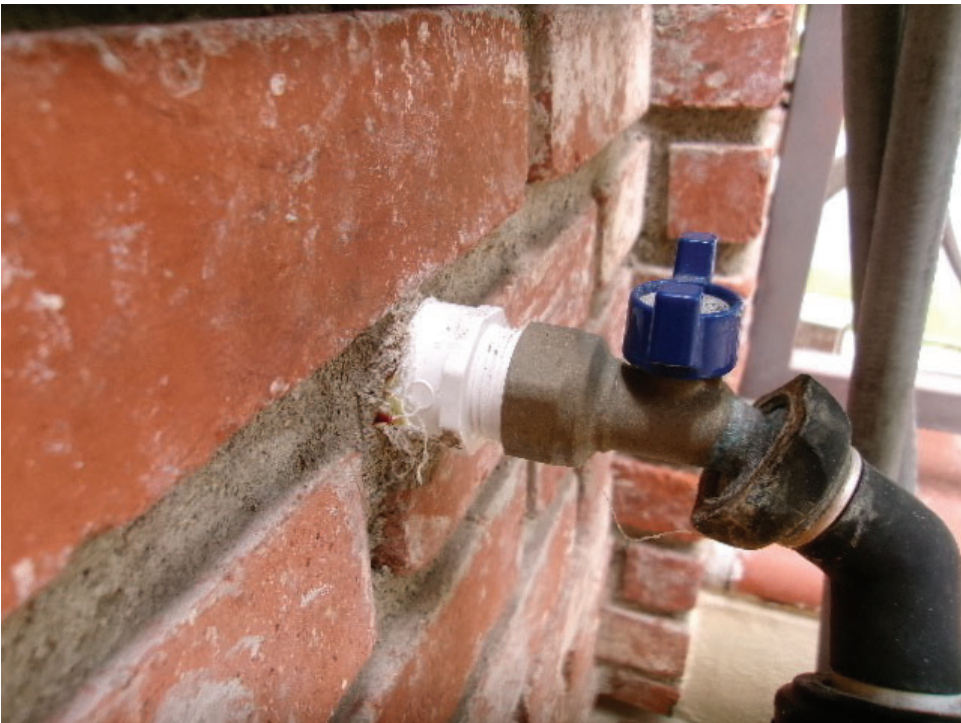
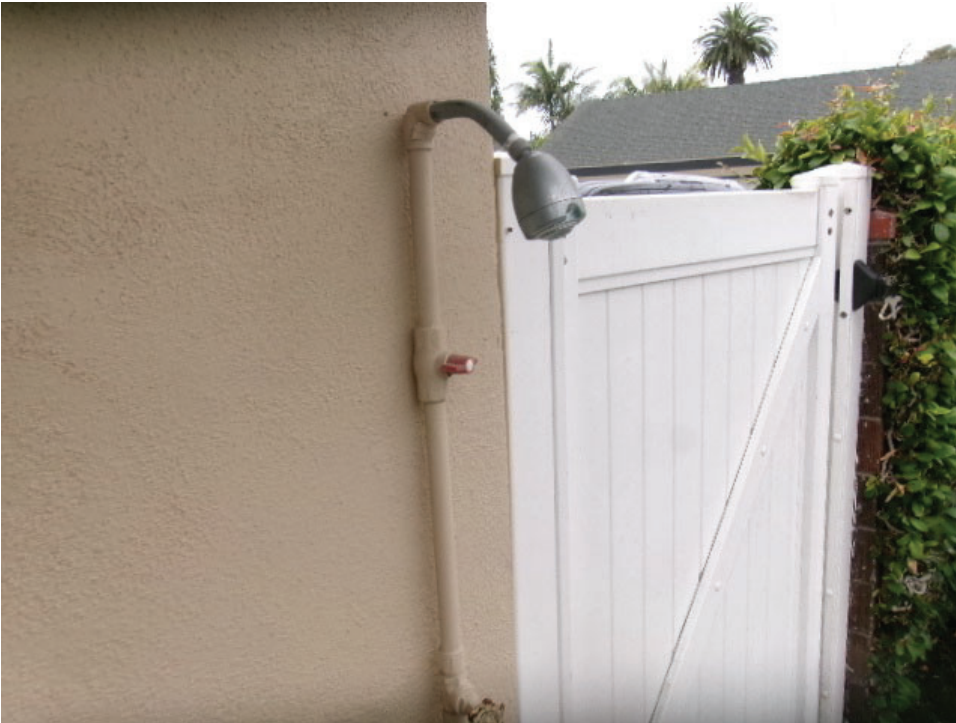
- 109a Hosebibs: PVC supply at the balcony hose bib. See photo. Shower noted at the garage wall, broken shut off handle noted. See photo.
- 110 Ext. Doors/Screens: S

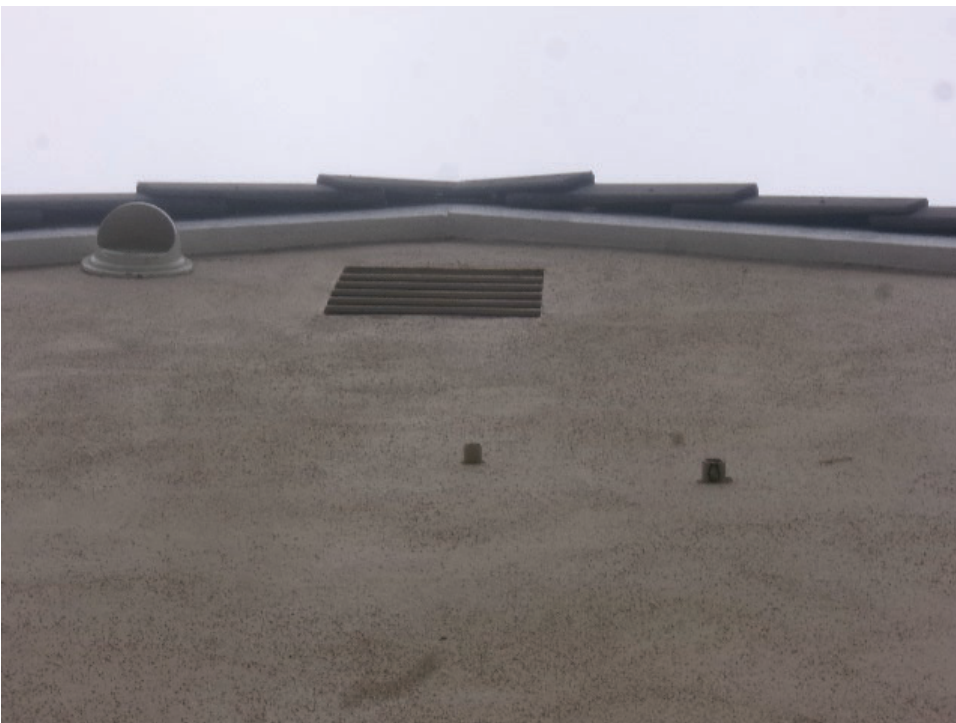
- 113 Gas Meter: Located at the right side.
- 114 Foundation: Concrete slab construction.
- 115 Crawl Space: N
- 116 Exterior Comments: Two discharge pipes are run out the left wall second level, suggest adding 90 degree elbow to prevent water from running back into the wall along one pipe and extending the water heater T and P discharge pipe to within six inches of the ground for safety as required. See photo.

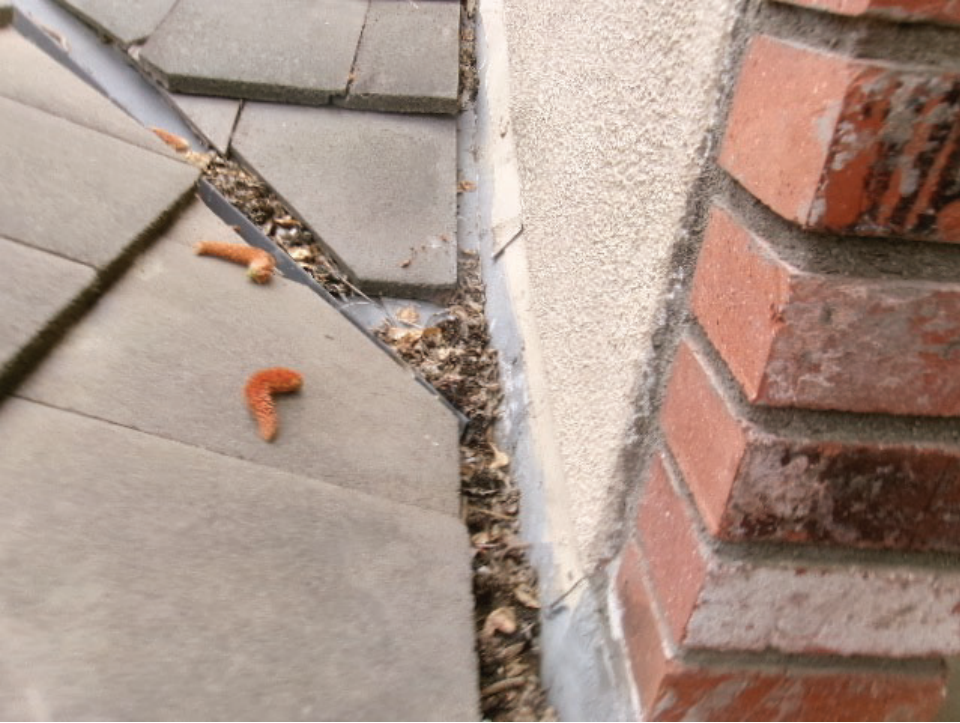
- 126 Type/Material: Sloped construction, tile covering. Observed from the ground and attic.
- 127 Flashing: Appears intact. Tree debris gets stuck in the cricket at the left of the balcony. See photo.
- 128 Roof Comments: Roof was visually inspected from accessible points on the interior and/or exterior. If a roof is too high, or is composed of materials which can be damaged if walked upon, the roof is not mounted. Therefore, client is advised that this is a limited review and a licensed roofer should be contacted if a more detailed report is desired. Broken tiles noted, suggest replacement. See photos. Several tiles have been replaced at the right chimney.

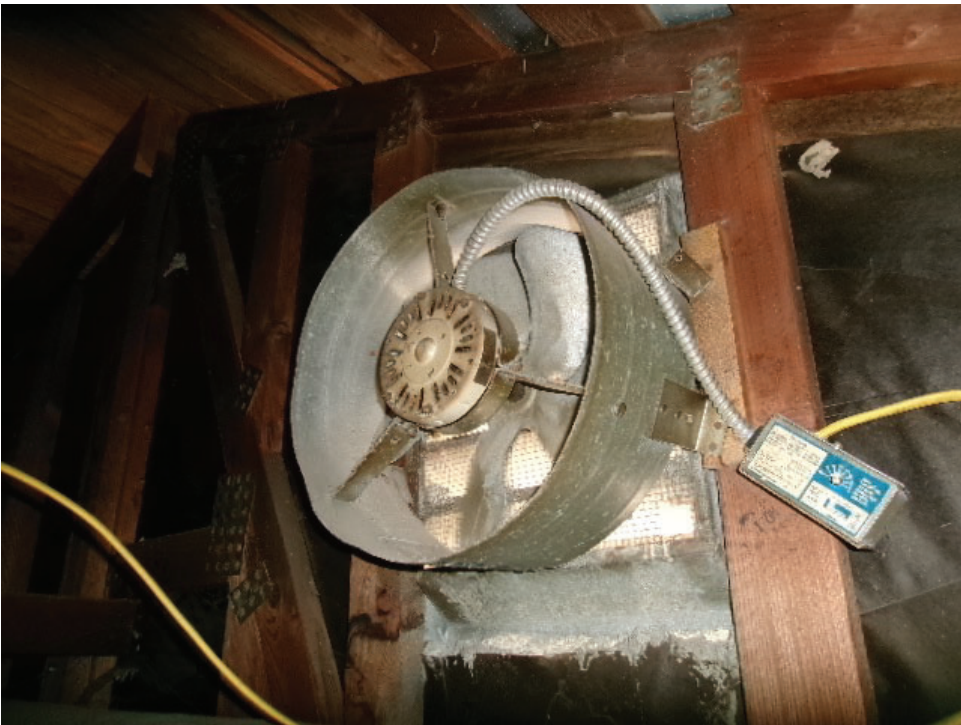
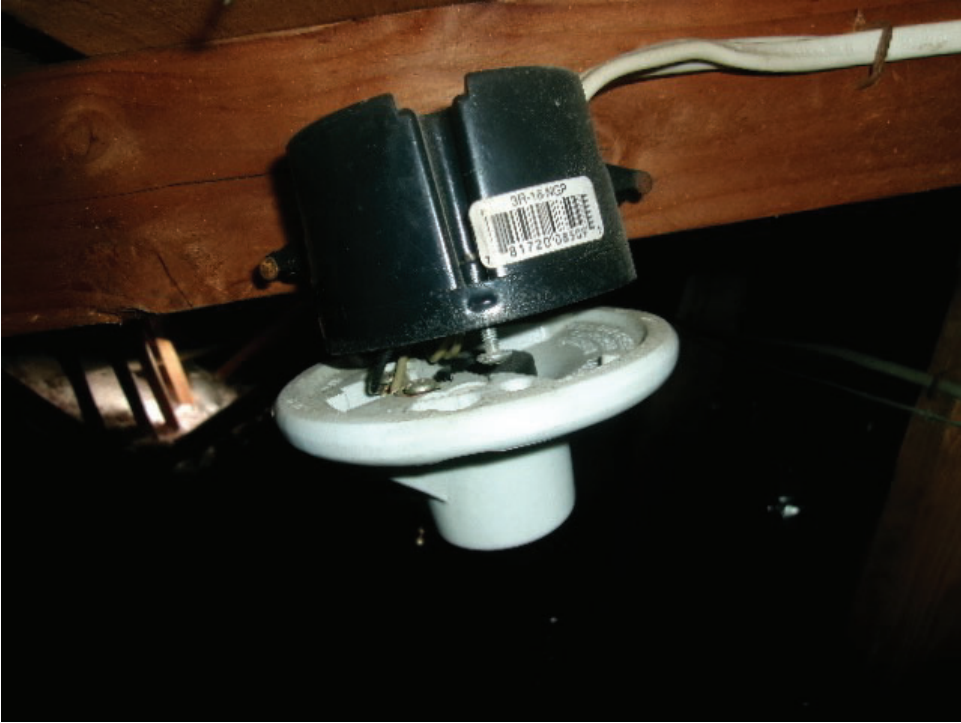
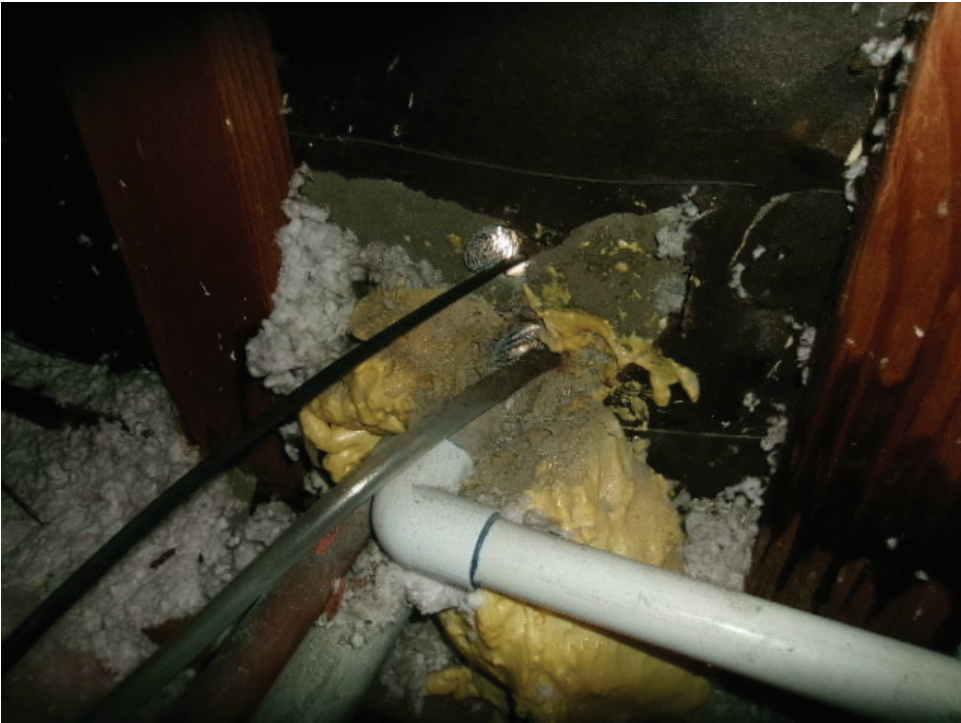
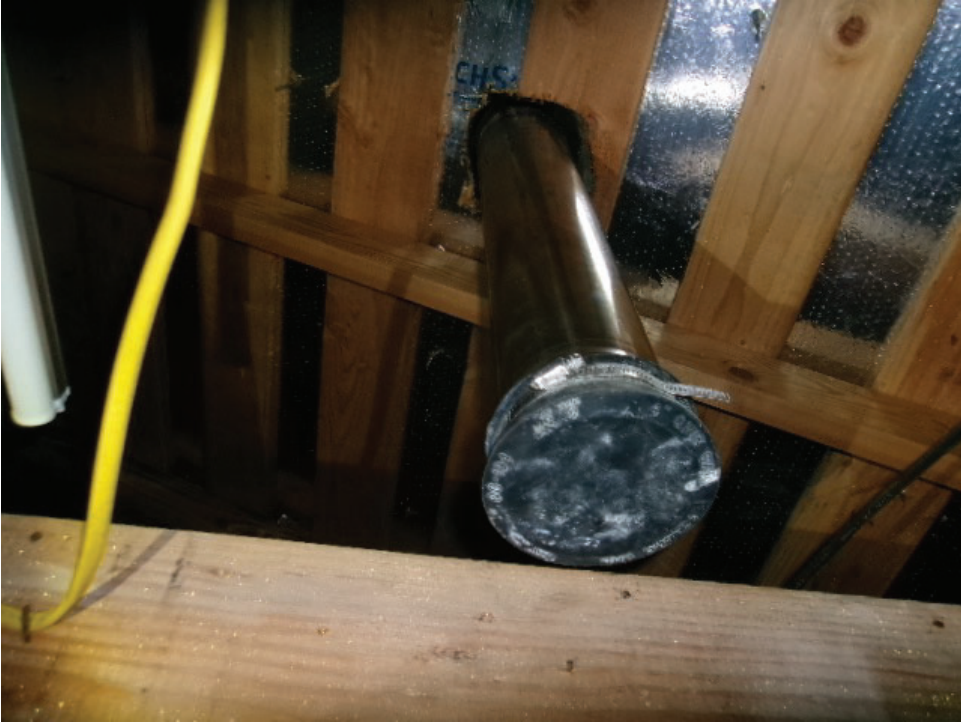
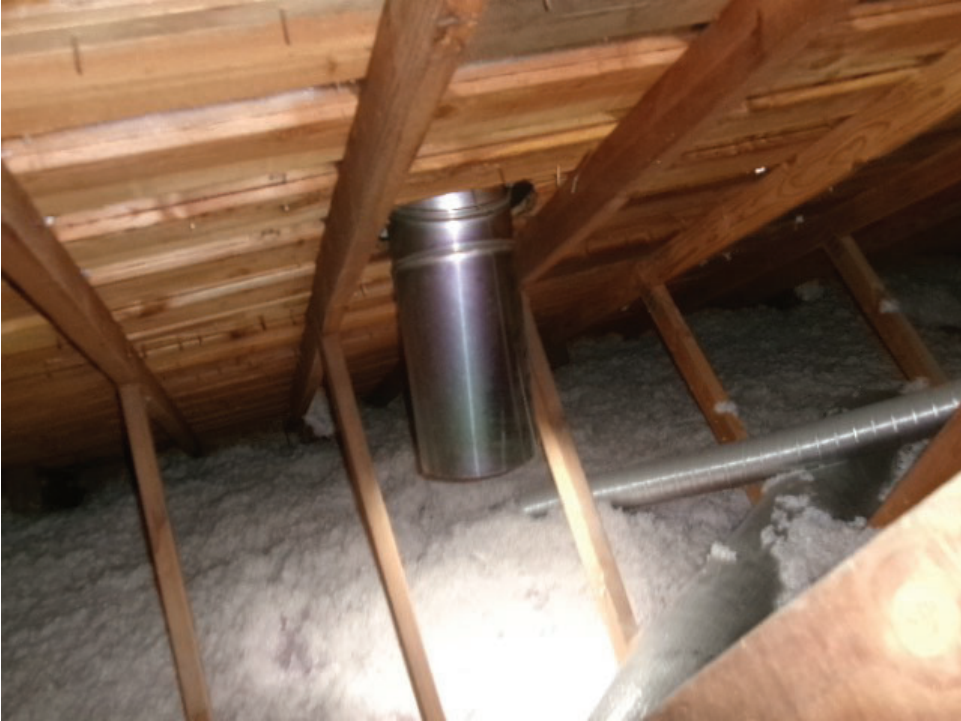
136 Access: Located at the laundry room and master closet. Accessed.  
 137 Framing: Trusses.  
 138 Sheathing: Oriented strand board.  
 139 Evidence of Leaking: No.  
 140 Insulation: Present. Blown insulation. Where visible, approximate thickness is ten inches.  
 141 Ventilation: Eave vents and attic fan noted. Operated. See photo.  
 142 Electrical: Present.  
 143 Attic Comments: Loose socket fixture above the laundry room. See photo. Hole in the right wall of the drain pipe run out of the wall. See photo. Old water heater vent pipe left in the roof above the master closet. See photo. Solar tube above the hall bathroom is no longer run through the ceiling. See photo.

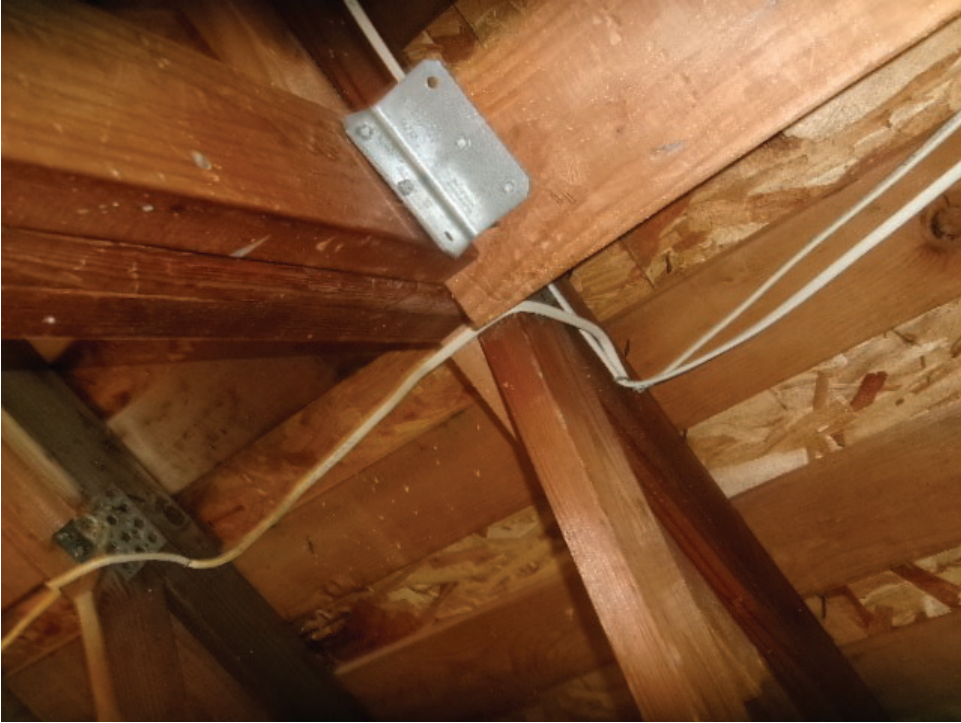
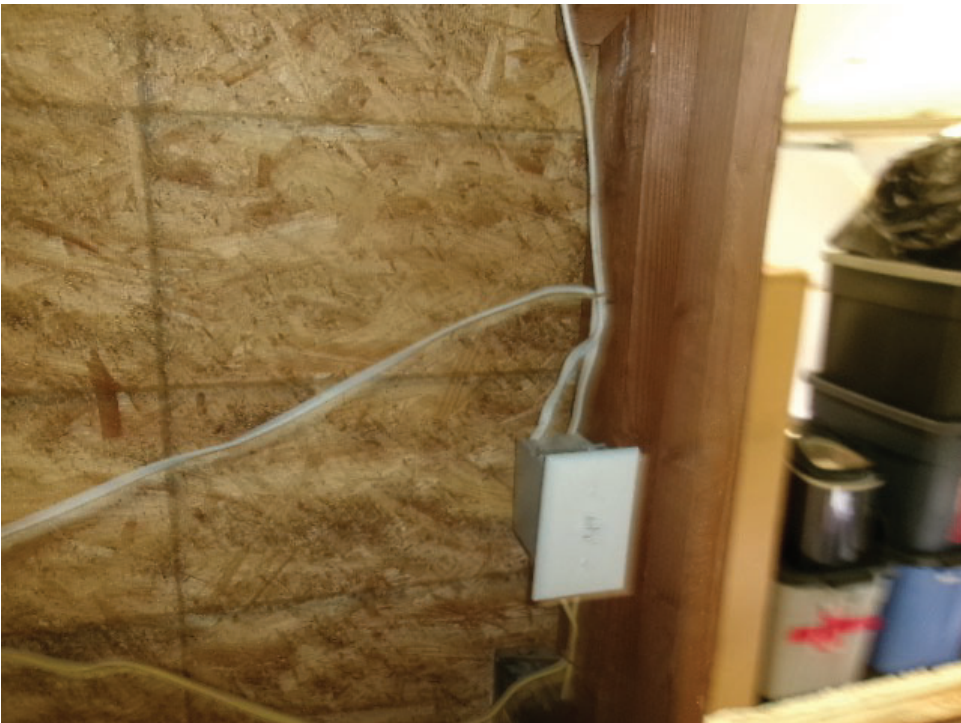
201 Exterior: Stucco. Patching and peeling paint at the rear wall.  
 202 Roof: See roof comments.  
 203 Slab: Concrete. Water ponds on the slab.  
 204 Garage Door: Metal. Two doors, damage at the frame of the large door.  
 205 Garage Door Hdwr: S  
 206 Door Opener: Safety reverse noted, we suggest periodic testing of the safety reverse operation.  
 207 Windows/Screens: N  
 208 Access Door: S  
 209 Fire Door: N  
 210 Fire Wall: N  
 211 Walls: S  
 212 Electrical: GFI present. Exposed wiring in the attic area overhead. See photos. Missing light panels.  
 213 Garage Comments: N

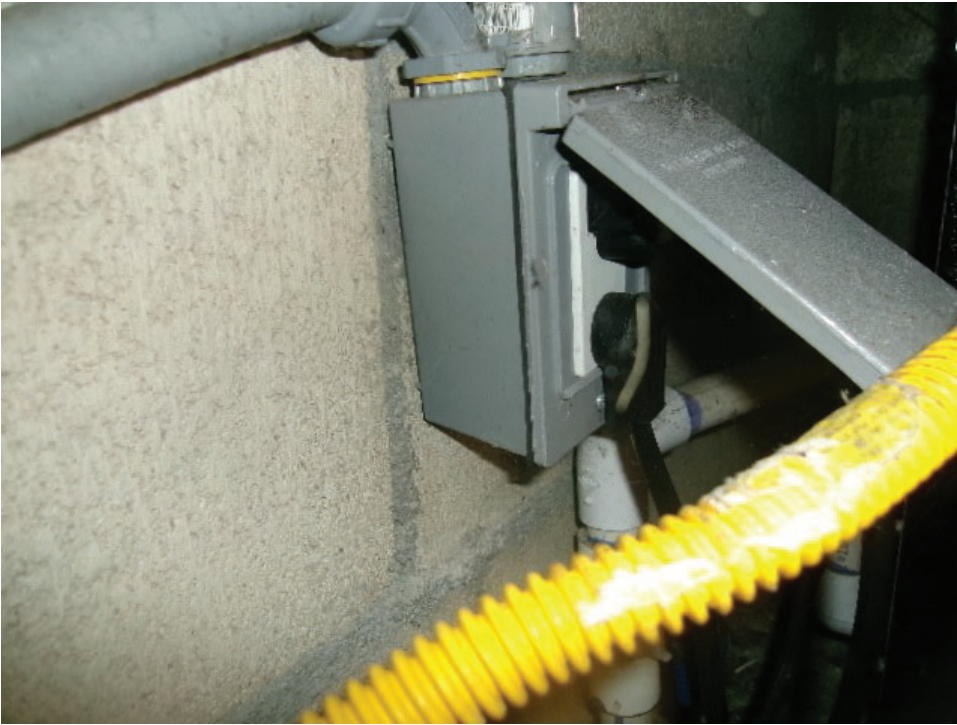
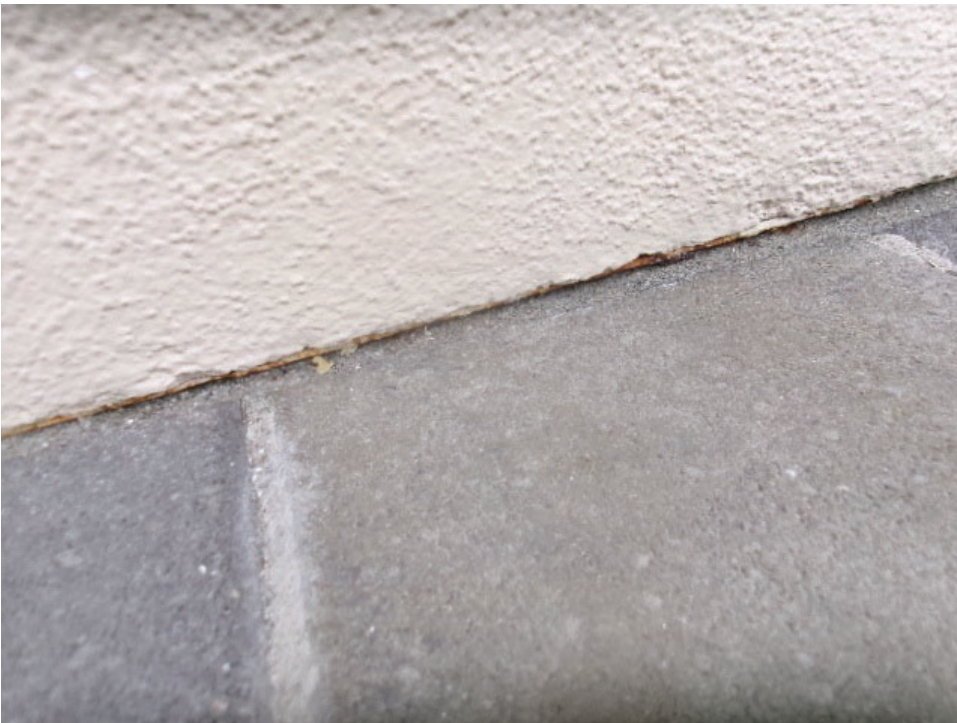
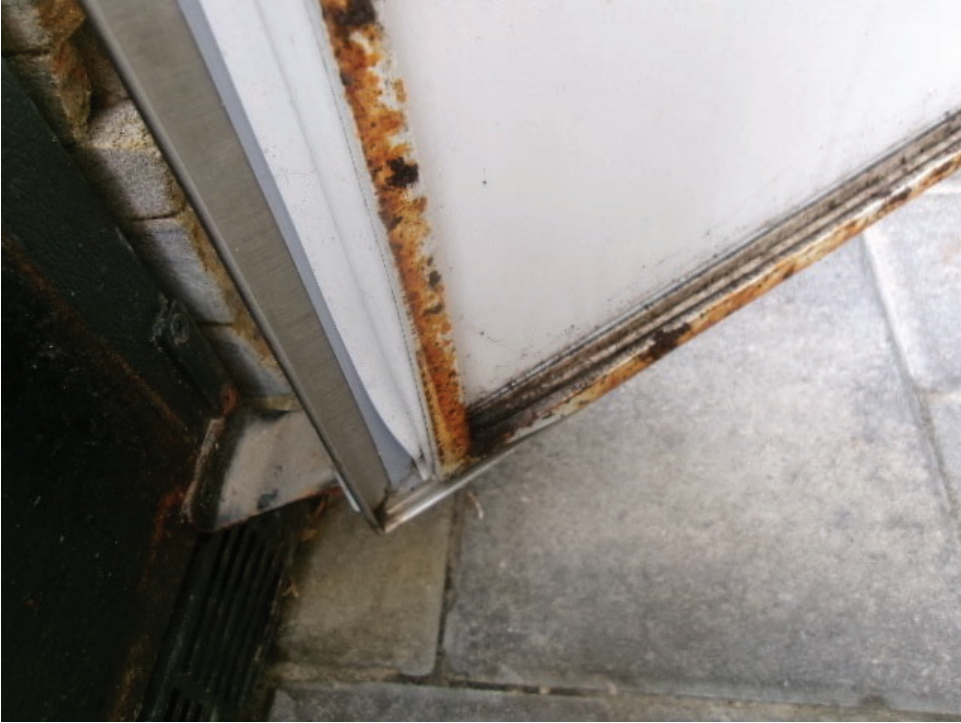
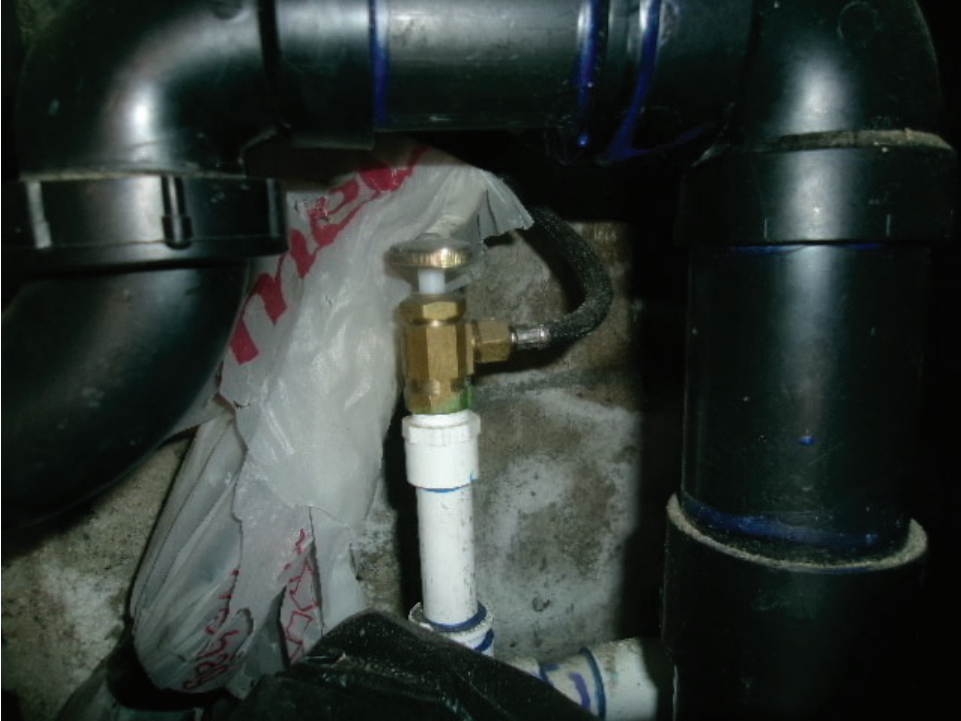
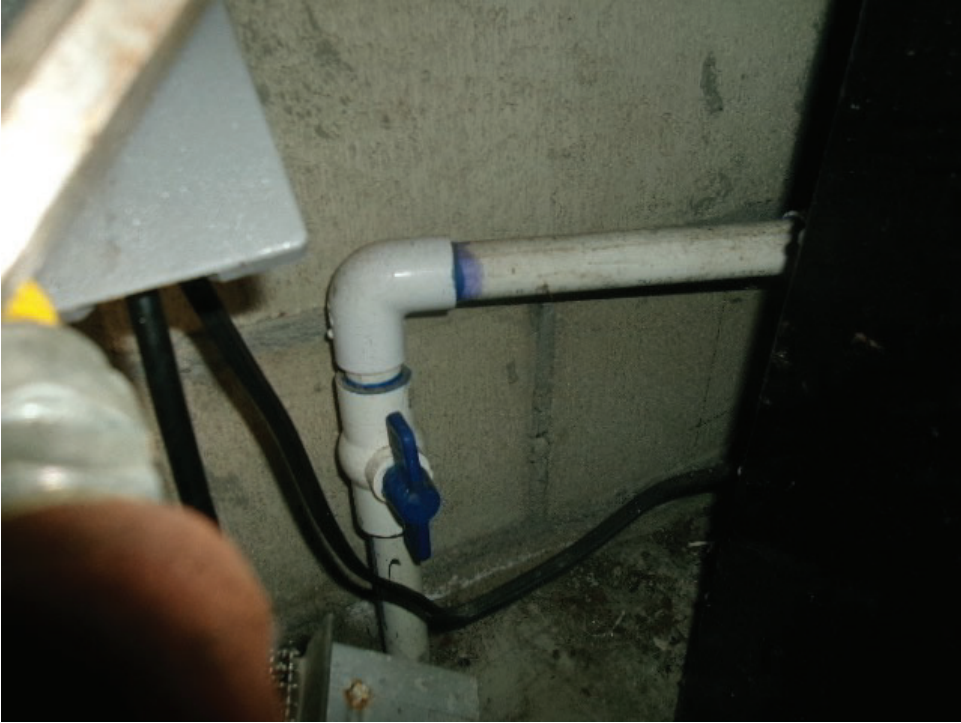
301 Cover: Aluminum. Motorized louvers tested.  
 302 Enclosure: N  
 303 Electrical: GFI present. Missing in use cover at the outlet below the grill. See photo.  
 304 Window/Screens: N  
 305 Deck/Slab: Pavers. Set up the weep screed, improper. See photo.  
 306 Stairs: N  
 307 Railing: N  
 308 Comments: The grill was tested. The center burner did not ignite. Two cooler drawers were cold. The ice make is not in use at this time. Evidence of what might be mold on the door. See photo. PVC supply to the sink and ice maker. See photos.

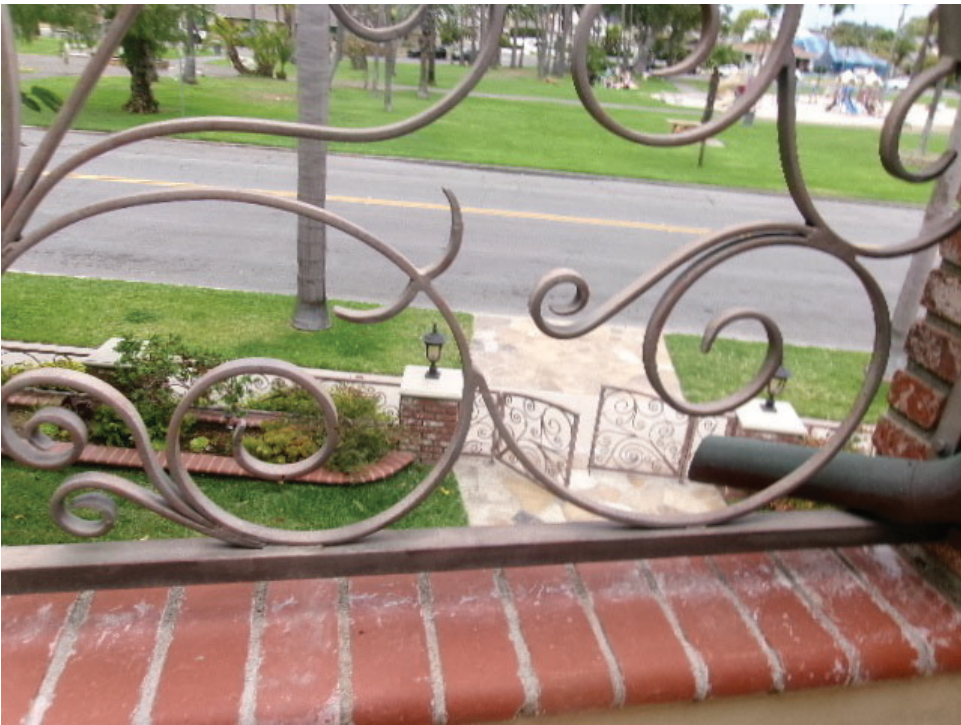
311 Cover: N  
 312 Enclosure: N  
 313 Electrical: GFI present. Two wall lights did not operate.  
 314 Window/Screens: N  
 315 Deck/Slab: Wood. No overflow drain noted, keep the drains clear to prevent damage.  
 316 Stairs: N  
 317 Railing: Large spaces noted between the railing spindles, potential safety hazard for children.  
 318 Comments: N

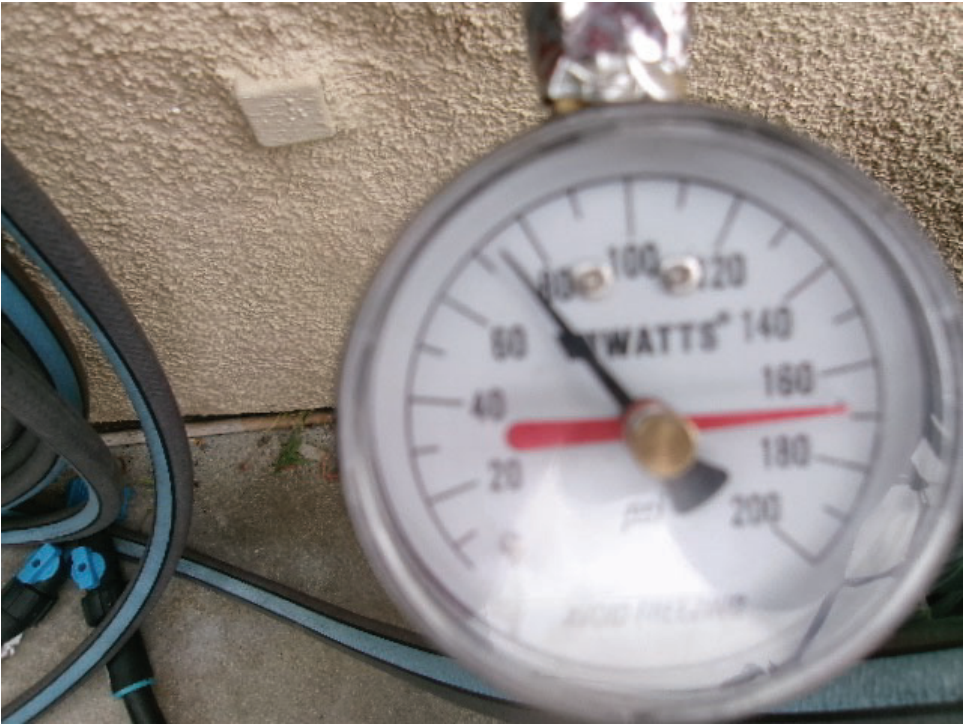
- 403 Thermostat: Operable. Located at the entry and upper hall.
- 404 Ducting: Intact.
- 405 Plumbing: Water supply provided by public system. Piping, where visible, is copper. Main shut off is located at the rear wall. 72 PSI at the main. See photo.

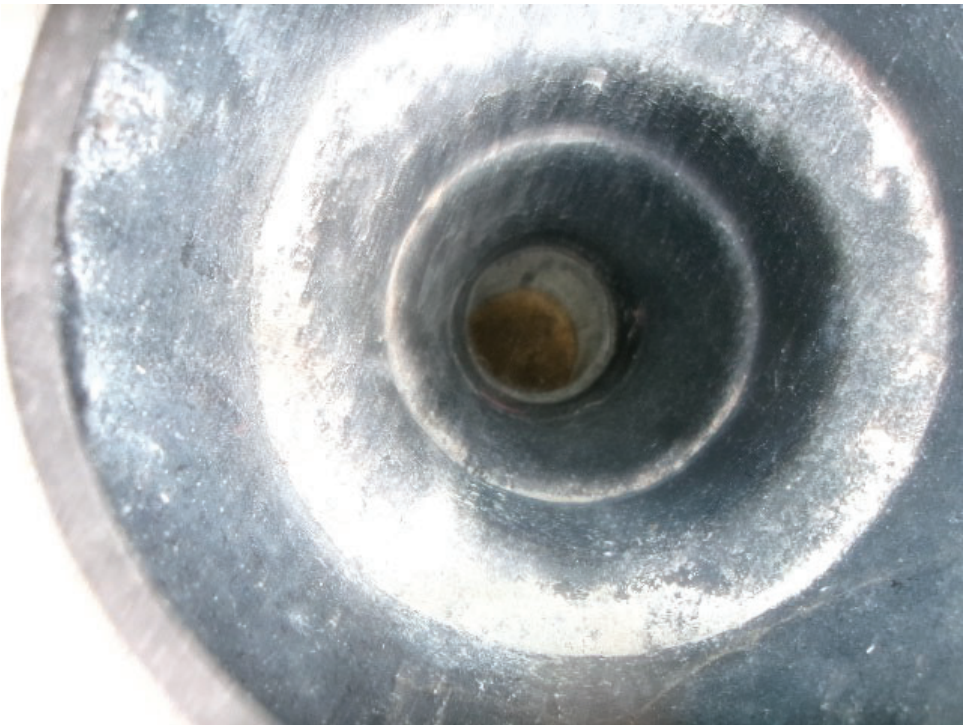
- 406 Waste System: Waste lines, where visible, are ABS. Waste disposal system is sewer. The pool back flush drain does not appear to have a trap. See photo.

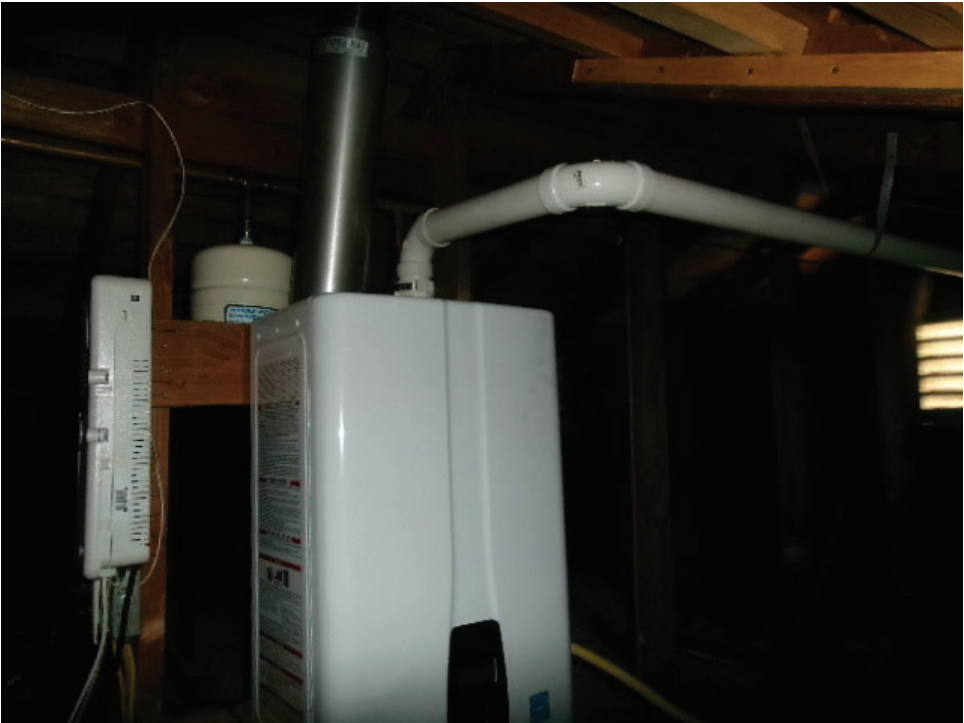
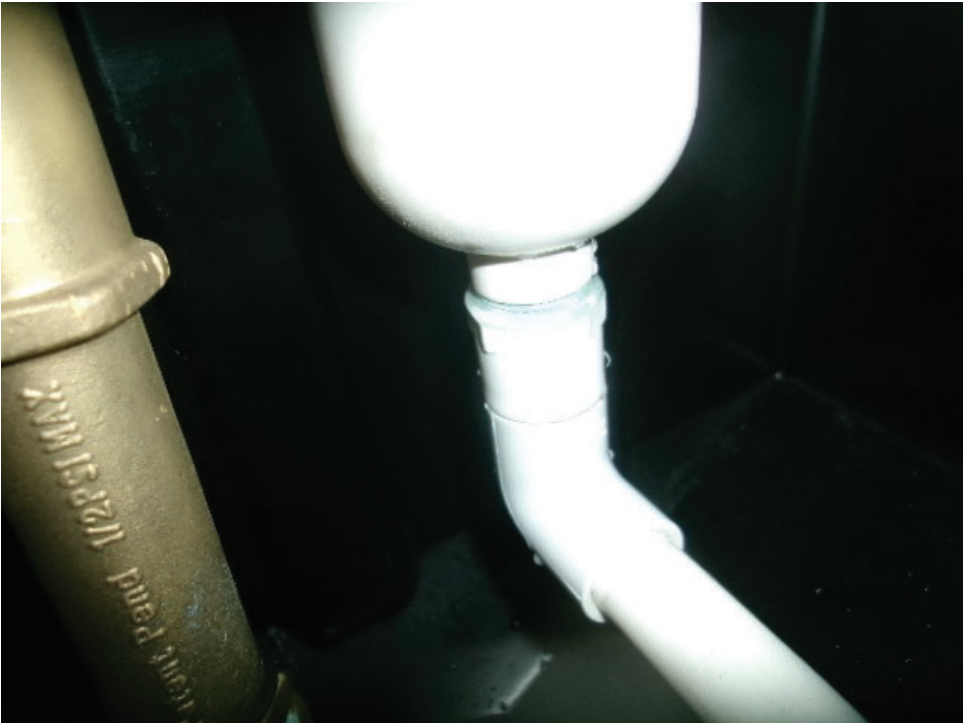
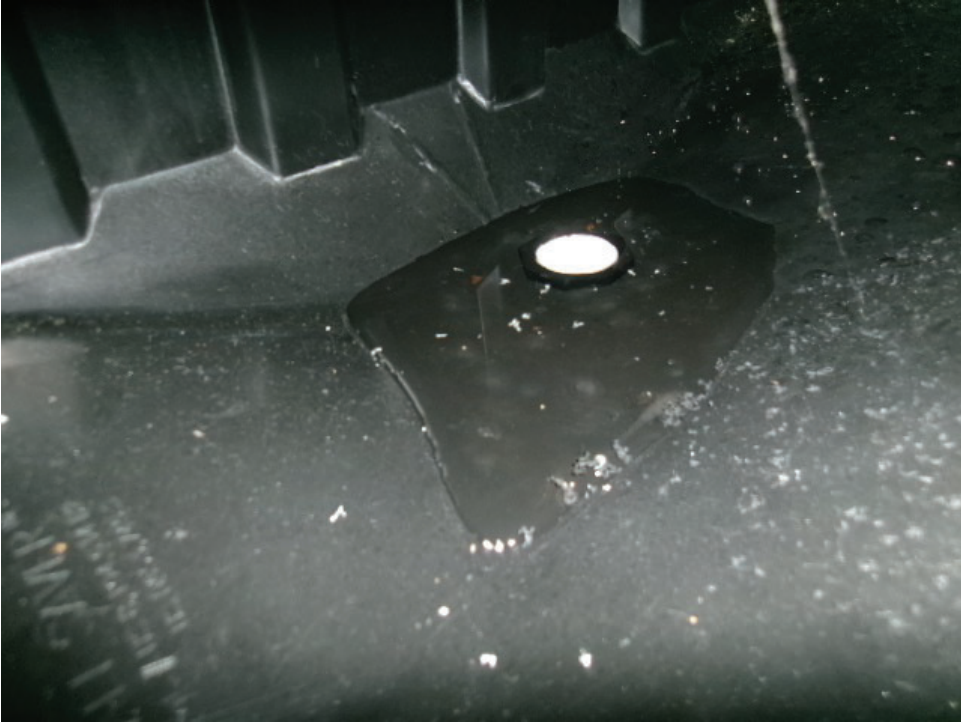
- 407 Water Heater: Tankless, gas unit, located at the attic. Temperature relief valve installed as a safety feature. Discharge line noted. Cold water shut off provided. Earthquake straps noted. Leaking at the condensate drain drips into a bucket. See photos.

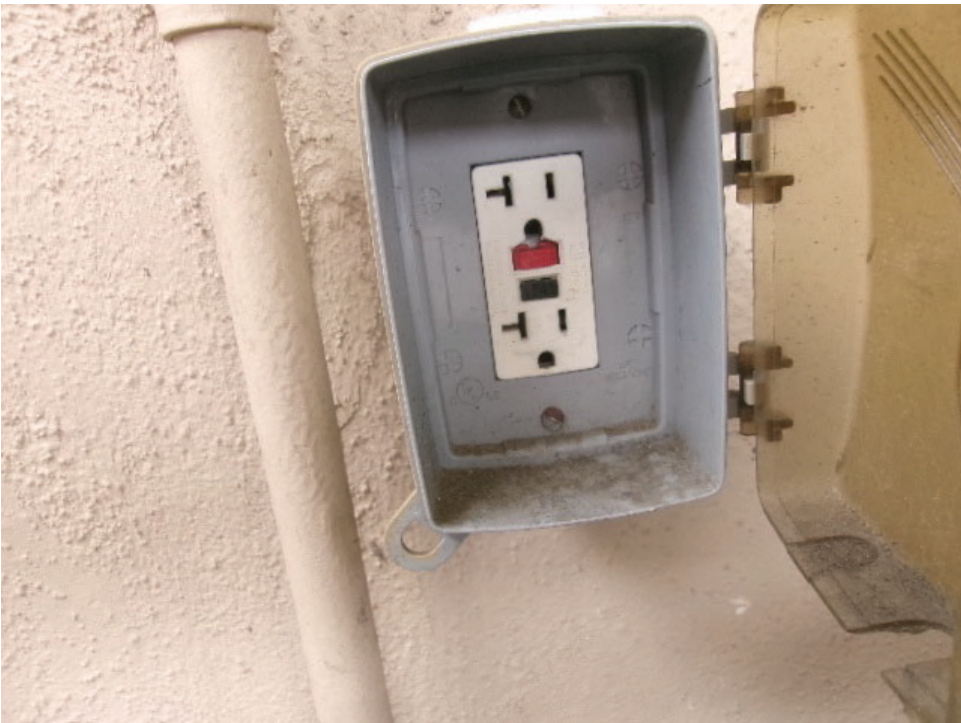
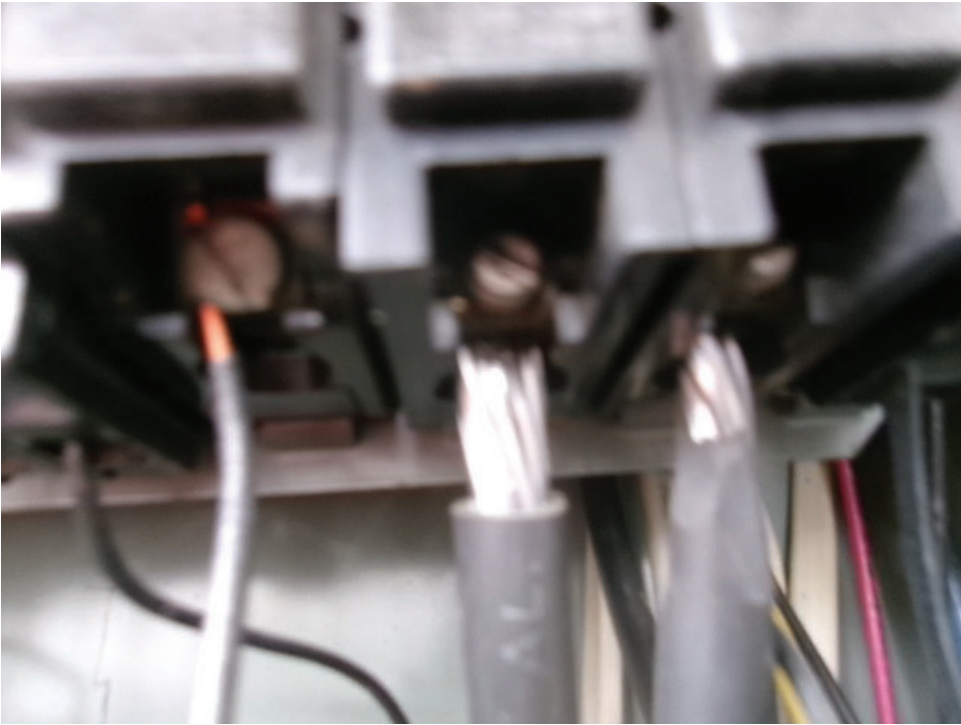
- 407a Venting: Intact.
- 408 Electrical: The main electrical service is 200 amps. Service entrance is underground, with main panel located at the rear wall of the garage. Overload protection is provided by breakers. A main disconnect is provided for safety. Futures provided for adding circuits. Grounding system present. Branch circuit conductor is copper. Aluminum wiring to the sub panel located at the lower hall. See photo. The GFI below the main panel does not trip. See photo.

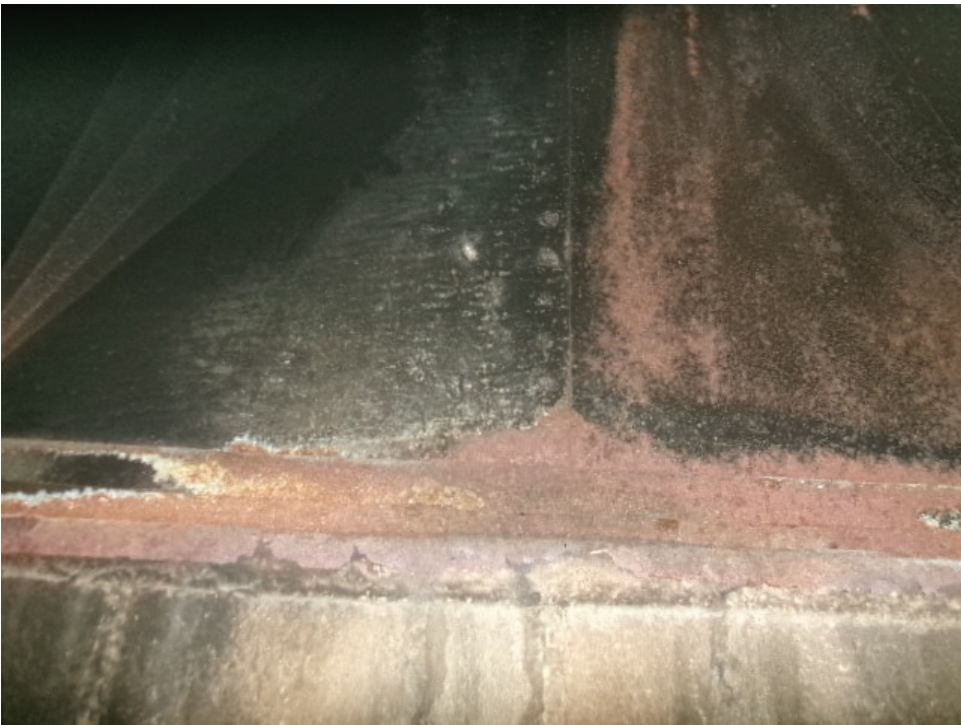
- 409 Smoke Detector: Located at the hall and bedrooms. Tested.
- 410 C O Detector: Carbon monoxide detector installed for safety.
- 411 Fireplace: Located at the living room, family room and master bedroom. Gas jets provided. Dampers tested. The dampers are not permanently blocked open, suggest installing C clamps on the dampers to block the dampers part way open allowing for continuous ventilation. Rusting noted in the flue at the living room. See photo. Only a 15 inch hearth at the master bedroom unit. Removed screen at the family room unit.

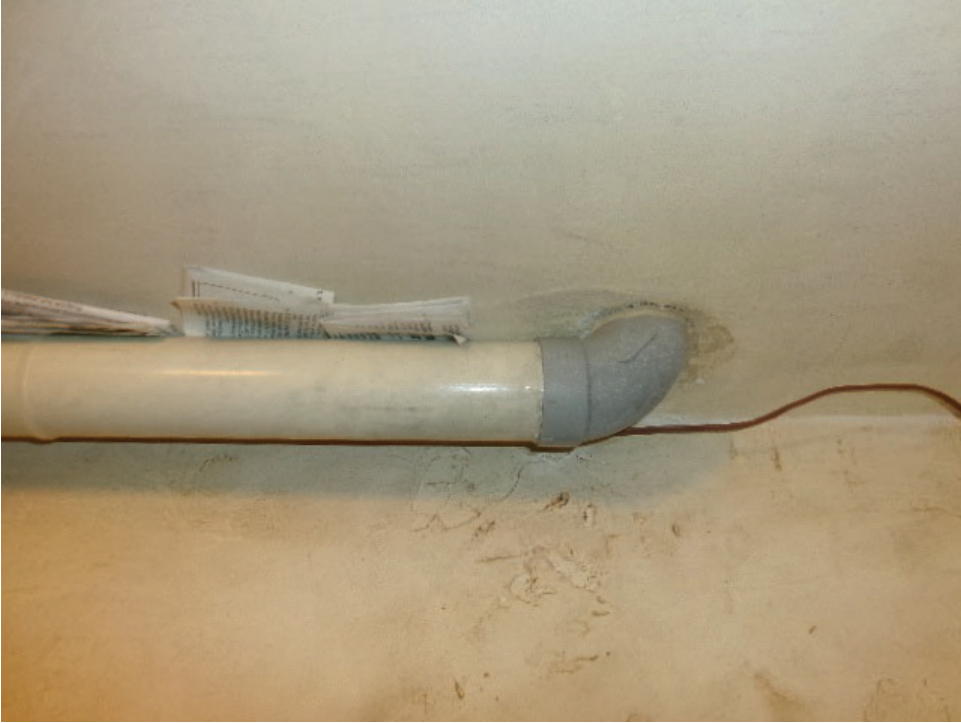
- 412 Comments: The central vacuum system head unit is removed. See photo.
