920 11<sup>th</sup> Street, Huntington Beach Ca

Inspection Date: 6/16/2026      Client: Don Archer  
 Inspector: Brian Spain      Address : 920 11<sup>th</sup> Street, Huntington Beach Ca

The home is a single family, two story structure built on a flat lot. Estimated age is approximately 35 to 40 years. Weather at time of inspection was cool and cloudy.

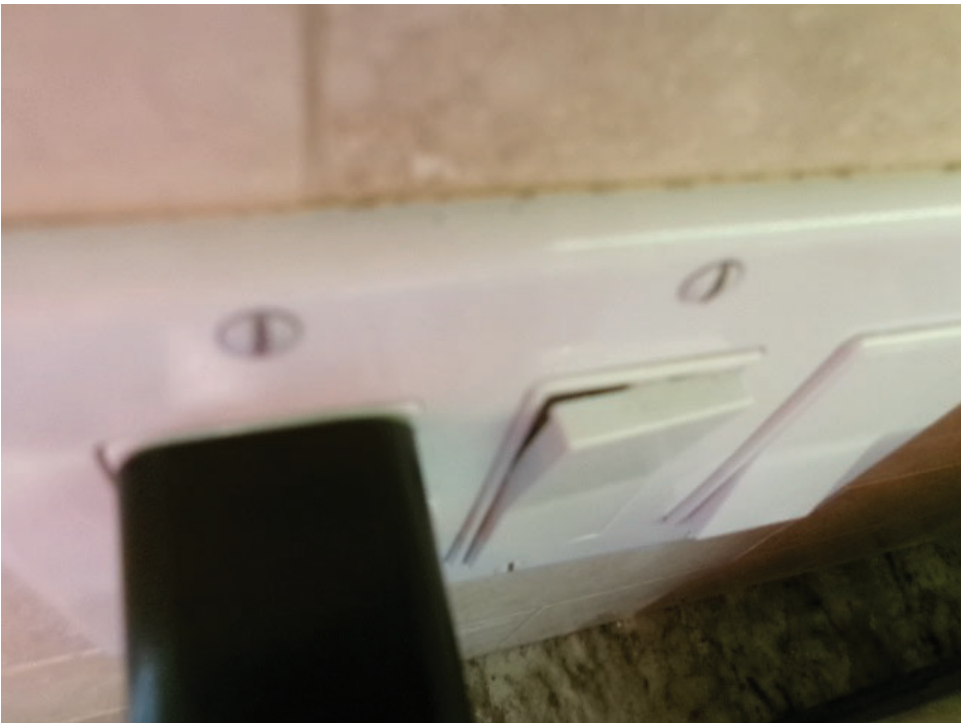
| 508 Electrical: | GFI present. Damaged switch at the right of the sink. See photo. |

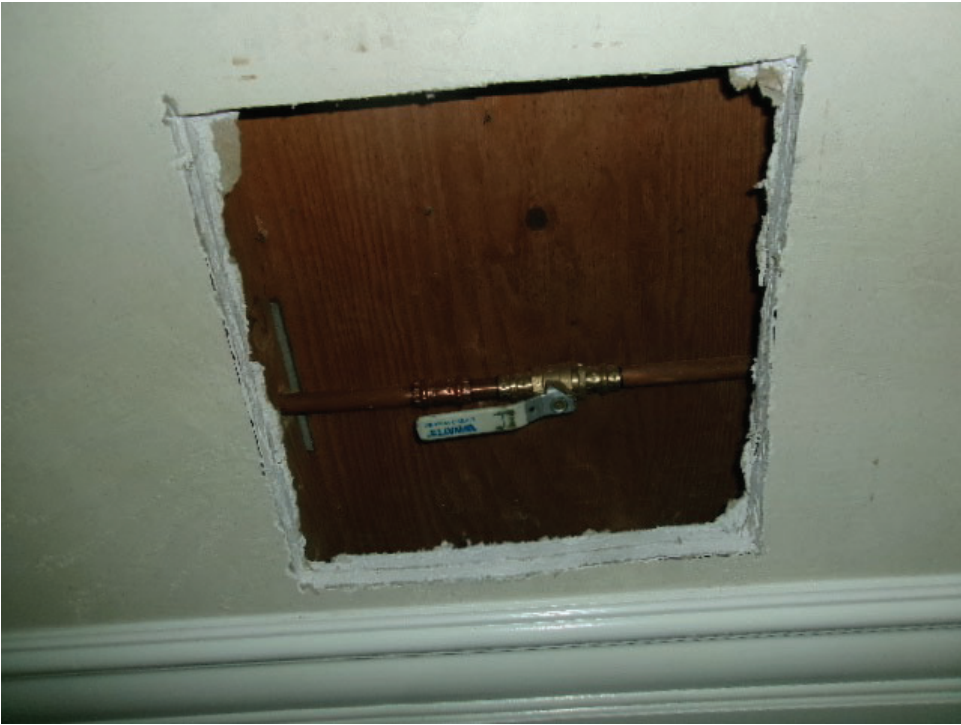
| 511 Traps/Drain/Supply: | The shut off valve for the refrigerator supply is below the stairs. See photo. |

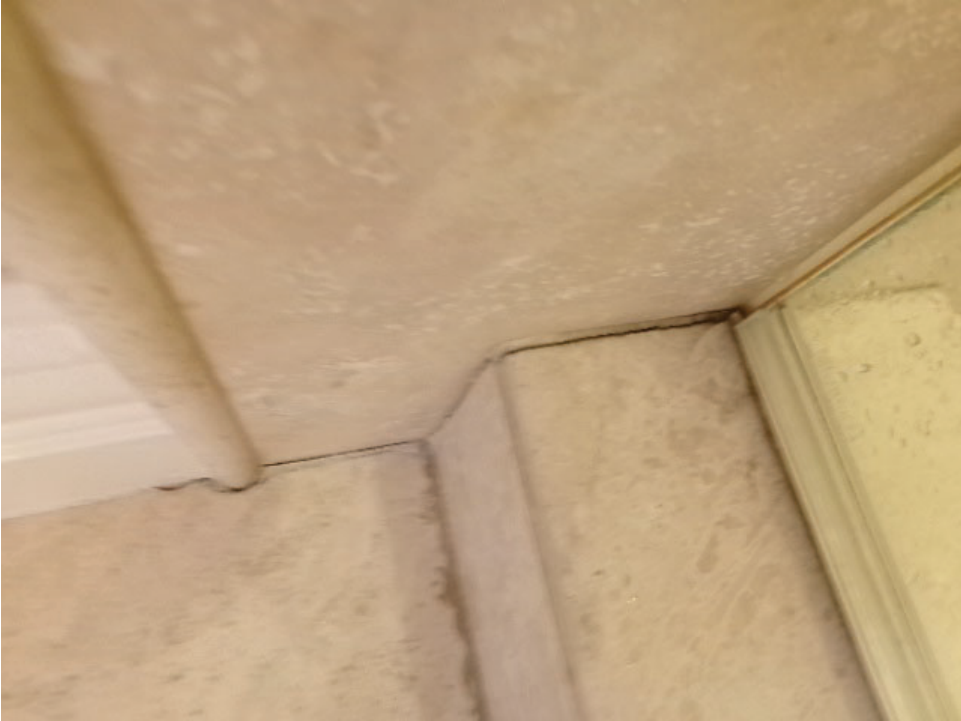
| 737 Shower & Surround: | Suggest resealing at the base of the surround to prevent water damage. See photo. |

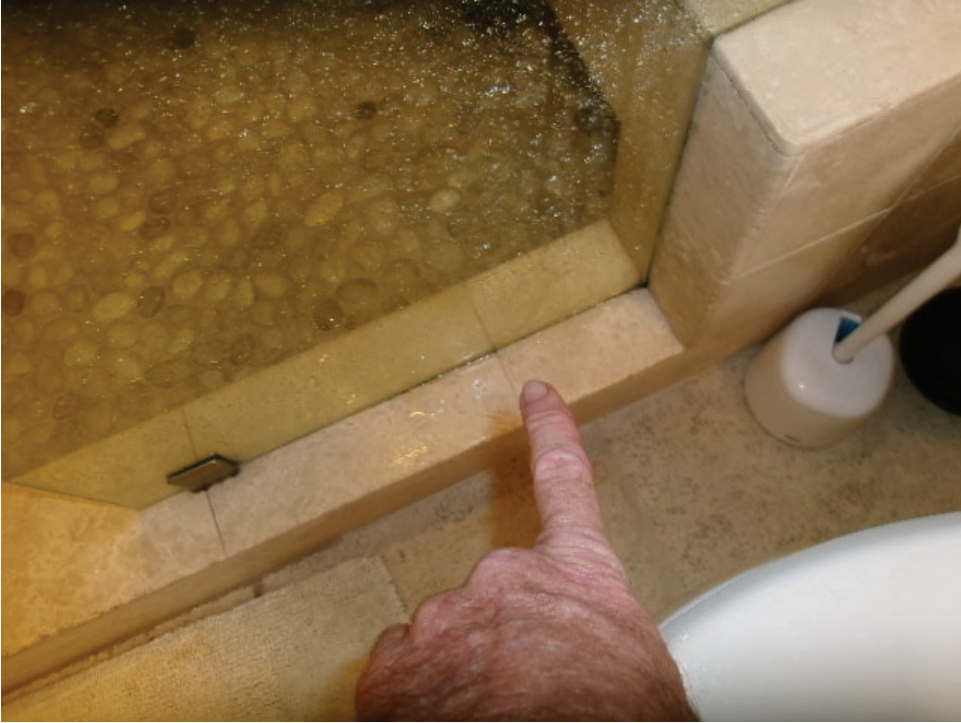
| 738 Shower Door: | Mildew at the glass and leaking at the curb. See photo. |

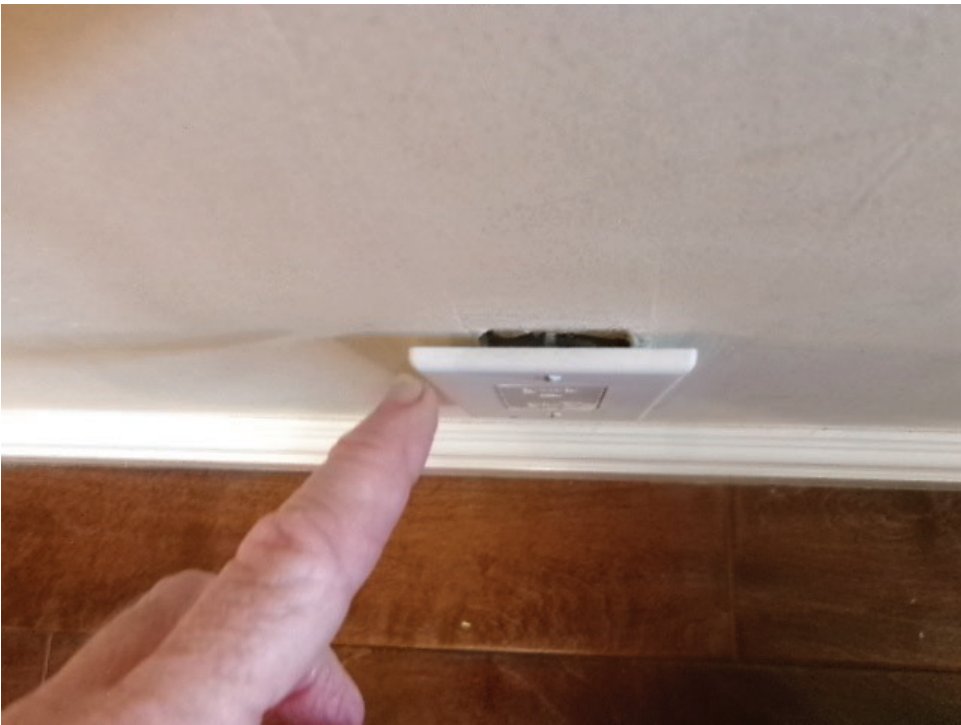
| 756 Electrical: | This circuit is protected by a GFCI located at the beginning of this circuit at the toilet, the added GFCI outlet at the sink is not needed and is not wired correctly to operate properly on this circuit. Suggest replacement of this outlet with a normal outlet or replacing all outlets on this circuit with individually controlled GFCI outlets wired correctly. Loose outlet across from the vanity. See photo. |

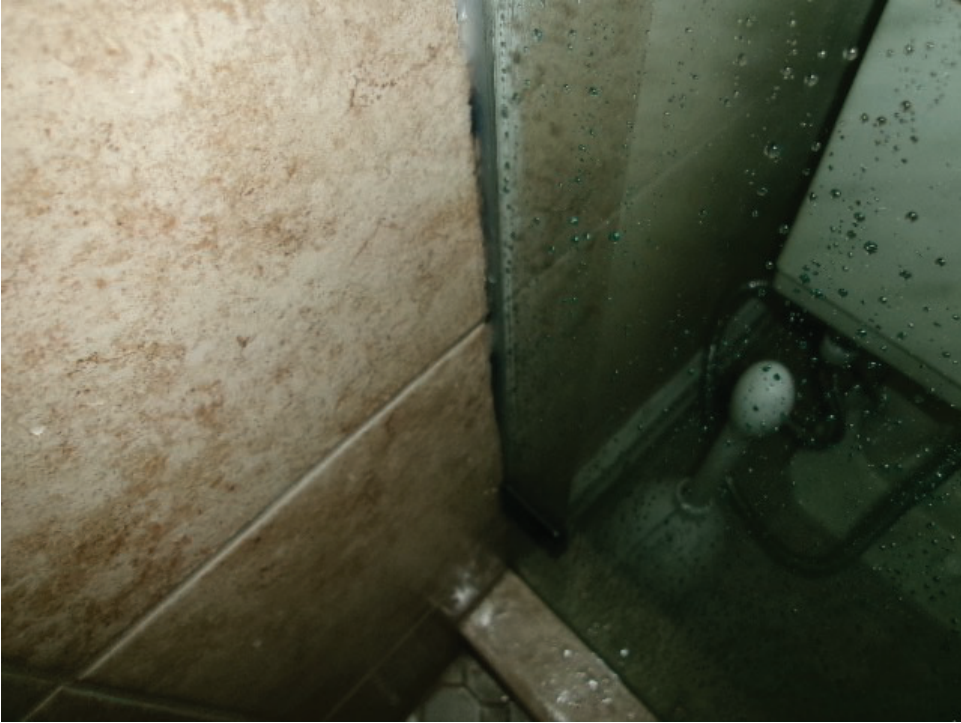
| 763 Shower Door: | Mildew in the caulking. See photo. |

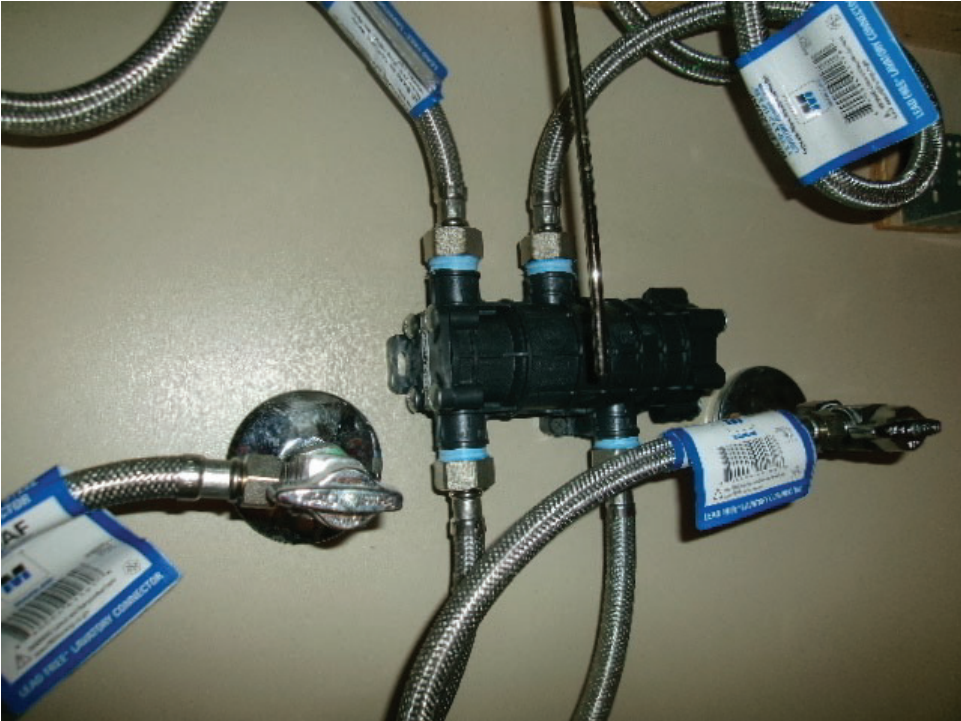
| 817 Trap/Drain/Supply: | Loop below the right sink allows hot water to circulate, unable to determine if the water heater has a circulation pump. See photo. |

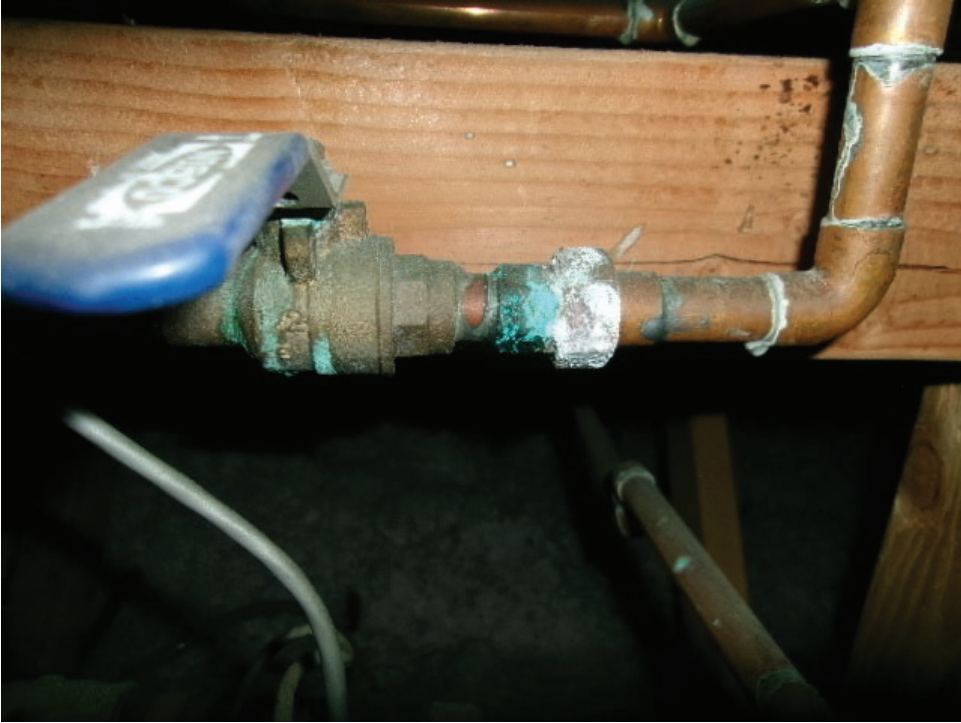
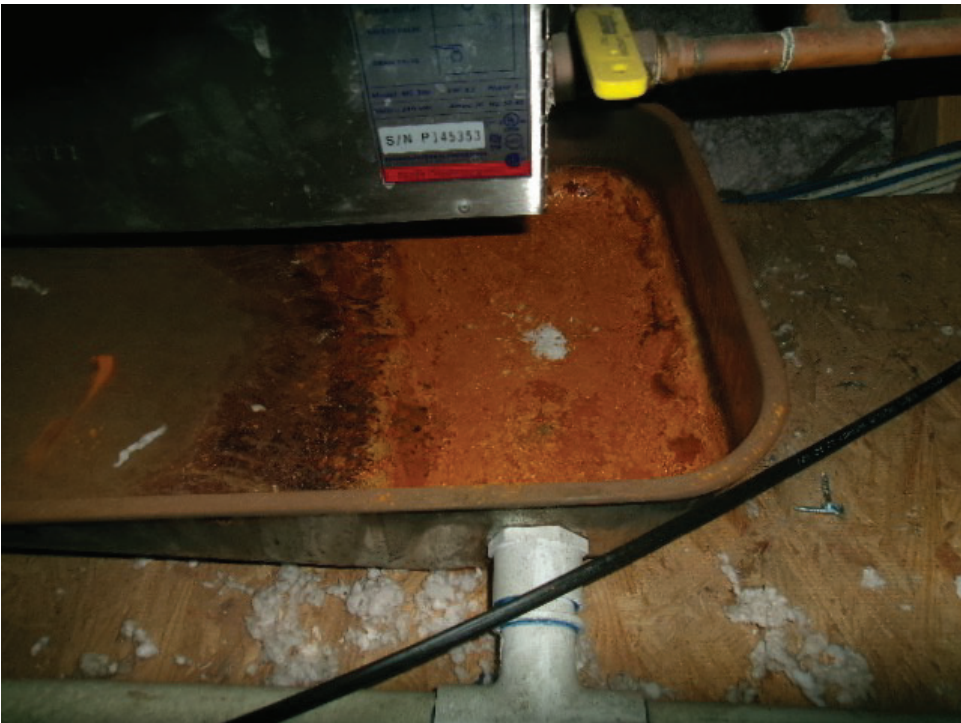
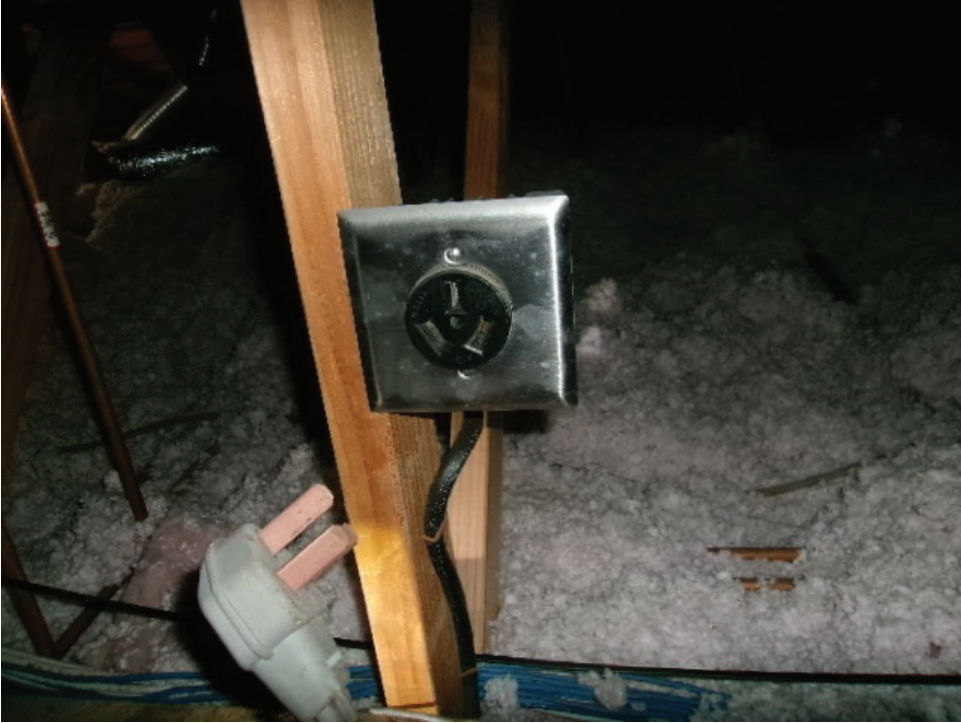
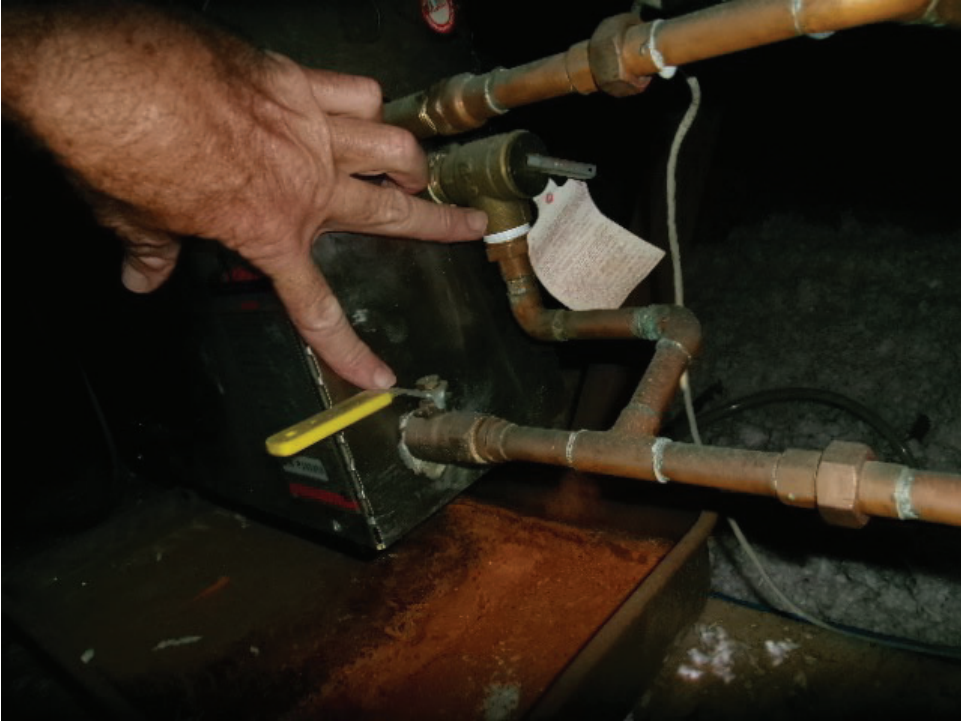
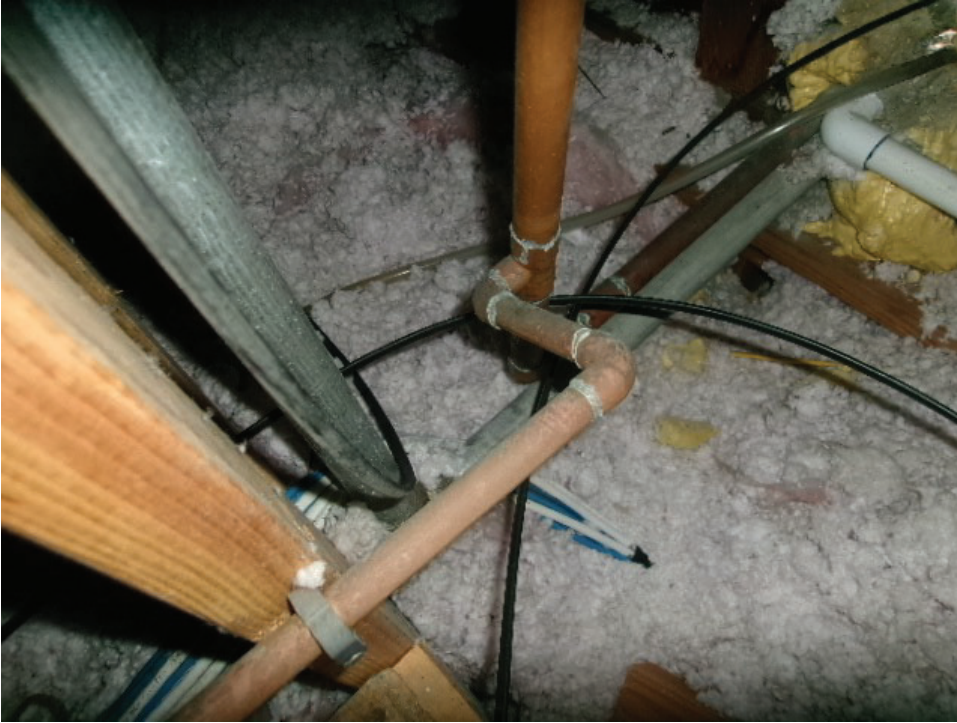
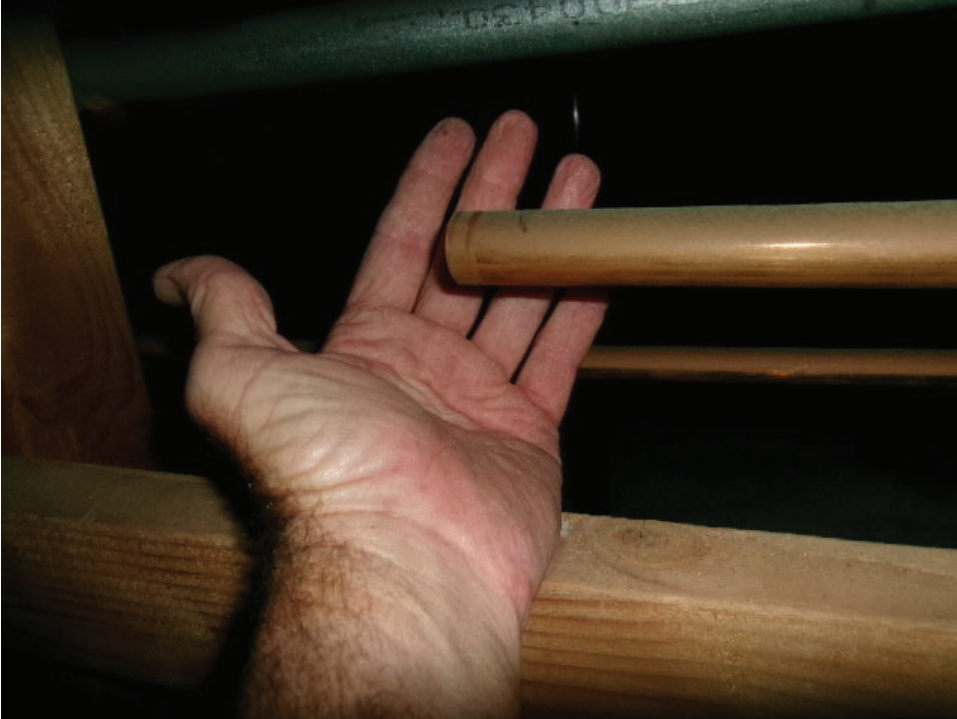
| 820 Comments: | Heavy corrosion at the supply to the steamer. See photo. The pan below the steamer is rusted. See photo. The steamer is no longer in use, it is unplugged in the attic. See photo. The T and P drain and the unit drain are run together to the exterior of the right wall, the pipe is open above the steamer. See photos. The wine closet condenser and steamer pans drain out the right wall of the attic together. See photo. |

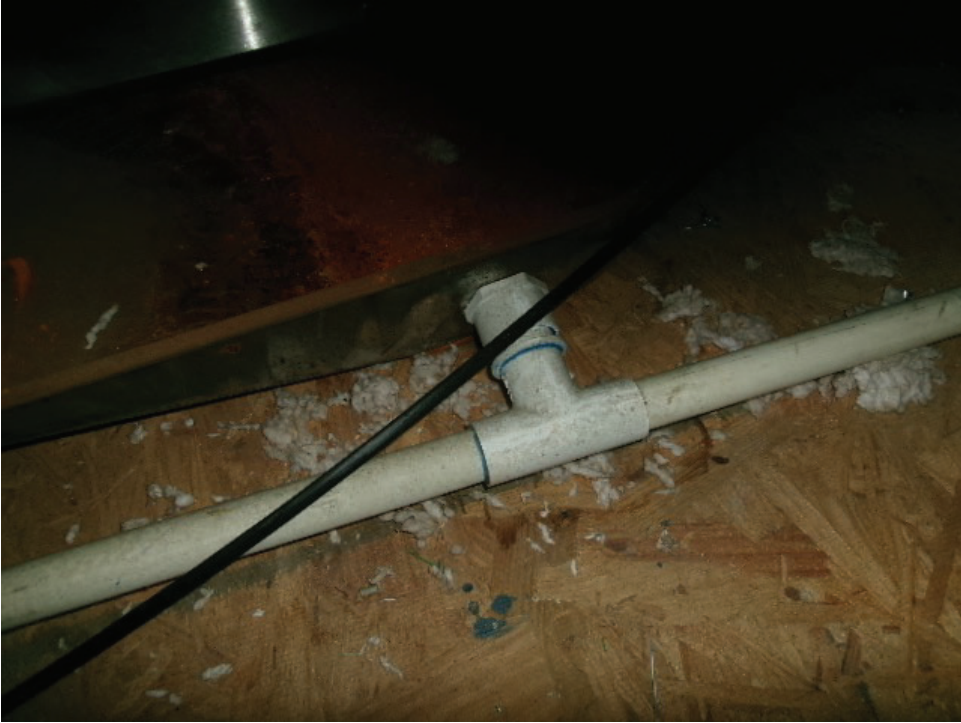
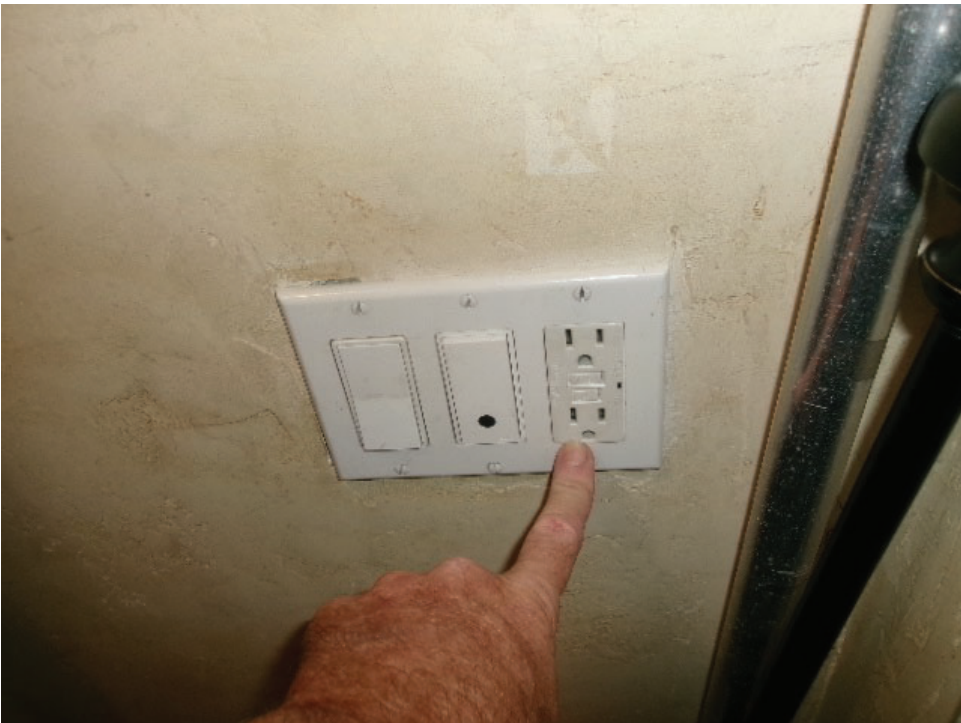
| 906 Electrical: | The GFI in the close is not grounded. See photo. Broken cover plate in the closet. See photo. |

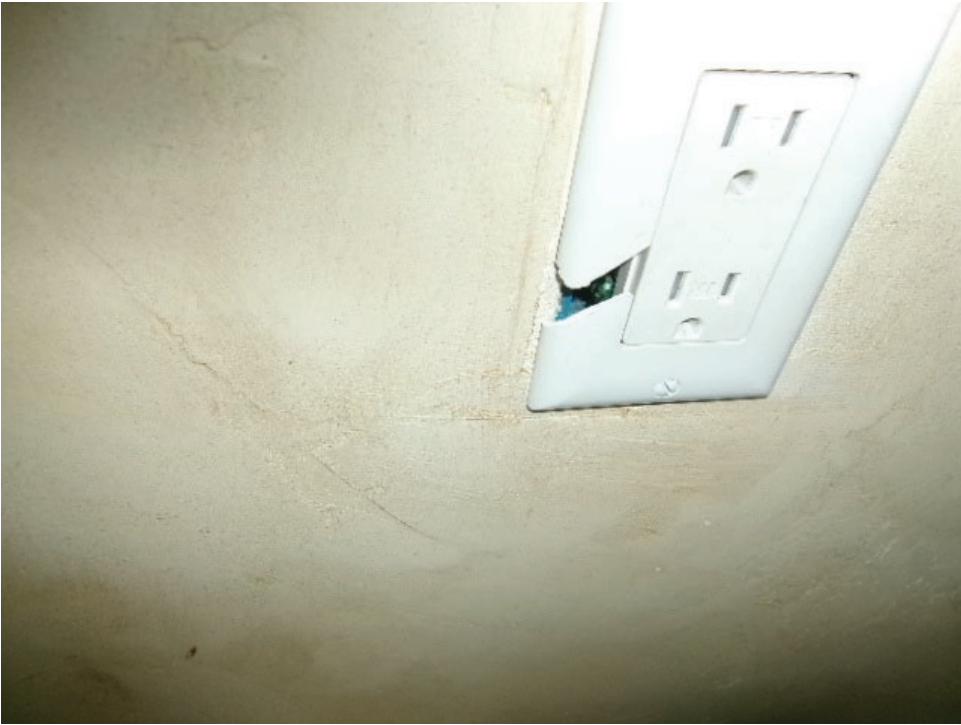
906

| 956 Electrical: | Hole in the outlet in the right front corner. See photo. One ceiling light did not operate. |

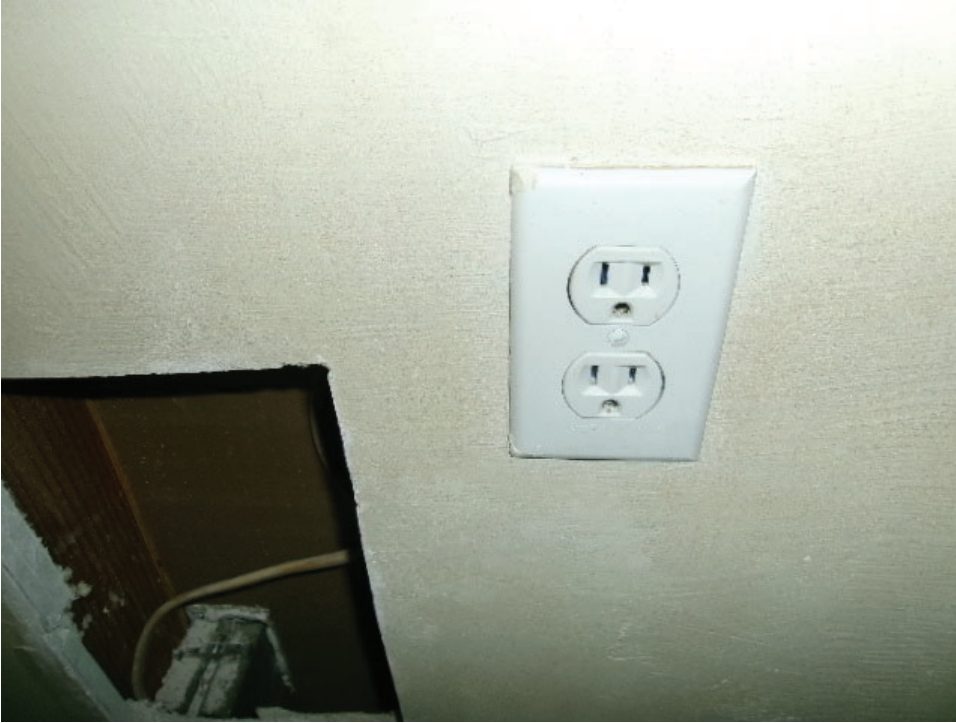
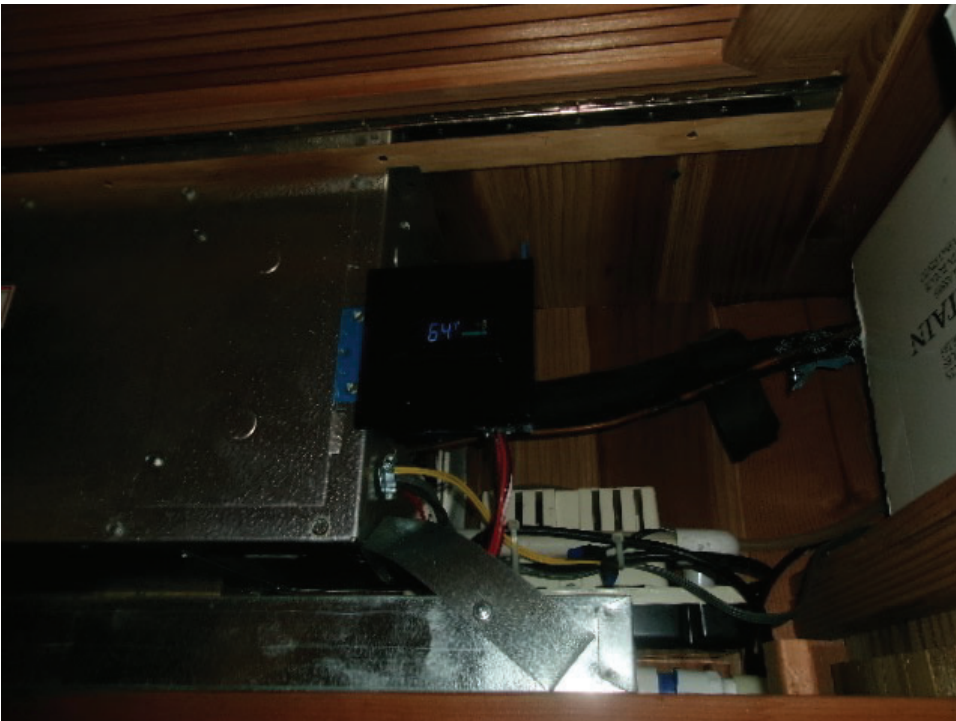
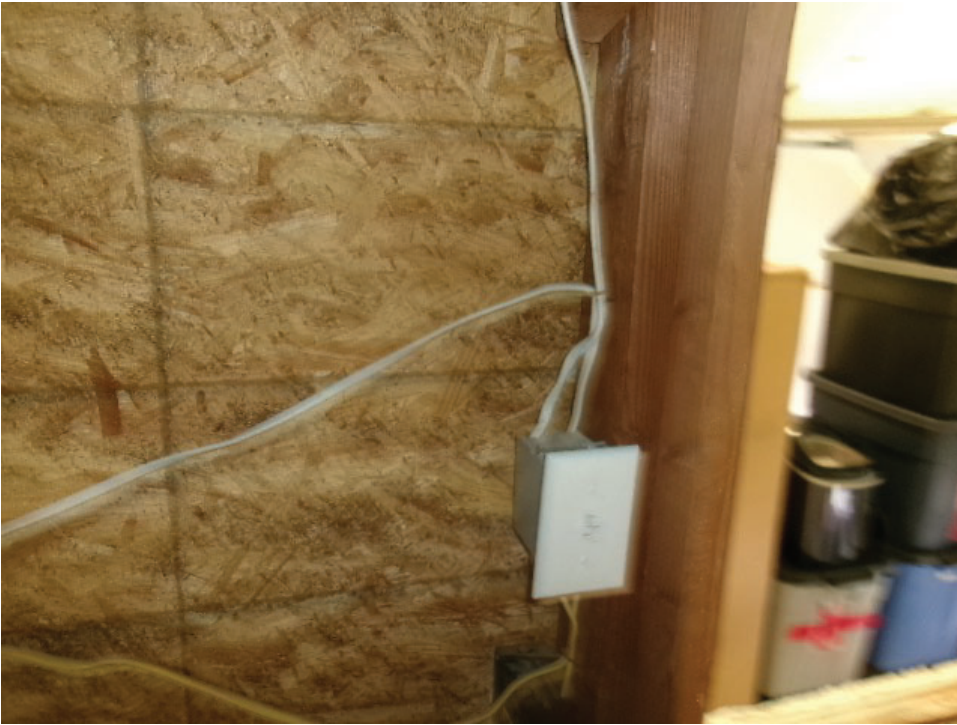
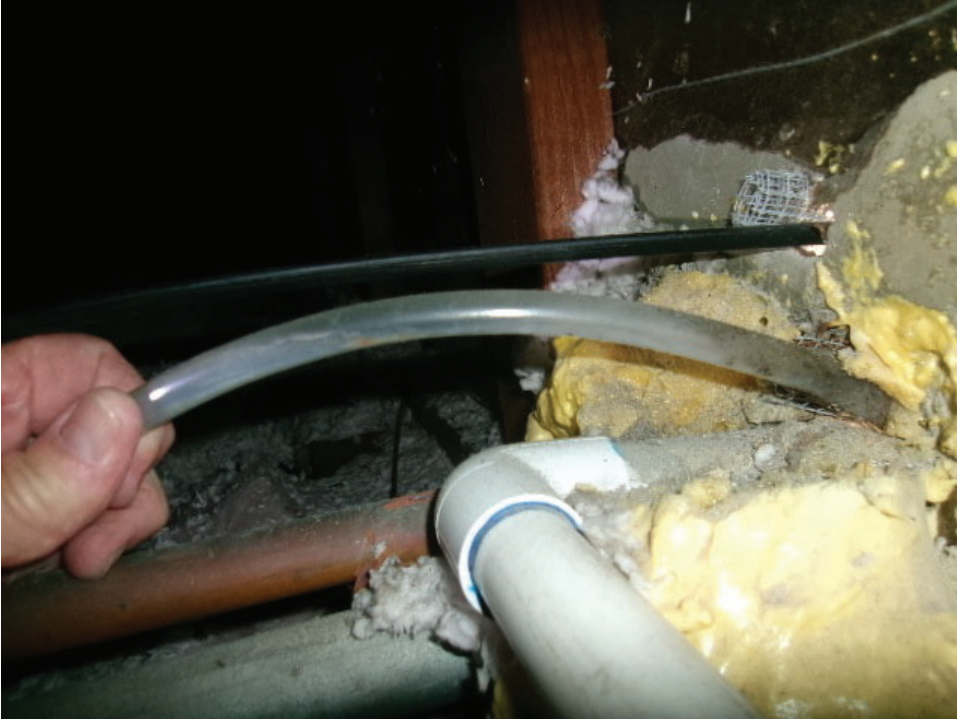
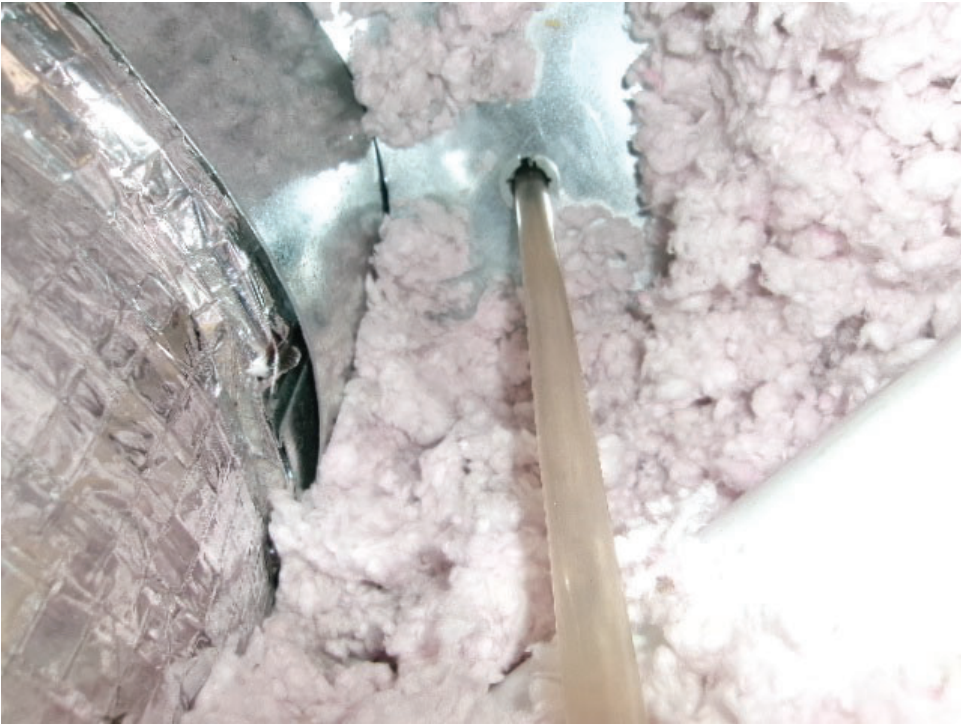
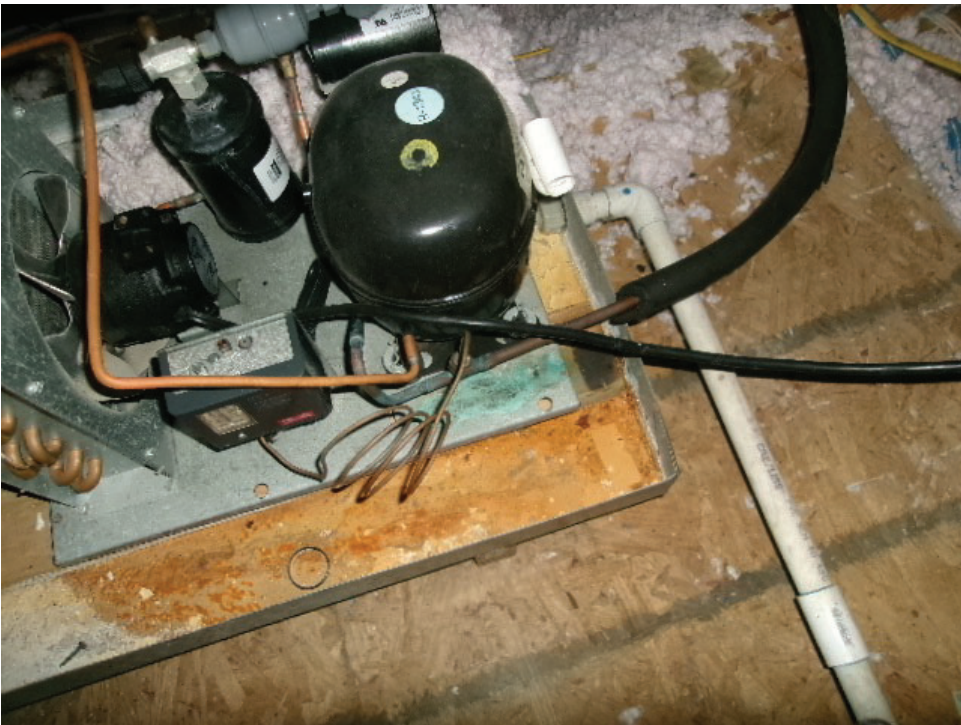
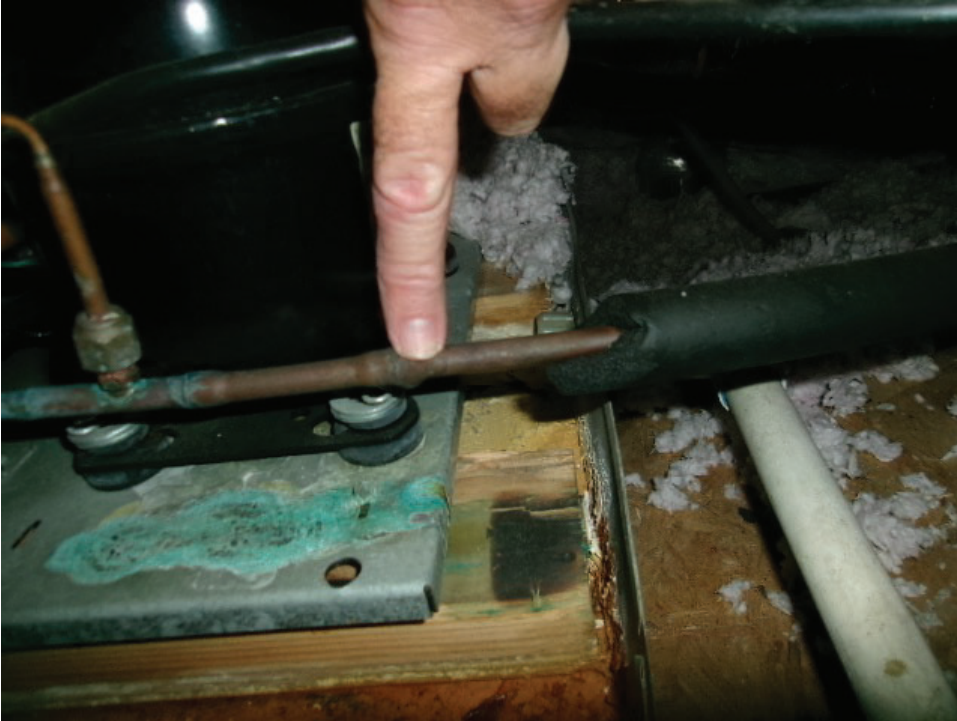
| <b><u>1200</u></b> | | <b><u>HALL/STAIRS</u></b> |
|---|---|---|
| 1207 | Comments: | The wine chiller wine is cold. See photo. The condensation pump sends water up to the attic and out the right wall. See photo. Missing insulation at the condensate locate din the attic, the condenser drips into the pan. See photo. The pan does not drain out of the closet. See photo. |

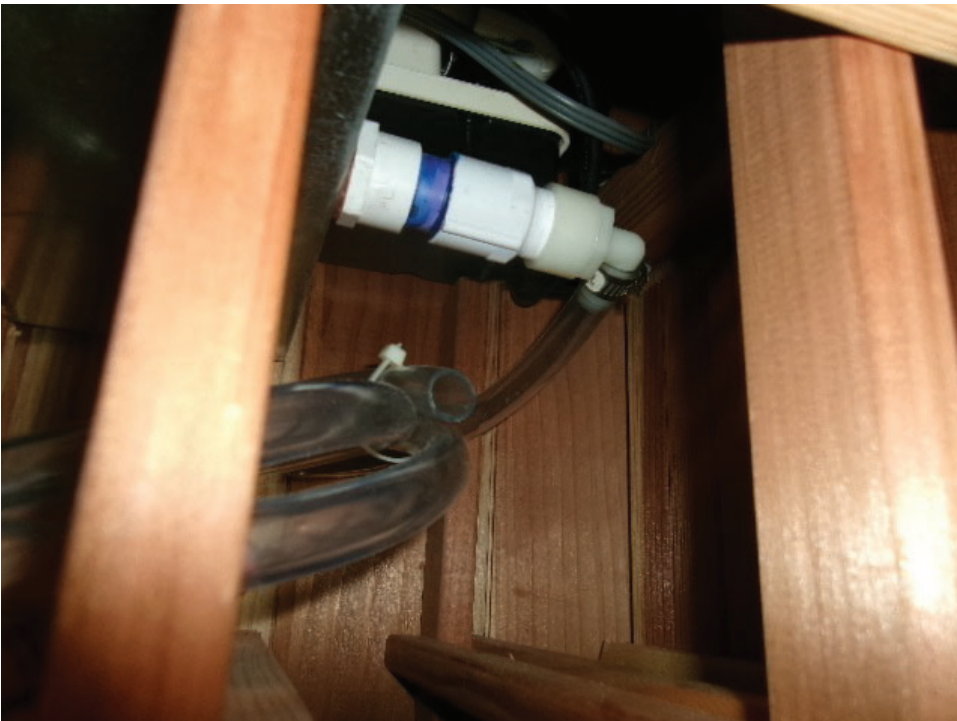
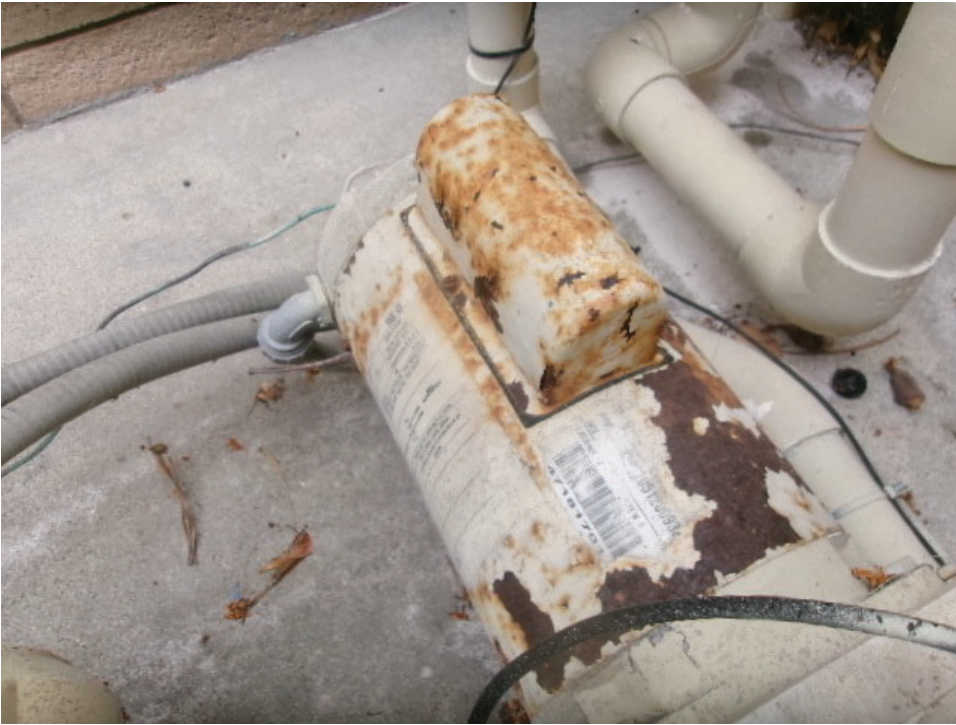
- 1701 Decking/Caulking: Concrete.
- 1702 Tile: S
- 1703 Dive Board: N
- 1704 Handrail: N
- 1705 Fill Line: Auto fill noted.
- 1706 Lights: Operable.
- 1707 GFI's: Responded to test.
- 1708 Skimmer: Good draw noted.
- 1709 Heater: Operable, gas.
- 1710 Filter: Operable.
- 1711 Pressure Gauge: Operable.
- 1712 Pump: Operable.
- 1713 Motor: Rusting noted at one motor. See photo.
- 1714 Ground wire: Present.
- 1715 Time Clock: Present.
- 1716 Gate Self Closers: Self closers and self latching latches on all gates and some doors leading to the pool/spa area and installing alarms at all doors leading from the house to the pool area are required. Some cities require a secondary alarm system to be installed inside the pool also. Suggest further review with the local building department to determine local requirements.
- 1717 Comments: Some deterioration at the pool and spa shell.
