2340 Joanna Drive #4, Santa Ana Ca

TRINITY HOME INSPECTION SERVICE LLC.

Inspection Date: 6/26/2026 Client: Letua Family and Madisyn Ujkic
Inspector: Brian Spain Address : 2340 Joanna Drive #4, Santa Ana Ca

The home is a condominium, two story structure built on a flat lot. Estimated age is approximately 50 to 55 years. Weather at time of inspection was warm and clear.

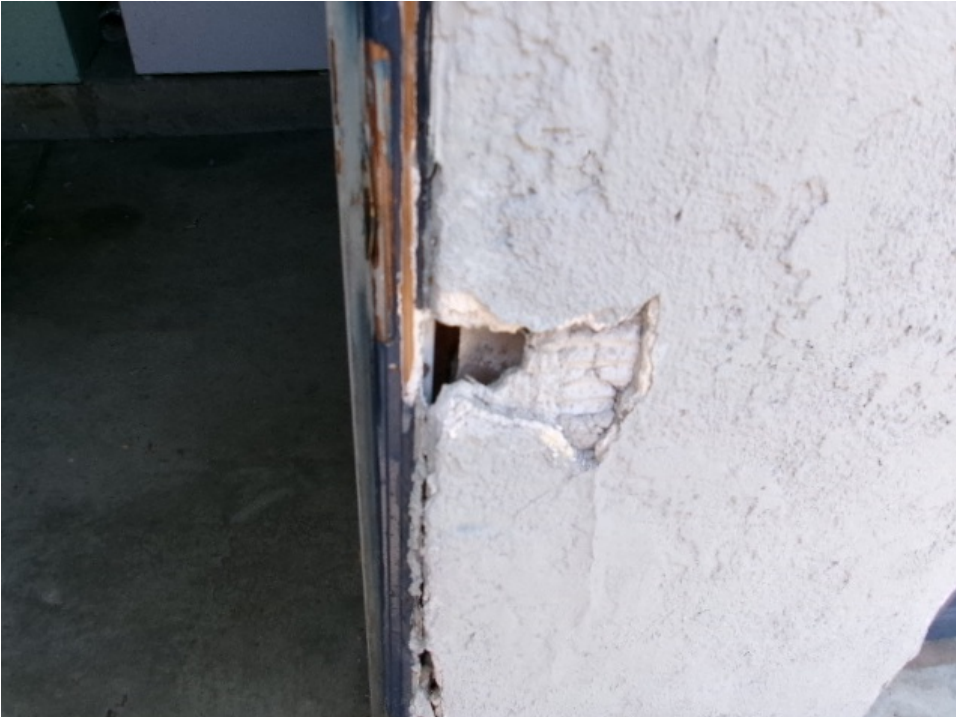
201 Exterior:	Stucco. Damage noted. See photo.
202 Roof:	See roof comments.
203 Slab:	Concrete.
204 Garage Door:	Metal.
205 Garage Door Hdwr:	The door is tied in place with a rope. Unable to test the hardware.
206 Door Opener:	Inoperable opener noted.
207 Windows/Screens:	N
208 Access Door:	Damage noted.
209 Fire Door:	S
210 Fire Wall:	S
211 Walls:	S
212 Electrical:	S
213 Garage Comments:	N

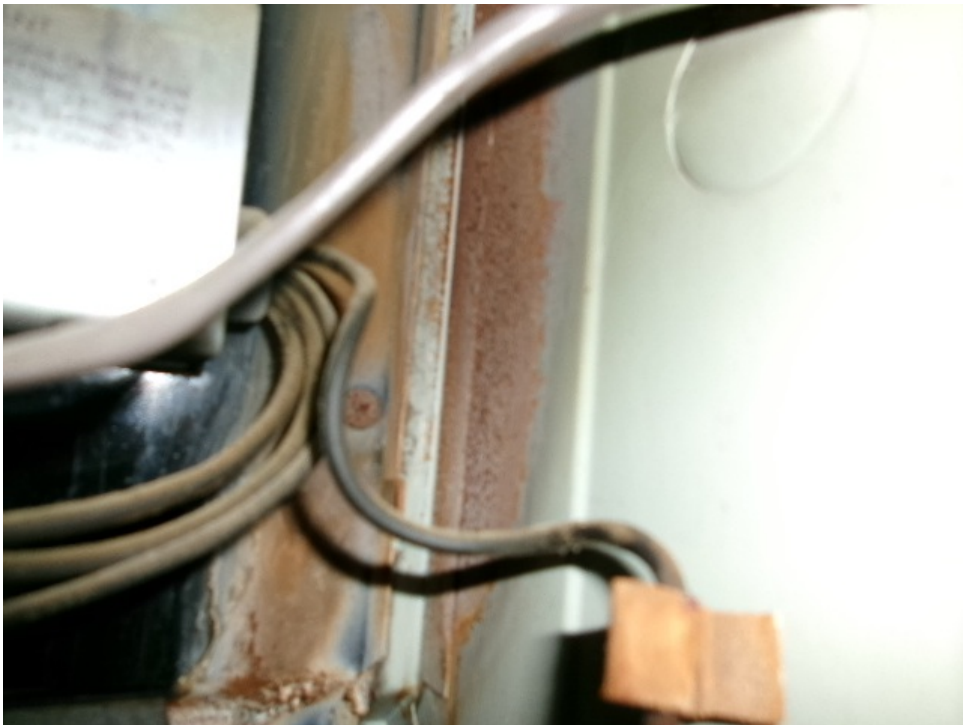
401 Heating:	Gas, forced air unit. Located at the living room closet. Gas shut off and electrical disconnect provided. Rusting noted up the sides of the front panel, this may indicate damage to the heat exchanger or improper venting, we suggest further review by the gas company or a heating contractor for repairs or replacement as needed. See photo.
401a Venting:	Unable to test.
402 Air Conditioning:	Electric. Compressor is located at the front. Inoperable. Corroded fins noted. See photo.
403 Thermostat:	Operable.
404 Ducting:	Intact.
405 Plumbing:	Water supply provided by public system. Piping, where visible, is copper. Main shut off is located at the front of the building.
406 Waste System:	Waste lines, where visible, are cast iron and galvanized. Waste disposal system is sewer.
407 Water Heater:	40 gallon, gas unit, located at the garage. Temperature relief valve installed as a safety feature. Discharge line noted. Cold water shut off provided. Earthquake straps noted. Suggest blocking the water heater from behind to prevent movement towards the wall. Corroded cold water shut off valve. See photo. The discharge line does not drain to the exterior, improper. See photo.

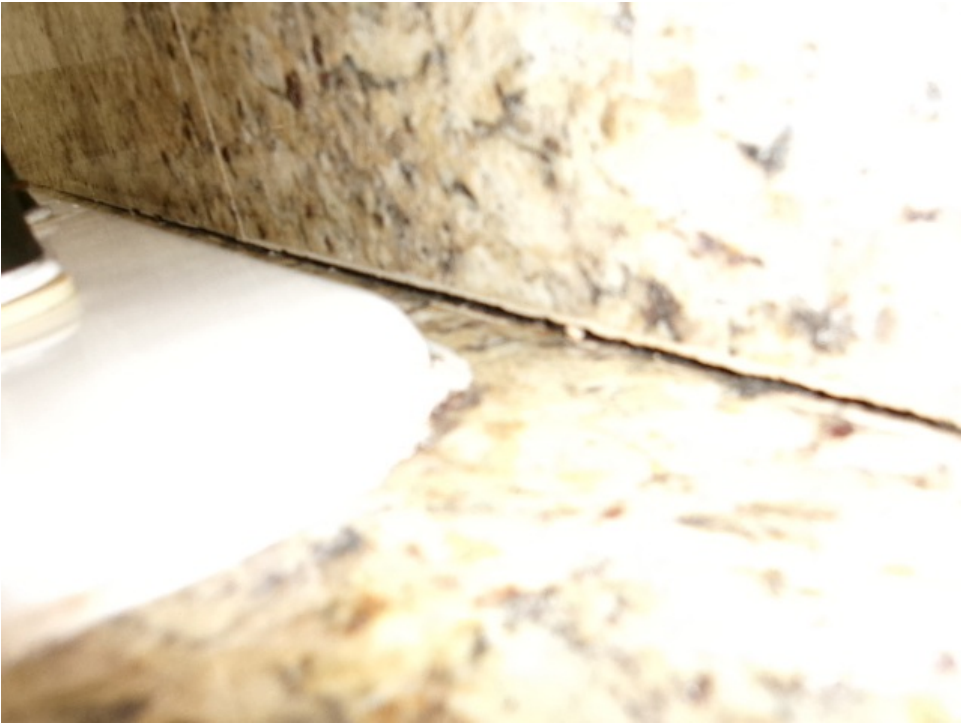
501 Floor: Vinyl.
 502 Walls: S
 503 Ceilings: S
 504 Doors: N
 505 Windows/Screens: S
 506 Cabinets: S
 507 Counter Tops: Suggest sealing at the corners and joints to prevent water damage. See photo.
 508 Electrical: GFI present. The outlet at the left of the sink and right of the range are not GFI protected.
 509 Sinks: S
 510 Faucets: S
 511 Traps/Drain/Supply: S
 512 Disposal: S
 513 Dishwasher: S
 514 Stove/Cook Top: Gas.
 515 Oven: Gas.
 516 Hood/Fan: S
 517 Microwave: Not installed level, sloped to the front.
 518 Kitchen Comments: N

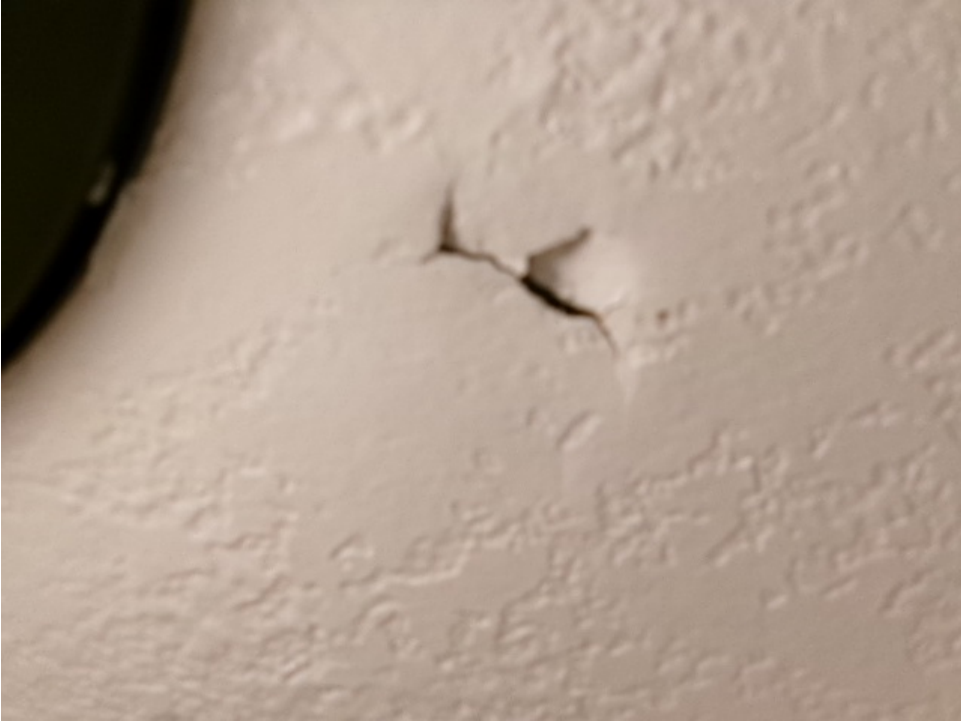
701 Floors:	Vinyl. Suggest sealing the floor in front of the tub to prevent water damage.
702 Walls:	Patching noted.
703 Ceilings:	Water damage in the water closet. See photos.
704 Doors:	Damage at the top of the door to the hall. Missing door stop.
705 Windows/Screens:	N
706 Electrical:	GFI present.
707 Exhaust Fan:	Inoperable.
708 Heating:	S
709 Tub & Stopper:	Corrosion at the drain, hair stuck in the drain.
710 Tub Enclosure:	S
711 Tub Faucet:	S
712 Shower & Surround:	S
713 Shower Door:	N
714 Shower Faucet:	S
715 Sink & Stopper:	S
716 Sink Faucet:	Corrosion at the front at the bedroom sink.
717 Trap/Drain/Supply:	Corroded at the inside sink drain. See photo.
718 Toilet:	S
719 Counter/Cabinets:	Cosmetic damage noted at the wall mirror.
720 Comments:	N

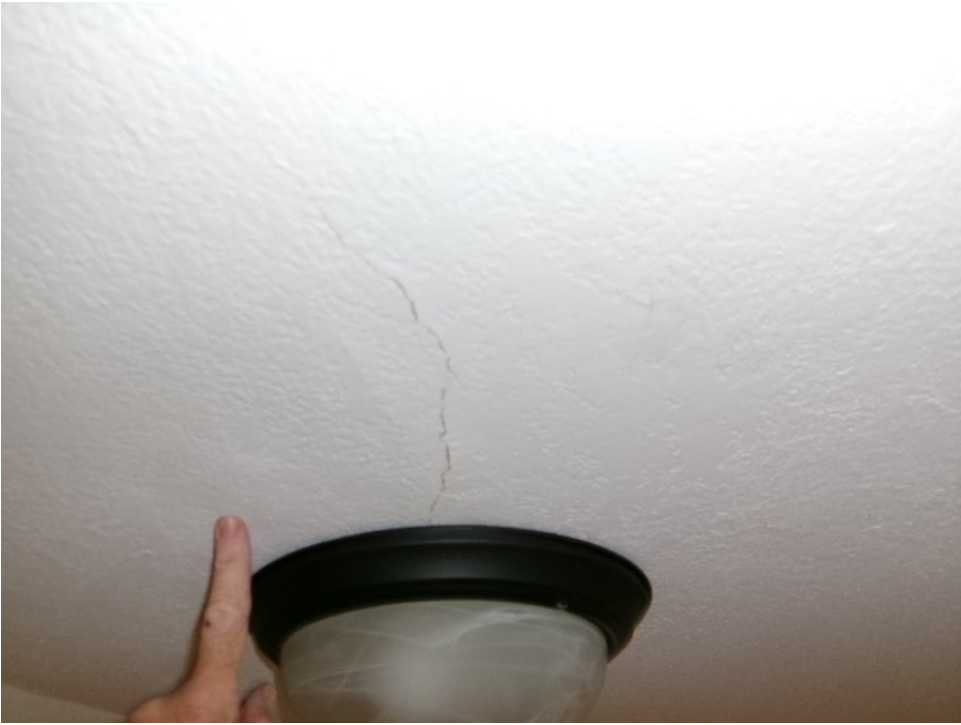
1201 Floors:	Vinyl.
1202 Walls:	S
1203 Ceilings:	Water damage and crack at the light. See photo.
1204 Doors:	S
1205 Electrical:	S
1206 Stairs:	N
1207 Comments:	N
