# Inspection Report

**Jeff Wall**  
**1470 Madonna Road**  
**San Luis Obispo, CA 93405**

Report Date: 6/15/2026

Inspection location: **1470 Madonna Road**  
**San Luis Obispo , CA 93405**

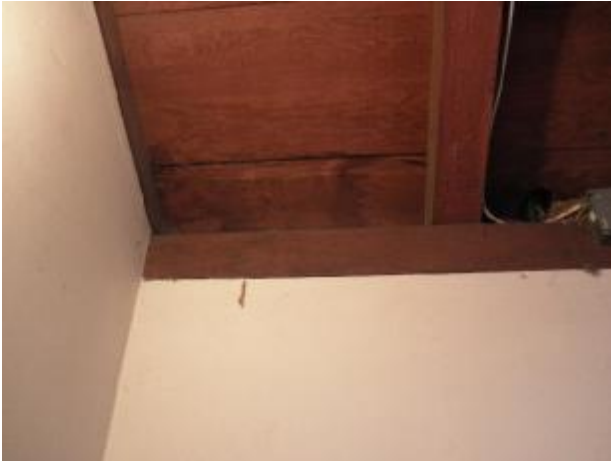
# R

- 1.) The clay tile roof at the community laundry room has missing edge flashing, has an improperly installed vent pipe penetration with no double flashing and evidence of a leak as seen from inside the room. This roof appears to be in need of replacement.

Evidence of a roof leak at the community laundry.

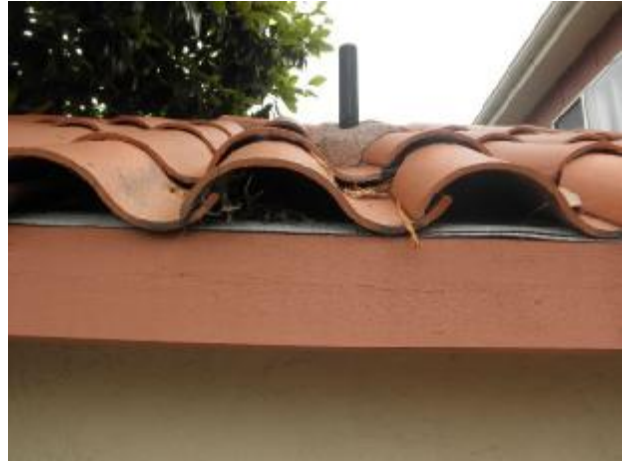
# R

No double flashing at the vent pipe at the community laundry roof.

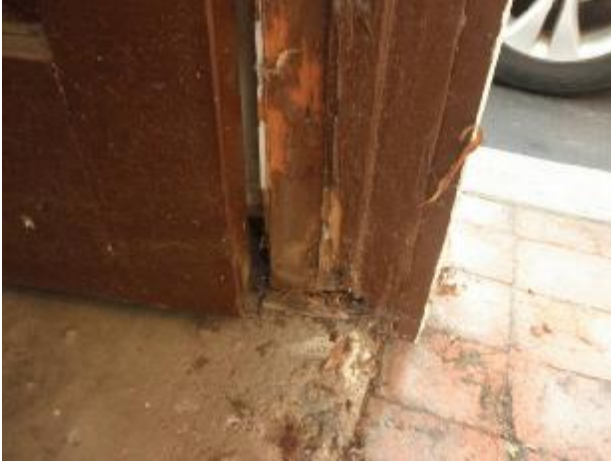
# EX

Termite infestation/damage to the base of the jamb at the exterior door in the community laundry.

4.) The entry door to the community laundry room has termite infestation/damage to the base of the jamb.

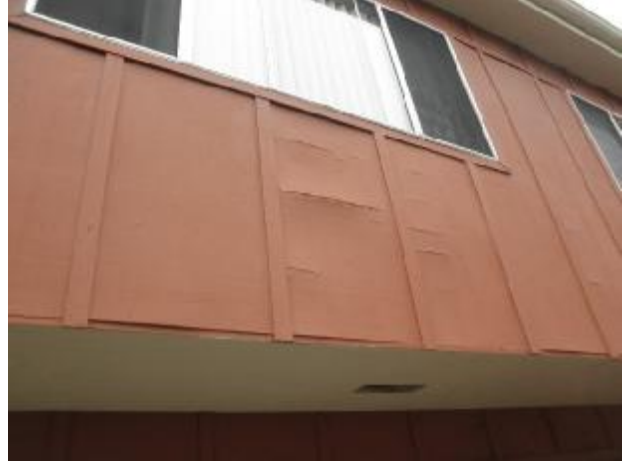
# EX

Example of some of the delamination at the exterior wood siding.

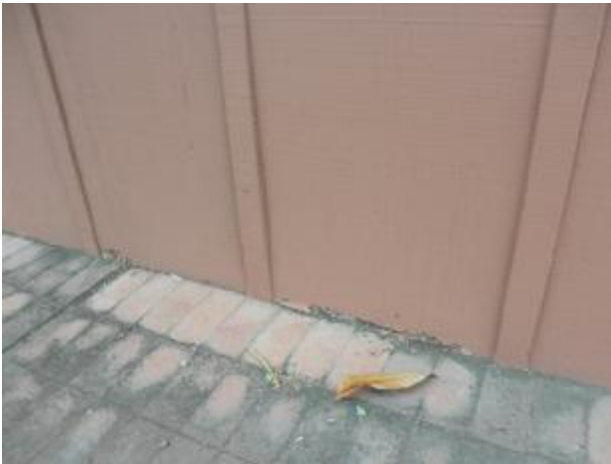
# EX

Moisture damage to the base of the wood siding.

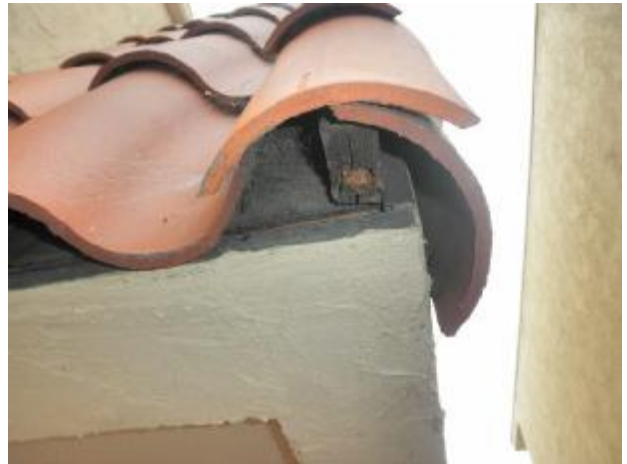
# EX

Moisture damage to the base of the 2X roof trim at the front of unit 3.

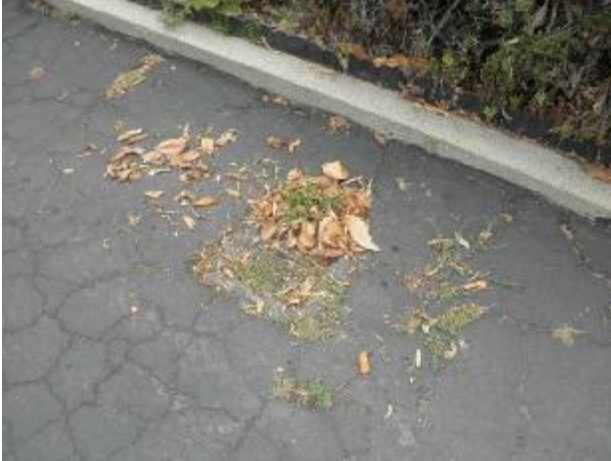
# GD

The surface site drain at the base of the driveway i clogged.

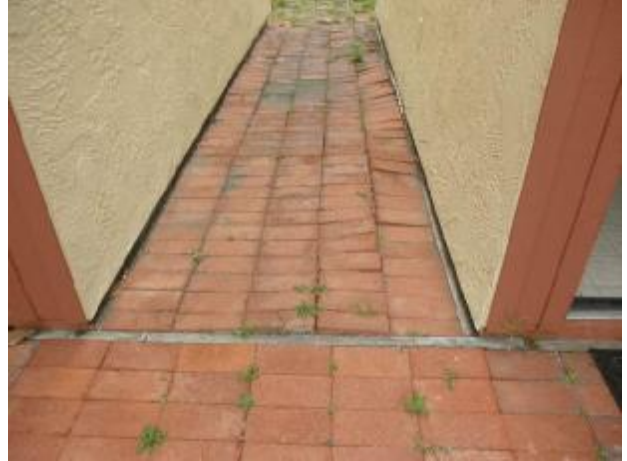
# GD

**Safety Hazard Note:** There are uplifted and dislodged brick walkways at the breezeway and at the south lawn area. This has created multiple tripping hazards.

Uplifted and dislodged bricks in the breezeway.

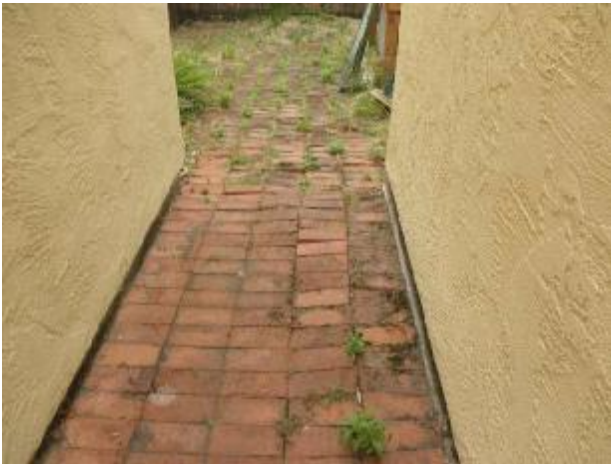
# GD

Uplifted and dislodged bricks in the breezeway.

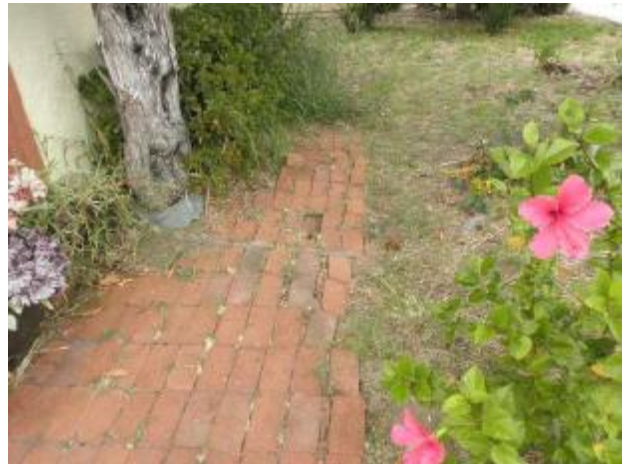
# GD

Uplifted and dislodged bricks in the south yard at unit 1.

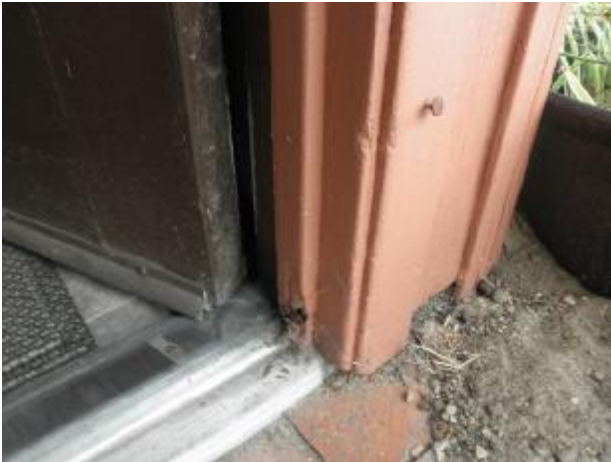
# GD

Moisture damage to the base of the jamb at the front entry door in unit 1.

3.) The front entry door to unit 1 has moisture damage to the base of the jamb and there is no weather stripping installed.

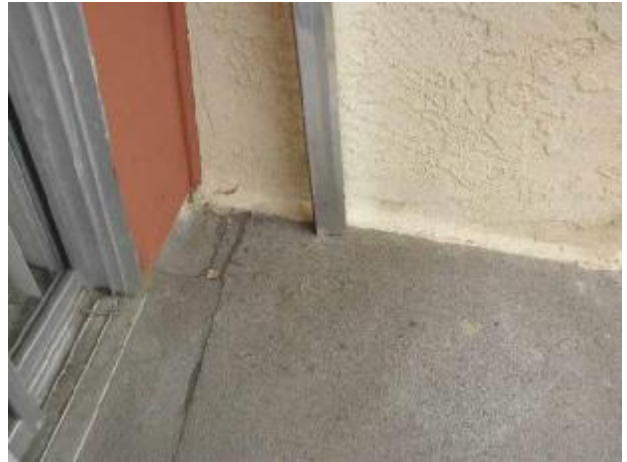
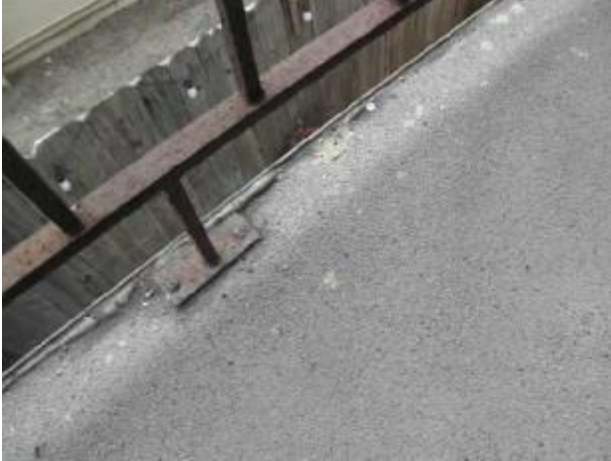
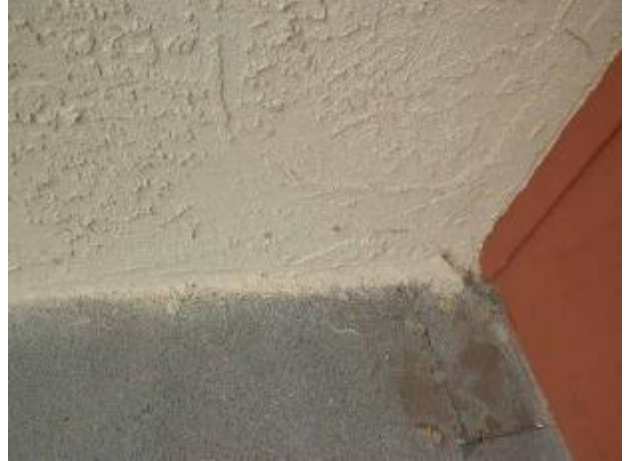
1.) The water proof decks at all four of the dwelling units are improperly installed with Modified Bitumen roofing material and not a proper water proofing material. Additionally, there is no visible flashing at the interface with the exterior stucco walls which may result in leaks. All of the water proof decks are recommended to be evaluated by a qualified and licensed tradesman that specializes in water proof deck construction prior to close of escrow.

Example of wrong material for water proof decks, no flashing installed, and splits/cracks in the material.

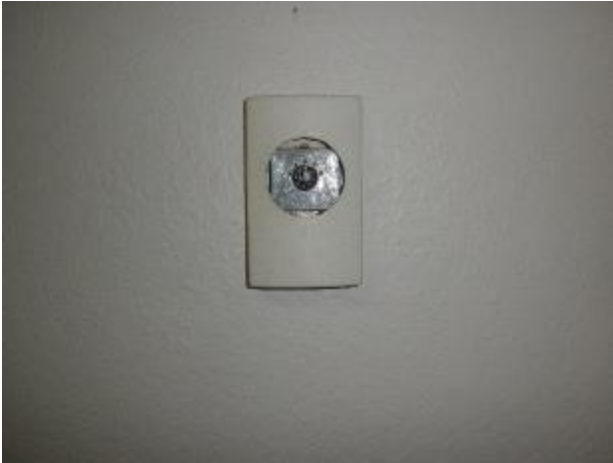
# HC

- 1.) The control knobs were missing at some of the thermostats in unit 4.

Example of missing control knobs for heating thermostats.

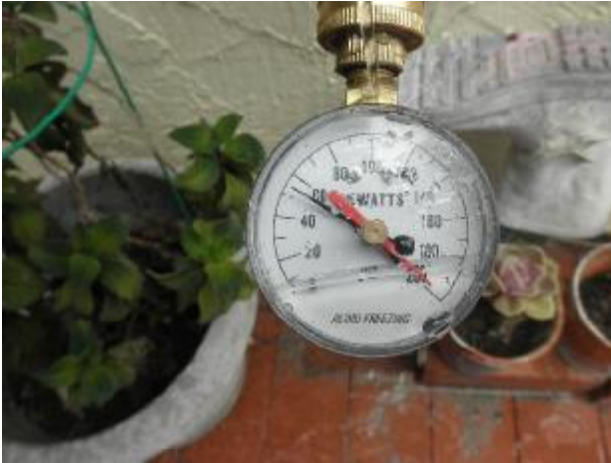
# P

The water pressure to the building was measured at 55 psi.

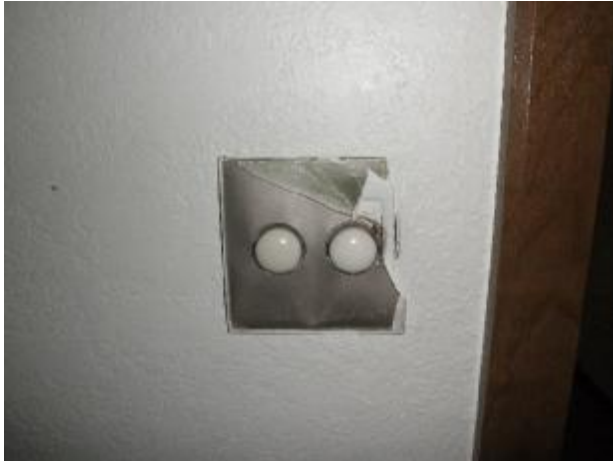
# EL

1.) There are cracked/damaged cover plates at the light switches throughout all four of the dwelling units.

Example of cracked/damaged light switch cover plates.

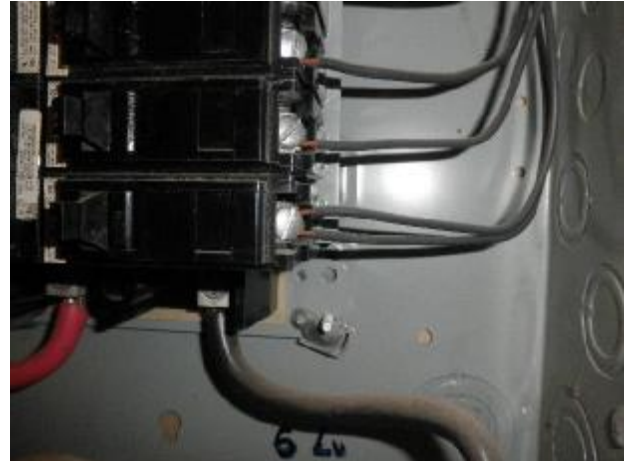
# EL

**Fire Safety Hazard Note:** There is double tapping in the electrical subpanels in all four units and at the subpanel in the community laundry. (This is where two conductors are connected to a single circuit breaker.) This is advised to be corrected by a qualified and licensed Electrical Contractor.

Example of double tapping in the subpanels.

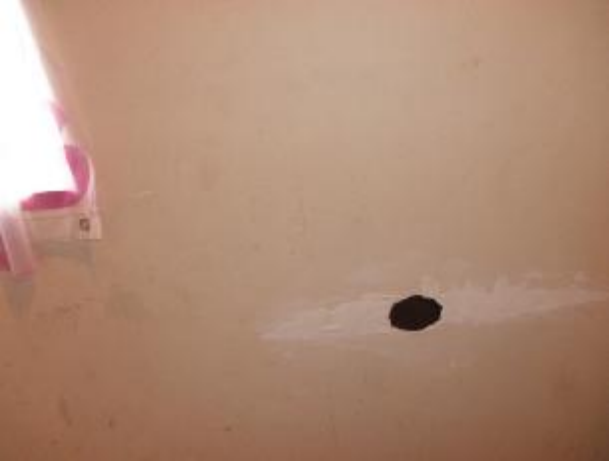
# K

Hole in the interior wall at the community laundry.

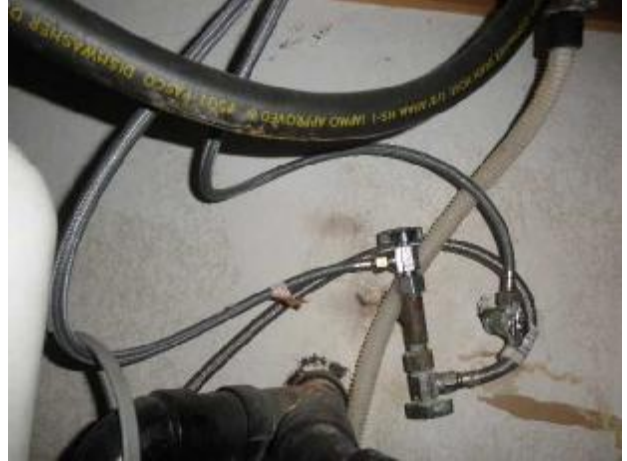
# K

Black mildew like substance under the kitchen sink in unit 4.

2.) There is a black mildew like substance at the drywall below the kitchen sink cabinets in unit 2 and 4. (See notes on the Deficiency Summary page at the end of the report regarding the potential for microbial contamination.)

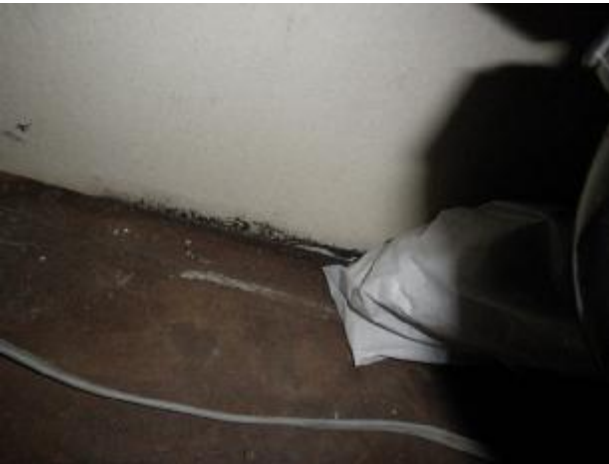
# K

Black mildew like substance below the kitchen sink in unit 2.

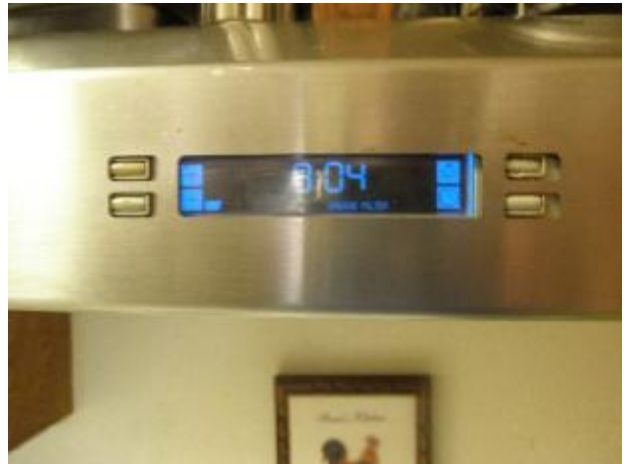
# K

Buttons missing for exhaust fan in unit 3.

4.) The buttons are missing at the exhaust fan above the kitchen range.

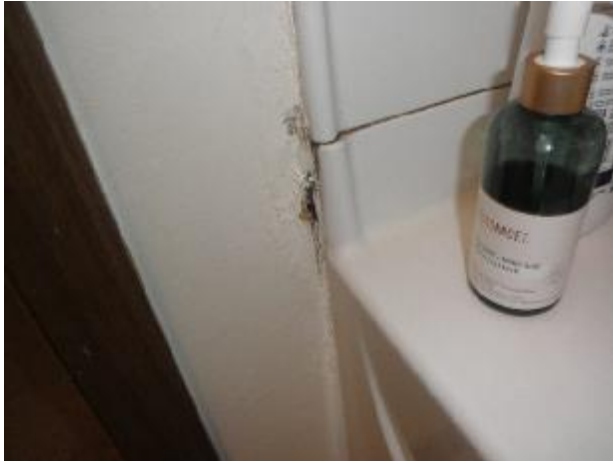
**# B**

Example of moisture damage to the side of the shower.

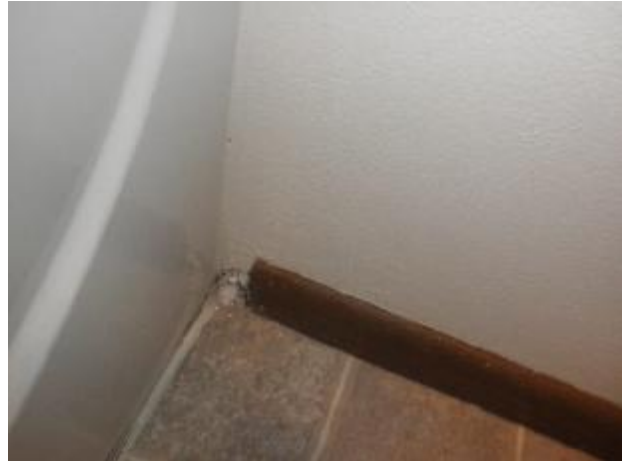
**# B**

Example of moisture damage to the side of the shower.

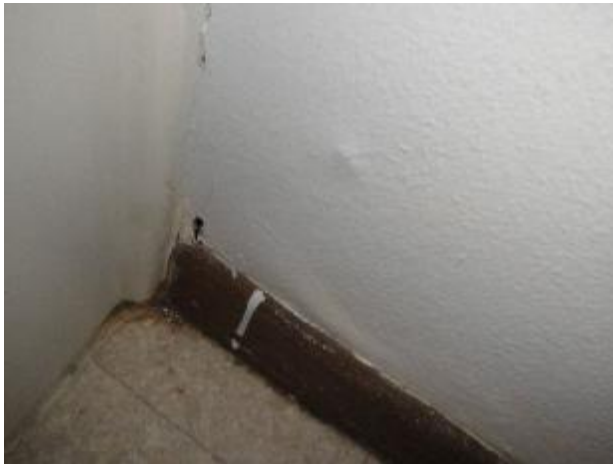
**# B**

Example of moisture damage tot he drywall next to the shower.

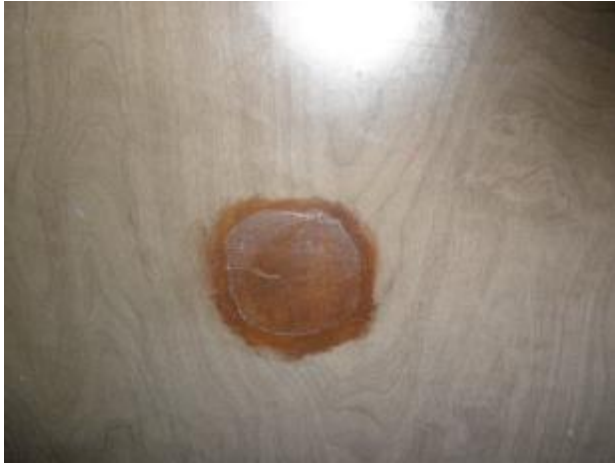
# IR

Patches and damage to bedroom door in unit 4.

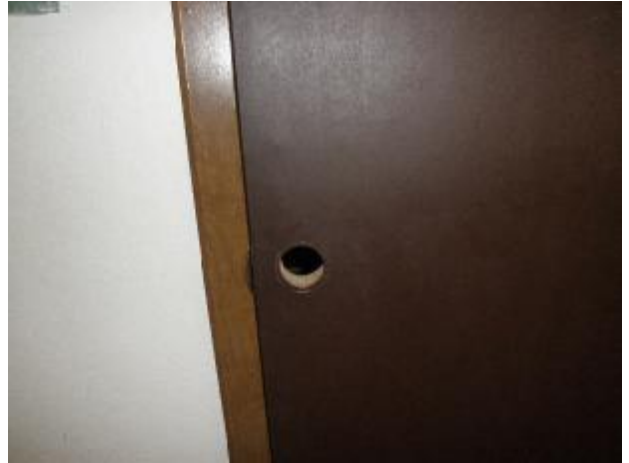
# IR

Door knob missing at living room closet in unit 2.
