# Summary Report, prepared exclusively for:

**7718 Eisenhower St. Ventura-Ransi Samantre 07-03-26 By Alex**

Inspected by: **BEST HOME** Inspection

RE: 7718 Eisenhower Street  
Ventura, CA.

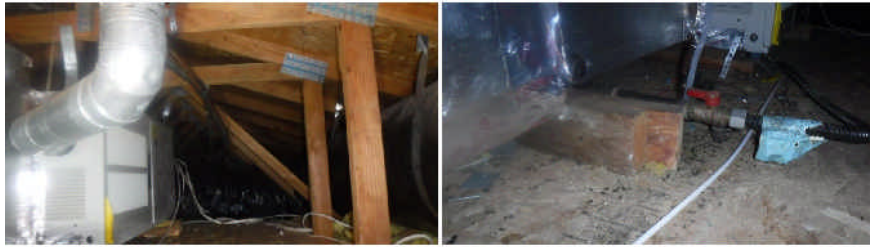
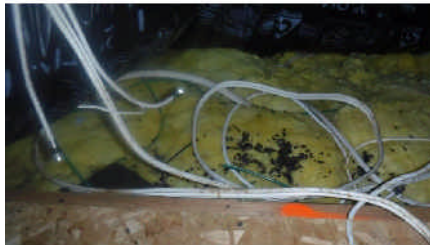
Attic is partial, over lower house ceilings. Truss roof framing system is present. Attic ventilation vents are provided. **NOTE: Heavy prior or current rodent activity was noted. Rodent waste build-up is present in the attic space. Rodents are a health hazard.** Rodent eradication and frequent monitoring is needed. **Call a licensed Exterminator.** (see photo, detailed report page - 5)

Attic is partial, over lower house ceilings. Truss roof framing system is present. Attic ventilation vents are provided. **NOTE: Heavy prior or current rodent activity was noted. Rodent waste build-up is present in the attic space. Rodents are a health hazard.** Rodent eradication and frequent monitoring is needed. **Call a licensed Exterminator.**

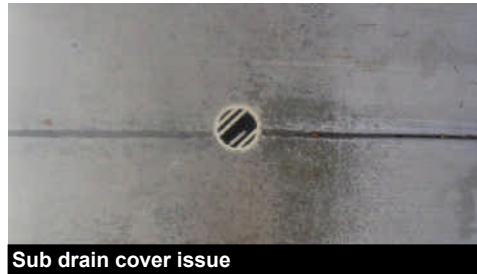
Sub drain cover issue

Full house gutters are installed, were observed by the inspector and found they are wearing well, durable and capable of being used. NOTE: ***A subsurface drain cover screen is broken / missing.*** Replace the cover for safety to foot traffic and to prevent debris from clogging the pipe. Subsurface drains noted, but not tested. They are not part of this inspection. (see photo, detailed report page - 6)

Full house gutters are installed, were observed by the inspector and found they are wearing well, durable and capable of being used. NOTE: **A subsurface drain cover screen is broken / missing.** Replace the cover for safety to foot traffic and to prevent debris from clogging the pipe.

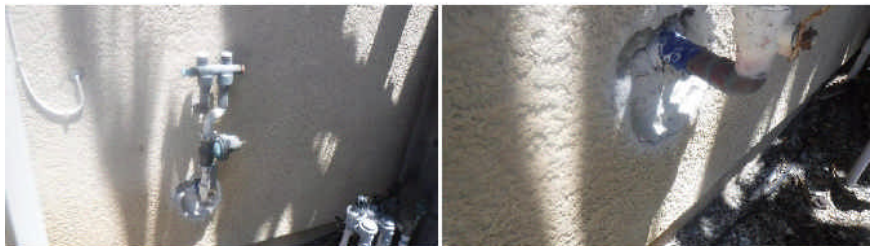
Exterior surfaces of house were observed by the inspector and found they are wearing well, durable and capable of being used. **NOTE:** Cracks noted are typical for this type of exterior surface. Cracks should be sealed at some time with exterior type sealant to prevent any future water penetration into the wood framed interior. Unfinished patch repair work noted. Recommend proper repairs by a qualified tradesperson. (see photo, detailed report page - 7)

Exterior surfaces of house were observed by the inspector and found they are wearing well, durable and capable of being used. NOTE: Cracks noted are typical for this type of exterior surface. Cracks should be sealed at some time with exterior type sealant to prevent any future water penetration into the wood framed interior. Unfinished patch repair work noted. Recommend proper repairs by a qualified tradesperson. (see photo, detailed report page - )

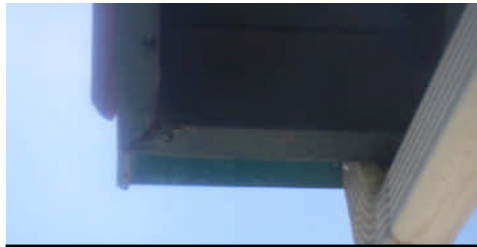
**Exterior trim issues**

Fungus damage (wood rot) is noted in some of the exterior wood boards. A fungus growth will continue to rot the wood. Replacement of parts or whole boards will be needed to affected areas. Also, at sometime in past or at present, there has been insect infestation in some exterior wood boards. Recommend referring to the present-in-effect Termite Report conducted on this property for findings / recommendations on the wood damage conditions, or arrange for further evaluation

Fungus damage (wood rot) is noted in some of the exterior wood boards. A fungus growth will continue to rot the wood. Replacement of parts or whole boards will be needed to affected areas. Also, at sometime in past or at present, there has been insect infestation in some exterior wood boards. Recommend referring to the present-in-effect Termite Report conducted on this property for findings / recommendations on the wood damage conditions, or arrange for further evaluation by a licensed Pest Control Operator. (see photo, detailed report page - )

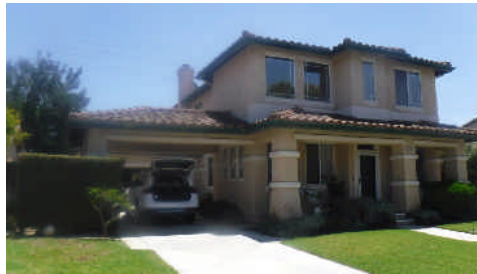
Chimney exterior was observed by the inspector and found it is wearing well; is durable; is capable of being used. Spark arrestor noted on top of chimney, appears serviceable. NOTE: Unable to fully access or view the chimney areas due to the height / type of roof. (see photo, detailed report

Chimney exterior was observed by the inspector and found it is wearing well; is durable; is capable of being used. Spark arrestor noted on top of chimney, appears serviceable. NOTE: Unable to fully access or view the chimney areas due to the height / type of roof. (see photo, detailed report page - )

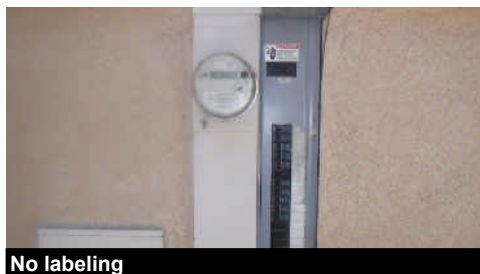
Circuit breakers and wire sizing are correct so far as visible. Electrical grounding system is present, was tested or observed by the inspector and found it is wearing well; is durable; is capable of being used. NOTE: Panels are without the benefit of complete labeling. Label all breakers. (see photo, detailed report page - 10)

Circuit breakers and wire sizing are correct so far as visible. Electrical grounding system is present, was tested or observed by the inspector and found it is wearing well; is durable; is capable of being used. NOTE: Panels are without the benefit of complete labeling. Label all breakers. (see photo, detailed report page - )

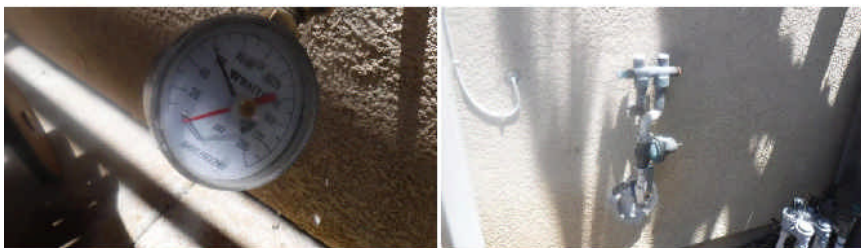
**PSI OK/ Shut off valve not tested**

Main entry water line is 1" diameter. An in-line pressure regular is installed to regulate the main street water pressure down to within the recommended 40 to 80 PSI for house use. Water pressure tested at a hose faucet was within recommended PSI pressure reading and appears adequate. PSI is approximately - 55. NOTE: House water shut off valve was not tested, because these valves oftentimes malfunction as they are in the on / open position all the time. Care should be taken in operating this valve if the water should ever need to be turned-off and on. (see photo, detailed report page - 13)

Main entry water line is 1" diameter. An in-line pressure regular is installed to regulate the main street water pressure down to within the recommended 40 to 80 PSI for house use. Water pressure tested at a hose faucet was within recommended PSI pressure reading and appears adequate. PSI is approximately - 55. NOTE: House water shut off valve was not tested, because these valves oftentimes malfunction as they are in the on / open position all the time. Care should be taken in operating this valve if the water should ever need to be turned-off and on. (see photo, detailed report page - )

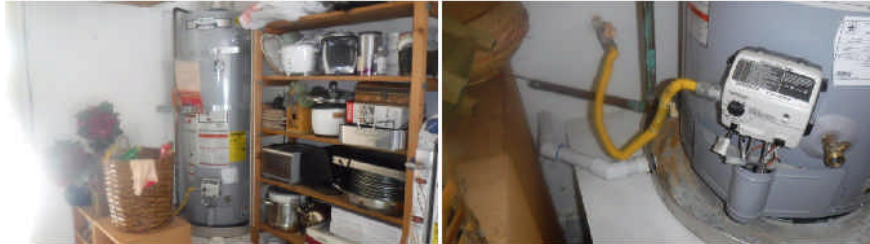
**Improper strapping/ No sediment trap**

Pressure relief valve noted, not tested. Pressure relief drain line is installed. Tank and heating system was tested or observed by the inspector and found it is functional. Approved earthquake strapping is properly installed. ***Earthquake strapping is not installed properly to prevent all movement of water heater tank.*** Properly install straps and block the tank to the wall. The gas line is not provided with a sediment trap. Recommend installation of trap by a licensed plumber. (see photo, detailed report page - 14)

Pressure relief valve noted, not tested. Pressure relief drain line is installed. Tank and heating system was tested or observed by the inspector and found it is functional. Approved earthquake strapping is properly installed. **Earthquake strapping is not installed properly to prevent all movement of water heater tank.** Properly install straps and block the tank to the wall. The gas line is not provided with a sediment trap. Recommend installation of trap by a licensed plumber. (see photo, detailed report page - )

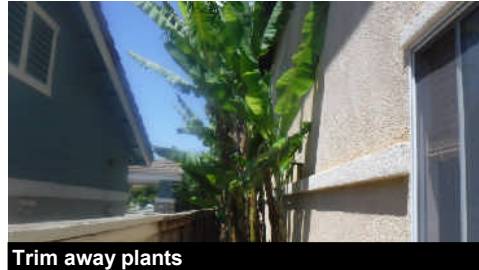
Maintained. EXCEPT: Recommend trimming plants / shrubs at least 12" away from structure to allow for air movement around the house to help keep it dry from moisture, and to not cause damage to exterior walls. (see photo, detailed report page - 16)

Maintained. EXCEPT: Recommend trimming plants / shrubs at least 12" away from structure to allow for air movement around the house to help keep it dry from moisture, and to not cause damage to exterior walls.

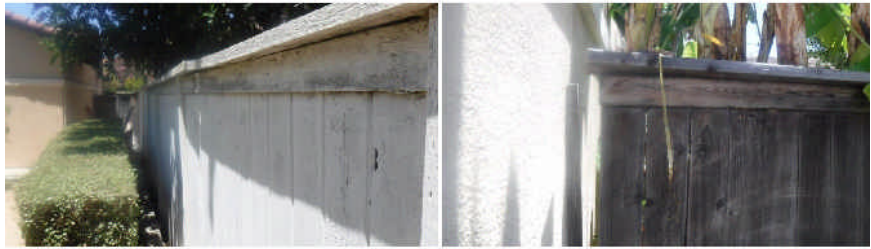
**Gate / fence issues**

Masonry wall fencing has typical cracks, was observed by the inspector and found it is wearing well, is durable and capable of being used. NOTE: Wood gate(s) need to be repaired or adjusted in order to properly open, close and latch. Wood fencing has some loose / rotted posts that should be replaced. Recommend proper repairs by a qualified tradesperson. (see photo, detailed report page - 17)

Masonry wall fencing has typical cracks, was observed by the inspector and found it is wearing well, is durable and capable of being used. NOTE: Wood gate(s) need to be repaired or adjusted in order to properly open, close and latch. Wood fencing has some loose / rotted posts that should be replaced. Recommend proper repairs by a qualified tradesperson. (see photo, detailed report page - )

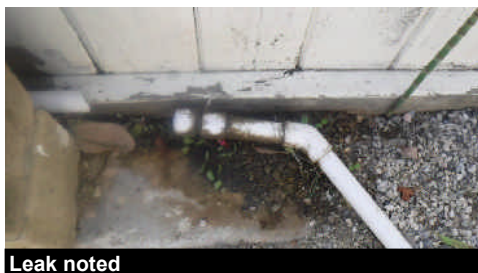
Leak noted

Future sprinkler line is leaking at rear right. Recommend repairs by a qualified tradesperson. (see photo, detailed report page - 18)

Future sprinkler line is leaking at rear right. Recommend repairs by a qualified tradesperson. (see photo, detailed report page - )

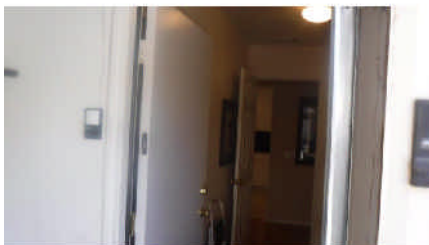
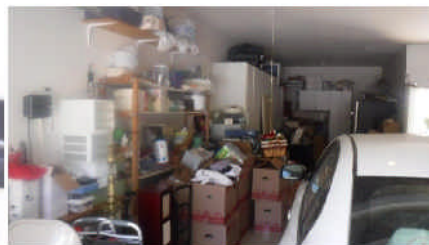
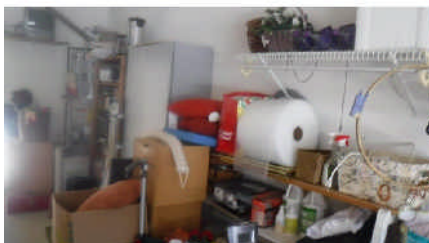
#### Fire door issues/ Viewing restricted

***Installed interior garage fire door, door closer should be either adjusted or replaced to fully***

**close and latch the fire door. This is a potential safety hazard.** Adjust or replace door closer. Garage interior and fire wall are not fully visible for inspection, due to stored items. Further inspection is recommended. In case of a fire these items increase the heat ratio against this wall. Fire walls should be clear of flammable stored items / fixtures for fire safety. (see photo, detailed report page - 19)

**Installed interior garage fire door, door closer should be either adjusted or replaced to fully close and latch the fire door. This is a potential safety hazard.** Adjust or replace door closer. **Garage interior and fire wall are not fully visible for inspection, due to stored items. Further inspection is**

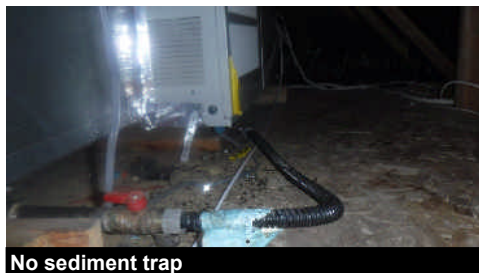
Natural gas. Electronic ignition is provided. NOTE: The gas line is not provided with a sediment trap. Recommend installation of trap by a licensed plumber. (see photo, detailed report page - 22)

Natural gas. Electronic ignition is provided. NOTE: The gas line is not provided with a sediment trap. Recommend installation of trap by a licensed plumber. (see photo, detailed report page - )

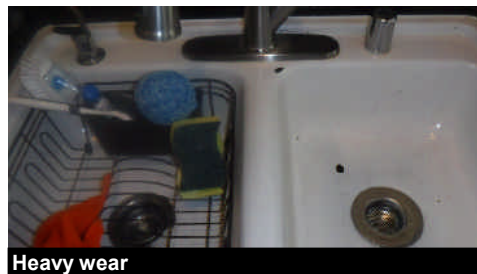
Heavy wear

Sink faucet appears serviceable. Sink hand sprayer appears serviceable. NOTE: Sink has heavy wear, some chips in surface are noted. Recommend filling porcelain chips with porcelain filler to retard rusting. (see photo, detailed report page - )

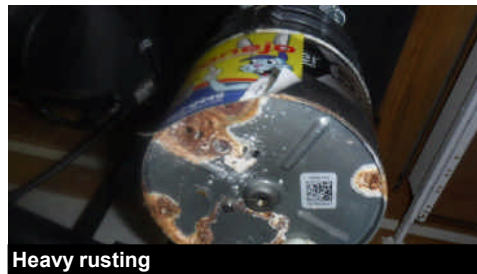
Ran short test of unit. NOTE: Heavy rusting of the garbage disposal is noted. Recommend replacement.. (see photo, detailed report page - 25)

Ran short test of unit. NOTE: Heavy rusting of the garbage disposal is noted. Recommend replacement.. (see photo, detailed report page - )

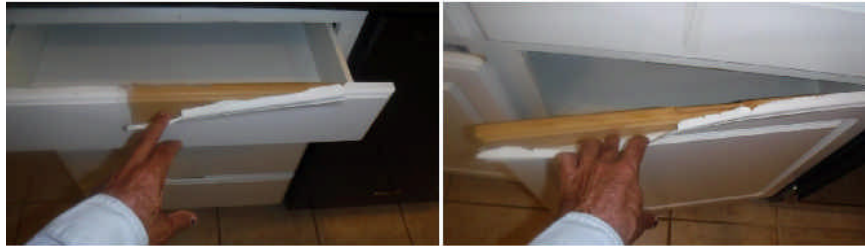
#### Damaged veneer

Cabinets have minor, normal wear. Cabinets were observed by the inspector and found they are wearing well, durable and capable of being used.

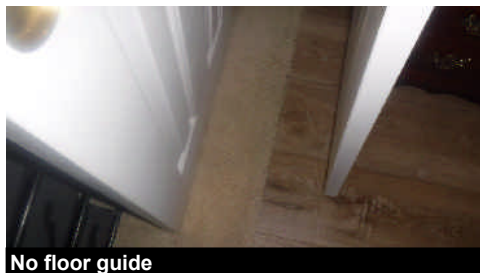
Interior closet doors were tested or observed by the inspector and found they are wearing well, durable and capable of being used. EXCEPT: Closet floor plastic track guide should be installed to hold bottom of doors in-place. (see photo, detailed report page - )

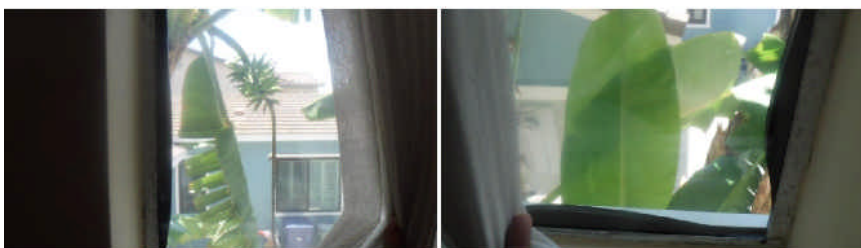
**Defective seal gaskets**

Metal sliding type. Double insulated glass. Window screens were observed by the inspector and found they are wearing well, durable and capable of being used. NOTE: Several windows have defective seal gaskets. Recommend window inspections and replacements, as needed by a qualified licensed glass tradesperson. (see photo, detailed report page - 29)

Metal sliding type. Double insulated glass. Window screens were observed by the inspector and found they are wearing well, durable and capable of being used. NOTE: Several windows have defective seal gaskets. Recommend window inspections and replacements, as needed by a qualified licensed glass tradesperson. (see photo, detailed report page - )

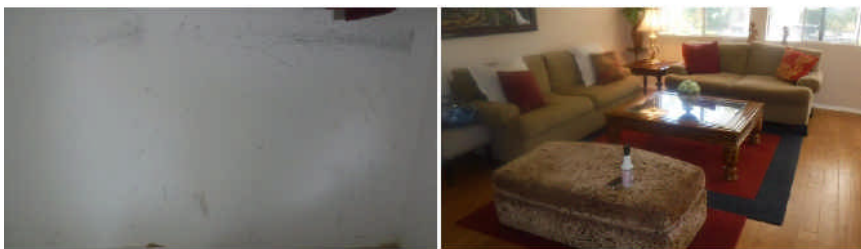
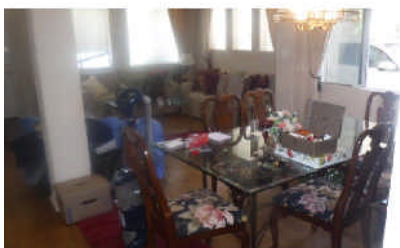
**Maintenance needed/ Limited inspection**

Drywall. Wall paper. NOTE: Interior walls need cosmetic work / should be maintenance painted. Stored items or furnishings prevent full inspection. Further inspection is recommended. (see photo, detailed report page - )

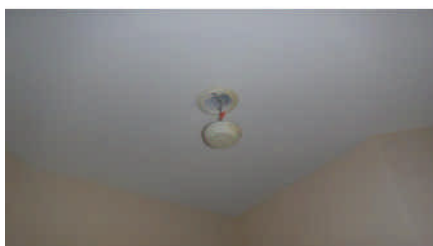
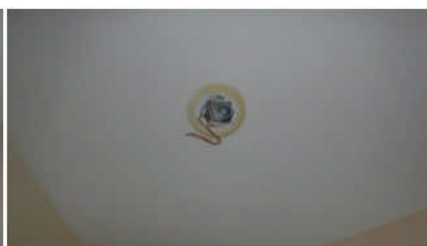
**Alarm issues**

**Some smoke alarms are loose and missing. This is a safety hazard.** Repair or replace alarm.

**No carbon monoxide alarms are installed at required locations. This is a safety hazard.**

***Some smoke alarms are loose and missing. This is a safety hazard.***  
Repair or replace alarm. ***No carbon monoxide alarms are installed at required locations. This is a safety hazard.*** Install alarms by a qualified tradesperson. (see photo, detailed report page - )

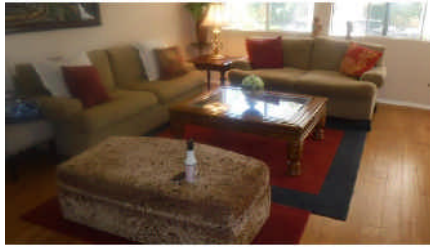
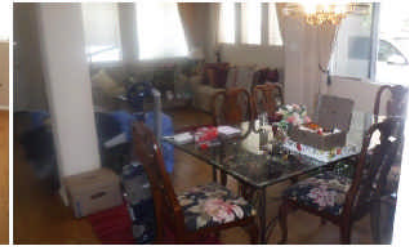
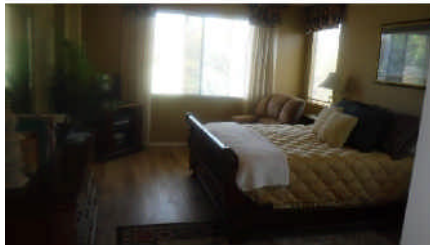
**Limited inspection**

A representative sampling of switches and outlets was tested. As a whole, interior outlets and switches in the house are in serviceable condition. EXCEPT: Stored items or furnishings prevent access and testing at some outlets and switches, condition(s) unknown. Further inspection is needed. (see photo, detailed report page - 32)

A representative sampling of switches and outlets was tested. As a whole, interior outlets and switches in the house are in serviceable condition.

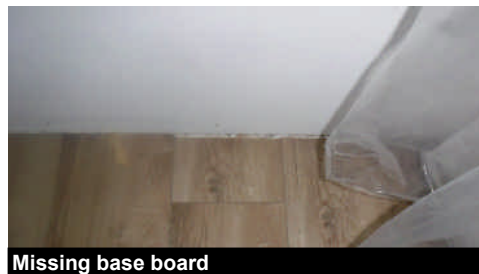
Missing base board noted at upstairs bedroom closet. (see photo, detailed report page - )

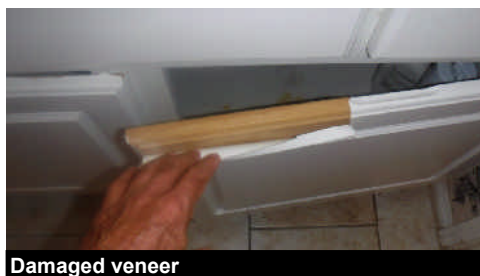
Counters / cabinets were observed by the inspector and found they are wearing well, durable and capable of being used. EXCEPT: Damaged veneer noted. Recommend proper repairs by a qualified tradesperson. (see photo, detailed report page - )

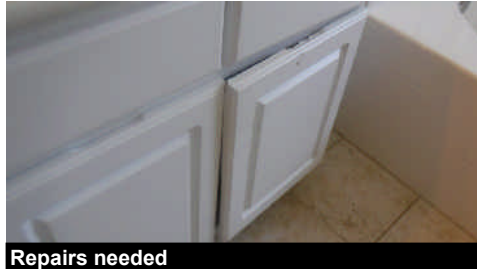
Counters / cabinets were observed by the inspector and found they are wearing well, durable and capable of being used. EXCEPT: Sink cabinet door(s) should have hinges adjusted or replaced for proper opening / closing of doors. (see photo, detailed report page - )

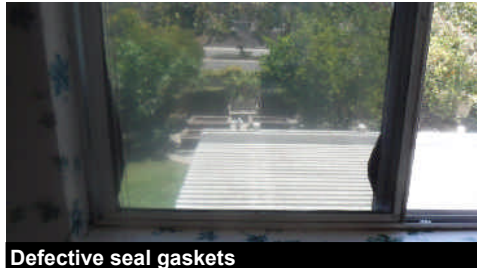
Bathroom window has defective seal gaskets. Recommend window inspections and replacements, as needed by a qualified licensed glass tradesperson. (see photo, detailed report page - 34)

Bathroom window has defective seal gaskets. Recommend window inspections and replacements, as needed by a qualified licensed glass tradesperson. (see photo, detailed report page - )

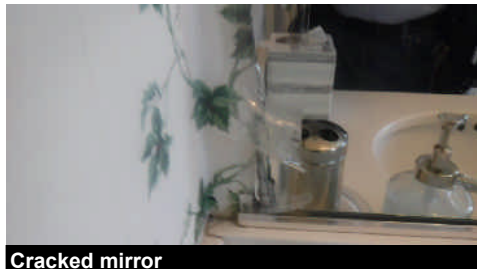
Wall mirror is cracked. Recommend replacement. (see photo, detailed report page - 34)

Wall mirror is cracked. Recommend replacement. (see photo, detailed report page - )

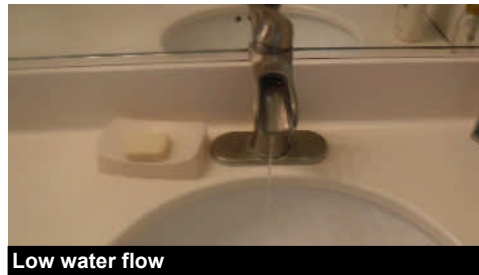
**Low water flow**

Sink(s) appear serviceable. Sink drain(s) appear serviceable. Sink faucet(s) appear serviceable. EXCEPT: Low water flow is noted at fixtures. A licensed plumber should be called to make further evaluation and repairs as needed. (see photo, detailed report page - 35)

Sink(s) appear serviceable. Sink drain(s) appear serviceable. Sink faucet(s) appear serviceable. EXCEPT: Low water flow is noted at fixtures. A licensed plumber should be called to make further evaluation and repairs as needed. (see photo, detailed report page - )

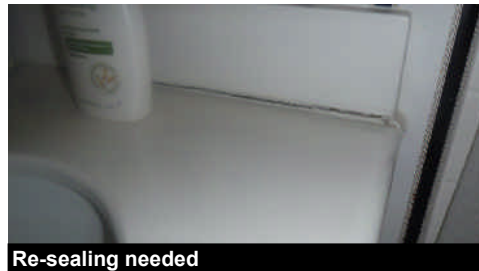
**Re-sealing needed**

Counters / cabinets were observed by the inspector and found they are wearing well, durable and capable of being used. EXCEPT: Area around the sink counter top and wall back splash should be sealed to prevent water damage to interior walls. (see photo, detailed report page - )
