# WOOD DESTROYING PESTS AND ORGANISMS INSPECTION REPORT

| Building No.<br><b>1409</b> | Street<br><b>Thayer Ave</b> | City<br><b>Los Angeles</b> | ZIP<br><b>90024</b> | Date of Inspection<br><b>07/04/2026</b> | Number of Pages<br><b>7</b> |
| <b>GENERAL DESCRIPTION:</b><br>Two story, single family residence. Stucco over wood framing. Tile roof. Interior floor coverings. Wallpaper and paper coverings to wall. Loose tile/broken tile noticed at the time of inspection. Soffit roof eaves. | | | | Inspection Tag Posted:<br>Attic<br><br>Other Tags Posted:<br>NONE | |

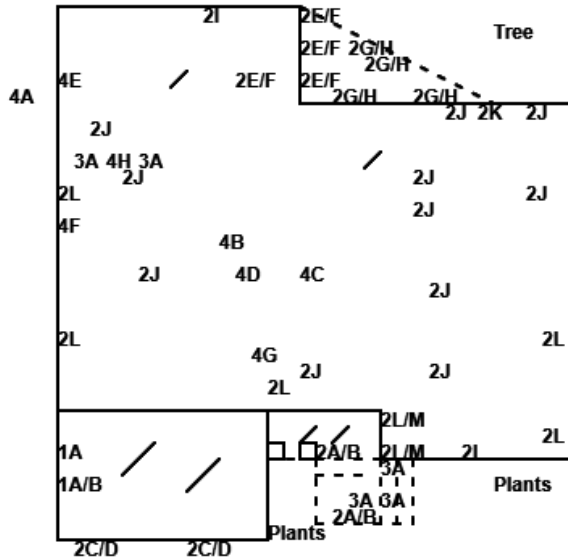
**Diagram Not To Scale**

Tree noted on the diagram had visible signs of termite infestation and damages. Recommended to remove tree to prevent infestation of termite to the house.
