Inspection reference: 26099

## Confidential Inspection Report

18301 Taylor Ct  
Torrance CA 90504

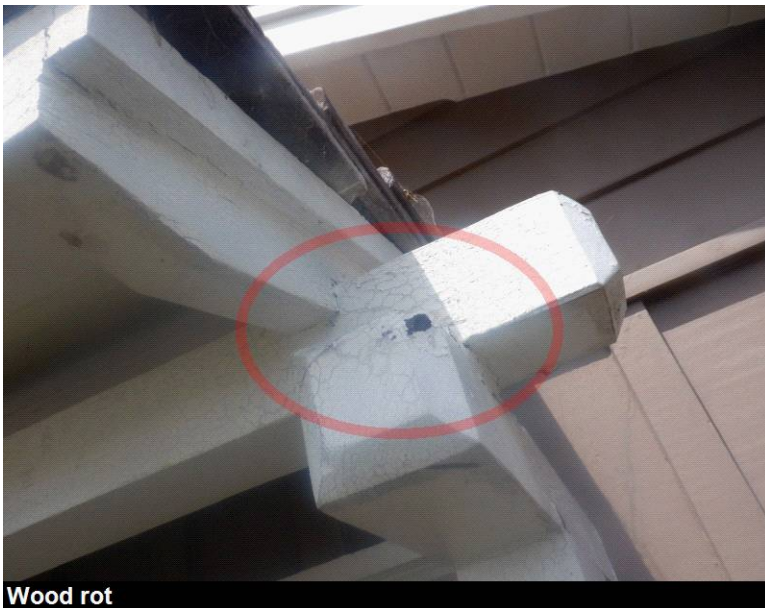
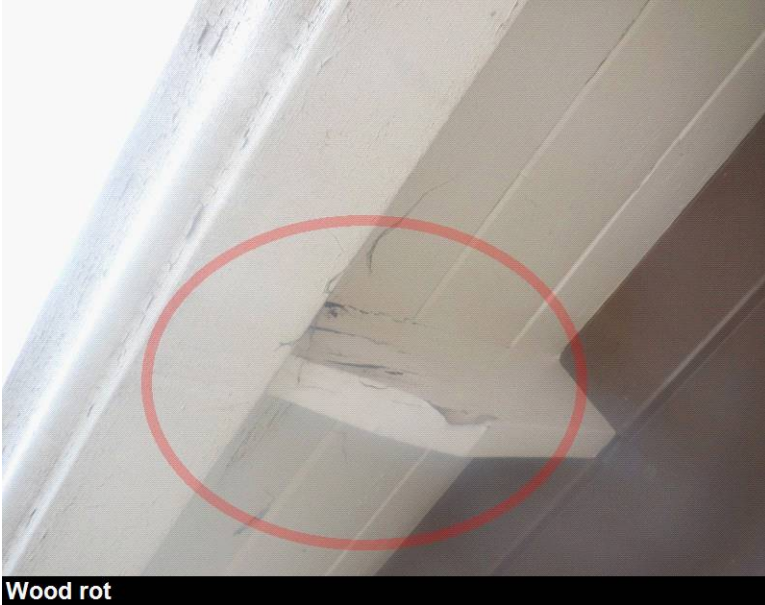
Wood; The termite inspection report should be reviewed as deteriorated wood was visible at exterior trim ( such as fascia boards, rafter tails, starter boards, window and door casings). Licensed pest control company will determine repair method and whether fumigation is necessary.

**Wood rot**

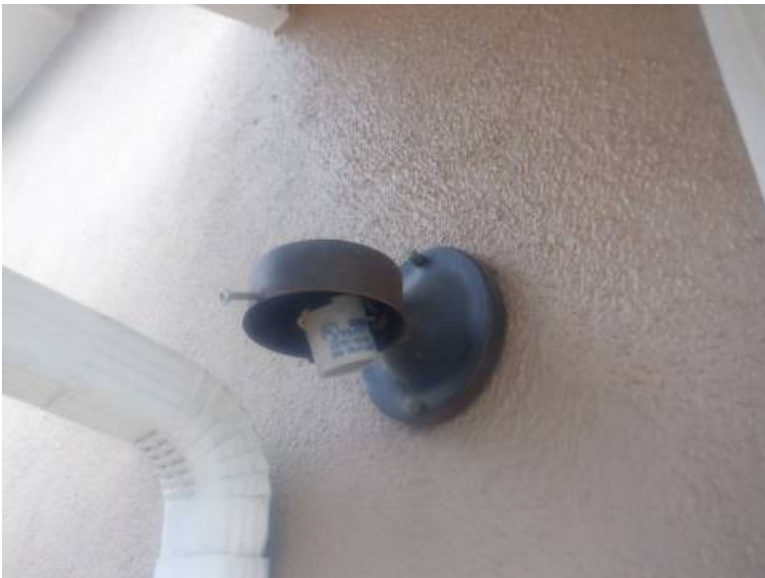
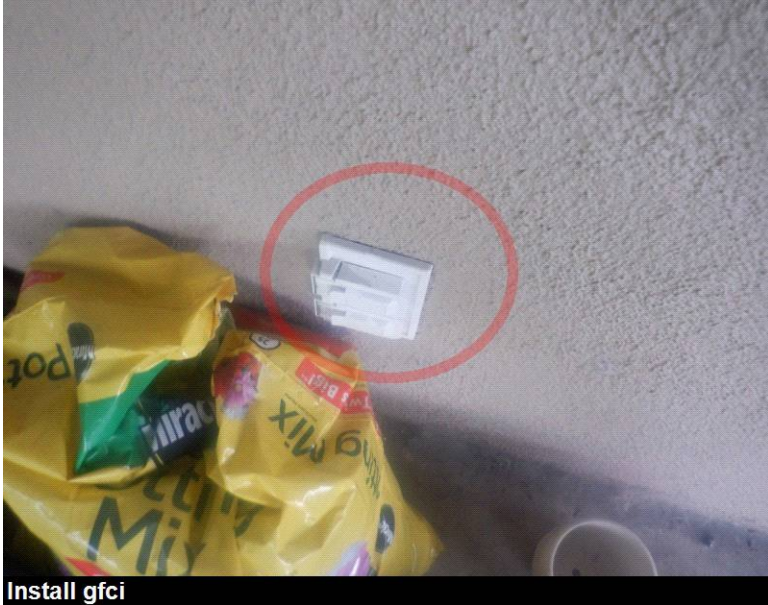
Contact licensed contractor for repair as outlet rear of the structure tested positive for reversed polarity. Reversed polarity is when the hot and neutral connections at a receptacle are wired "backwards." Home wiring is color-coded, and the black wire is "hot," meaning that it is electrically charged or, as it is sometimes called, the "live" wire. Its the one that will shock you if you come in contact with it in a way that will complete a circuit to the earth. The white is called the "neutral." It completes a circuit when connected with the hot wire through a switch, providing electric power to an appliance, and will not shock you.

Install gfci

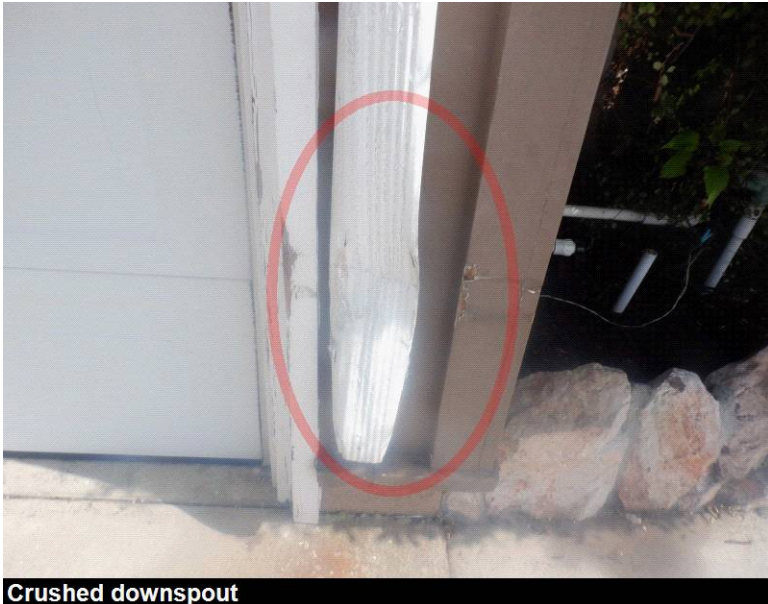
Downspouts are used to control the flow of water from the gutters away from the structure, damaged gutter downspouts were noted and should be replaced as needed.

Crushed downspout

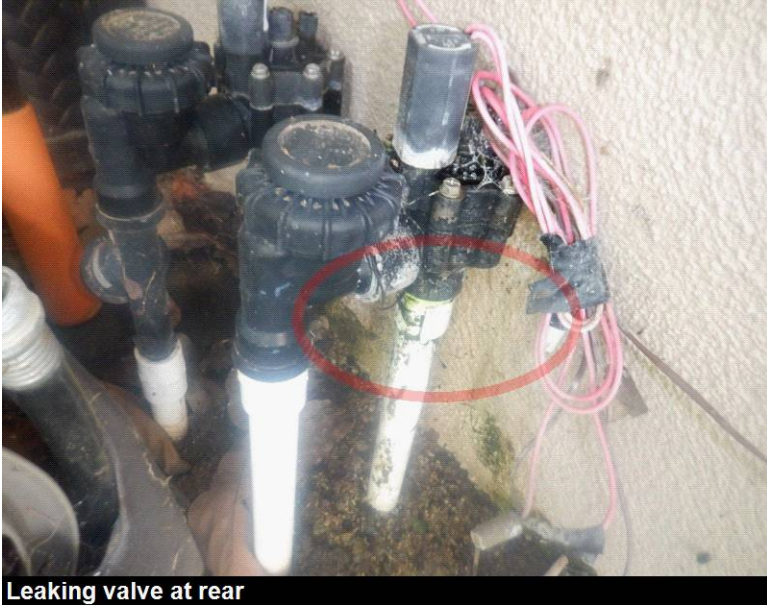
Maintenance is needed as a leaking sprinkler valves were noted, contact licensed contractor for review and replacement of any leaking valves to prevent unnecessary water loss.

Leaking valve at rear

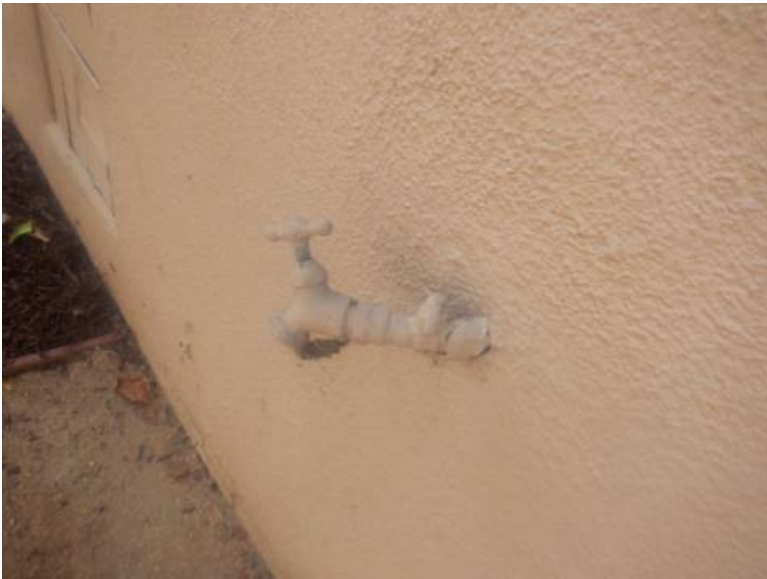
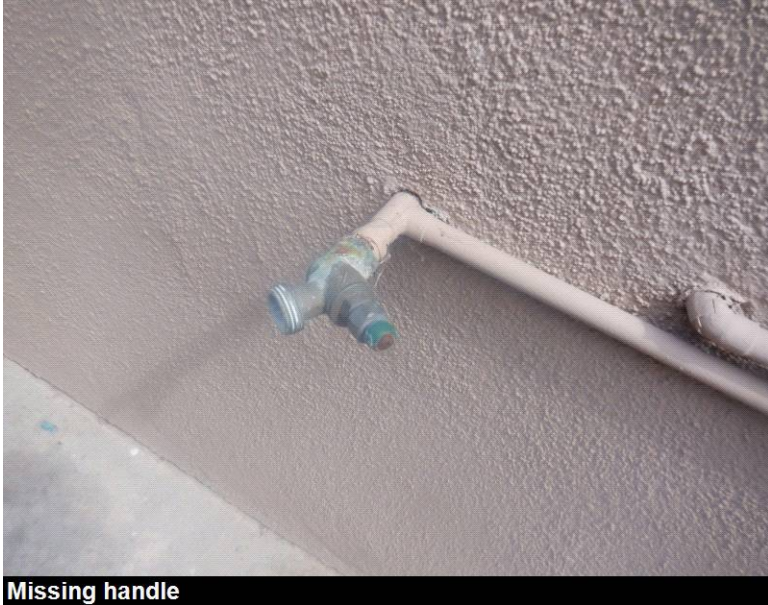
Missing handle on hose faucet at left side, replace handles as needed (maintenance).

Missing handle

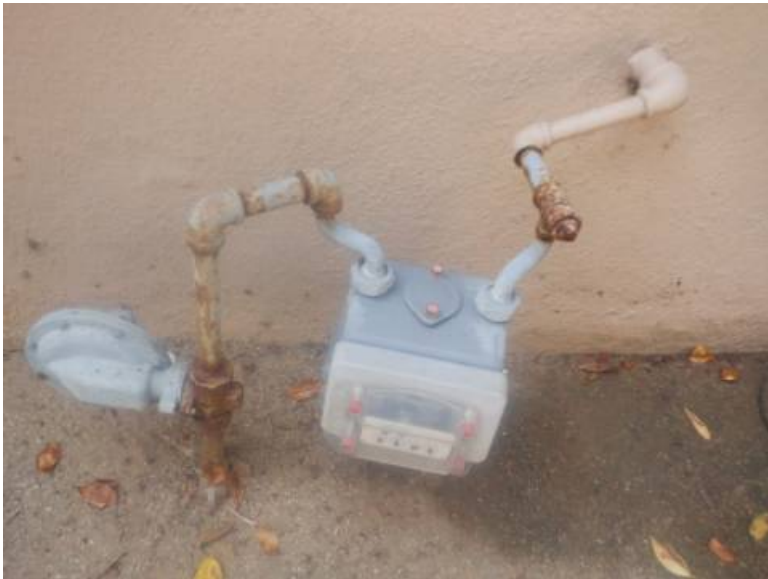
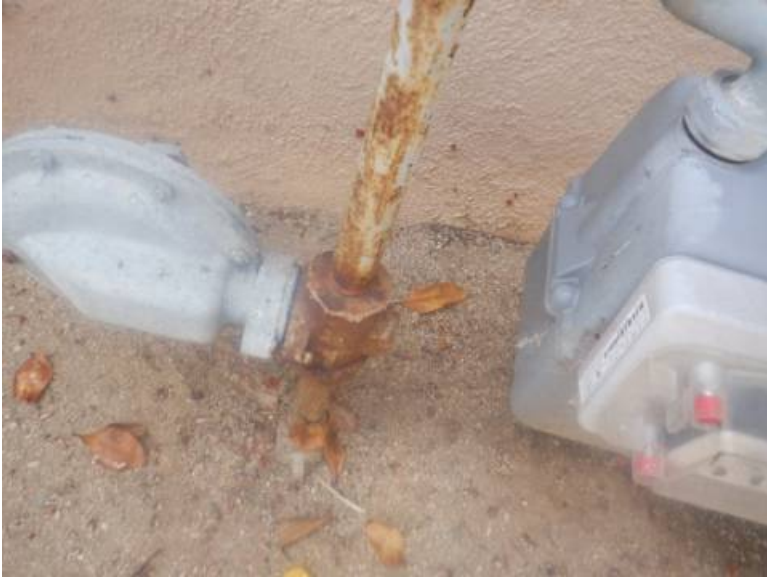
Rusted fittings visible to/ from the gas meter. Paint or wrap these fittings to slow rust process. Heavily corroded lines may need replacement to prevent a gas leak as they are under pressure. The Gas Company can be contacted for free inspection.

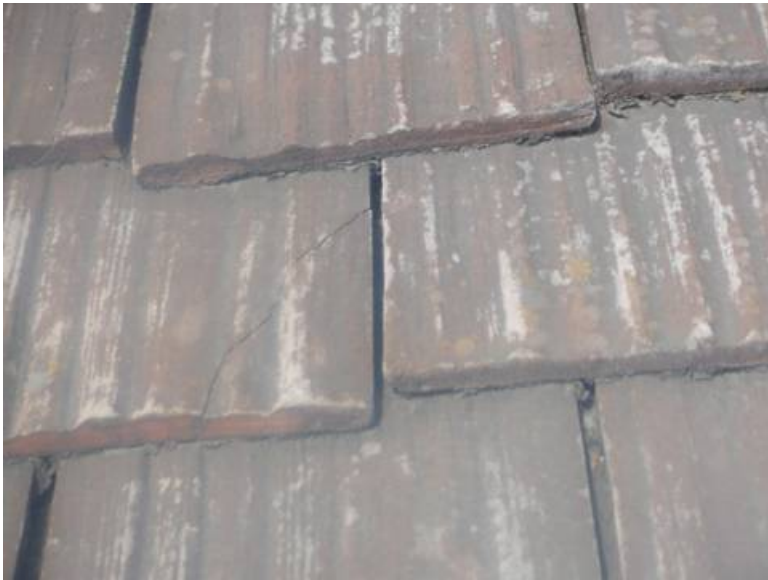
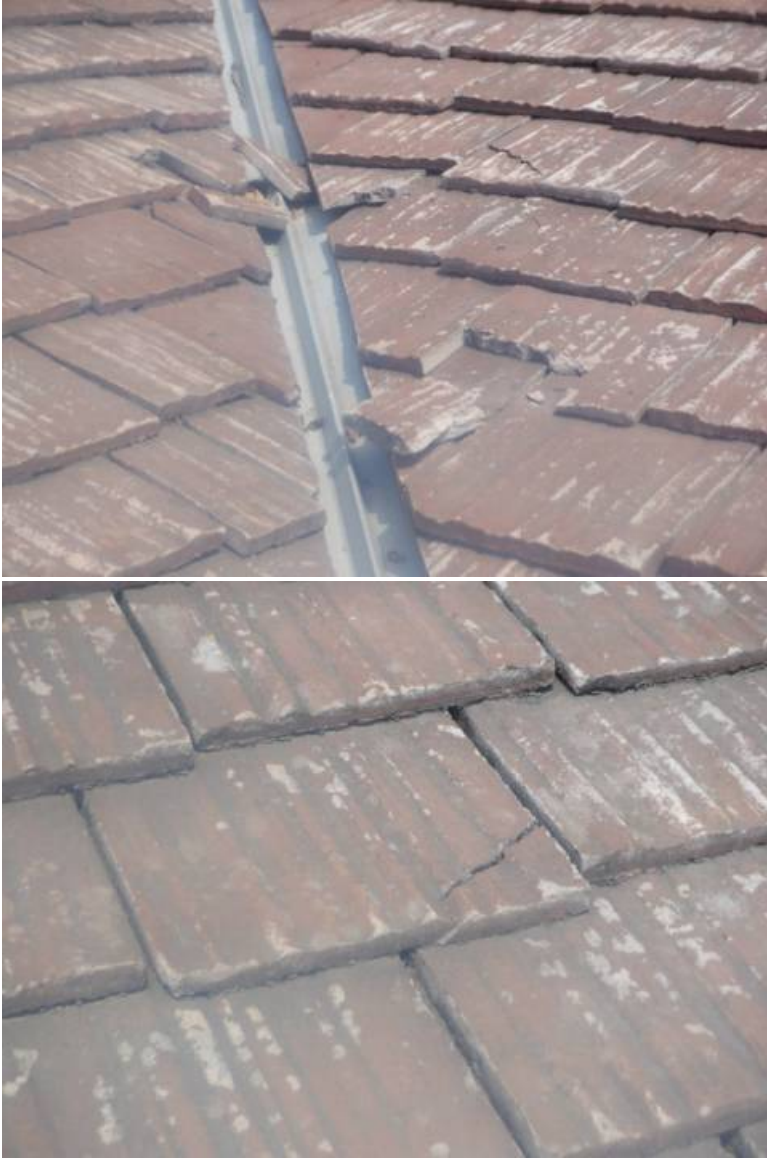
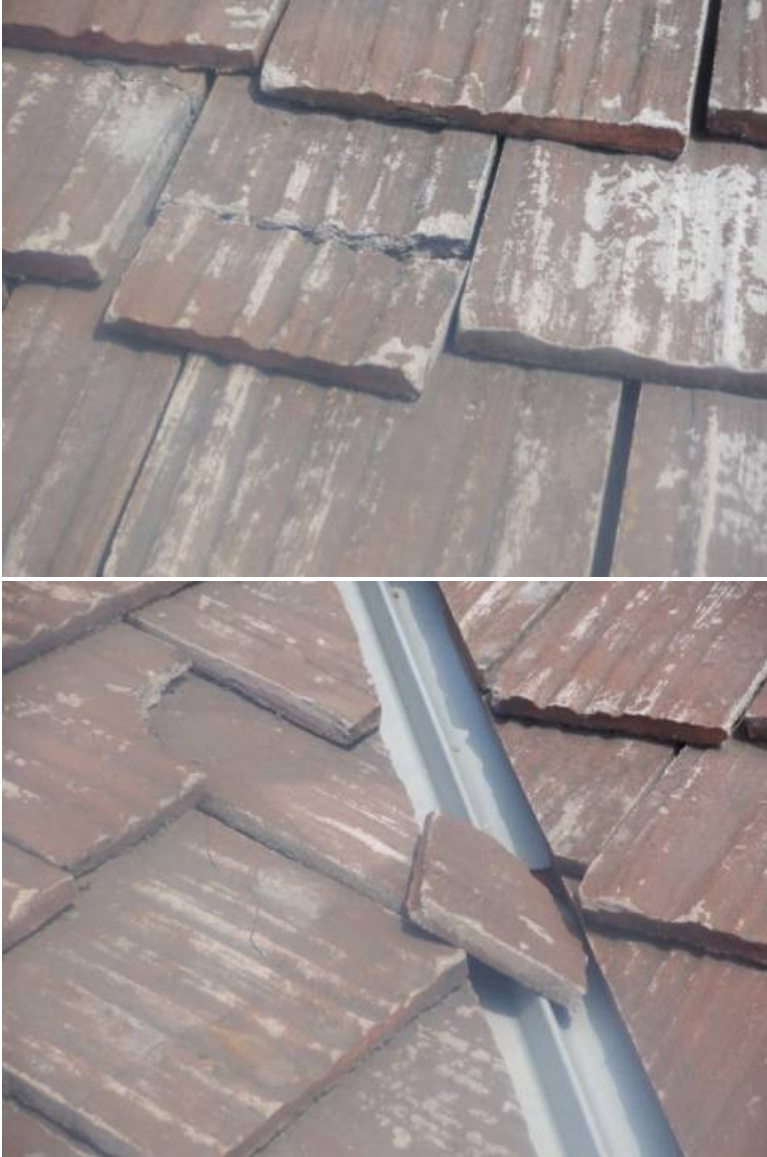
The roof has many cracked tiles and deterioration, replacement is suggested to prevent leakage. Contact a licensed roofing contractor for replacement options.

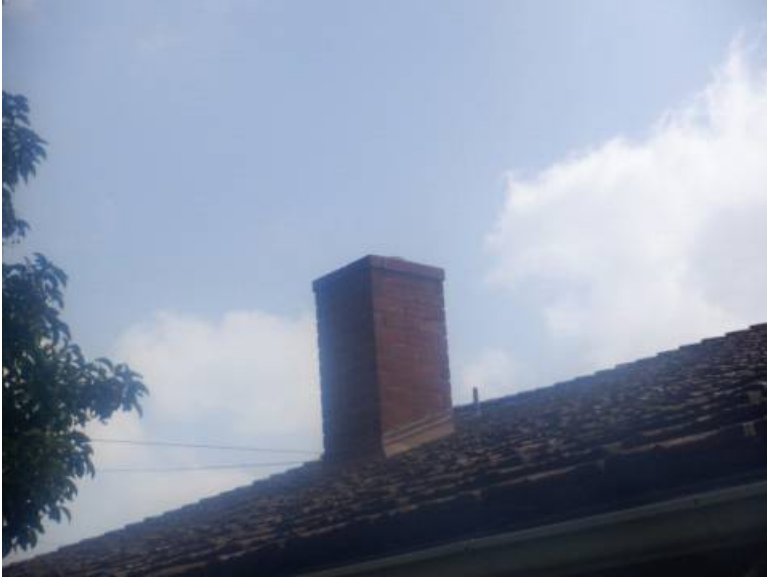
The chimney does not have a spark arrester installed. A spark arrester (sometimes spark arrester) is any device which prevents the emission of flammable debris from combustion sources, such as internal combustion engines, fireplaces, and wood burning stoves.

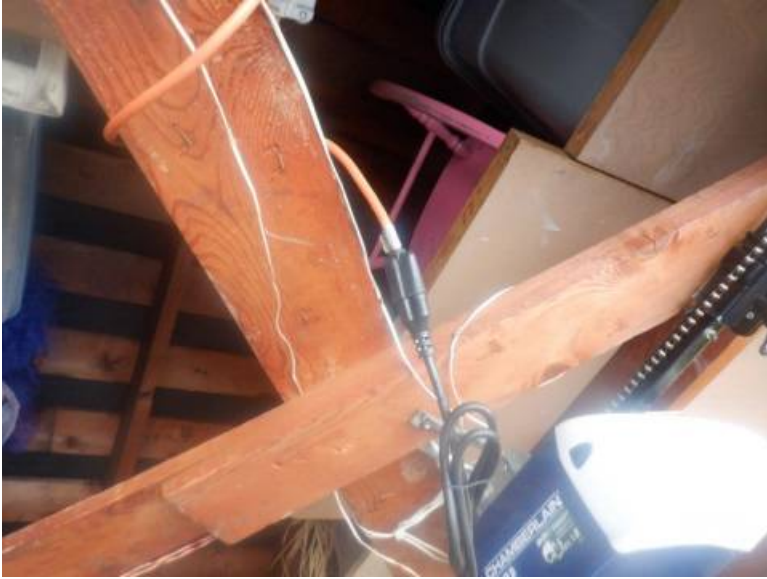
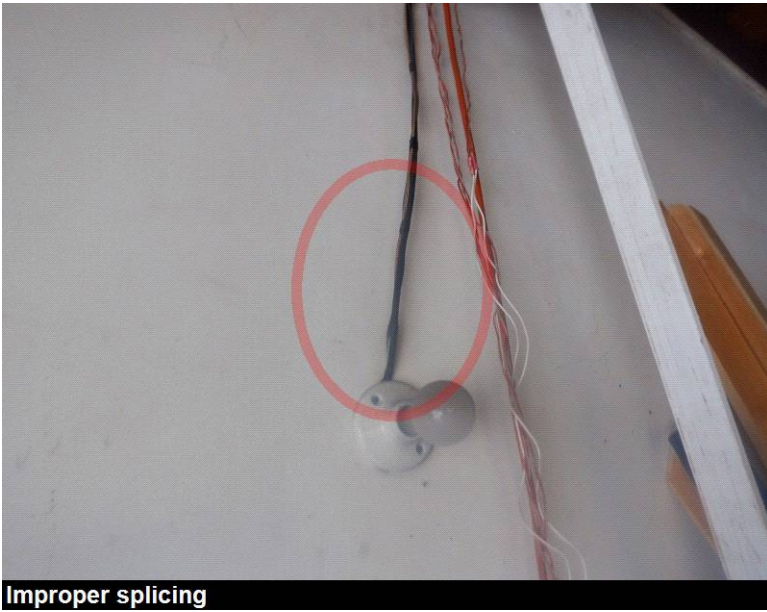
Improper splicing off rear wall light fixture, repair needed.

**Improper splicing**

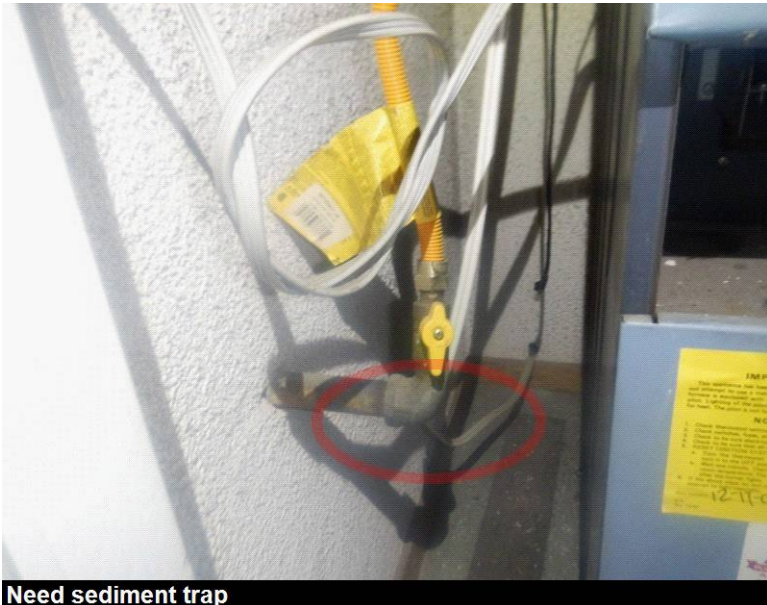
Installation of a sediment trap is suggested on the heater gas line. A sediment trap which is sometimes called a drip leg is a capped off section of gas line which is installed in such a way that any debris or moisture in the gas line will be caught in the trap where it can be cleaned out easily.

Need sediment trap

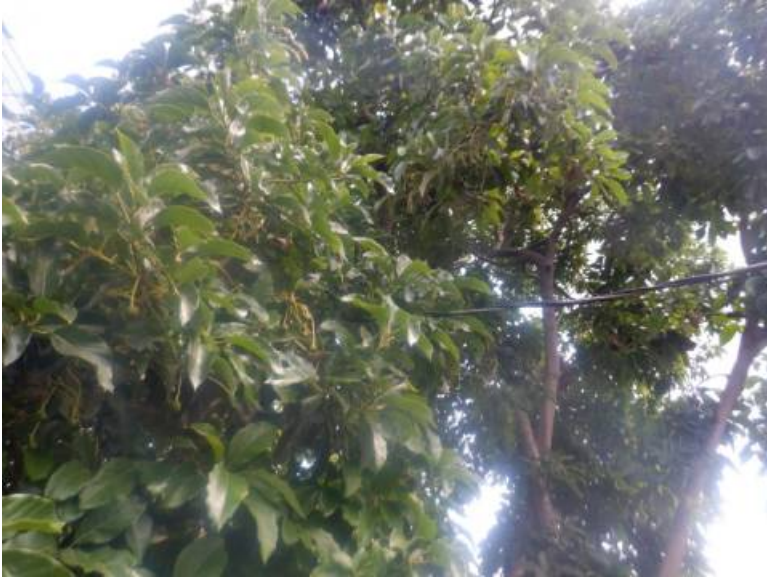
The service lines enter the structure from overhead, The service lines are coming through trees, cut back or remove.

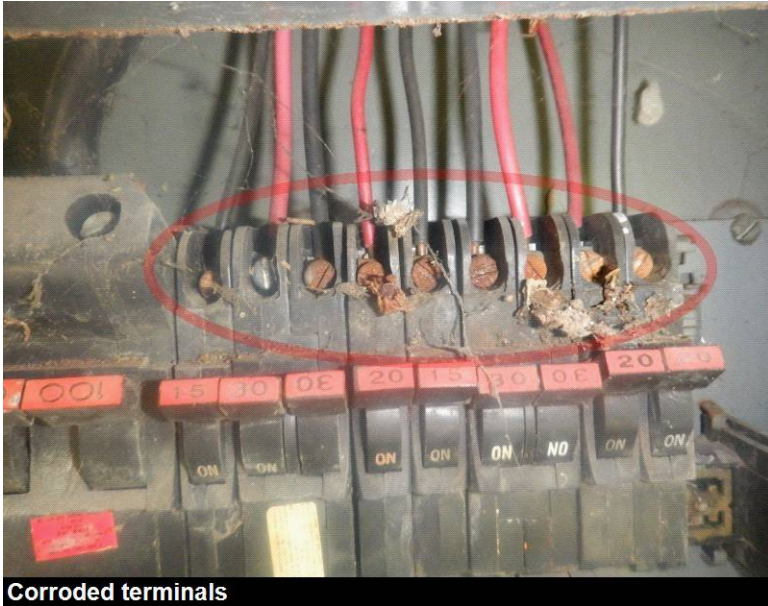
a recall by the consumer product safety commission. As many electricians recommend replacement of FPE panels, a licensed electrician should be contacted for review of this panel.

Corroded terminals

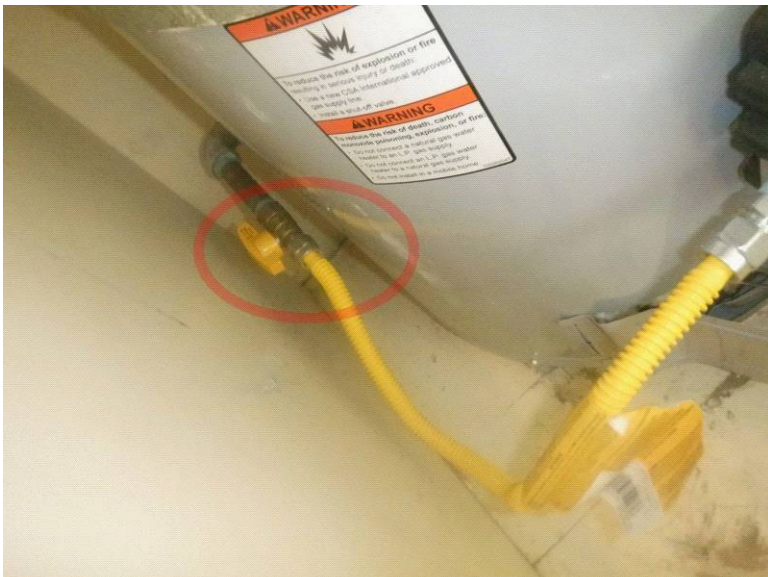
**No sediment trap**

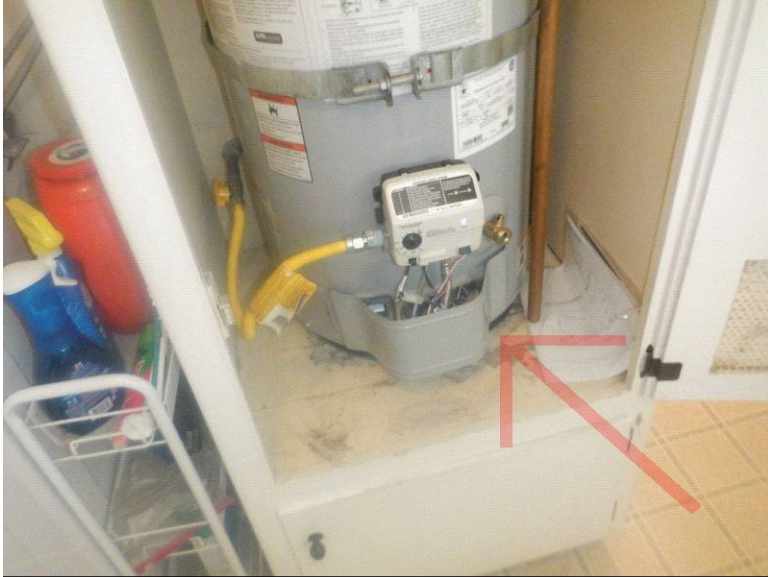
No pan

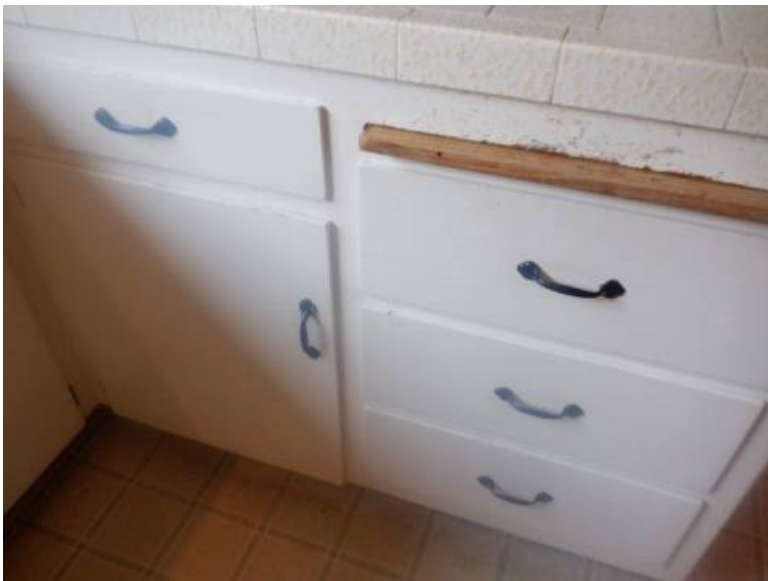
Old water damage to wall and cabinet under sink.

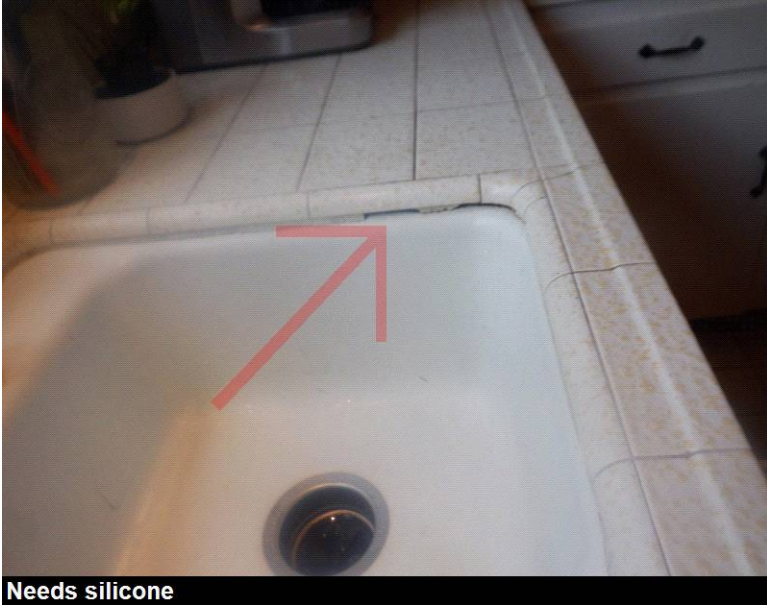
Apply silicone caulking around sink to prevent water from passing into cabinet below (maintenance needed).

**Needs silicone**

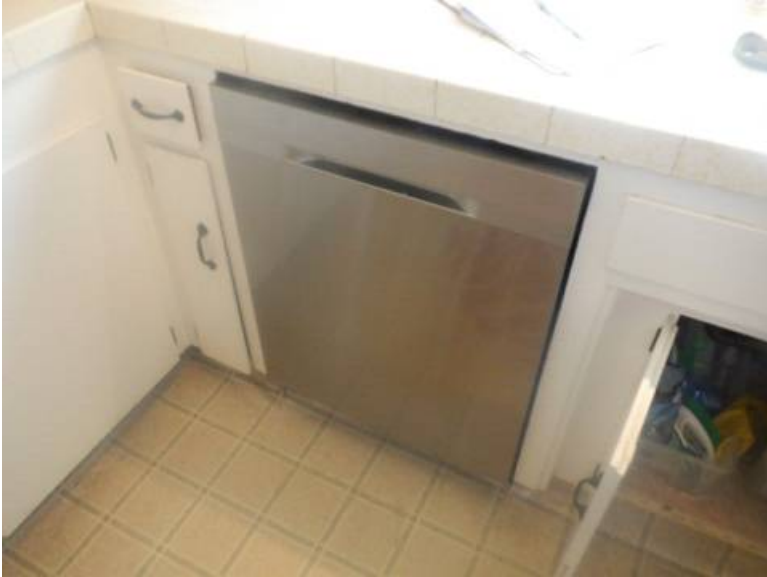
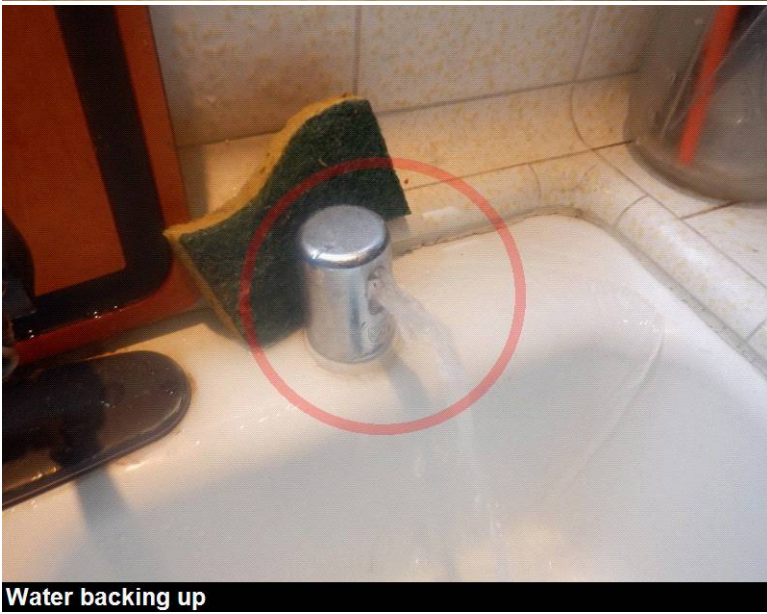
**Water backing up**

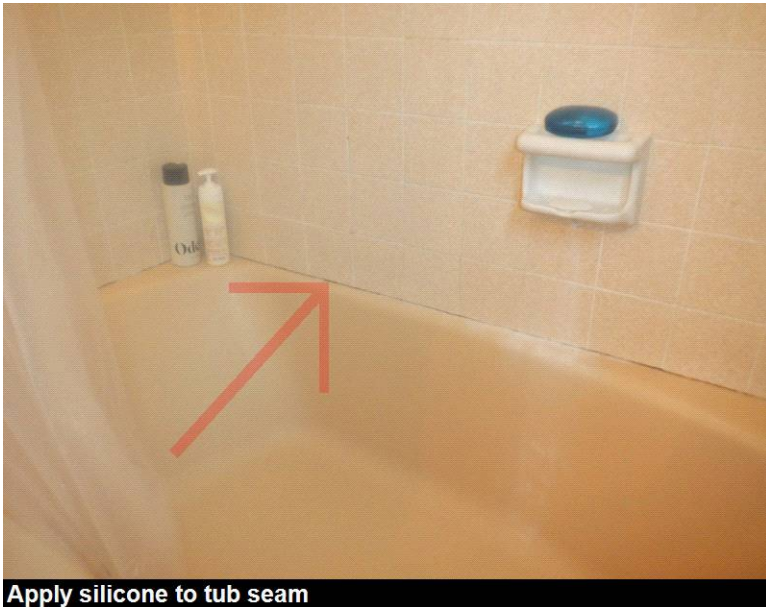
Hall; The reapplication of silicone caulking is common maintenance in bathrooms to prevent water penetration and damage, maintenance currently needed at the tub surround.

Apply silicone to tub seam

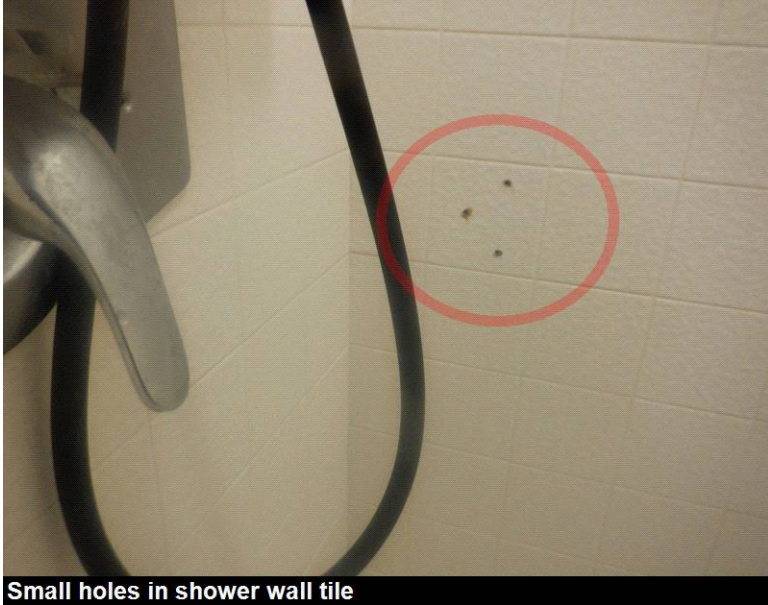
Small holes in shower wall tile
