**WOOD DESTROYING PESTS AND ORGANISMS INSPECTION REPORT**

| Building Address:<br><b>30435 Horsethief Dr., Tehachapi, CA 93561</b> | | Date of Inspection<br><b>03/06/2025</b> | Number of Pages<br><b>6</b> |
| General Description:<br><b>Two story single family house with comp roof, furnished and occupied.</b> | | Inspection Tag Posted: <b>Close</b><br>Other Tags Posted:<br><b>None</b> | |

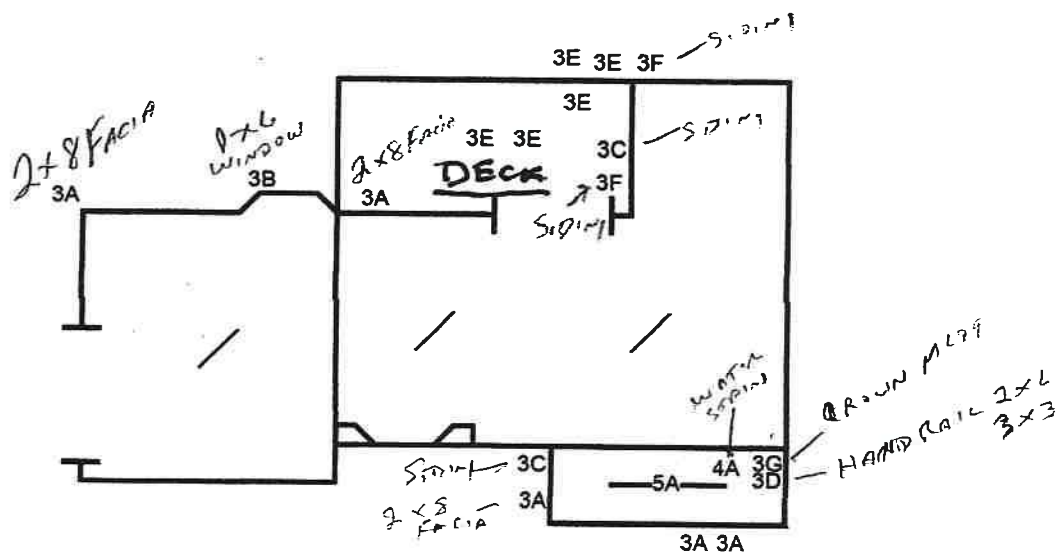
### Front of House

- 3A (Section I)  
FINDINGS: Dry-rot wood members found at time of inspection at fascia (2x8) as indicated on the diagram.  
RECOMMENDATION: Replace dry-rot damaged wood members as necessary. No painting is included in the estimate.

- 3B (Section I)  
FINDINGS: Dry-rot wood members found at time of inspection at window trim (1x6) and siding trim (1x8) as indicated on the diagram.  
RECOMMENDATION: Replace dry-rot damaged wood members as necessary. No painting is included in this estimate.

- 3C (Section I)  
FINDINGS: Dry-rot wood members found at time of inspection at siding (3-tier fiberboard) as indicated on the diagram.  
RECOMMENDATION: Replace dry-rot damaged wood members as necessary. No painting is included in this estimate.

- 3D (Section I)  
FINDINGS: Dry-rot wood members found at time of inspection at handrail (2x6)(3x3) as indicated on the diagram.  
RECOMMENDATION: Replace dry-rot damaged wood members as necessary. No painting is included in this estimate.

- \* 3E (Section I) *Deck - Repaired 4/17/26 - FLEX*  
FINDINGS: Evidence of dry-rot wood members noted at time of inspection at balcony framing, floor boards and main support beam as indicated on the diagram.  
RECOMMENDATION: Contact proper tradesman to replace dry-rot damaged wood members and correct cause of any adverse conditions. If additional adverse conditions are found during repairs, further inspection is recommended and a supplemental report indicating any infection, adverse conditions or repairs will be made.

- 3F (Section I)  
FINDINGS: Dry-rot wood members found at time of inspection at exterior siding (textwood paneling) as indicated on the diagram.  
RECOMMENDATION: Replace dry-rot damaged wood members as necessary. No painting is included in this estimate.

**FINDINGS:** Dry-rot wood members found at time of inspection at porch crown molding as indicated on the diagram.

**FINDINGS:** Water stains noted at time of inspection at porch ceiling.

**FINDINGS:** Inaccessible areas at under wood porch (no access/clearance) due to construction and or, storage, or other condition preventing inspection.

**RECOMMENDATION:** Replace dry-rot damaged wood members as necessary. No painting is included in this estimate.

**RECOMMENDATION:** Contact proper tradesman to inspect for cause of water stains and correct if needed.

**RECOMMENDATION:** Owner to make area accessible for further inspection.
