## **HOME INSPECTION REPORT**

**3732 Mayfield Ave., La Crescenta, CA 91214**

**Prepared for: Steve Aranda**

Inspection Date: 7/11/2026  
Report Number: 2026071101ATja  
Real Estate Agent: Steve Aranda  
Home Inspector: Ali Tfaily

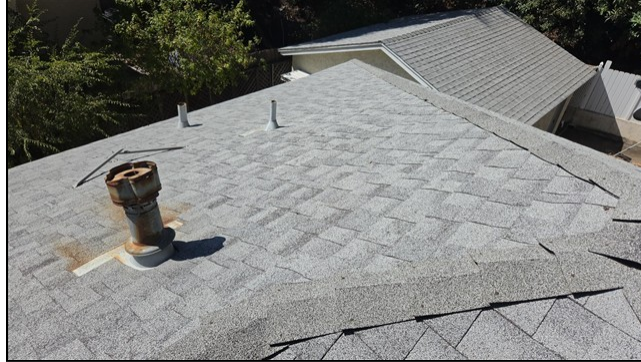
1.0 Item 1 (Picture)

🏠 (2) Roof coverings are degranulating in areas. Recommend maintenance.

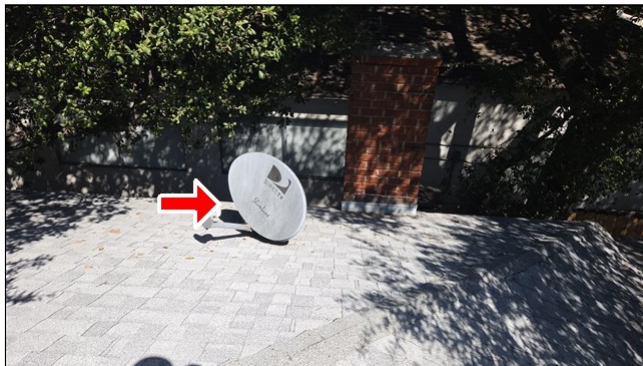
1.0 Item 2 (Picture)

🏠 (3) Satellite dish(s) and hardware are bolted through the roof deck. Recommend removal and properly sealing the penetrations.

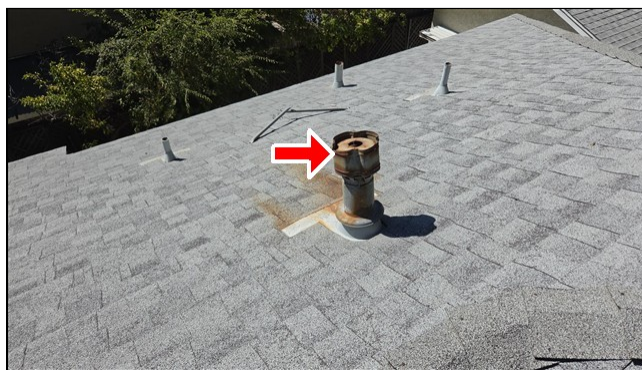
1.1 Item 1 (Picture)

Rusted/deteriorated vent cap observed. Recommend replacing.

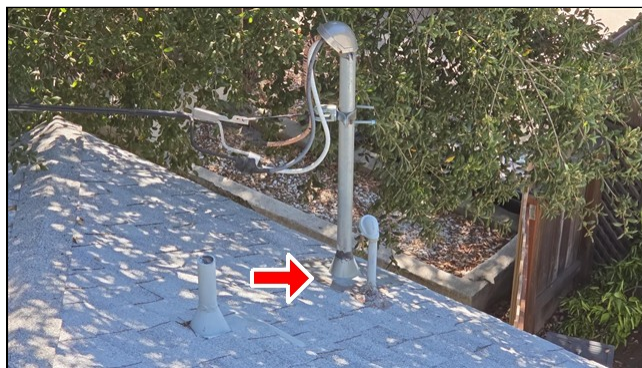
1.2 Item 1 (Picture)

Flashing is incorrectly installed at front left side (service wiring mast). Recommend correcting by a qualified roofer.

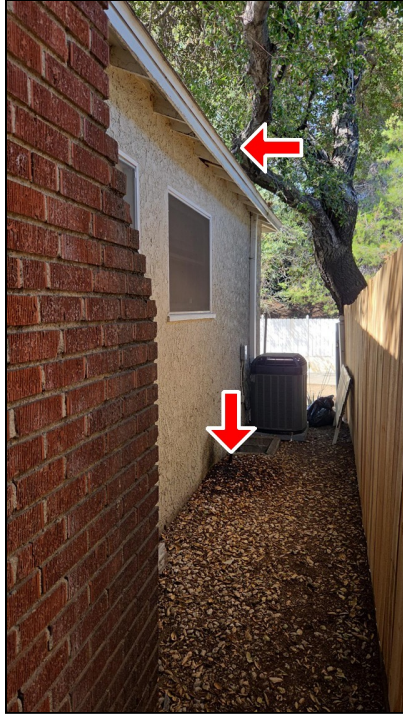
1.3 Item 1 (Picture)

Gutters are not installed. Suggest installing for enhanced drainage around the foundation and exterior walls.

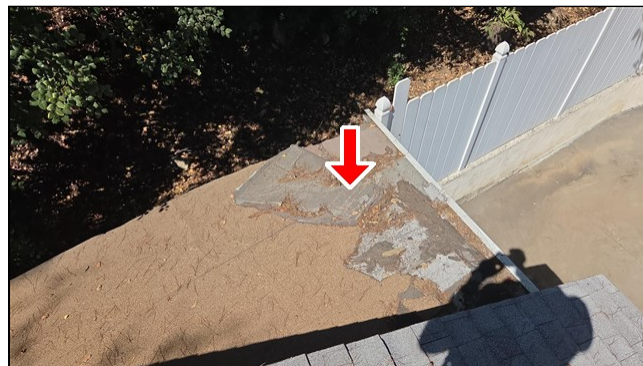
1.4 Item 1 (Picture)

Deteriorated roofing material observed at the patio cover behind the garage. Recommend correcting.

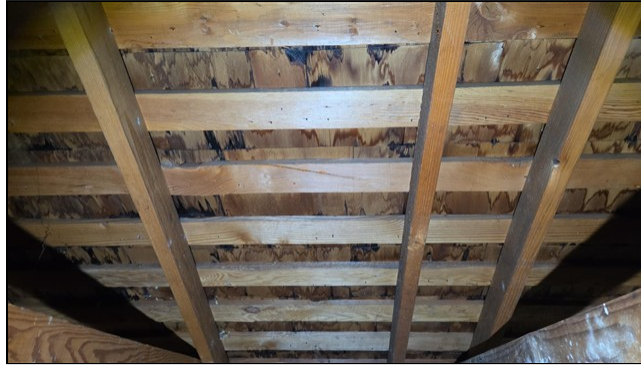
2.1 Item 1 (Picture)

📌 Roofing material is installed over wood shakes or wood shingles. Recommend further review by a qualified roofer.

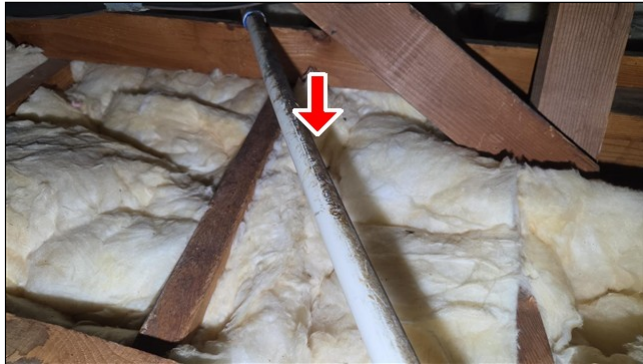
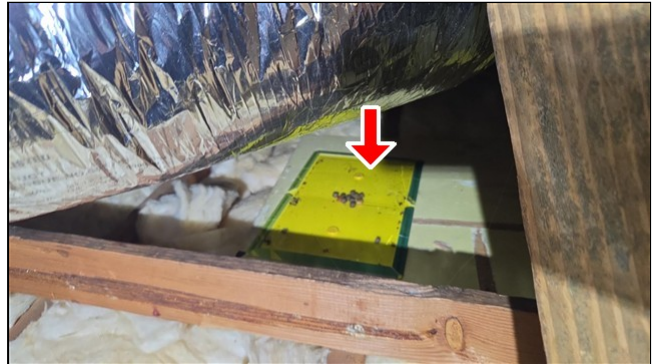
📌 Evidence of rodent activity observed. Recommend correcting.

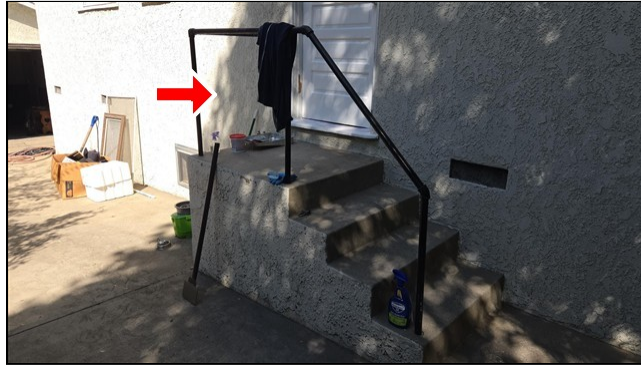
3.1 Item 1 (Picture)

- 🏠 (1) Balusters are not installed at the left side landing pad. Recommend correcting.

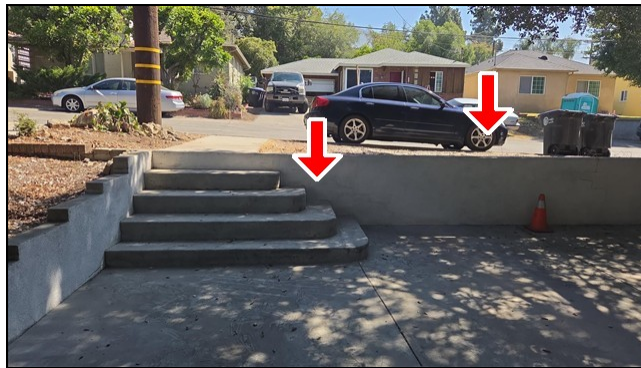
3.1 Item 2 (Picture)

- 🏠 (2) Hand and guard railings are not installed at the front. Recommend correcting.

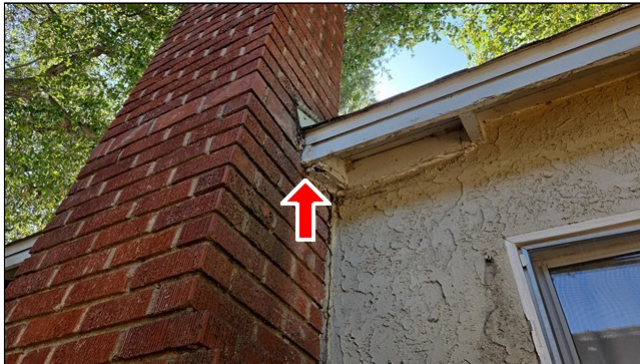
3.3 Item 1 (Picture)

- 🏠 Deterioration observed at the exterior wood trim, rafter tails in areas and at the rear patio cover. Recommend further evaluation by a qualified termite specialist.

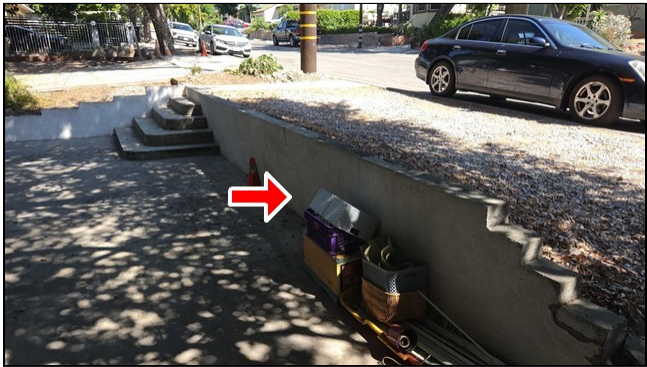
3.4 Item 1 (Picture)

Cracking and leaning observed at front retaining wall(s). Recommend repair.

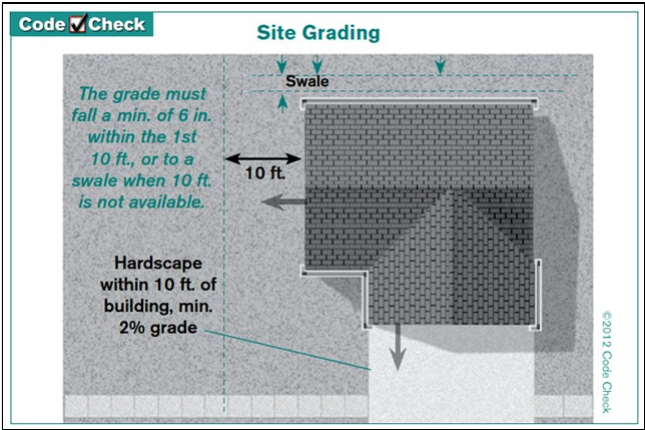
3.5 Item 1 (Picture) Grading

Inadequate grade drainage observed at right side of the house and rear and left side of the garage. Regarding, filling low lying areas or adding alternative means of drainage is recommended to assure all water drains away from the foundation and exterior walls.

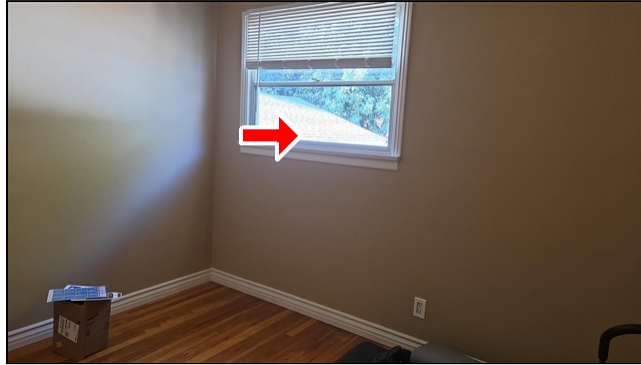
3.7 Item 1 (Picture)

- 🏠 (1) Bedroom windows height and opening clearance do not meet current building safety standards - emergency egress concern. Recommend correcting.

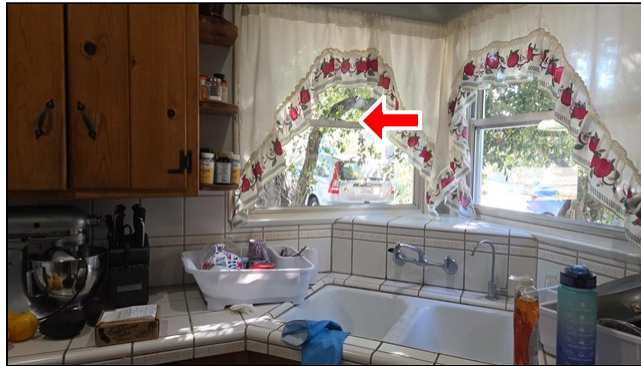
3.7 Item 2 (Picture)

- 🏠 (2) Locking hardware is missing at the kitchen front window. Recommend correcting.

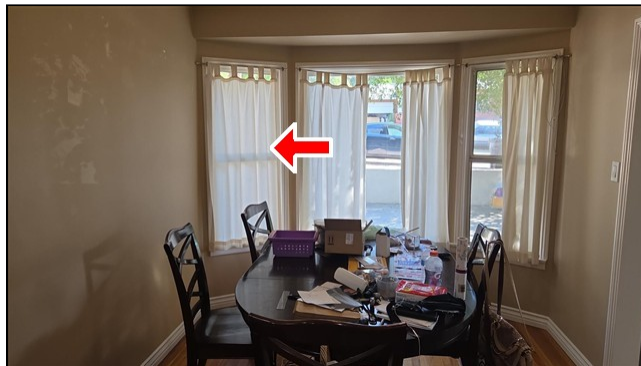
3.7 Item 3 (Picture)

- 🏠 (3) Inoperable sash/wire or spring observed at dining area front window. Recommend repair.

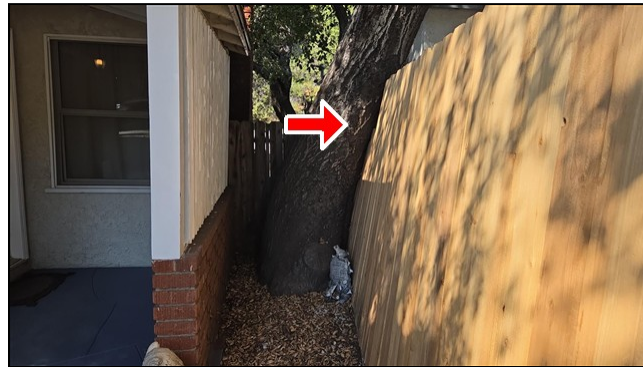
3.9 Item 1 (Picture)

🏠 (3) Tree at right side is in close proximity to the structure and leaning. Recommend verifying condition with a qualified arborist.

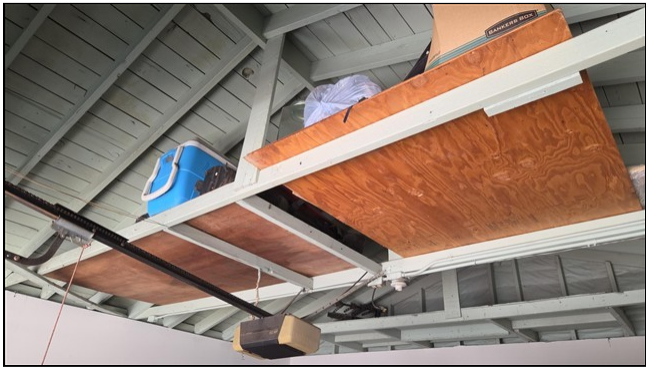
4.0 Item 1 (Picture)

Storage racks/platform are hung from the roof framing. Recommend correcting.

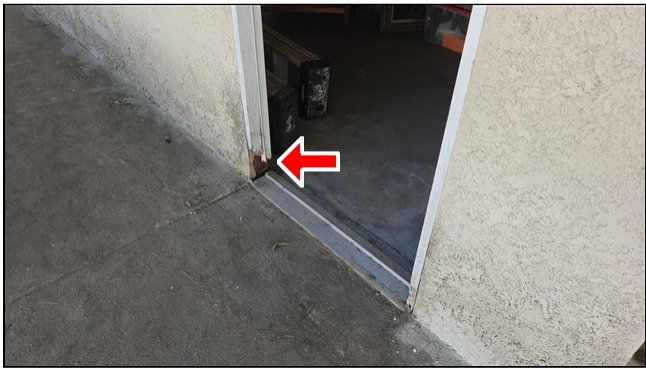
4.3 Item 1 (Picture)

Gaps observed at the service door framing. Recommend correcting.

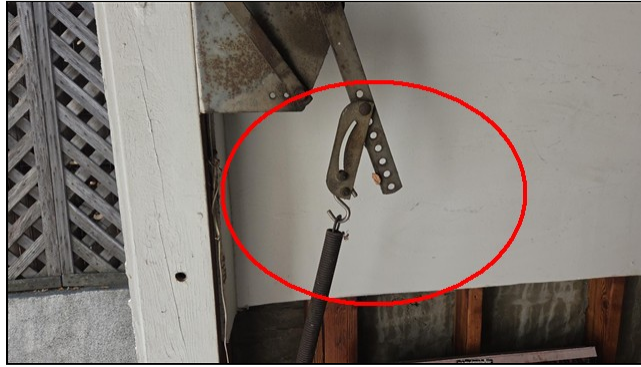
4.4 Item 1 (Picture)

🏠 The door springs are not protected with safety clips - safety concern. Recommend correcting.

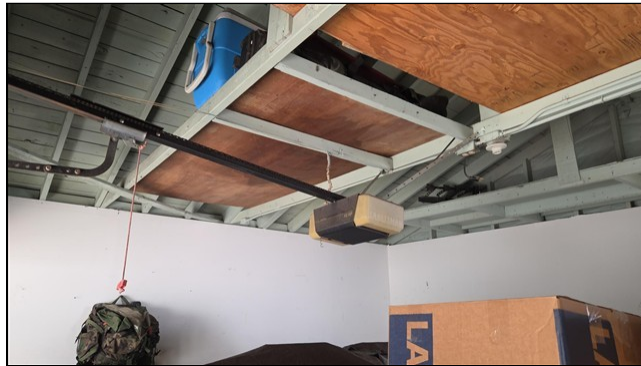
4.5 Item 1 (Picture)

🏠 Door opener did not respond to test. Recommend repair and verifying proper operation of all safety features.

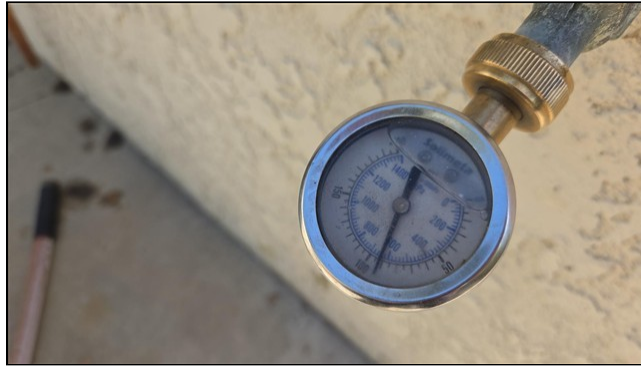
6.0 Item 1 (Picture)

🏠 Water pressure at the time of inspection was 90 static PSI . The water pressure is not between the recommended 40 to 80 PSI range. The pressure regulator should be adjusted so the water pressure is between 40 and 80 PSI. Recommend correcting.

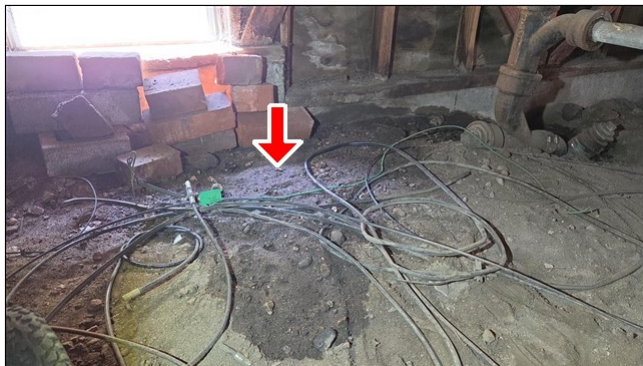
6.2 Item 1 (Picture)

🏠 (4) Improperly sloped branch drain line observed under the bathroom, leaking observed at the joint. Recommend repair by a qualified plumber.

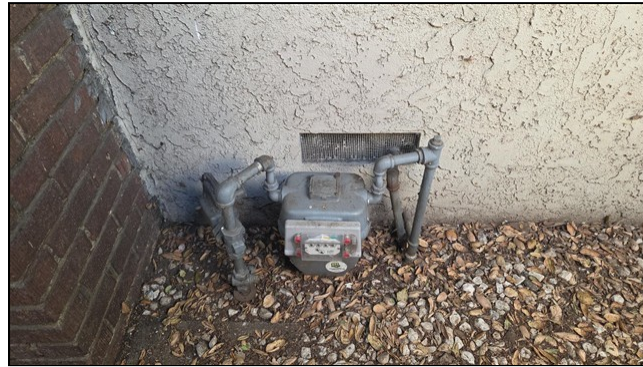
6.3 Item 1 (Picture)

🏠 (2) Seismic shut-off valve is not installed. We recommend installing as a safety enhancement. The client is advised to check with local city ordinances, as not every city requires a shut-off valve. Recommend installing.

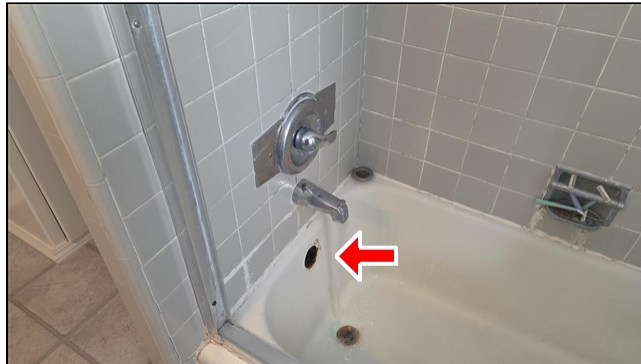
6.5 Item 1 (Picture)

🏠 (2) Missing hardware observed at the bathroom tub, tub faucet is loose and not sealed to the wall. Recommend correcting.

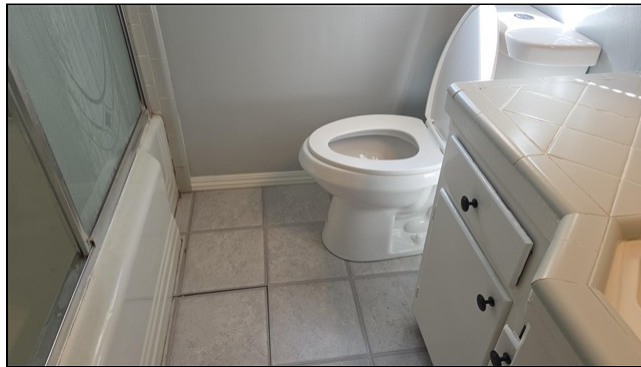
6.6 Item 1 (Picture)

🏠 (1) Toilet base is not secured to the floor at bathroom. The wax ring at the base of the toilet must have a water tight seal, to prevent leakage from occurring. Recommend replacing the wax ring and securing the base to the floor.

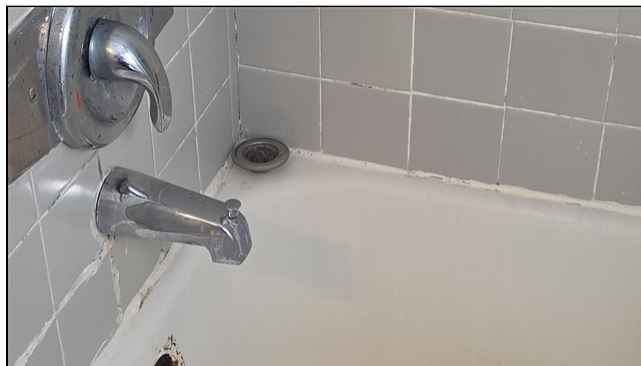
6.6 Item 2 (Picture)

🏠 (2) Caulking/grout at bathroom tub is deteriorated. Recommend repair.

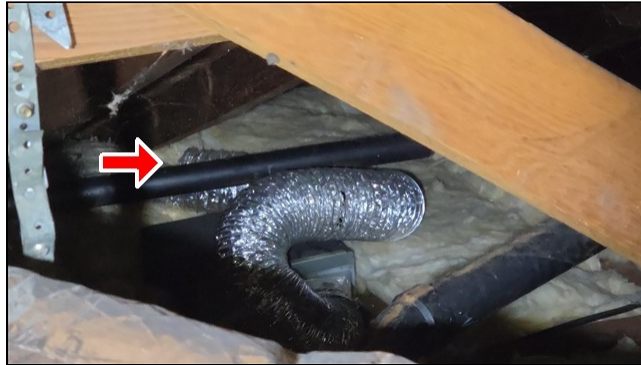
6.7 Item 1 (Picture)

Bathroom exhaust vent terminates directly into attic. Recommend correcting.

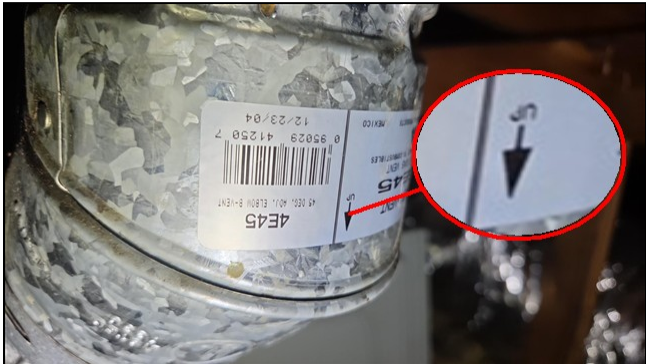
8.0 Item 1 (Picture)

Exhaust vent connectors are not installed correctly. Recommend correcting.

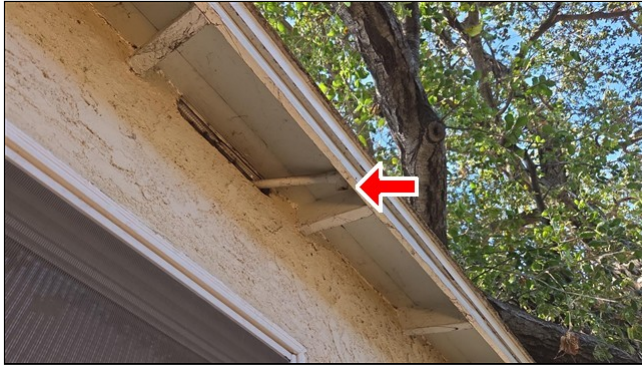
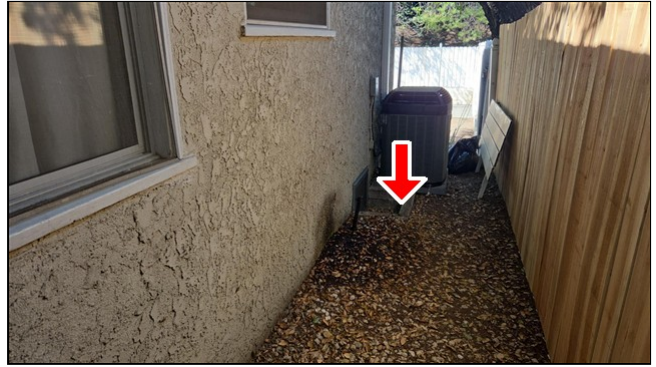
- 🏠 (1) Incorrect termination point of the primary drain line(s) observed. Recommend correcting.

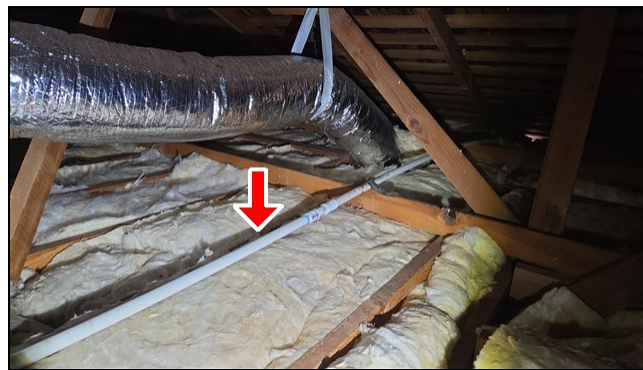
8.3 Item 3 (Picture)

- 🏠 (2) Alternate condensate drain line is not sloped properly in the attic. Recommend correcting.

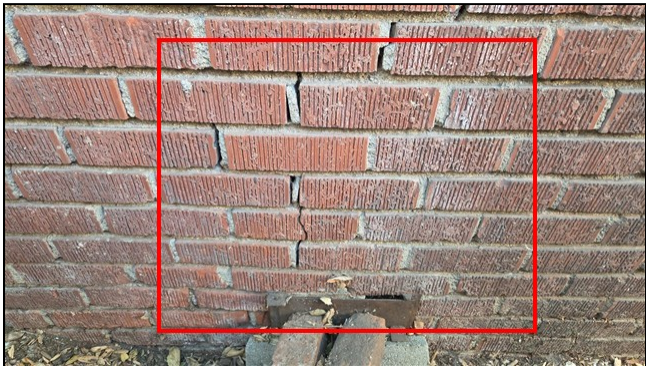
9.0 Item 1 (Picture)

(1) Cracking observed at the chimney structure. Recommend further review by a qualified fireplace specialist.

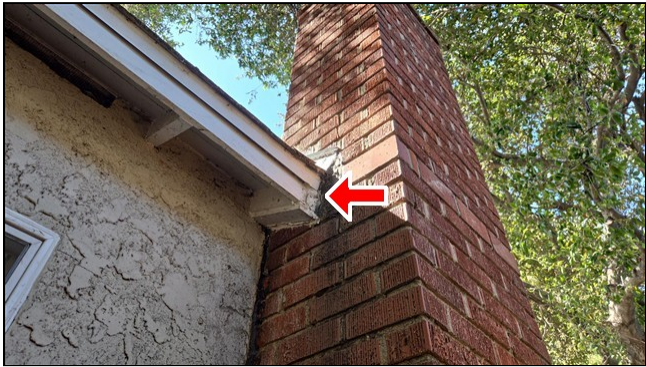
9.0 Item 2 (Picture)

🏠 (2) Inadequate clearances observed around the chimney structure and wood framing. Recommend correcting.

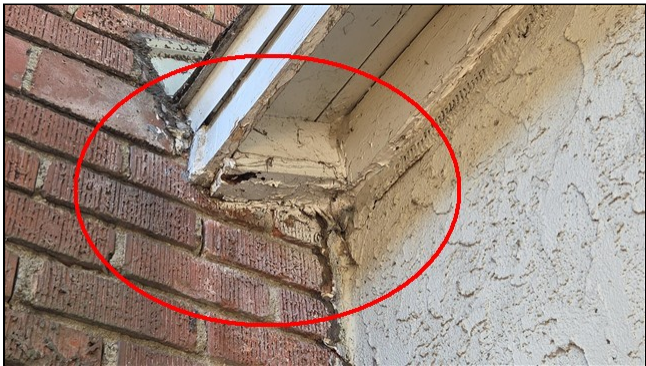
9.0 Item 3 (Picture)

🏠 (3) Poor workmanship and deteriorated sealant observed at the chimney flashing. Recommend correcting.

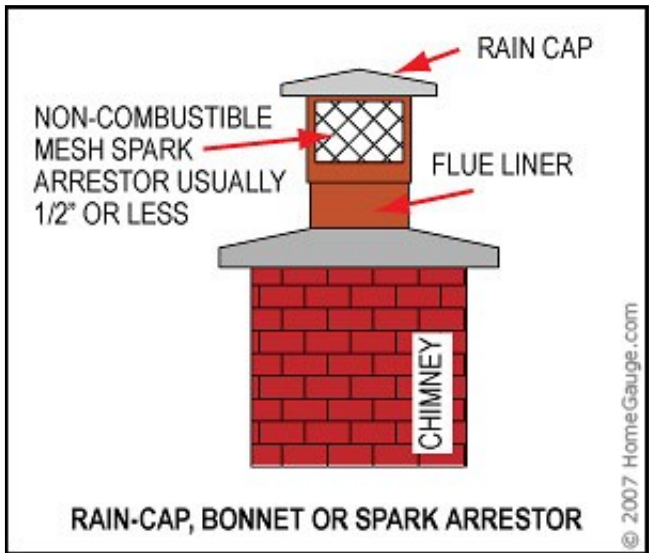
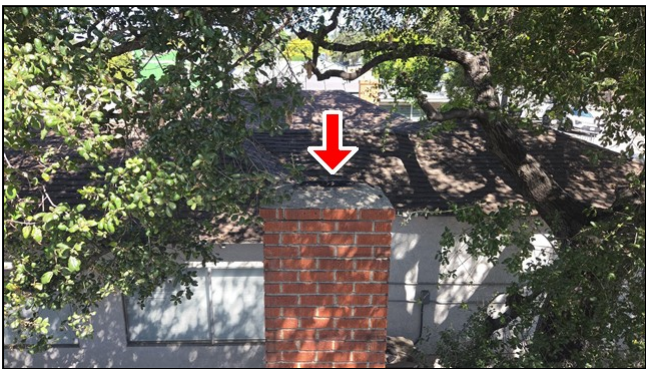
9.1 Item 2 (Picture)

🏠 (1) Spark arrestor with rain cover is not installed. Recommend installing.

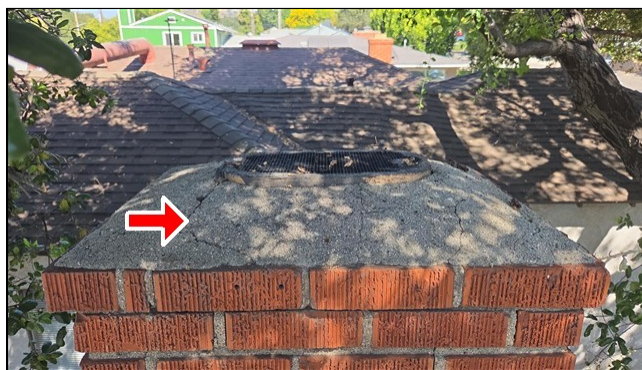
9.1 Item 3 (Picture)

🏠 (2) Cracked cap observed. Recommend repair.

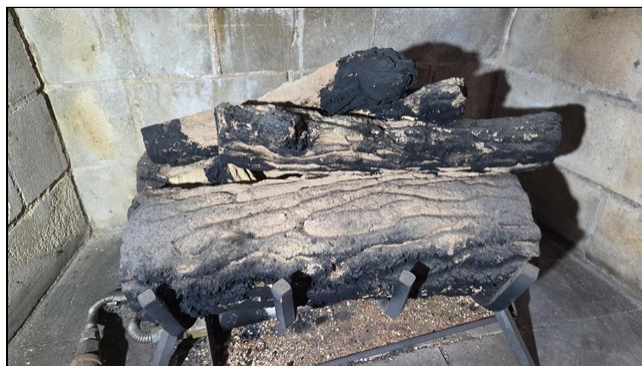
9.3 Item 1 (Picture)

🏠 (2) Soot and creosote buildup observed at the logs. Recommend further review by a qualified fireplace specialist.

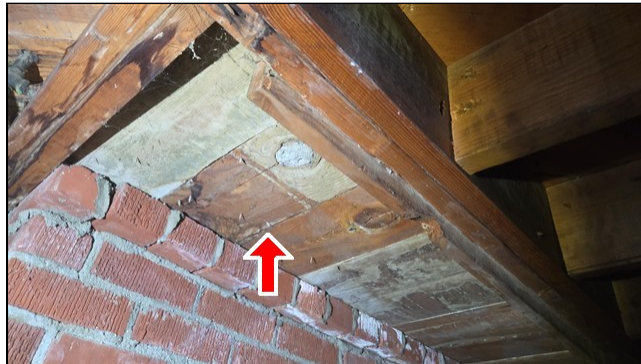
9.3 Item 2 (Picture)

🏠 (4) Wood form remains under the hearth in the crawlspace. Recommend removal.

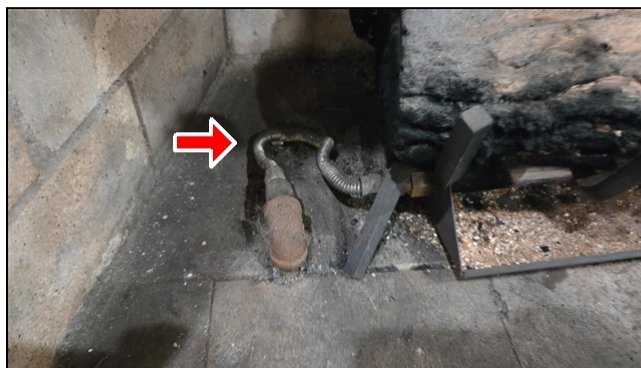
9.5 Item 1 (Picture)

🏠 (2) Semi-rigid gas flex pipe observed in the firebox. Recommend correcting.

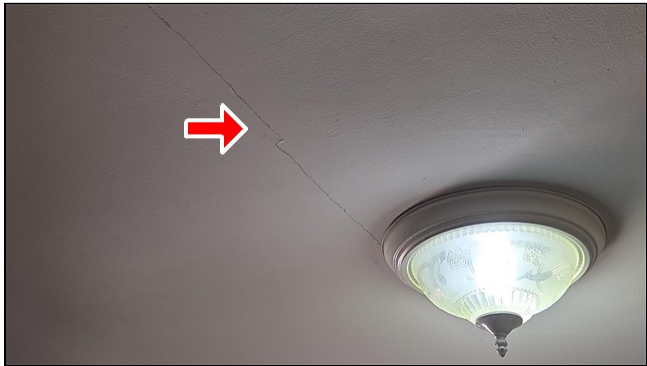
11.1 Item 1 (Picture)

(1) Cracks observed in a number of areas at the walls and ceiling. Suggest repairs.

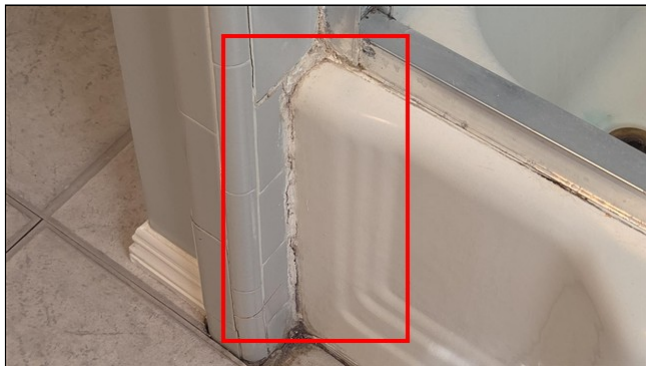
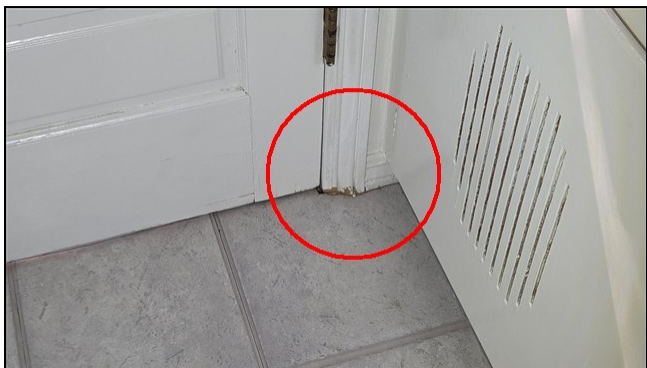
(2) Moisture damage observed at the bathroom shower surround at at the laundry area service door trim. Hidden damage may not be observable. Recommend further review by a qualified professional.

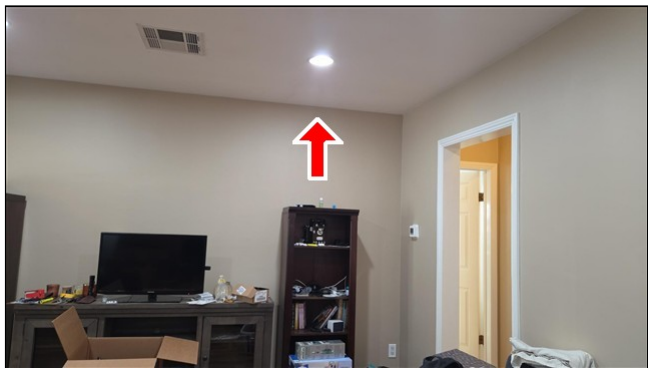
11.1 Item 5 (Picture)

📍 (3) Blistering finish and discoloration observed at the family room ceiling and blistering observed on the wall above the fireplace mantel. Recommend further review by a qualified professional.

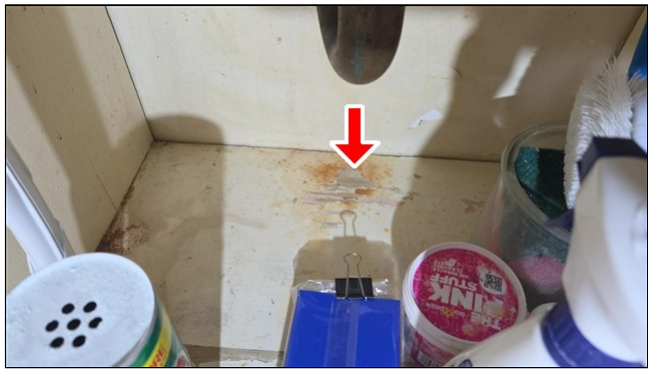
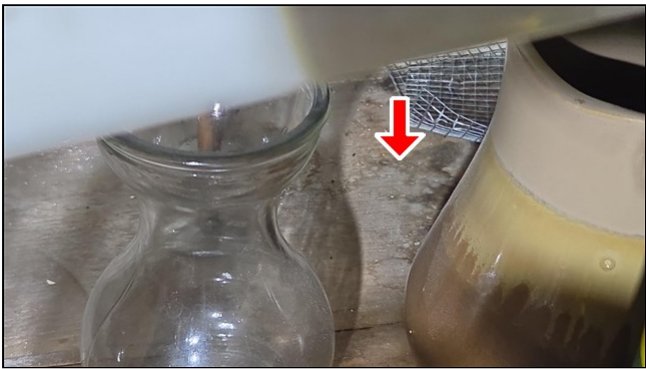
📍 (1) Water staining observed at the bathroom and kitchen sinks cabinetry. Hidden damage may not be observable. Recommend further review by a qualified professional.

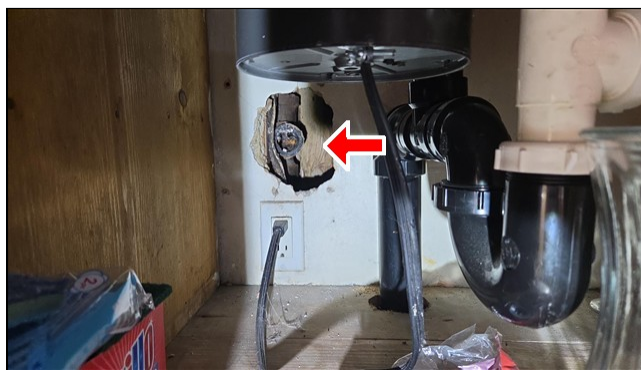
11.4 Item 3 (Picture)

🏠 (2) Gaps/holes observed at the kitchen sink cabinet wall. Recommend correcting.

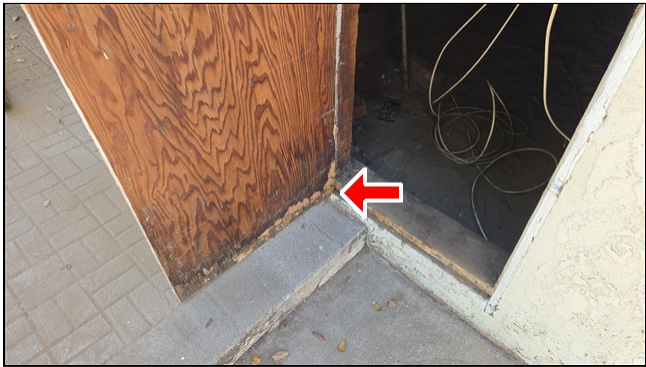
12.1 Item 1 (Picture)

🏠 Moisture damage and microbial growth observed at the access door. Recommend correcting.

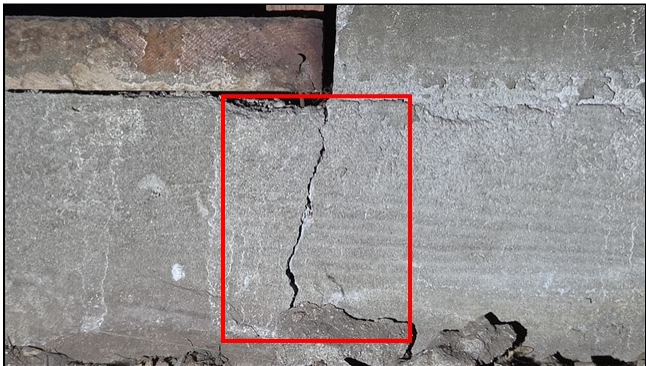
12.2 Item 1 (Picture)

🏠 (1) Cracking observed at the middle stem wall. Recommend repair.

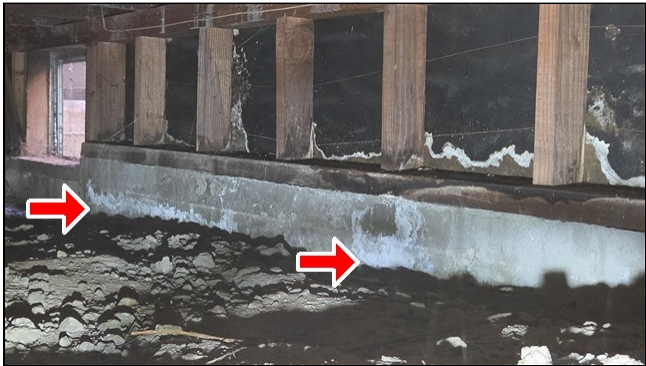
12.2 Item 2 (Picture)

(2) Efflorescence observed on foundation walls. See grading/drainage comments in the exterior category.

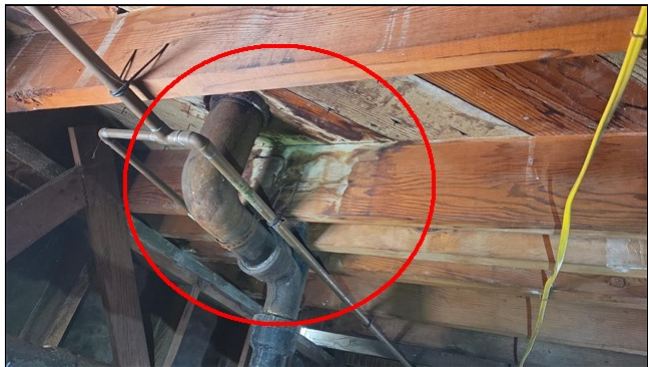
12.3 Item 1 (Picture)

Water staining observed at the subflooring under the kitchen, laundry area and bathroom in the crawlspace. Recommend further review by a qualified professional.

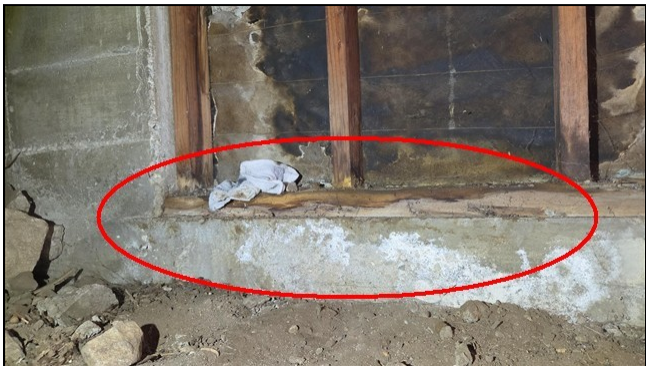
12.5 Item 1 (Picture)

Deterioration observed at left side middle sill plate. Recommend further review by a qualified termite contractor.
