# PROPERTY INSPECTION REPORT

**FOUR POINT**  
HOME INSPECTION INC.

**810 Sebastian**

**Inspection Prepared For: Paso Robles Waste**  
**Agent: Alicia DiGrazia - RE/MAX Parkside**  
**Date of Inspection: 7/2/2026**  
**Year Built: 2010 Size: 1742**  
**Weather: Mild/Dry**

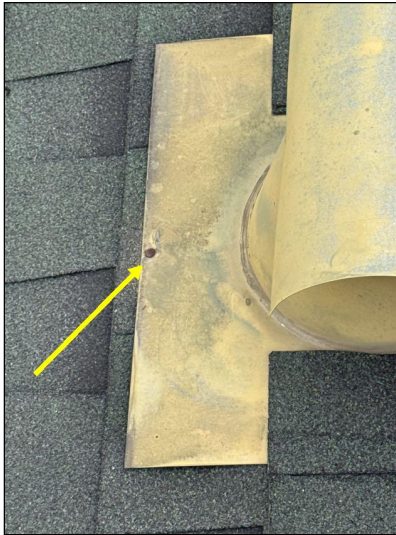
Flashing protecting the point at which one or more exhaust vents penetrated the roof had exposed nail heads. The inspector recommends sealing all exposed nail heads to help prevent damage from moisture intrusion to the home materials, the roof structure. All work should be performed by a qualified contractor.

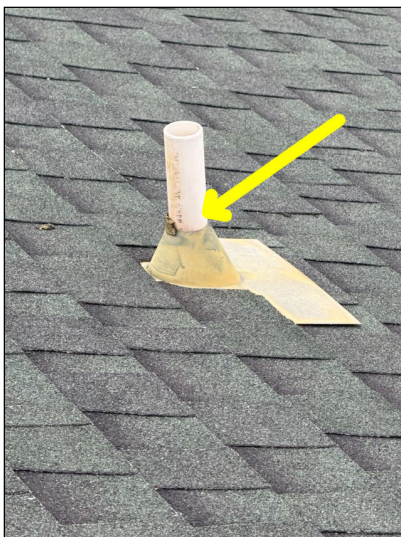
**Maintenance Needed:** Plumbing vent flashings are mastic covered and some are showing signs of cracked mastic/mastic deterioration from sun exposure.

**Maintenance Needed:** Plumbing vent flashings are mastic covered and some are showing signs of cracked mastic/mastic deterioration from sun exposure. Recommend re-sealing all through the roof vents and projections as a part of routine maintenance to prevent unwanted moisture intrusion.

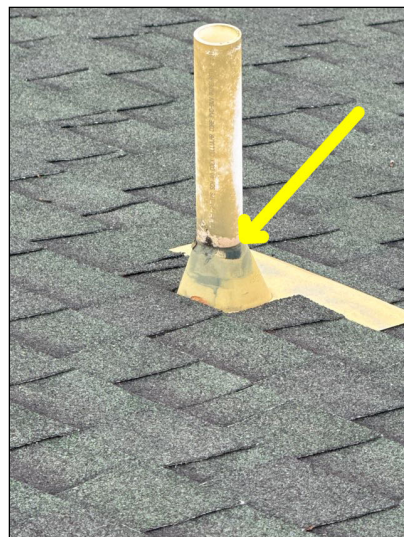
**Maintenance Needed:** Plumbing vent flashings are mastic covered and some are showing signs of cracked mastic/mastic deterioration from sun exposure.

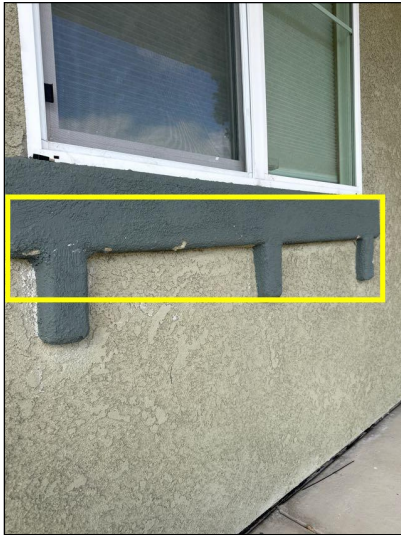
**Maintenance:** All gaps and holes in the stucco surface should be sealed to keep unwanted moisture out.

**Maintenance:** All gaps and holes in the stucco surface should be sealed to keep unwanted moisture out. Recommend having these areas sealed and painted. Continue to monitored as part of annual maintenance.

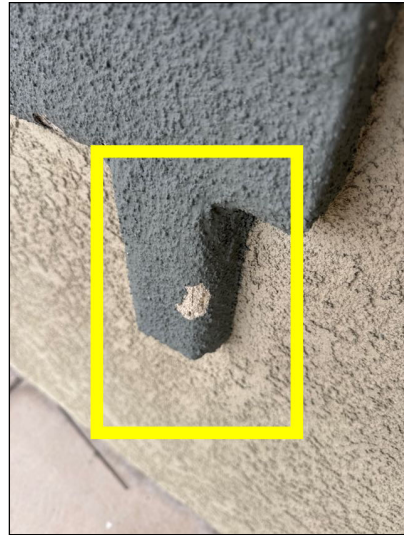
**Maintenance:** All gaps and holes in the stucco surface should be sealed to keep unwanted moisture out.

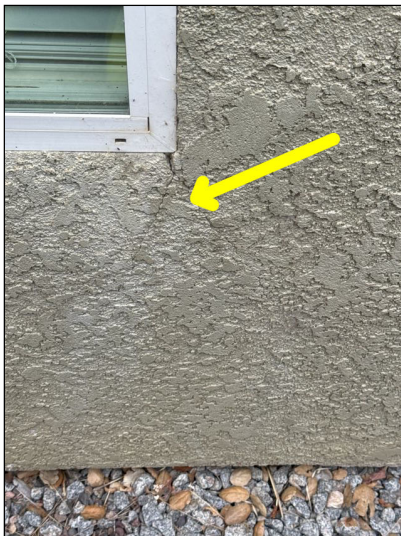
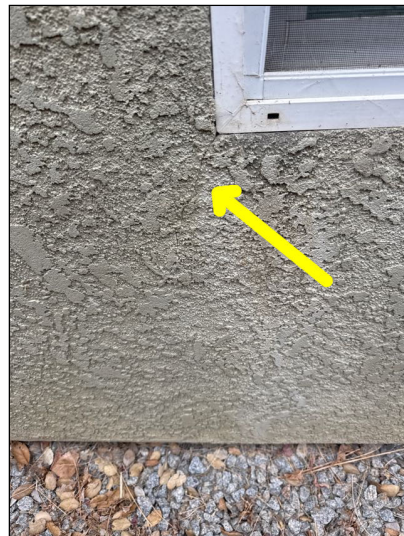
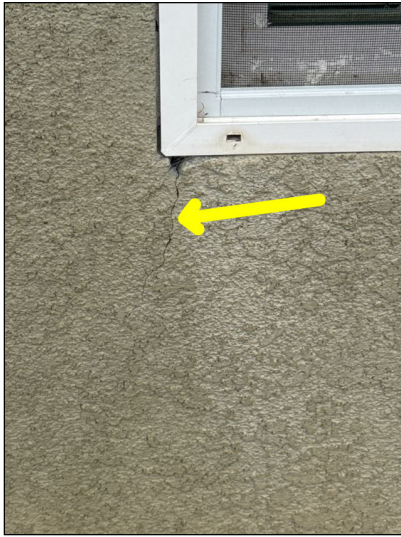
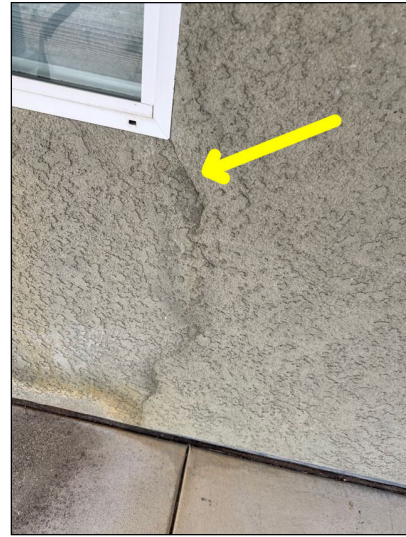
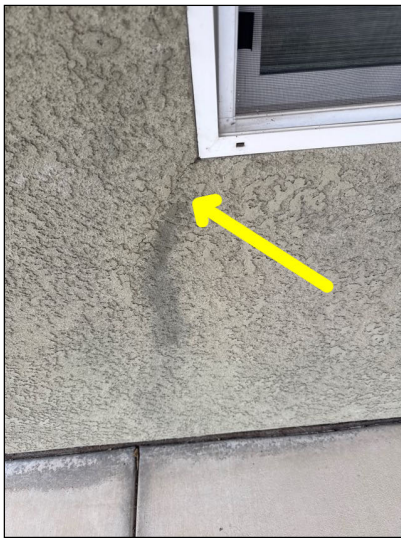
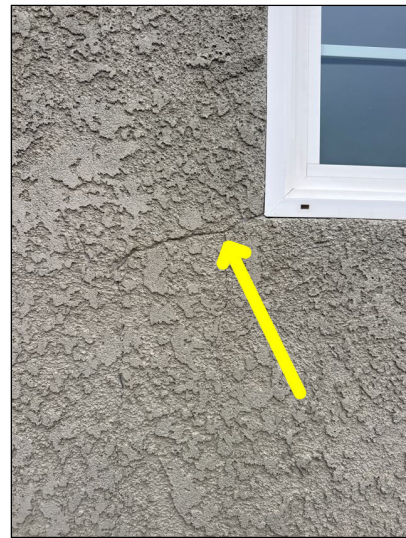
**Monitor:** Normal cracking was visible in stucco covering exterior walls of the home at the time of the inspection. This cracking appeared to be consistent with that caused by normal soil settlement. Settlement typically takes place in the first few years after original construction, and then stops. Cracks exceeding 1/16-inch (about the thickness of a penny) in width should be filled with an appropriate material to prevent future damage from moisture and monitored in the future for continued activity. Repainting with an Elastomeric paint on the stucco surface will help seal all surface cracks.

**Monitor:** Normal cracking was visible in stucco covering exterior walls of the home at the time of the inspection.

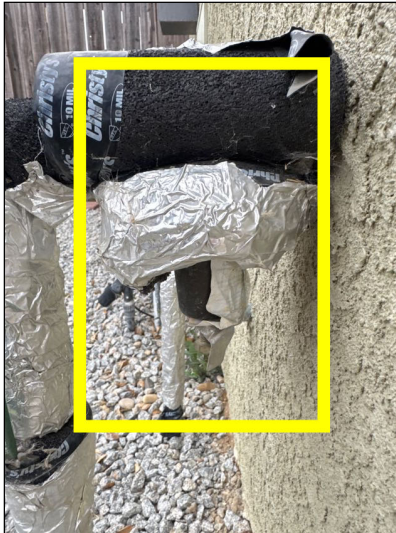
**Monitor:** Pressure regulator is mounted upside down. While you can mount it facing upside down, this is not recommended.

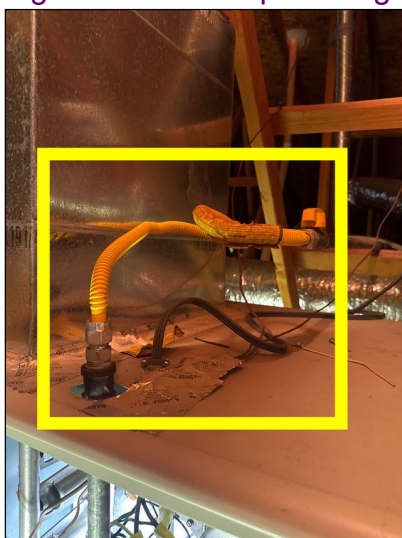
**Recommended Improvement:** The gas supply pipe contained no sediment trap. A sediment trap is generally recommended but not always required, depending on the local Authority Having Jurisdiction (AHJ). The purpose of a sediment trap is to prevent sediment or debris particulates from entering and clogging the heaters gas valve, which can cause the heater to shut down. You may wish to consult with local contractor concerning the advisability of installing a sediment trap in the gas line.

**Improvement:** The gas supply pipe contained no sediment trap.

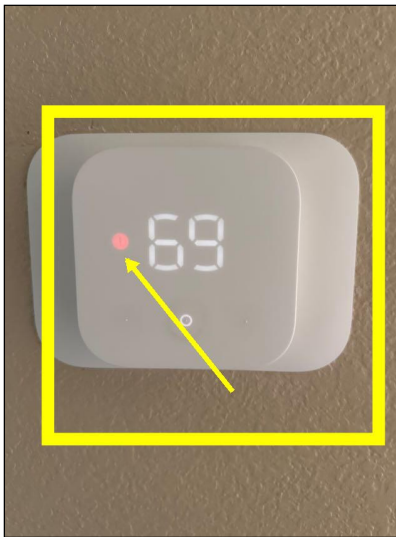
**Maintenance Needed:** The thermostat has an error message, recommend service by qualified contractor

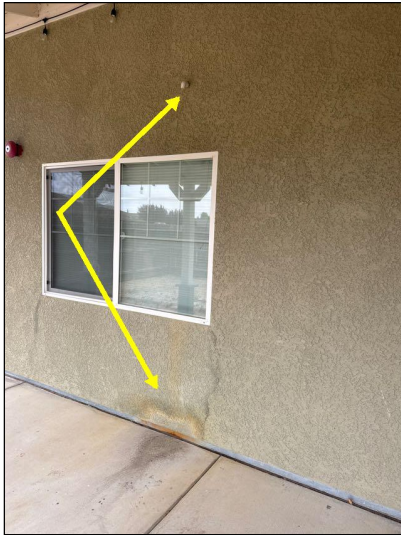
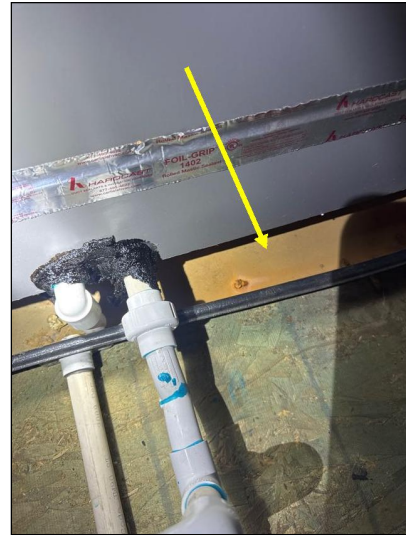
| Heat/AC | | | |
|---|---|---|---|
| | Page 27 Item: 12 | Condensate Drain/Overflow Pan | The secondary condensate discharge and the overflow pan showed signs of rust. This sign usually means that either your condensate lines are corroded or they were blocked at one time. No standing water was present at the time of inspection. Monitor condition for changes and consult with a qualified HVAC contractor. |

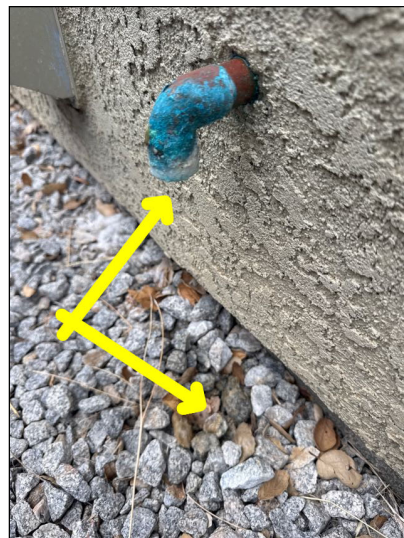
| Heat/AC | | | |
|---|---|---|---|
| | Page 31 Item: 4 | TPRV | The pressure relief valve was leaking at the time of the inspection and should be replaced by a qualified HVAC technician or plumbing contractor. |

The pressure relief valve was leaking at the time of the inspection and should be replaced by a qualified HVAC technician or plumbing contractor.

The pressure relief valve was leaking

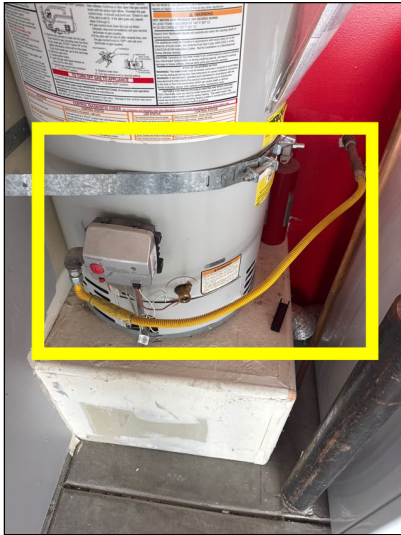
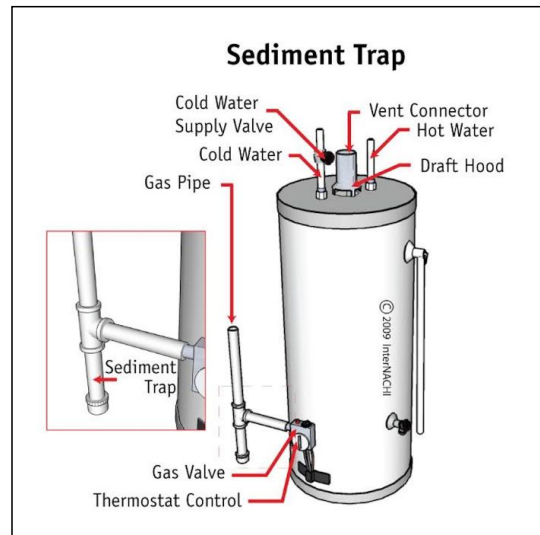
**Improvement:** The gas supply pipe contained no sediment trap.

The purpose of a sediment trap is to prevent sediment or debris particulates from entering and clogging the water heaters gas valve

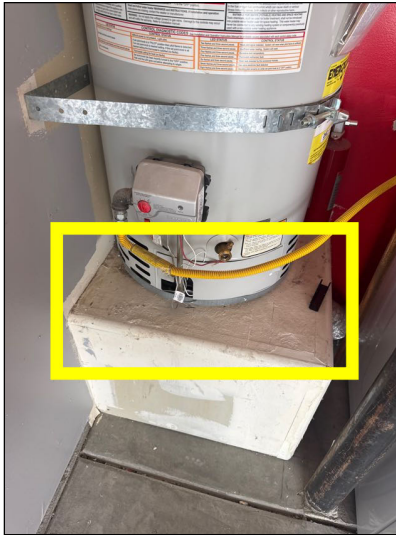
*Improvement:* no drip pan was installed.

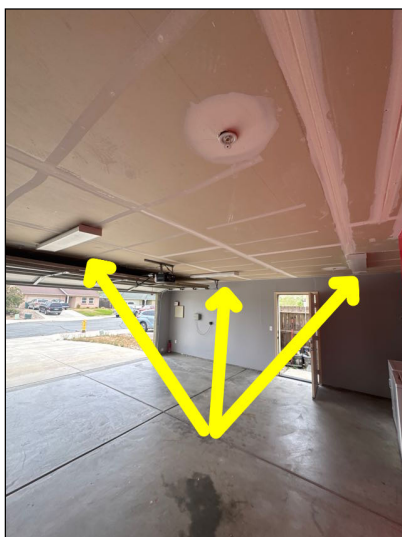
All light fixture in the garage did not respond to the switch at the time of the inspection.

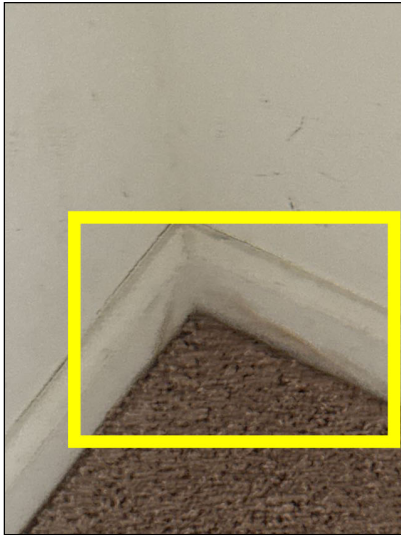
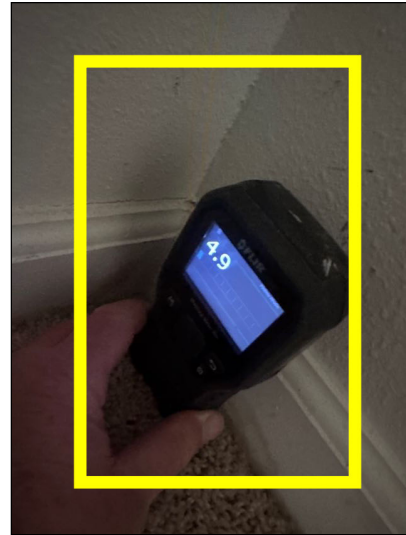
**Monitor:** Stains on the interior wall was visible at the time of the inspection appeared to be the result of moisture intrusion. (hall closet)

The moisture meter showed no elevated levels of moisture present in the stained areas (Normal moisture is considered between 5-12%)

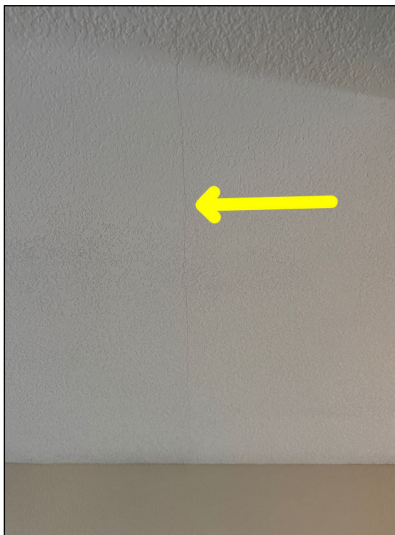
**Monitor:** Normal settlement cracking was visible in interior ceiling of the home at the time of the inspection. This cracking appeared to be consistent with that caused by normal settlement. Settlement typically takes place in the first few years after original construction, and then stops. Cracks can be repaired and sealed, but may reappear over time with temperature and humidity levels.

**Monitor:** Normal settlement cracking was visible in interior ceiling of the home at the time of the inspection.

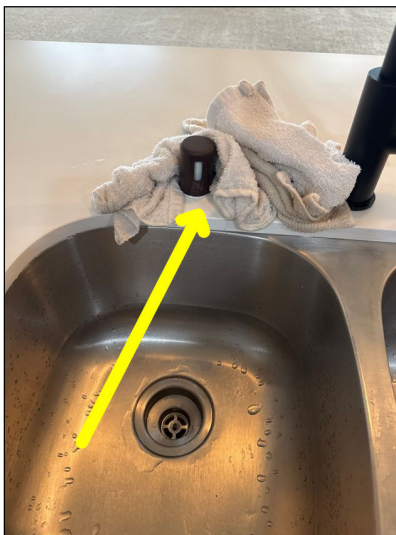
- The dishwasher drains from the **air gap**. This is normally due to a kink or blockage in the drain line from the air gap to the tail piece drain assembly below the sink. The air gap may need to be cleaned, or the drain line below the sink may be plugged.

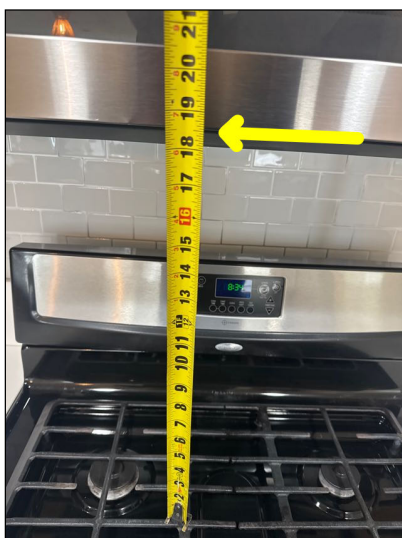
**Safety:** Any range hood, including microwaves, installed above the stove must be a minimum of 24 inches

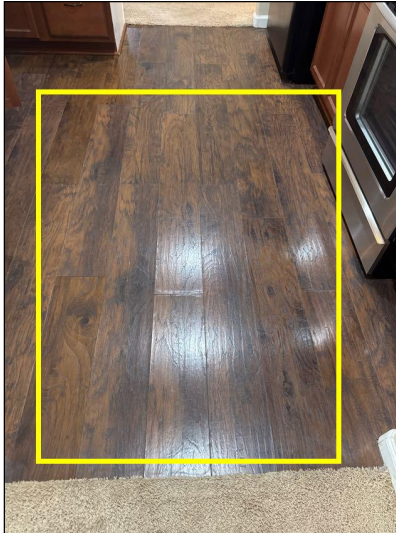
- At the time of the inspection, floating laminate floors in the Kitchen had areas of visible moisture damage. The Inspector recommends that before the expiration of your Inspection Objection Deadline you consult with a qualified contractor to discuss options and costs for repair or replacement.

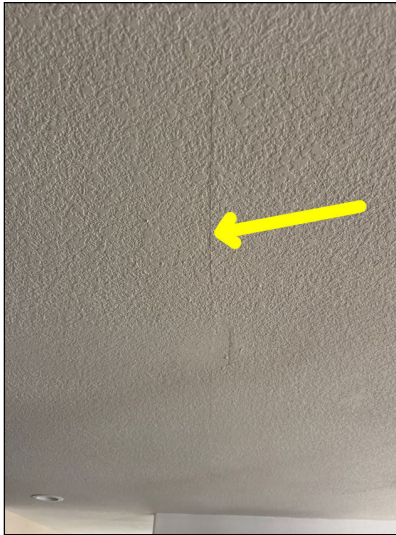
**Monitor:** Normal settlement cracking was visible in interior ceiling at the time of the inspection.

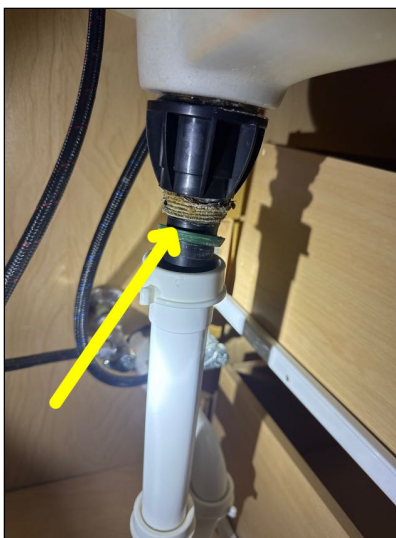
| | Page 49 Item: 2 | Sinks | Leaking connections at the trap assembly beneath the bathroom sink should be repaired to avoid future/additional damage to the cabinet floor and possibly the wall/floor structures below. The Inspector recommends repair by a qualified plumbing contractor. |

Leaking connections at the trap assembly beneath the bathroom sink should be repaired to avoid future/additional damage to the cabinet floor and possibly the wall/floor structures below. The Inspector recommends repair by a qualified plumbing contractor.

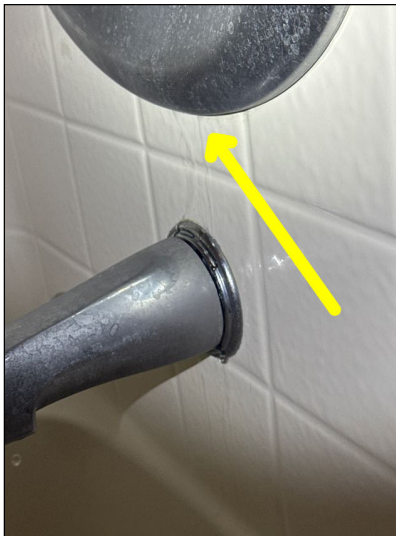
| | Page 50 Item: 4 | Showers | In this bathroom, a water control valve leaked when it was operated. This typically indicates that valve stem seals need replacement. The inspector recommends service by a qualified plumbing contractor. |

In this bathroom, a water control valve leaked when it was operated. This typically indicates that valve stem seals need replacement. The inspector recommends service by a qualified plumbing contractor.

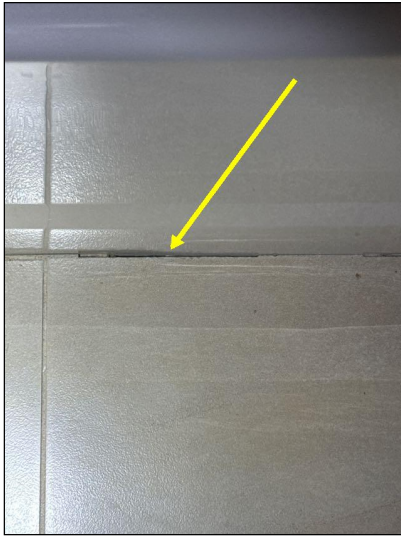
Sealant where the tub meets the floor was old and had sections of missing sealant

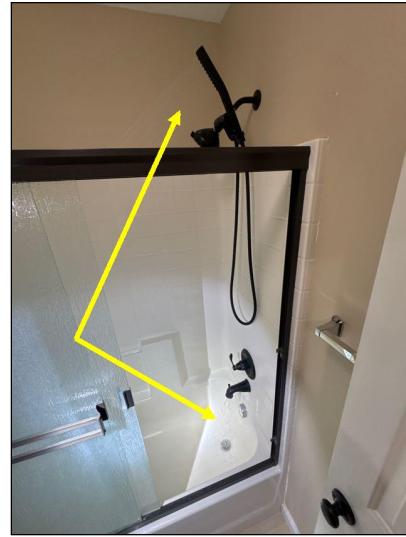
| | Page 55 Item: 6 | Bath Tubs | The diverter valve was leaking during operation or did not operate correctly (the diverter is the valve which diverts water from the tub faucet to the shower head). At the time of inspection water continued to flow from the tub spout when the shower was on. This is most commonly caused by a deteriorated diverter valve seal in the tub spout. The Inspector recommends maintenance/repair be performed by a qualified contractor. |

The diverter valve was leaking during operation or did not operate correctly (the diverter is the valve which diverts water from the tub faucet to the shower head).

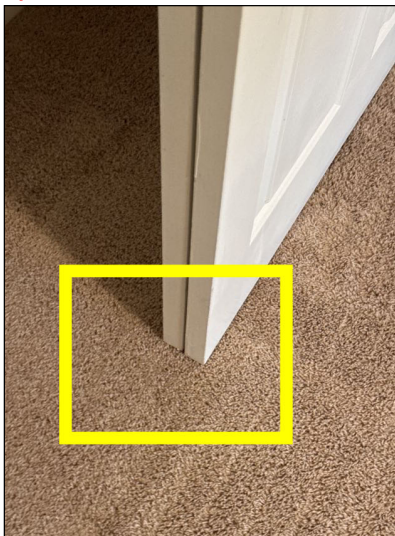
- The closet is in serviceable condition.
- **Safety:** The closet door has no door stop to keep doors from swinging in and out. This could allow the doors to fall off the track and injure a person. The inspector recommends that the proper hardware is installed by qualified contractor.

**Safety:** The closet door has no door stop

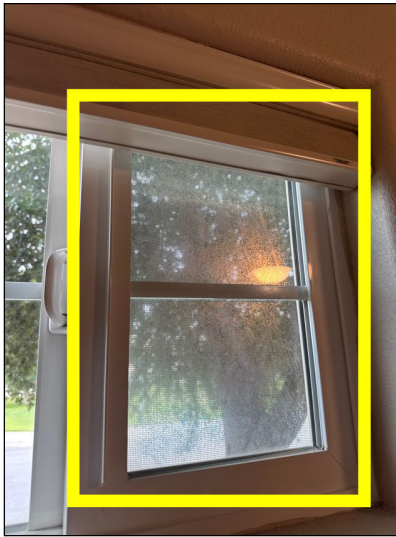
Although no condensation was visible at the time of the inspection, staining and etching of the glass at a window indicated a loss of thermal integrity. Etching of the glass from long-term exposure to condensation constitutes permanent damage. The Inspector recommends that before the expiration of your Inspection Objection Deadline you consult with a qualified contractor to discuss options and costs for replacement.

Staining and etching of the glass at the window indicated a loss of thermal integrity.

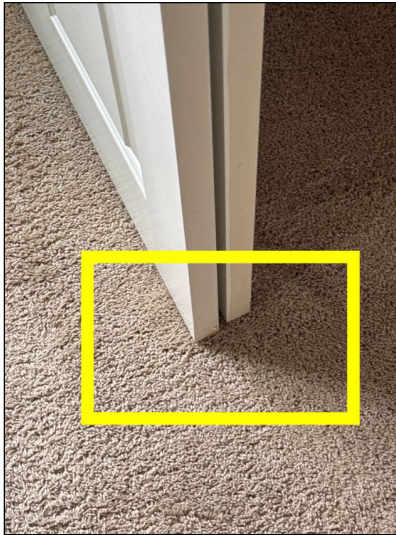
Safety: The closet door has no door stop

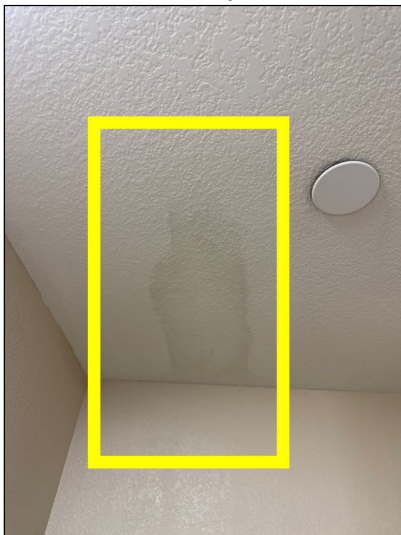
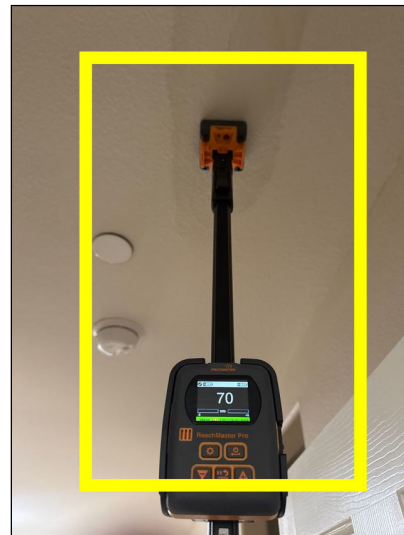
- **Monitor:** Stains on the ceiling visible at the time of the inspection appeared to be the result of moisture intrusion. The moisture meter showed no elevated levels of moisture present in the stained areas at the time of the inspection, indicating that the source of moisture may have been corrected, or leakage may be intermittent. Normal moisture reading in drywall is 5-12% based on relative humidity with in the home. A reading up to 17% means that the drywall is salvageable, but any moisture level above 17% tells us that the drywall has been compromised and will need to be replaced.

**Monitor:** Stains on the ceiling visible at the time of the inspection appeared to be the result of moisture intrusion.

The moisture meter showed no elevated levels of moisture present in the stained areas at the time of the inspection (Normal moisture is considered between 5-12%)

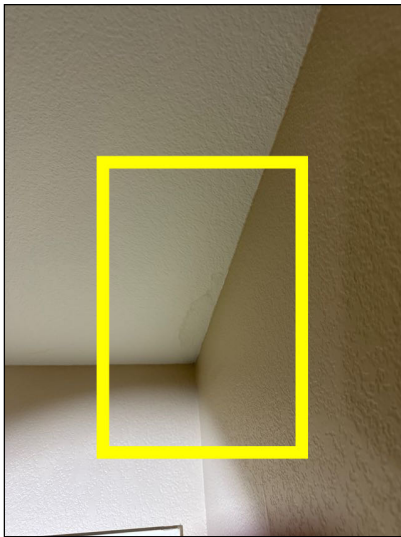
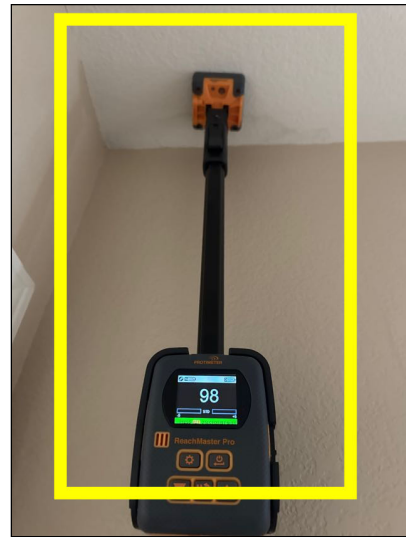
**Monitor:** Stains on the ceiling visible at the time of the inspection appeared to be the result of moisture intrusion.

The moisture meter showed no elevated levels of moisture present in the stained areas at the time of the inspection (Normal moisture is considered between 5-12%)

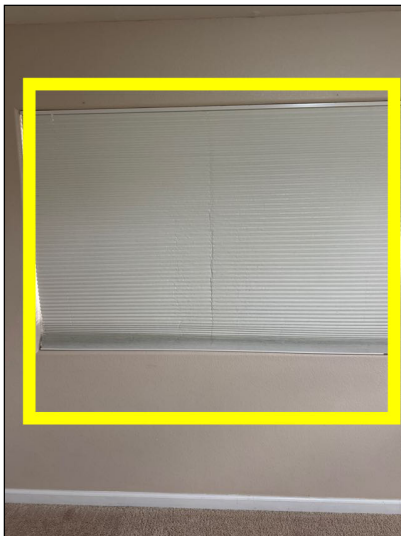
Window blind is broken and inoperable

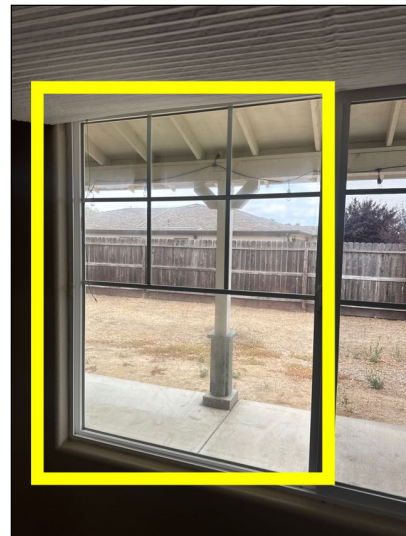
Although no condensation was visible at the time of the inspection, staining and etching of the glass at a window indicated a loss of thermal integrity. Etching of the glass from long-term exposure to condensation constitutes permanent damage. The Inspector recommends that before the expiration of your Inspection Objection Deadline you consult with a qualified contractor to discuss options and costs for replacement.

Staining and etching of the glass at the window indicated a loss of thermal integrity.

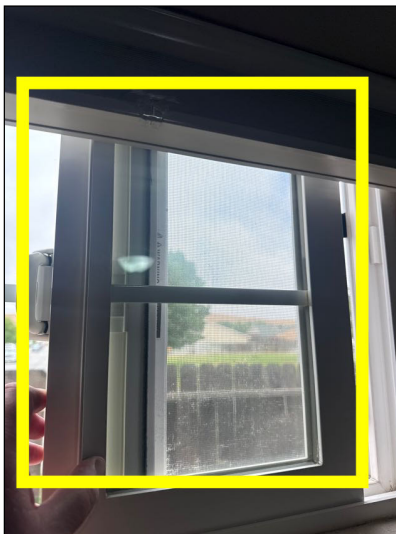
Staining and etching of the glass at the window indicated a loss of thermal integrity.
