# Professional

## Inspection Services

### *Inspection Report*

Address: 329 N 14th St Grover Beach, CA 93433

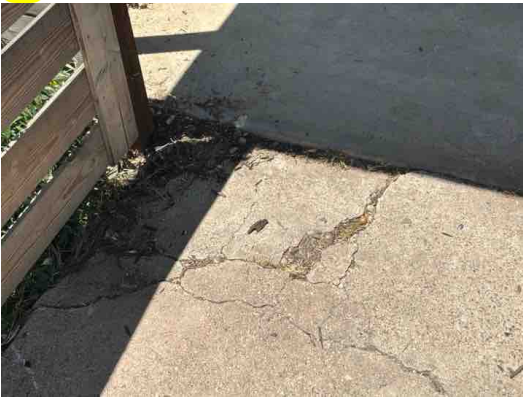
**SU** 18: Areas of the walkways are uneven with potential trip hazards.

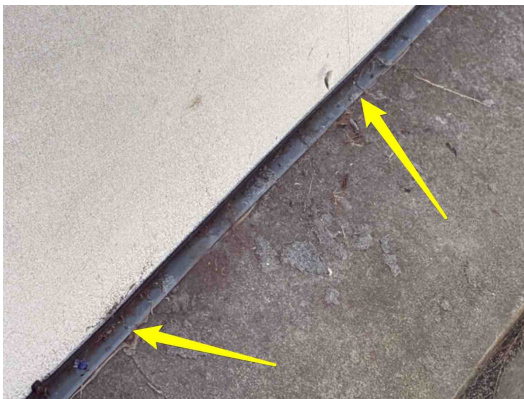
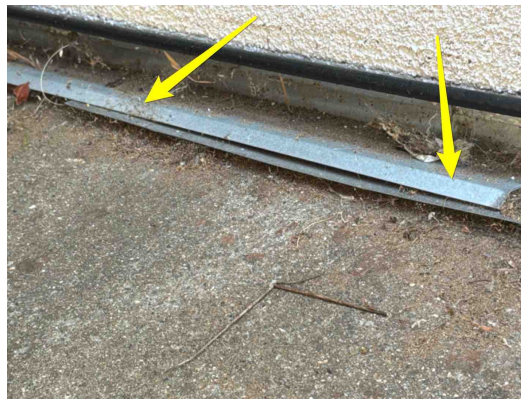
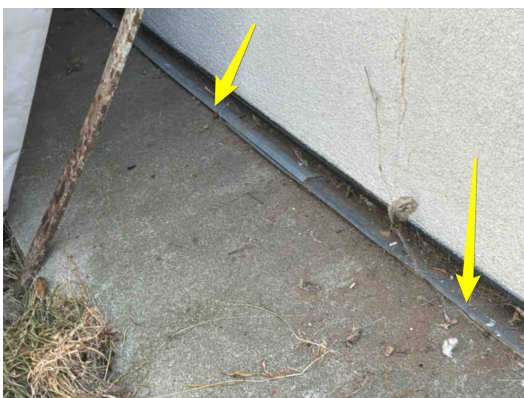
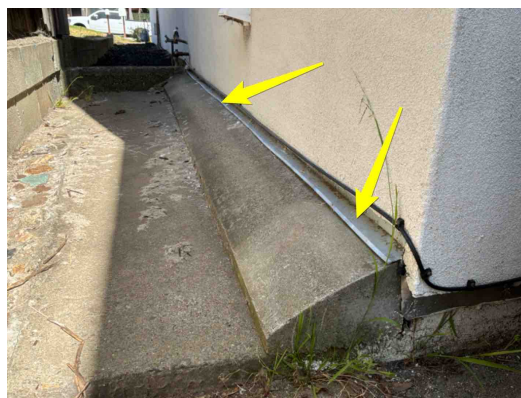
**FI** **UPG** 29: An unusual Stucco termination and watershed flashing installed along the north side of the home. Unable to verify reason for the flashing. Flashing not sealed if installed to be watertight. Recommend additional review and testing by a licensed contractor.

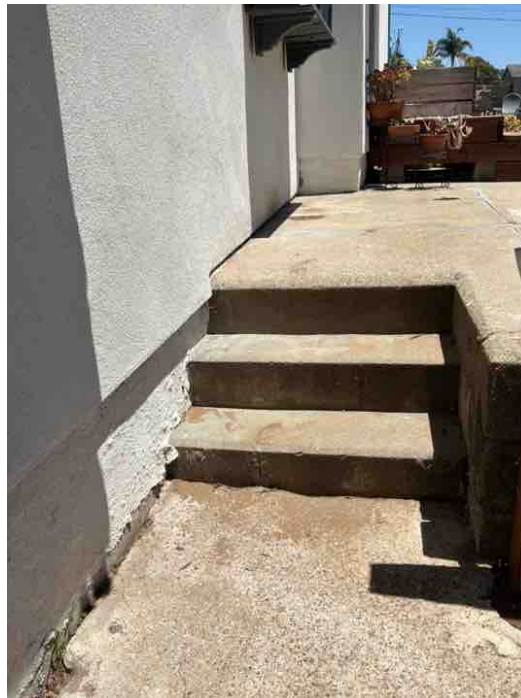
**SC 33:** Uneven step tread rise, step heights are not all the same, AND top tread exceeds maximum height at the exterior stairway off the FRONT PATIO WEST END CONCRETE STEPS. Potential trip or fall hazard.

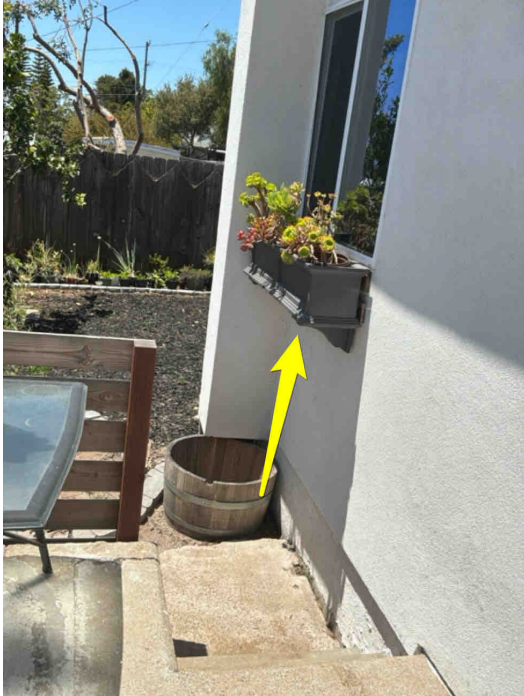
**SU 34:** An Unusual hazard at the exterior stairway off the front entry patio as there is a pot shelf installed on the outside under the window within the path of travel within the stairway.

Someone could hit their head

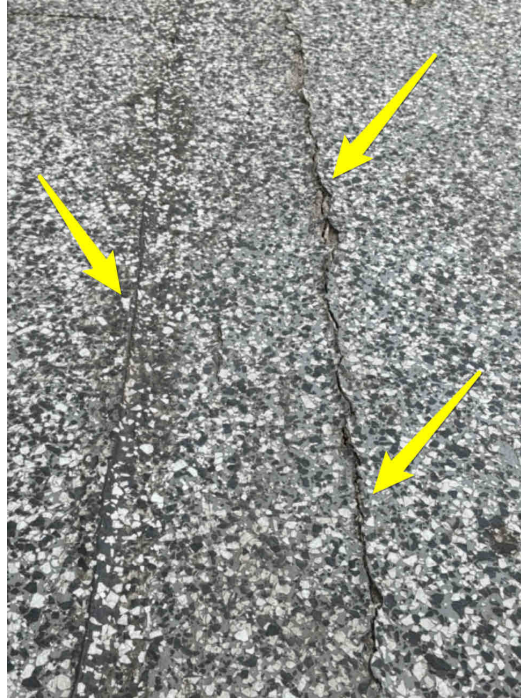
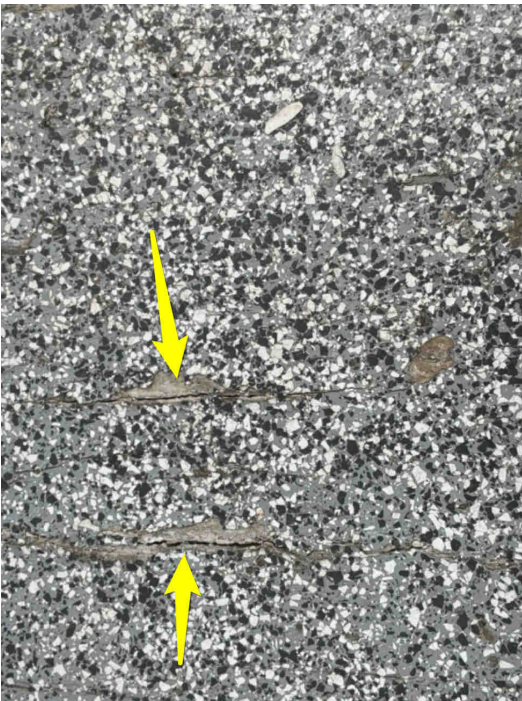
**E&C 39: WATERPROOF DECK COATING CONDITION:** Areas of deterioration, cracking of the waterproof deck coating noted at areas of the UPSTAIRS DECK OFF THE UPSTAIRS BEDROOM. Repairs or replacement is needed by a licensed waterproof deck contractor. Recommend further review and/or repairs by a certified or licensed waterproof deck coating professional familiar with minimum requirements.

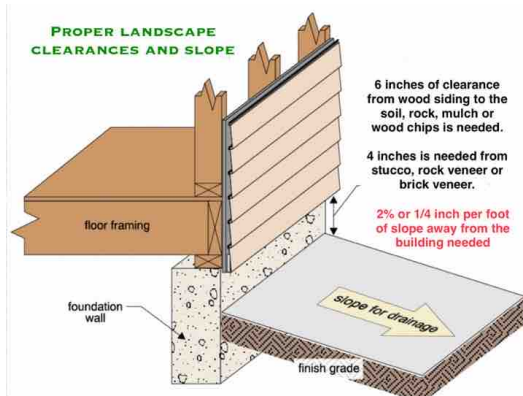
**E&C** **MR** **45:** Soil level found high at areas of the foundation. (Recommend 4 inches from the bottom of the exterior stucco siding to dirt, rock, mulch or wood chips).

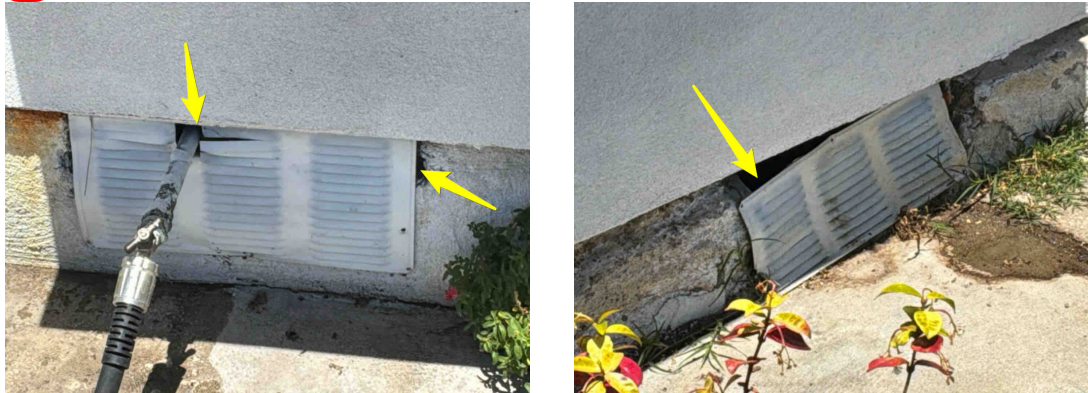
**E&C 54:** Damaged exterior crawlspace ventilation screens found in need of repair to help prevent critter intrusion.

Unprotected openings into the crawlspace

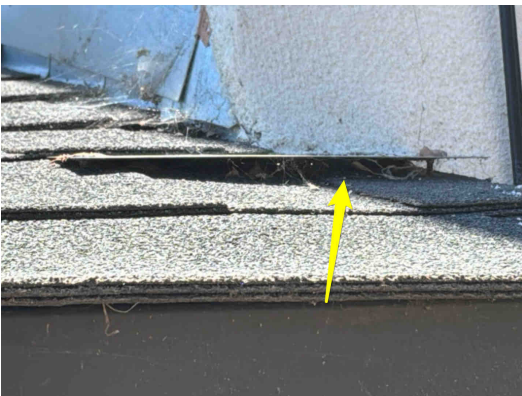
At the main house on the back at the primary bedroom

**E&C MR 63:** Some lifting roof flashings. Corrections, maintenance or repairs are recommended to help prevent water intrusion and/or roof leakage from windy, wet weather.

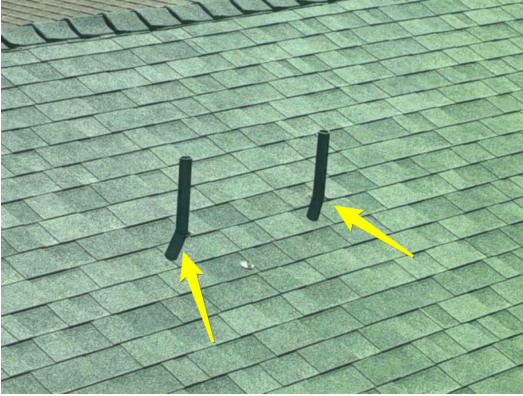
Example - ADU

**E&C 64:** Missing a roof jack flashings at the ADU where some plumbing vents penetrate through the roof.

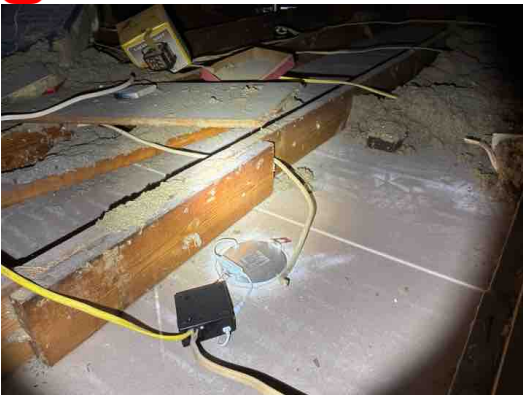
**E&C 66:** Areas of poor coverage, missing attic insulation above the UPSTAIRS ATTIC. Corrections recommended.

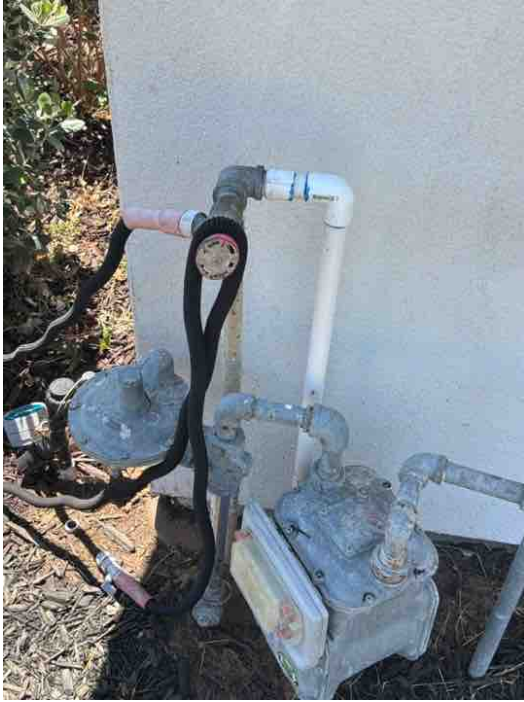
**UPG DS 72: Disclosure:** The White Plastic PVC pipe used above ground for faucet, sprinkler or supply piping is fragile, not UV rated, and can break easily. Upgrades are recommended to help prevent future damage or water leakage.

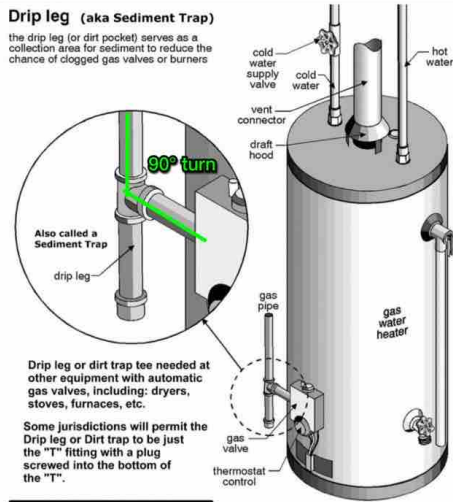
**UPG 87:** Recommend the installation of a sediment trap / drip leg at the MAIN HOUSE WATER HEATER gas piping at flex connection by a certified or licensed plumbing professional familiar with minimum requirements.

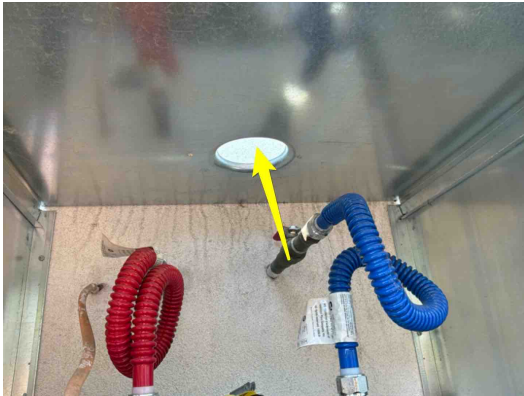
**E&C 95:** Open hole found at the top of the ADU WATER HEATER enclosure. Hole should be sealed to help prevent water and critter inclusion

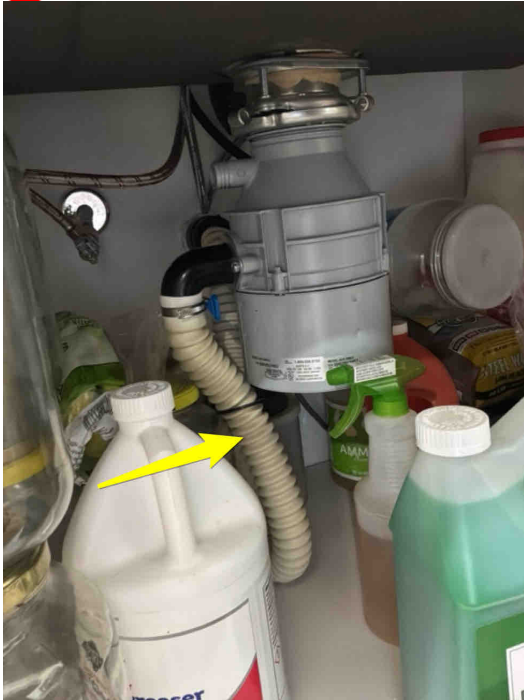
**E&C 115:** Improper waste piping found under the ADU Kitchen sink.

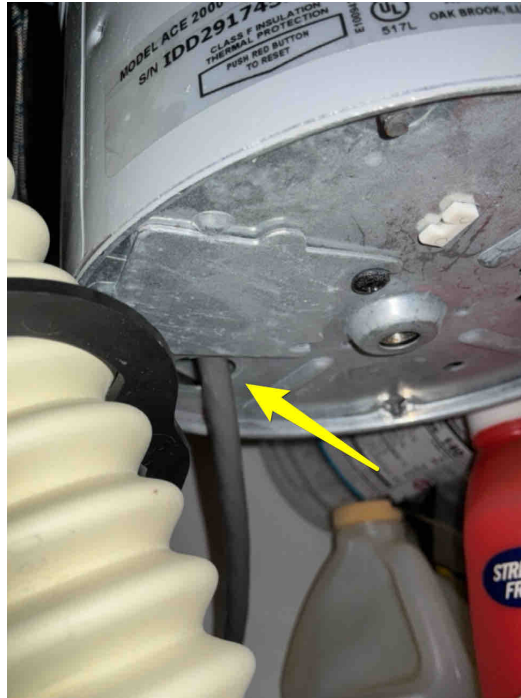
**SC 121:** Missing a proper electrical wire-bushing clamp at bottom of ADU kitchen sink disposal.

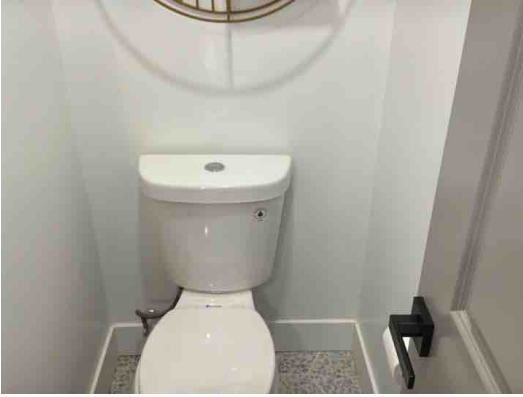
**DS** 144: Disclosure: the toilet is not centered in the enclosure in the UPSTAIRS BEDROOM BATHROOM.

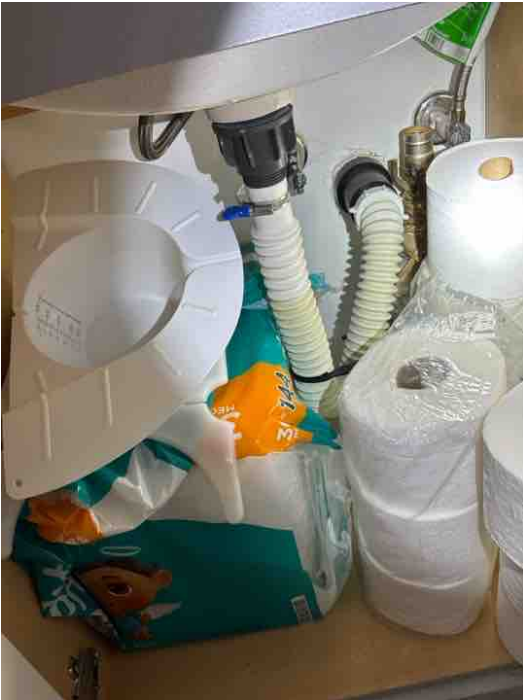
**E&C** 145: Improper drain piping under bathroom sink: ADU BATHROOM. Recommend additional review and repairs by licensed plumbing contractor.

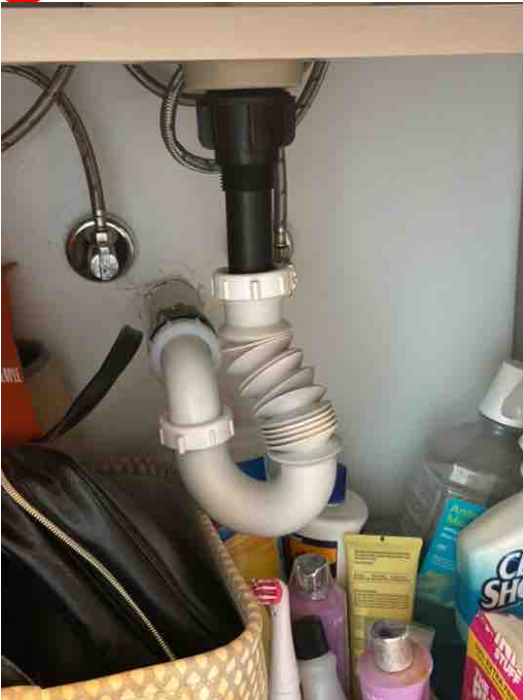
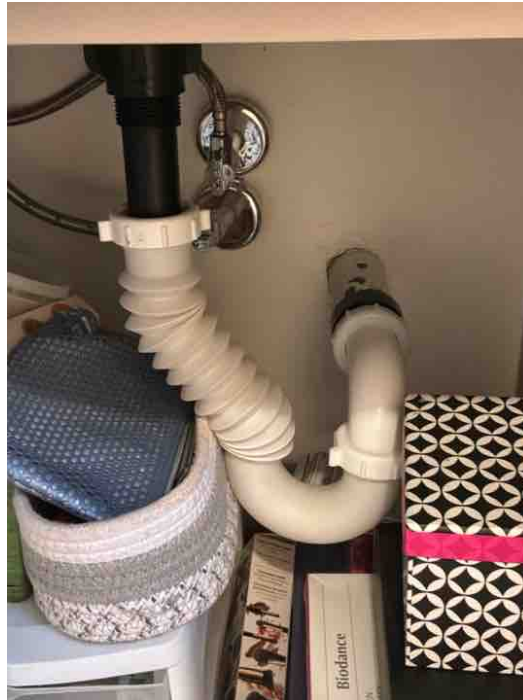
**E&C 147:** Improper use of corrugated drain piping below the bathroom sink: UPSTAIRS BEDROOM BATHROOM

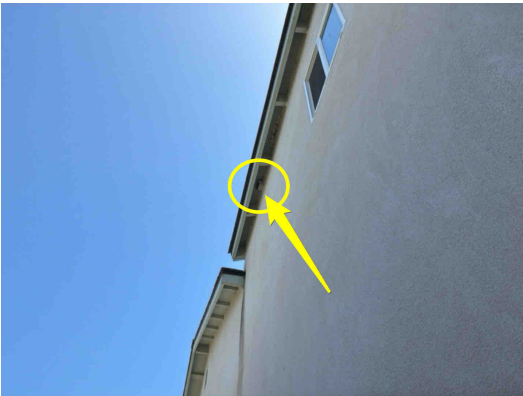
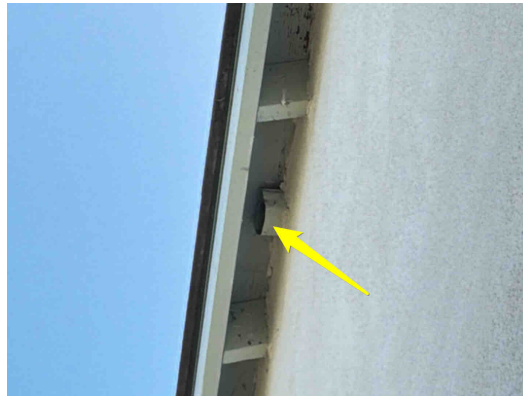
**E&C 152:** Missing / Recommend screens on the bathroom exhaust fan vent termination cap per standards to help prevent critter intrusion.

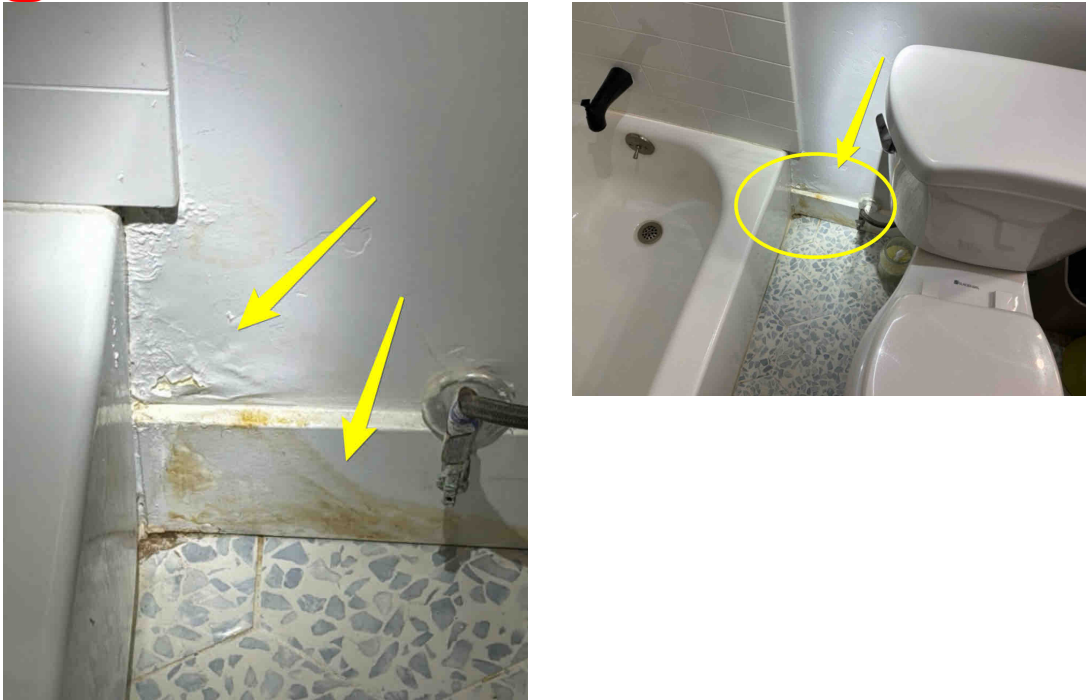
**E&C 154:** Moisture stains and damage to wall, floor and baseboards outside tub: ADU BATHROOM

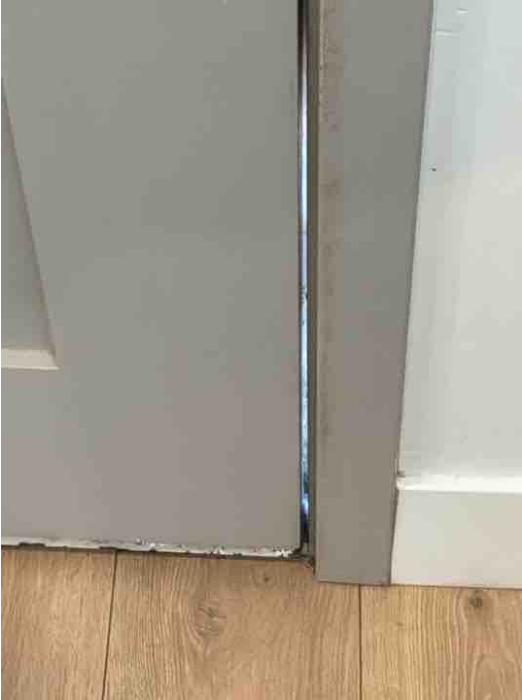
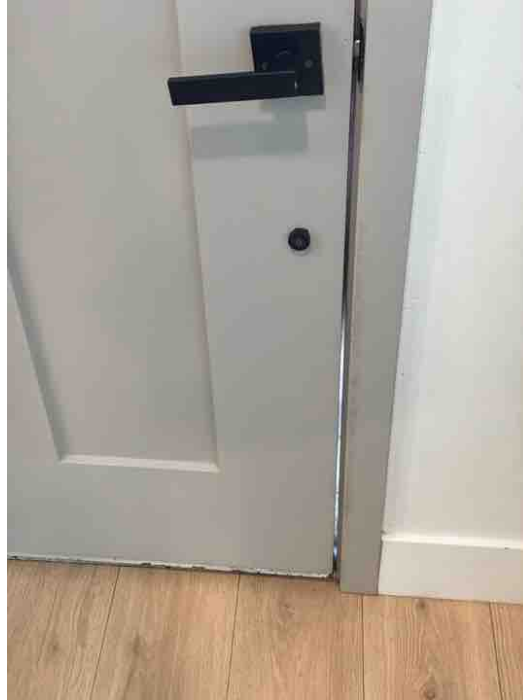
**MR 156:** Some visible daylight noted around the MAIN HOUSE exterior front entry door. Adjustment and/or repair of the weather stripping is recommended to help prevent water and critter intrusion.

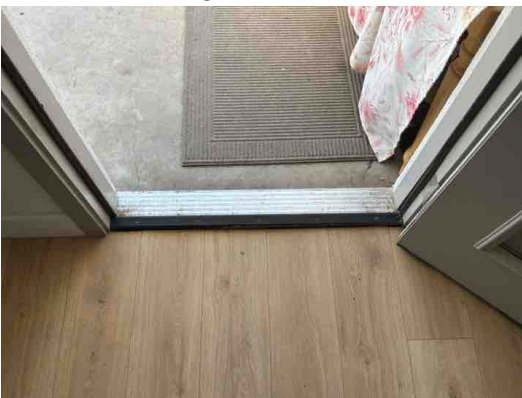
**MR UPG 160:** Loose and unsealed exterior door threshold found at the DOWNSTAIRS BEDROOM exterior door. This could damage the threshold and/or create a water leak.

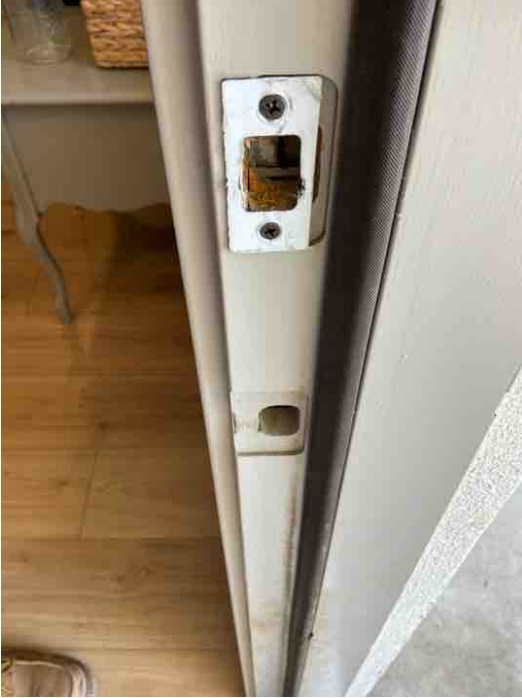
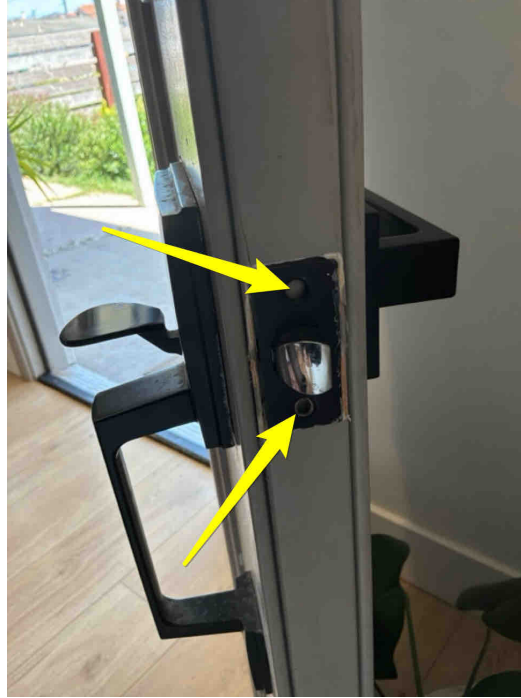
**MR SU 161:** Missing the DOWNSTAIRS BEDROOM metal strike plate at the exterior doorframe AND the door knob striker is loose and not screwed to the door

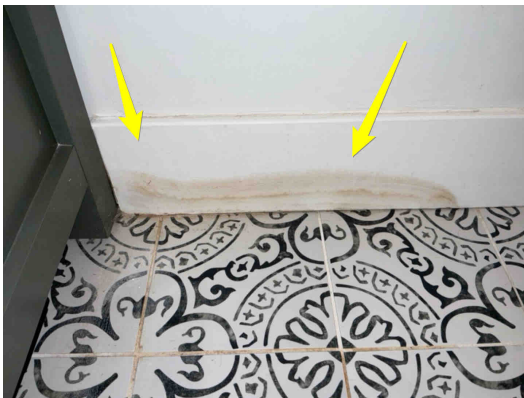
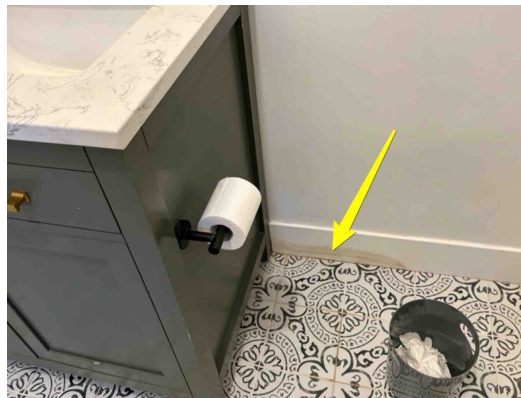
**FI 179:** Evidence of moisture stains and/or damage at the walls in the DOWNSTAIRS HALLWAY BATHROOM. Recommend further review of the water stains to determine the cause, the current condition and if repairs are needed.

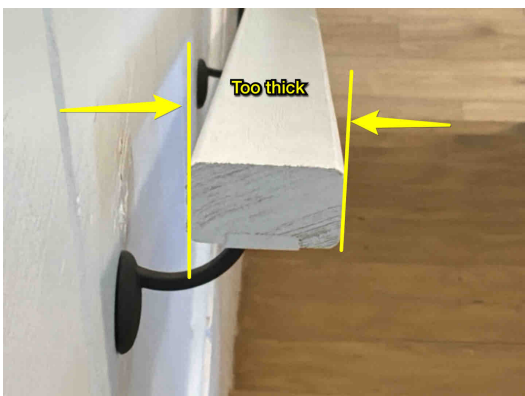
**SC 181:** An improper gripable handrail at the interior stairway for safety per standards. The Graspable portion of the railing is too thick and does not meet current standards. Upgrade recommended.

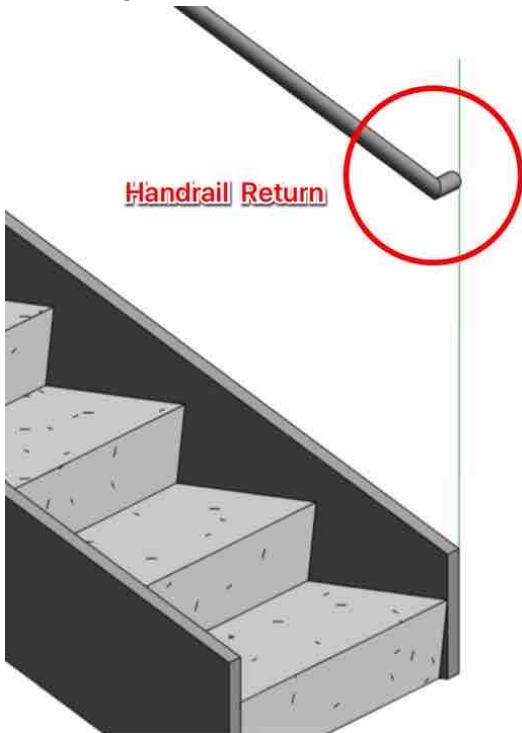
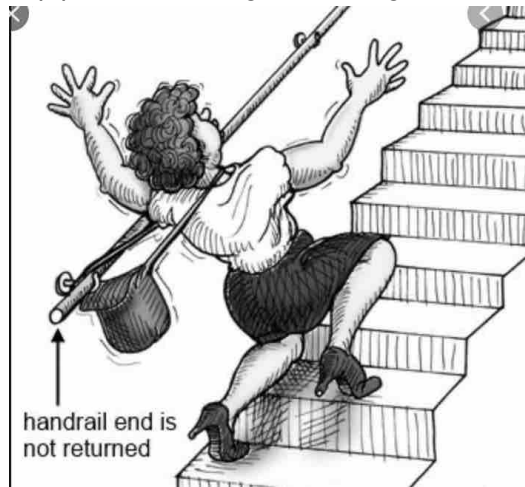
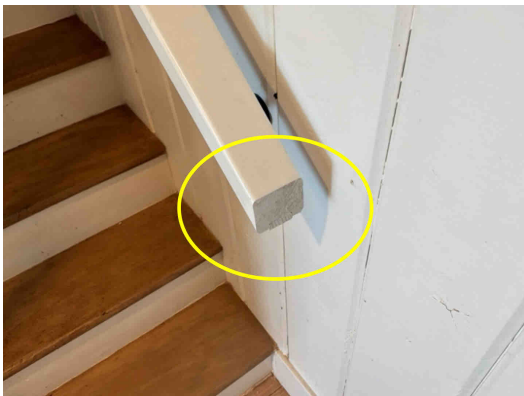
**UPG 182:** Recommend / missing returns at the interior stairway gripable handrails for safety per standards. Return are turning the ends of the handrail into wall to help prevent catching coat or bag on the railing.

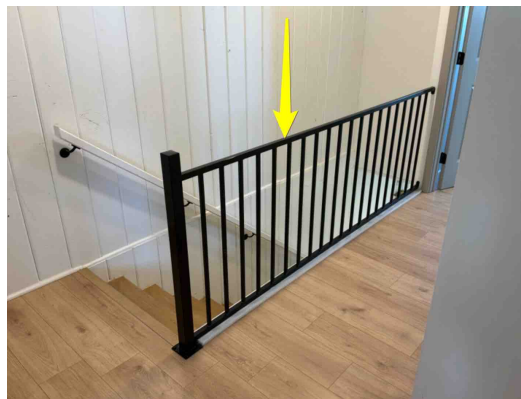
**185:** Openings between the spindles and the height of the railings at the stairway landings do not meet current standards. Upgrades Recommended for safety.

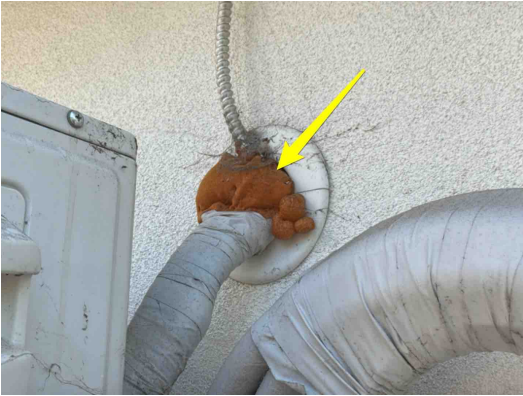
**197:** Recommend sealing the hole or opening BETTER - then using only expandable foam, through the exterior wall where the Air Conditioner's refrigeration pipes enter the building. This will help prevent rodent, bug and /or water intrusion through this area as need per standards.

Expandable foam is not an acceptable alternative to a proper seal

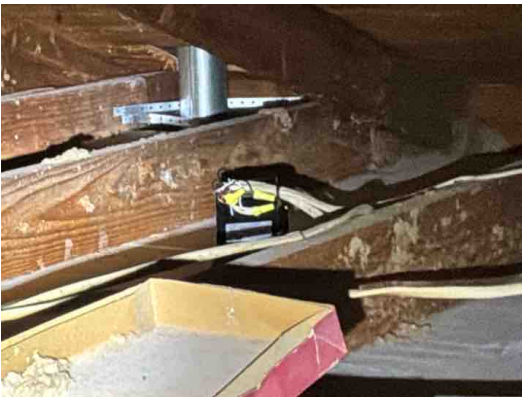
**SC 204:** Improper and unsafe electrical wiring IN THE MAIN HOUSE ATTIC. recommend additional review by licensed electrician.

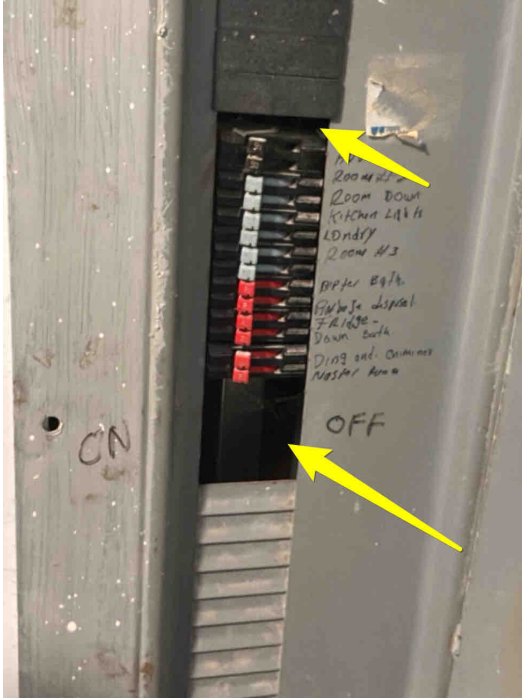
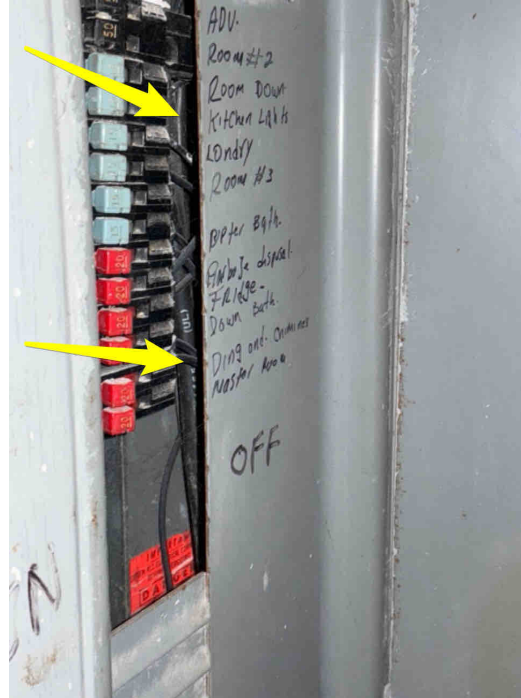
**SC 210:** Improper and unsafe openings in the dead front cover inside the LAUNDRY ROOM ELECTRICAL SUB PANEL. Openings are needing to be plugged or sealed for safety per standards.

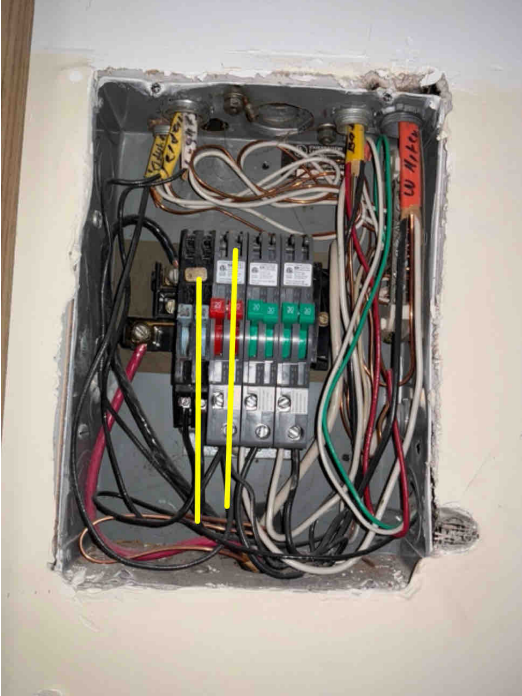
**SC 219:** Improper installation of two wires on single-wire rated circuit breaker in the ADU ELECTRICAL SUB-PANEL.
