# PROPERTY INSPECTION REPORT

**519 W Taylor St Spc 185**

**Santa Maria CA 93458**

**Date of Inspection: 7/20/2026**

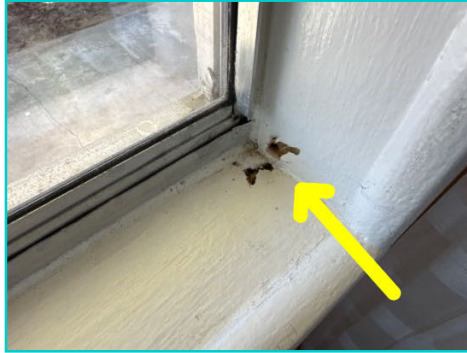
- **A window in this room had a damaged and/or deteriorated sill at the time of the inspection. The Inspector recommends repair.**

*minor damage here*

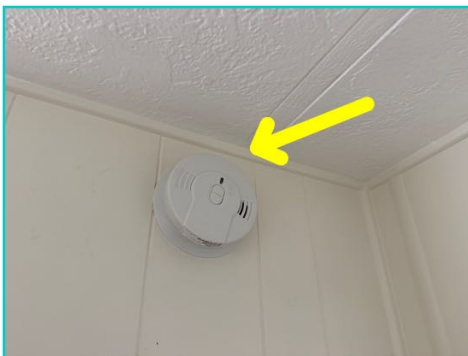
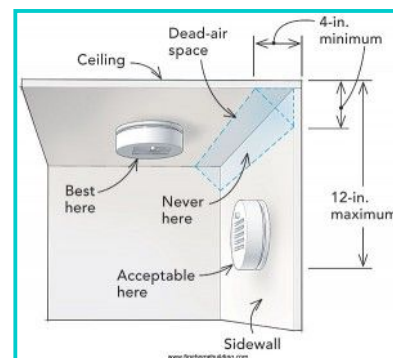
- The smoke detector appeared to be improperly placed. Manufactures recommend placing detectors near the sleeping areas. The Inspector recommends correction. Smoke detectors can be located on the ceiling with the side of the detector greater than four (4) inches from the wall or on the wall of a bedroom with the top of the detector located four (4) to twelve (12) inches down from the ceiling.

*must be between 4 & 12 inches of ceiling*

*proper placement of smoke detector*

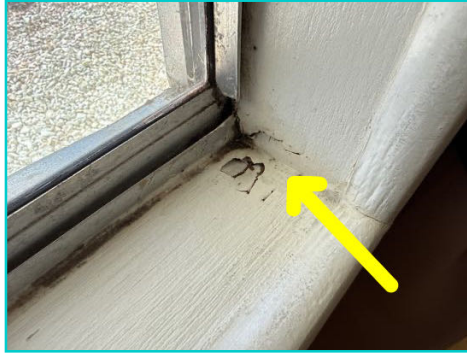
- A window in this room had a damaged and/or deteriorated sill at the time of the inspection. The Inspector recommends repair.

*minor damage here*

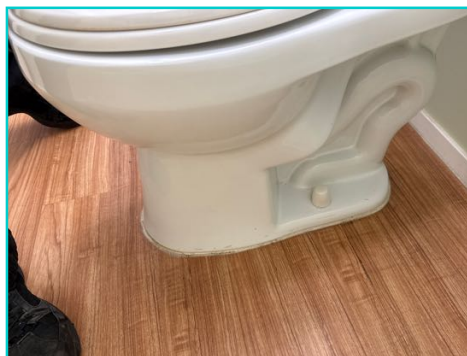
- In the hall bathroom, the toilet was loose at the floor and should be repaired.

*loose at floor*

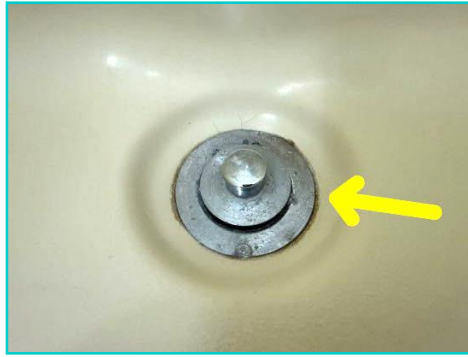
- The tub had functional flow and functional drainage at the time of the inspection.
- The tub drain was severely corroded. Suggest replacement.

*corrosion here*

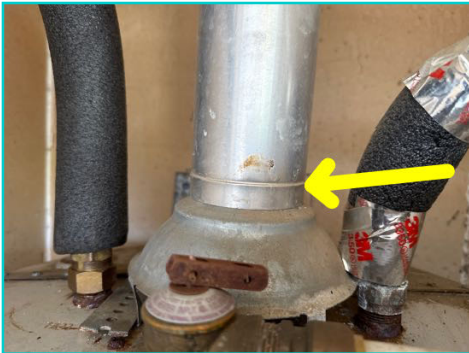
- Water heater exhaust flue vent connections require 3 screws at any connection. Suggest this be repaired.
- There was no firestop wall/ceiling plate installed. Suggest repair.

*vent pipe needs screws at connections*

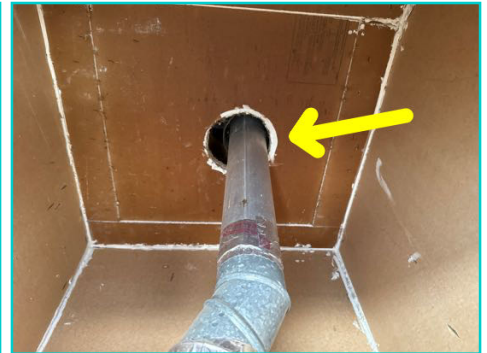
*missing fire stop flange*

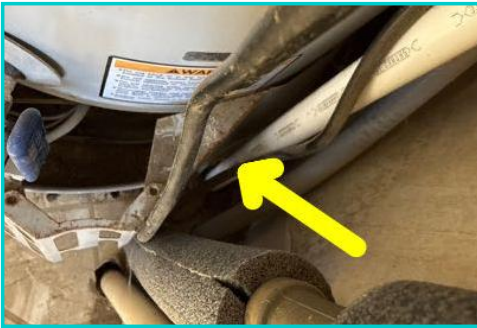
- At the time of the inspection, the Inspector observed no deficiencies in the condition of the temperature/pressure relief (TPR valve), (not tested).
- The discharge pipe of this water heater temperature/pressure relief (TPR) valve was of an improper material. TPR discharge pipes should be galvanized steel, copper pipe, or CPVC. The Inspector recommends correction. (FLEX CONNECTORS ARE NOT ALLOWED HERE)
- The discharge pipe of this water heater temperature/pressure relief (TPR) valve discharged into the crawlspace. This condition is improper, the discharge pipe termination must be visible. The Inspector recommends correction.

improper termination

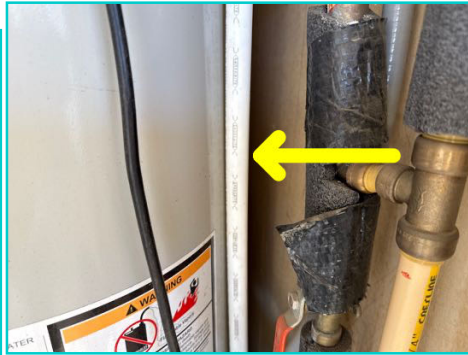
improper material used here

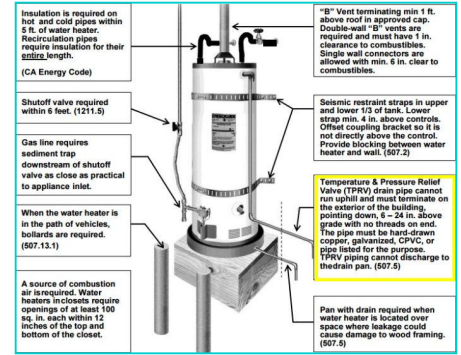
termination not visible

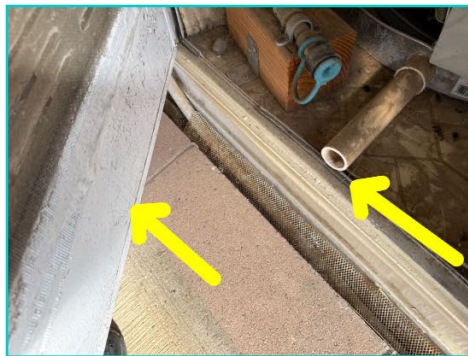
- Drip pan overflow pipe terminated against the door. Suggest adding a hole through the door to allow any water to exit the cabinet in the event of a leak.

Suggest hole in door

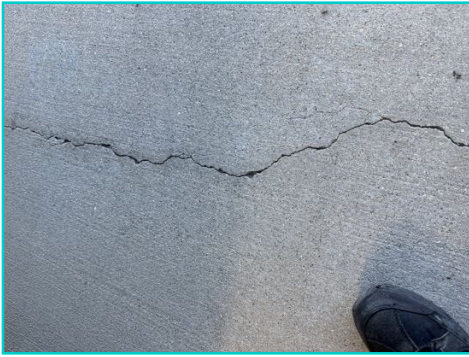
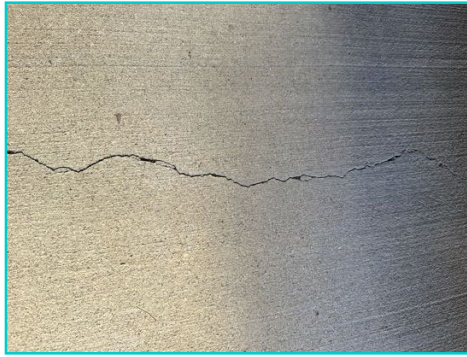
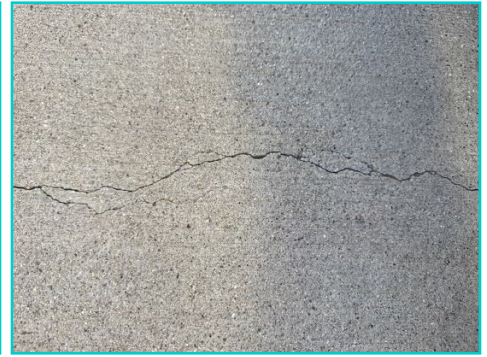
- The home had a concrete driveway.
- Common cracks (1/4-inch or less) were visible in the driveway. Cracks exceeding 1/4-inch should be filled with an appropriate material to avoid continued damage to the driveway surface from freezing moisture. (PICTURES ARE JUST A REPRESENTATION OF THE MINOR CRACKS AND MAY NOT INCLUDE ALL CRACKS PRESENT)

*common cracks here*

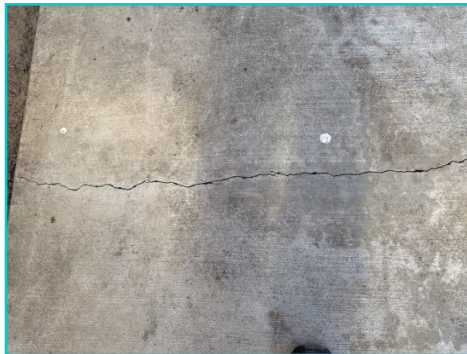
- Home walkways were constructed of poured concrete.
- Common cracks (1/4 inch or less) were visible in the sidewalk at the time of the inspection. Cracks exceeding 1/4 inch should be patched with an appropriate sealant to avoid continued damage to the walkway surface from freezing moisture. (PICTURES ARE JUST A REPRESENTATION OF THE MINOR CRACKS AND MAY NOT INCLUDE ALL CRACKS PRESENT)

*common cracks here*

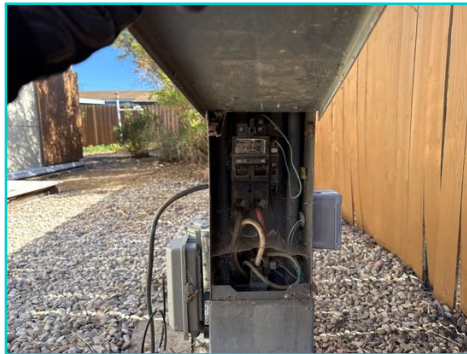
- The dead front cover of the service panel was missing and energized electrical components were exposed to touch. This condition is a shock/electrocution hazard and should be corrected immediately.

*missing dead front cover*

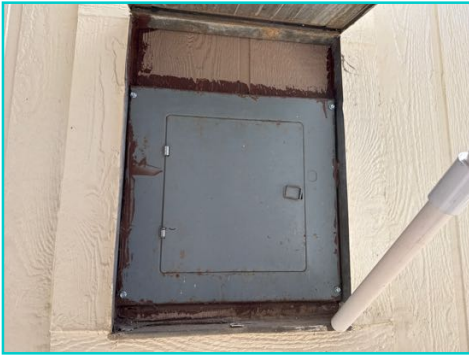
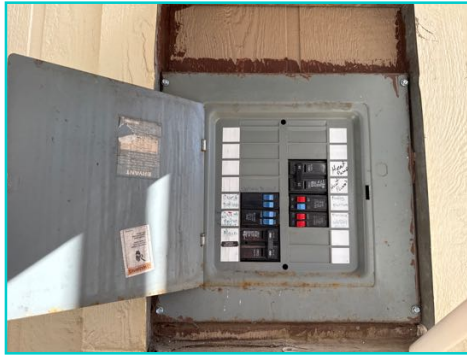
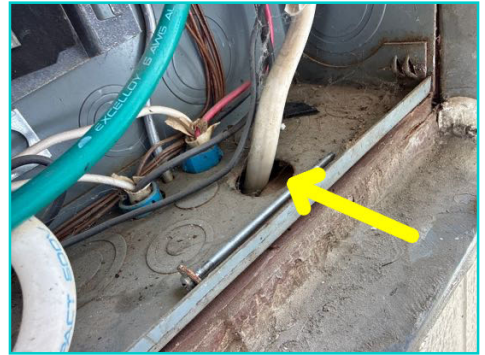
- Non-metallic conductors passed through knock-outs in this subpanel that had no protective device installed. Connectors designed to protect conductors where they pass through sheet metal include bushings, cable clamps, grommet, or other connectors. Without some protective device, the sharp edges of sheet metal may damage the conductors. This condition is a potential a shock/electrocution or fire hazard. The Inspector recommends that protective devices approved for this purpose be installed.
- The subpanel dead front cover was held in place by the wrong type of screws. The installed pointed, coarse-thread screws can cut conductors, causing damage that can create electrical arcing (eye injury, burns), or can energize the metal panel (electrical shock, electrocution). Blunt, fine-thread screws are required for this application. This condition should be corrected.

*missing bushings, cable clamps, or grommets*

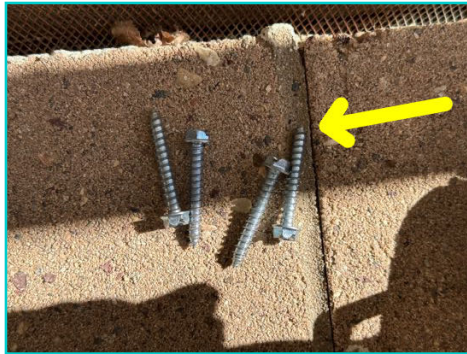
*improper pointed screws*

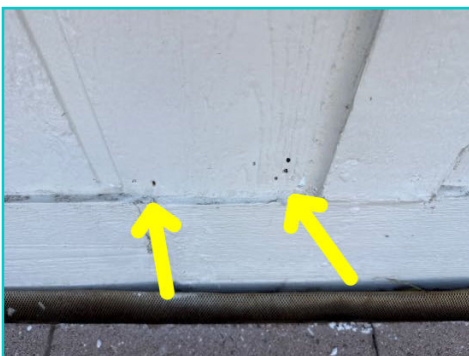
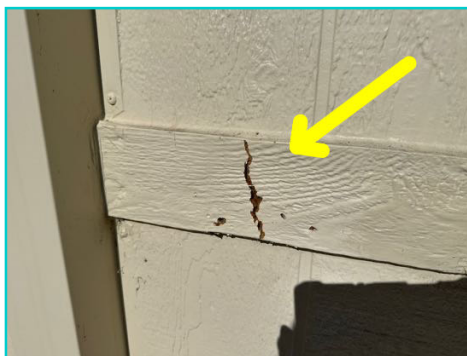
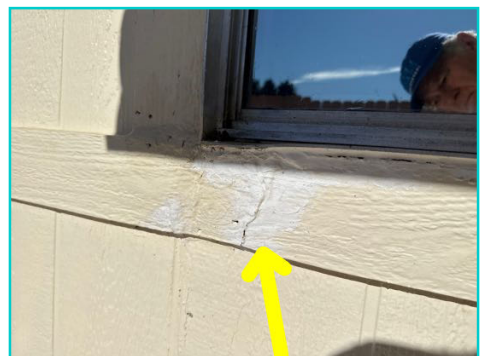
- Exterior walls were covered with a composite siding.
- **The composite siding was damaged in several places and may allow moisture intrusion. Damaged areas should be repaired to avoid future problems from moisture intrusion.**

*damage here*

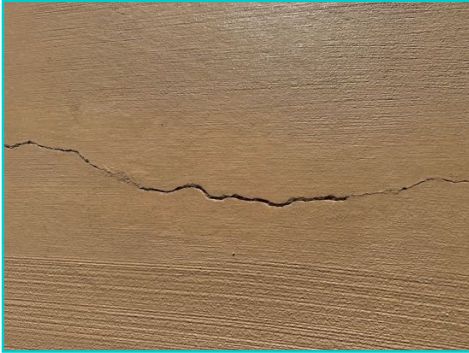
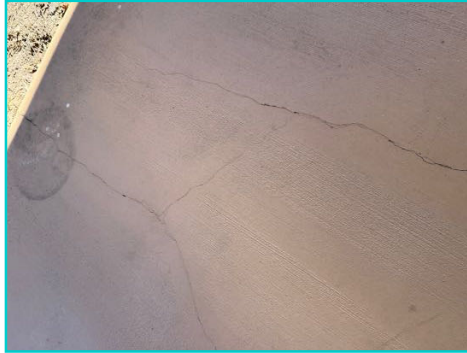
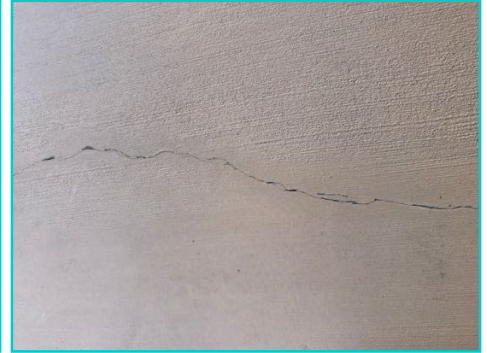
- Common cracks ( $\frac{1}{4}$ -inch or less) were visible in the concrete at the time of the inspection. Cracks exceeding  $\frac{1}{4}$ -inch should be filled with an appropriate sealant to avoid continued damage to the concrete porch floor surface from freezing moisture.

*common cracks here*

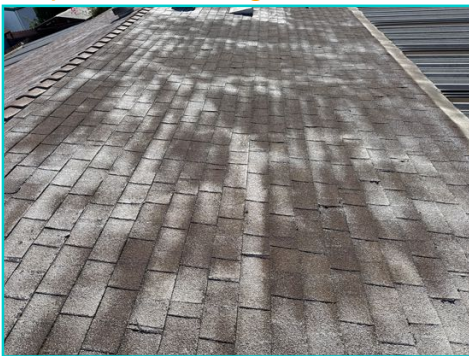
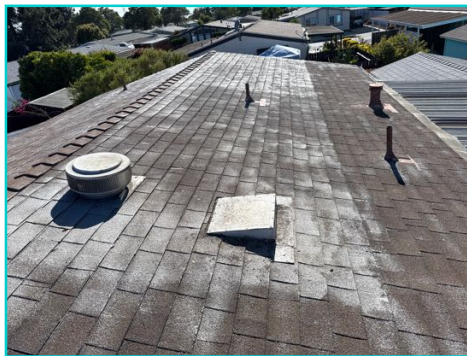
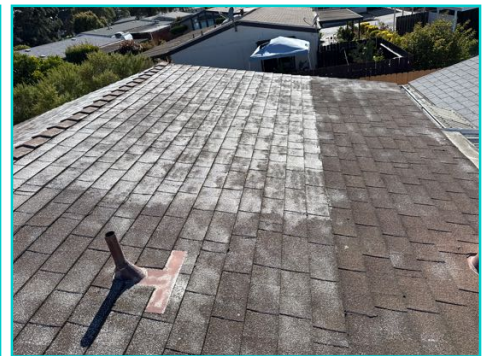
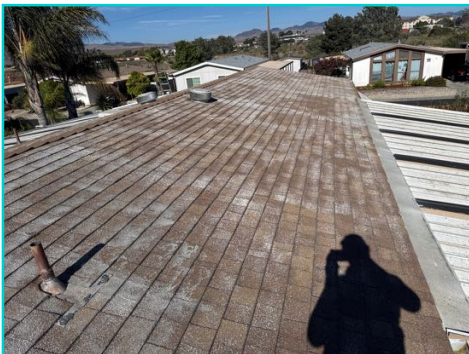
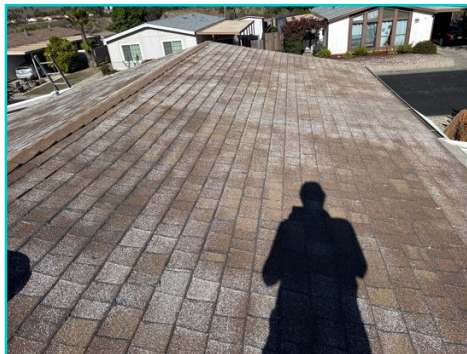
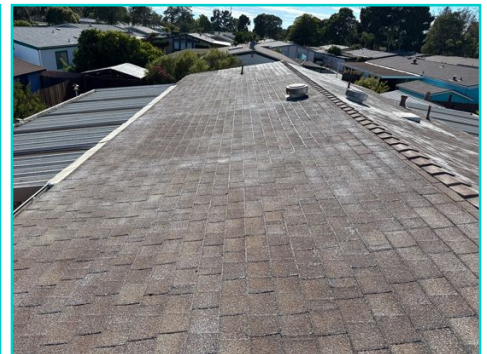
- Asphalt composition shingles covering the roof of this home exhibited moderate general deterioration commensurate with the age of the roof. They appeared to be adequately protecting the underlying home structure at the time of the inspection. Suggest you have the roof inspected by a qualified roofing contractor.

*deteriorated shingles*

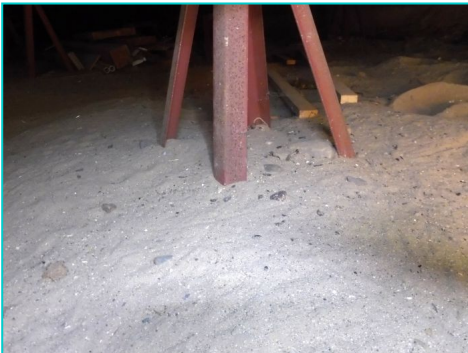
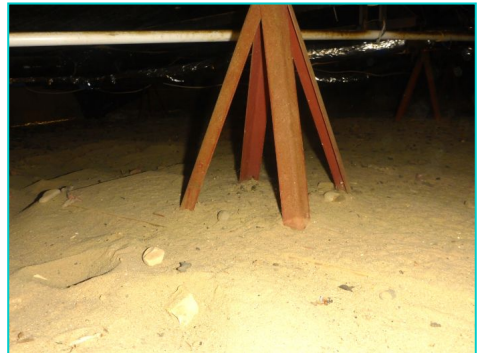
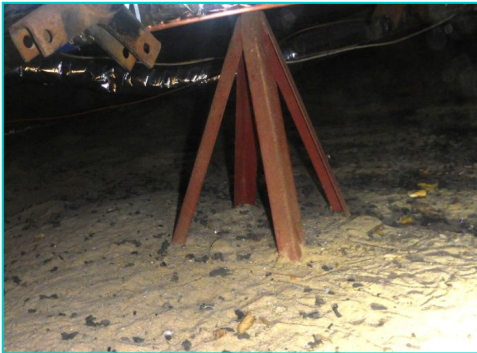
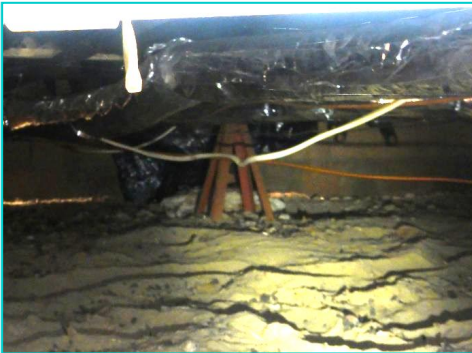
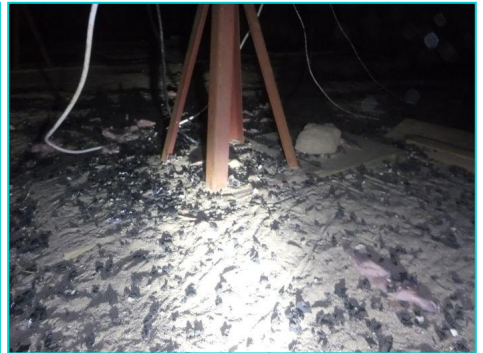
- Inspector noted one or more screw jacks that were buried in soil. This will accelerate the corrosion and failure of these jacks. Suggest removal of soil on and around the jacks.

*screw jacks covered in soil*

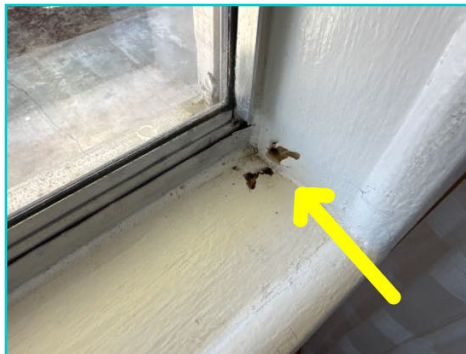
| Page 4 Item: 2 | Window Condition | <ul style="list-style-type: none"> <li>• A window in this room had a damaged and/or deteriorated sill at the time of the inspection. The Inspector recommends repair.</li> </ul> |

*minor damage here*

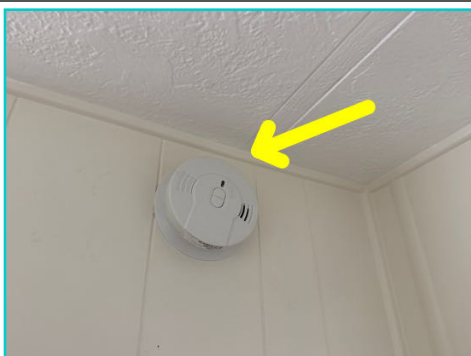
| Page 6 Item: 1 | Smoke/CO Detectors | <ul style="list-style-type: none"> <li>• The smoke detector appeared to be improperly placed. Manufacturers recommend placing detectors near the sleeping areas. The Inspector recommends correction. Smoke detectors can be located on the ceiling with the side of the detector greater than four (4) inches from the wall or on the wall of a bedroom with the top of the detector located four (4) to twelve (12) inches down from the ceiling.</li> </ul> |

*must be between 4 & 12 inches of ceiling*

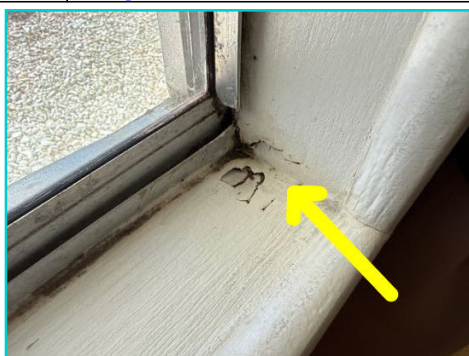
- A window in this room had a damaged and/or deteriorated sill at the time of the inspection. The Inspector recommends repair.

*minor damage here*

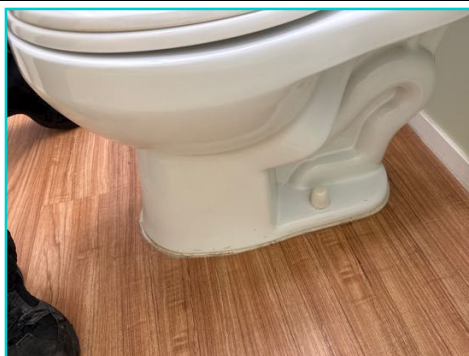
- In the hall bathroom, the toilet was loose at the floor and should be repaired.

*loose at floor*

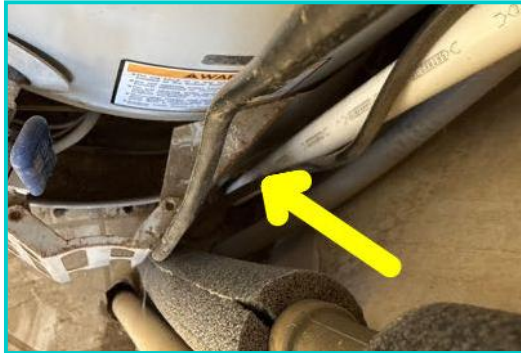
- The discharge pipe of this water heater temperature/pressure relief (TPR) valve was of an improper material. TPR discharge pipes should be galvanized steel, copper pipe, or CPVC. The Inspector recommends correction. (FLEX CONNECTORS ARE NOT ALLOWED HERE)
- The discharge pipe of this water heater temperature/pressure relief (TPR) valve discharged into the crawlspace. This condition is improper, the discharge pipe termination must be visible. The Inspector recommends correction.

*improper termination*

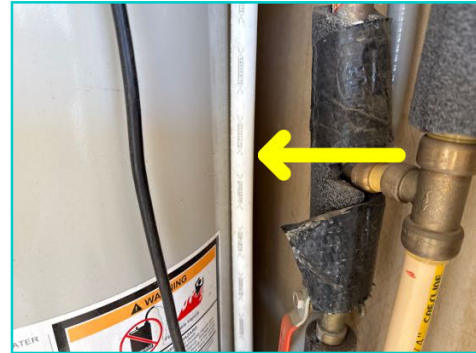
*improper material used here***SERVICE PANEL**

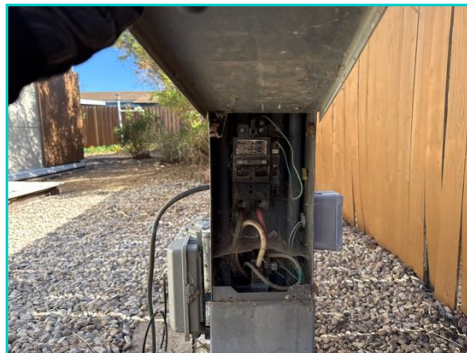
Page 17 Item: 2

- The dead front cover of the service panel was missing and energized electrical components were exposed to touch. This condition is a shock/electrocution hazard and should be corrected immediately.

*missing dead front cover*

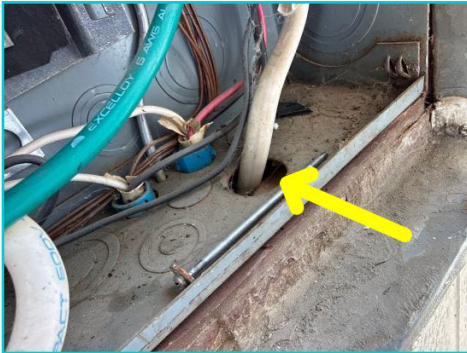
| Page 18 Item: 2 | Cabinet Condition | <ul style="list-style-type: none"><li>• Non-metallic conductors passed through knock-outs in this subpanel that had no protective device installed. Connectors designed to protect conductors where they pass through sheet metal include bushings, cable clamps, grommet, or other connectors. Without some protective device, the sharp edges of sheet metal may damage the conductors. This condition is a potential a shock/electrocution or fire hazard. The Inspector recommends that protective devices approved for this purpose be installed.</li><li>• The subpanel dead front cover was held in place by the wrong type of screws. The installed pointed, coarse-thread screws can cut conductors, causing damage that can create electrical arcing (eye injury, burns), or can energize the metal panel (electrical shock, electrocution). Blunt, fine-thread screws are required for this application. This condition should be corrected.</li></ul> |

*missing bushings, cable clamps, or grommets*

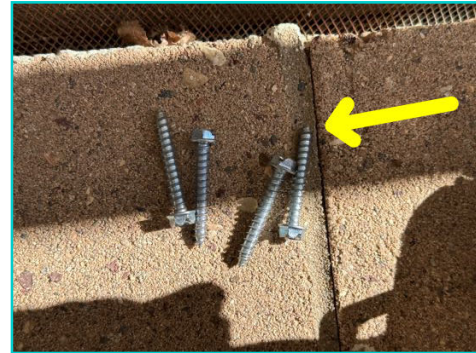
*improper pointed screws*

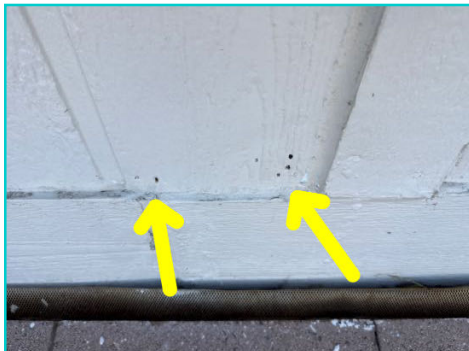
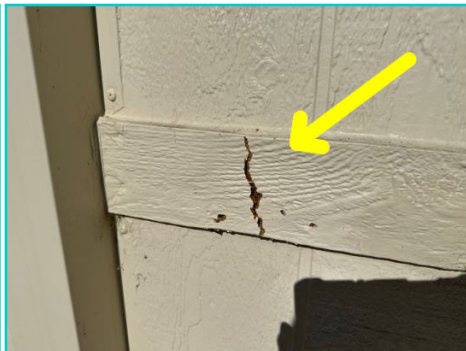
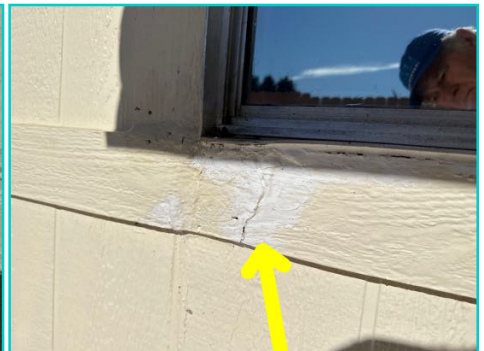
| Page 19 Item: 1 | Composite Siding | <ul style="list-style-type: none"><li>• The composite siding was damaged in several places and may allow moisture intrusion. Damaged areas should be repaired to avoid future problems from moisture intrusion.</li></ul> |

*damage here*

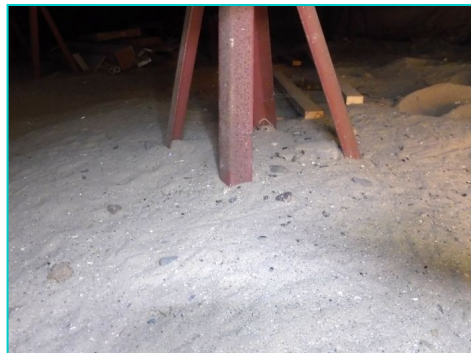
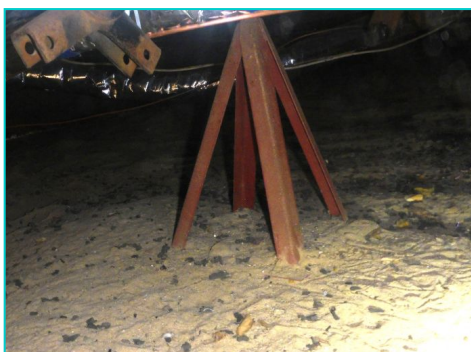
- Inspector noted one or more screw jacks that were buried in soil. This will accelerate the corrosion and failure of these jacks. Suggest removal of soil on and around the jacks.

*screw jacks covered in soil*
