# Imperial Home Inspection Services

## **General Information**

**BUILDING ADDRESS:** 3255 Mystery Run  
**CITY:** Chico  
**STATE / PROVINCE:** Ca.  
**POSTAL CODE:** 95973  
**INSPECTION DESCRIPTION:** Whole Home Inspection  
**SQUARE FOOTAGE:** 1759

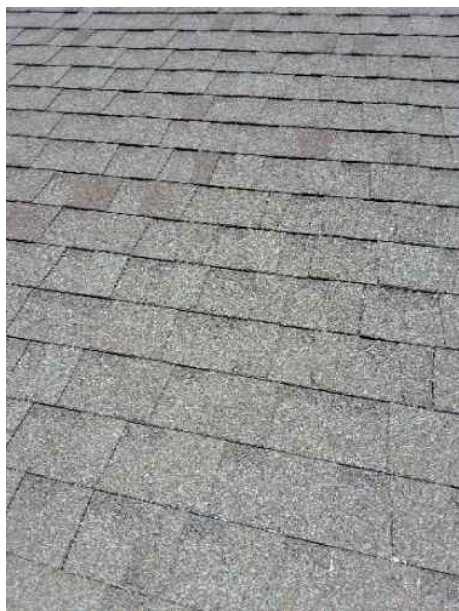
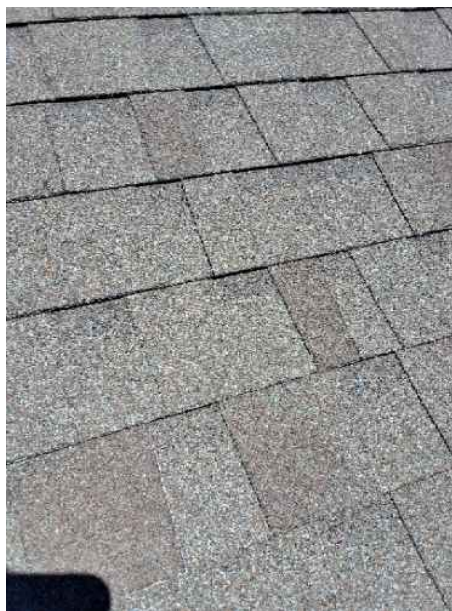
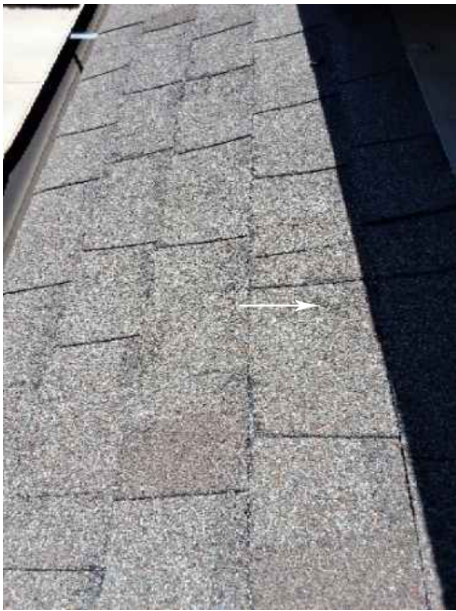
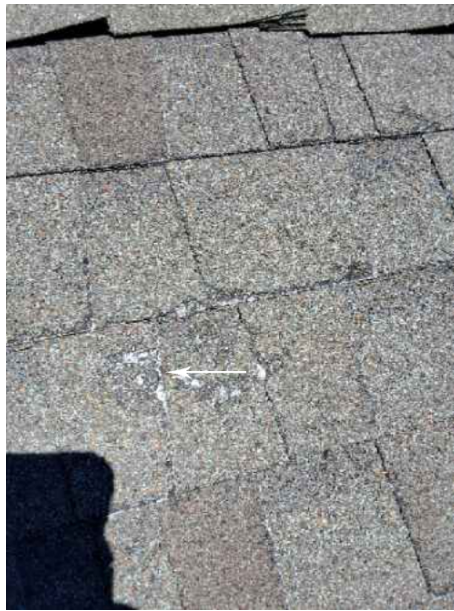
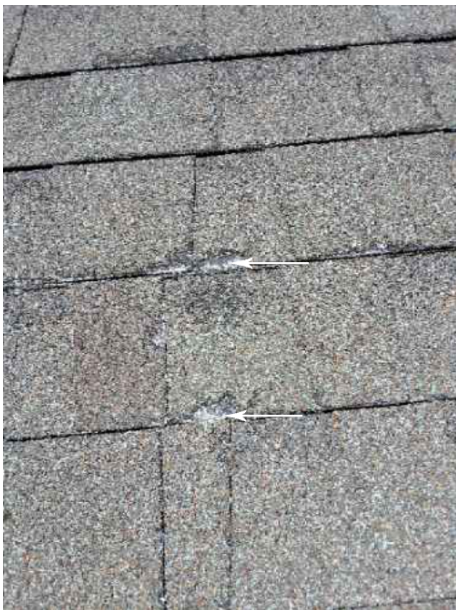
**SHINGLES MISSING / DAMAGED?** Fair

The majority of this roof appears to be somewhere in the middle of life, areas of minor granular deterioration were observed.

There are a few shingles on the front of the home that are damaged and should be replaced/repared. Recommend further evaluation by licensed roofing contractor for the damaged shingles.

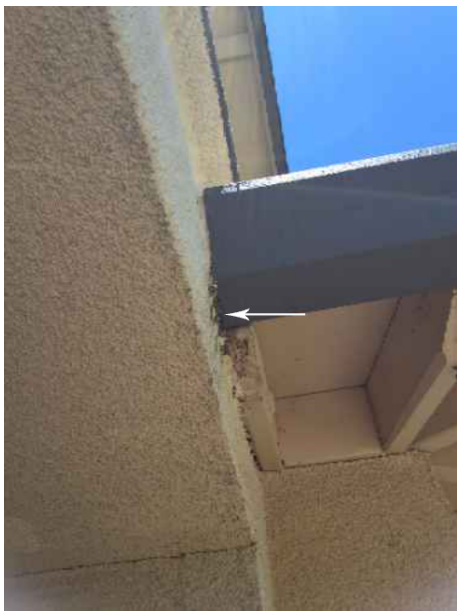
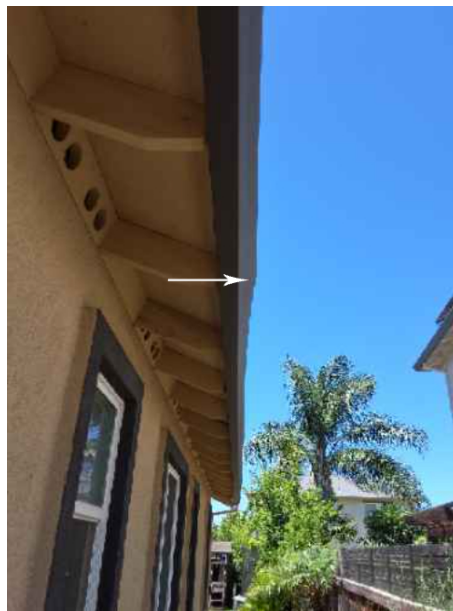
**GUTTERS AND DRAINAGE** Fair

Stains/moss growth was observed at a gutter end on the front of the home. This portion of gutter may be leaking, sealant may need to be re-applied.

A portion of the gutter on the right side of the home is dented.

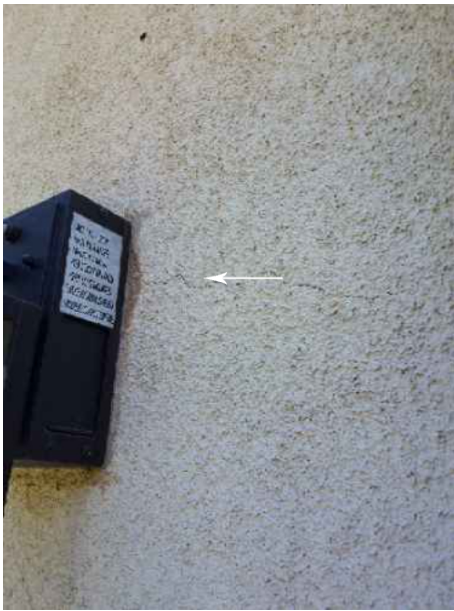
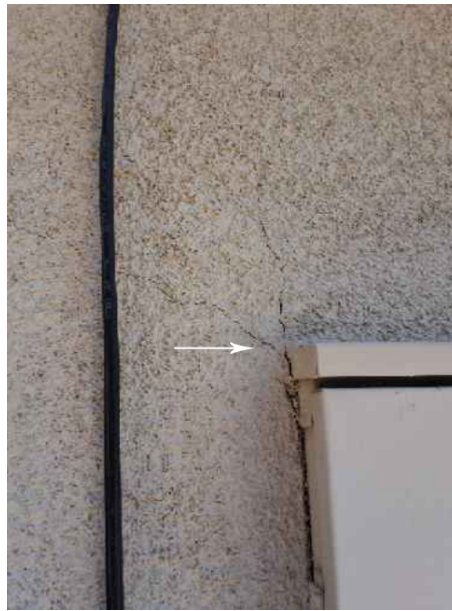
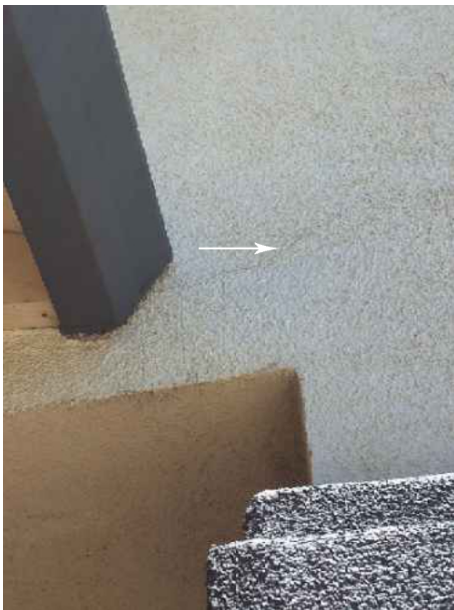
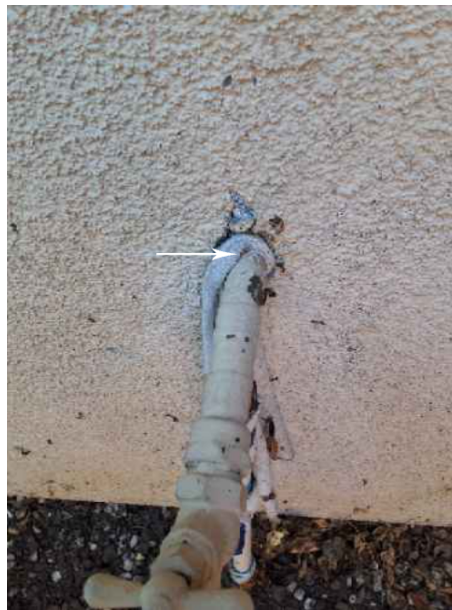
### **SIDING CONDITION** Fair

The stucco for this home appears to be in generally good condition but there are areas of common cracking that were observed and gaps where piping enters the home.

The hose bib on the right side of the home that has a rag stuffed into the gap is loose.

Portions of the exterior of this home would benefit from paint maintenance.

Recommend application of elastomeric sealant to all gaps and cracks larger than 1/16 of an inch wide to prevent water intrusion.

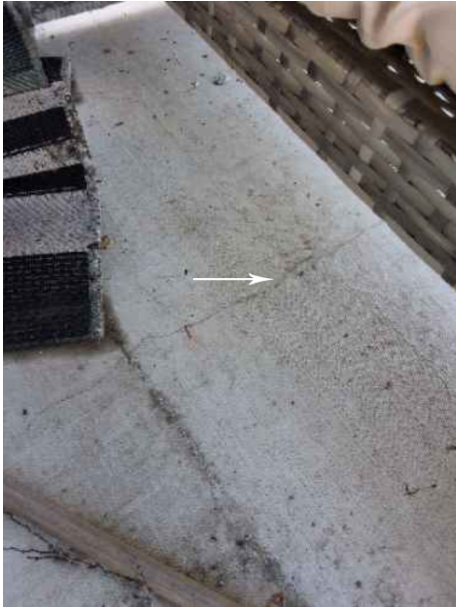
**PATIO** Fair

Common cracking of concrete was observed.

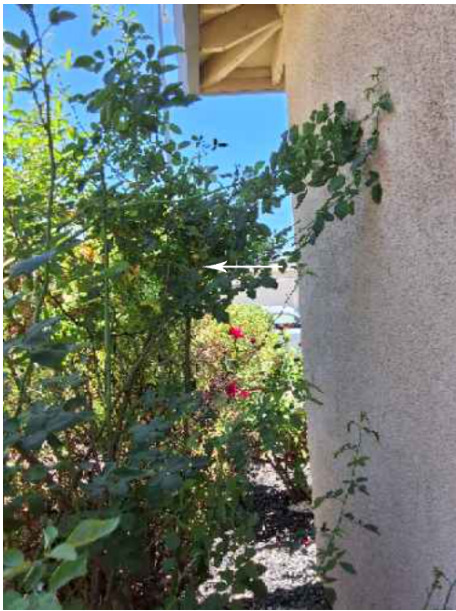
**VEGETATION** Fair

Recommend keeping vegetation cut back from home to a distance of at least one foot to prevent damage. Dead leaves and vegetation are food for wood destroying organisms.

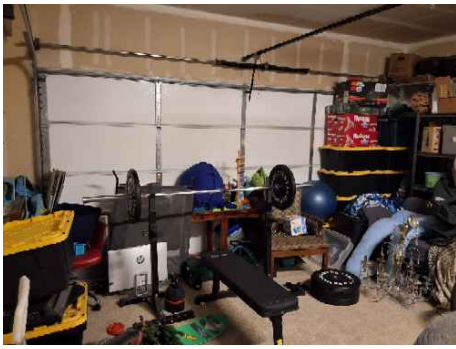
A large amount of personal belongings were stacked against the garage door, the opener was not tested.

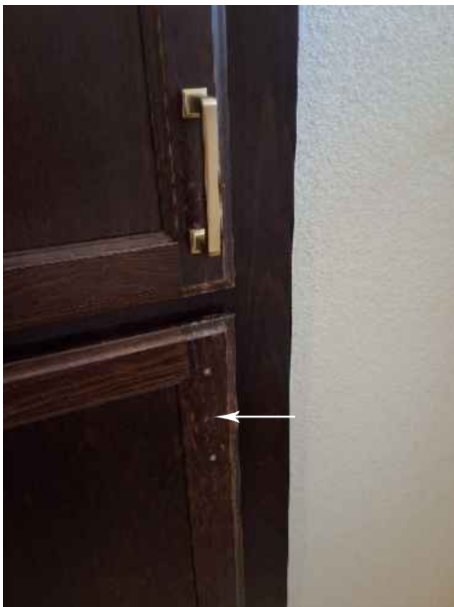
One of the caninet door handles is missing.

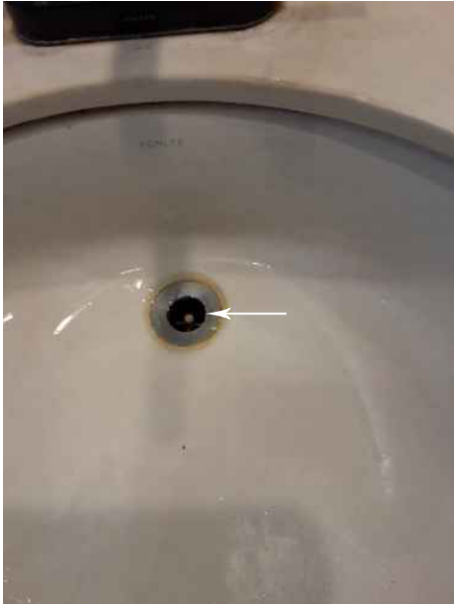
**SINKS** Fair

A portion of the drain stop is missing.

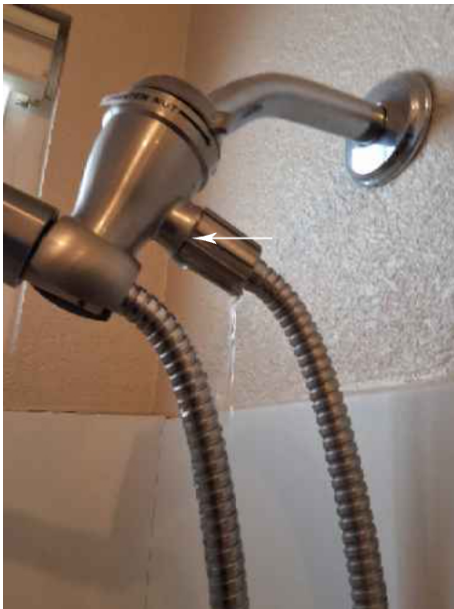
**BATHTUB / SHOWER** Fair

The shower head leaks and the tub drains slowly.

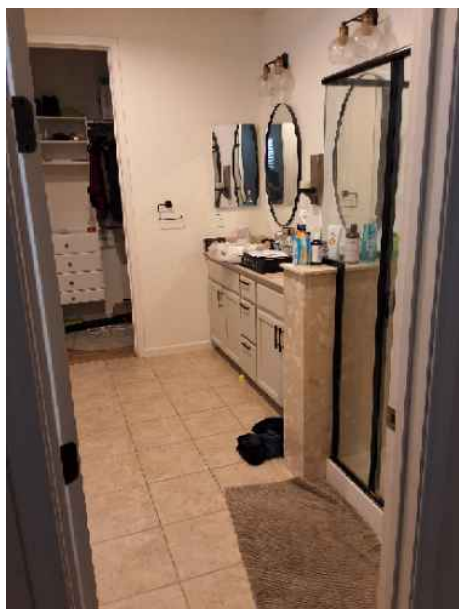
A door stop has not been installed for this door, recommend ensuring door stops are installed and functioning on all interior doors.

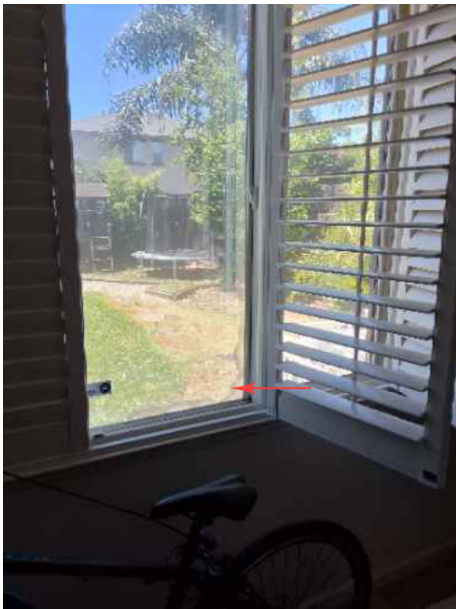
**WINDOWS** Fair

Condensation stains were observed in between the panes of glass in one of the windows overlooking the back yard, this indicates failed seals.

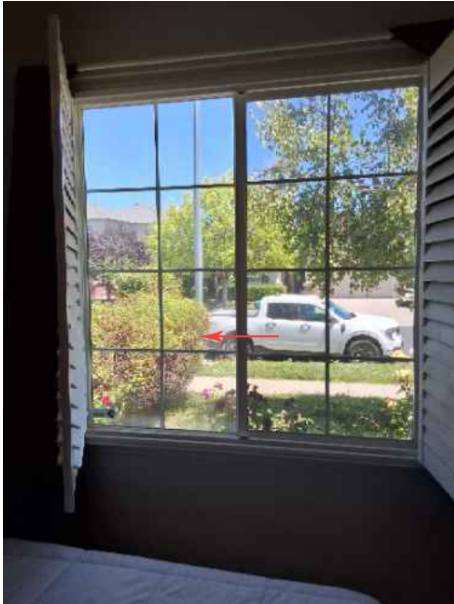
**WINDOWS** Fair

Condensation stains were observed in between the panes of glass, this indicates failed seals.

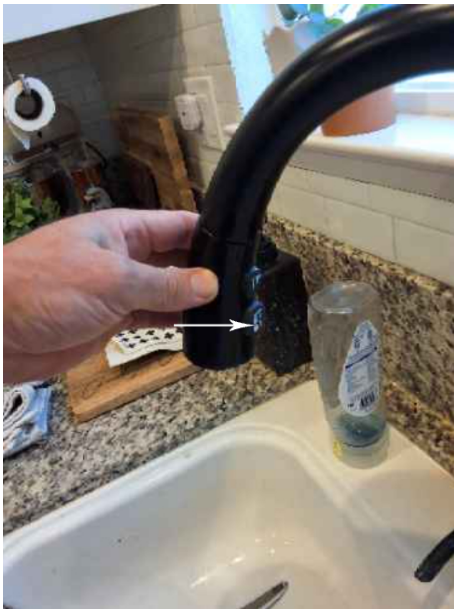
**SINK / GARBAGE DISPOSAL** Fair

The button on the faucet that switches from spray to full gets stuck.

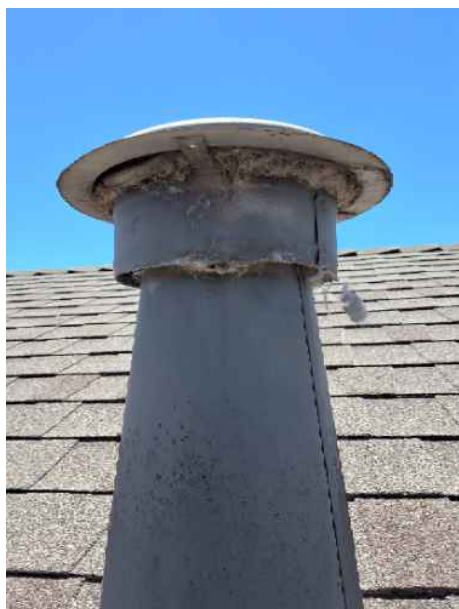
**VENTILATION** Fair

A Type B gas vent hood cover has been installed instead of a dryer vent hood cover. The hood cover that has been installed is not equipped with a backdraft damper and has a small opening that will collect lint.

This hood cover is currently obstructed by lint.

Recommend installation of a hood cover with a backdraft damper that is designed to be used with a dryer vent in a roof application. If this hood cover becomes obstructed by lint it is a fire hazard.

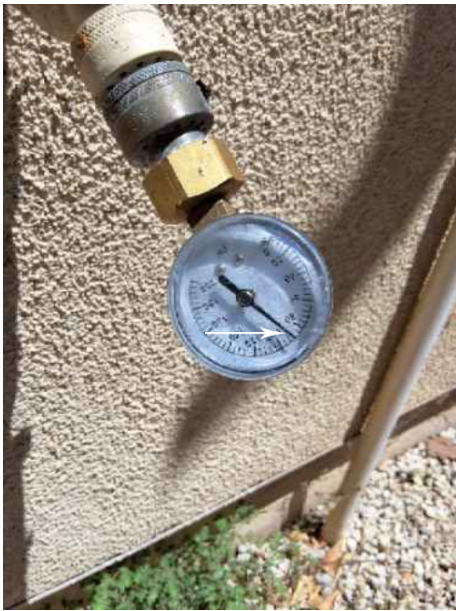
**WATER SUPPLY PRESSURE** Fair

The water supply pressure read roughly 90 PSI at the time of inspection. This is higher than the recommended range of 40-70 PSI for a home. Recommend installation of pressure regulator and reducing the pressure to 60 PSI.

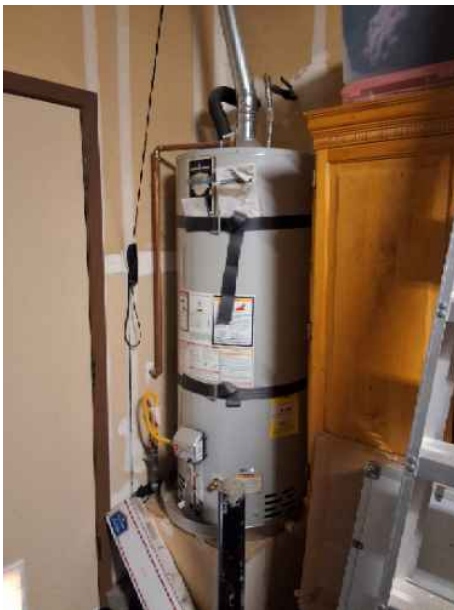
The gas water heater is a 50 gallon unit and was manufactured in 2014, the expected life span of a storage tank water heater is 10-15 years. This system is nearing the end of its expected life span but still functioning.

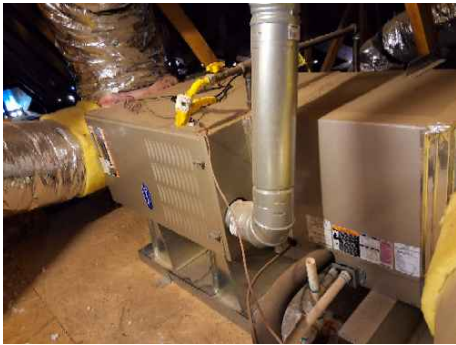
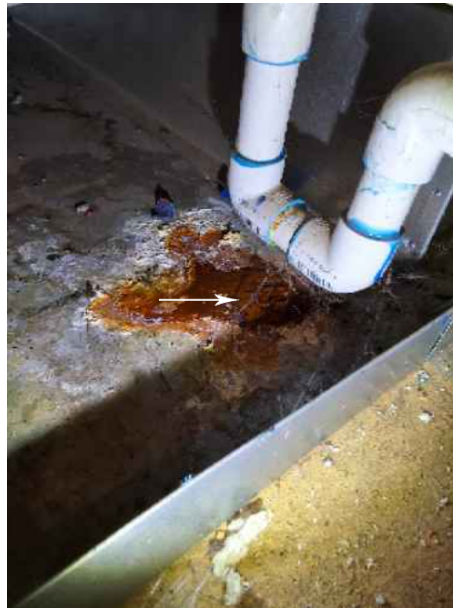
The forced air furnace is a 66,000 BTU system, is sufficient for the square footage of the home and was manufactured in 2014. The expected life span of a heating system is 20-25 years.

A small leak was observed at a fitting for the condensate drain, recommend further evaluation by licensed HVAC contractor.

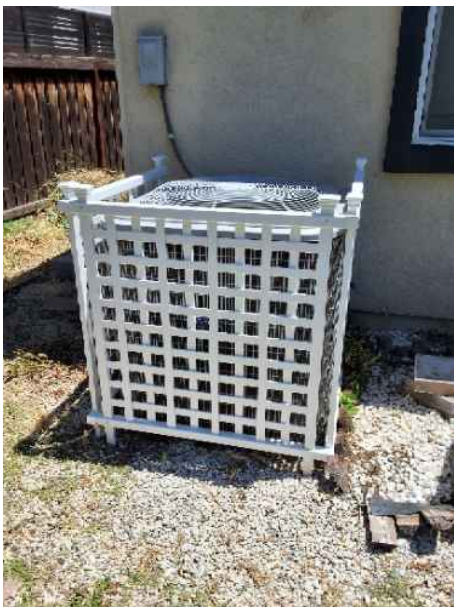
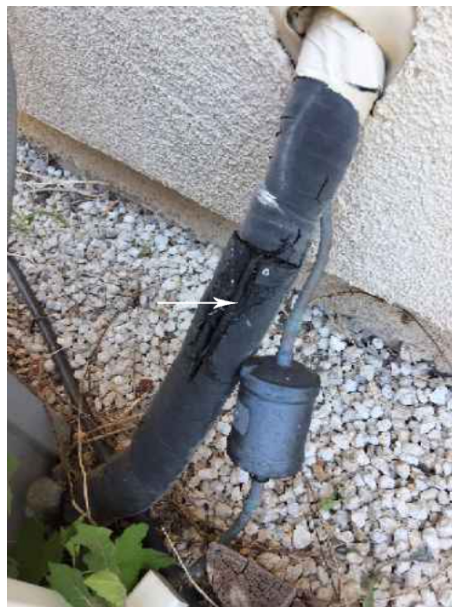
The cooling system is a 3.5 ton system, is sufficient for the square footage of the home and was manufactured in 2014. The expected life span of a cooling system is 10-15 years, this system is nearing the end of its expected life span but still functioning.

Gaps were observed in the insulation wrap for the suction line at the condenser unit, recommend closing the gaps in the insulation wrap.

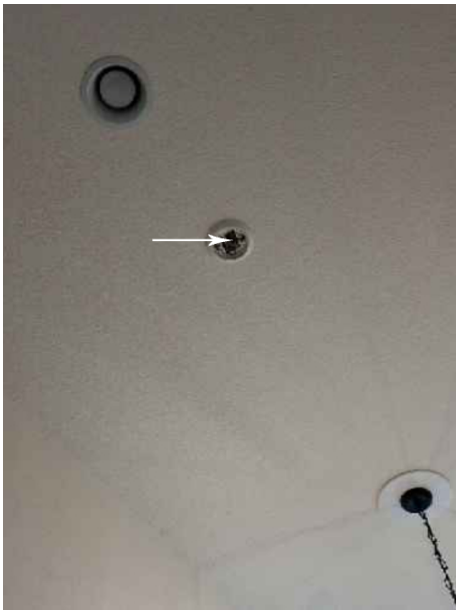
**CARBON MONOXIDE ALARM(S)** N/A

A CO alarm was not observed in this home. It may have been removed from the entryway hallway, recommend installation of combination smoke/CO alarm in the entryway hallway.
