**Service:** Full Home Inspection

**Prepared for:** Austin & Jenie Vang

Site Address: **4200 Canyon Crest Road West, San Ramon, CA, 94582**

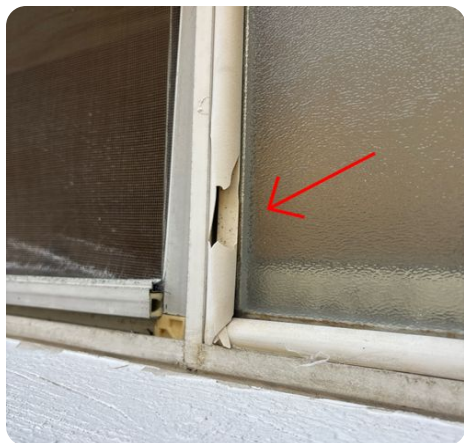
Damaged vinyl cladding was observed at the exterior window frames at the time of the inspection and it is recommended that the damage cladding be further evaluated and replaced by a qualified professional.

Damaged exterior window frame cladding at bathroom exterior.

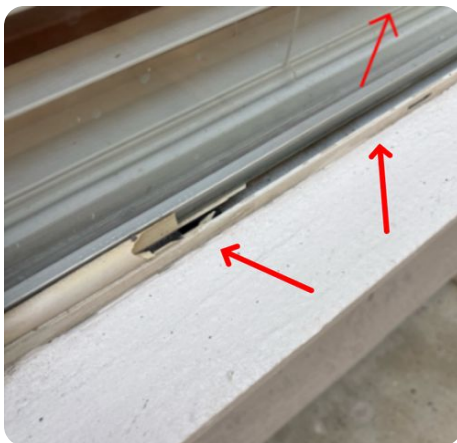
Damaged exterior cladding at bedroom window

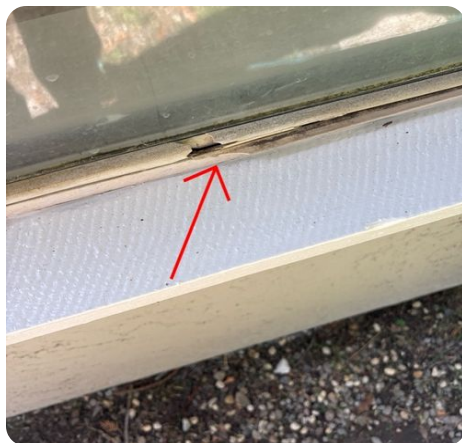
Damaged vinyl cladding at kitchen window exterior.

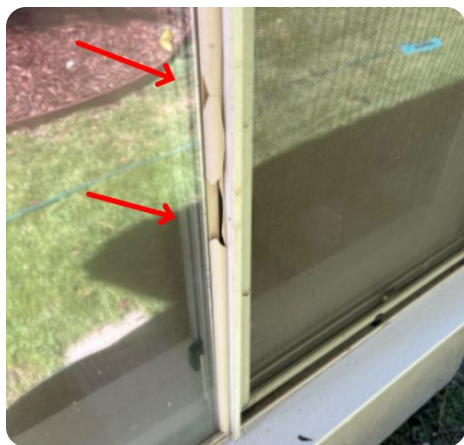
Damaged vinyl cladding at kitchen window exterior.

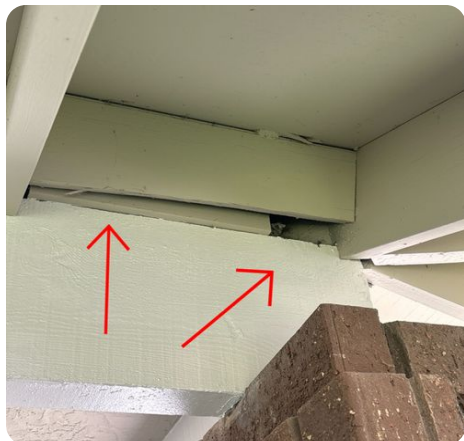
Open soffit blocking was observed at the main entry porch cover, and it is recommended that the opening be patched and sealed to prevent birds and other pests from nesting.

Open soffit blocking at main entry porch cover.

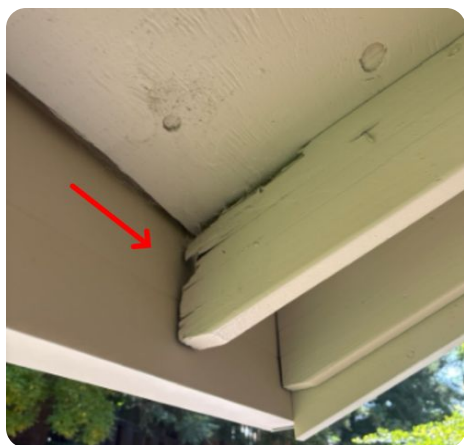
Moisture related wood damage was observed at the rafter tail and eave sheathing and it is recommended that the structural pest control report be consulted for additional information regarding this observation, as well as any recommendations for further evaluation, treatment, repair, or replacement.

Moisture related damage at rafter tail.

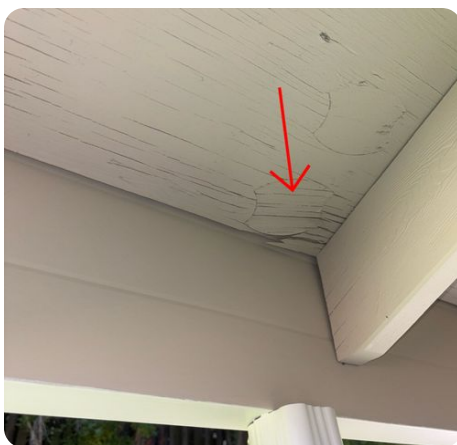
Moisture related damage at eave sheathing at kitchen exterior.

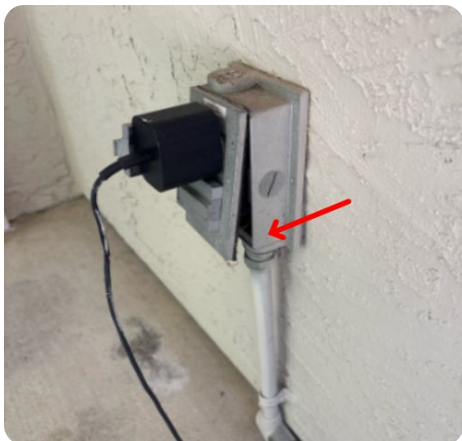
An electrical outlet displayed movement when tested which may place unnecessary stress on wire connections. The outlet in question has been marked with a colored dot for identification purposes and it is recommended that the outlet be secured by an electrician or other qualified professional.

Loosely installed electrical outlet at rear patio.

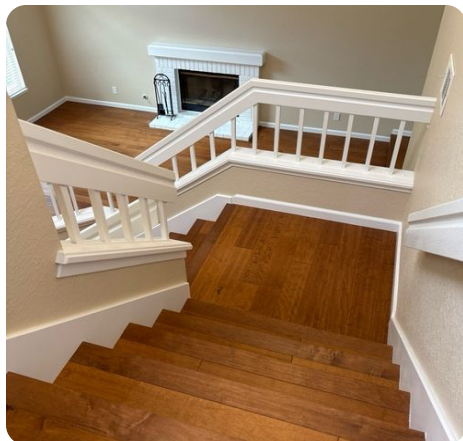
The stairwell railing segments are installed upon a pony wall which may allow a child to climb and potentially fall and should be a point of awareness. The observation is informational in nature and only intended to heighten the awareness of the homebuyer.

Stairwell railing installed on pony wall.

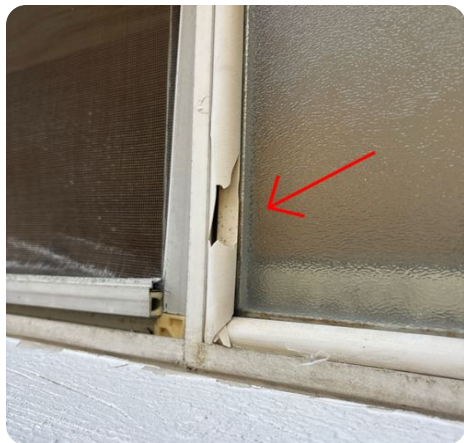
Damaged vinyl cladding was observed at the exterior window frames at the time of the inspection and it is recommended that the damage cladding be further evaluated and replaced by a qualified professional.

Damaged exterior window frame cladding at bathroom exterior.

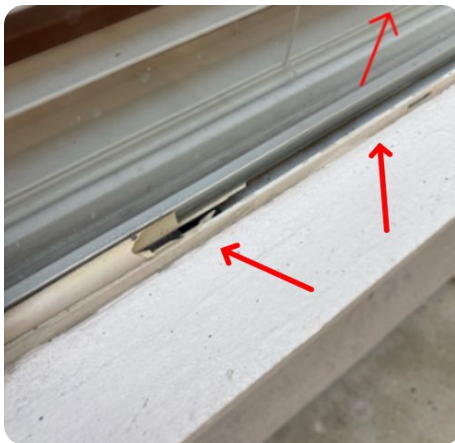
Damaged exterior cladding at bedroom window

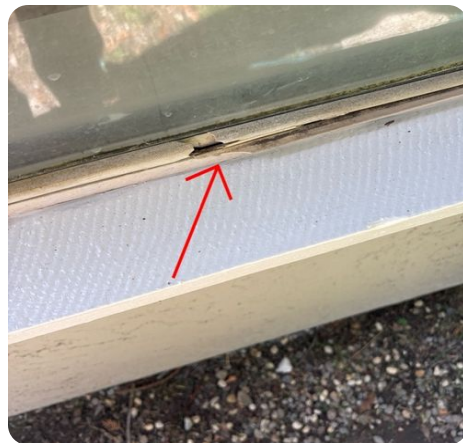
Damaged vinyl cladding at kitchen window exterior.

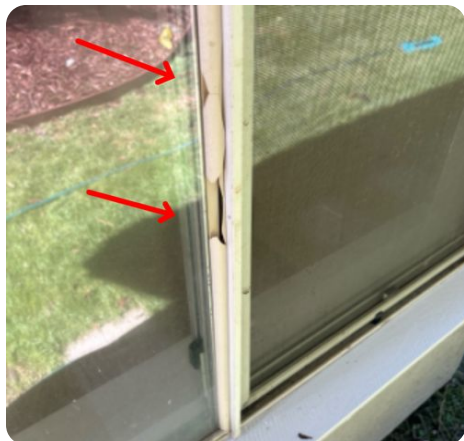
Damaged vinyl cladding at kitchen window exterior.

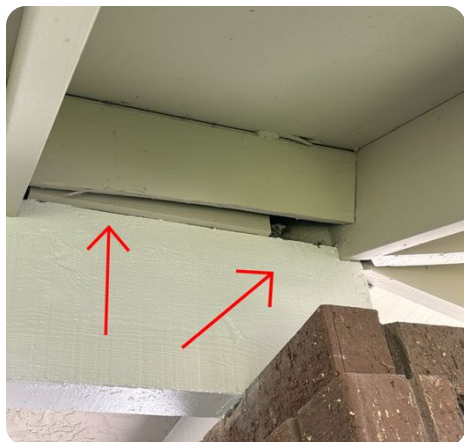
Open soffit blocking was observed at the main entry porch cover, and it is recommended that the opening be patched and sealed to prevent birds and other pests from nesting.

Open soffit blocking at main entry porch cover.

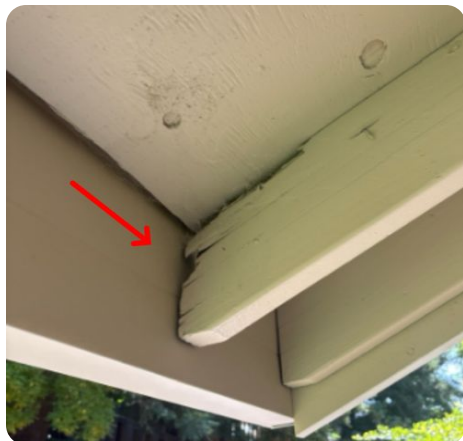
Moisture related wood damage was observed at the rafter tail and eave sheathing and it is recommended that the structural pest control report be consulted for additional information regarding this observation, as well as any recommendations for further evaluation, treatment, repair, or replacement.

Moisture related damage at rafter tail.

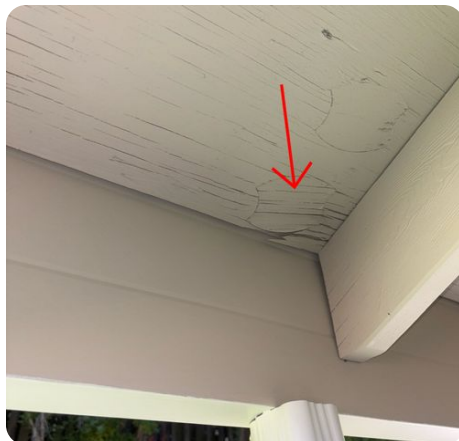
Moisture related damage at eave sheathing at kitchen exterior.

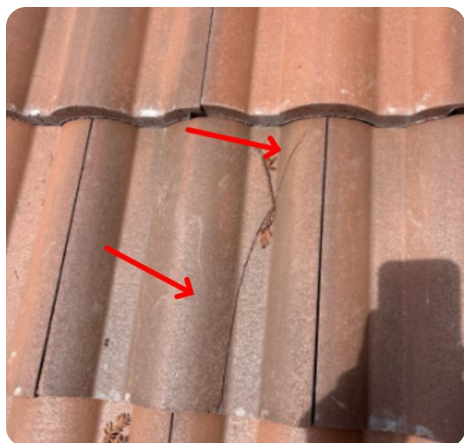
The roof surface is composed of a cement tile application which contained multiple cracked tiles and it is recommended that the installation be further evaluated and repaired by a roof professional. The installation contains a life expectancy of approximately 50 years and periodic evaluation and maintenance of the roof surface and all related installations is recommended to maintain weathertight integrity, as well as to maximize the service life of the materials utilized. The most common issues related to a cement tile application are cracked or slipped/displaced tiles. Due to the concealed nature of the installation, the inspector cannot guarantee that all facets of the manufactures installation guidelines have been followed by the contractor responsible for installation.

Cracked tile at upper roof surface.

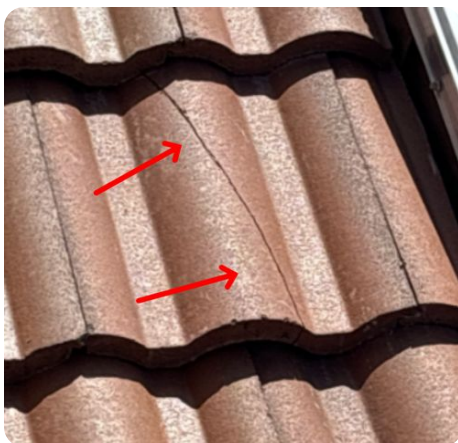
Cracked tile at upper roof surface.

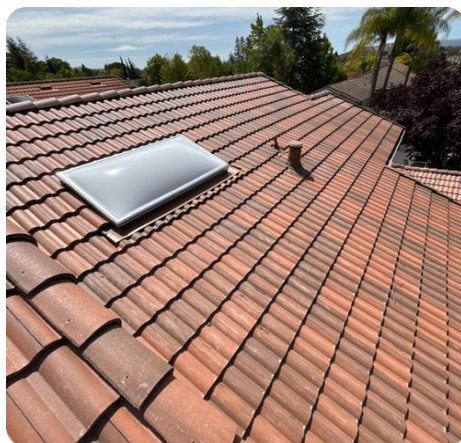
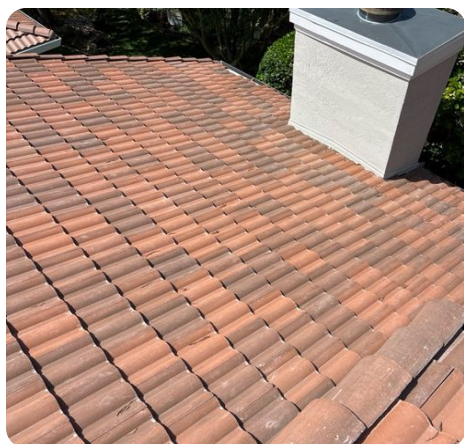
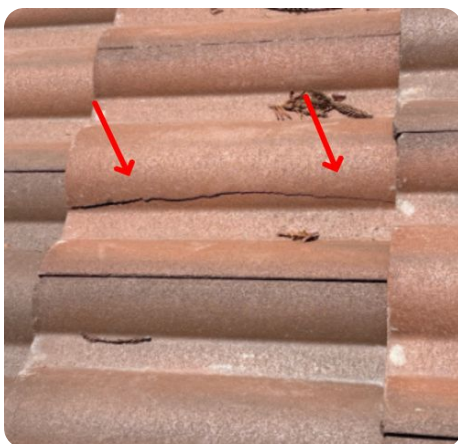
Cracked tile at upper roof surface.

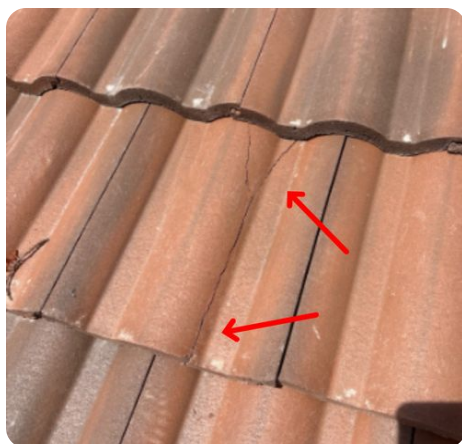
Cracked tile at upper roof surface.

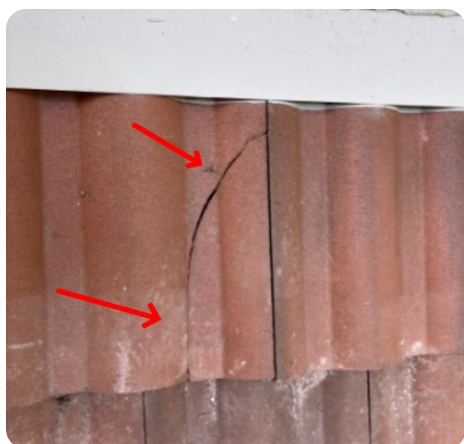
Cracked tile at lower roof surface.

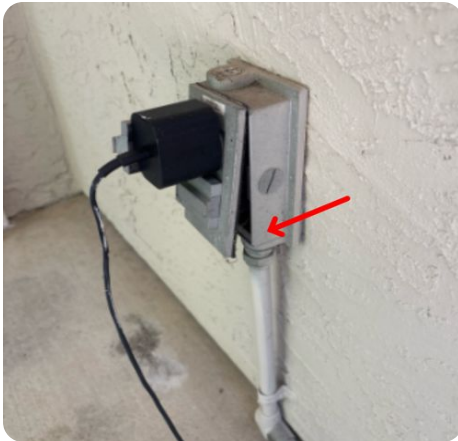
An electrical outlet displayed movement when tested which may place unnecessary stress on wire connections. The outlet in question has been marked with a colored dot for identification purposes and it is recommended that the outlet be secured by an electrician or other qualified professional.

Loosely installed electrical outlet at rear patio.

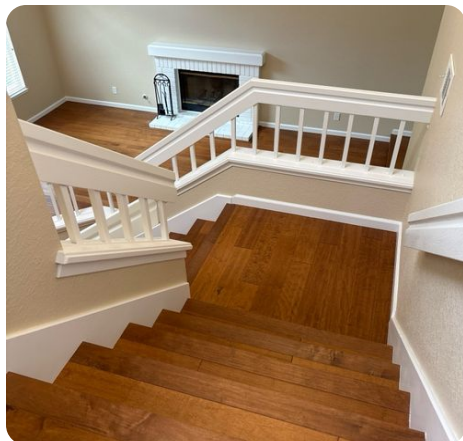
The stairwell railing segments are installed upon a pony wall which may allow a child to climb and potentially fall and should be a point of awareness. The observation is informational in nature and only intended to heighten the awareness of the homebuyer.

Stairwell railing installed on pony wall.

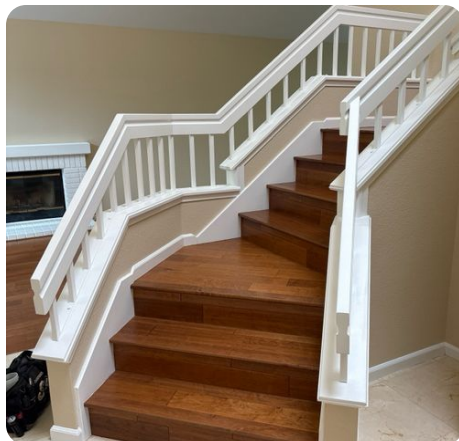
Stairwell railing installed on pony wall.
