# WOOD DESTROYING PESTS AND ORGANISMS INSPECTION REPORT

| Building No.<br>1038 | Street<br>W. 5th St | City<br>Chico | ZIP<br>95926 | Date of Inspection<br>07/20/2026 | Number of Pages<br>7 |
| GENERAL DESCRIPTION:<br>Single family residence; vacant | | | | Inspection Tag Posted:<br>Subarea<br><br>Other Tags Posted:<br>None noted | |

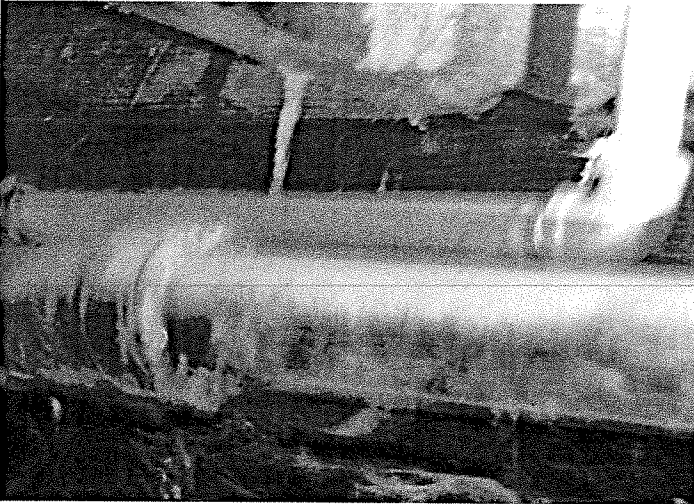
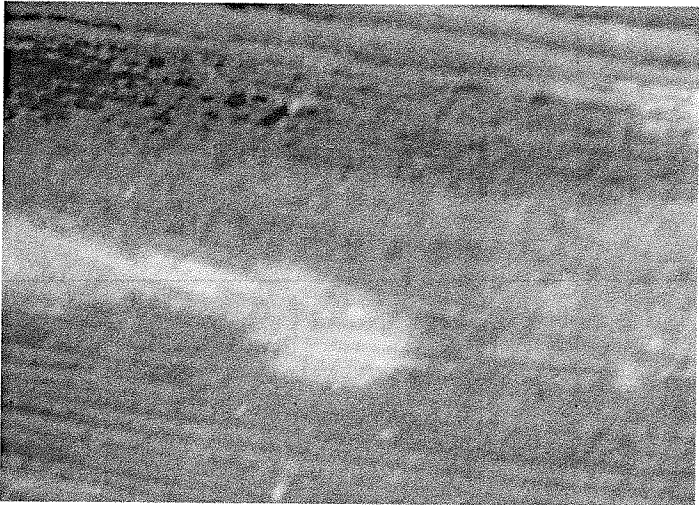
**FINDING:** Evidence of subterranean termites were noted at the subfloor wood members.

**RECOMMENDATION:** Remove accessible termite shelter tubes. Chemically treat the soil at all probable entry points with an approved termiticide in the entire structure for the control of subterranean termites. This may included drilling the concrete slab along the perimeter of the garage walls, drilling the concrete patios and/or walkways abutting the foundation.

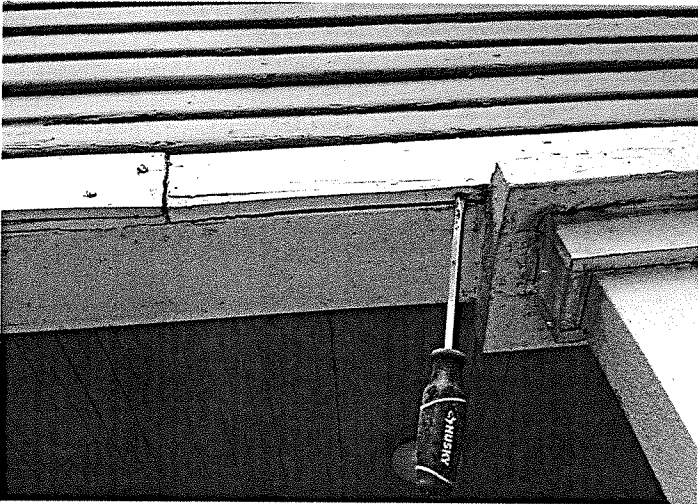
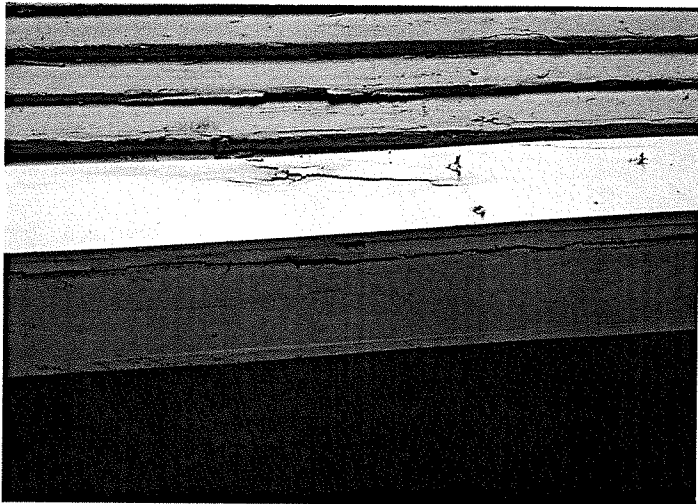
**FINDING:** Fungus infection/damage noted at the front porch cover header and trim. Damage may extend into inaccessible areas.

**RECOMMENDATION:** Remove the fungus damaged portions of the header and trim. Call for a reinspection of the inaccessible areas. The inaccessible areas will be inspected for a fee if made accessible by the interested parties at his/her expense. A supplemental report will be filed at such time. No opinion is rendered concerning the conditions in the area at this time. Replace with new material. Scrape and/or power wash fungus infected wood members and treat with a registered fungicide.

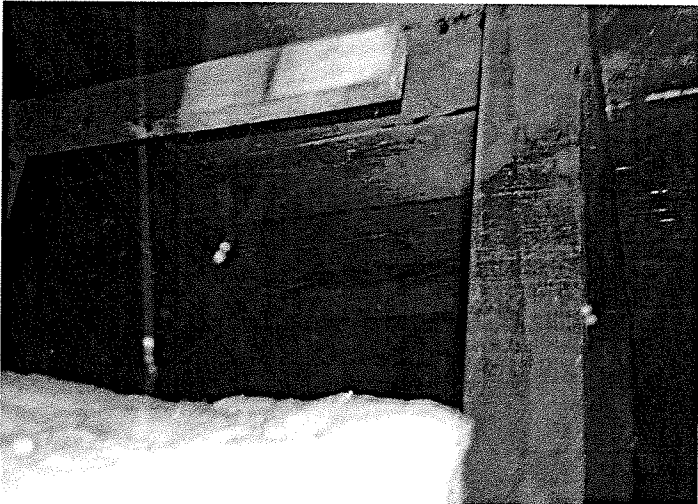
7A

**FINDING:** Stains were noted at the attic wood members as viewed from the access opening. Unable to determine if stains are active or passive.

**RECOMMENDATION:** Interested parties should engage the services of a licensed contractor to check for leaks and to perform any corrective work needed.

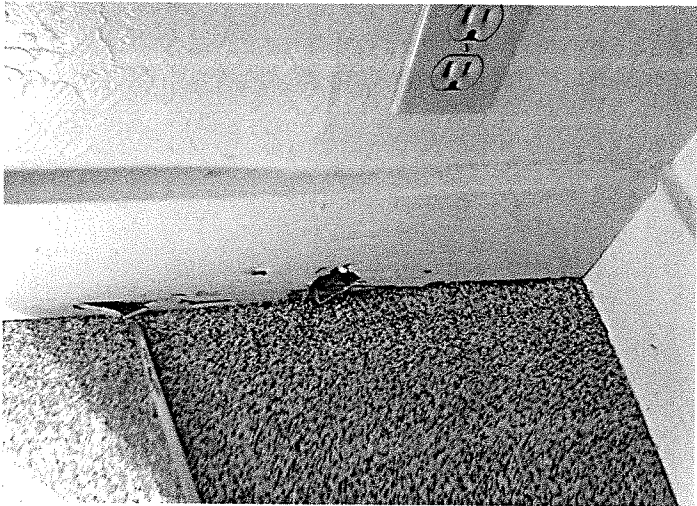
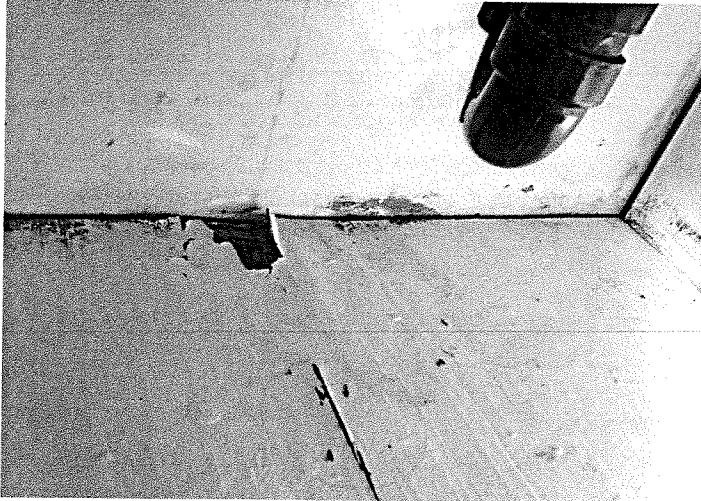
**FINDING:** Evidence of subterranean termites were noted at the bedroom baseboards and walls and at the bathroom sink cabinet.

**RECOMMENDATION:** Remove accessible termite shelter tubes. Chemically treat the soil at all probable entry points with an approved termiticide in the entire structure for the control of subterranean termites. This may included drilling the concrete slab along the perimeter of the garage walls, drilling the concrete patios and/or walkways abutting the foundation.

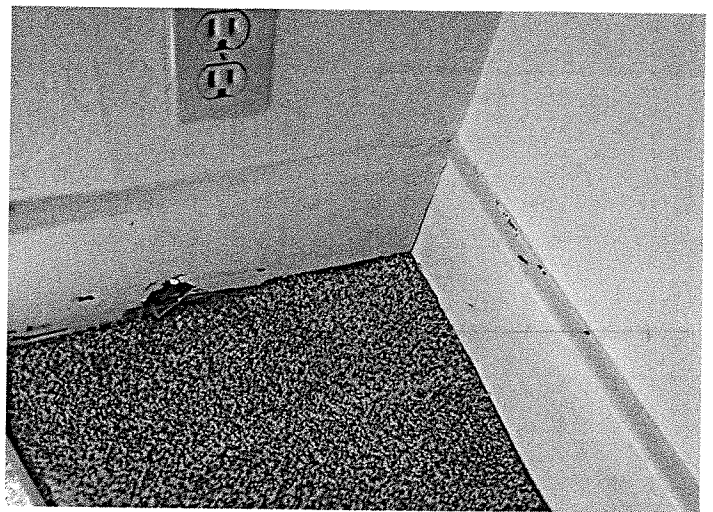
10B

**FINDING:** Subterranean termite damage noted at the bedroom walls and baseboards. Damage may extend into inaccessible areas.

**RECOMMENDATION -** Remove the subterranean termite damaged portions of the walls and baseboards. Call for a reinspection of the inaccessible areas. The inaccessible areas will be inspected for a fee if made accessible by the interested parties at his/her expense. A supplemental report will be filed at such time. No opinion is rendered concerning the conditions in the area at this time. Replace with new material.

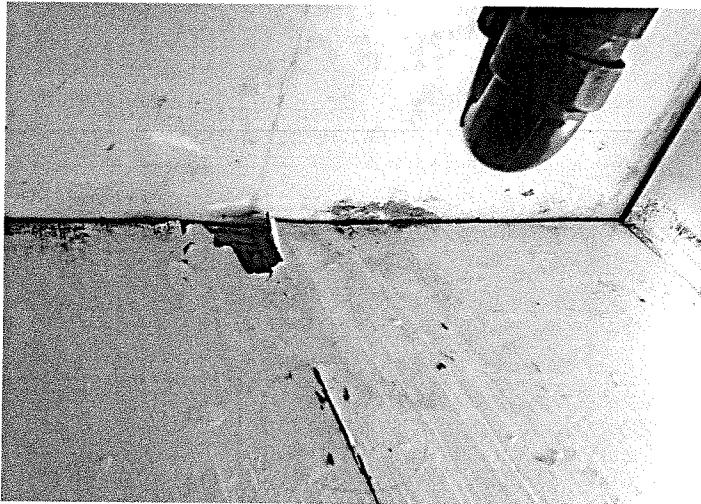
10C

**FINDING:** Stains and subterranean termite damage noted at the bathroom sink cabinet. Damage may extend into inaccessible areas.

**RECOMMENDATION:** Interested parties should engage the services of a licensed plumber to check for leaks and to perform any corrective work needed. Remove the subterranean termite damaged portions of the bathroom sink cabinet. Call for a reinspection of the inaccessible areas. The inaccessible areas will be inspected for a fee if made accessible by the interested parties at his/her expense. A supplemental report will be filed at such time. No opinion is rendered concerning the conditions in the area at this time. Replace with new material.

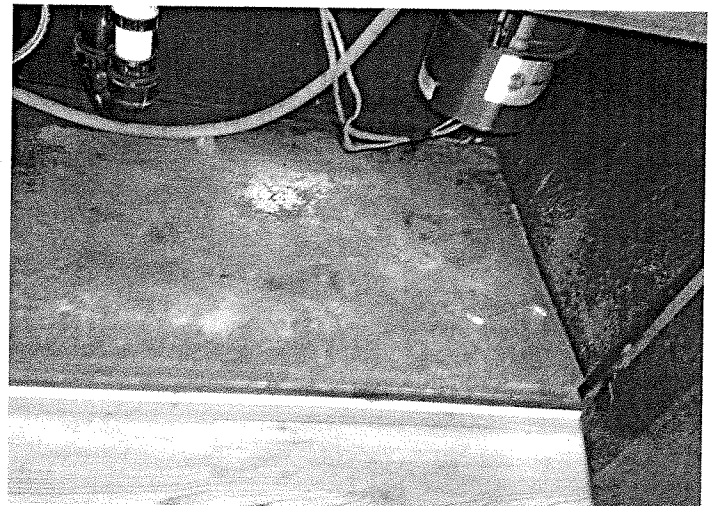
10D

**FINDING:** Stains and moisture damage noted at the kitchen sink cabinet. Damage may extend into inaccessible areas.

**RECOMMENDATION:** Interested parties should engage the services of a licensed plumber to check for leaks and to perform any corrective work needed. Remove the moisture damaged portions of the kitchen sink cabinet. Call for a reinspection of the inaccessible areas. The inaccessible areas will be inspected for a fee if made accessible by the interested parties at his/her expense. A supplemental report will be filed at such time. No opinion is rendered concerning the conditions in the area at this time. Replace with new material.

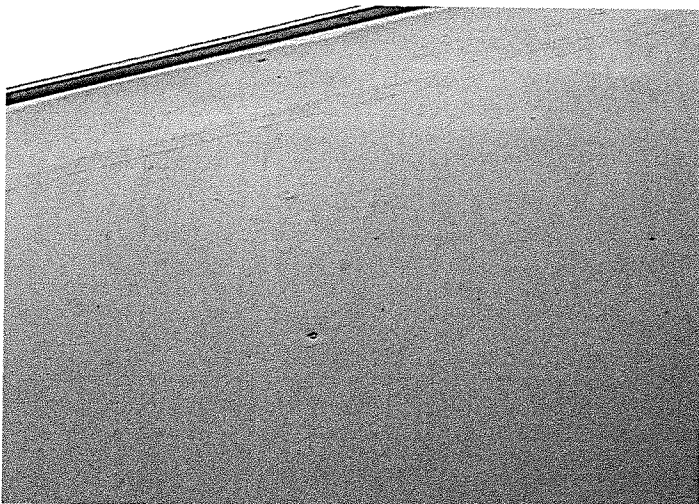
10E

FINDING: Stains were noted at the kitchen ceiling skylight. Unable to determine if stains are active or passive.

RECOMMENDATION: Interested parties should engage the services of a licensed contractor to check for leaks and to perform any corrective work needed.

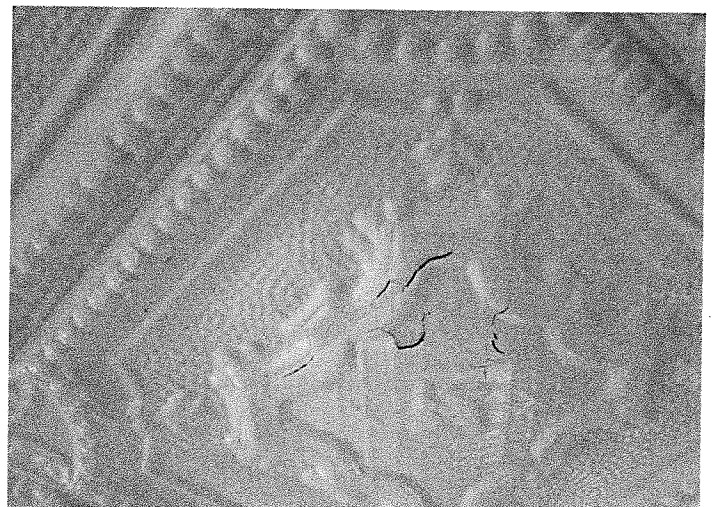
10G

FINDING: Moisture damage noted at the living room ceiling panels Damage may extend into inaccessible areas.

RECOMMENDATION: Remove the moisture damaged portions of the ceiling panels. Call for a reinspection of the inaccessible areas. The inaccessible areas will be inspected for a fee if made accessible by the interested parties at his/her expense. A supplemental report will be filed at such time. No opinion is rendered concerning the conditions in the area at this time. Replace with new material.

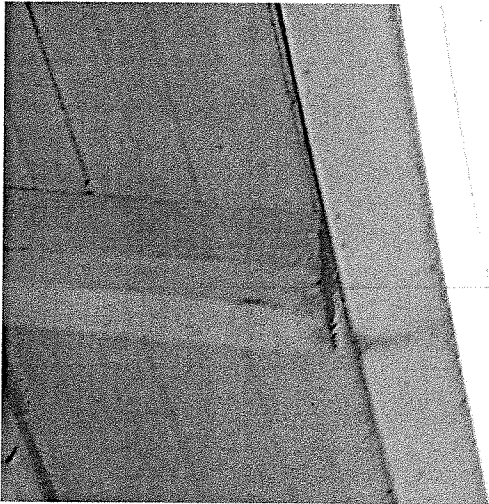
11A

FINDING: Stains and fungus damage noted at the rafter tail.

RECOMMENDATION: Interested parties should engage the services of a licensed contractor to check for leaks and to perform any corrective work needed. Remove the fungus damaged portions of the rafter tail and replace with new material.

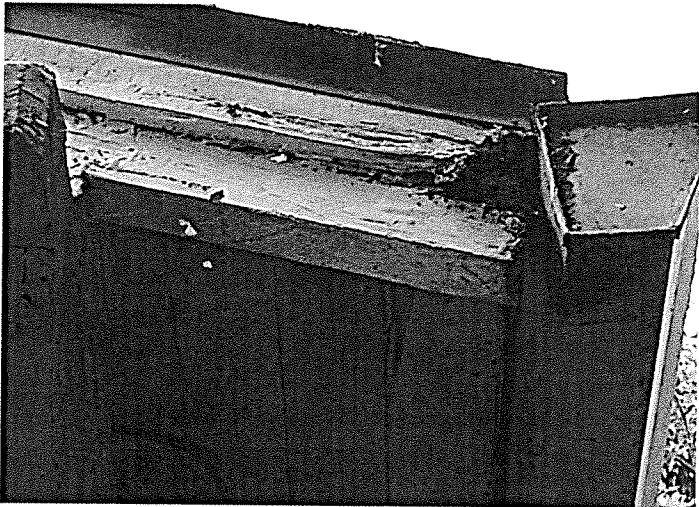
11B

FINDING: Stains and fungus damage noted at the barge rafters and trim at the eaves. Damage may extend into inaccessible areas.

RECOMMENDATION: Interested parties should engage the services of a licensed contractor to check for leaks and to perform any corrective work needed. Remove the fungus damaged portions of the barge rafters and trim. Call for a reinspection of the inaccessible areas. The inaccessible areas will be inspected for a fee if made accessible by the interested parties at his/her expense. A supplemental report will be filed at such time. No opinion is rendered concerning the conditions in the area at this time. Replace with new material.

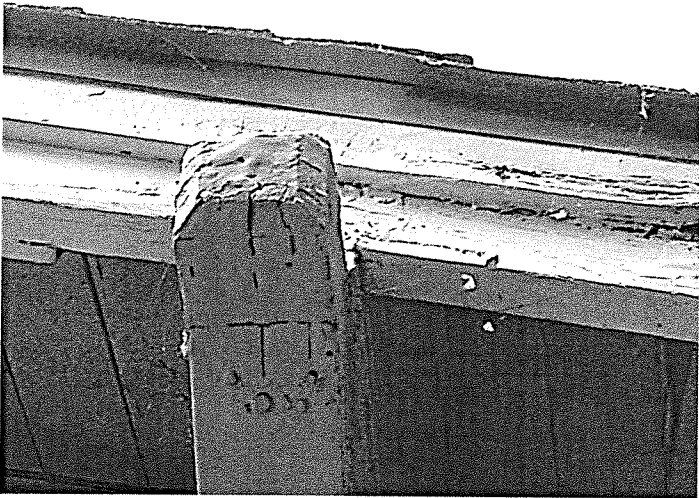
11C

FINDING: Stains and fungus damage noted at the eave support beamS. Damage may extend into inaccessible areas.

RECOMMENDATION: Interested parties should engage the services of a licensed contractor to check for leaks and to perform any corrective work needed. Remove the fungus damaged portions of the eave support beamS. Call for a reinspection of the inaccessible areas. The inaccessible areas will be inspected for a fee if made accessible by the interested parties at his/her expense. A supplemental report will be filed at such time. No opinion is rendered concerning the conditions in the area at this time. Replace with new material.

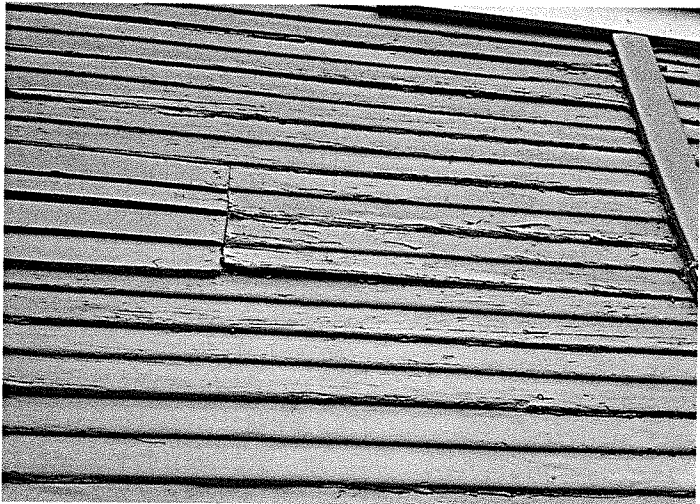
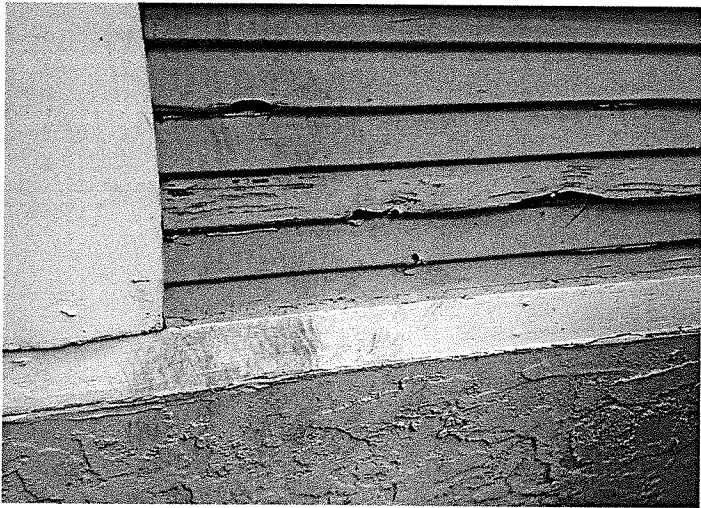
FINDING: Fungus damage noted throughout the siding. Damage may extend into inaccessible areas.

RECOMMENDATION: Remove the fungus damaged portions of the siding. Call for a reinspection of the inaccessible areas. The inaccessible areas will be inspected for a fee if made accessible by the interested parties at his/her expense. A supplemental report will be filed at such time. No opinion is rendered concerning the conditions in the area at this time. Replace with new material.

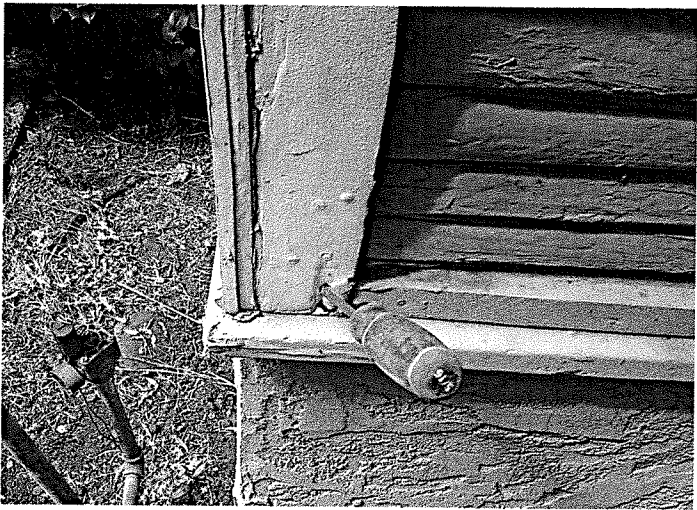
11E

FINDING: Fungus damage noted at the corner trim. Damage may extend into inaccessible areas.

RECOMMENDATION: Remove the fungus damaged portions of the corner trim. Call for a reinspection of the inaccessible areas. The inaccessible areas will be inspected for a fee if made accessible by the interested parties at his/her expense. A supplemental report will be filed at such time. No opinion is rendered concerning the conditions in the area at this time. Replace with new material.

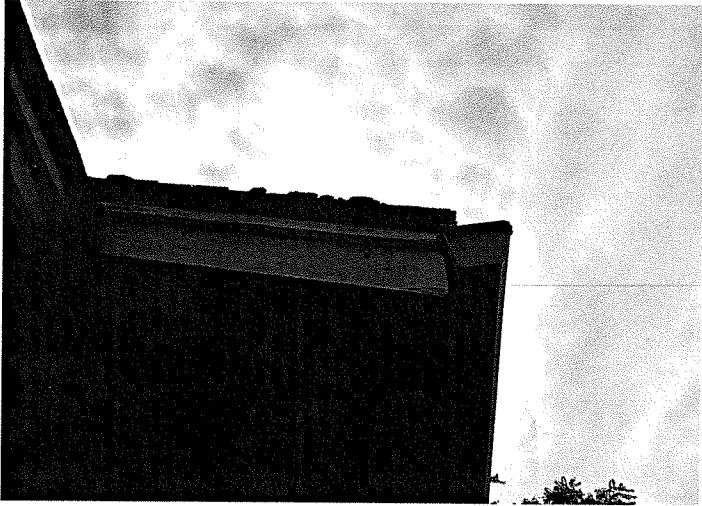
11F

FINDING: Stains and fungus damage noted at the rafter and trim.

RECOMMENDATION: Interested parties should engage the services of a licensed contractor to check for leaks and to perform any corrective work needed. Remove the fungus damaged portions of the rafter and trim and replace with new material.

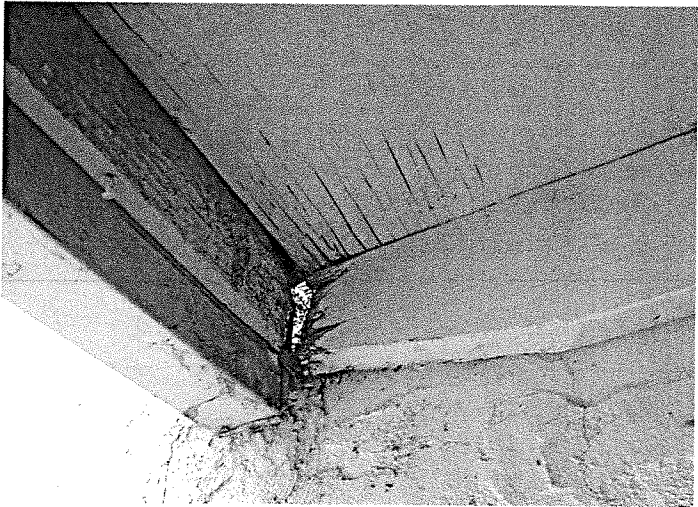
11G

FINDING: Stains and fungus damage noted at the fascia, roof sheathing and rafter tails. Damage may extend into inaccessible areas.

RECOMMENDATION: Interested parties should engage the services of a licensed contractor to check for leaks and to perform any corrective work needed. Remove the fungus damaged portions of the fascia, roof sheathing and rafter tails. Call for a reinspection of the inaccessible areas. The inaccessible areas will be inspected for a fee if made accessible by the interested parties at his/her expense. A supplemental report will be filed at such time. No opinion is rendered concerning the conditions in the area at this time. Replace with new material.

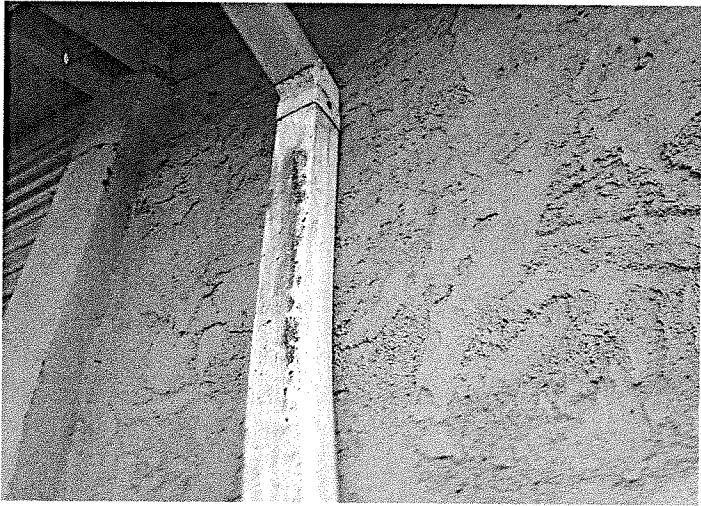
11H

FINDING: Leaking gutter downspout were noted.

RECOMMENDATION: Seal the leaking gutter downspout as needed to help prevent moisture-related problems in this area.
