# Inspection Report

**Gary & Pam Linney**  
**2424 Cumbre Court**  
**San Luis Obispo, CA 93401**

**PROPERTY / CLIENT INFORMATION**Report Date: **7/9/2026**Customer File # **21803****Gary & Pam Linney**

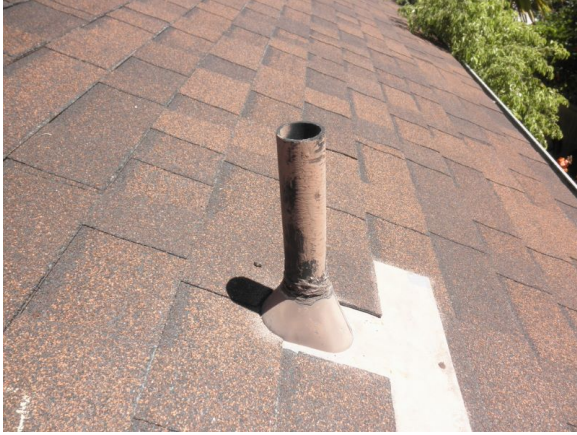
#R

**Maintenance Note:** The sealant at the roof flashings has become brittle and cracked from exposure to the sun. Recommend resealing the flashings to prevent water intrusion.

Deteriorated sealant at the vent flashings.

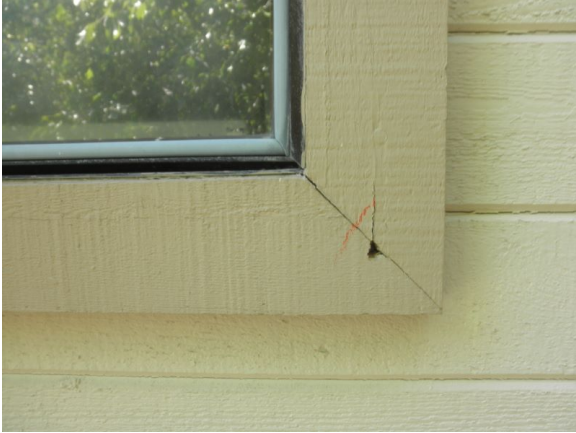
#EX

Moisture damage to the wood trim at the window in the laundry closet.

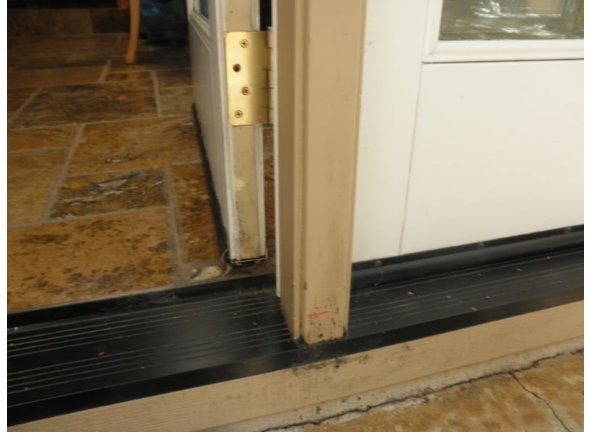
#EX

- 1.) There is some minor moisture damage at the base of the door frame in the kitchen nook.
- 2.) The screen door is torn at the exterior door in the master bedroom.
- 3.) Fogged windows were observed in the following locations: (See info note above)
  - A.) The fixed half of the window in the laundry room.
  - B.) The fixed half of the window on the south wall of the kitchen nook.
  - C.) The upper fixed window on the SW wall of the living room.
  - D.) The fixed half of the window on the north wall of the upstairs NW bedroom.
  - E.) The fixed half of the window in the dining room.
- 4.) There are two damaged window screens.
- 5.) There is moisture damage at the window trim at the laundry room closet.
- 6.) There is moisture damage to the fascia board at the SW corner of the roof.

Moisture damage to the base of the door frame in the kitchen nook.

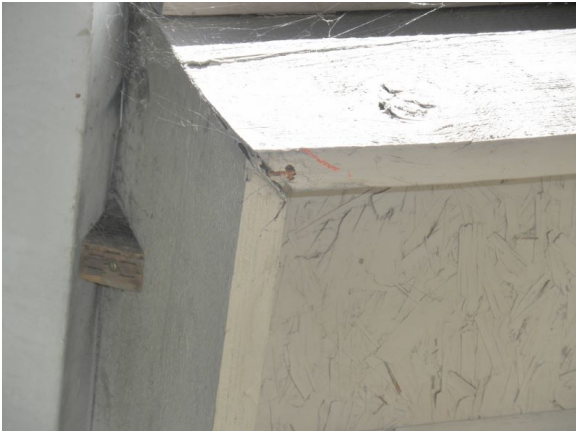
#EX

Moisture damage at the fascia board.

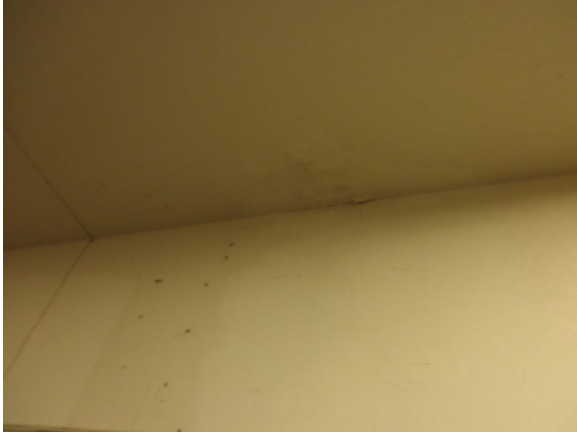
#GD

1.) There is evidence of a possible leak at the water proof balcony with a water stain on the ceiling in the garage below the deck. Also, the deck surface drain appears to be clogged.

Evidence of a possible leak at the water proof deck as seen from inside the garage.

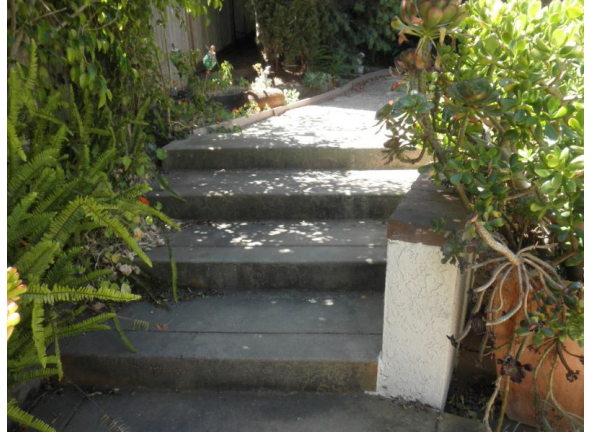
#GD

**Safety Hazard Note:** There is no railing at the concrete stairs at the upper part of the backyard. This is required when there is four or more continuous risers. This can be a falling hazard.

Missing railing at the concrete stairs in the backyard.

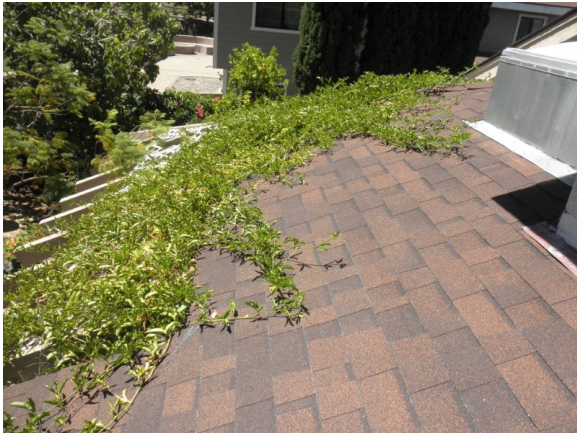
#GD

The foliage needs to be cut back off the roof.

Maintenance Note: Trim the tree limbs and/or foliage to avoid contact with the home and prevent damage to the property.

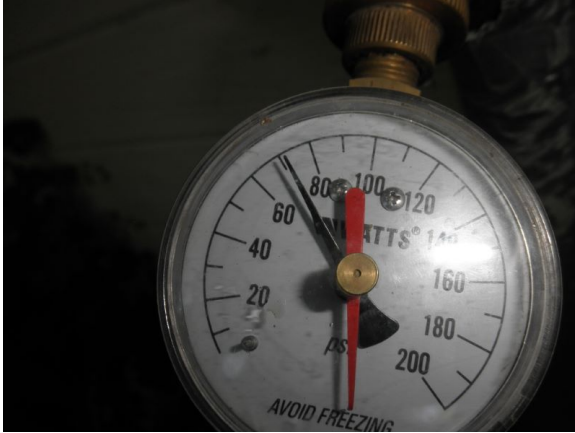
#P

**Information Note:** The water pressure was measured at 70 psi at the time of inspection. This is within a normal and acceptable range.

The water pressure was measured at 70 psi at the time of inspection.

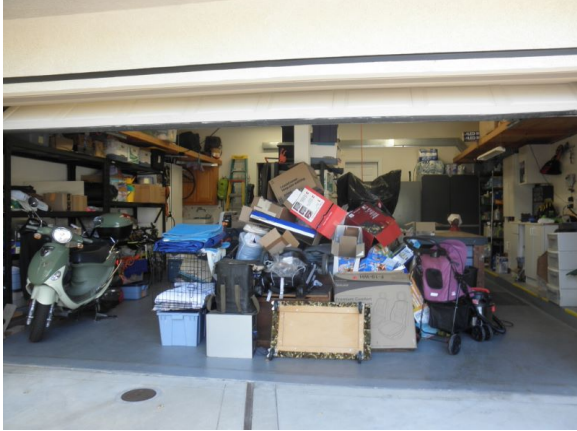
#GC

The garage was 75% blocked by storage at the time of inspection.

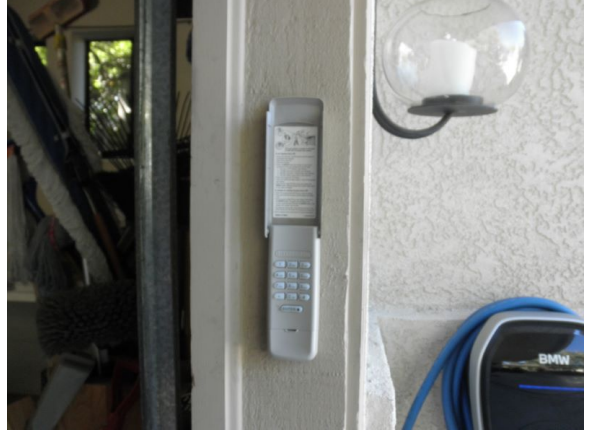
#GC

Remote combination pad for the garage door opener.
