# WOOD DESTROYING PESTS AND ORGANISMS INSPECTION REPORT

| Building No.<br>3070 | Street<br>Royal Meadow Lane | City<br>Paradise | ZIP<br>95969 | Date of Inspection<br>05/28/2025 | Number of Pages<br>4 |

## HOUSE DETECTIVE TERMITE CONTROL INC

Report #: 16181

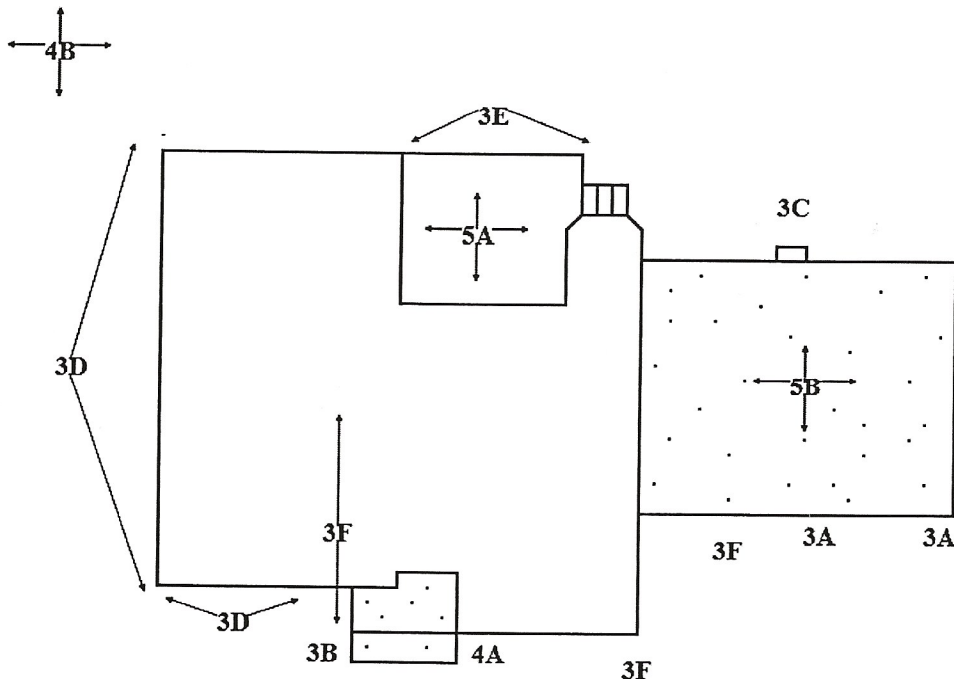
### Diagram Not To Scale

**FINDING:** Fungus damage was found to the front garage door jambs.

**FINDING:** Fungus damage was found to the 6x6 post on the front porch overhang.

**FINDING:** Fungus damage was found to the rear garage door.

**FINDING:** Fungus damage was found to areas of siding, trim and window trim along the front and left side of the structure. The damage along the left side extends up to the roof line with possible hidden damage to enclosed framing.

**FINDING:** Fungus damage was found to the the decking and deck fascia with possible hidden damage.

**FINDING:** Fungus damage was found to roof eave members.

**FINDING:** Earth wood contacts were noted to lower siding.
