SUBJECT: BALCONY INSPECTION

ADDRESS: 4301 FULTON AVENUE

SHERMAN OAKS, CA 91423

DATE: JUNE 9, 2023

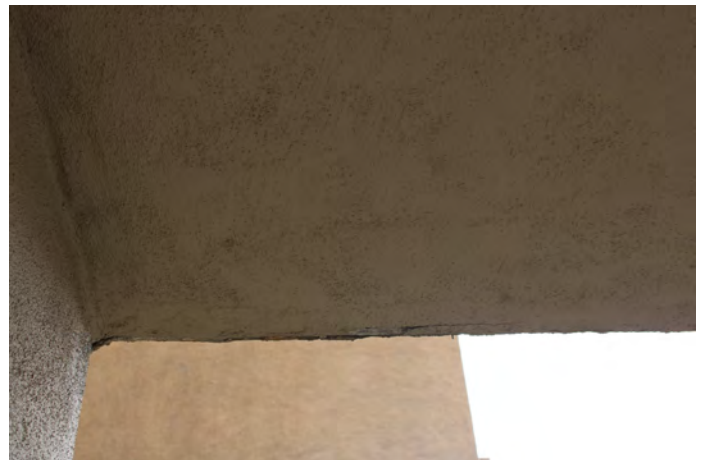
LIVING ROOM BALCONY- THE BEST ONE I HAVE SEEN TO THIS POINT. MASTER BEDROOM BALCONY- THERE ARE SOME STUCCO CRACKS IN THE CEILING, SOME AT THE EDGE OF THE BALCONY ABOVE. THEY ARE CAUSED BY WATER EXITING THE STRUCTURE. EXPECT THIS DAMAGE TO GET WORSE WITH TIME- KEEP AN EYE ON IT.

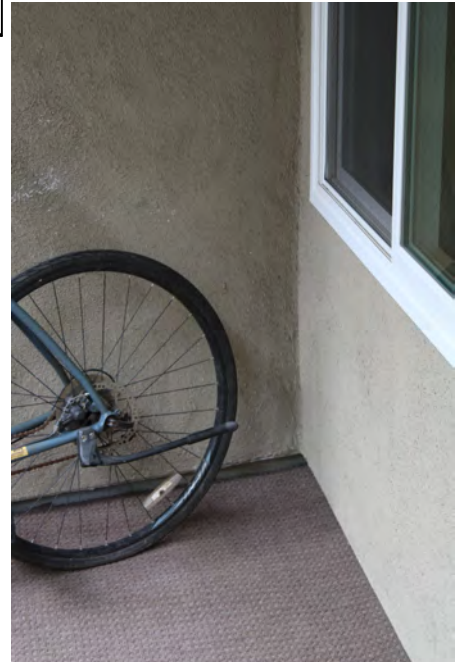
THIS IS ONE OF THE FEW BALCONIES WHERE THERE ARE A LOT OF FLIES IN THE AIR. THE FLOOR IS COVERED WITH A CARPET. CARPETS HOLD ON TO MOISTURE WHEN IT RAINS, AND DO NOT ALLOW FOR THE BALCONY TO DRAIN/ DRY PROPERLY. THIS IS A FIRST FLOOR BALCONY, AND IN A GENERALLY GREAT SHAPE.

CARPETS DO NOT ALLOW THE BALCONIES DRY/ DRAIN PROPERLY. THE FLOOR FINISH SHOULD BE SMOOTH AND OF A WATER RESISTING MATERIAL.

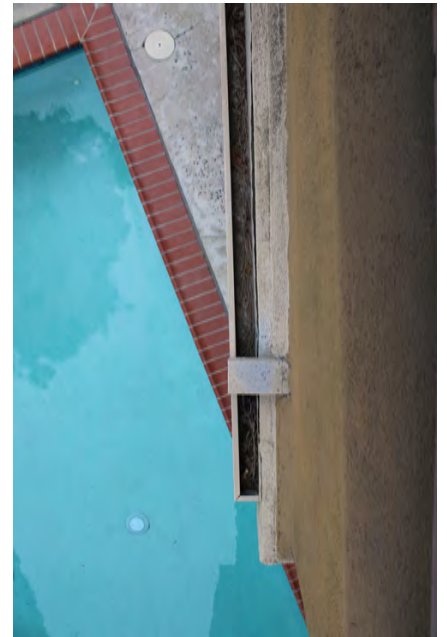
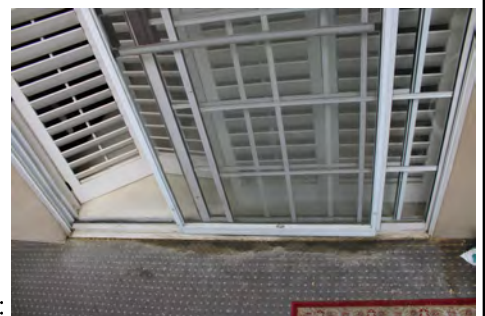
UNIT # 107

LIVING ROOM BALCONY- CARPET @ FLOOR, IN GREAT SHAPE, THE GUTTER SHOULD BE KEPT CLEAR OF DEBRIS. MASTER BEDROOM BALCONY- ALSO CARPET ON THE FLOOR. THIS CARPET HAS DARK WATER STAIN, AND THERE'S EVIDENCE OF WATER INTRUSION INTO THE WALL BELOW THIS BALCONY. ALSO, IN BOTH BALCONIES, THE FLOOR IS RAISED TOO CLOSE TO THE WEEP SCREDS.

CARPETS DO NOT ALLOW THE BALCONIES DRY/ DRAIN PROPERLY. THE FLOOR FINISH SHOULD BE SMOOTH AND OF A WATER RESISTING MATERIAL.

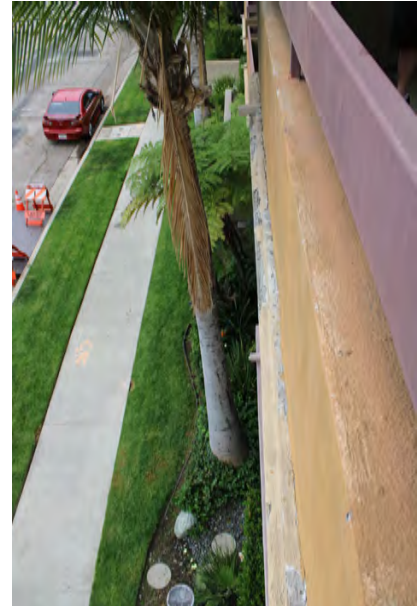
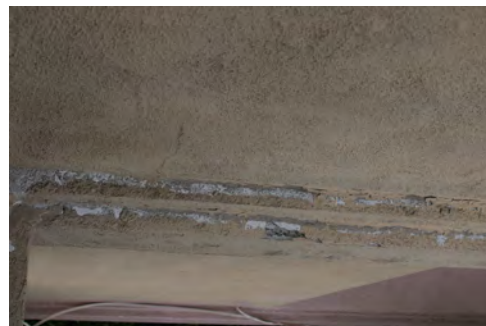
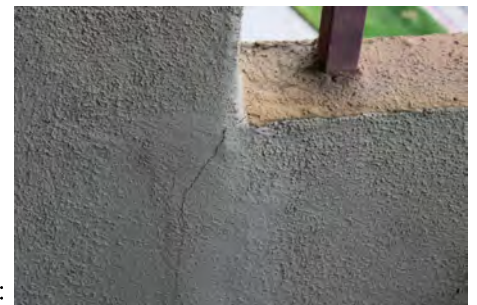
UNIT # 201

THIS UNIT IS FACING EAST AND THE BALCONIES ARE EXPOSED TO HEAVIER RAINS. THERE ARE WATER MARKS ON THE CEILING, DETERIORATION OF THE STUCCO IN ALL THE USUAL PLACES. THE BALCONIES ABOVE THIS UNIT SEEM TO BE SLOPING TOO MUCH, AWAY FROM THE BUILDING. THE FLOOR FELT GOOD WHEN I WALKED ON IT, BUT THERE IS AT LEAST ONE OPENING AT THE FLOOR MEMBRANE.

REPAIR/ REPLACE THE FLOOR MEMBRANE, AND WHEN THE STRUCTURE IS EXPOSED FOR THE NEW MEMBRANE, EVALUATE THE STRUCTURE'S CONDITION.

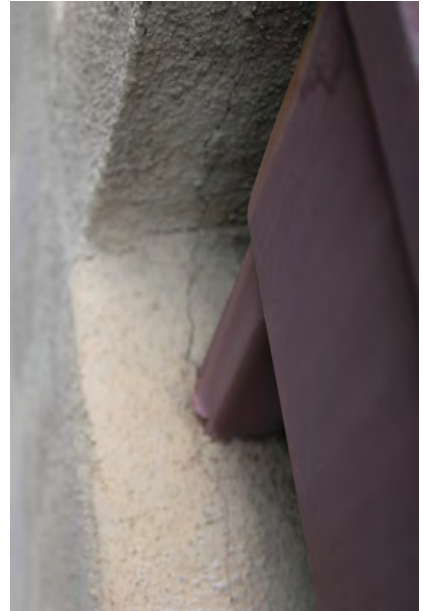
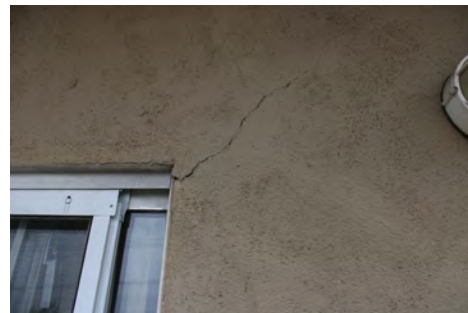
UNIT # 202

DINING ROOM BALCONY- THERE IS A HOLE IN THE STUCCO @ THE ACCESS PANEL. LIVING ROOM BALCONY- CRACKS AND HOLES @ RAILING CONNECTION TO WALL, THE FLOOR MEMBRANE IS IN BAD SHAPE. MASTER BEDROOM BALCONY- CRACKS AT STUCCO, BIG CRACK AT THE EXTERIOR TRIM AT THE EDGE OF THE BALCONY.

ANY OPENING AT THE BUILDING'S SKIN (BALCONY FLOOR MEMBRANE, STUCCO) SHOULD BE SEALED/ REPAIRED TO REDUCE POTENTIAL BIGGER ISSUES.

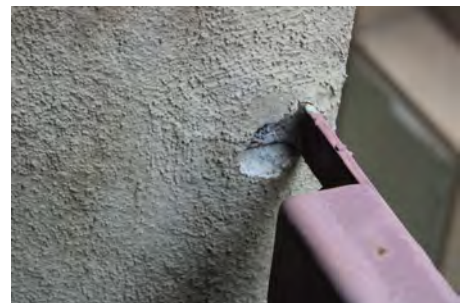
LIVING ROOM BALCONY- WATER MARKS IN THE CEILING, STUCCO DETERIORATION @ RAIL CONNECTION.  
MASTER BEDROOM BALCONY- THE TILE IS VERY CLOSE TO THE WEEP SCREED. THERE IS EVIDENCE OF WATER INTRUSION @ THE BALCONY DOOR'S HADDER, FROM THE BALCONY ABOVE.

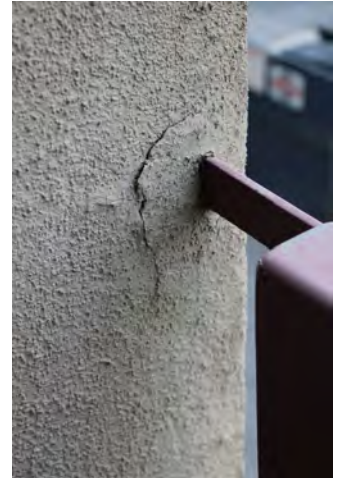
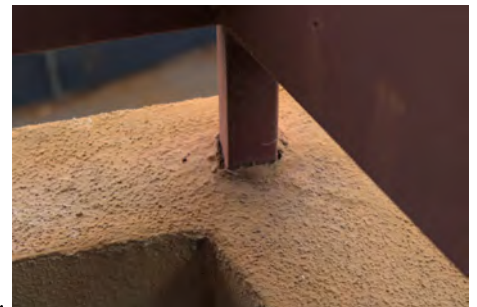
UNIT # 205

LIVING ROOM BALCONY- THE STUCCO HAS MINOR CRACKS. THE FLOOR IS BUBBLING, THE FLOOR FINISH AT SOME AREAS IS TOO CLOSE TO THE WEEP SCREED. MASTER BEDROOM BALCONY- THE FLOOR IS A LITTLE SOFT. THERE ARE STUCCO GAPS BETWEEN THE WALL AND RAIL @ CONNECTION.

THIS UNIT'S BALCONIES SHOULD BE OBSERVED FOR FURTHER DETERIORATION OF THE FLOOR WATERPROOFING MEMBRANE.

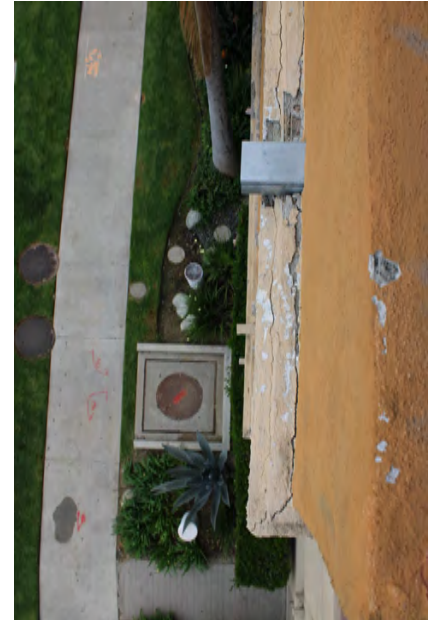
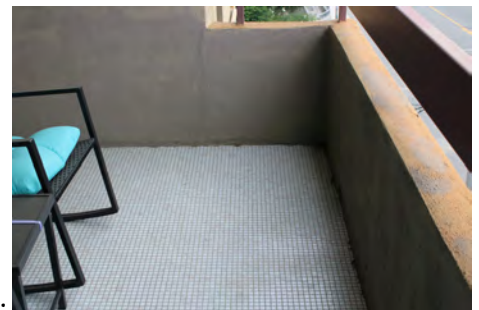
THIS UNIT HAS THE WORST BALCONIES. THEY FEEL SOLID, BUT THEY ARE CLEARLY LEANING HEAVILY TOWARDS THE ENDS. THERE ARE CRACKS EVERYWHERE.

THE ROOF TOP HAS A BROKEN ELECTRIC COVER THAT NEEDS REPLACING, BUBBLING IN THE STUCCO, AND A CLEAR PATCH JOB @ THE ROOF WALL CONNECTION.

THE MASTER BEDROOM BALCONY FLOOR MEMBRANE SHOULD BE REDONE. WHEN THE CURRENT TOP IS STRIPPED, CHECK THE STRUCTURE, TO SEE WHY THE FLOOR IS SLOPING MORE THAN IT USED TO. FINDING OUT WHAT HAPPENED TO THIS BALCONY, MIGHT LEAD TO STRIPPING THE LIVING ROOM BALCONY TOO.

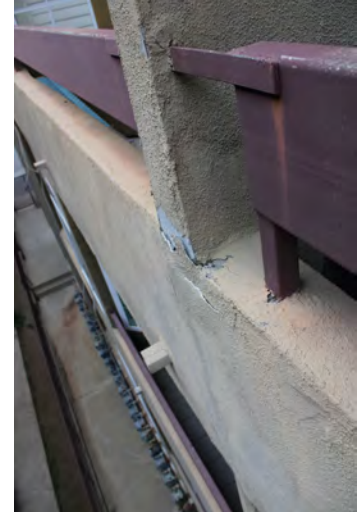
UNIT # 302

SOUTH BALCONY- COVERED BUT HIGH ROOF. THERE IS A BIG CRACK AT THE RAIL/WALL CONNECTION ON THE RIGHT SIDE. THERE IS A GAP BETWEEN THE TILE AND DOOR THRESHOLD IN 2 OF THE BALCONIES- IDEAL LOCATION FOR WATER TO ENTER THE STRUCTURE. THE TILE FINISH IS TOO CLOSE TO TH WEEP SCREEDS IN SOME AREAS. AT THE ROOF, THERE IS AN AREA WHERE THE WEEP SCREED WAS SEALED. THERE IS A WATER LEAK FROM ONE OF THE WATER STOPS

CHECK @ THE UNIT BELOW THIS ONE, FOR WATER DAMAGE. FIX/STOP ANY WATER LEAKS.

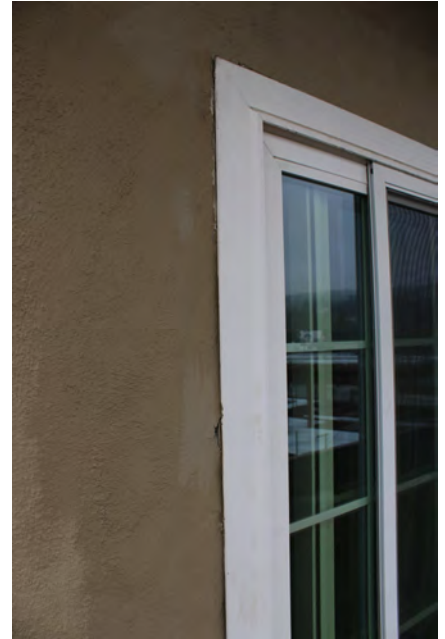
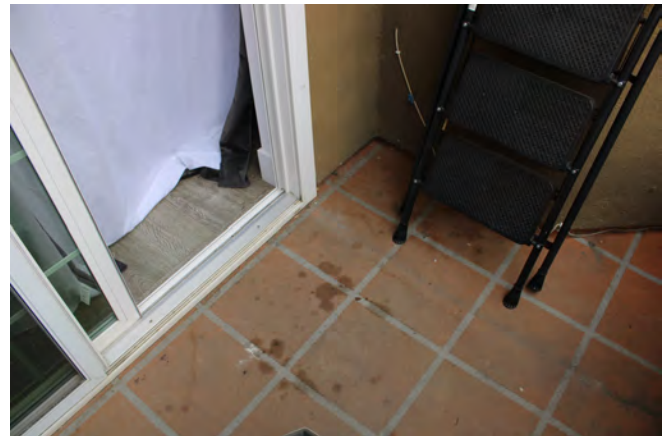
LIVING ROOM BALCONY- THE MEMBRANE MADE NOISE OF AIR BUBBLES WHEN WALKED ON IT. MASTER BEDROOM BALCONY- IN GREAT SHAPE. THERE IS A SPOT OF PAINT, PEELING NEAR THE DOOR JAMB, FROM WHEN THE DOOR WAS REPLACED. ROOF DECK- IN GREAT SHAPE. THERE ARE HOLES IN THE STUCCO, REMNANTS FROM SOMETHING THAT WAS REMOVED. THEY SHOULD BE SEALED.

KEEP AN EYE ON THE LIVING ROOM BALCONY FLOOR, FOR FURTHER DETERIORATION.  
SEAL HOLES @ WALL AT ROOF LEVEL.

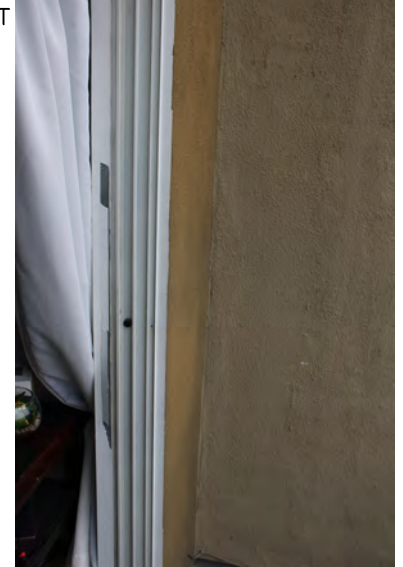
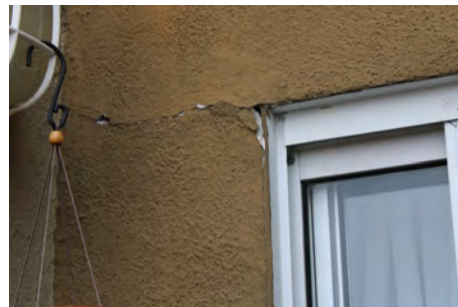
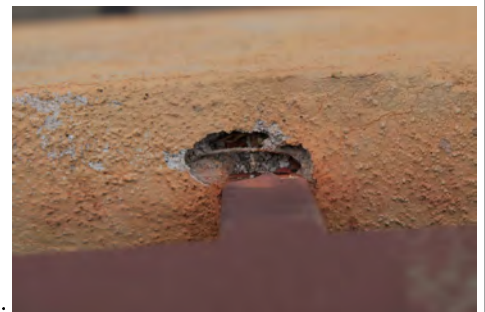
ALL BALCONIES AND ROOF DECK, MADE BUBBLING NOISE WHEN I WALKED ON THEM. THERE WERE STUCCO CRACKS IN ALL THE TYPICAL LOCATIONS. IT LOOKS LIKE THERE WAS WATER DAMAGE AT THE ROOF LEVEL AT SOME POINT, AND THE BOTTOM ONE FOOT OF STUCCO WAS REPLACED AS PART OF THAT PROCESS. THE DRYWALL @ THE LIVING ROOM DOOR JAMB IS DETRIORATINGG FROM THE DOOR HITTING THE JAMB (NOT WATER RELATED).

KEEP A CLOSE EYE ON THE FLOOR FINISH, IT WILL BE TIME TO REFINISH IT SOON.  
 SEAL HOLES IN STUCCO.

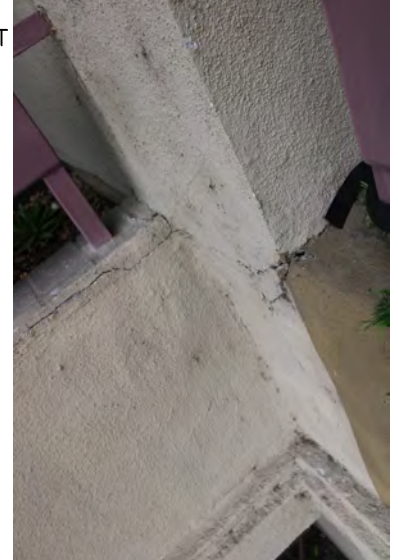
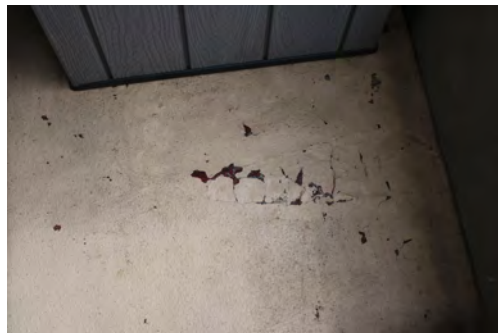
LIVING ROOM BALCONY- THE BALCONY WAS COVERED WITH FAU GRASS. IF IT HOLDS WATERE, IT SHOULD BE REMOVED, LIKE A CARET SHOULD. BIG CRACK 2 STUCCO @ RAIL CONNECTION TO WALL. MASTER BEDROOM BALCONY- FLOOR BUBBLING AND RISING IN THE CENTER- MEMBRANE NEEDS TO BE REPLACED. ROOF TOP- SOME BUBBLING IN THE STUCCO.

REPLACE MEMBRANE @ MASTER BEDROOM BALCONY. WHEN REMOVING EXISTING MEMBRANE, REPLACE ANY DAMAGED FRAMING.

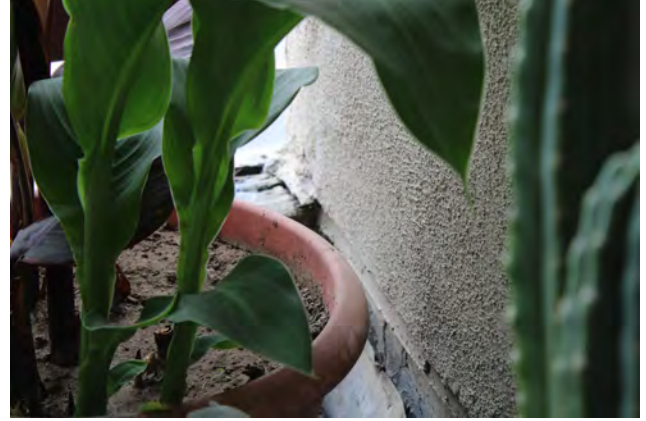
There is a loose electrical outlet, and the planter rail is rotting and letting water enter the structure.

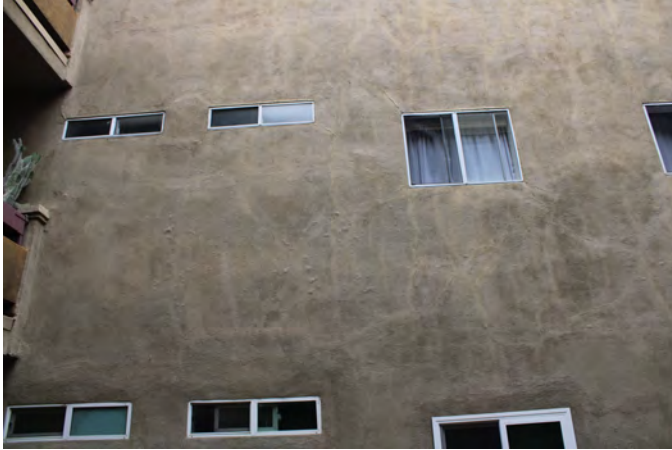
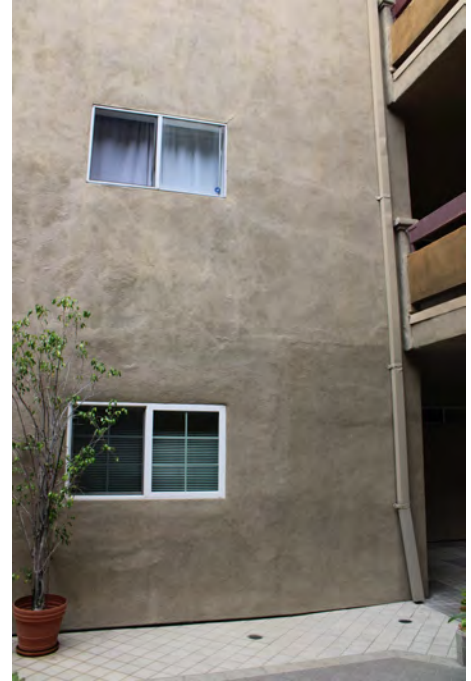
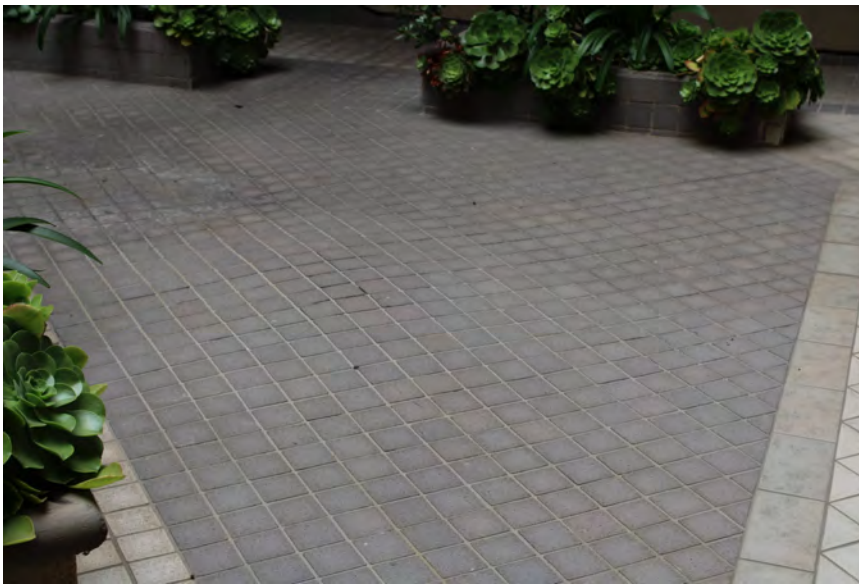
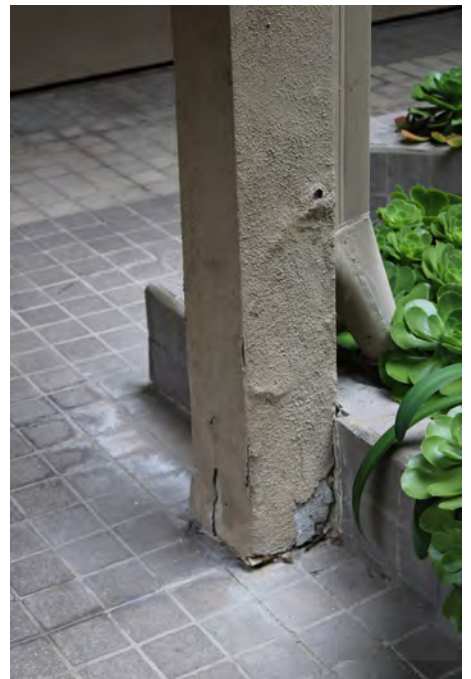
### Center atrium

The stucco is generally in good shape, considering its age. there are some bubbling and deterioration, but it is not s threat to the structure.

The floor is rising in one area. Another example of moisture being trapped between two non permeable surfaces.

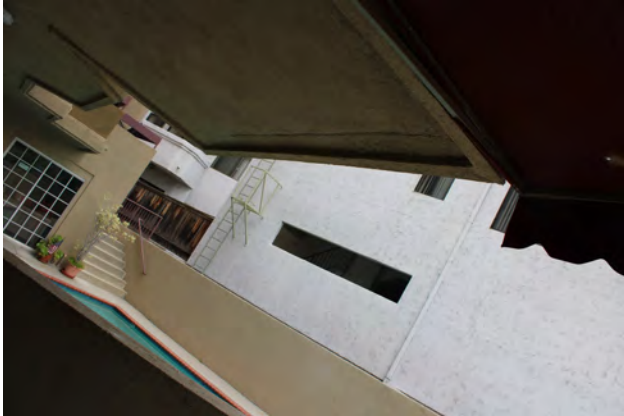
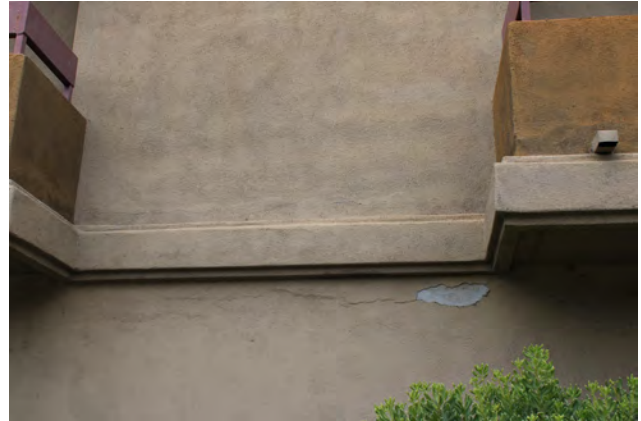
Cracks at the stucco at the first floor.

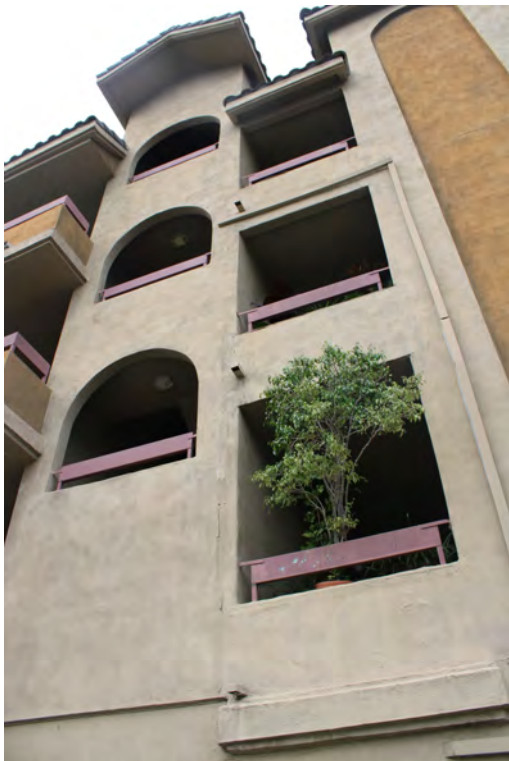
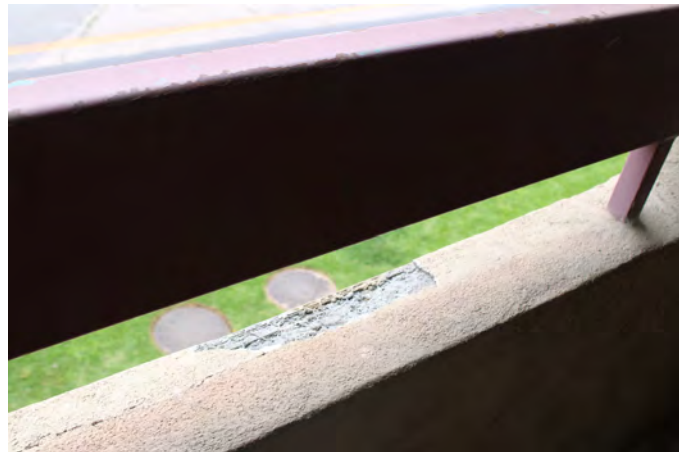
Common staircase

There is a long vertical crack in the stucco, and a deterioration at one of the railing.
