# WOOD DESTROYING PESTS AND ORGANISMS INSPECTION REPORT

| Building No.<br>2011 | Street<br>Rachelle Pl | City<br>Escondido | ZIP<br>92025 | Date of Inspection<br>07/21/2026 | Number of Pages<br>5 |
| GENERAL DESCRIPTION:<br>1 story, slab foundation, single family residence, stucco siding, light weight concrete tile roof, and attached garage. | | | | Inspection Tag Posted:<br>Garage | |

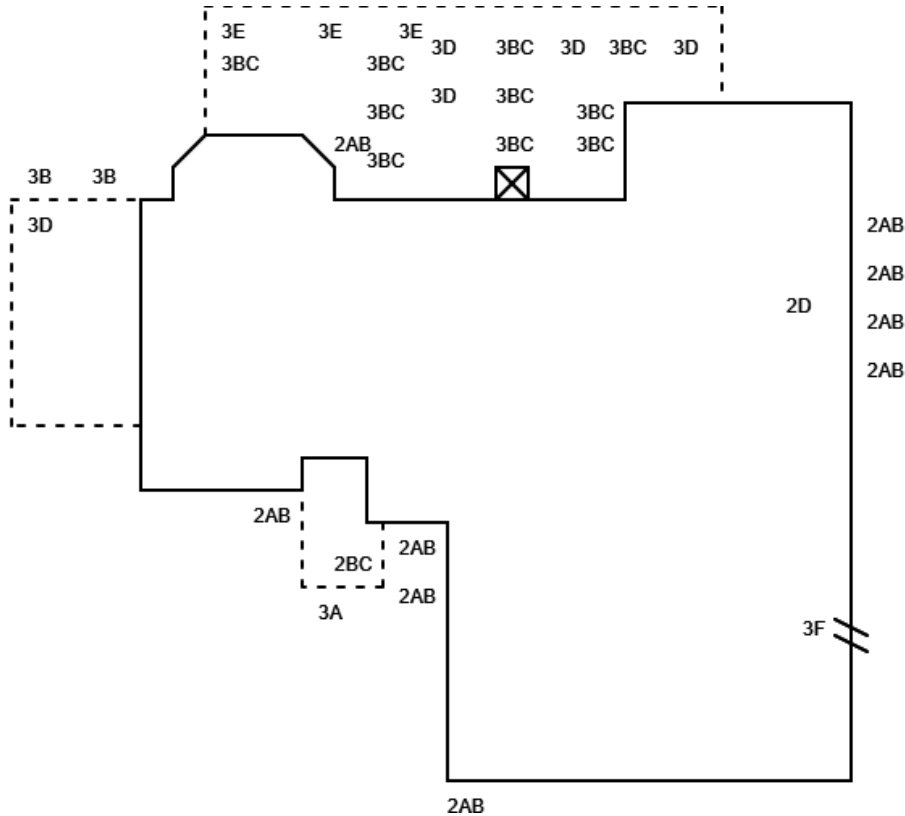
**Diagram Not To Scale**

FINDING - Evidence of drywood termite infestations at fascia and rafter tail as indicated on the diagram.

FINDING - Evidence of termite damaged wood members noted at time of inspection at fascia, rafter tail, and joist as indicated on the diagram.

FINDING - Evidence of drywood termite infestations at joist as indicated on the diagram.

FINDING - Evidence of drywood termite infestations at attic as indicated on the diagram.

FINDING - Dry-rot wood members found at time of inspection at beam as indicated on the diagram.

FINDING - Dry-rot wood members found at time of inspection at pergola slats as indicated on the diagram.

FINDING - Dry-rot wood members found at time of inspection at pergola joist as indicated on the diagram.

FINDING - Dry-rot wood members found at time of inspection at pergola post as indicated on the diagram.

FINDING - Dry-rot wood members found at time of inspection at pergola beam as indicated on the diagram.

FINDING - Dry-rot wood members found at time of inspection at pedestrian door as indicated on the diagram.

RECOMMENDATION - Chemically treat visible and accessible infestations. Remove or cover accessible pellets.

RECOMMENDATION - Remove and replace and/or repair the damaged wood member(s) as necessary in currently available widths and grades. Minor damage may be filled, or where impractical, reinforcement will be done. If, upon performance of the work, the damage extends into inaccessible areas, a new supplemental report with cost estimate may be issued.

RECOMMENDATION - EcoForce Thermal Treatment.

RECOMMENDATION - Repair the damaged wood member(s) as necessary. Minor damage may be filled, or where impractical, reinforcement will be done. If, upon performance of the work, the damage extends into inaccessible areas, a new supplemental report with cost estimate may be issued.

RECOMMENDATION - Replace pedestrian door. Prior to work, door will need to be measured and ordered.
