# INSPECTION REPORT

For the Property at:  
**714 SUZANNE DR**  
MERCED, CA 95348

RE: Report No. 8956  
714 Suzanne Dr  
Merced, CA  
95348

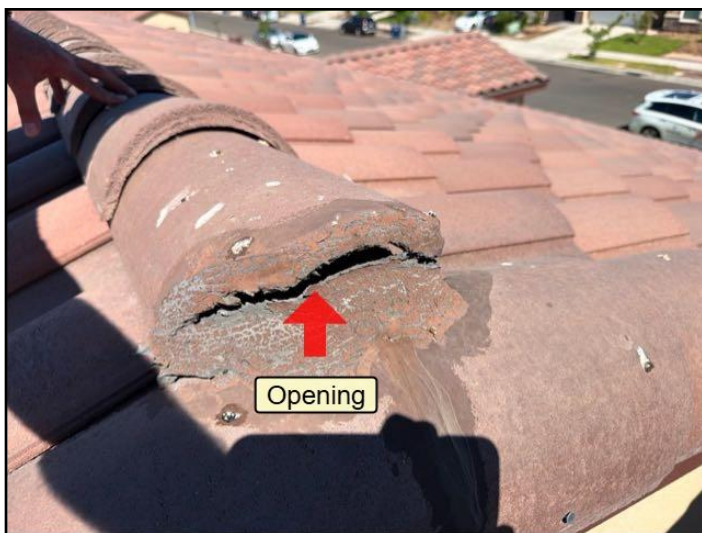
2. Vulnerable areas

#### 1. Condition: • [Vulnerable areas](#)

Repairs recommended by a qualified handyman or a licensed roofing contractor. Recommend repairing to prevent water intrusion.

**Implication(s):** Chance of water damage to structure, finishes and contents

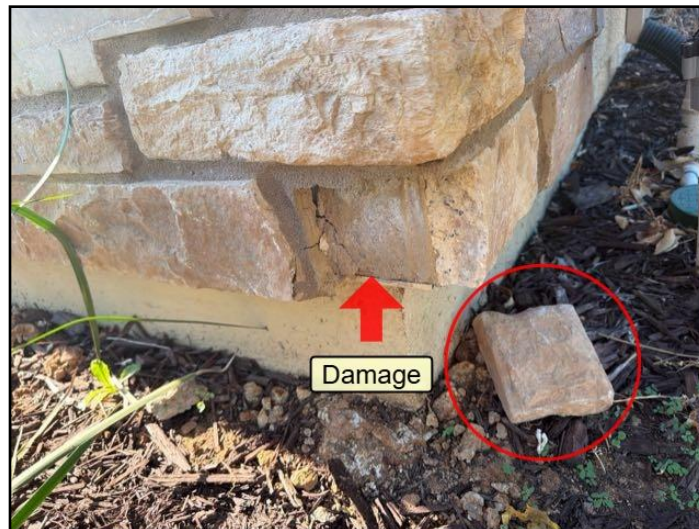
15. Mechanical damage

#### 2. Condition: • [Mechanical damage](#)

Loose and missing artificial stones. Recommend repairs by a qualified handyman or a licensed contractor.

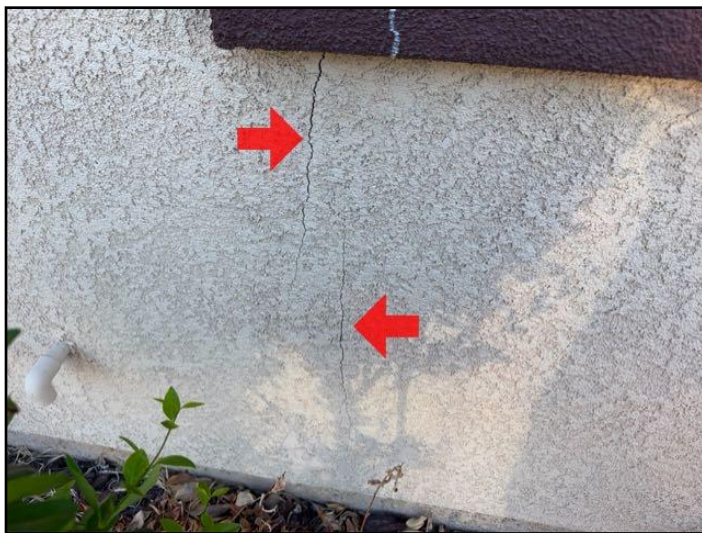
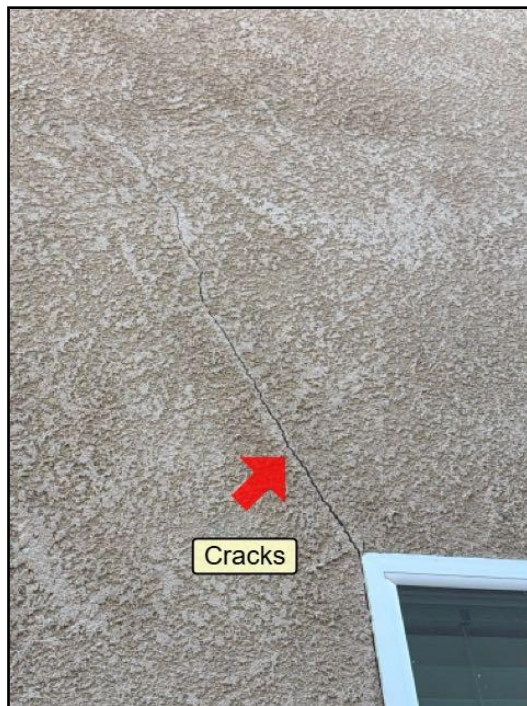
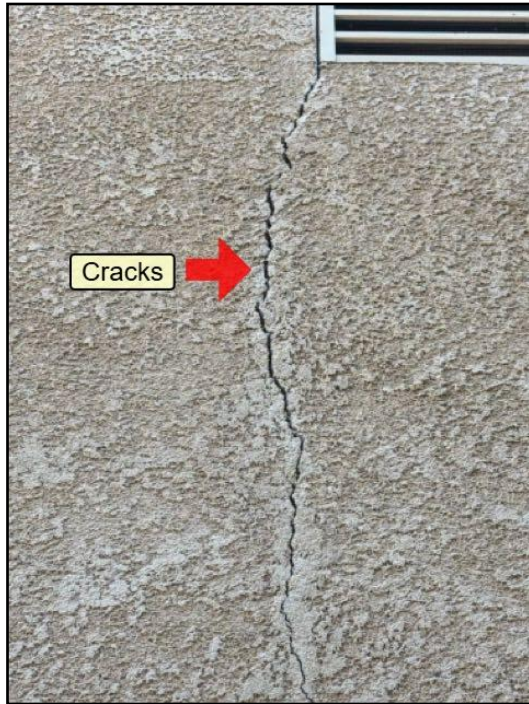
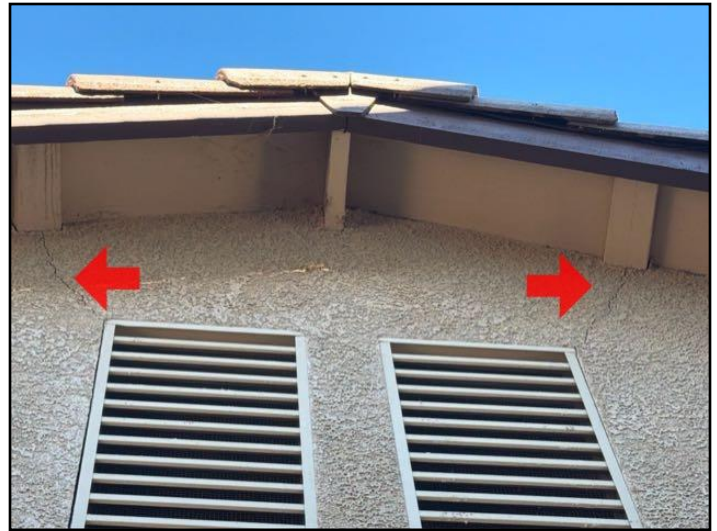
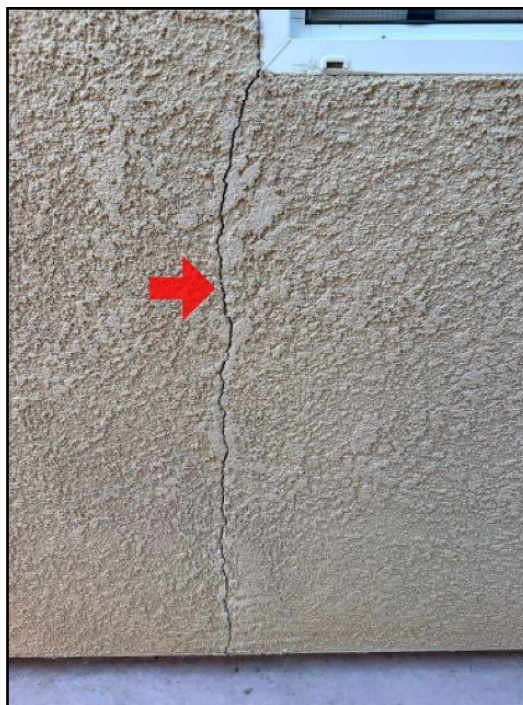
#### 3. Condition: • [Cracked](#)

Majority of stucco cracks are common cracks; however, some cracks need repair to prevent water intrusion into the structure. Repairs recommended by a qualified handyman or licensed contractor.

**Implication(s):** Chance of water damage to structure, finishes and contents | Material deterioration

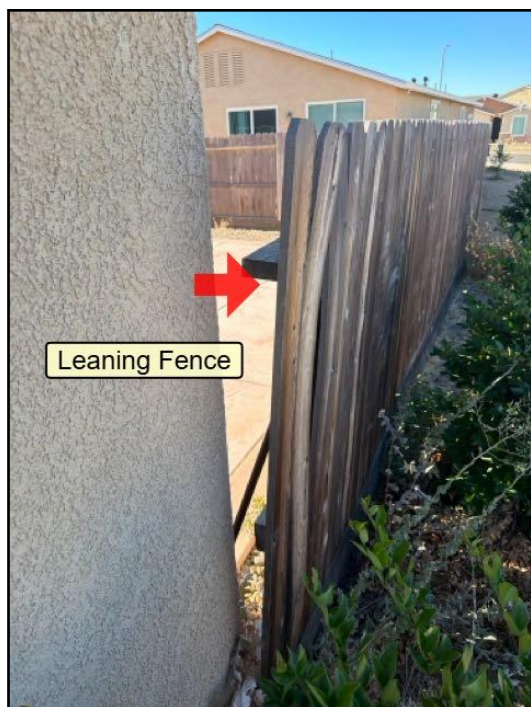
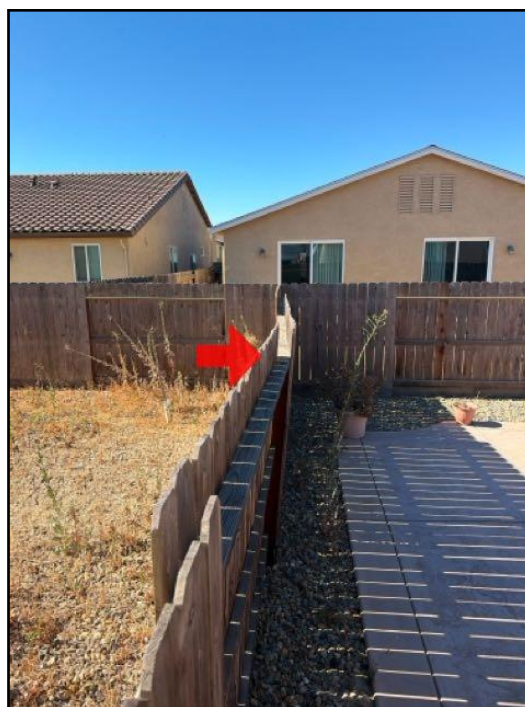
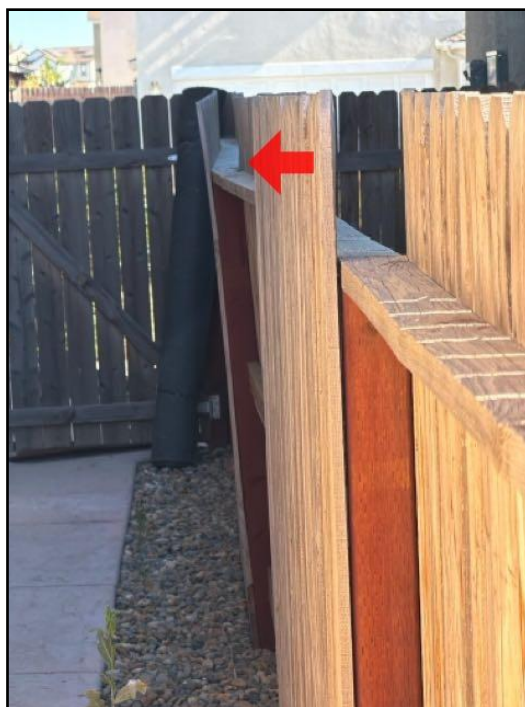
### 4. Condition: • Leaning

Fence is leaning. Repairs recommended by a qualified handyman or a licensed contractor.

**Implication(s):** Chance of movement | Damage or physical injury due to falling materials

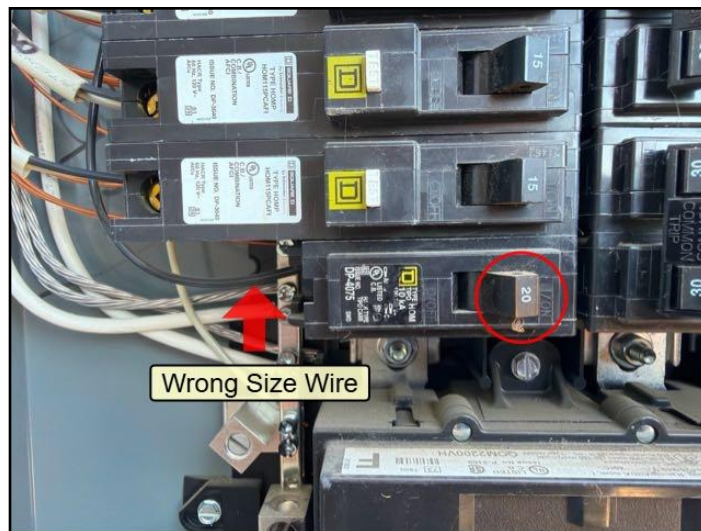
26. Wire size too small for breaker

**SERVICE BOX, GROUNDING AND PANEL \ Distribution fuses/breakers****5. Condition:** • Wire size too small for breaker

In the service panel, a branch conductor was connected to a circuit breaker for which the wire size was insufficient. This defective condition should be corrected by a licensed electrical contractor.

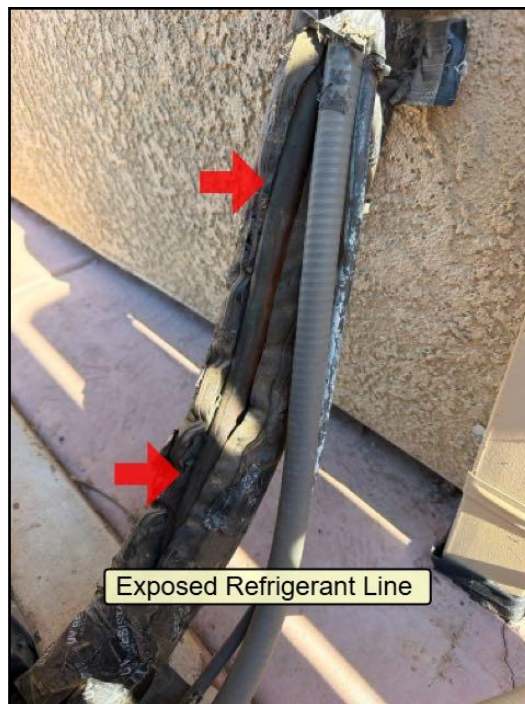
35. Insulation Damaged

**6. Condition:** • Insulation Damaged

Insulation damaged. Recommend repairs by a qualified handyman or licensed HVAC contractor.

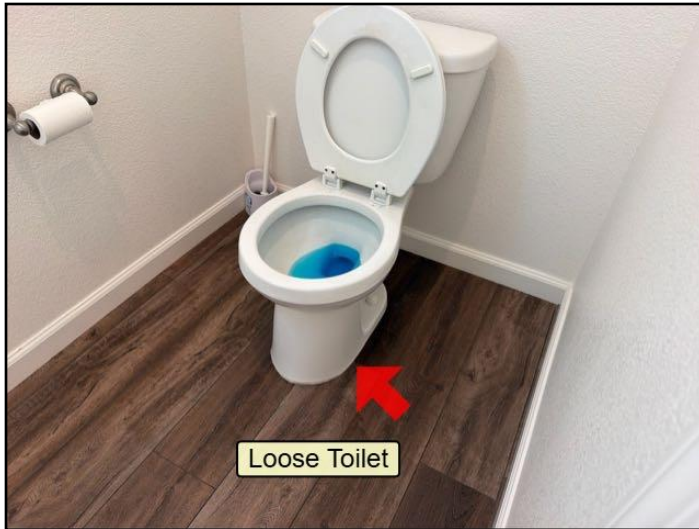
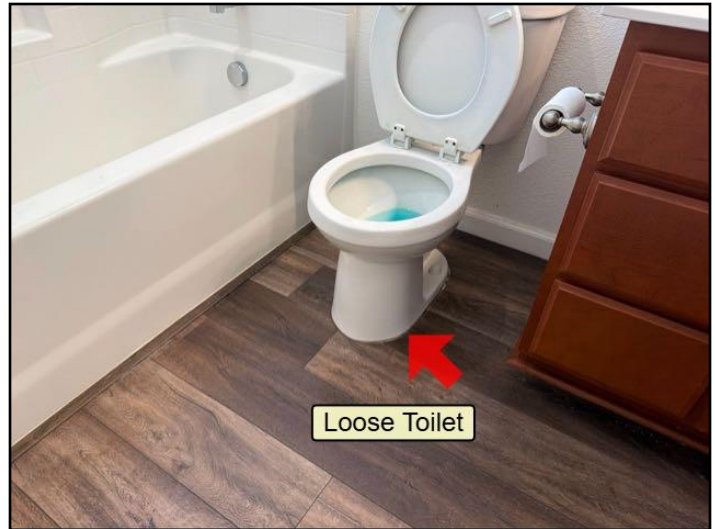
**7. Condition:** • Toilet is loose on floor.

Bathroom toilet was loose at the floor indicating that anchors designed to secure the toilet to the floor have pulled loose. A variety of solutions may be available, depending on the exact nature of the problem. We recommend re-attaching by a qualified handyman or a licensed plumbing contractor.

**Implication(s):** Chance of leak and possible water damage to structure, finishes and contents.

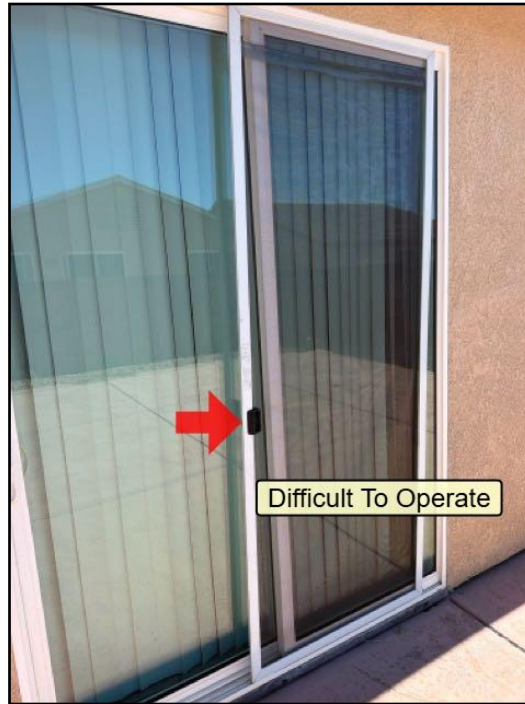
57. Difficult to operate

**8. Condition:** • Difficult to operate

Screen door is difficult to operate. Recommend repairs or replacement by a qualified handyman or licensed contractor.

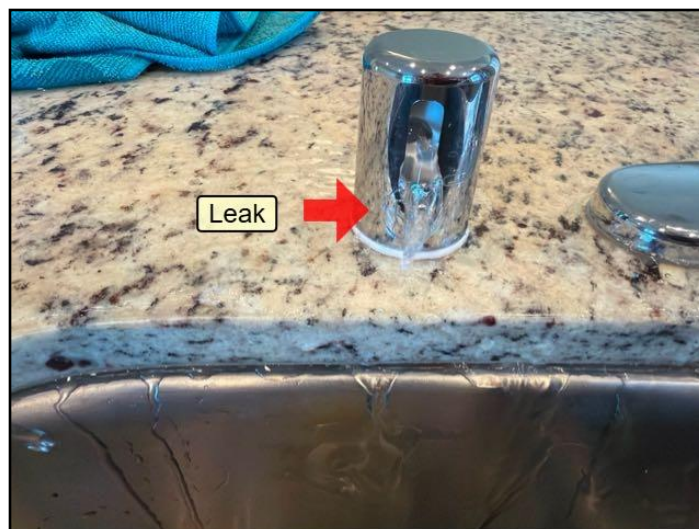
58. Air-Gap Device Leaks

### 9. Condition: • Air-Gap Device Leaks

Air-Gap device leaks. Recommend checking to see if knockout plug has been removed. If not, remove plug. If plug has been removed, check to see if drain line from air-gap device to garbage disposal is free from any obstruction. Repairs recommended by a qualified handyman or a licensed plumbing contractor.

**Implication(s):** Possible water leaking into cabinet and damaging structure.

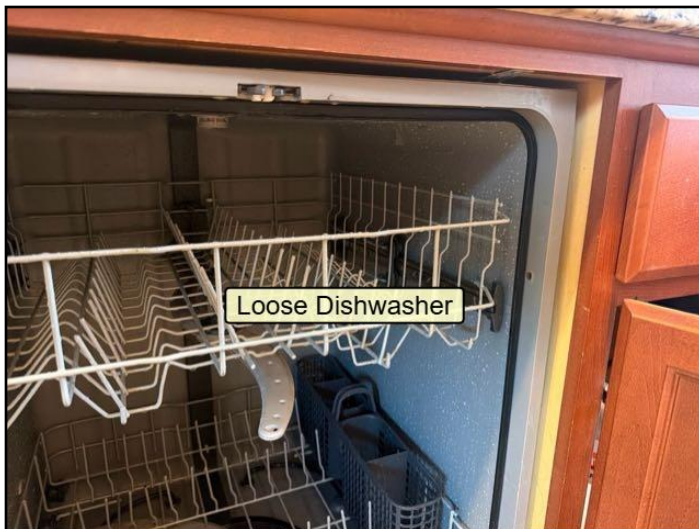
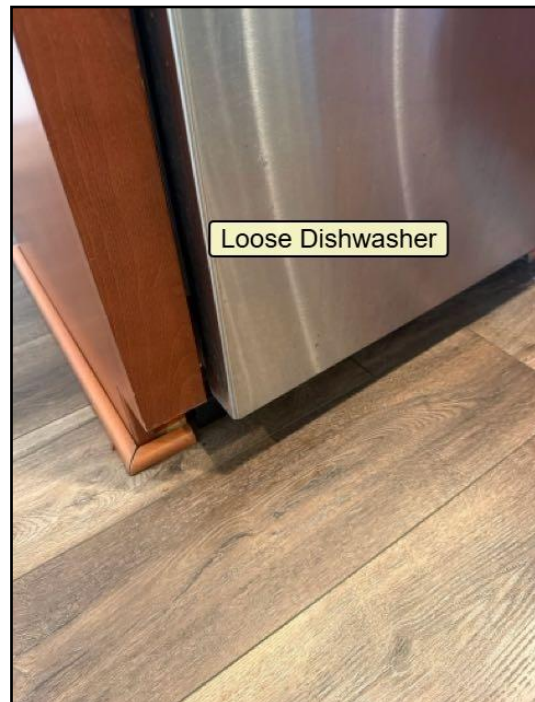
## 10. Condition: • Loose

Dishwasher not attached properly. Repairs recommended by a licensed contractor.

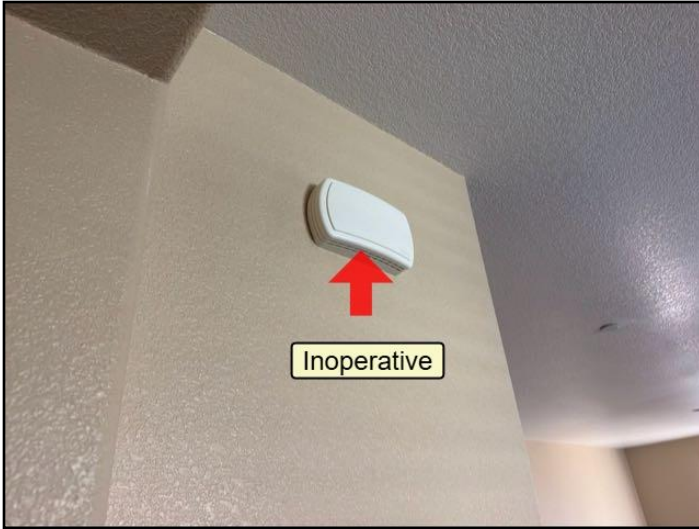
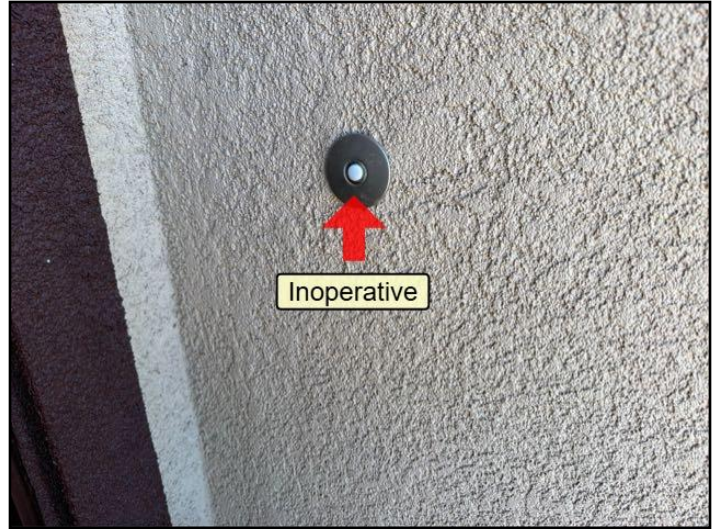
### 11. Condition: • Inoperative

Repairs recommended by a qualified handyman or a licensed electrician.
