# ***Cornerstone Inspection***

## **Property Inspection Report**

***794 Cardinal Ct, Arroyo Grande, CA 93420***

***Date of Inspection: 7/14/2026 Time: 1:00 PM***

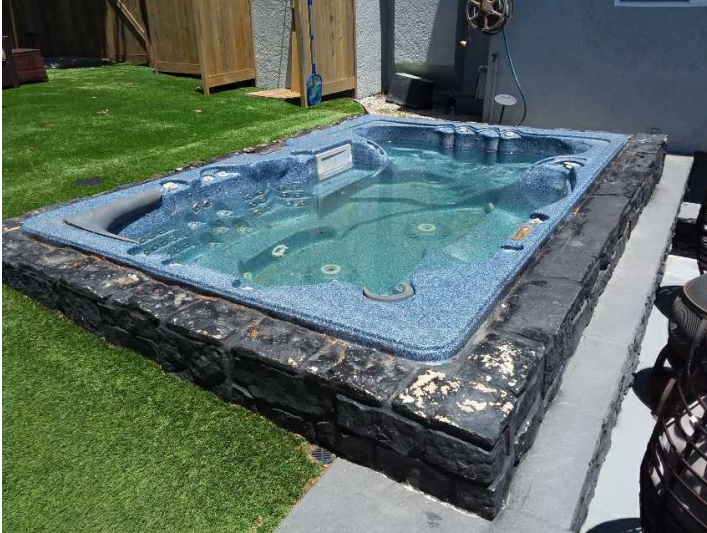
We do not evaluate pools or spas as part of our inspection service. Therefore, you should have a pool/spa contractor evaluate them before the close of escrow, and you should be aware of local ordinances governing pool and spa safety.

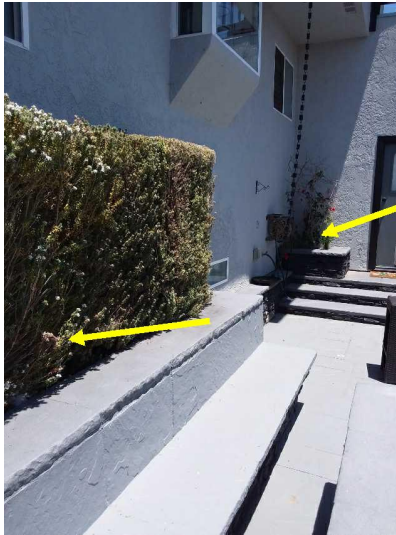
2.4. There are planter beds that will trap water against the walls of the residence which can never be sensibly approved. This condition may allow the possibility of moisture intrusion into the residence. If they are to remain, they should be retrofitted to have several one-inch weep holes at their base. It would be prudent to periodically monitor the adjacent interior walls.

There are planter beds that will trap water against the walls of the residence which can never be sensibly approved. This condition may allow the possibility of moisture intrusion into the residence. If they are to remain, they should be retrofitted to have several one-inch weep holes at their base. It would be prudent to periodically monitor the adjacent interior walls.

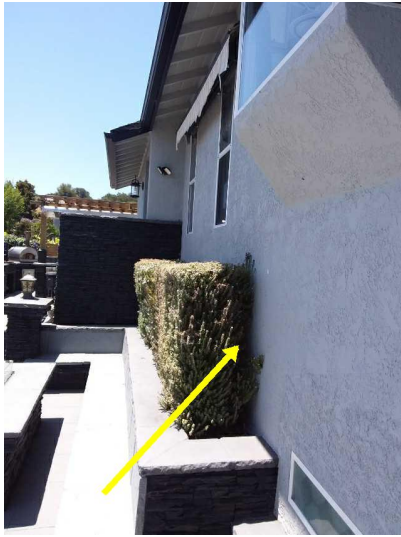
3.3. Vines, shrubs or bushes are growing on the house walls and although they are attractive they can introduce pests and rodents and accelerate deterioration. Therefore, you may wish to consider having them removed or cut back to 12 inches away from the home.

Vines, shrubs or bushes are growing on the house walls and although they are attractive they can introduce pests and rodents and accelerate deterioration. Therefore, you may wish to consider having them removed or cut back to 12 inches away from the home.

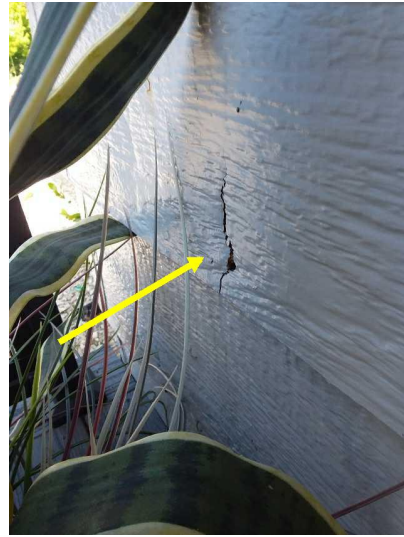
3.5. Portions of the siding are dry rot or moisture damaged, and should be evaluated by a termite inspector.

Portions of the siding are dry rot or moisture damaged, and should be evaluated by a termite inspector.

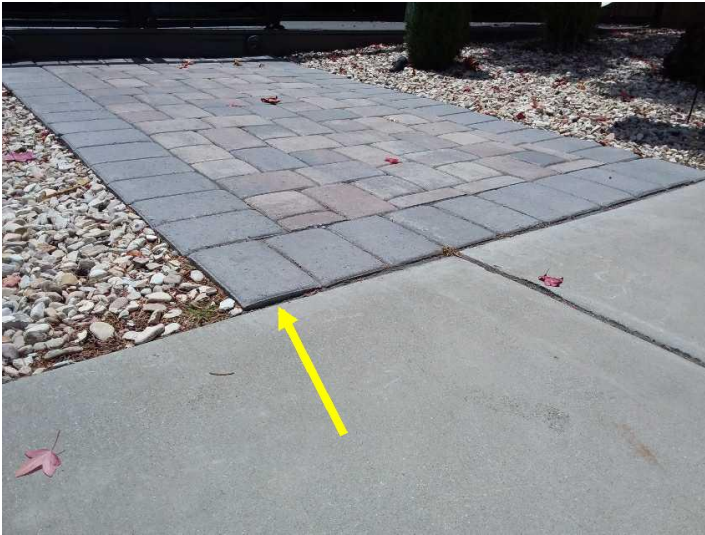
There is one or more offsets in the walkways that could prove to be trip-hazards.

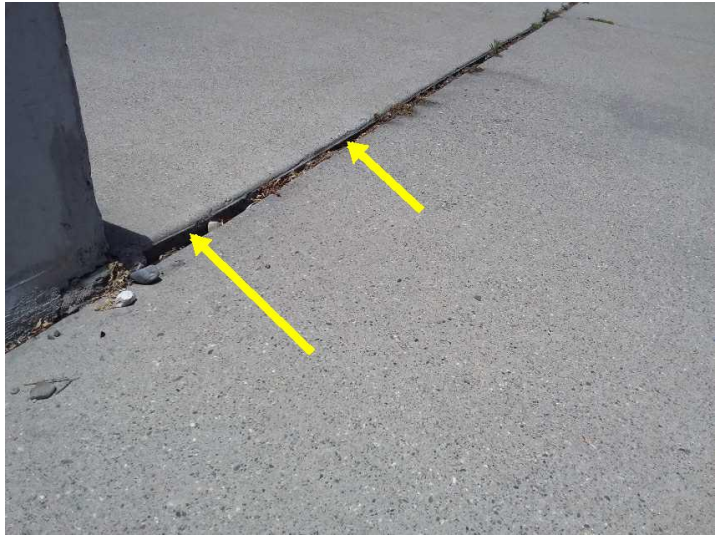
There is one or more offsets in the driveway that could prove to be trip-hazards.

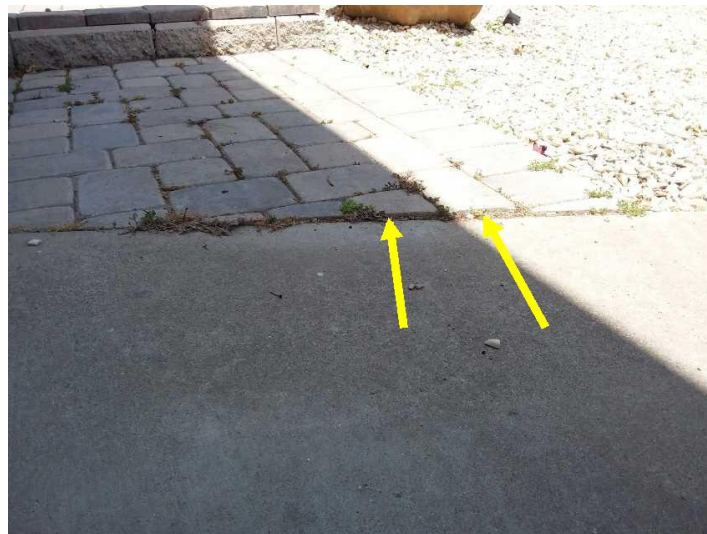
There is one or more offsets in the walkways that could prove to be trip-hazards.

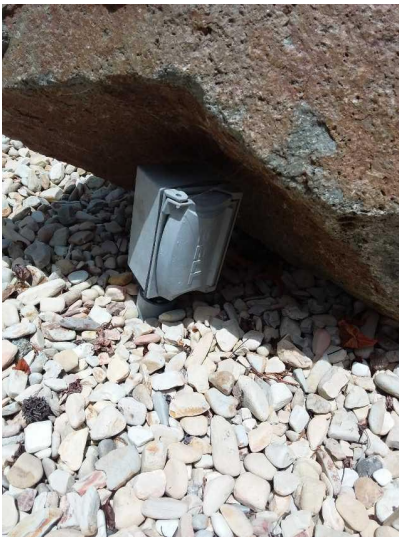
The exterior outlets are functional, but should be upgraded to have ground fault protection.

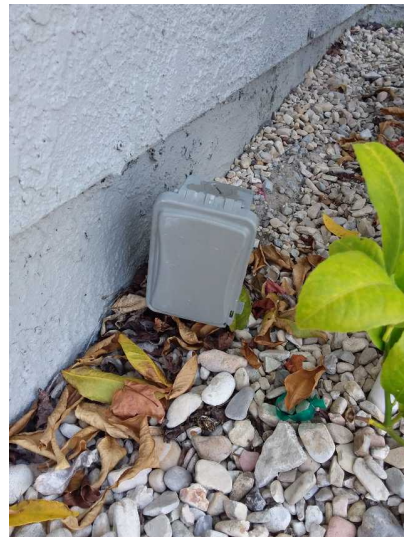
The exterior outlets are functional, but should be upgraded to have ground fault protection.

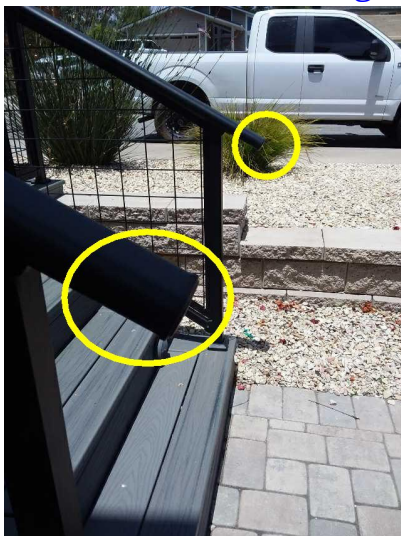
9.3. The handrail does not return which is required at the top and bottom of the stairs which is required by current building standards. This condition could allow a purse or clothing to initiate a fall.

The handrail does not return which is required at the top and bottom of the stairs which is required by current building standards. This condition could allow a purse or clothing to initiate a fall.

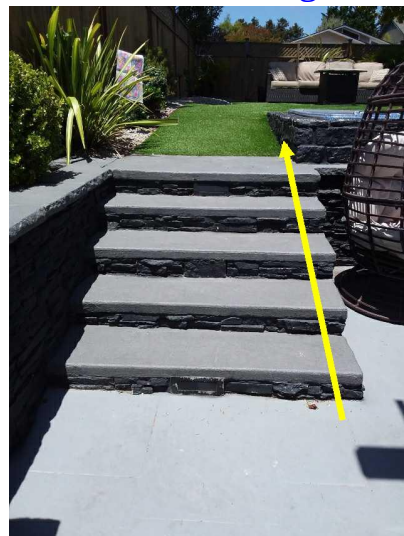
Current building standards require handrails to be installed on steps which have 4 or more risers, and particularly if children or the elderly visit or occupy this property.

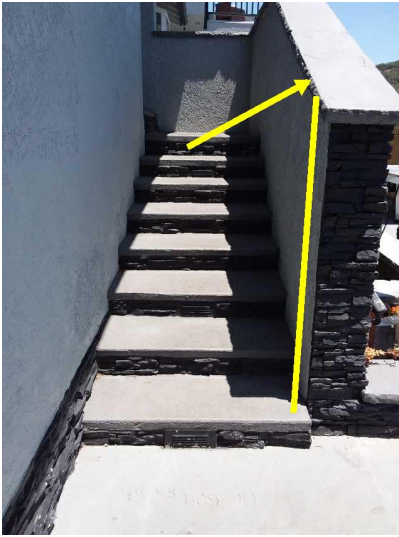
9.4. The handrail is not located at the proper height according to current standards. Current standards call for a height between 34" and 38" above stair nosing.

The handrail is not located at the proper height according to current standards. Current standards call for a height between 34" and 38" above stair nosing.

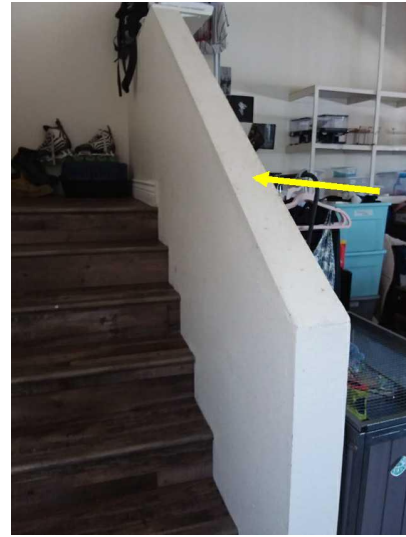
The stair handrails do not have a proper grip which is required by current standards.

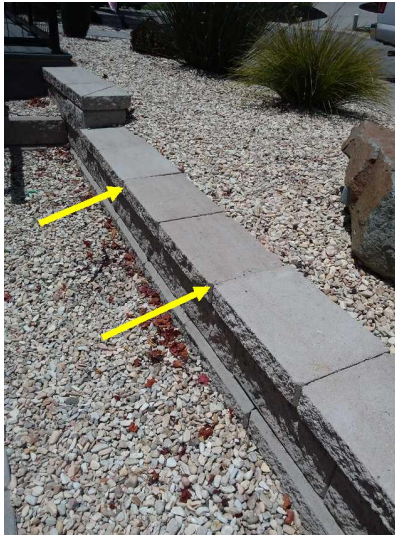
Some of the planter block-caps are loose or missing and should be serviced.

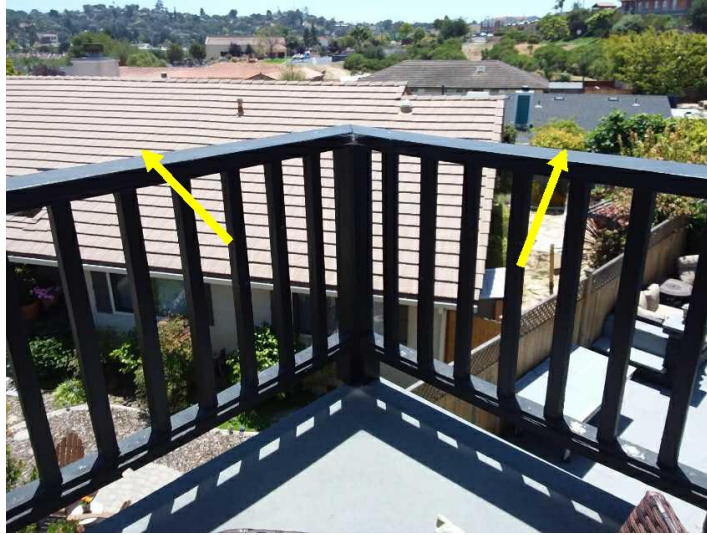
The balcony guardrail does not conform to common safety standards. Common safety standards require them to be a minimum of 42 inches high when the standing surface is thirty inches or more above grade.

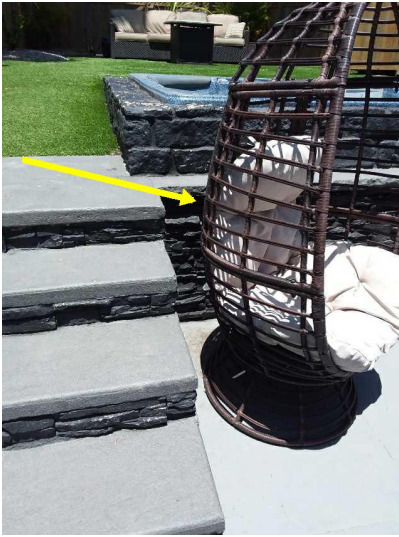
There are areas of this property that do not have guardrails, which are required for walk-offs greater than thirty inches. While there are walk offs less than 30 inches, appropriate precautions should be taken to safeguard children and the elderly.

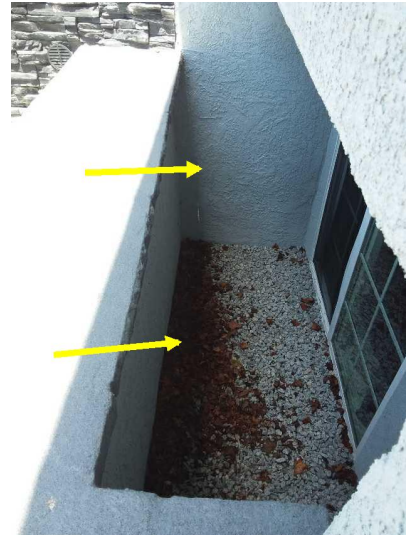
There are areas of this property that do not have guardrails, which are required for walk-offs greater than thirty inches, and appropriate precautions should be taken to safeguard children and the elderly.

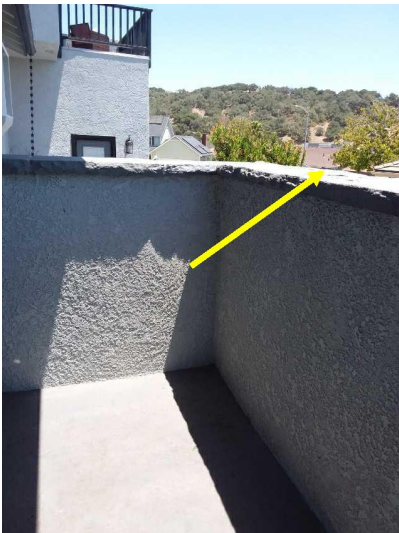
The balcony/deck guardrail does not conform to common safety standards. Common safety standards require them to be a minimum of 42 inches high when the standing surface is 30" or more above grade.

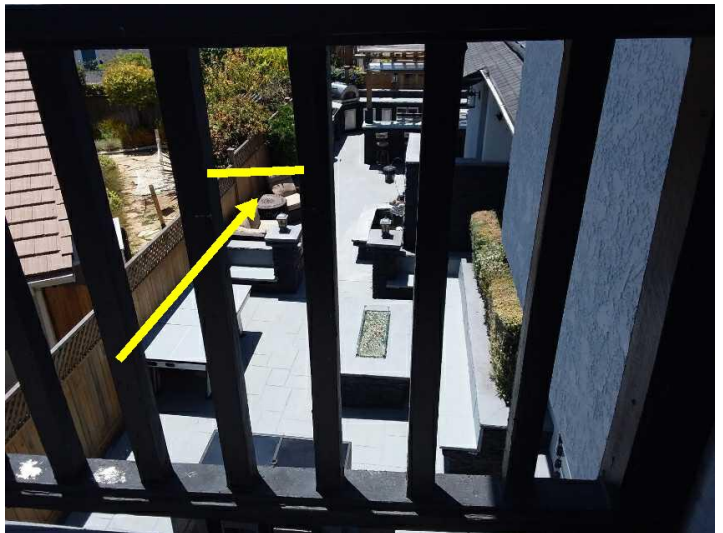
The balusters in the guardrail are more than 4" apart and are not child safe. Therefore, you may wish to add a protective barrier.

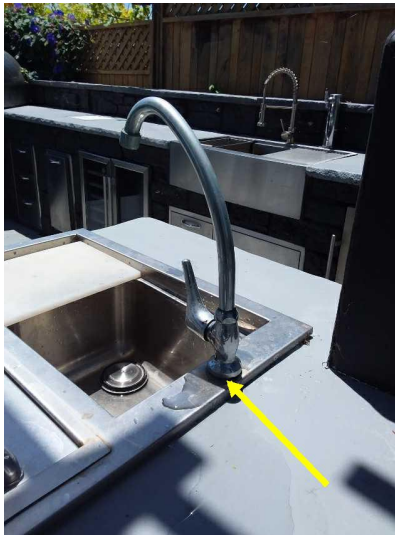
The middle faucet leaks around the stem while in use and should be serviced.

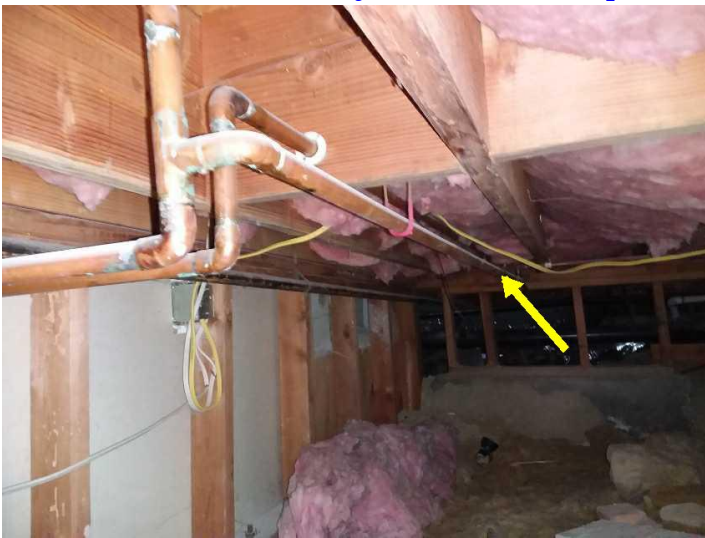
Some of the water supply lines are insufficiently supported and should be serviced.

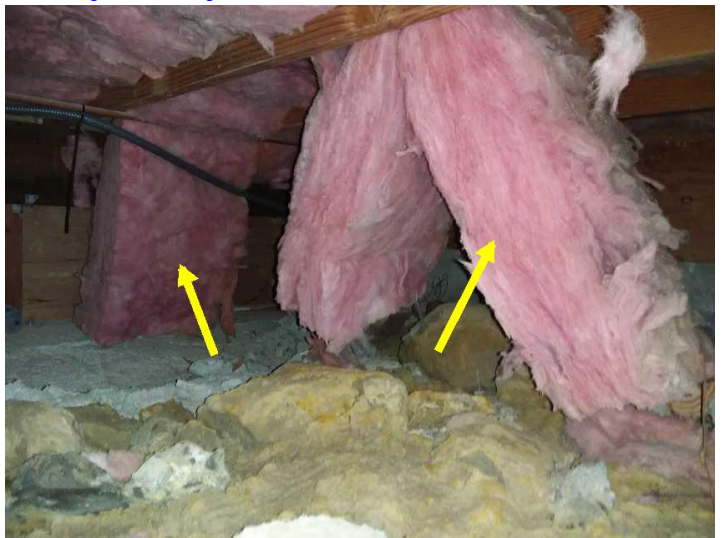
1.13. Some pieces of insulation are hanging or have fallen from between the floor joists. This does not have any serious consequences, but you may wish to have it serviced.

Some pieces of insulation are hanging or have fallen from between the floor joists. This does not have any serious consequences, but you may wish to have it serviced.

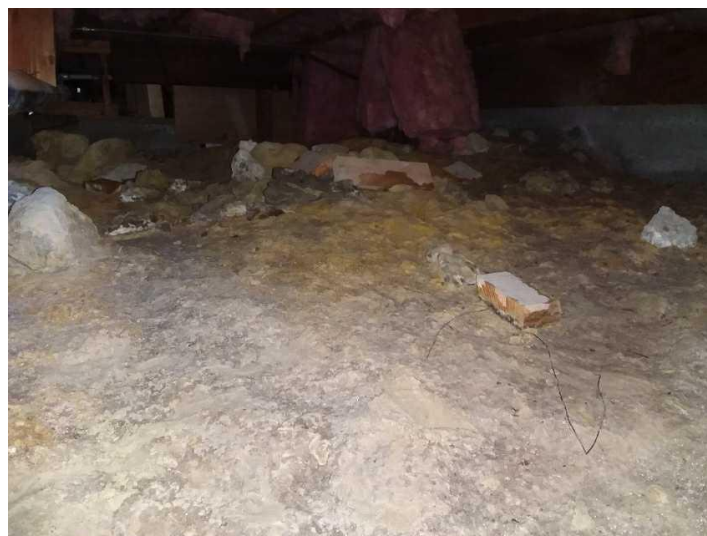
The soils in the crawlspace are moist or desiccated, which could indicate a chronic drainage problem that should be evaluated by a specialist.

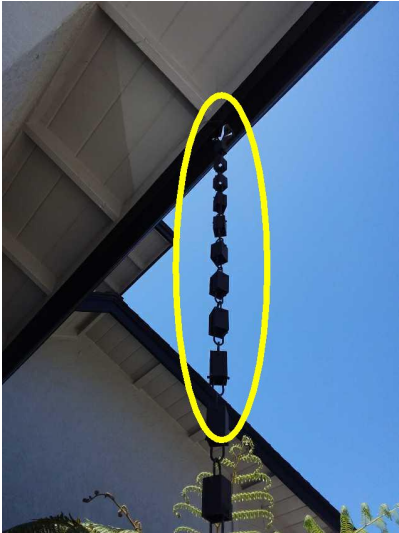
Some downspouts are missing or need to be reconnected, and should be serviced.

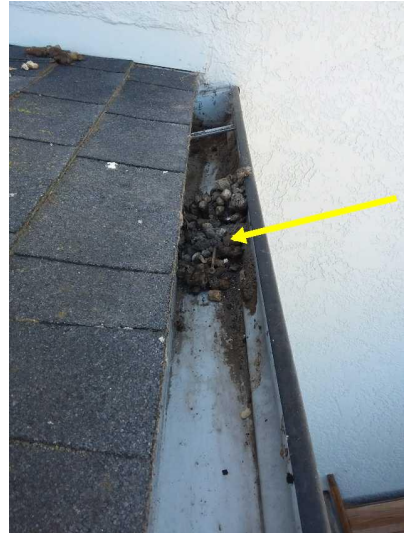
Some of the gutters need to be cleaned to drain properly.

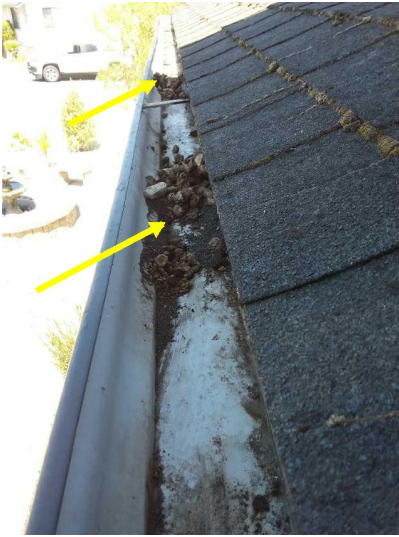
Some of the gutters need to be cleaned to drain properly.

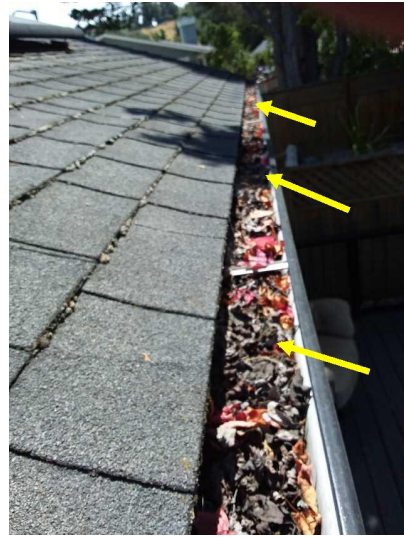
Some of the gutters need to be cleaned to drain properly.

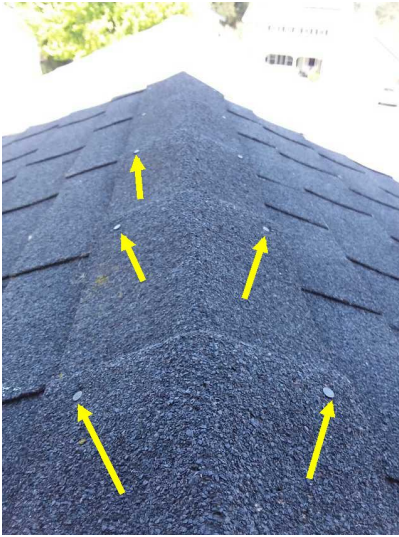
The roofing material has been improperly installed with exposed fasteners and should be monitored closely for leaks.

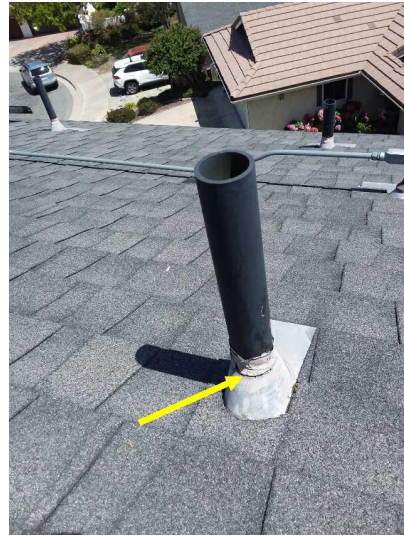
Some of the roof flashing need to be sealed or serviced. They are comprised of metal that seals valleys and vents and other roof penetrations, and are the most common point of leaks. This is particularly true of the flashing on a layered roof, which are covered by the roofing material and which are even more susceptible to leaks.

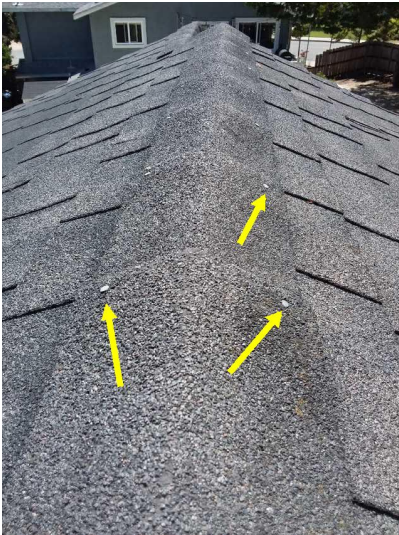
The roofing material has been improperly installed with exposed fasteners and should be monitored closely for leaks.

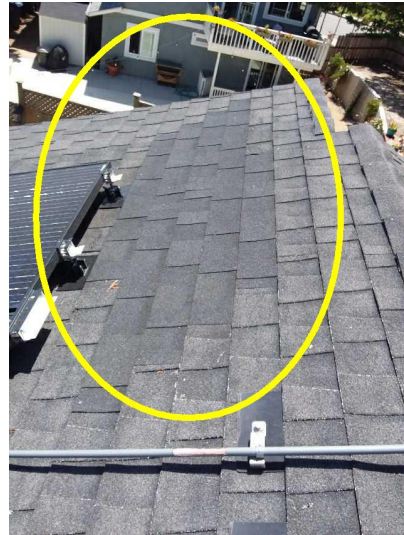
We observed repairs done to the roof that should be explained by the sellers as to why these repairs were needed.

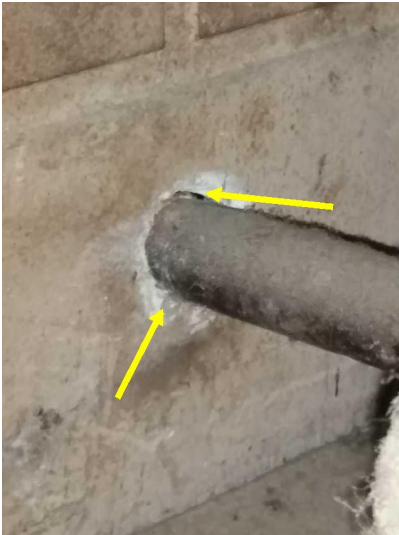
The void around the gas pipe in the sidewall of the fireplace should be sealed with refractory sealant to prevent any possibility of back-drafting a flame beyond the combustion chamber, where it could come into contact with combustible material such as the wood framing.

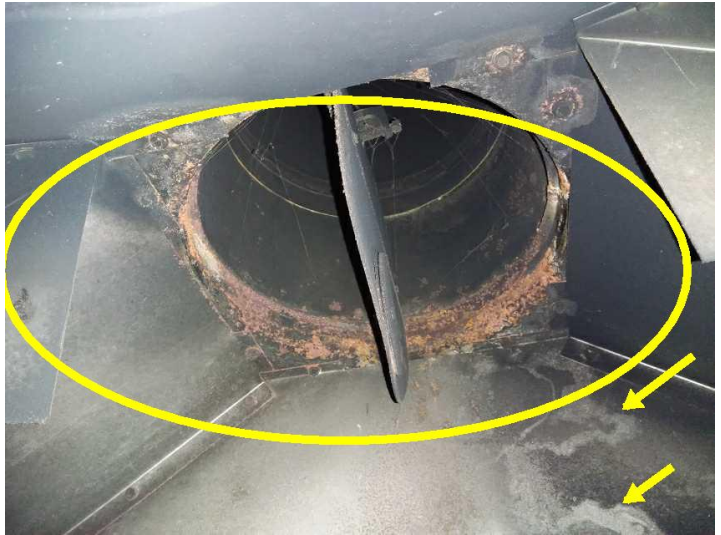
There is evidence that implies the flue may be leaking which should be evaluated to determine if the flue is leaking, or the roof flashing is defective.

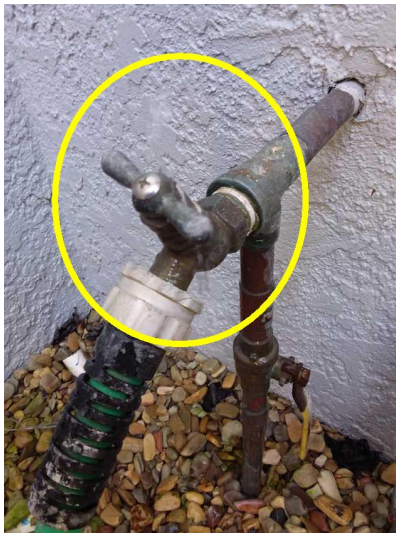
| Page 30 Item: 3 | Irrigation and Hose Bibb Information | 3.3. A hose bib at the left side leaks and should be serviced. |

3.3. A hose bib at the left side leaks and should be serviced.

A hose bib at the left side leaks and should be serviced.

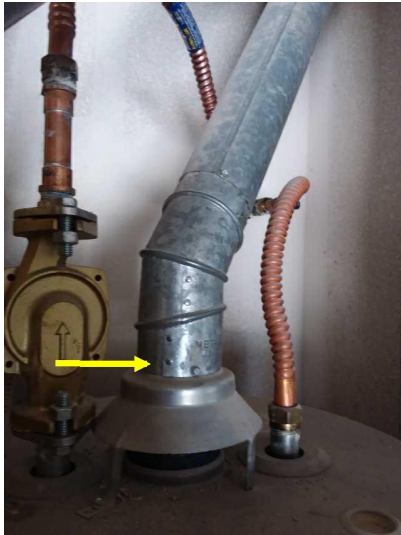
The vent pipe is not properly connected. It is required to have a minimum of 3 fasteners where the pipe connects to the draft hood or other single wall vent pipes.

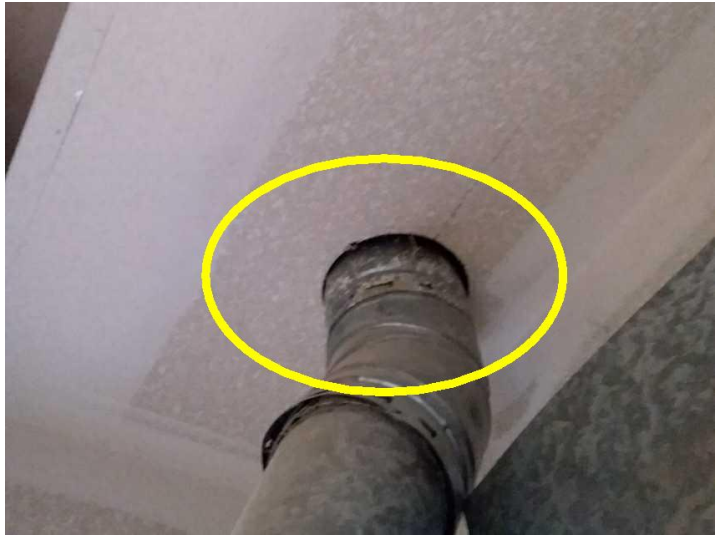
| Page 31 Item: 4 | Gas Water Heater Comments | <p>4.14. The vent pipe is too close to combustible material, and should be serviced before the close of escrow. A single-walled vent pipe should be six inches away from any combustible material, and a double-walled vent pipe should be one inch away.</p> <p>4.15. The discharge pipe appears to be plumbed incorrectly to discharge into the sub area which is improper and should be plumbed to discharge at the exterior and terminate at a point no more than twenty-four inches above grade and no less than six inches to it.</p> |

The vent pipe is too close to combustible material, and should be serviced before the close of escrow. A single-walled vent pipe should be six inches away from any combustible material, and a double-walled vent pipe should be one inch away.

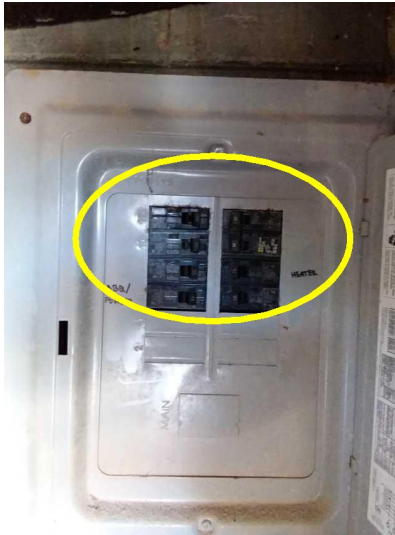
Various circuits within the sub-panel are not labeled, and should be serviced by an electrician so that the appropriate load calculations and breaker sizes could be determined.

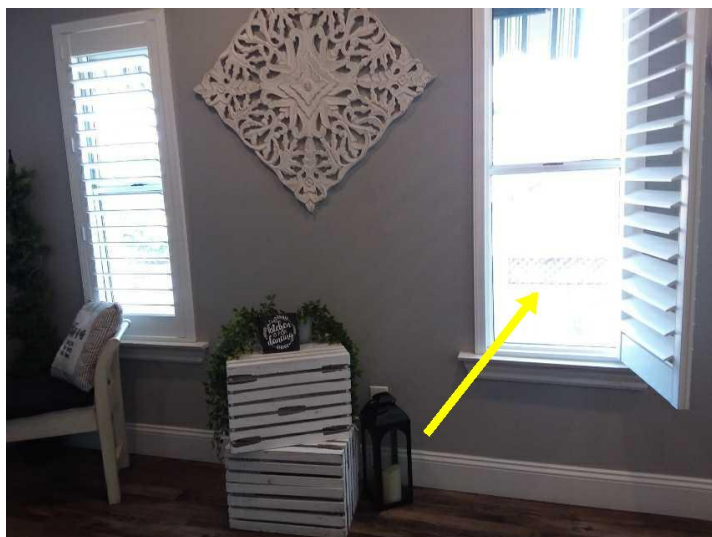
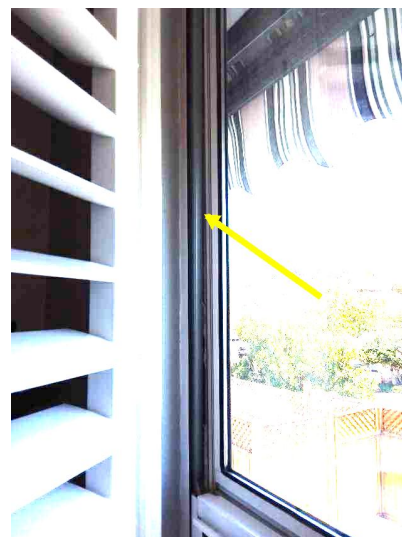
One or more of the single-hung windows will need to be serviced to function properly. Single-hung windows are typically designed so that the lower panel opens. The hardware needs to be serviced as the window will not properly stay in place when opened.

Single or double hung windows do not open smoothly, which could indicate the "balancer" bar needs to be adjusted. We recommend a licensed professional evaluate and service this issue.

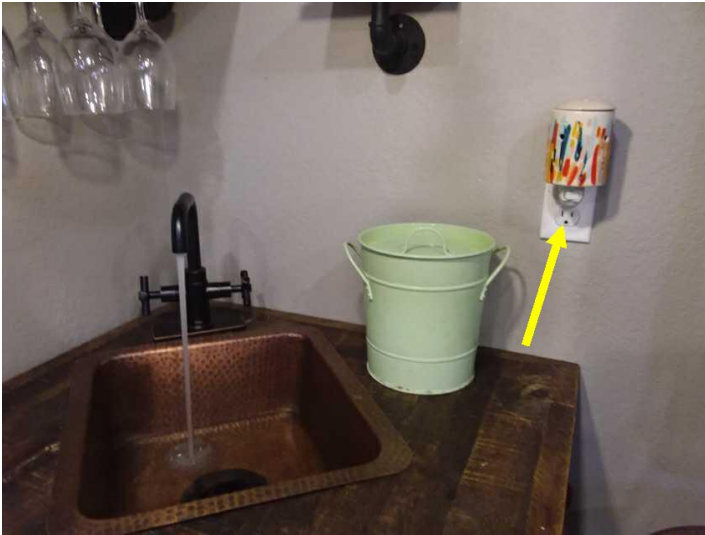
The outlets are functional, but should be upgraded to have ground-fault protection.

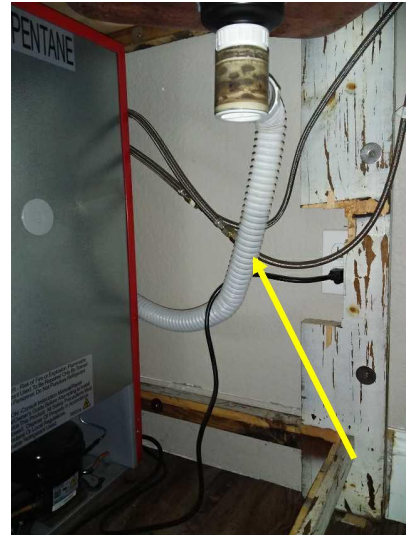
The bar sink does not have a standard drain trap, and should be evaluated by a plumber.

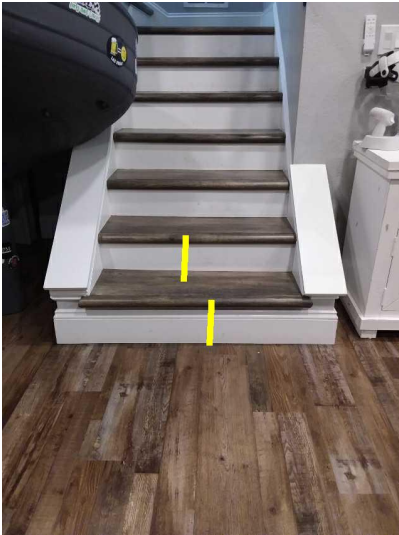
The treads or risers are unequal in depth or height, and could prove to be a trip hazard. The rise should not be less than 4 inches, nor greater than 7 3/4 inches, and the treads should not be less than 11 inches. In addition, the dimensions of the treads and the risers should not exceed 3/8 of an inch of the smallest on the entire run of the stairs.

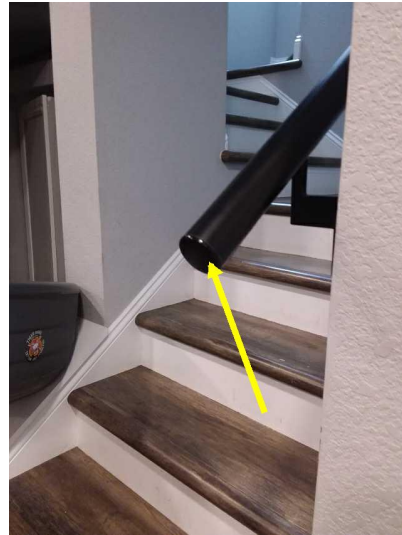
The handrail does not return which is required at the top and bottom of the stairs which is required by current building standards. This condition could allow a purse or clothing to initiate a fall.

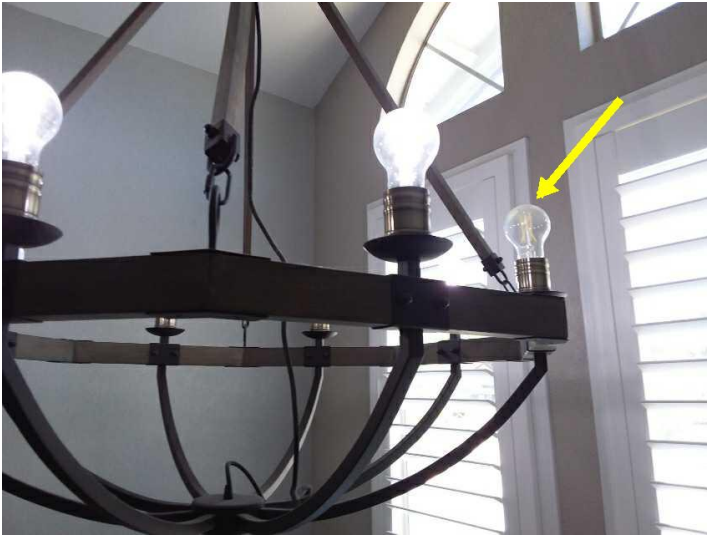
7.7. A ceiling light bulb does not respond, and should be serviced.

A ceiling light bulb does not respond, and should be serviced.

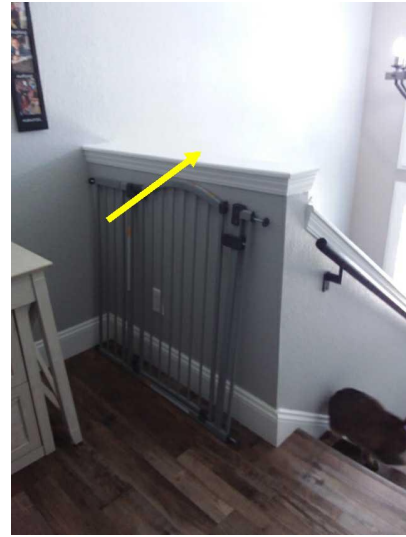
The Guardrail at the top of the stairs is not the recommended 42 inches high when the standing surface is more than 30 inches below.

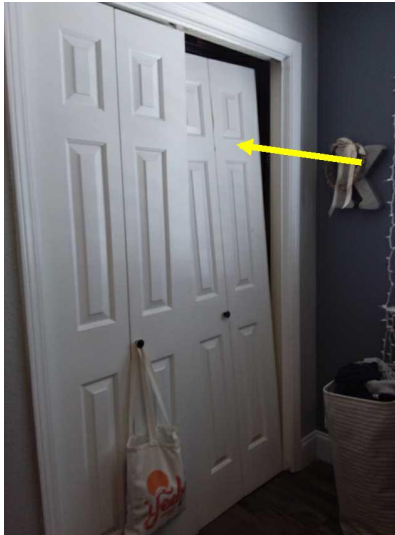
The closet doors do not roll smoothly and should be serviced.

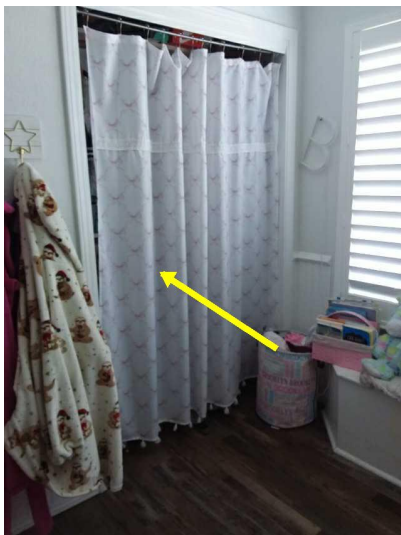
Closet doors are missing and you may wish to have it installed.

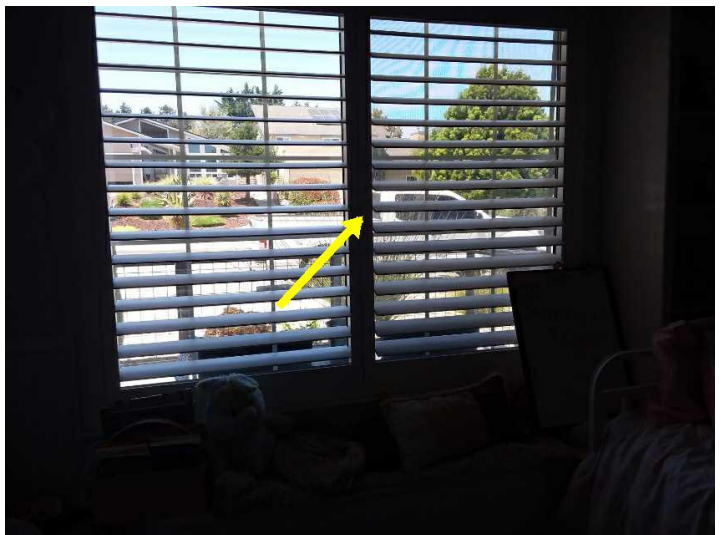
3.5. A lock on the window is missing or does not engage and should be serviced.

A lock on the window is missing or does not engage and should be serviced.

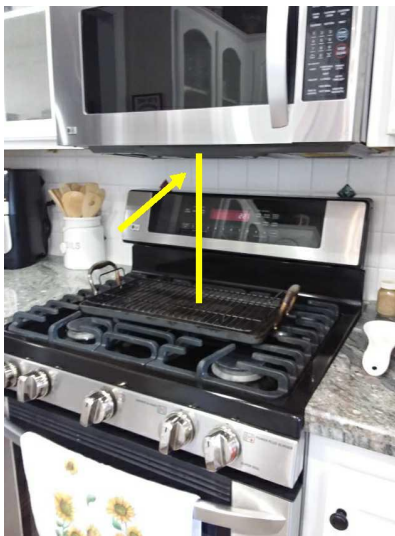
9.2. The range hood exhaust-fan is closer than the recommended 24 inches and should be used with caution.

The range hood exhaust-fan is closer than the recommended 24 inches and should be used with caution.

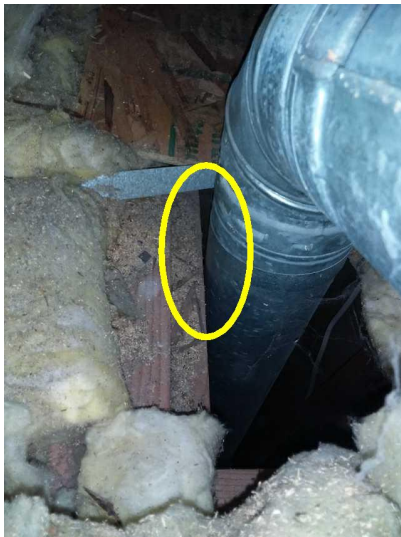
The vent pipe of the gas appliance is too close or in contact with the combustibles and should be serviced. A single-walled vent pipe should be six inches away from any combustible material, and a double-walled type should be one inch away.

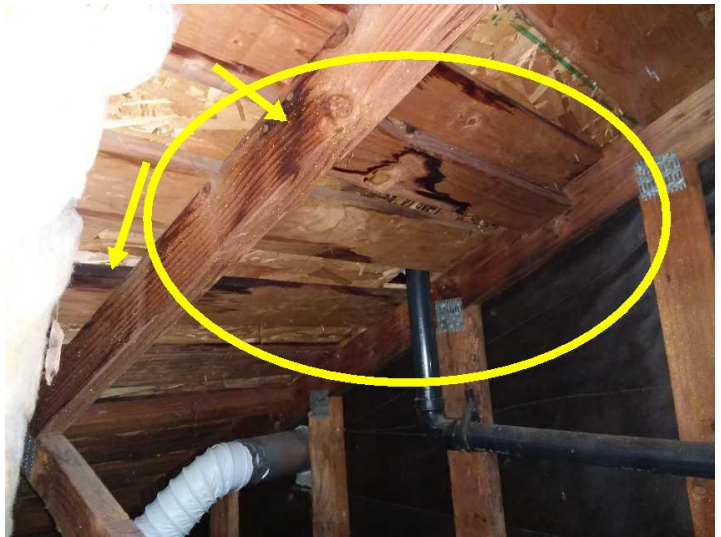
There are moisture stains on the attic ceiling at a roof penetration that indicate a past or present leak. This is a common area for leaks. We are unable to determine if the leak is current, or a past leak, in any case it should be further investigated or explained.

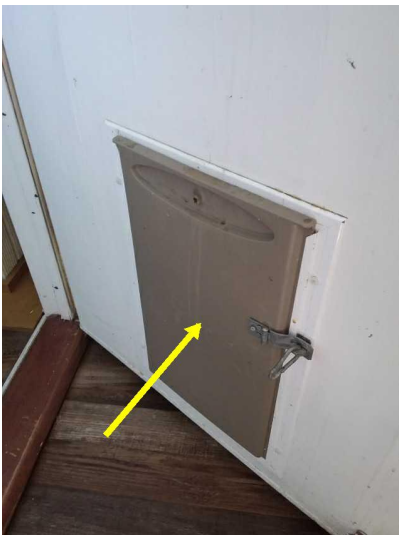
A pet door has been added that violates the firewall and the door should be replaced.

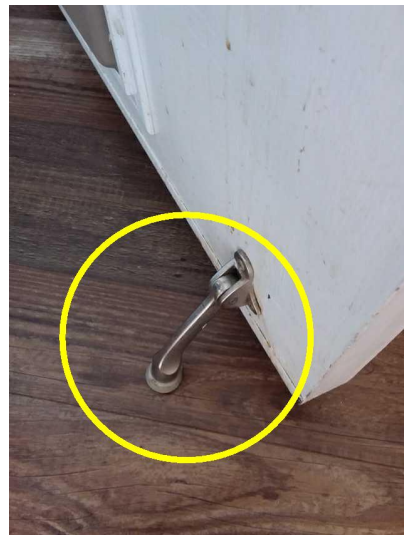
The fire rating of the house entry door has been nullified by the addition of a foot operated door stop.

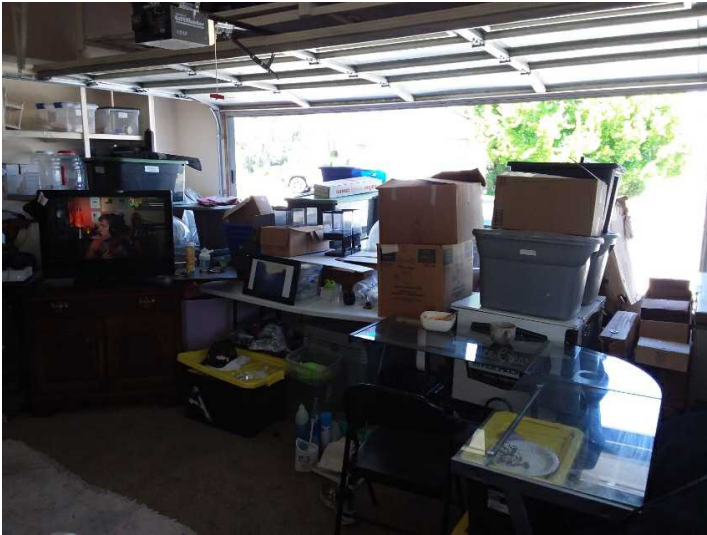
The garage is too full to permit a clear view of the entire slab and other components of the garage.

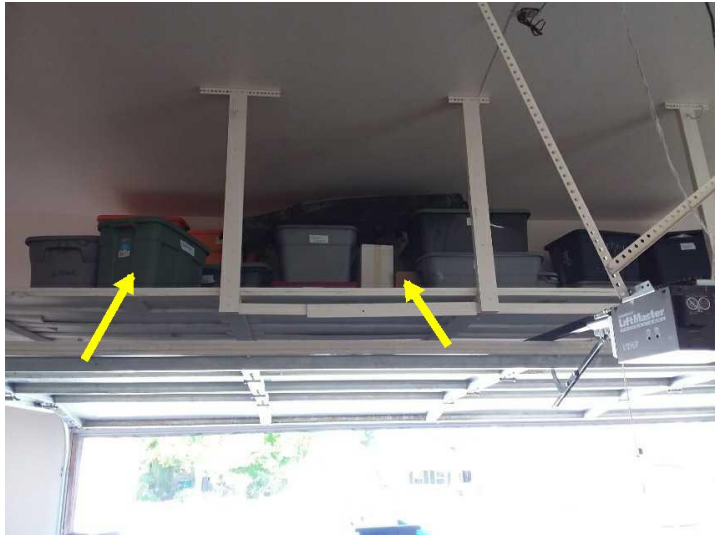
The storage space may have been added without the benefit of a permit, which could stress the roof framing. You may wish to verify this with the sellers. Regardless, you should limit the storage to lightweight items.

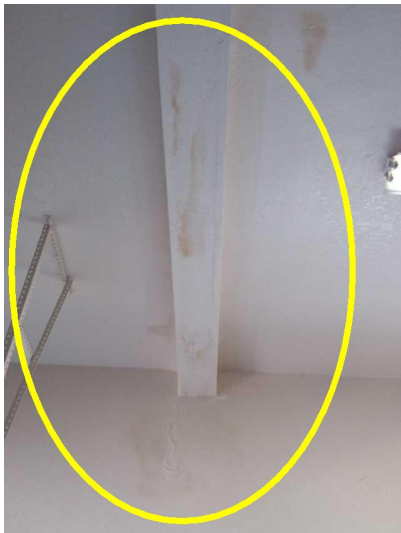
There is a moisture stain on the garage ceiling, the cause of which should be explained or explored further. However, we were not able to confirm that it is being caused by an active leak.

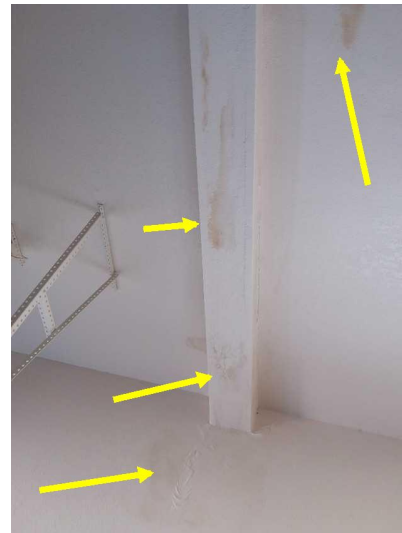
There is evidence of moisture intrusion that you may wish to have further evaluated. It appears to be the result of the above balcony.

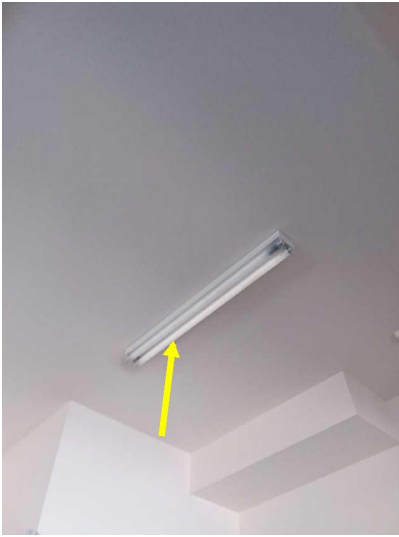
A ceiling light does not respond, and should be serviced.

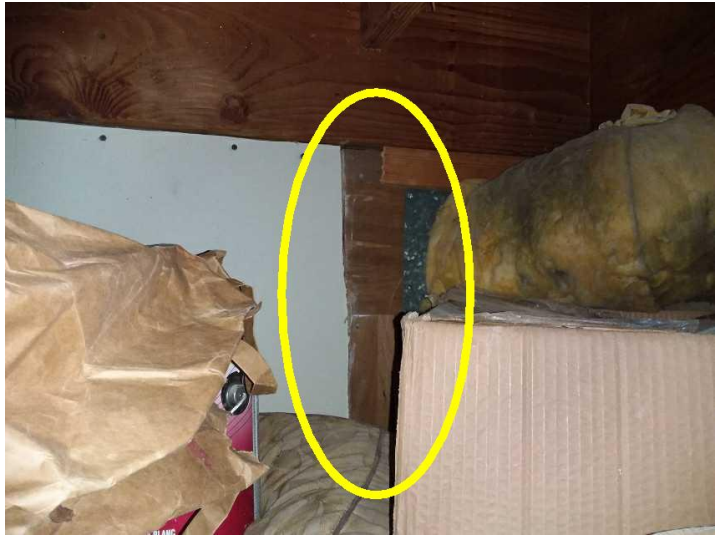
The voids in the garage firewall under stairs must be repaired, in order to maintain the necessary firewall separation between the garage and the residence.
