Report: **96791**

Property Address: **34618 Fremont Blvd. Fremont, CA. 94555**

Inspection Date: **7/28/2026**

## Roof Inspection

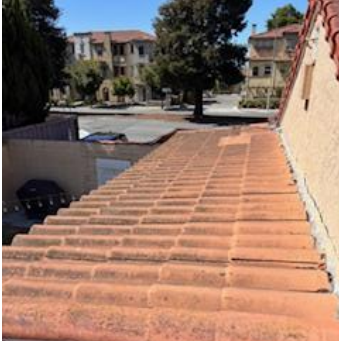
**PHOTO 1**

1. Overviews of the current conditions of the roof and its related components. Photos 2 - 5. Patio cover is not part of this inspection. Photo 1. Style of tiles have been discontinued therefore tiles will be matched as close as possible with what's available at the time of repair.

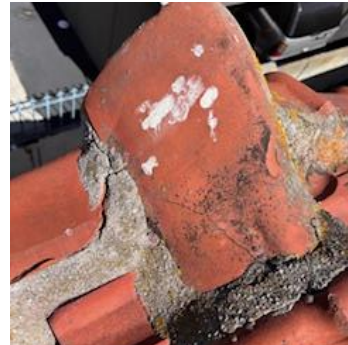
**PHOTO 6**

2. **Finding:** There are approximately 15-20 broken rake/ridge tiles. Photos 6, 17 & 20

**Recommendation:** Repair/replace all the broken tiles.

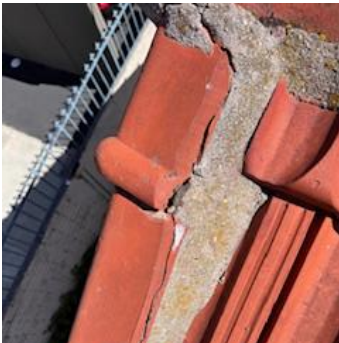
**PHOTO 7**

3. **Finding:** There is cracked or missing mortar at the hip ridges. Photos 7 & 18

**Recommendation:** Repair/seal/replace the mortar as needed.

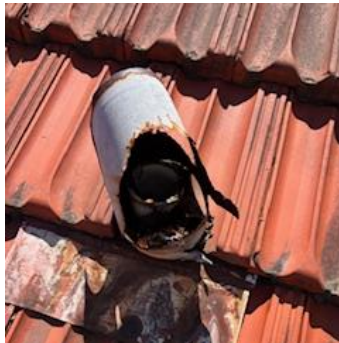
**PHOTO 8**

4. **Finding:** The vent flashing is damaged. Photo 8

**Recommendation:** Replace the damaged vent top.

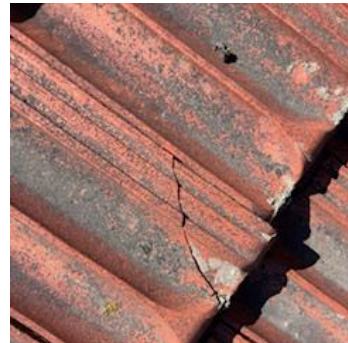
**PHOTO 9**

5. **Finding:** There are 30-40 broken field tiles. Photos 9, 14, 16 & 21

**Recommendation:** Repair/replace all the broken field tiles.

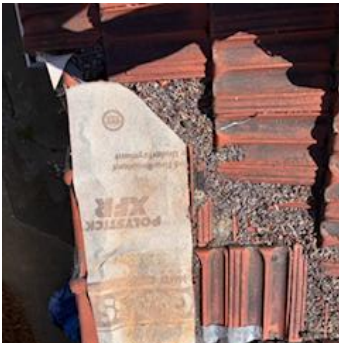
**PHOTO 10**

6. **Finding:** There are improper repairs in the field. Photos 10 & 15

**Recommendation:** Remove improper repairs to further assess damage. If additional damage is found upon removal of improper repairs, a supplemental bid will be issued.

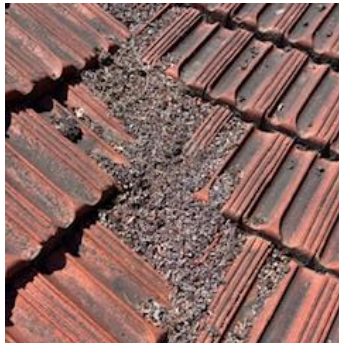
**PHOTO 11**

7. **Finding:** Debris impedes water travel at the valley and roof surface. Photos 11 & 13

**Recommendation:** Clean the debris where needed.

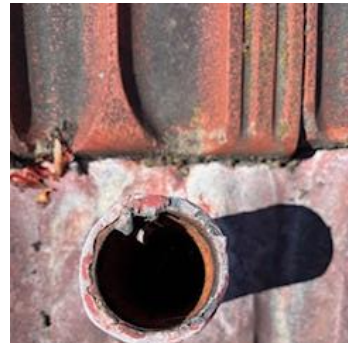
**PHOTO 12**

8. **Finding:** The lead plumbing vent flashing is not properly tucked into the pipe. Photo 12

**Recommendation:** Properly tuck the lead flashing into the pipe.

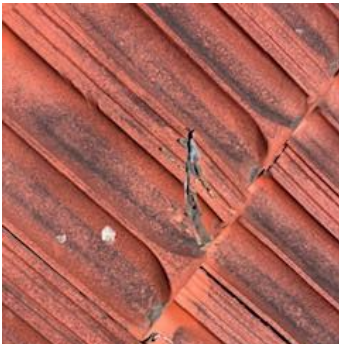
**PHOTO 19**

9. **Finding:** There are previously sealed tiles on the roof. Photo 19

**Recommendation:** Reseal the previously sealed tiles.

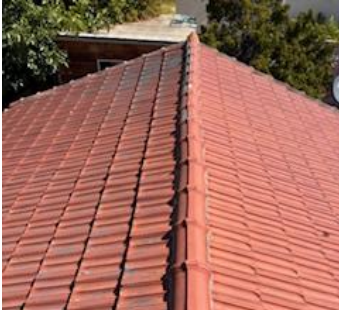
**PHOTO 22**

11. Overviews of the current conditions of the roof and its related components. Photo 22. Patio cover is not part of this inspection. Photo 31

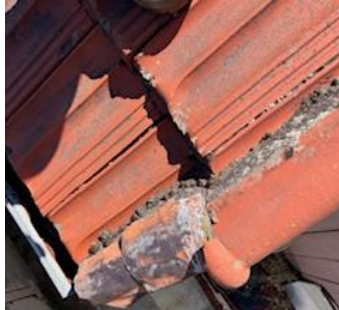
**PHOTO 23**

12. **Finding:** There are (5-10) missing rake tiles. Photo 23

**Recommendation:** Install rake tiles where missing.

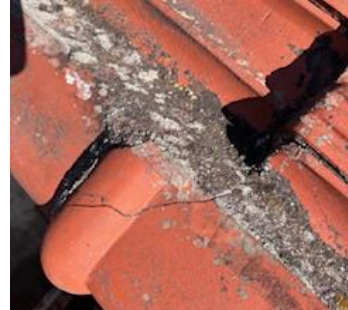
**PHOTO 24**

13. **Finding:** There are (5-10) broken rake/ridge tiles. Photos 24, 25 & 27

**Recommendation:** Replace all the broken tiles.

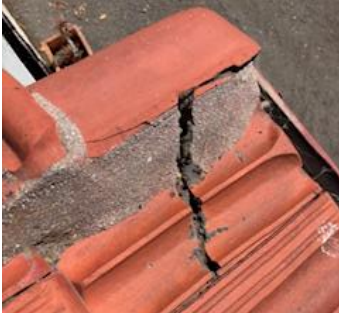
**PHOTO 28**

14. **Finding:** There are (5-10) broken field tiles. Photos 26, 28 & 29

**Recommendation:** Replace all the broken field tiles.

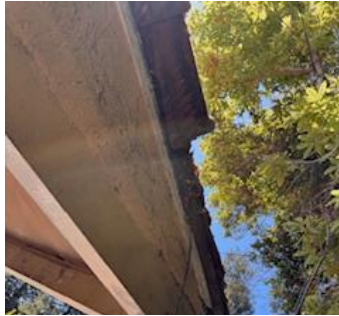
**PHOTO 32**

10. **Finding:** There are (10-15) missing rake tiles. Photo 32

**Recommendation:** Install rake tiles where missing.

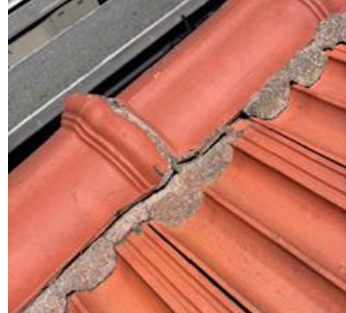
**PHOTO 30**

15. **Finding:** There is cracked or missing mortar at the hip ridges. Photo 30

**Recommendation:** Repair/seal/replace the mortar as needed
