# WOOD DESTROYING PESTS AND ORGANISMS INSPECTION REPORT

| Building Address:<br><b>22026 Crystal Falls Dr., Sonora, CA 95370</b> | | Date of Inspection<br><b>06/09/2026</b> | Number of Pages<br><b>7</b> |
| General Description:<br>Single Family Single Story Manufactured Home Occupied Carpeted Fully<br>Furnished | | Inspection Tag Posted:    Sub Area | |

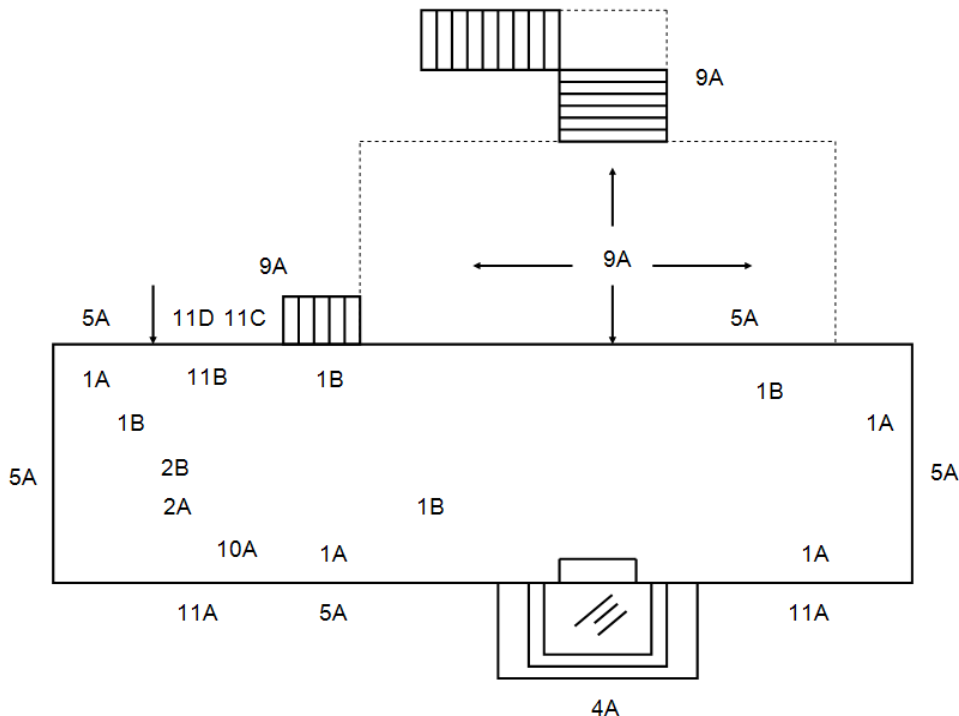
This Diagram is not to scale

1A (Section I)  
FINDINGS: Wood decay fungi is present on the framing.  
RECOMMENDATION: Scrape and treat with TIM-BOR.

1B (Section II)  
FINDINGS: Cellulose debris was found in the subarea. This condition is conducive to subterranean and dampwood termites.  
RECOMMENDATION: Remove and dispose of the cellulose debris large enough to rake in accordance with the Structural Pest Control Regulations.

2A (Section Unknown)  
FINDINGS: The ceiling has been patched in the guest bathroom. The reason for the patch could not be determined.  
RECOMMENDATION: This company offers no in this area.

2B (Section I)  
FINDINGS: Wood decay fungi have infected and damaged the baseboard in the master bathroom.  
RECOMMENDATION: Remove up to 20 lineal feet of baseboard and further inspect the exposed wood members. If no further damage is observed, replace the damaged wood members with new material.

4A (Section Unknown)  
FINDINGS: The underside of the front porch was found to be inaccessible for inspection due to lack of an access.  
RECOMMENDATION: This company renders no opinion in this inaccessible area. If further information is desired several of the tread boards will have to be removed to allow for further inspection.

- 5A (Section I)  
FINDINGS: This structure has louvered foundation vents that can restrict airflow into the subarea.  
RECOMMENDATION: Replace the existing foundation vents with wire mesh vents to increase airflow into the subarea.

- 9A (Section I)  
FINDINGS: Wood decay fungi has infected and damaged the wood treadboards, support joists, girders and steps.  
RECOMMENDATION: Due to extent of damage this company recommends removing and replacing the entire wood deck with new pressure treated and redwood material.

- 10A (Section I)  
FINDINGS: Wood decay fungi has infected and damaged the subflooring of the small storage area in the laundry room and extends behind the cabinet in the adjacent bathroom.  
RECOMMENDATION: Remove up to 16 square feet of subflooring and further inspect the exposed wood members. If no further damage is observed, replace the damaged wood members with new material and install new waterproof laminate flooring in the laundry room. Reinstall the existing cabinet.

- 11A (Section I)  
FINDINGS: Open voids were noted at the exterior strucco at the windows. This condition can contribute to the damage described in Item 10A.  
RECOMMENDATION: Seal the open voids as needed with a waterproof sealant.
- 11B (Section II)  
FINDINGS: Water stains were found on the ceiling.  
RECOMMENDATION: A licensed roofing contractor should be contacted to inspect and make necessary repairs.
- 11C (Section I)  
FINDINGS: Wood decay fungi have infected and damaged the subflooring in front of the water heater.  
RECOMMENDATION: Remove up to 3 square feet of subflooring and further inspect the exposed wood members. If no further damage is observed, replace the damaged wood members with new material.
- 11D (Section II)  
FINDINGS: The water heater pressure relief valve is expelling into the subarea.  
RECOMMENDATION: Reroute the drain to expel to the exterior.
