Property Address: 1857 Potomac Ave

## PRIVATE SEWER LATERAL INSPECTION REPORT OBSERVATION CODES

## LATERAL INSPECTION LOG

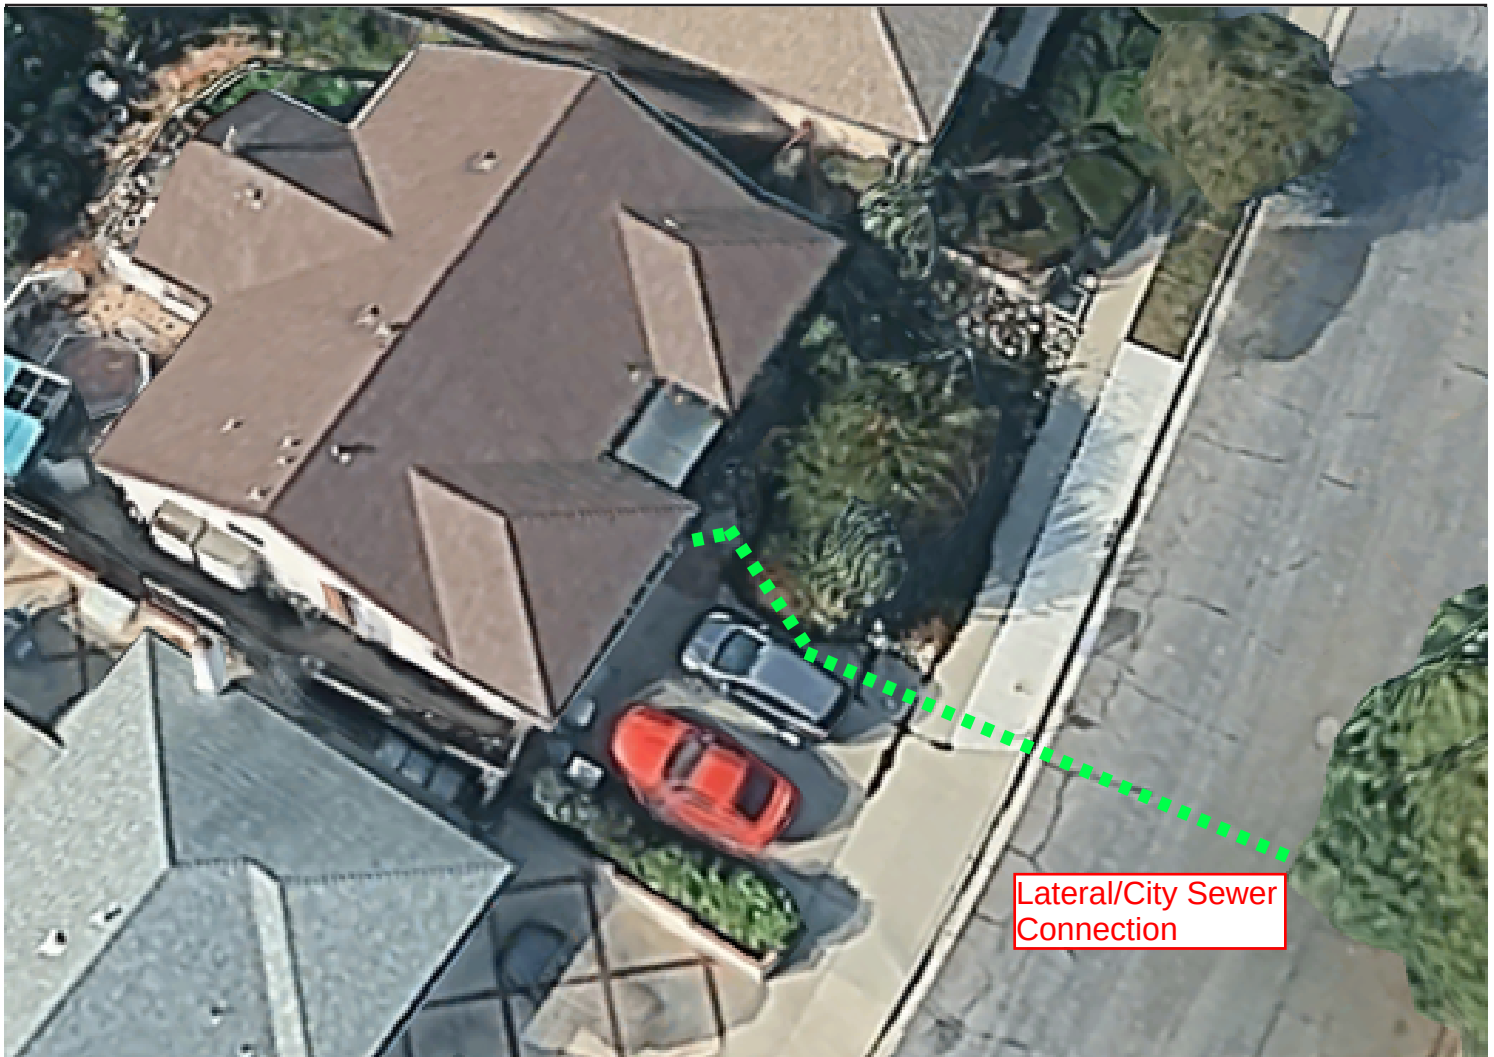
## SITE SKETCH

| CODE | DISTANCE | OBSERVATION |
|---|---|---|
| | | Below measurements taken from 1-1/2" undersink drain in the bathroom on the right side of the house. |
| | 29' | Start of ABS lateral. Cleanout is buried. |
| CP | 57' | ABS to clay pipe connection. |
| | 87' | Lateral to city connection. End of inspection. |
