# Inspection Report

**Cynthia Fowler**  
**503 N. Via Belmonte**  
**Arroyo Grande, CA 93420**

Report Date: 8/4/2026

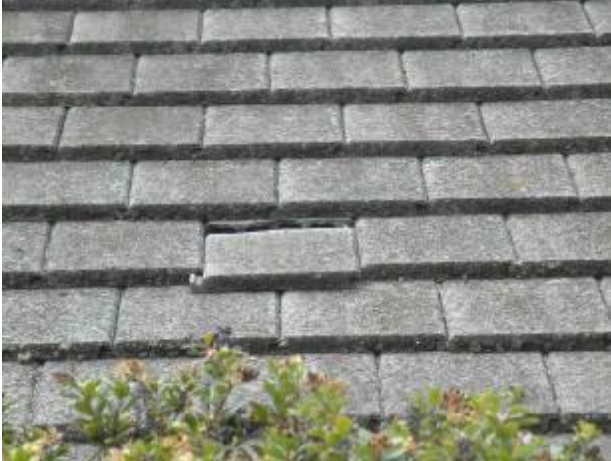
- 1.) There are two cracked and displaced roof tiles at the north facing slope.

Cracked and displaced roof tile on the north facing slope.

1.) There are two cracked and displaced roof tiles at the north facing slope.

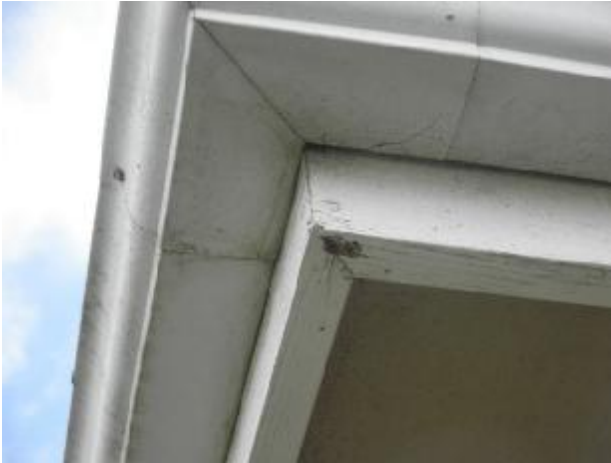
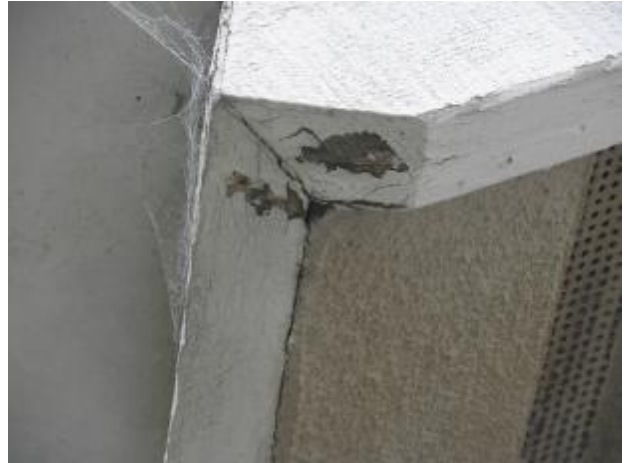
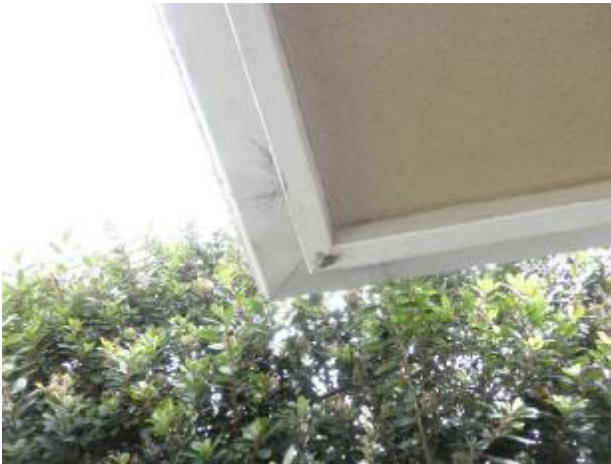
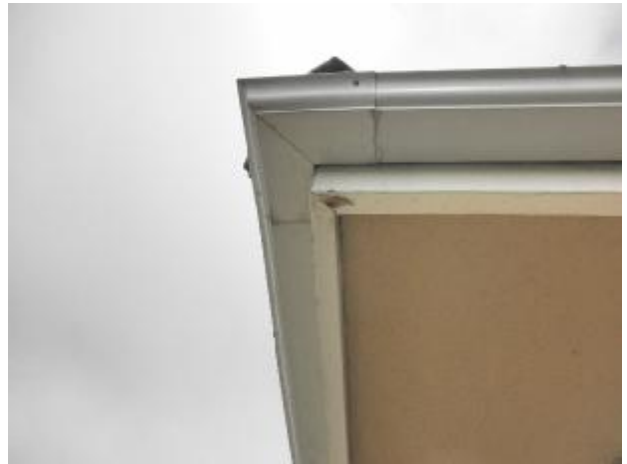
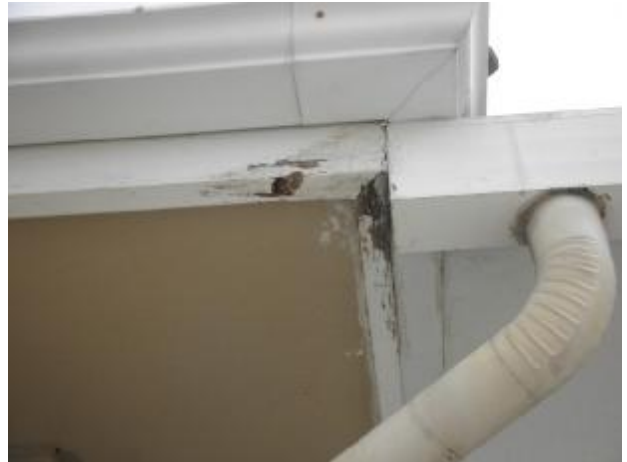
3.) There is moisture damage in multiple locations and the outside corners of the roof. (See photos) Refer to the Pest Control Report for a full accounting of this damage.

Example of the moisture damage to the fascia boards at the outside corners of the roof.

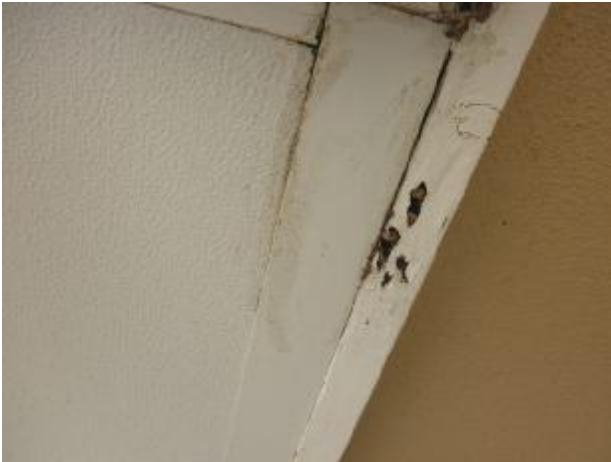
4.) There is evidence of possible drywood termite infestation/damage to the fascia board on the west side of the garage. This condition is recommended to be evaluated by a qualified and licensed Pest Control inspector prior to close of escrow.

Evidence of possible termite infestation/damage to the fascia board on the west side of the garage,

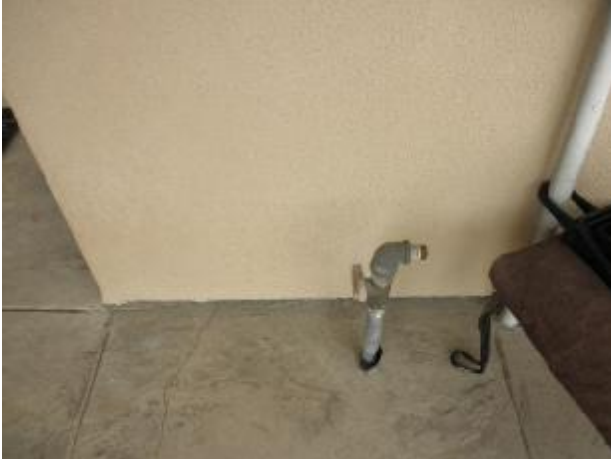
Recommend capping off the unused gas valve at the backyard patio.

**Safety Hazard Note:** Recommend capping off the unused gas valve at the backyard patio.

**Safety Hazard Note: Recommend capping off the unused gas valve at the backyard patio.**

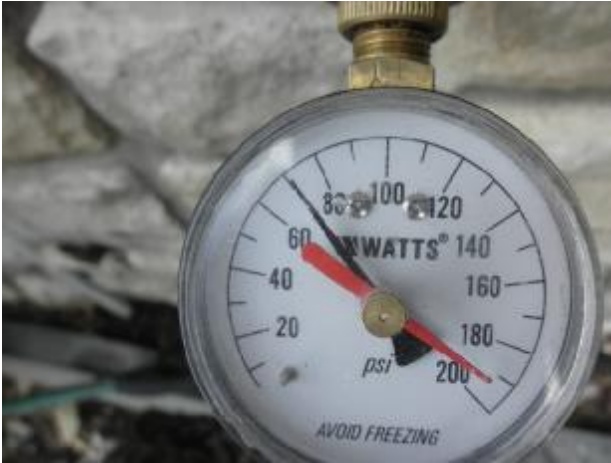
Information Note: The water pressure was measured at 70 psi. This is within a normal and acceptable range.

The water pressure was measured at 70 psi.

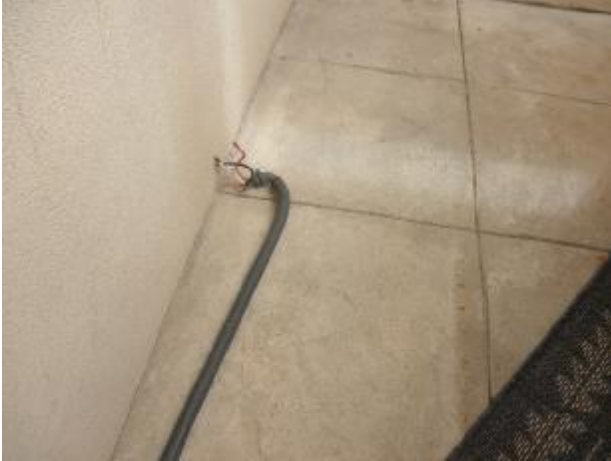
**Safety Hazard Note:** There is some exposed electrical wiring laying on the ground at the backyard patio where a spa was removed. This wiring should terminate in an approved outdoor rated junction box.

Electrical wiring on the ground at the backyard patio should terminate in a junction box.

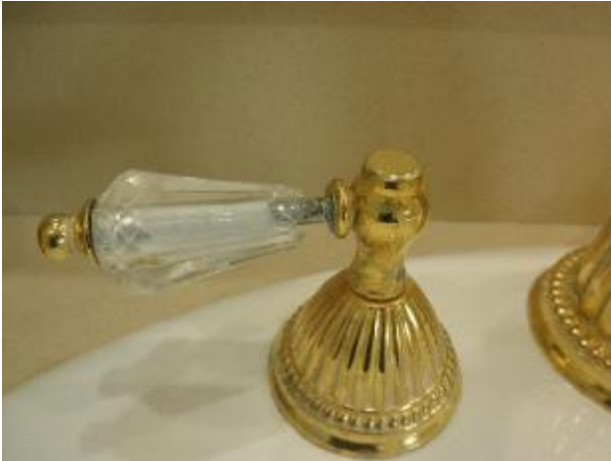
**Damaged faucet handle in the master bathroom.**

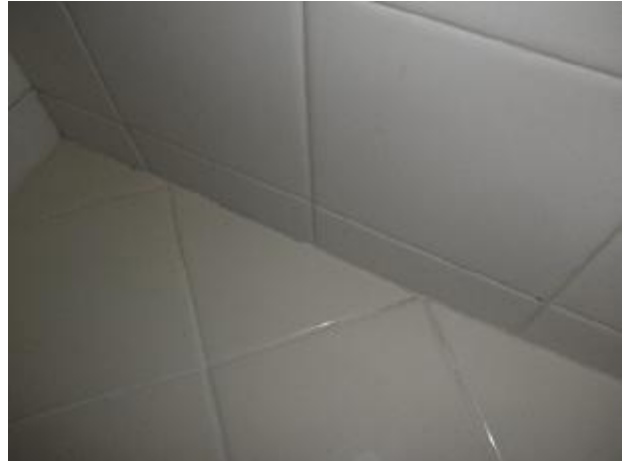
**Minor grout work needed at the hall bathroom shower.**

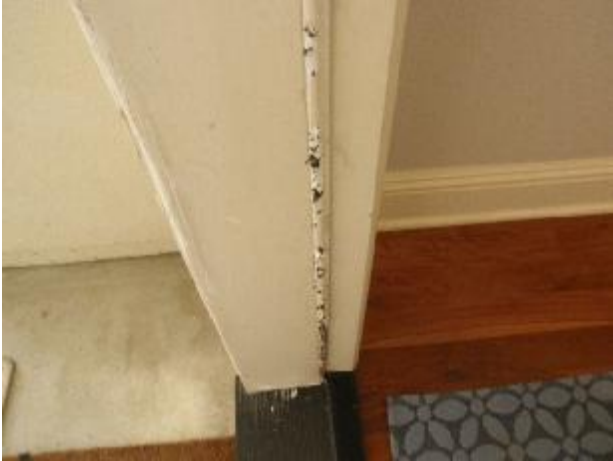
1.) There is damage to the weather stripping at the garage fire door.

Damaged weather stripping at the garage fire door.

- 1.) There is damage to the weather stripping at the garage fire door.
