### *Inspection Report*

Address: 1363 Black Sage Cir Nipomo, CA 93444

07/29/2026

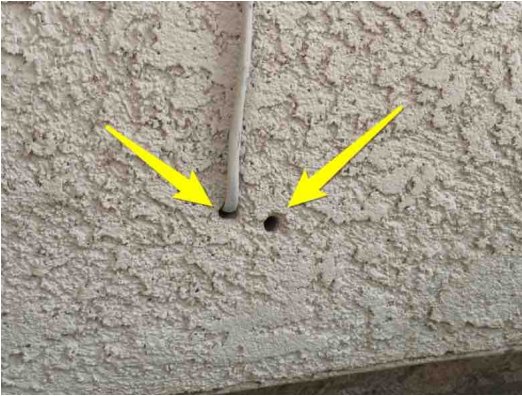
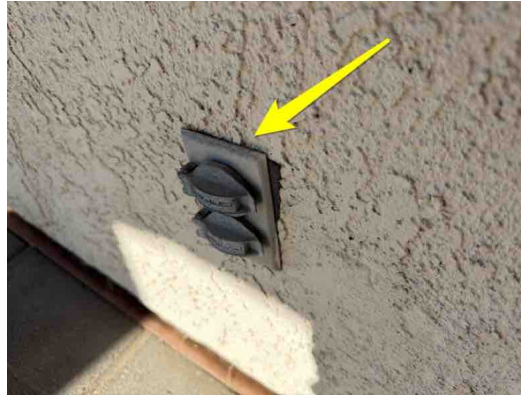
**MR 35:** Recommend sealing holes in exterior walls to prevent water intrusion around areas such as unused open holes in the exterior siding and trim, exterior light fixtures, around exterior electrical boxes and covers, and where utility pipes and/or wires pass through the exterior walls. Have a qualified painter or licensed professional evaluate the entire exterior and seal where needed.

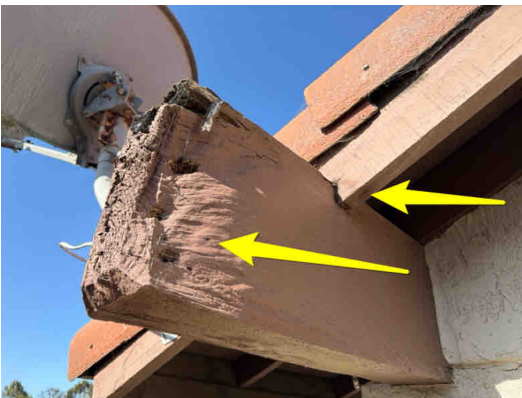
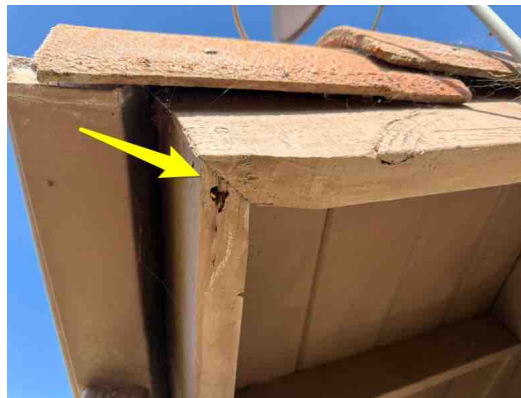
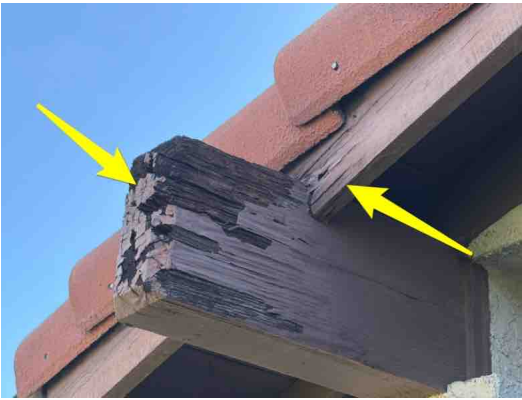
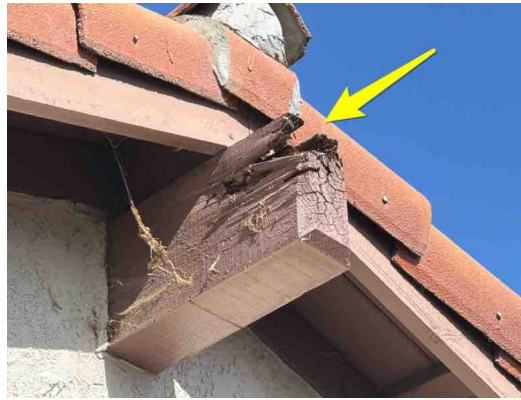
**E&C 39:** Some moisture and/or bug type damage & deterioration found at exterior areas such as eaves, fascia and/or trim. Refer to the termite report for locations and extent.

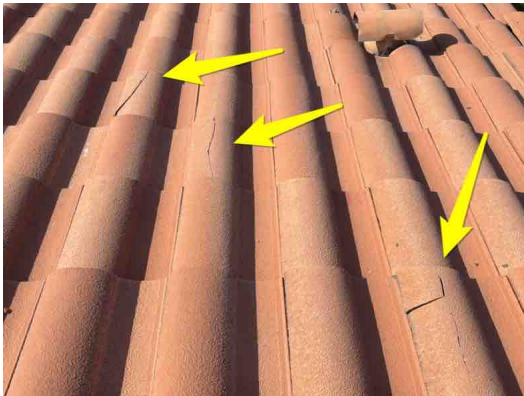
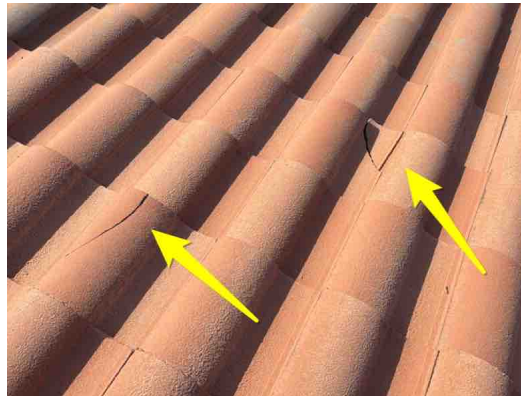
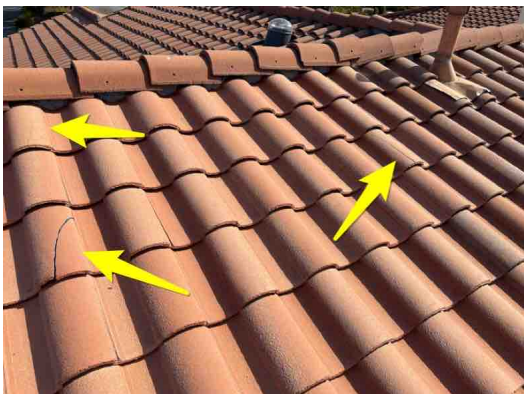
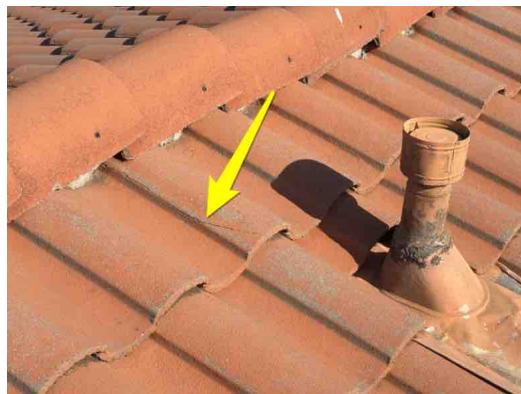
**E&C 50:** Multiple cracked and damaged roof tiles needing repair or replacement. Contact a licensed roofing contractor for further evaluation of the roof and to determine location(s) and quantity of the roof tiles needing repair or replacement.

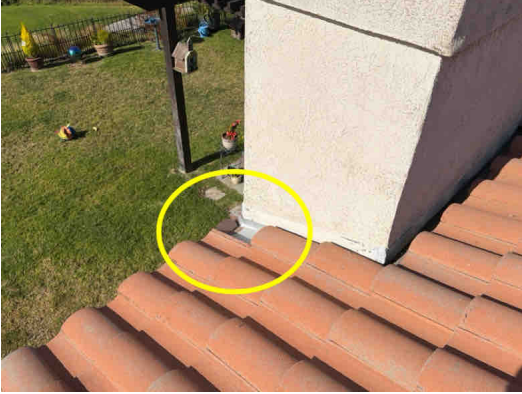
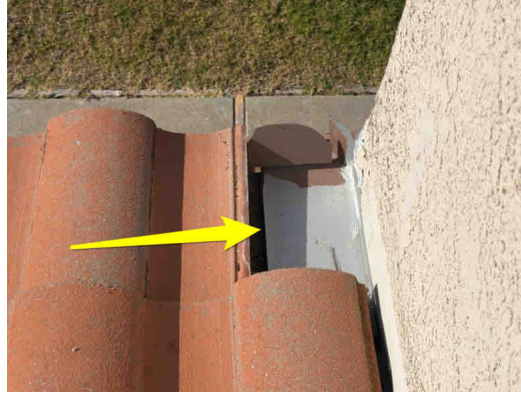
**E&C 51:** A missing roof tile found NEAR THE FIREPLACE CHIMNEY. Contact a licensed roofing contractor for repair or replacement.

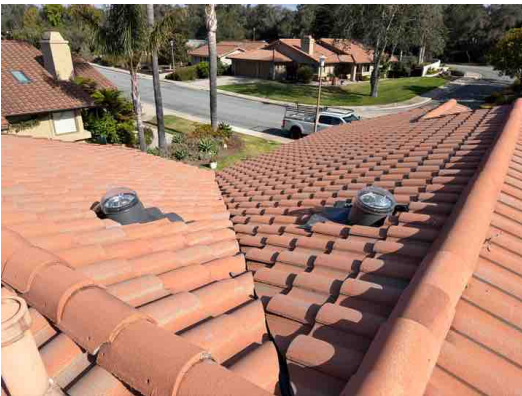
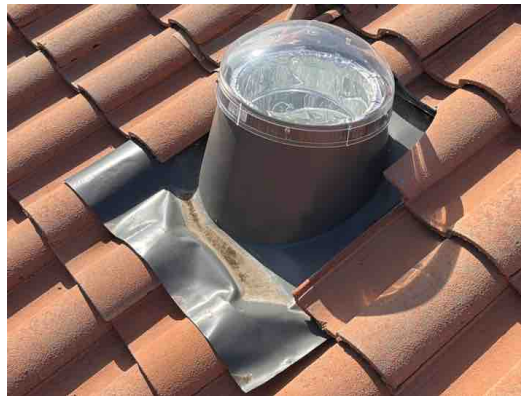
**E&C MR 52: ROOF FLASHING CONDITION:** Some roof flashing were found to be needing maintenance, servicing and/or repair. Contact a qualified roofing professional to review all roof flashings and provide maintenance and/or repairs as needed.

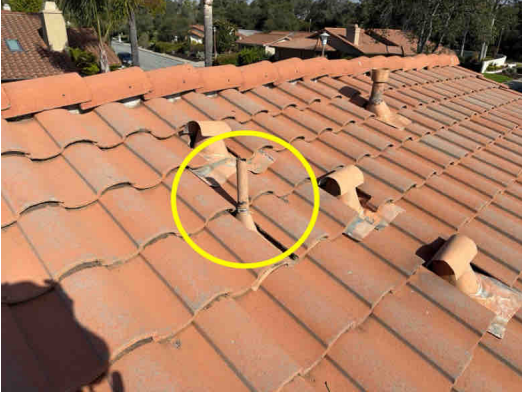
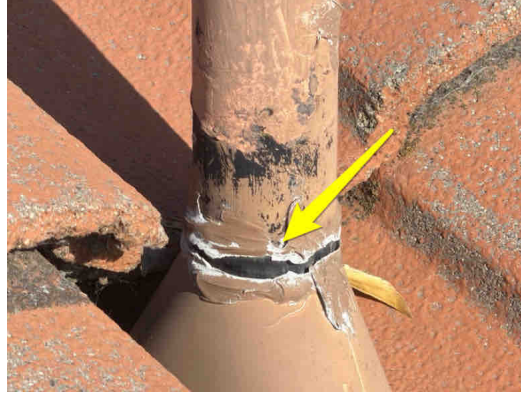
**MR 53:** Deteriorated sealant at some roof flashings, around the roof penetrations. Maintenance recommended to help prevent water intrusion into areas of the attic. Have roofer evaluate the roof flashings and correct as needed.

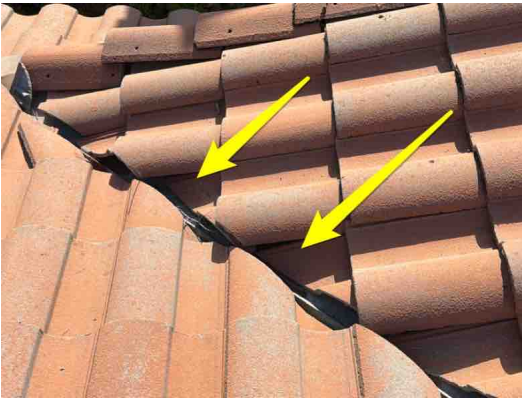
**E&C 54:** Evidence of some loose roof tiles improperly installed in the roof valley flashings (Missing the required batten extenders with the use of a single crown valley flashing). This allows the tile to drop onto the valley flashing causing damming of the water and may create a roof leak.

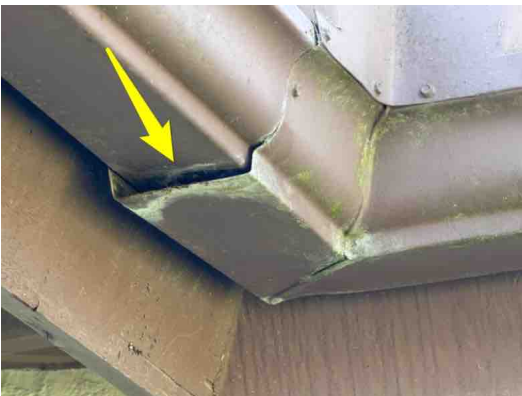
**MR 63:** Recommend some typical rain gutter maintenance. This should at minimum consist of cleaning, sealing, and re-fascinating of loose gutters and downspouts.

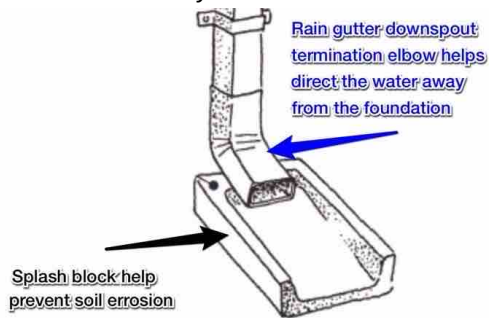
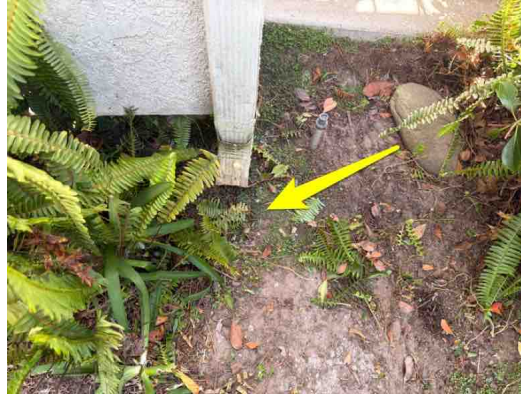
**MR 64:** Recommend splash blocks and diverting the rain gutter downspouts at the bottom to assist in proper flow of roof water away from the house and to help prevent soil erosion where not installed.

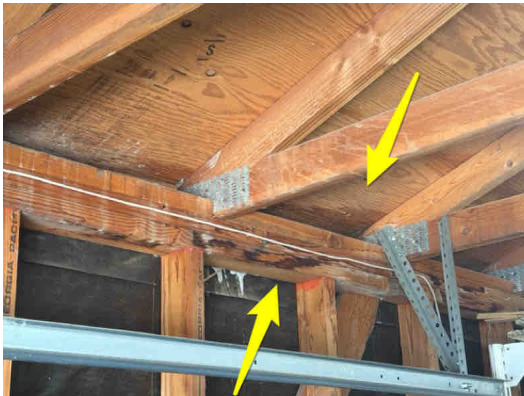
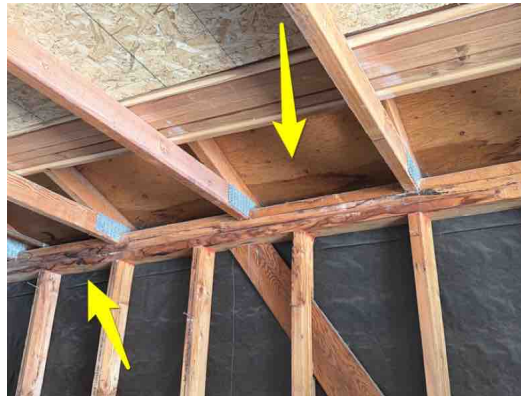
**FI DS 65:** Some minor and moderate moisture stains noted in areas throughout the attic. All water stains should be investigated by a licensed roofer. Refer to termite report for additional comments and/or recommendations.

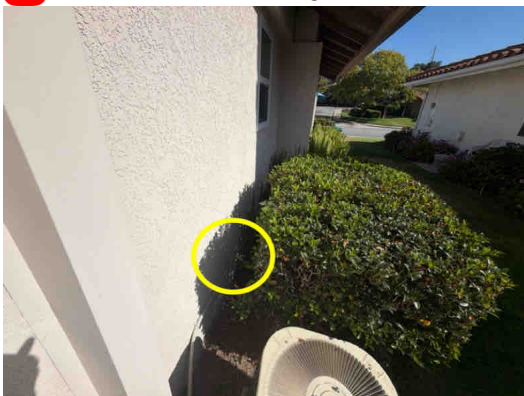
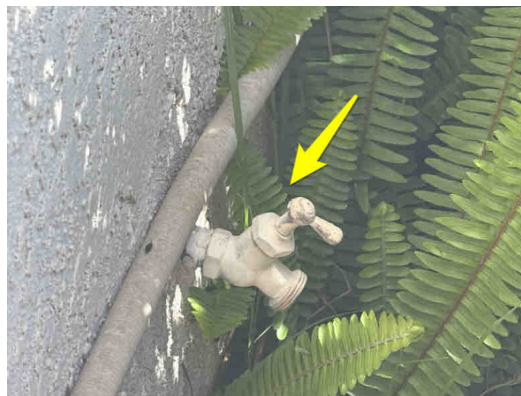
**E&C** **73:** Broken or Missing handles at some exterior hose faucets: EAST SIDE

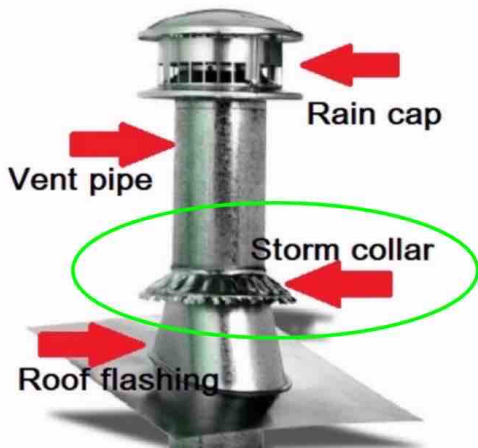
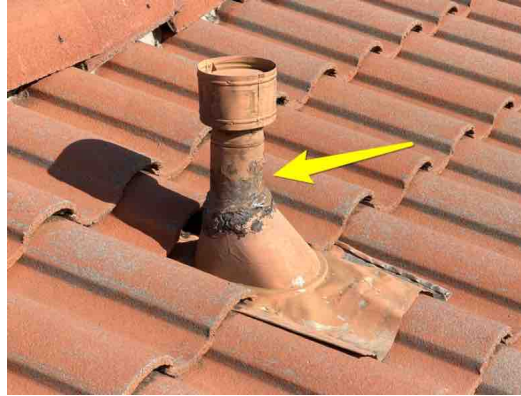
**E&C 87:** Missing / Recommend a proper storm collar per standards at the water heater vent pipe at the roof termination.

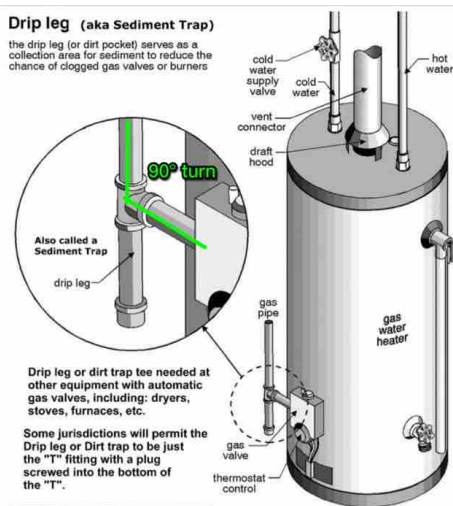
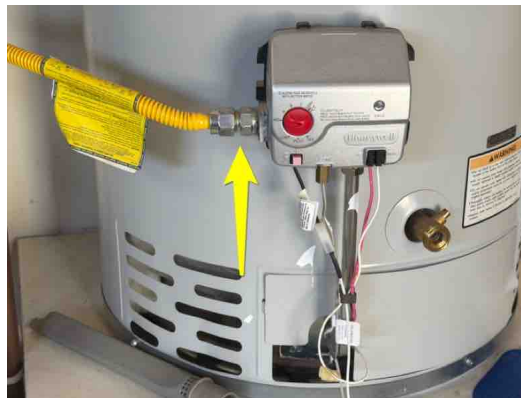
**SU 91:** Recommend the installation of the missing sediment trap / drip leg at the WATER HEATER gas piping at flex connection by a certified or licensed plumbing professional familiar with minimum requirements. [CPC 1212.8]

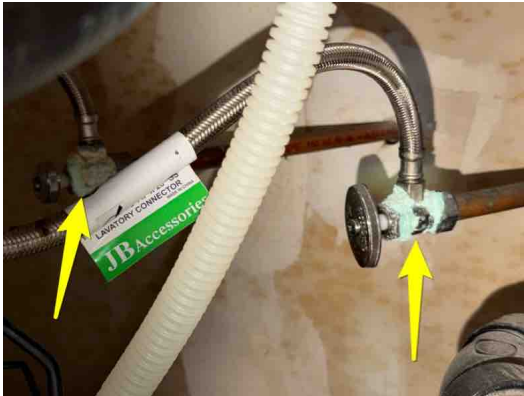
**FI 100:** Some corrosion found at the water supply shutoff valves under the Kitchen sink / evidence of past leaking. Client should investigate further until satisfied as to the cause, condition and potential future issues. Correction Recommended.

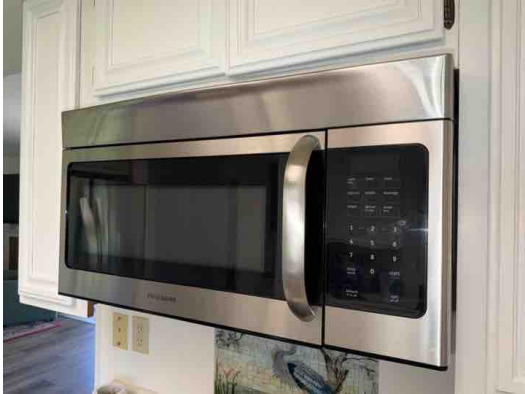
**E&C 111:** The kitchen Microwave trips a breaker when opened during operation indicative of a short inside the unit. Contacted qualified Professional for evaluation and repairs.

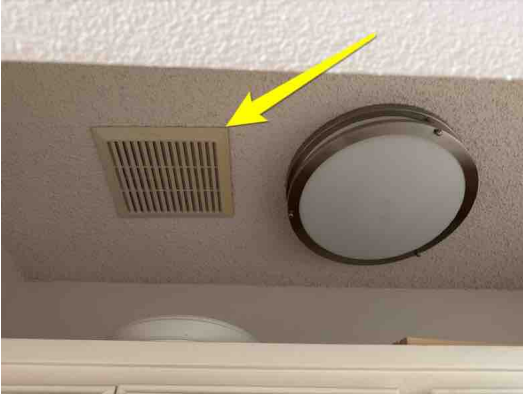
**E&C 116:** Laundry room exhaust fan DID NOT OPERATE when tested.

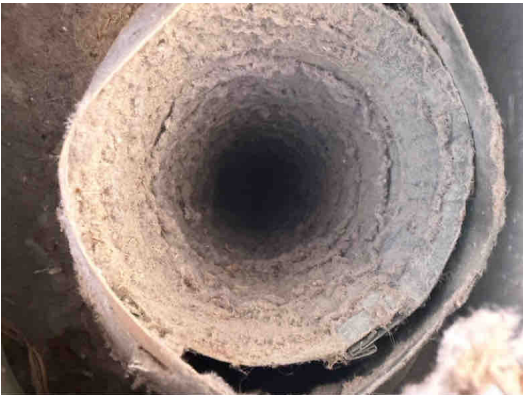
**MR 120:** Recommend cleaning and servicing the laundry dryer vent system, pipe and cap, for safety as part of typical ongoing maintenance.

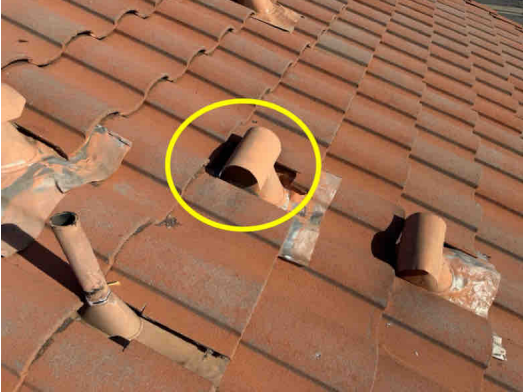
**SU 121:** Recommend upgrading to a proper flapper type laundry dryer vent termination cap. This will help to reduce the risk of critter, rodent or bird intrusion into the laundry dryer vent system.

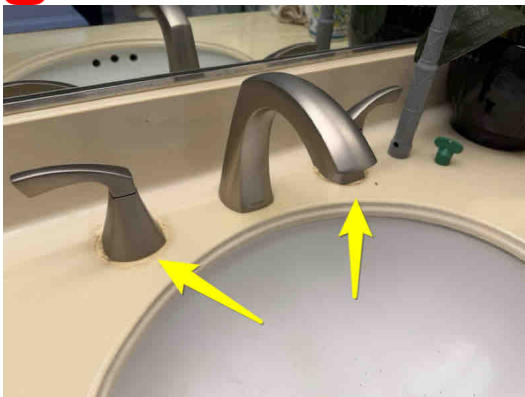
**FI 130:** The HOT and COLD water found non-operational at the bathroom sink faucet: HALLWAY BATHROOM

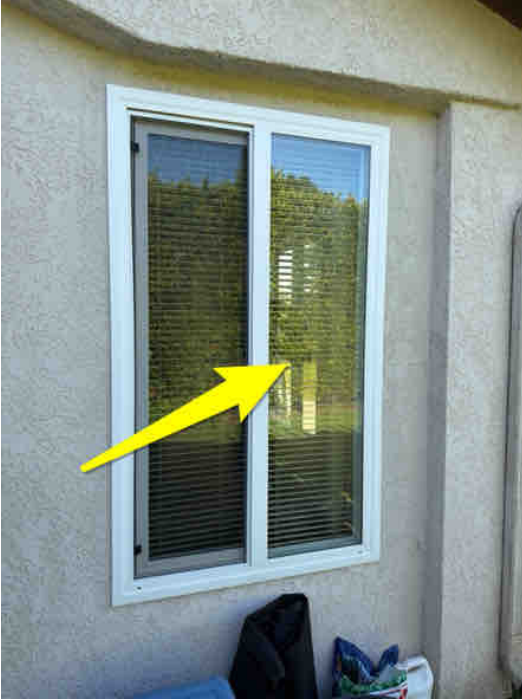
**DS 144:** Some of the dual-pane window seals have failed and are visibly fogged or have a defective UV film. If concerned have all windows tested by a licensed or certified window company professional to determine exact locations and quantity of defective windows.

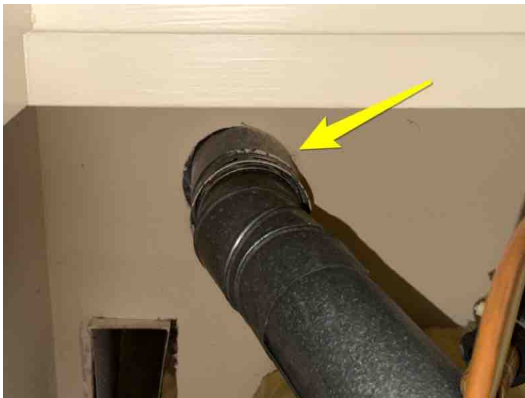
**E&C 159:** Furnace / water heater combination vent pipe lacks proper clearance to combustible material through the drywall ceiling. A minimum of 1 inch of space between the vent pipe and combustibles is needed per minimum standards.

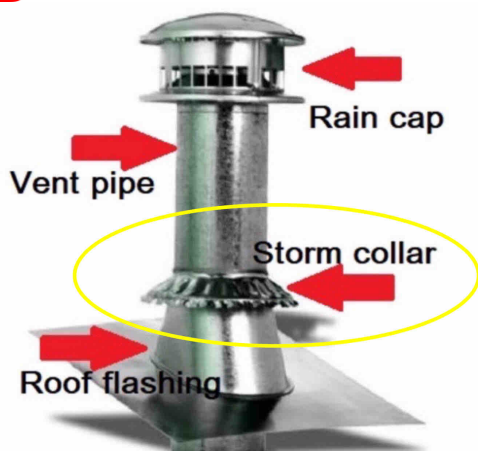
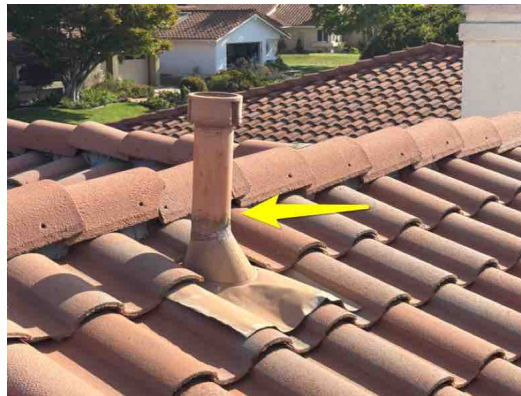
**E&C 160:** Missing / Recommend a proper storm collar per standard at the furnace vent pipe at the roof termination.

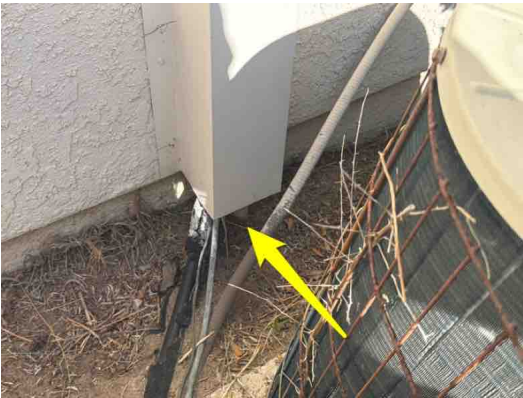
Recommend sealing the wall penetration with an approved material to help prevent moisture, pest intrusion, and air leakage.

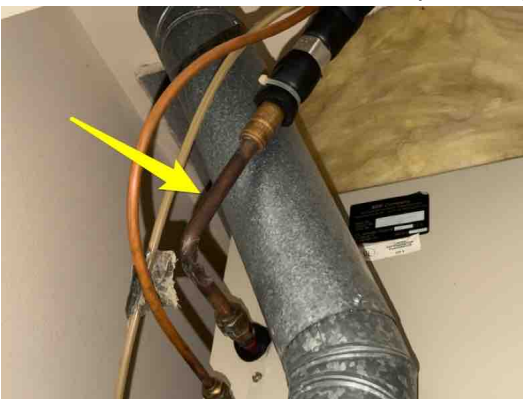
**E&C 171:** Insulation damaged or missing at areas of the Air Conditioner refrigerant piping near or at the coil. This allows water to condensate and drip causing water stains and/or damage. Repairs or additional insulation needed.

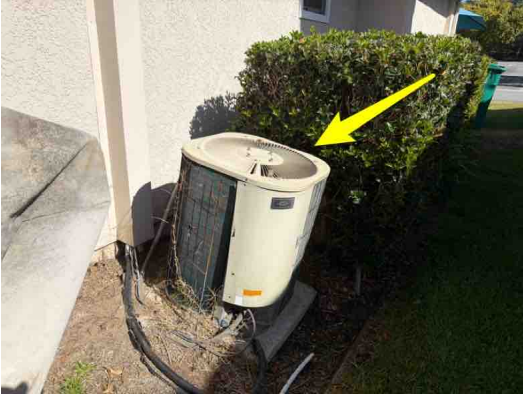
**E&C** **MR** **172:** The air conditioner condenser pad is not sitting level per requirements. Corrections recommended.

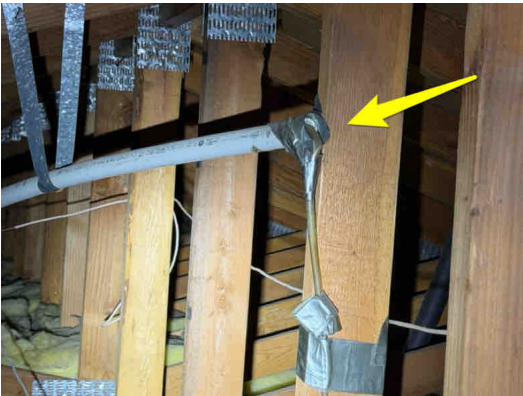
**E&C** **175:** Improper installation of the Air conditioner condensate drip piping in the ATTIC. Too many defects list recommend evaluation and repairs by a qualified HVAC professional familiar with minimum installation standards for condensate lines.

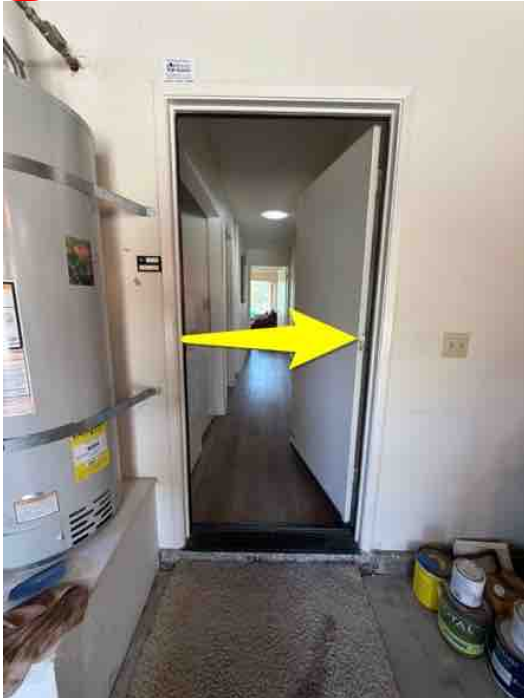
**SC 194:** Self-closer is non-operational at garage fire rated door to the living space.

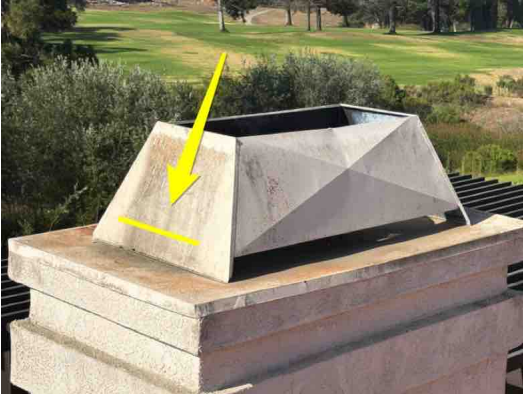
**SU 208:** Improper use and installation of a non-UL listed decorative surround atop the chimney. All UL listed four sided surrounds require a 4 inches air inlet opening on all four sides of the surround at the bottom. This surround only has opening on two sides. This can negatively affect the drafting of the chimney. Proper repairs are warranted per standards. Recommend having a qualified professional open the two sides, easy repair.

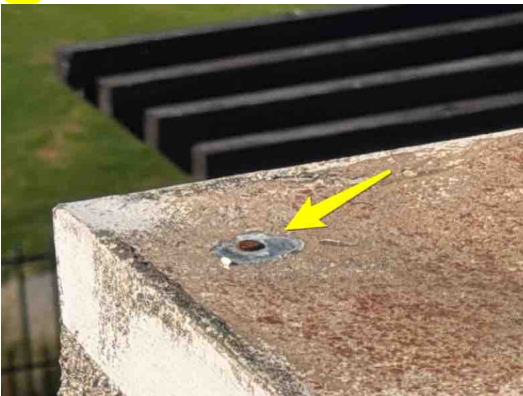
**MR 209:** Recommend resealing the fasteners at the metal fireplace chimney chase cap.
