# Inspection Report

**Property Address:**  
503 Red River Dr  
Paso Robles CA 93446

8/4/2026

**Harper Homes: Home Inspection Services**

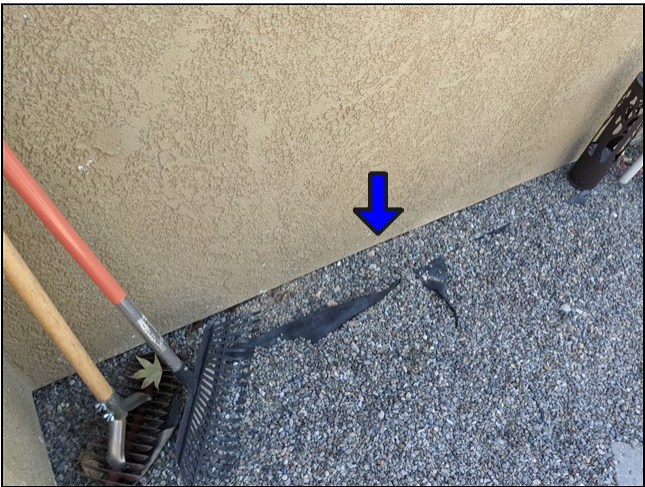
1.0 Item 1(Picture)

Soil or landscape materials are pushed up against the stucco siding at various areas around the home. Landscape maintenance is needed to remove material from holding moisture at the siding while maintaining functional drainage away from the foundation.

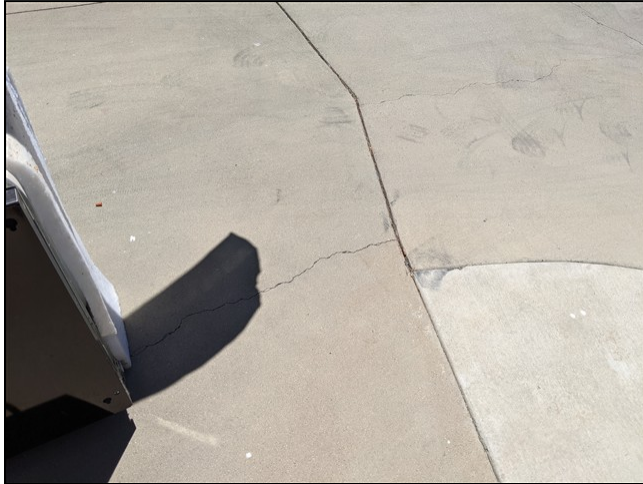
1.2 Item 1(Picture)

Concrete cracks were noted on the walkways, likely due to tree roots or expansive soil. Walkway cracking is

not affecting the structure. Any walkway height variance over 3/4" should be altered or repaired to prevent a possible trip hazard.

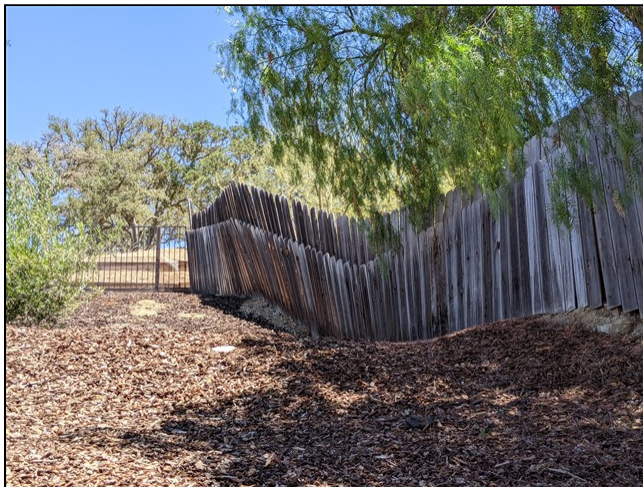
1.3 Item 1(Picture)

Loose or damaged fence posts were noted and sections of the fence are loose and leaning. Fence repairs can be made, as needed.

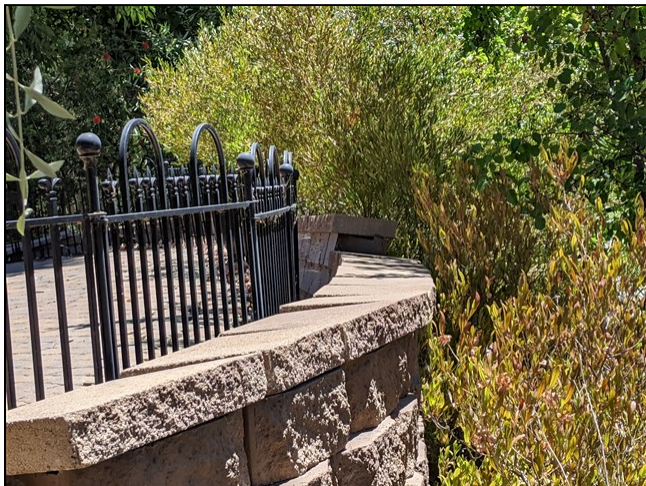
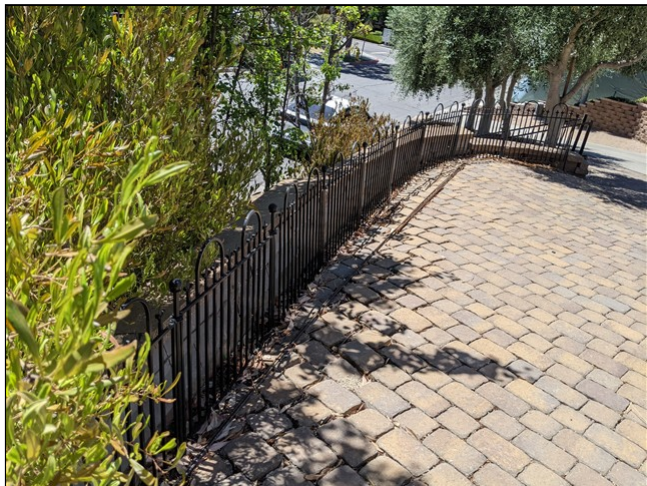
Landscape retaining wall at the front driveway is leaning and alterations or repairs should be made as needed.

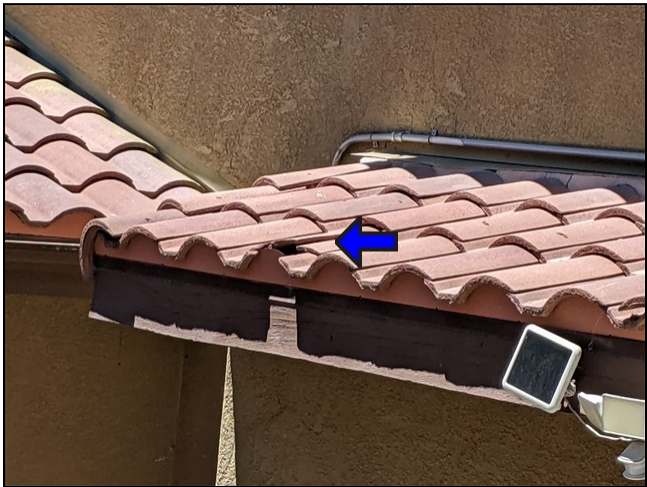
2.0 Item 1(Picture)

One damaged tile was noted on the roof, and should be replaced to prevent weather exposure at the roofing paper and a possible future leak.

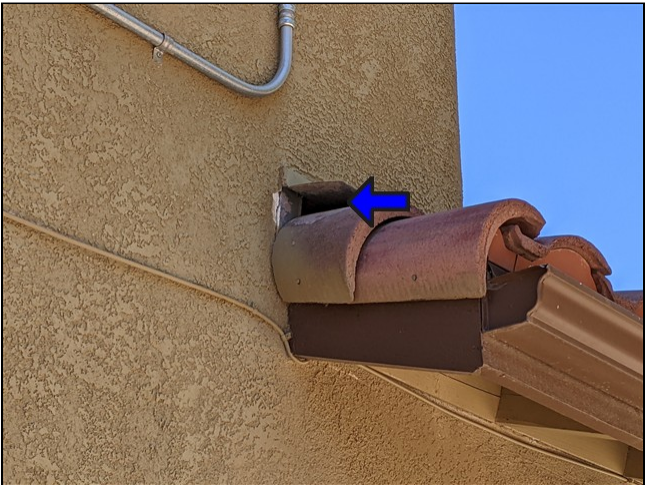
2.1 Item 1(Picture)

Metal roof flashing is lifting and gaped at right exterior allowing possible moisture intrusion. Recommend all flashings be secured or altered as needed.

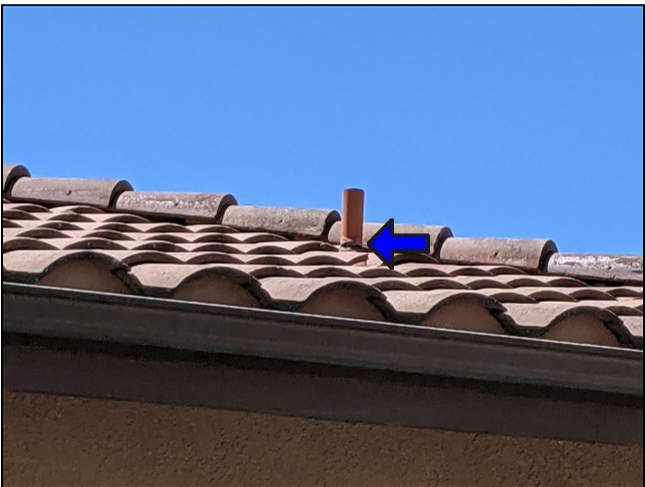
2.2 Item 1(Picture)

Plumbing vents need resealed at the roof.

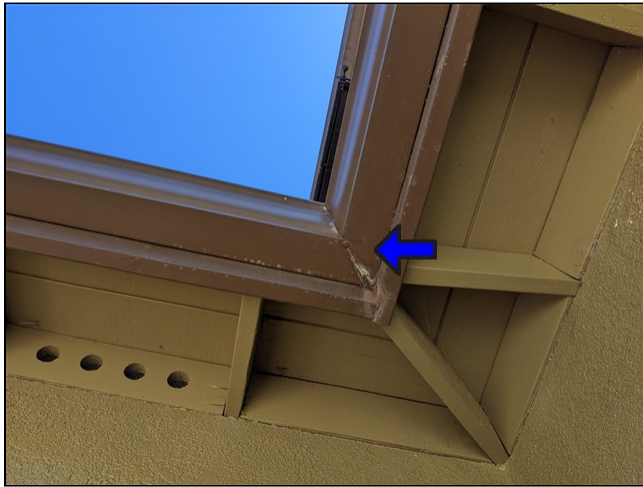
2.3 Item 1(Picture)

Gutter seams show signs of leaking. Recommend cleaning and sealing the seams with gutter sealant to prevent continued moisture exposure at the fascia.

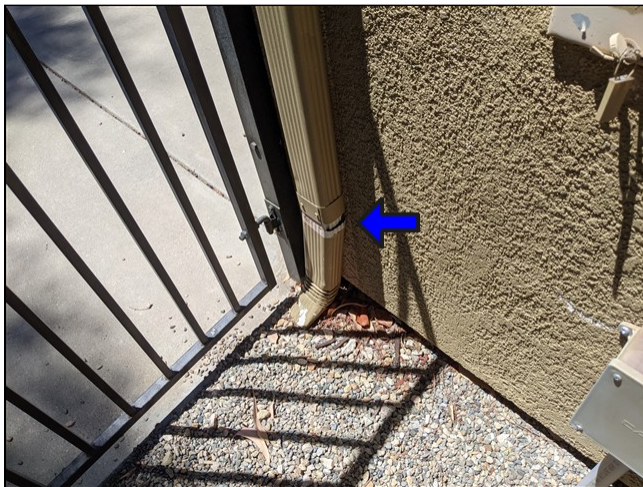
2.3 Item 2(Picture)

Downspout at the front right corner needs properly connected to the drain line to insure intended drainage.

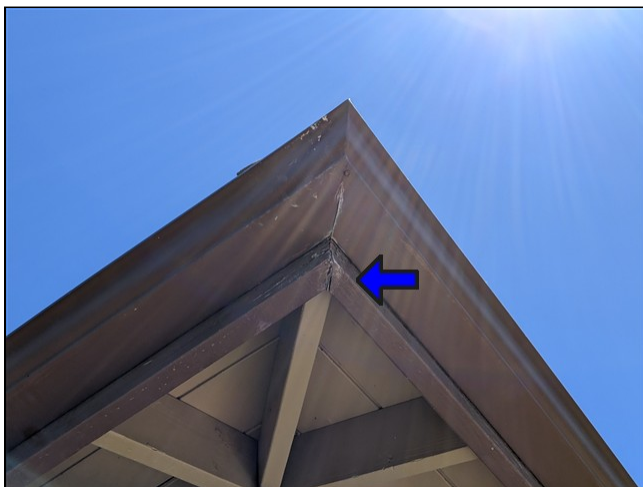
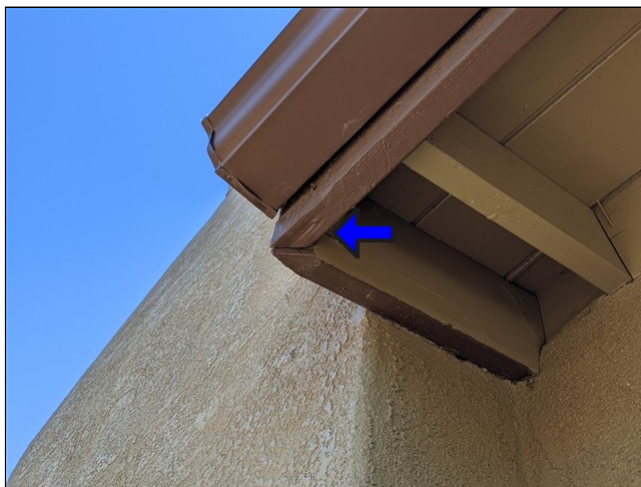
Moisture damage noted at the fascia. Recommend further evaluation by a structural pest control operator and make repairs as prescribed.

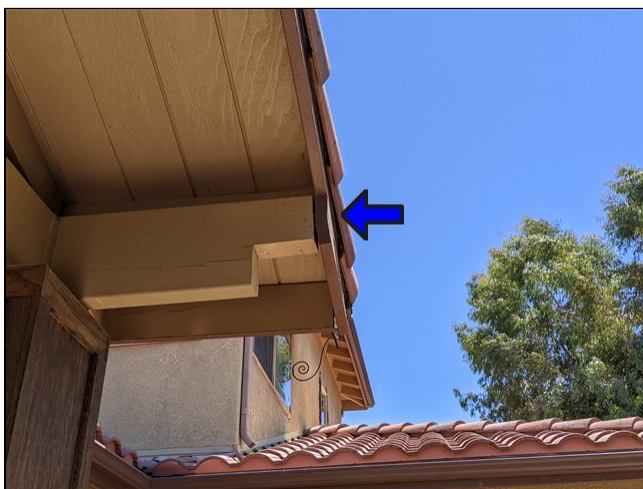
2.4 Item 3(Picture)

Areas of the fascia are separated and in need of proper reattachment and caulking. This will help prevent damage to the wood building materials.

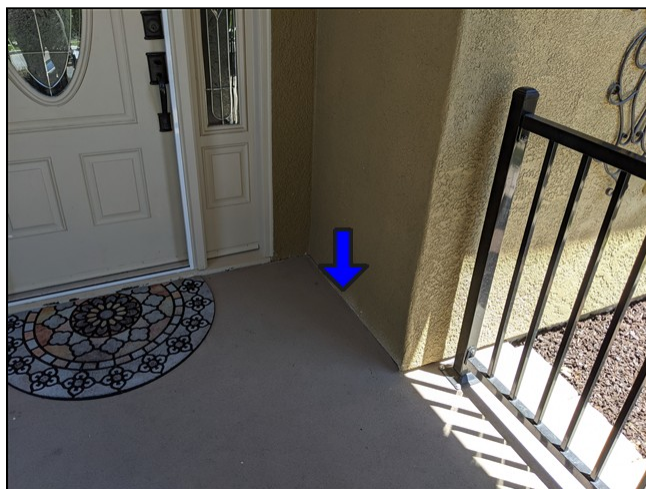
2.4 Item 4(Picture)

The concrete patio at the front exterior is installed improperly and in contact with the bottom of the stucco. This can interfere with the function of the stucco weep screed and trap moisture in the wall. No signs of current moisture or previous damage were noted. Recommend further evaluation and repairs, as needed, by a qualified licensed contractor.

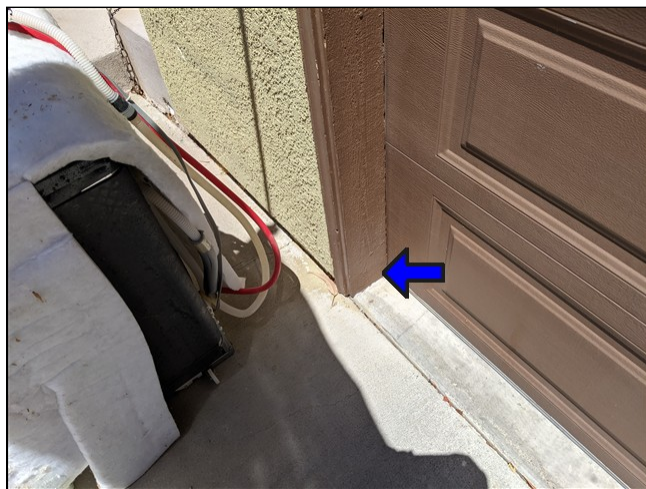
2.4 Item 5(Picture)

Wood trim is in contact with the concrete at the garage door jambs and needs to be cut back to prevent moisture intrusion into the wood and future damage.

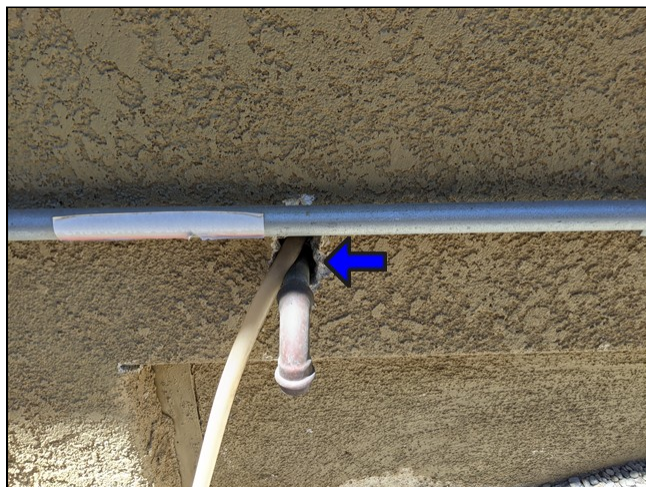
2.4 Item 6(Picture)

Perforations in the siding at the right exterior should be patched or repaired to prevent pest or moisture intrusion.

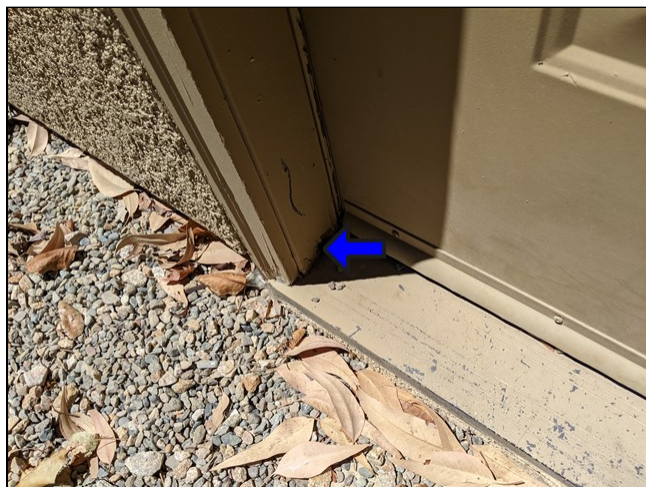
2.5 Item 1(Picture)

Moisture damage noted at the right garage door. Recommend further evaluation by a structural pest control operator and make repairs as prescribed.

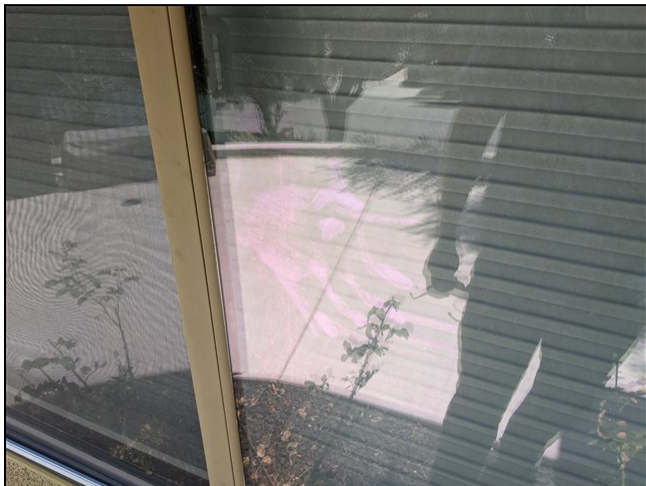
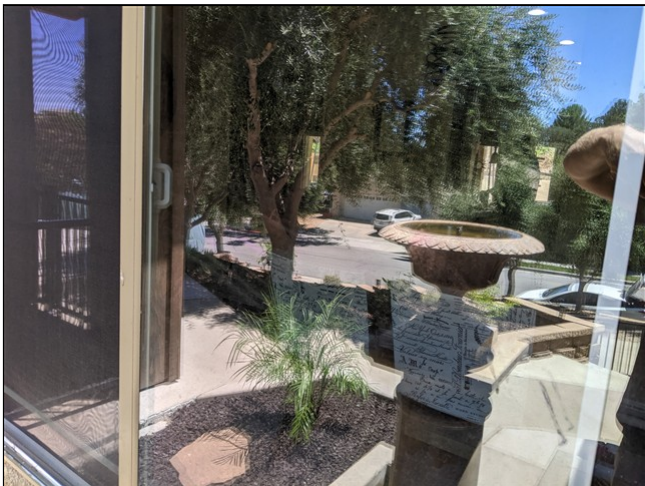
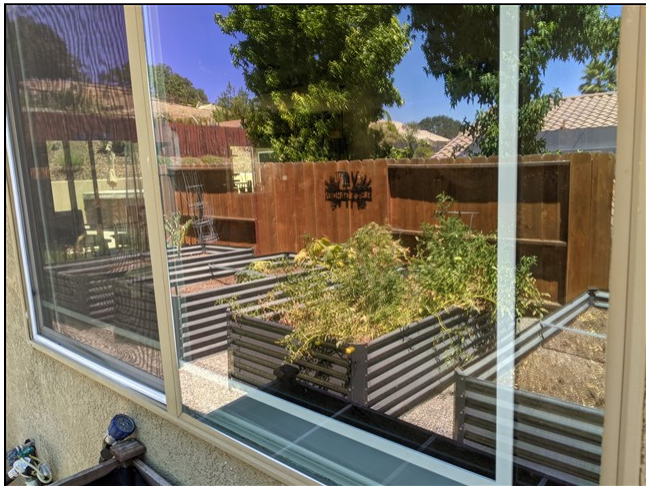
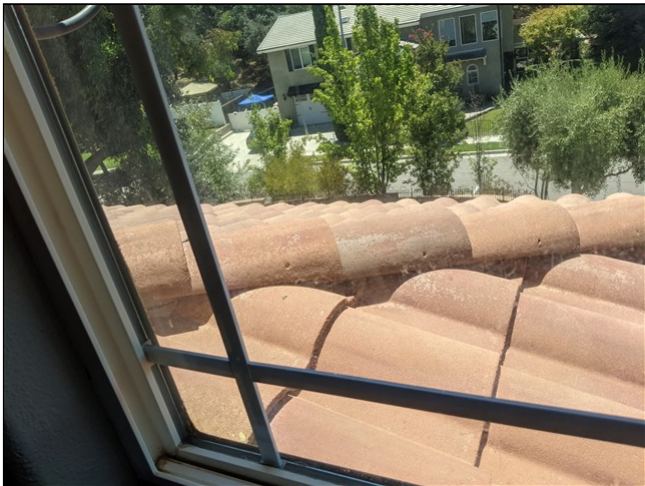
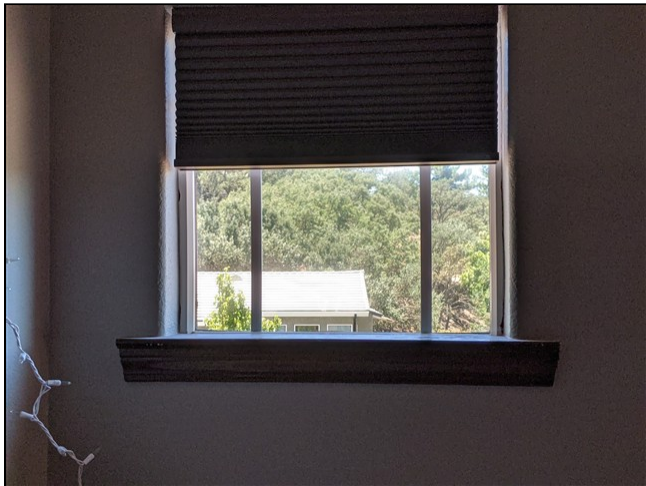
Failed seals in dual pane windows, noted at the front living room window, front kitchen window, left living room window and 2 front windows and condensation build up or stains were noted within the window. Recommend windows repaired or replaced to ensure full insulation capabilities and improve aesthetics.

Failed seals in dual pane windows, noted at the front living room window, front kitchen window, left living room

window and 2 front windows and condensation build up or stains were noted within the window. Recommend windows repaired or replaced to ensure full insulation capabilities and improve aesthetics.

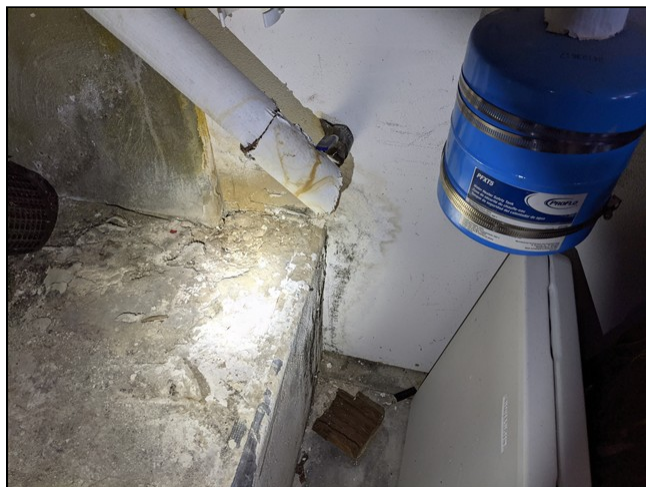
2.7 Item 1(Picture)

Drywall material damaged around the water heater due to probable previous tank failure and water leak. Possible microbial growth was noted. Repairs can be made as desired.

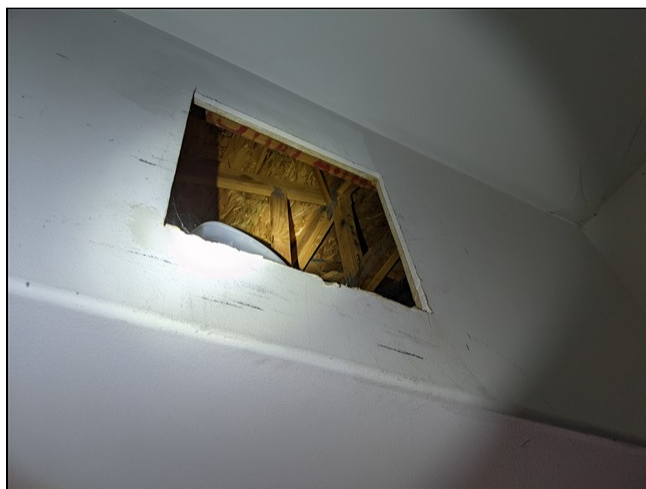
2.7 Item 2(Picture)

The fire separation between the garage and living space is gaped or damaged at the attic access and in need of proper drywall repair and fire taping to ensure intended passive fire safety.

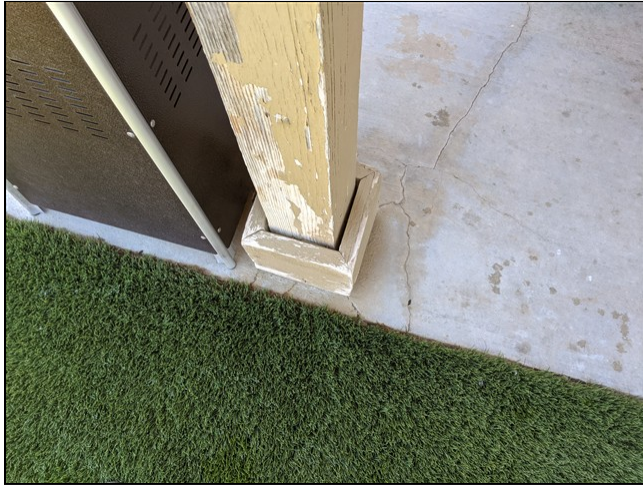
2.8 Item 1(Picture)

Peeling paint was noted at the wood trim and paint maintenance is needed.

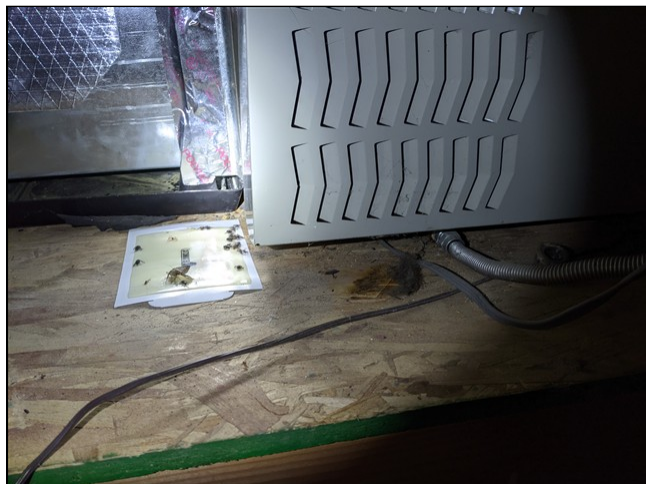
5.4 Item 2(Picture)

Moisture stains noted on the wood platform under the A/C evaporator coil in the attic from a probable condensation leak. No current leaks were noted. Recommend further evaluation by a qualified HVAC contractor to determine if a current condensate drain issue is present, and make repairs, as prescribed, to help prevent a future leak.

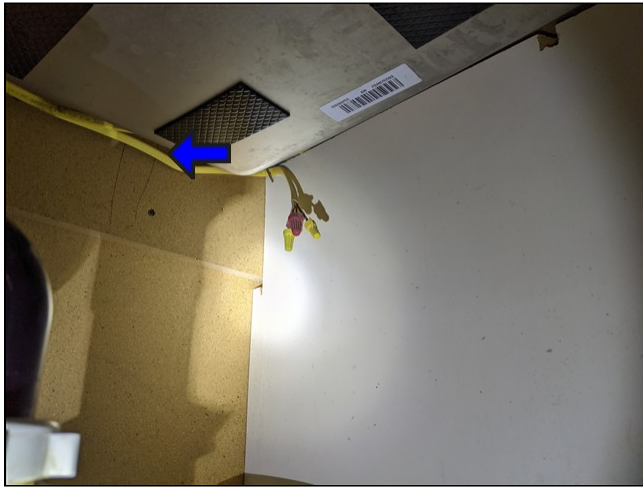
7.3 Item 1(Picture)

Wiring installed improperly and exposed where damage could occur, noted at the kitchen cabinet. Recommend the wiring be installed inside conduit or behind walls.

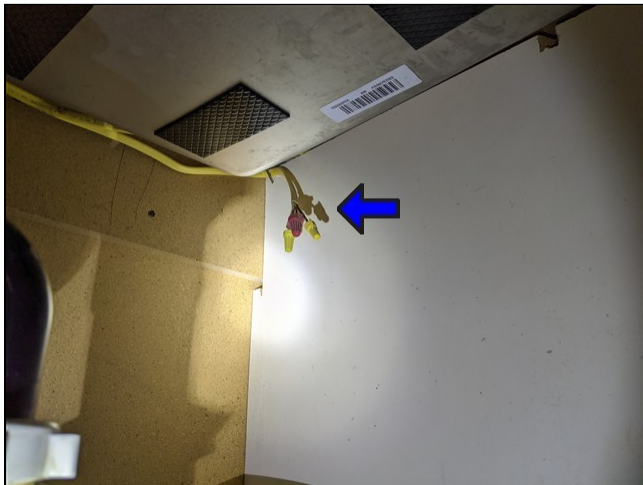
7.3 Item 2(Picture)

Wire terminates improperly in the kitchen cabinet. Exposed wire needs installed in a junction box or removed back to the previous connection point.

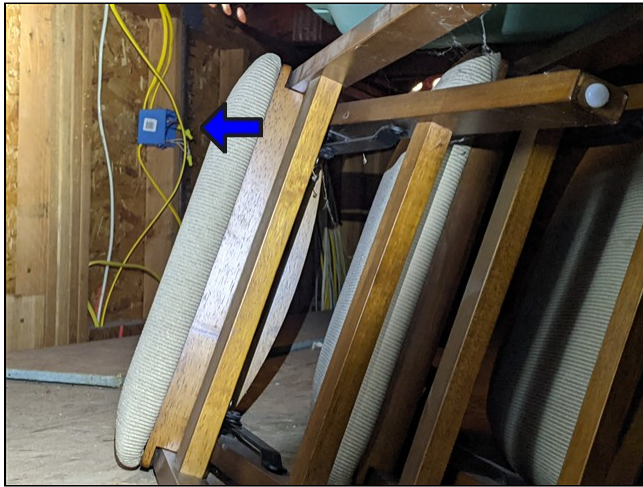
7.4 Item 1(Picture)

Junction box cover plate missing at the attic above the garage and needs installed to prevent accidental contact and contain heat in the event of a circuit failure.

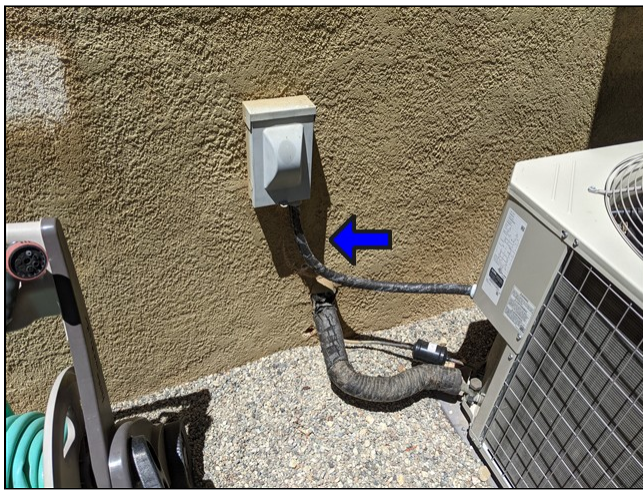
7.4 Item 2(Picture)

Conduit needs properly secured at the air conditioner power supply.

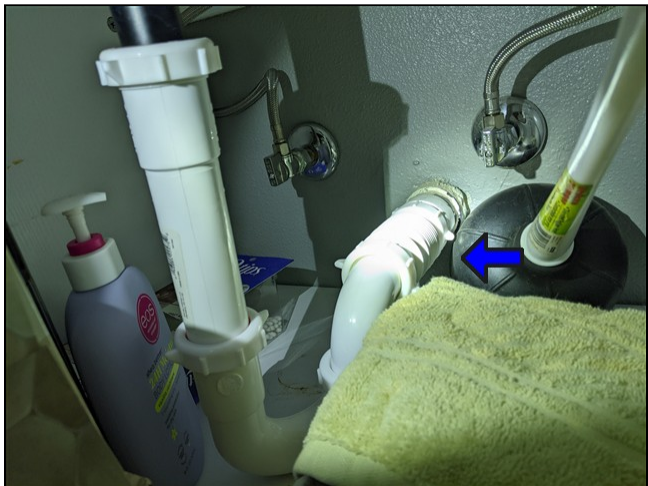
8.2.B Item 1(Picture)

Flex drain line utilized in the drain system under the sink. Recommend proper drain parts and methods utilized to prevent unnecessary clogging or displacement and leaks in the drain line.

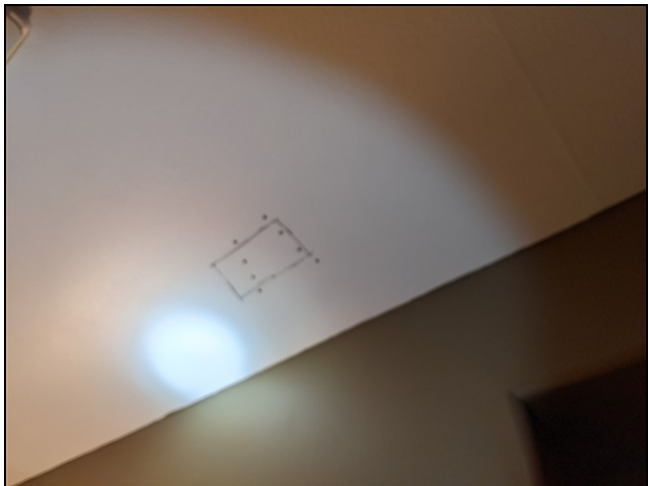
9.0 Item 1(Picture)

Signs of a previous ceiling repair was noted in the master bathroom. Recommend referring to the sellers disclosures for more information on previous repairs made at this location.

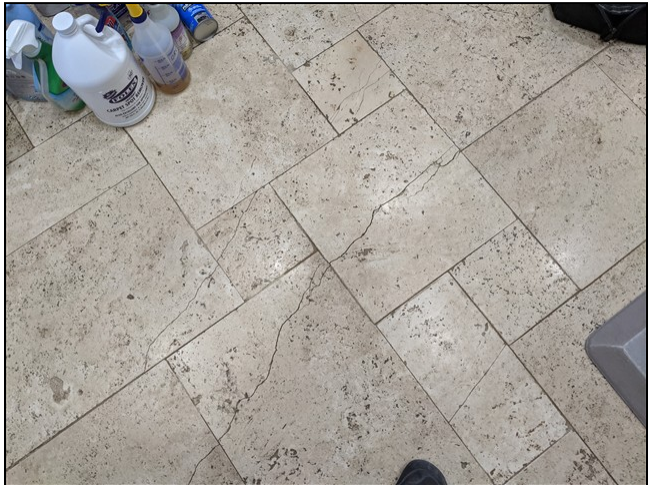
9.1 Item 1(Picture)

Cracked tiles noted at the kitchen appear stable and can be replaced as needed.

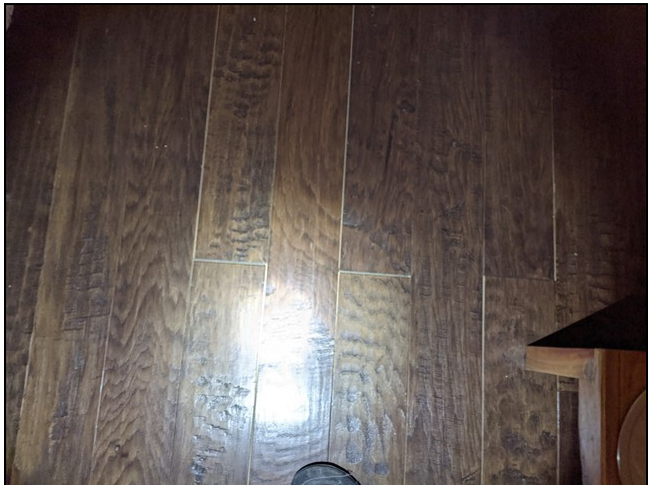
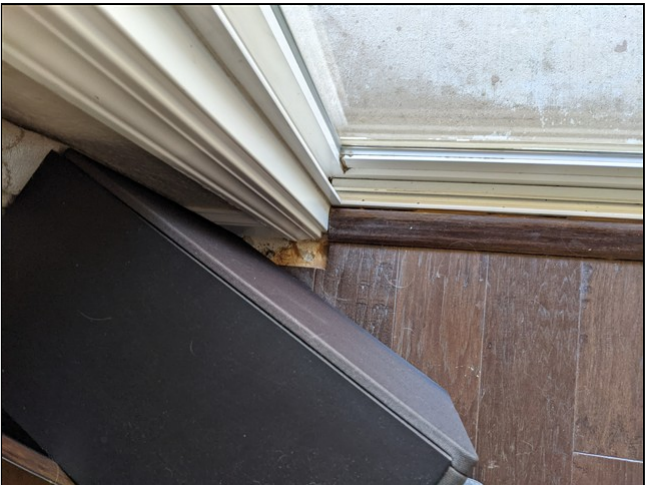
Flooring is separating at a few seams and should be repaired or replaced to prevent further deterioration.

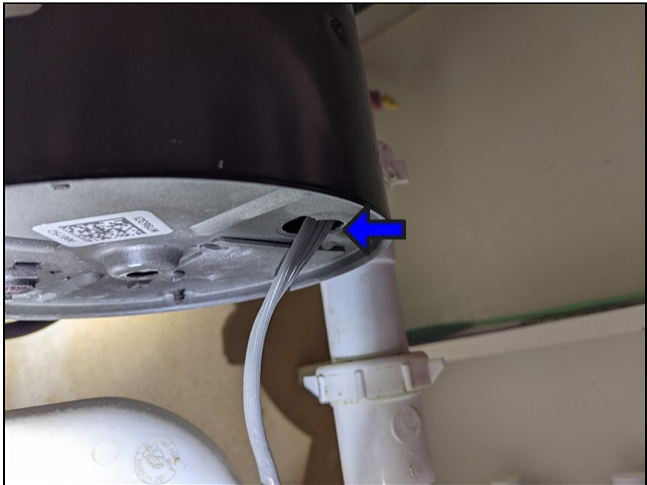
10.3 Item 1(Picture)

Wire clamp not installed on the power supply cord under the food disposal and should be properly installed to prevent wire strain damage.

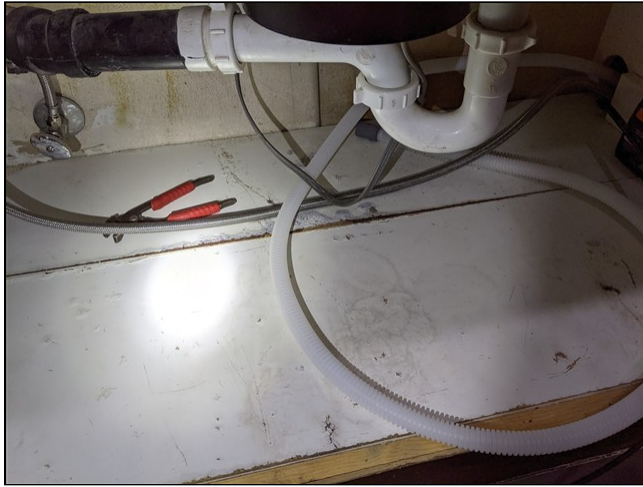
10.4 Item 1(Picture)

Slight moisture damage noted to the cabinet under the sink. Moisture damage may extend into the enclosed areas, and should be further evaluated and repaired, as needed.
