# THE HOMETEAM INSPECTION SERVICE

## Property INSPECTION REPORT

July 13, 2026

24354 Chandler Rd  
Hayward, Ca 94545

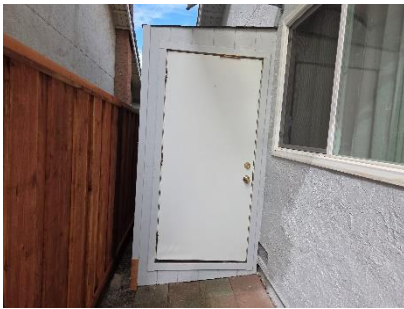
P-1

***NOTE: The storage shed at the right side is not within the scope of inspection. P-1***

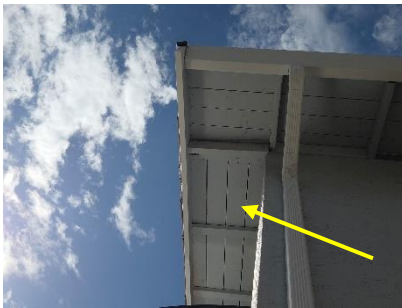
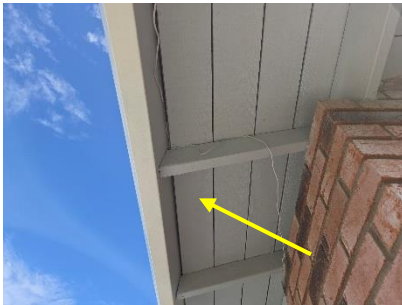
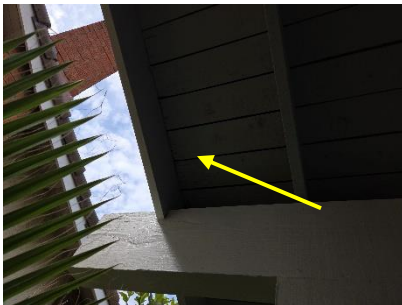
- A. Moisture damage was observed to the soffit boards and roof trim at the front and rear. See TERMITE REPORT. P-2,3,4

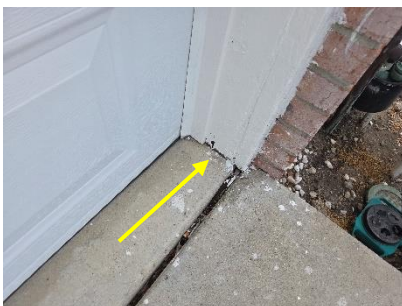
- A. Moisture damage was observed to the garage door jamb. See TERMITE REPORT, P-5
- B. Repair work was observed on the ceiling. Recommend consulting with property owner for the cause.
- C. Due to storage, not all areas of the garage were visible for inspection. If a complete inspection is desired, contact us after the storage is removed.

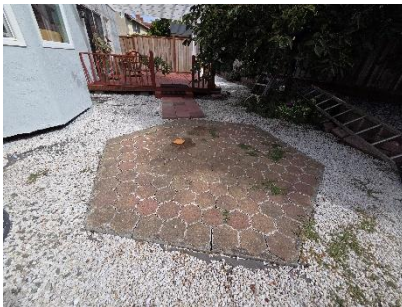
There was a cement block patio located in the back of the home. P-6

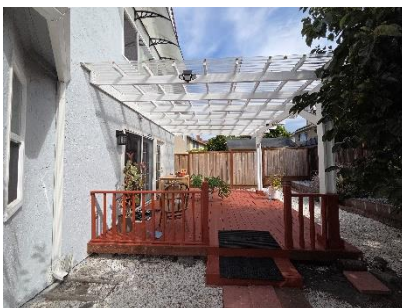
P-8

There was a corrugated plastic roof over the deck. P- 8

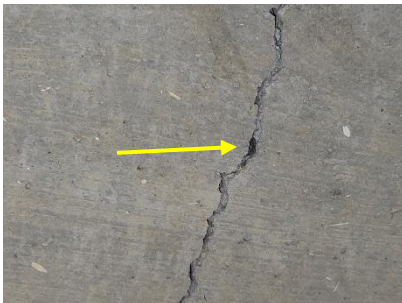
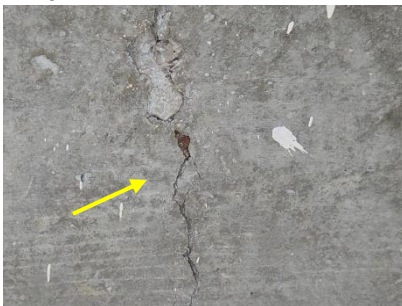
- A. There was a condition known as efflorescence on portions of the foundation walls. It indicates that the foundation is experiencing wet and dry cycles. Recommend improvement of the exterior grading and drainage to help minimize these conditions. Further evaluation of the drainage conditions and any corrective action recommended by a qualified drainage specialist is advised.
- B. There were cracks (vertical) observed in the foundation at the left & rear side. There was no major movement or settlement observed. However, recommend repairing to prevent further damage. P-10,11

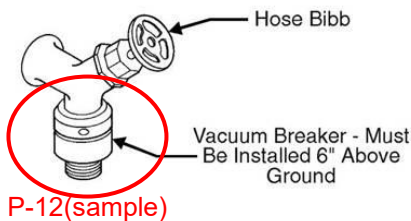
**IMPROVE:** One or more exterior valves did not have an anti-siphon valve. Recommend installing anti-siphon valves to prevent back-flow into the home. P-12

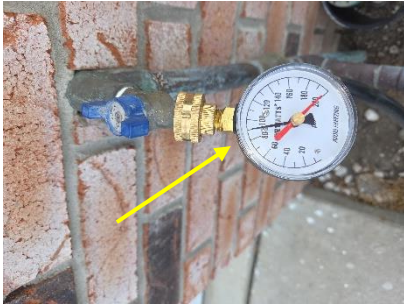
- A. The water pressure was tested to be above 80 pounds per square inch. Recommend installing a water pressure regulator.

Water pressure was tested at an outdoor sillcock and found to be 80-90 pounds per square inch. P-13

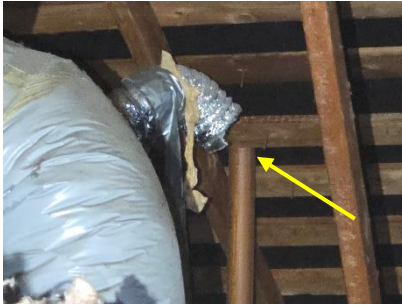
- A. The exhaust vent in the attic discharged in the attic. Recommend installing a dedicated vent termination for this exhaust line. P-24
