# ***Cornerstone Inspection***

## **Property Inspection Report**

***3315 Barranca Ct, San Luis Obispo, CA 93401***

***Date of Inspection: 6/26/2026 Time: 9:00 AM***

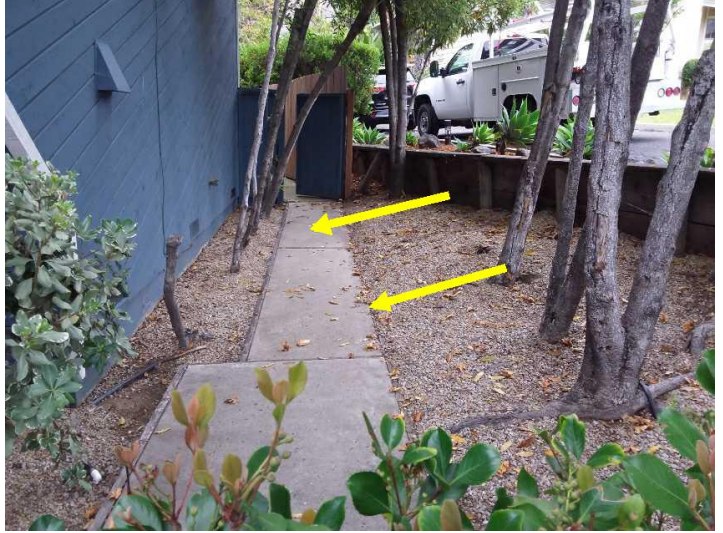
2.3. There are areas at the front where water will be directed toward the house instead of away from it, as recommended. This not only allows for the possibility of moisture intrusion but also differential settling.

There are areas at the front where water will be directed toward the house instead of away from it, as recommended. This not only allows for the possibility of moisture intrusion but also differential settling.

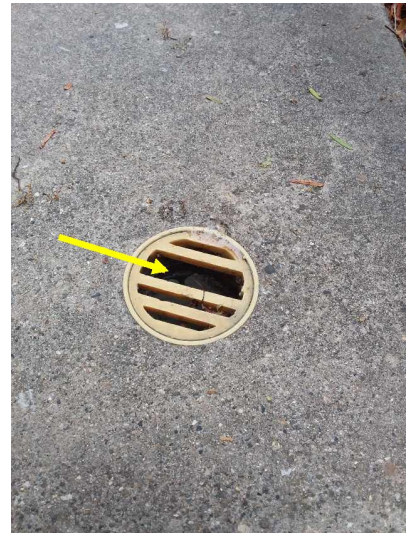
There are areas at the residence where water will percolate and pond, which is not ideal. You may wish to consider upgrading the site by adding hard surfaces, or area drains that direct water away from the residence.

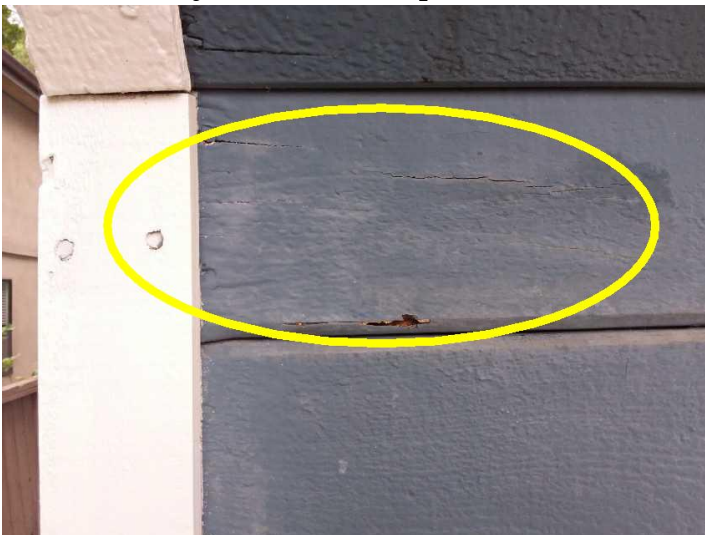
3.5. Portions of the wood siding are dry rot or moisture damaged, and should be evaluated by a termite inspector.

Portions of the wood siding are dry rot or moisture damaged, and should be evaluated by a termite inspector.

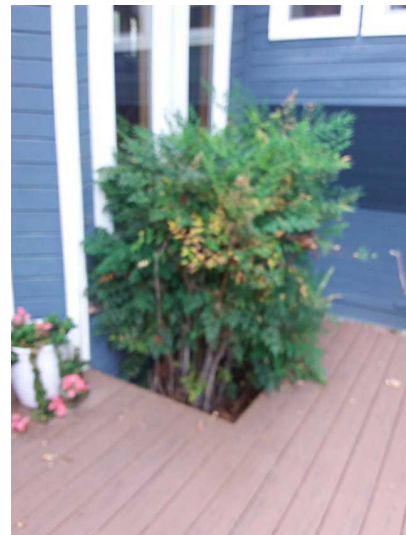
Vines, shrubs or bushes are growing on the house walls and although they are attractive they can introduce pests and rodents and accelerate deterioration. Therefore, you may wish to consider having them removed or cut back to 12 inches away from the home.

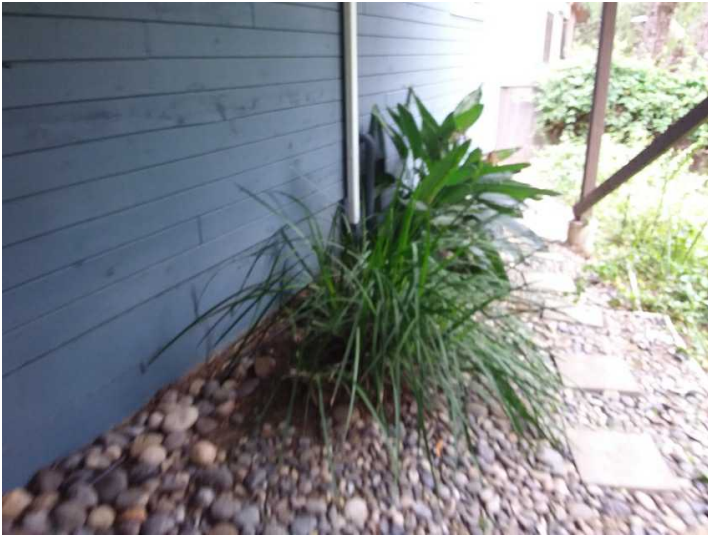
Vines, shrubs or bushes are growing on the house walls and although they are attractive they can introduce pests and rodents and accelerate deterioration. Therefore, you may wish to consider having them removed or cut back to 12 inches away from the home.

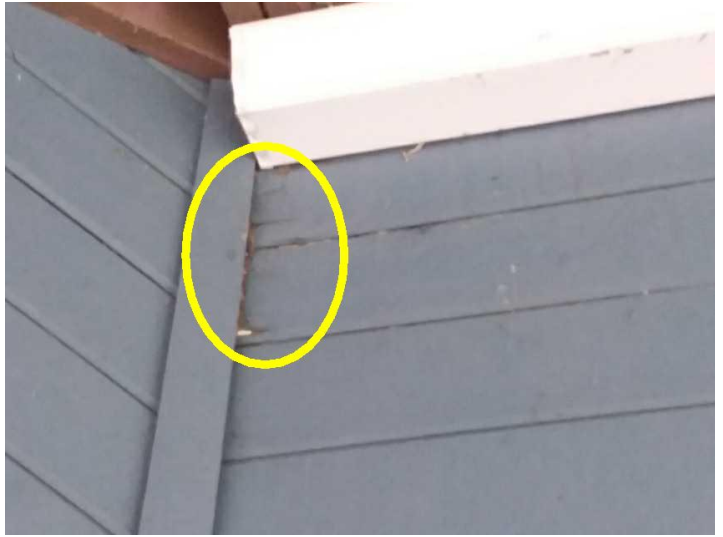
Portions of the wood siding are dry rot or moisture damaged, and should be evaluated by a termite inspector.

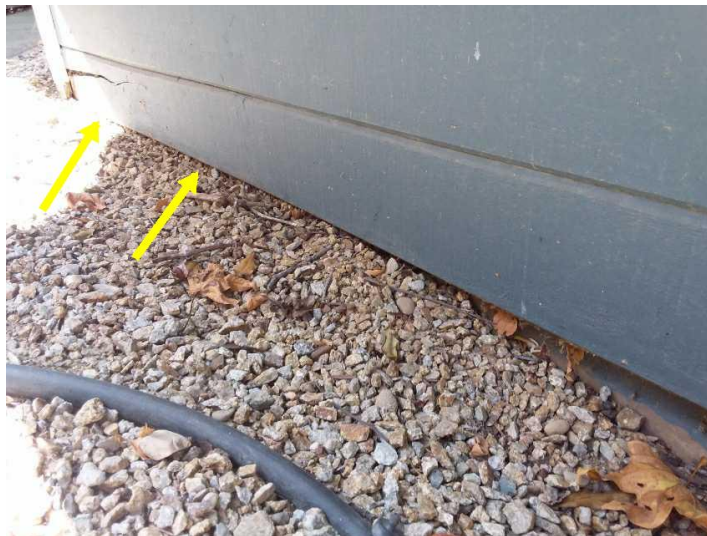
3.4. There are areas where the wooden siding is close to or touching the ground and is subject to moisture damage. These areas should be monitored closely and sealed frequently to prevent moisture damage. Wooden siding should be a minimum of 4 inches from soil and 2 inches from hard surfaces.

There are areas where the wooden siding is close to or touching the ground and is subject to moisture damage. These areas should be monitored closely and sealed frequently to prevent moisture damage. Wooden siding should be a minimum of 4 inches from soil and 2 inches from hard surfaces.

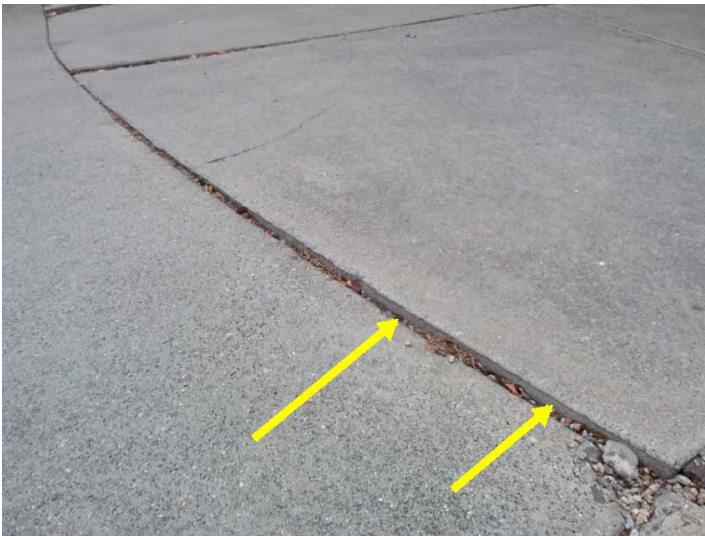
There is one or more offsets in the driveway that could prove to be trip-hazards.

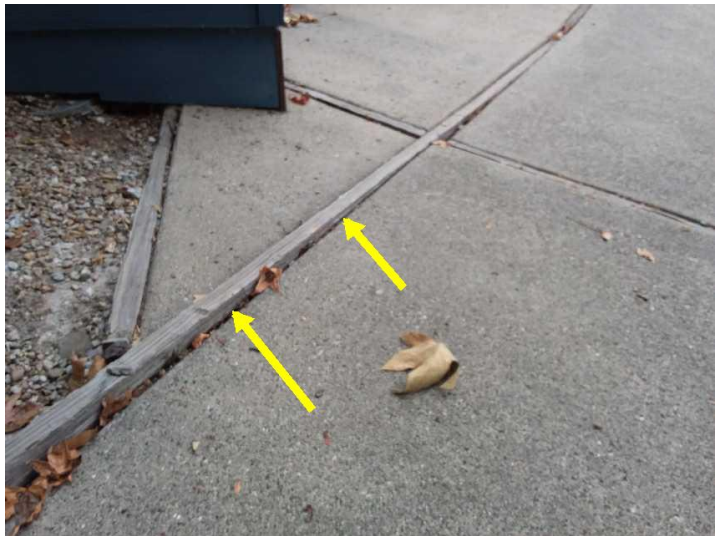
There is one or more offsets in the driveway that could prove to be trip-hazards.

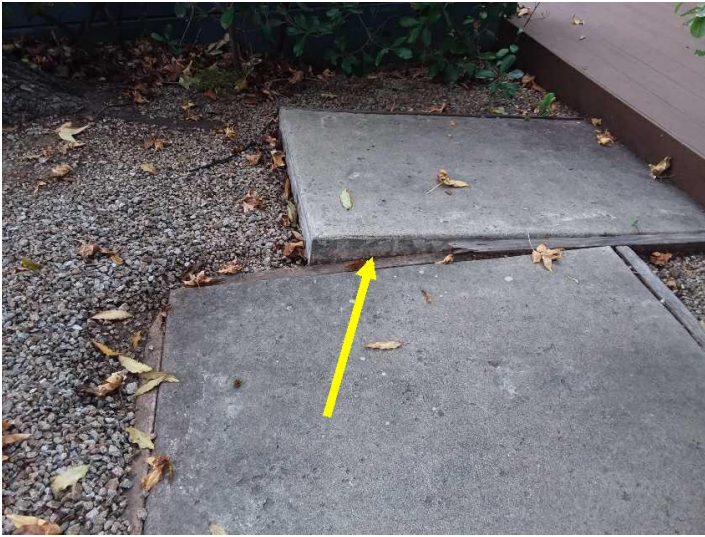
A walkway has been displaced by root movement and could present a trip-hazard.

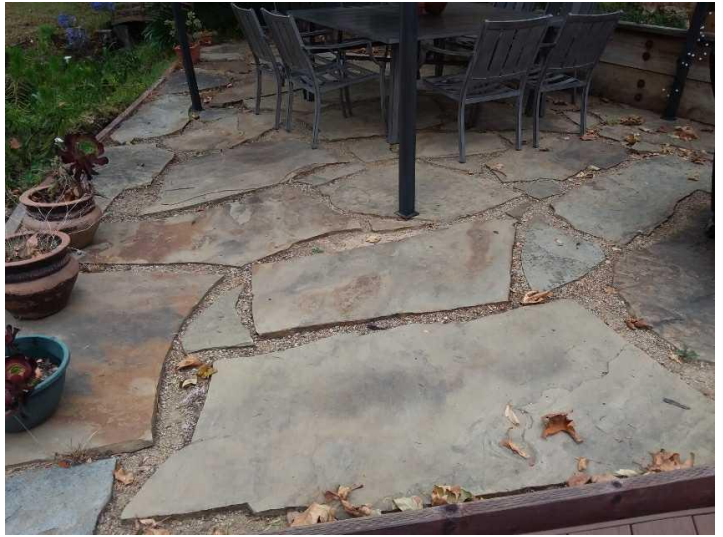
The paver patio or walkway has multiple offsets. This may be due to unsuitable soil below the pavers.

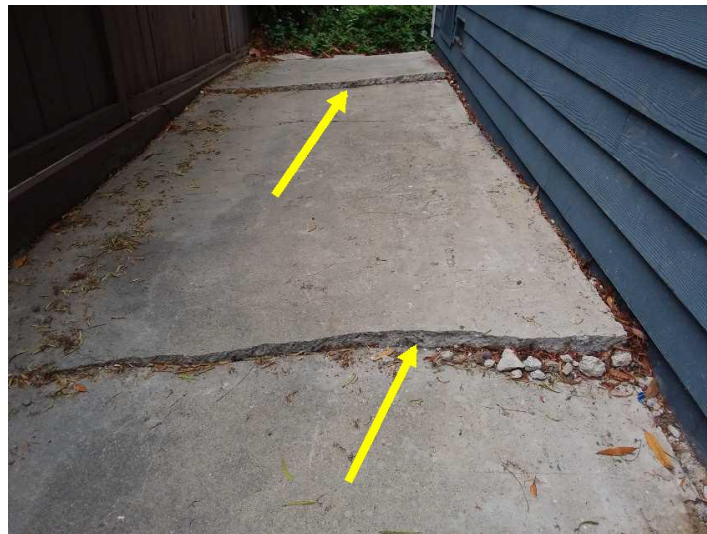
The walkways are variously damaged and should be repaired or replaced.

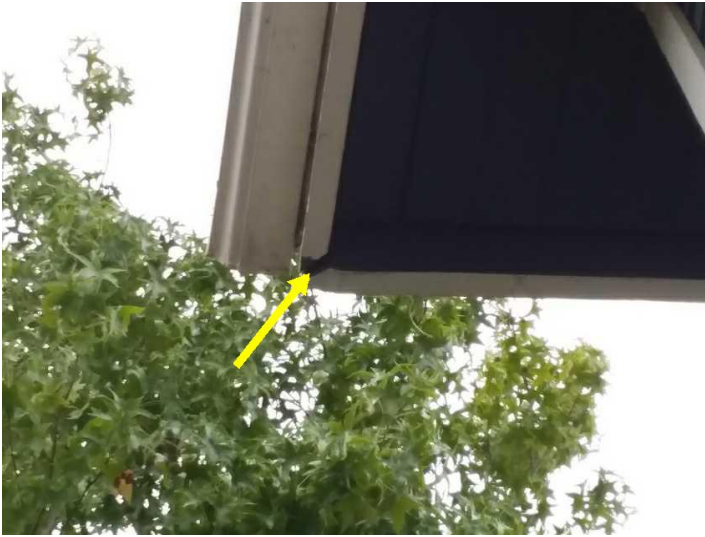
Sections of the fascia board or wood trim are weathered and have separated slightly, and should be serviced to prevent further deterioration.

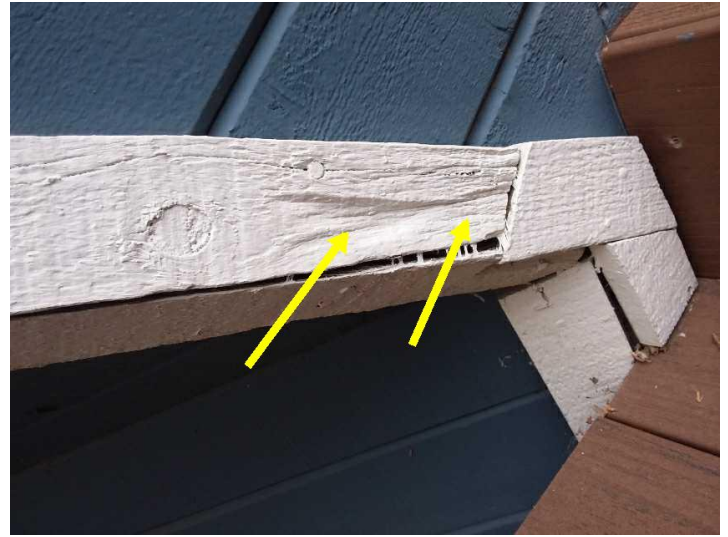
There is damage to the wood trim that should be evaluated by a termite inspector.

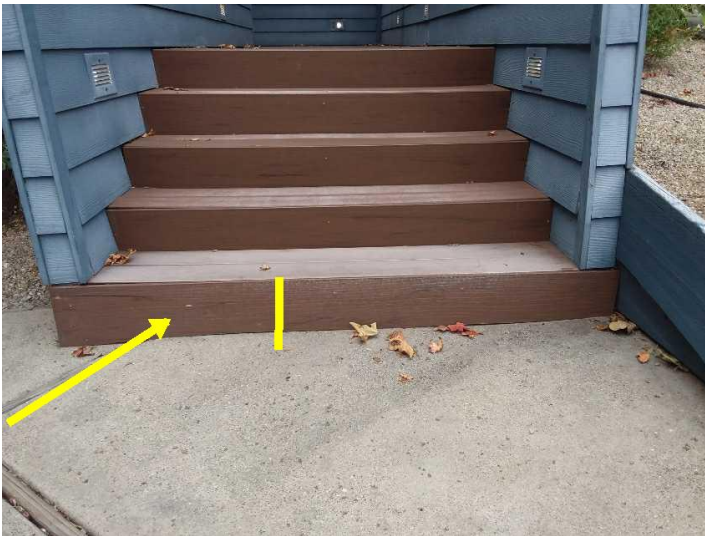
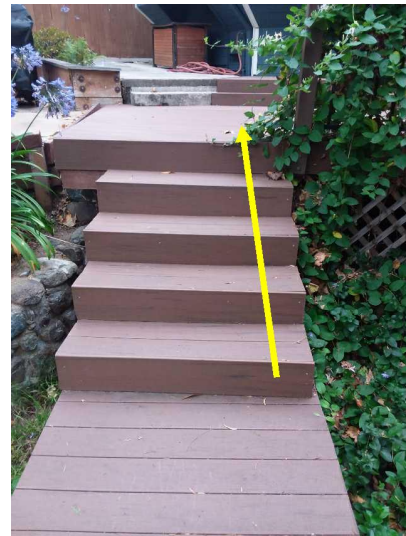
9.1. Some of the steps have unequal treads or risers. Steps are required to be uniform to prevent trip-hazards. The rise of any step should be no less than four inches and no greater than seven inches, and the run should be no less than eleven inches. Also, the dimensions of the largest step should not exceed that of the smallest by more than three-eighths of an inch.

Some of the steps have unequal treads or risers. Steps are required to be uniform to prevent trip-hazards. The rise of any step should be no less than four inches and no greater than seven inches, and the run should be no less than eleven inches. Also, the dimensions of the largest step should not exceed that of the smallest by more than three-eighths of an inch.

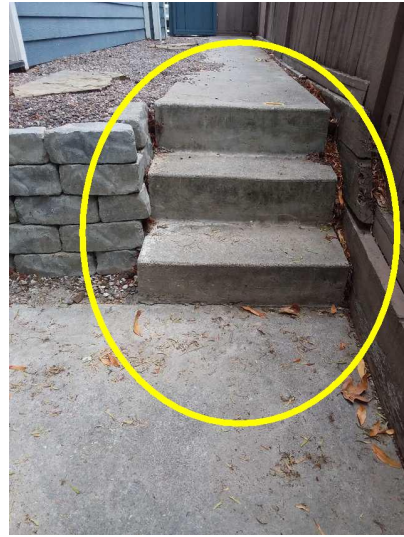
Some of the steps have unequal treads or risers. Steps are required to be uniform to prevent trip-hazards. The rise of any step should be no less than four inches and no greater than seven inches, and the run should be no less than eleven inches. Also, the dimensions of the largest step should not exceed that of the smallest by more than three-eighths of an inch.

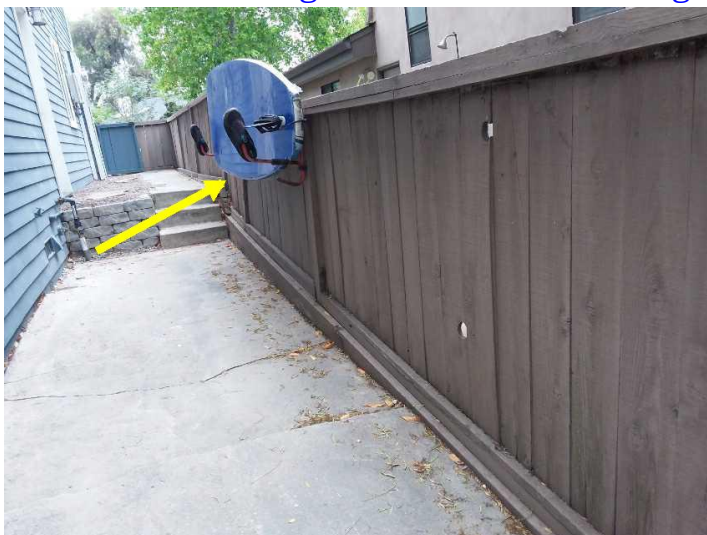
10.3. Sections of the fence are leaning or missing which you may wish to have repaired or replaced.

Sections of the fence are leaning or missing which you may wish to have repaired or replaced.

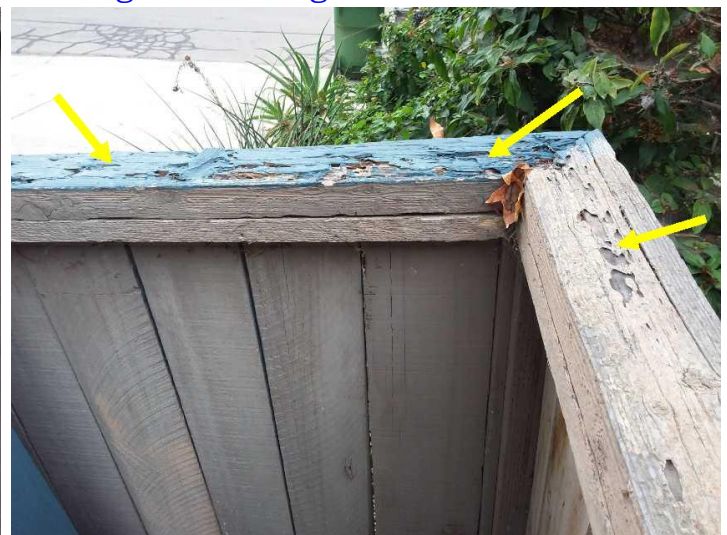
Portions of the fences or gates are dry rot or termite damaged, which should be evaluated by a termite inspector. However, you may wish to confirm that fences and gates are included in the termite inspection.

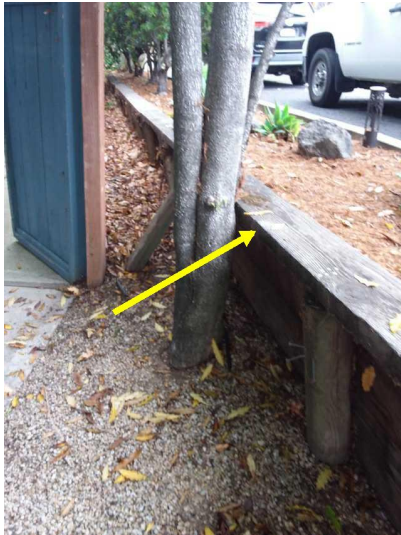
11.4. The yard walls at the front are leaning but stable at this time. However we recommend that you have a licensed specialist such as a block mason or structural engineer to evaluate this issue.

The yard walls at the front are leaning but stable at this time. However we recommend that you have a licensed specialist such as a block mason or structural engineer to evaluate this issue.

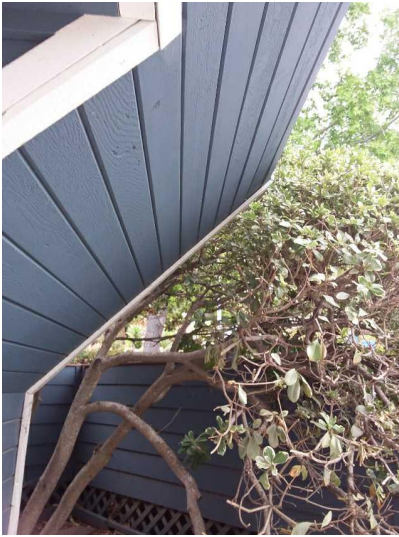
Vegetation is encroaching on the structure, and should be kept a minimum of twelve inches away for the general welfare of the walls and foundation.

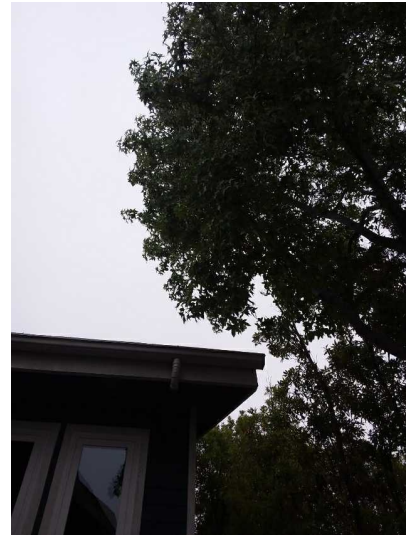
There are tree limbs over growing the residence that should be trimmed or monitored to insure that they do not impact or damage the roof or its components.

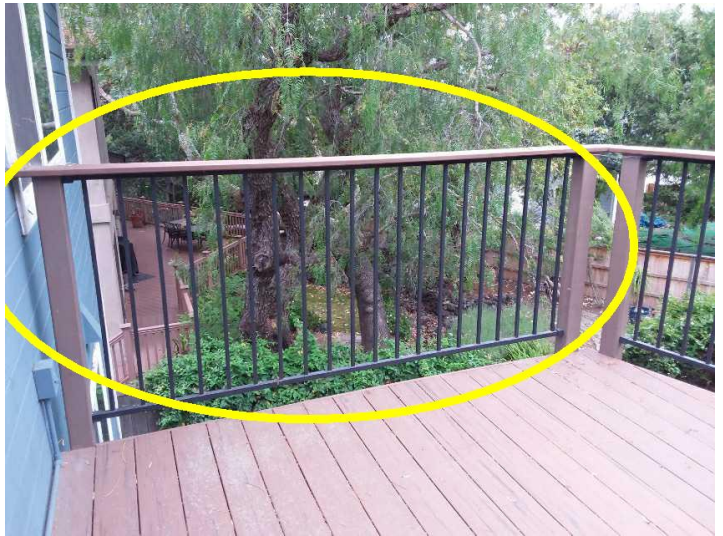
Sections of the guardrail are not secure, and should be serviced.

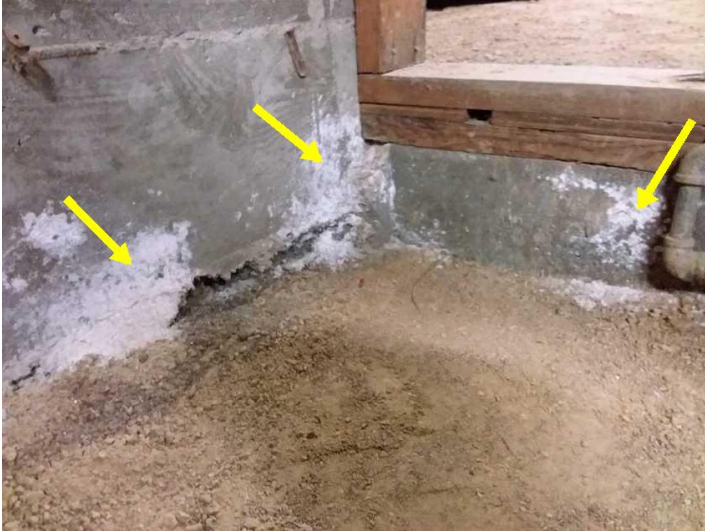
Moisture has entered the crawlspace, as is evident by salt crystal formations around the base of the stem walls. However, this is a common phenomenon that does not necessarily indicate a chronic or serious problem. The soils are currently dry, but it would be prudent to monitor this area.

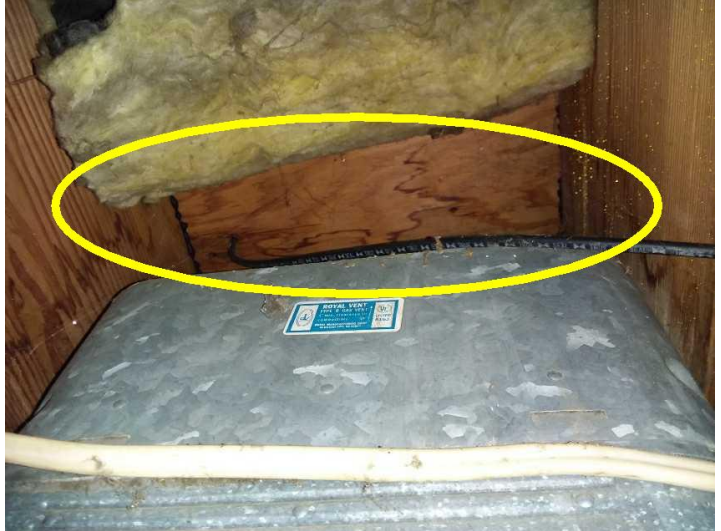
There are stains or moisture damage to the sub-floor beneath the residence. The termite inspector is responsible for pressure testing shower pans, and will evaluate and comment on the condition of the shower pan and any resulting damage to the intermediate floor framing.

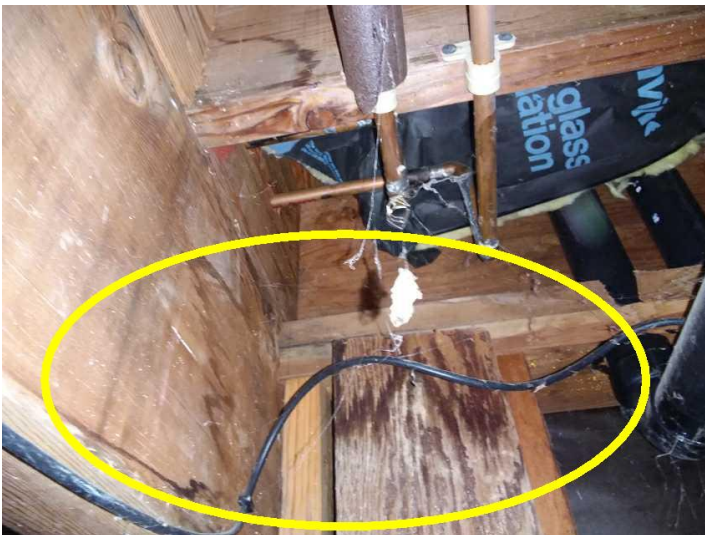
There are stains or moisture damage to the sub-floor beneath the residence. The termite inspector is responsible for pressure testing shower pans, and will evaluate and comment on the condition of the shower pan and any resulting damage to the intermediate floor framing.

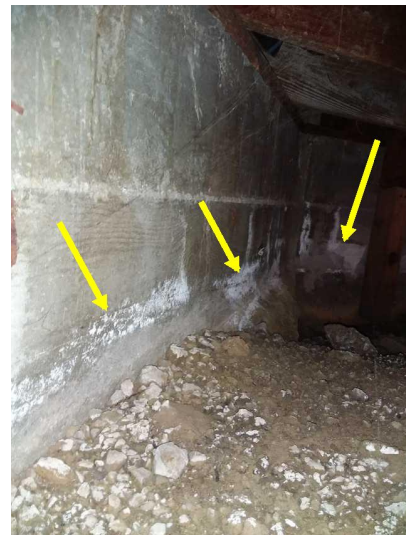
Moisture has entered the crawlspace, as is evident by salt crystal formations around the base of the stem walls. However, this is a common phenomenon that does not necessarily indicate a chronic or serious problem. The soils are currently dry, but it would be prudent to monitor this area.

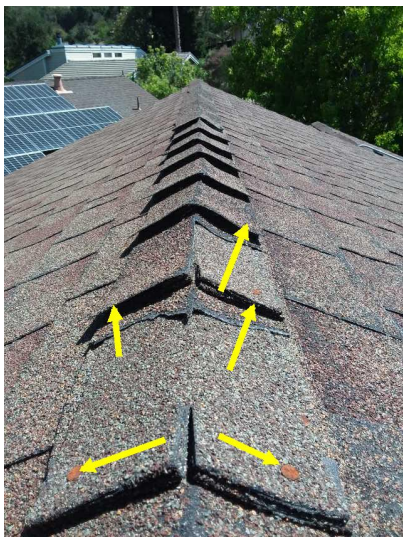
The roofing material has been improperly installed with exposed fasteners and should be monitored closely for leaks.

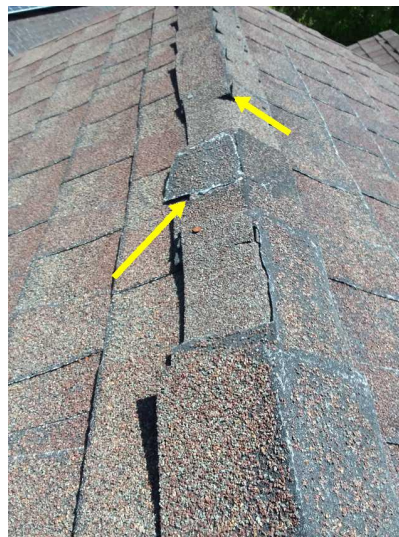
The roof has one or more damaged or missing shingles that should be repaired by a licensed roofing contractor.

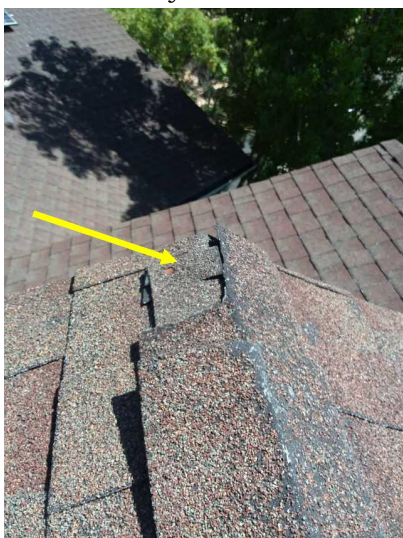
The roof has one or more damaged or missing shingles that should be repaired by a licensed roofing contractor.

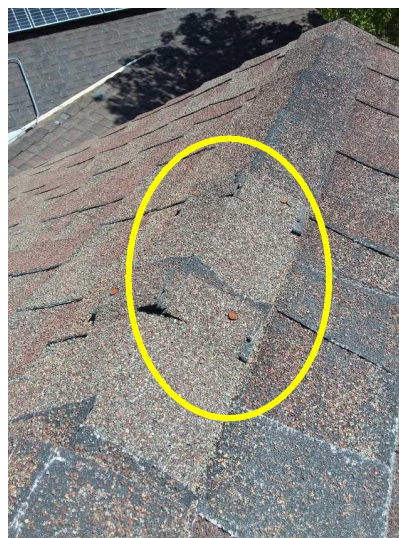
The roof has one or more damaged or missing shingles that should be repaired by a licensed roofing contractor.

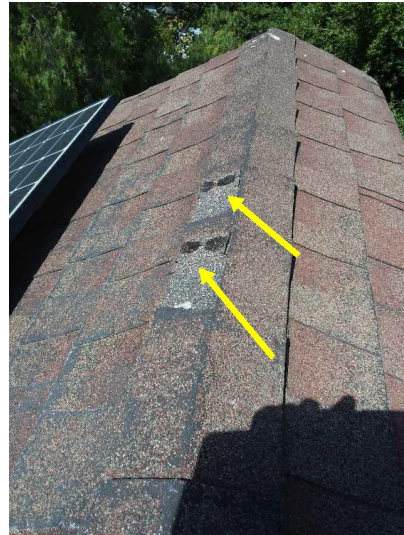
The roof has one or more damaged or missing shingles that should be repaired by a licensed roofing contractor.

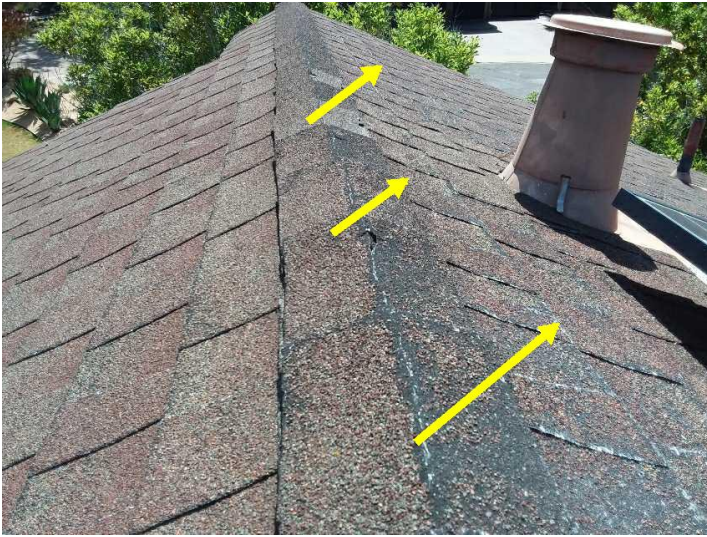
The southside roof is approaching the end of its serviceable life, and should be evaluated by a licensed roofing contractor, because it could leak and the cost of replacing it could affect you evaluation of the property.

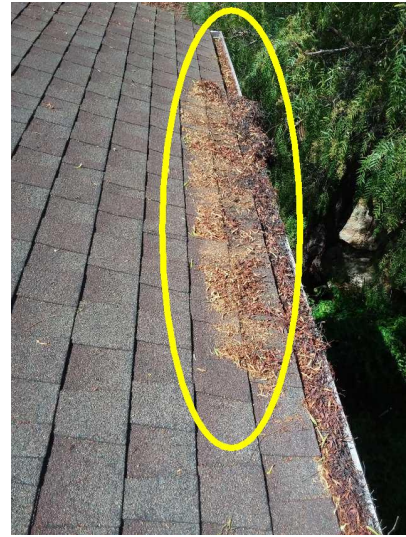
The roof needs to be cleaned and any foliage trimmed away to promote and insure proper drainage.

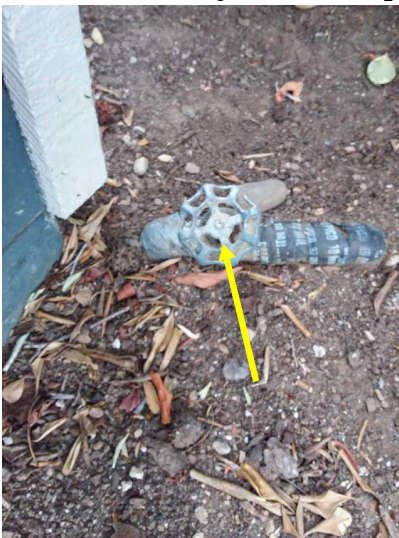
The main water shutoff valve is an older "Gate" style valve. This older valve may no longer properly function. We recommend it be upgraded to a newer "Ball" valve.

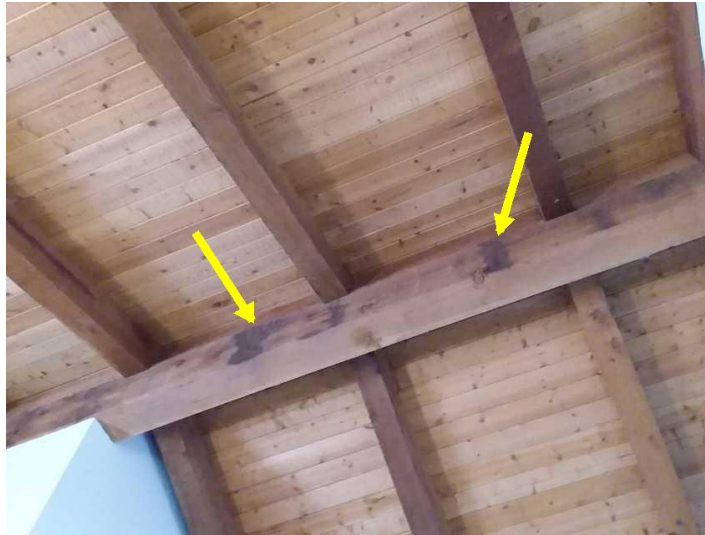
There is a moisture stain on the ceiling that should be explained or explored further.

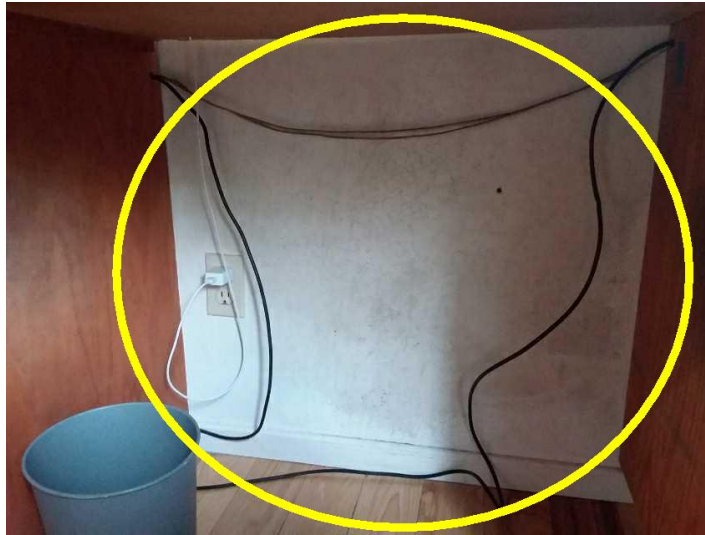
There is a stain on the wall that should be explained or explored further.

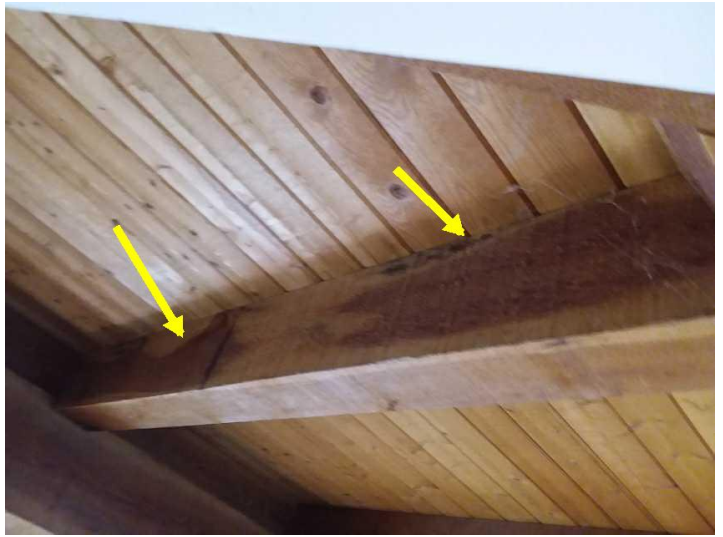
There is a moisture stain on the ceiling that should be explained or explored further.

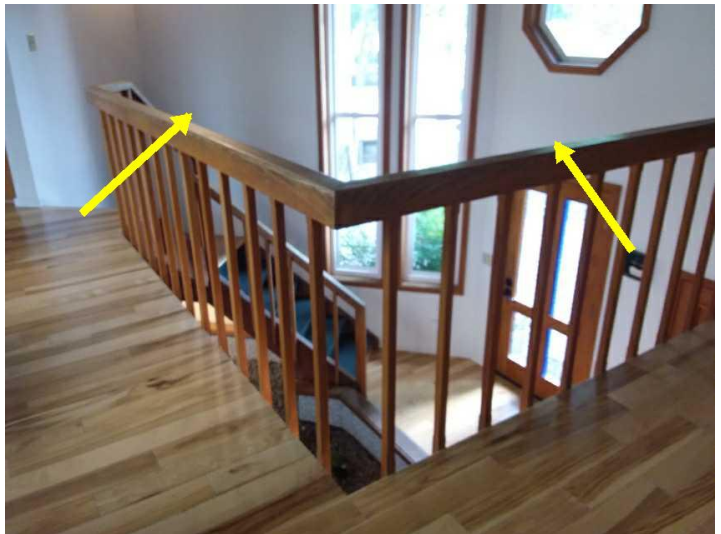
The Guardrail at the top of the stairs is not the recommended 42 inches high when the standing surface is more than 30 inches below.

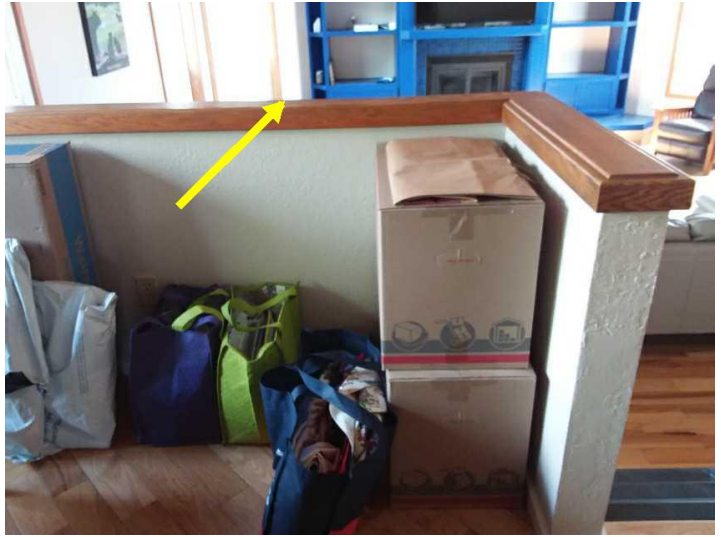
The Guardrail at the top of the stairs is not the recommended 42 inches high when the standing surface is more than 30 inches below.

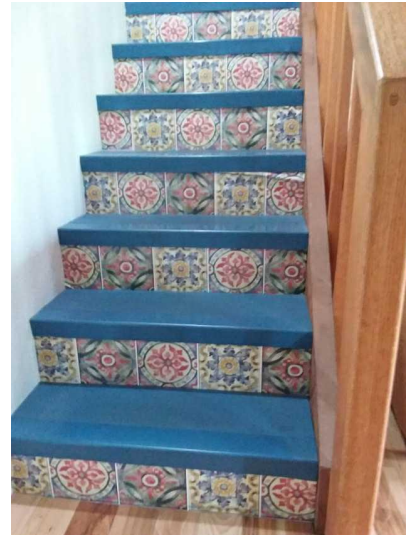
The treads or risers are unequal in depth or height, and could prove to be a trip hazard. The rise should not be less than 4 inches, nor greater than 7 3/4 inches, and the treads should not be less than 11 inches. In addition, the dimensions of the treads and the risers should not exceed 3/8 of an inch of the smallest on the entire run of the stairs.

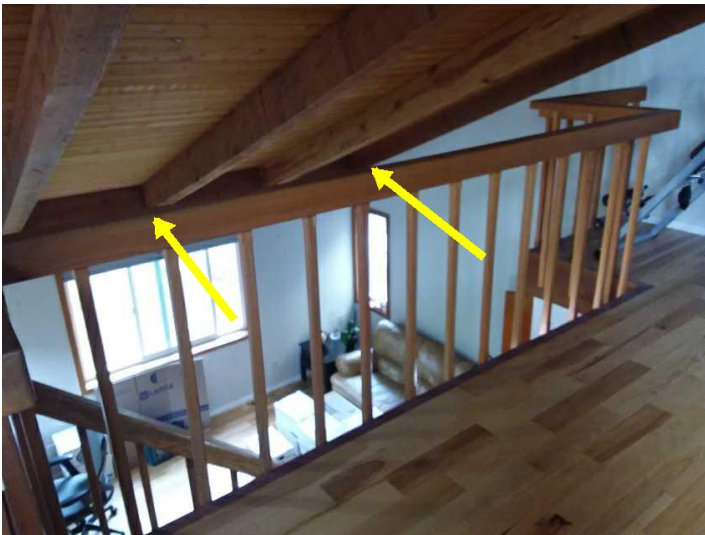
The Guardrail at the top of the stairs is not the recommended 42 inches high when the standing surface is more than 30 inches below.

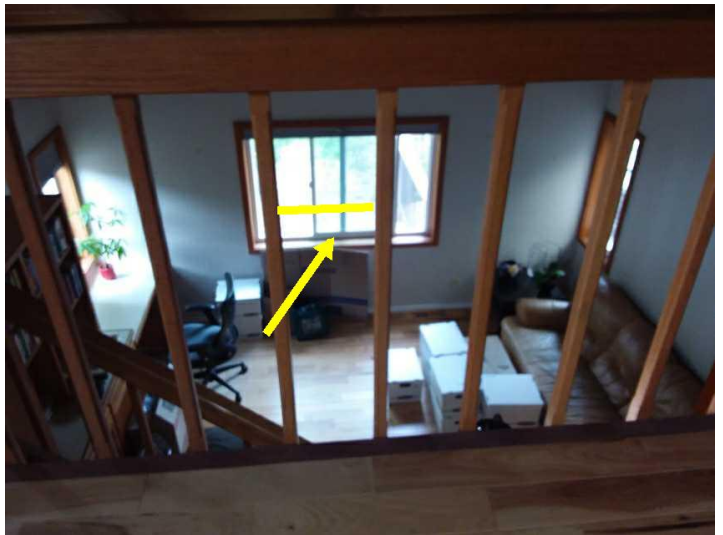
The balusters in the stair or guard rails are more than four-inches apart and are not child safe. Therefore, you may wish to add a protective barrier.

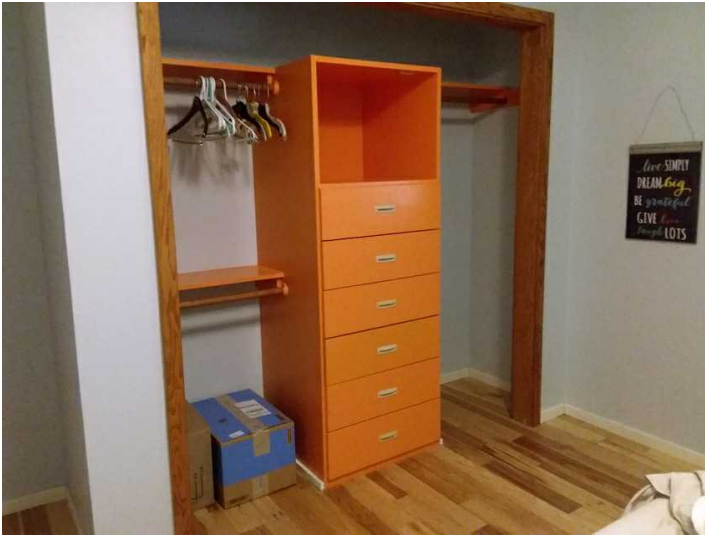
Closet doors are missing and you may wish to have it installed.

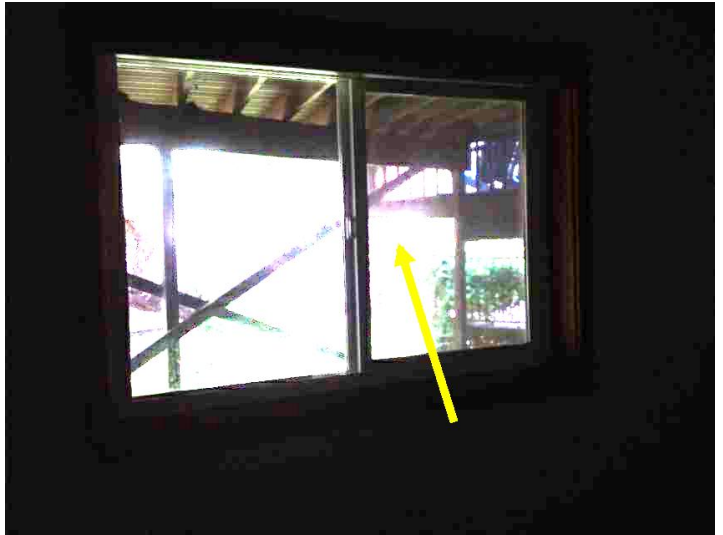
A window(s) may have a broken hermetic seal which you may wish to have replaced. This is evident from fogging, or condensation forming between the panes of glass that confirm that the seal has failed.

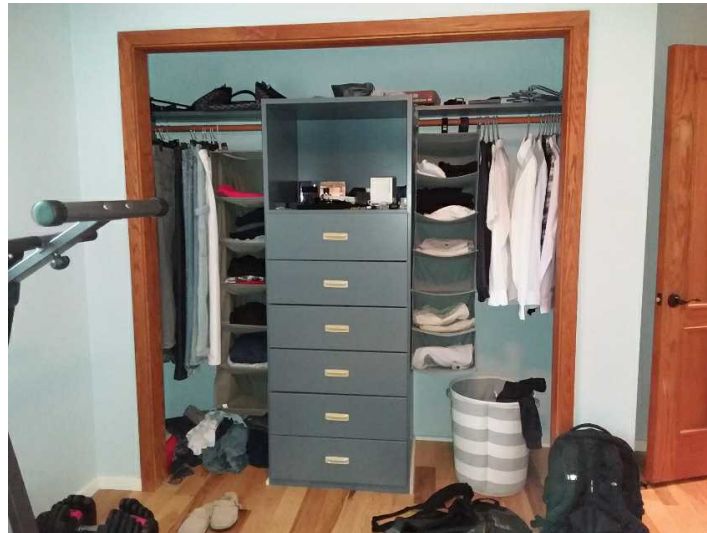
Closet doors are missing and you may wish to have it installed.

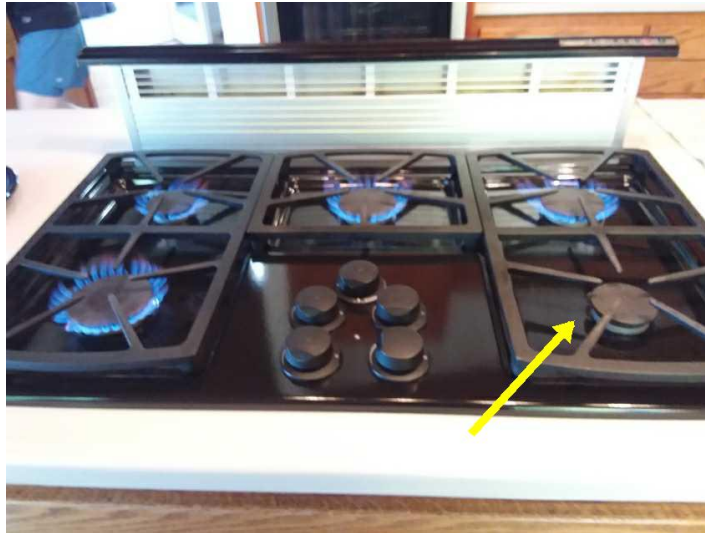
Burner(s) on the range did not light and should be serviced.

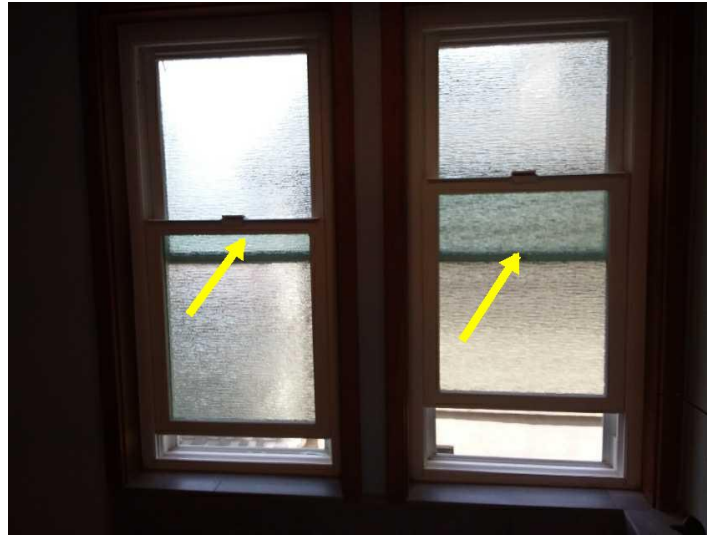
A window lock is missing, or needs to be serviced, to be functional.

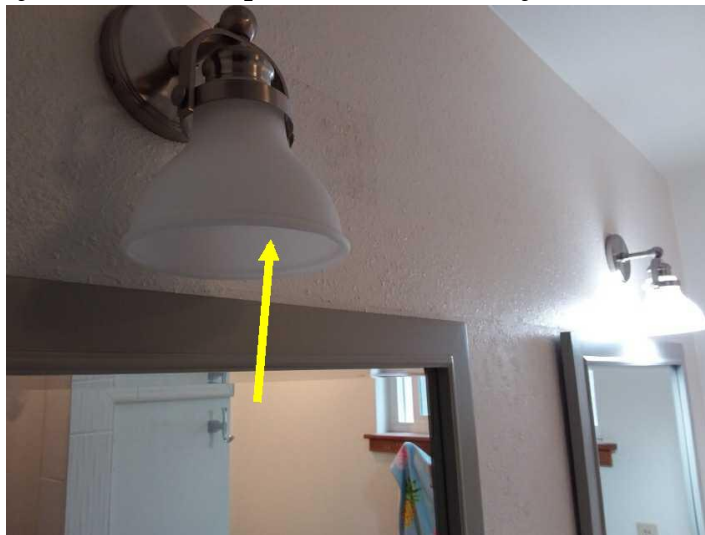
The wall light does not respond and should be serviced.

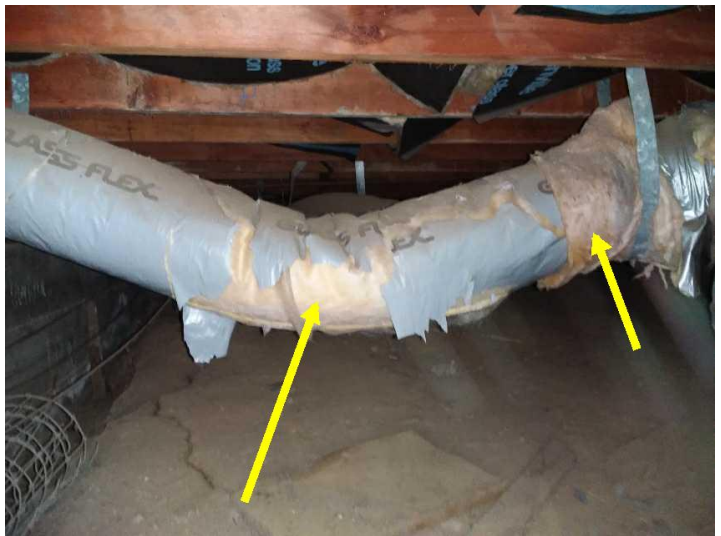
Sections of outer shell of the flexible ducting has been damaged by ultra-violet contamination, which has caused the outer shell to deteriorate and, therefore should be evaluated by a licensed HVAC contractor with a view toward replacement.

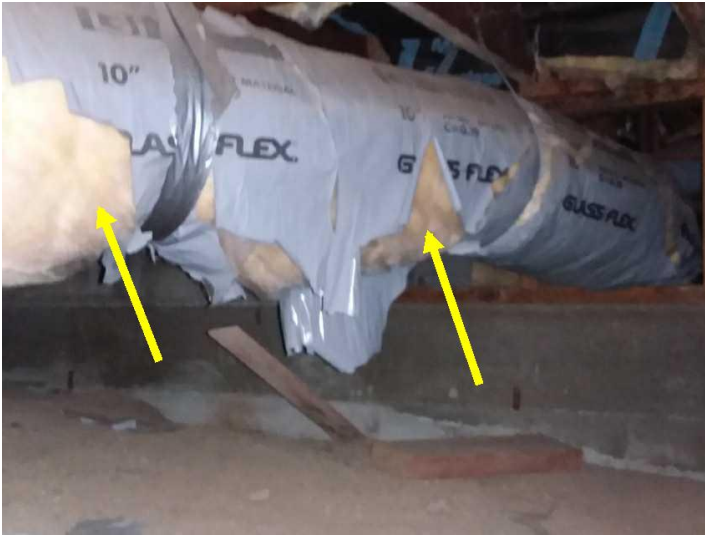
Sections of outer shell of the flexible ducting has been damaged by ultra-violet contamination, which has caused the outer shell to deteriorate and, therefore should be evaluated by a licensed HVAC contractor with a view toward replacement.

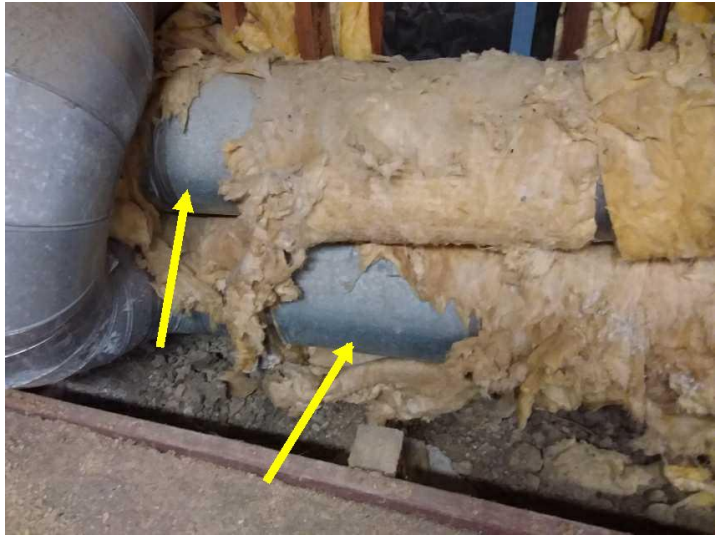
Sections of outer shell of the flexible ducting has been damaged by ultra-violet contamination, which has caused the outer shell to deteriorate and, therefore should be evaluated by a licensed HVAC contractor with a view toward replacement.

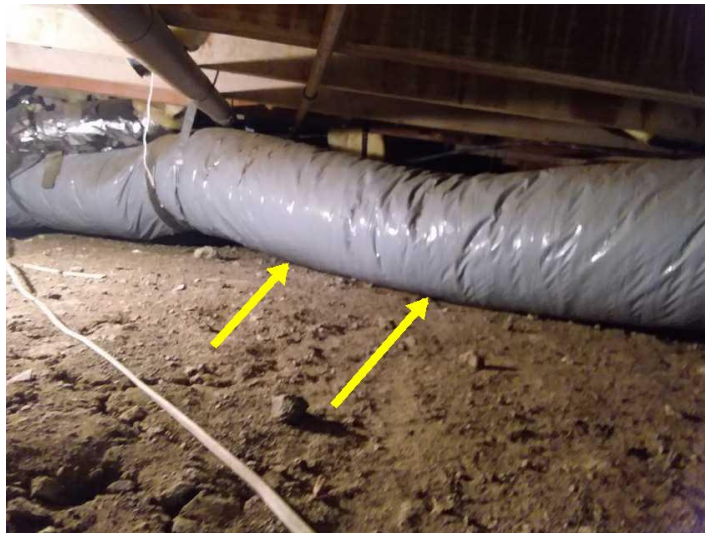
The flexible ducts in the crawlspace are in contact with the soil and should be a minimum of 4" off the ground. The plastic covering will deteriorate when in contact with the soil.

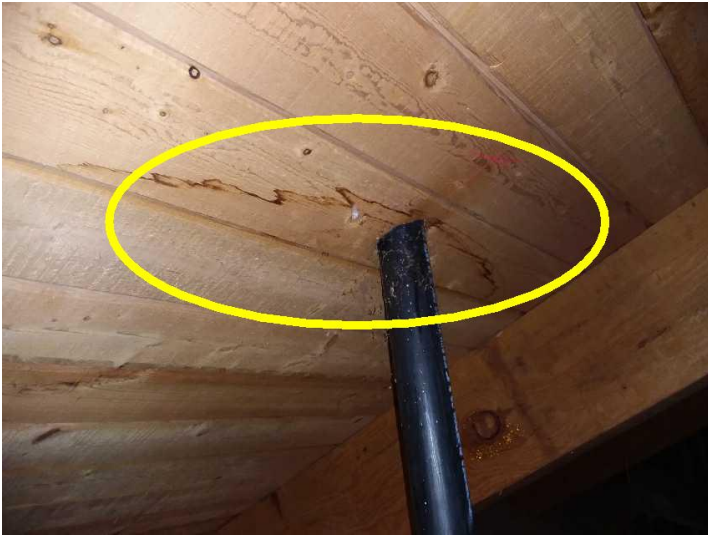
There are moisture stains on the attic ceiling at a roof penetration that indicate a past or present leak. This is a common area for leaks. We are unable to determine if the leak is current, or a past leak, in any case it should be further investigated or explained.

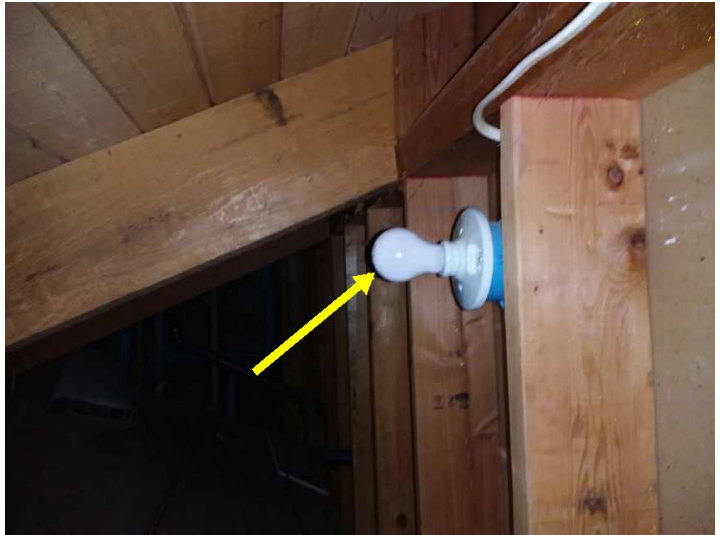
A light in the attic does not respond, and should be serviced.

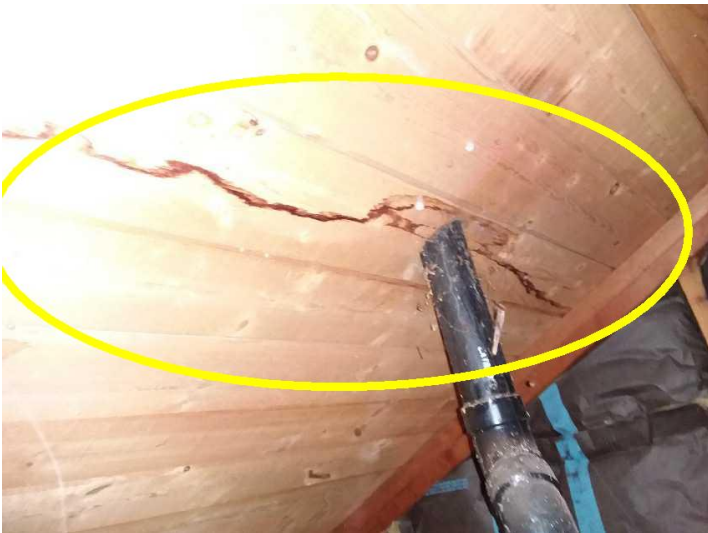
There are moisture stains on the attic ceiling at a roof penetration that indicate a past or present leak. This is a common area for leaks. We are unable to determine if the leak is current, or a past leak, in any case it should be further investigated or explained.

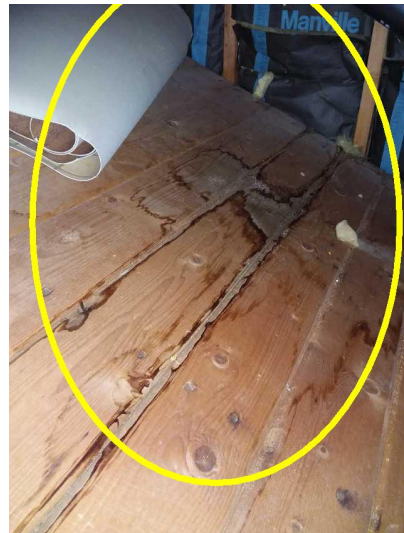
There are moisture stains on the attic ceiling at a roof penetration that indicate a past or present leak. This is a common area for leaks. We are unable to determine if the leak is current, or a past leak, in any case it should be further investigated or explained.

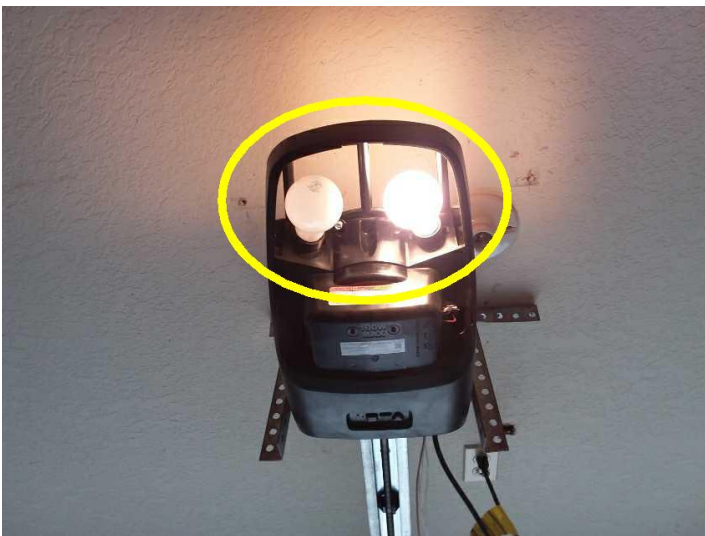
The automatic opener is missing its light cover and you may wish to have one installed.

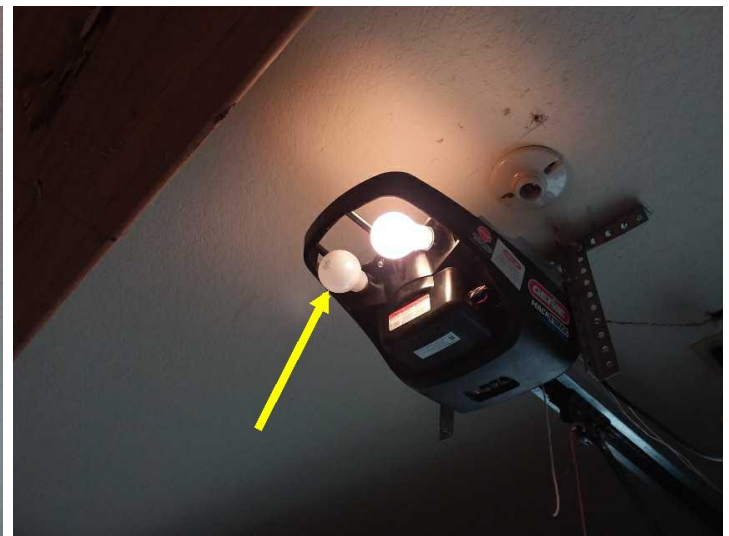
The garage door opener light bulb did not respond when the auto-reverse mechanism was activated, which should be serviced. This is important because it typically is the only light on when pulling into the garage at night.
