# **REAL ESTATE INSPECTION REPORT**

11410 Richland Ave. Los Angeles, CA 90064

Inspector - Francheska Lopez

DATE OF INSPECTION: Tuesday, August 4, 2026

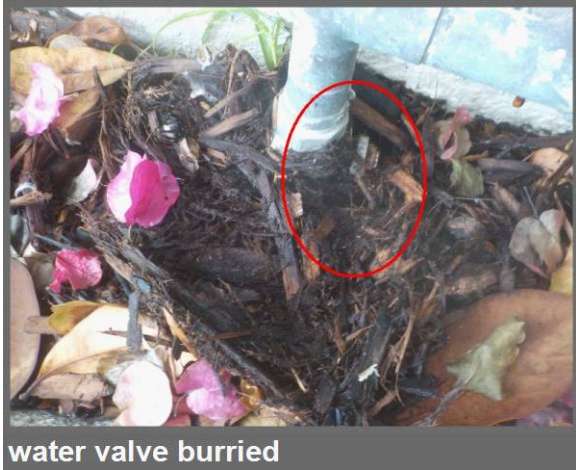
**NEEDS ATTENTION.** The main water valve is buried and will be difficult to access, the condition of this valve is unknown. The access for this valve should be restored and the valve evaluated and corrected/repaired as needed.

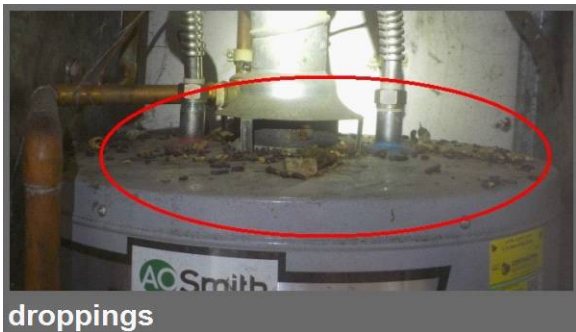
**NEEDS ATTENTION.** While not part of a standard home inspection signs of animal droppings at the top. It is advised to have a specialist in this area examine the structure and property to determine the presence or not of any infestation and recommend any corrective measures.

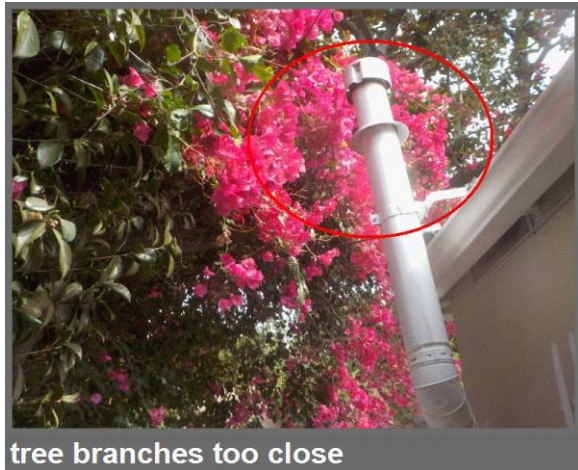
**NOT ACCEPTABLE.** The water heater vent is too close to combustible material (tree branches). It needs to have adequate clearance to minimize any possible fire hazard.

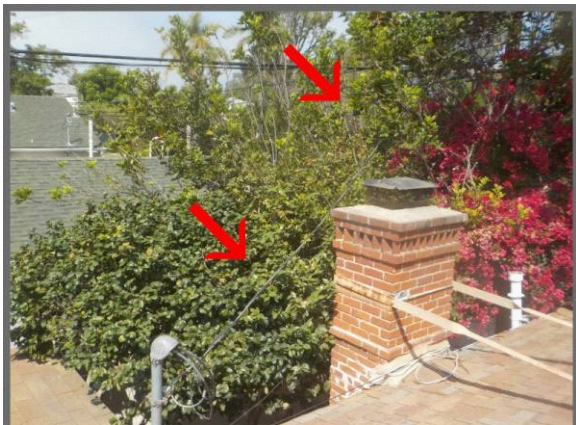
**NEEDS ATTENTION.** The main electrical line from the power pole to the building has some contact from tree branches and limbs and they may need to be trimmed back at times to keep them from putting pressure on the line

contact from tree branches

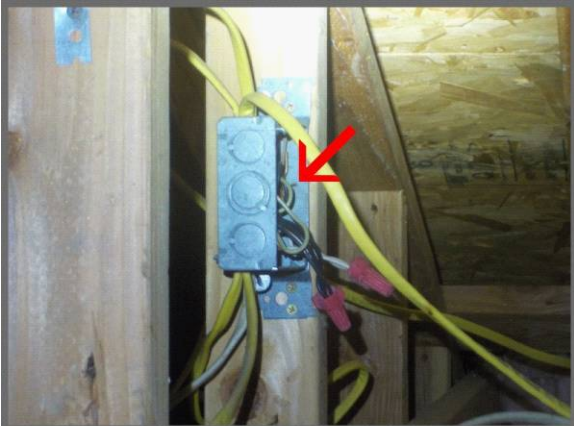
There are open junction boxes with wires exposed, such as in the Garage attic. Junction boxes should have protective covers over them and exposed wires should always be protected/properly capped for safety reasons.

opened junction box

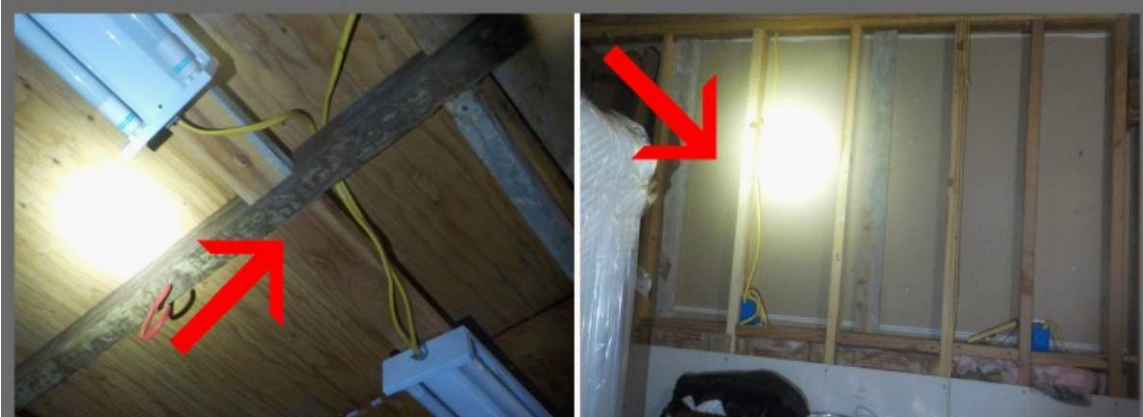
**NEEDS ATTENTION.** There is non-metallic sheathed wiring ("romex") installed in areas where it is exposed and can be damaged, such as in the Garage.

exposed romex

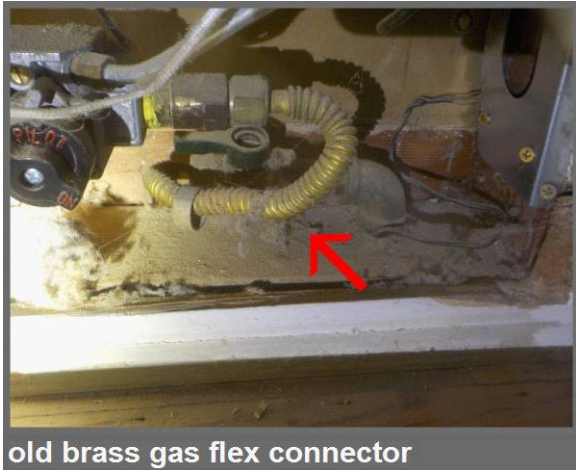
**NOT ACCEPTABLE.** This uses the old brass gas flex connector which is no longer approved for use due to the risk of cracks and leaks. This should be promptly replaced.

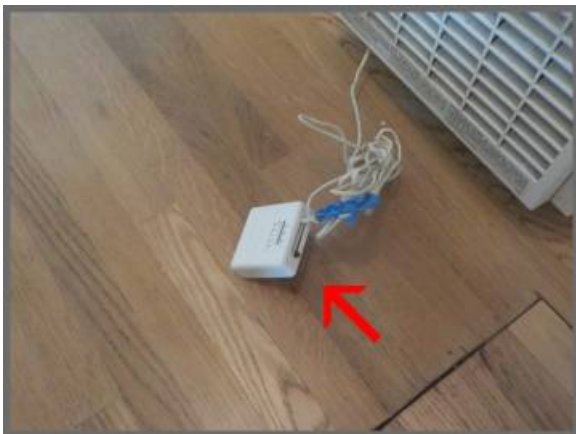
**NOT ACCEPTABLE.** The thermostat is lying on the floor and not properly secured or installed on the wall.

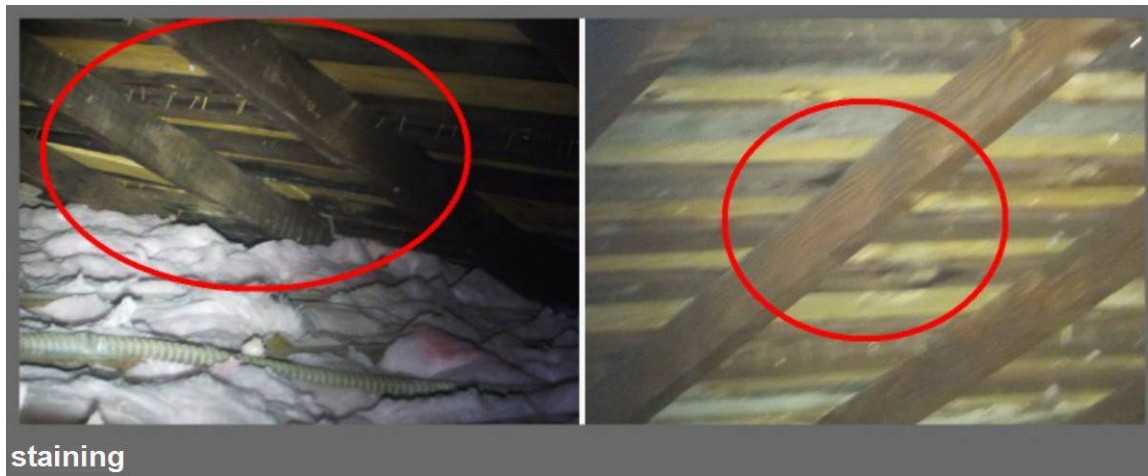
**NEEDS ATTENTION.** There are areas of staining noted to the framing lumber that may be due to current or former roof leaks. It is not determined if the staining is from a past or current condition.

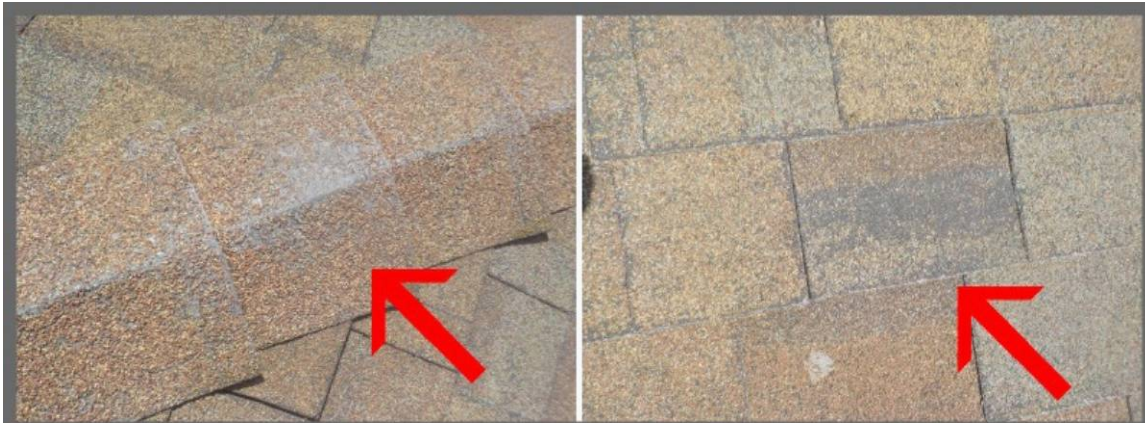
old & worn

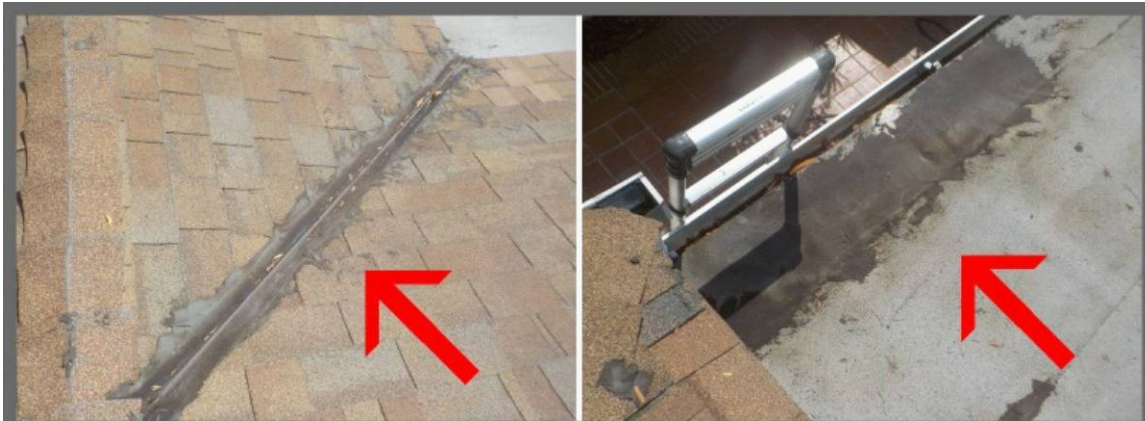
patches

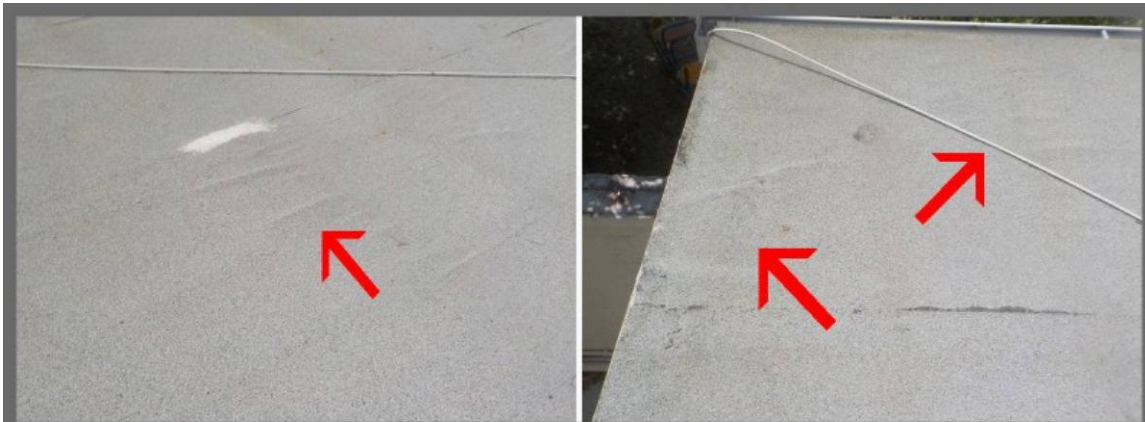
bubbled areas

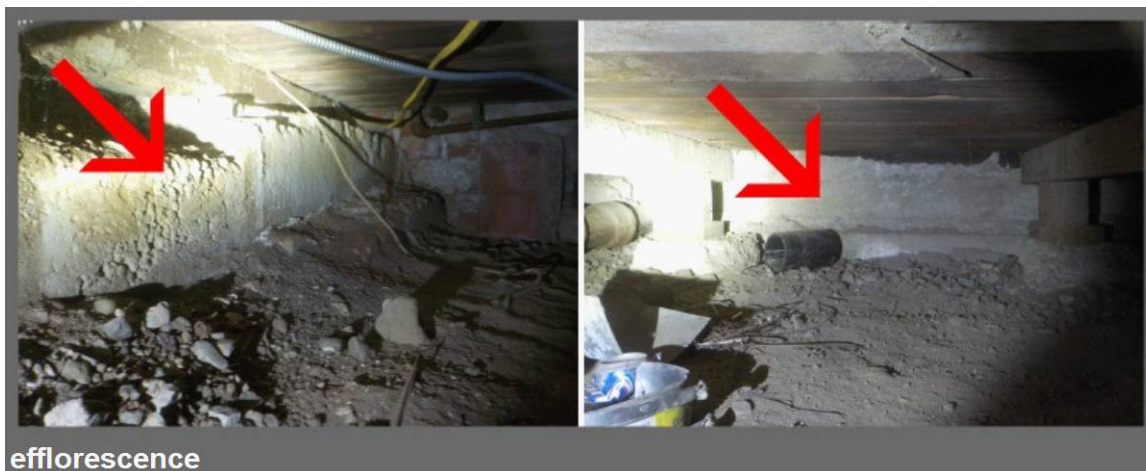
**NEEDS ATTENTION.** There is white staining and powder that may be efflorescence, indicating moisture in / through the foundation. This can damage any steel 'rebar' in the foundation and is not ideal.

efflorescence

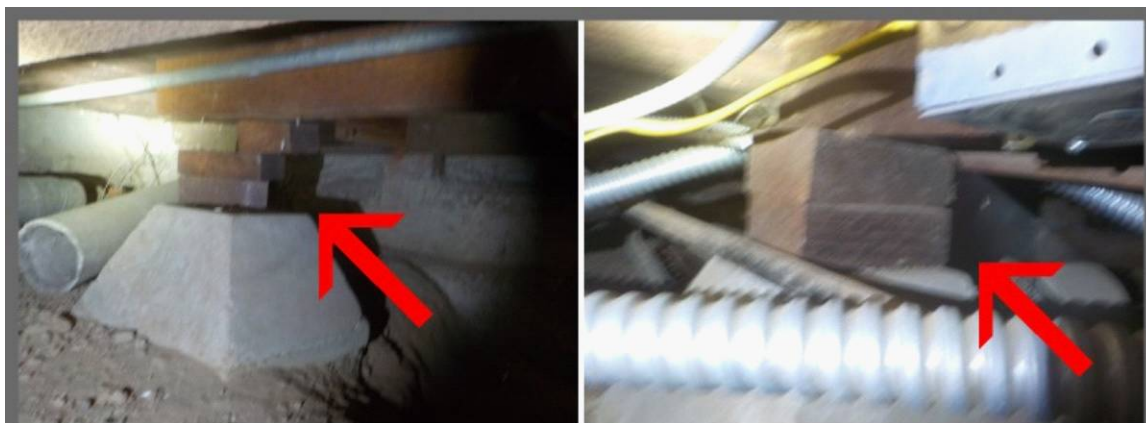
It is noted that some areas have shifted shims on them.

shims

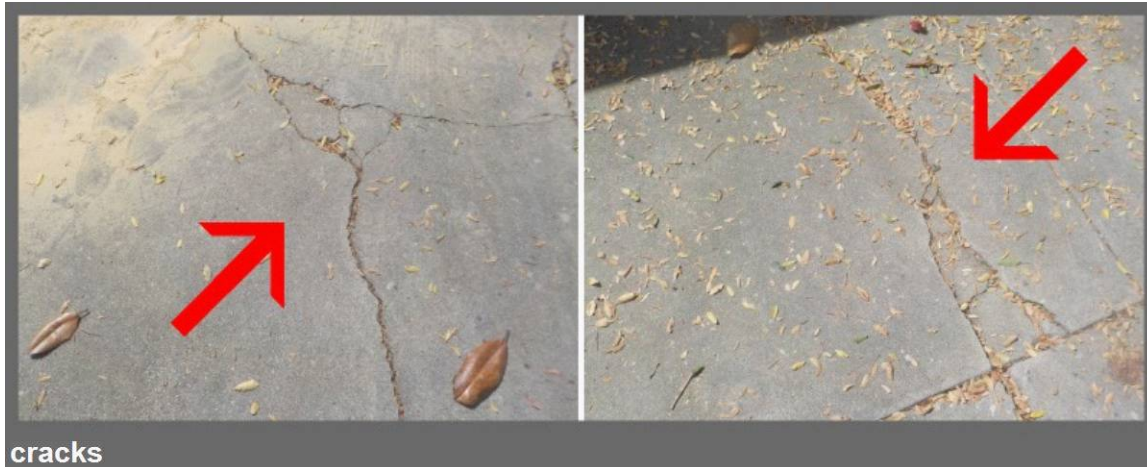
**NEEDS ATTENTION.** There are areas of cracks on the driveway.

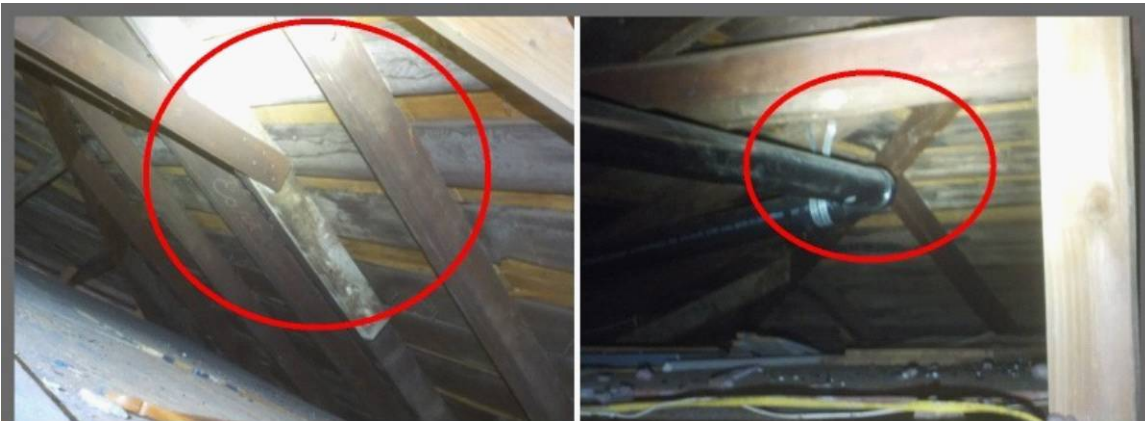
staining

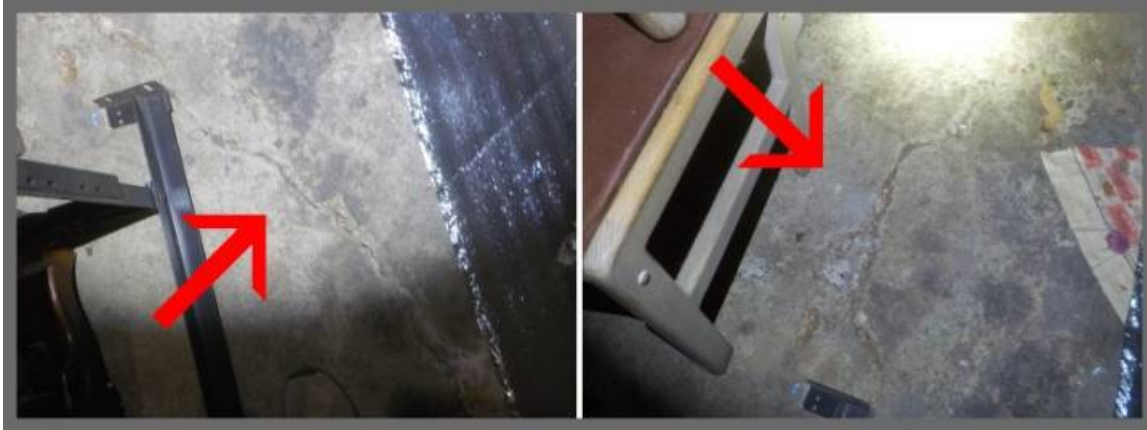
**NEEDS ATTENTION.** There are areas of cracks and stains on the floor.

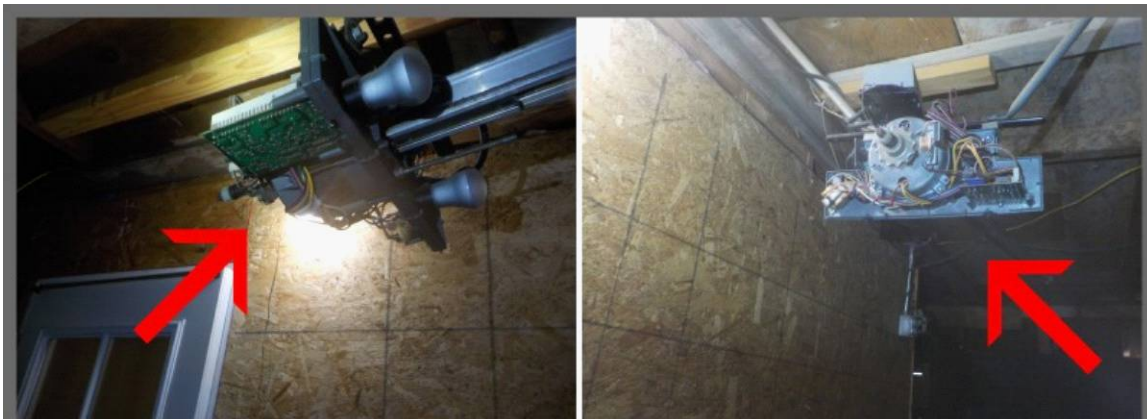
**NEEDS ATTENTION.** The opener motor area is missing the cover.

cover missing

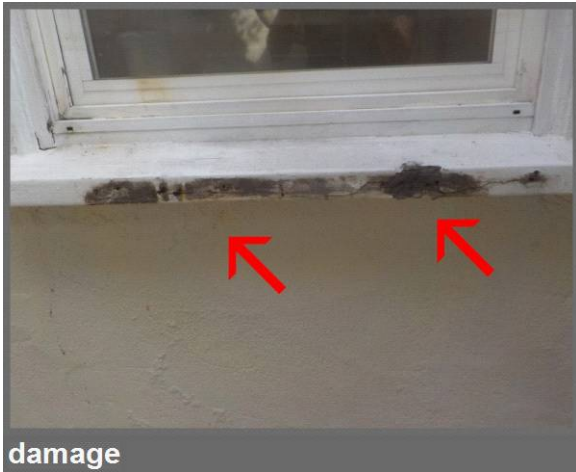
**NEEDS ATTENTION.** There are areas of damage to the exterior of the windows. It is advised to consult with a qualified specialist regarding this issue.

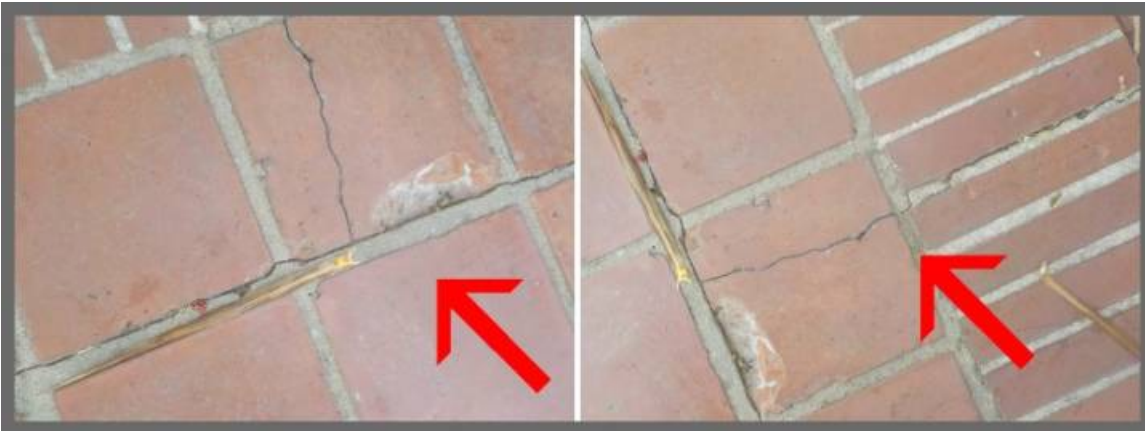
**NEEDS ATTENTION.** There are areas of cracked brick and deteriorated grout on the deck.

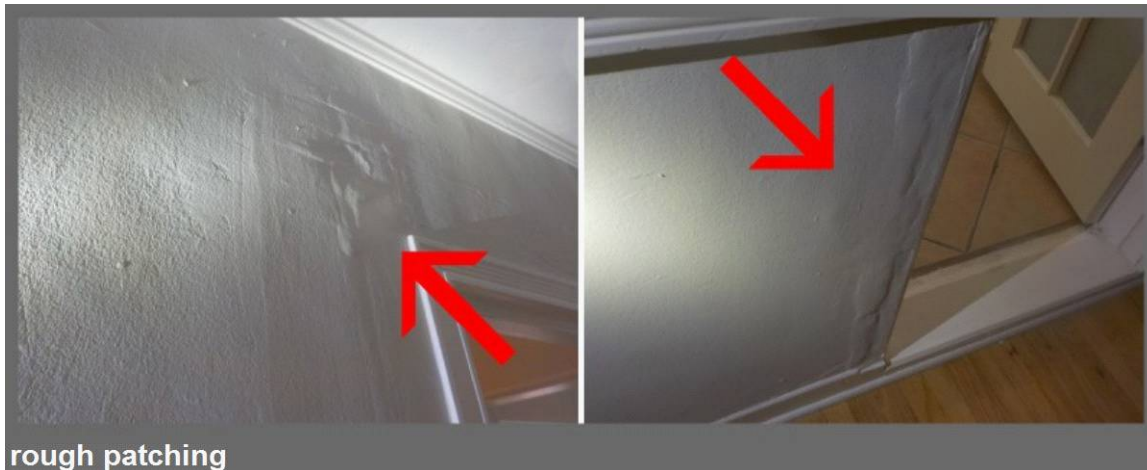
**NEEDS ATTENTION.** There are areas of rough patching and apparent repairs on the walls. The seller / owner should be asked the history of these repairs.

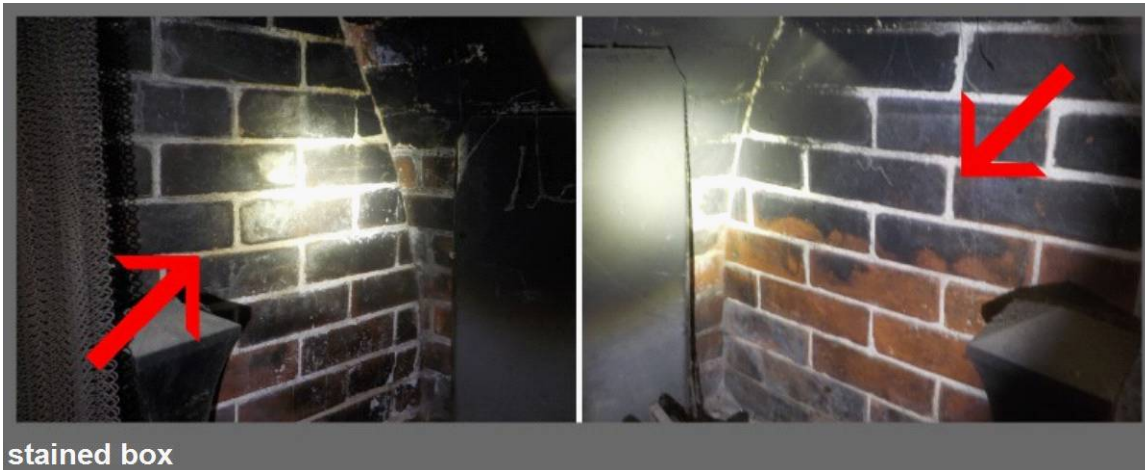
**NEEDS ATTENTION.** There are stains in the firebox. This is usually due to water entering down through the chimney. Further evaluation is recommended by a specialist.

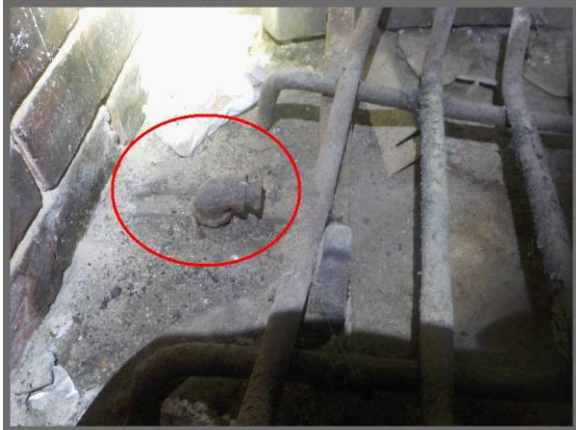
**SAFETY ALERT.** The gas pipe into the firebox is open, not capped or not connected to gas log or log lighter. This is considered unsafe and should be capped or completed with approved system.

gas line is not capped

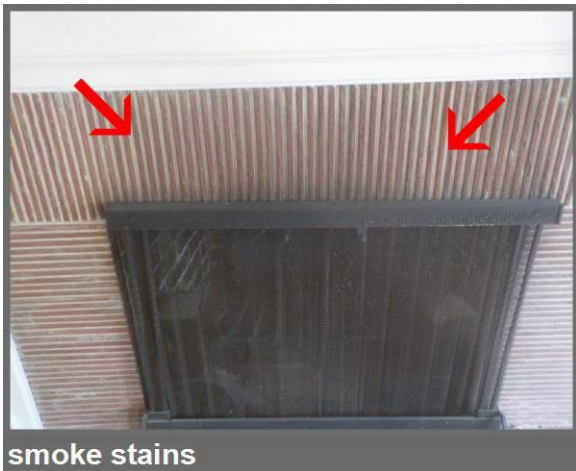
**NEEDS ATTENTION.** The mantel over the fireplace has smoke stains, this is usually from the chimney not drawing properly or burning too large a fire.

smoke stains

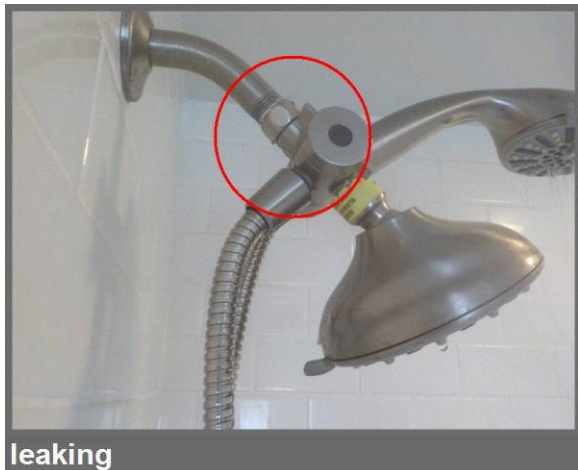
**NEEDS ATTENTION.** The shower head leaks at the connections.

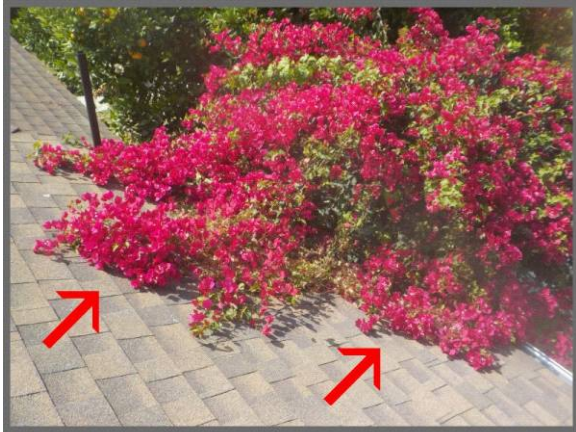
There are branches on the roofing material. These need to be trimmed back or removed to help prevent damage from occurring to the roof.

branches on the roof

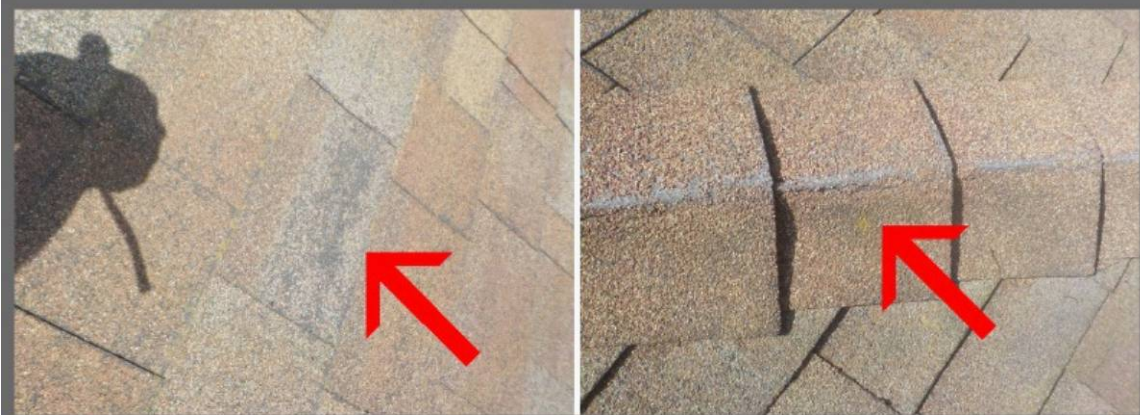
**NEEDS ATTENTION.** The shingles are older, deteriorating and losing their surface granules. It appears to be past it's expected useful service life, and while it may continue to work it is no longer considered reliable and will need to be replaced.

deteriorated & worn

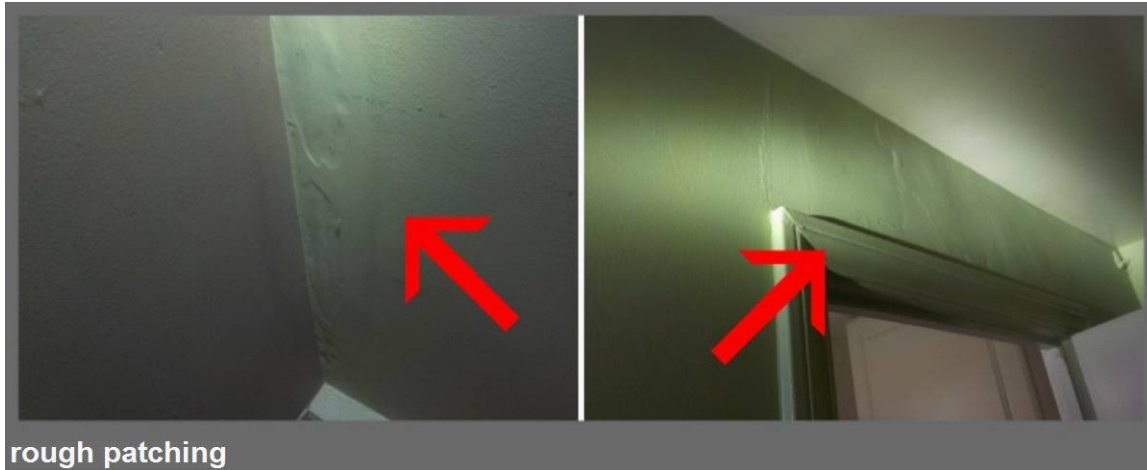
**NEEDS ATTENTION.** There are areas of rough patching and apparent repairs on the walls. The seller / owner should be asked the history of these repairs.

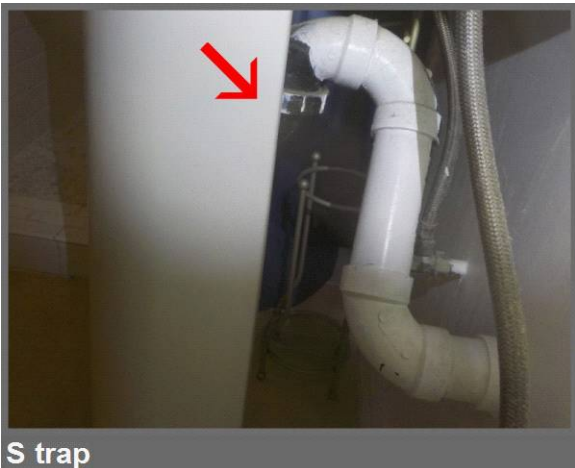
**NOT ACCEPTABLE.** There is an "S" trap design for the sink drain. This is no longer allowed as the trap can siphon and empty and allow sewer gasses up into the ADU.

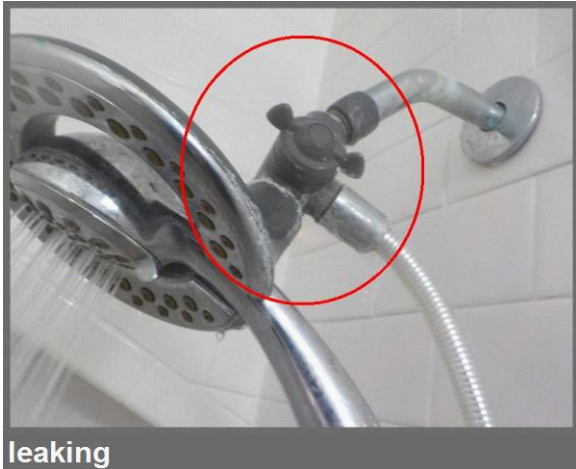
**NEEDS ATTENTION.** The shower head leaks at the connections.
