## FOUNDATION OBSERVATION REPORT

Project: Foundation Replacement/Repair  
136 San Fernando Ave., Oxnard, CA 93035

T&S Job No.: 240462

Subject: Site Visit – September 24, 2025

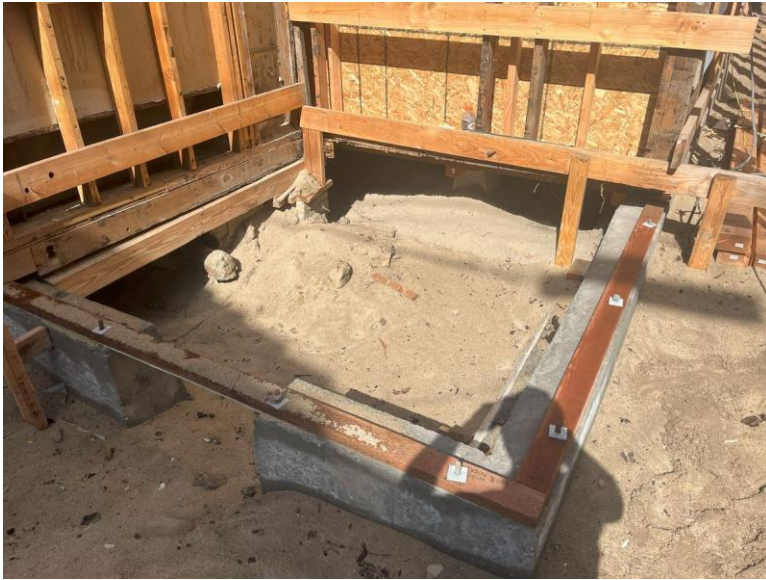
Photo 1: New Footing at Rear of House (Overview)

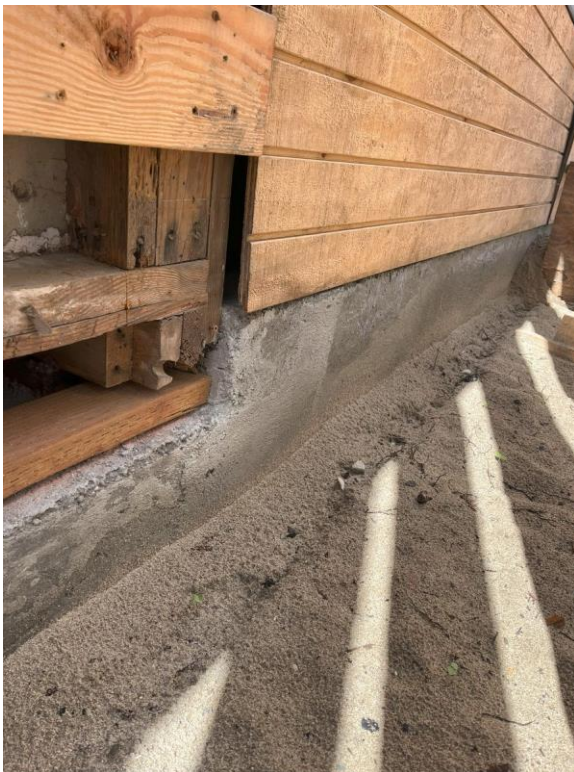
Photo 2: New Footing at Side of House

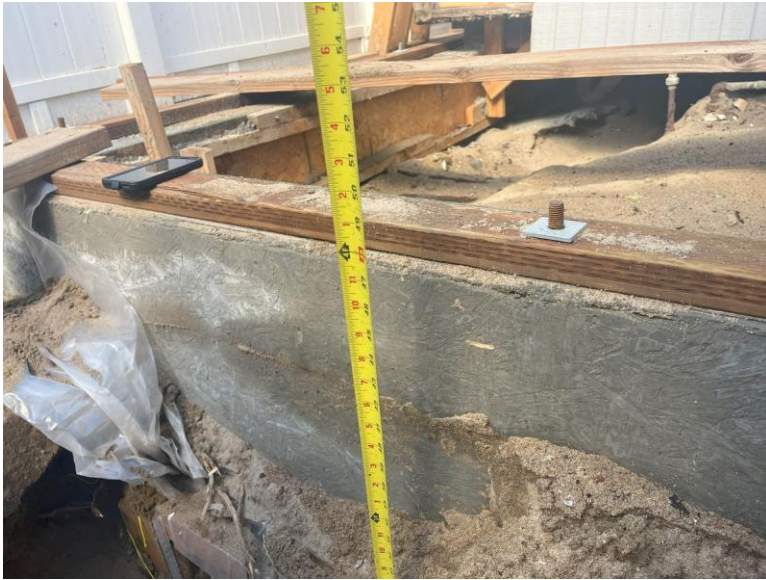
Photo 3: New Footing (Total Depth Measurement – ~4'-0")

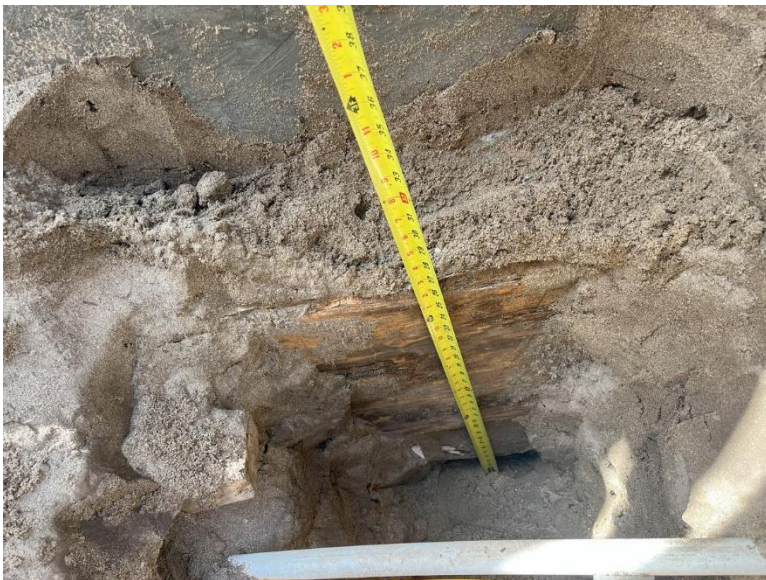
3. At all three holes, the footing embedment below adjacent grade was measured to be between 3'-0" and 3'-3". The footing excavation at one of the rear locations was additionally excavated so that the footing width could be verified; the minimum width there noted was 16", and stem widths of 12" were measured at spot checks elsewhere.

Photo 4: New Footing (Embedment Measurement – ~3'-0")
