# Inspection Report

32181 Paseo de Manuel  
San Juan Capistrano CA 92675

Anderson Inspections

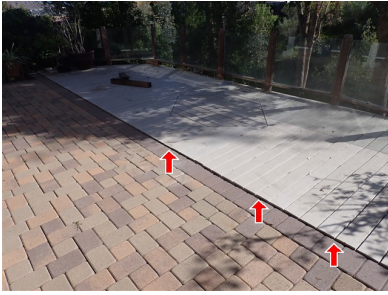
Item 3 - Item 1 (Picture)

3. (3) The surface of the rear patio is uneven, creating trip hazards in some areas.- Repairing the affected areas is recommended for improved safety.

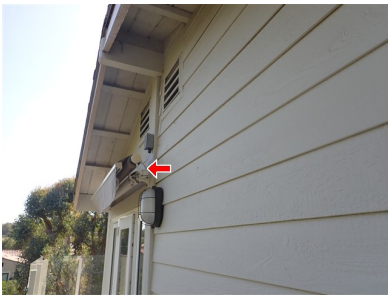
Item 4 - Item 1 (Picture)

4. One or more electric awnings were installed at the exterior. No switch or remote control was located for the awnings. - We recommend having the seller(s) demonstrate the operation of the awnings. Repairs should be made as needed by a qualified specialist.

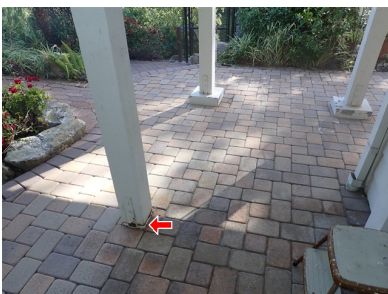
Item 5 - Item 1 (Picture)

5. (1) One or more of the left rear patio cover support posts are damaged or deteriorated at their base. -All damaged posts should be repaired by a qualified contractor to ensure proper support of the structure.

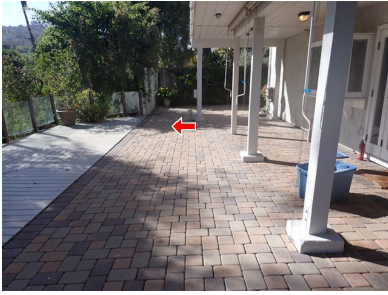
Item 6 - Item 1 (Picture)

6. (2) The patio pavers are uneven at section at the right rear. - A qualified technician should repair as needed.

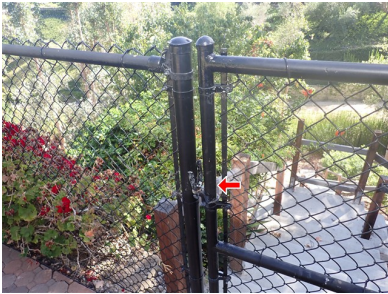
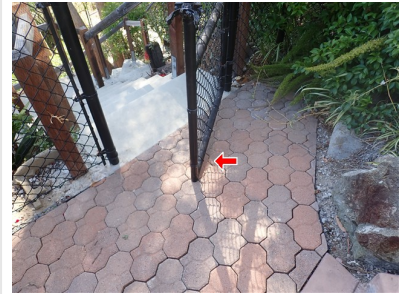
7. (1) The gate latch at the left rear of the property is does not latch.  
- A qualified technician should repair/replace the latch, as needed.

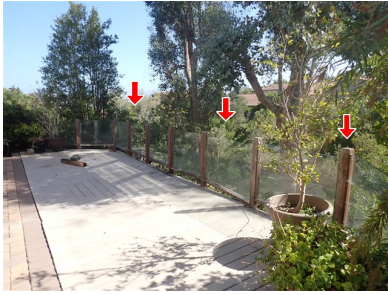
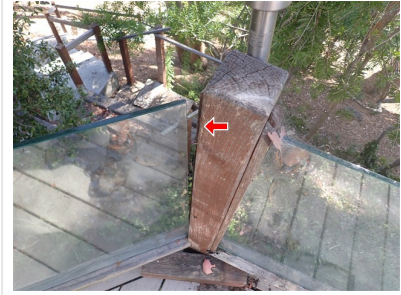
9. (1) The guardrail for the deck at the rear is very loose and is a safety hazard (some of the glass panels are loose and at risk of falling out).  
- The railing should be replaced by a qualified technician.

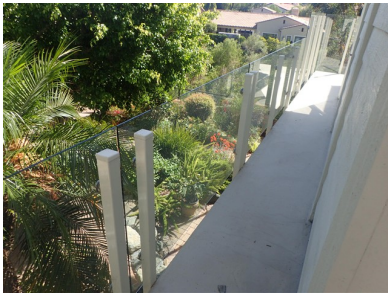
Item 10 - Item 1 (Picture)

10. (2) The railing for the upper deck is loose.  
- The railing should be reinforced or replaced as necessary by a qualified technician.

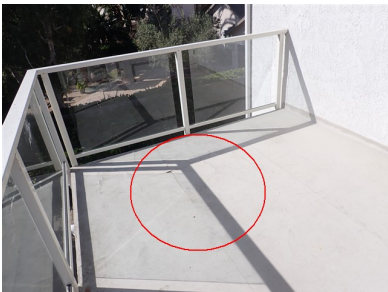
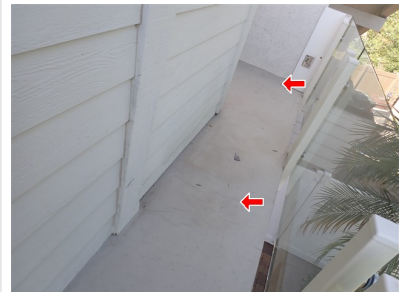
11. The deck is finished with a coating that provides both the walking surface and the waterproof membrane. The coating is cracked and split, exposing the underlying material to deterioration.  
- The coating and substrate should be recoated as necessary.

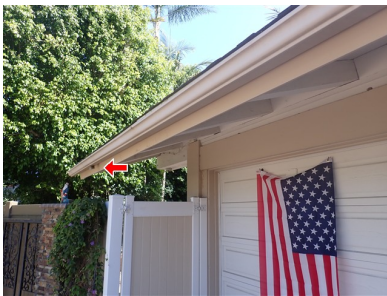
Item 12 - Item 1 (Picture)

12. One or more downspouts at the left front were missing. - Any missing downspouts should be replaced where needed.

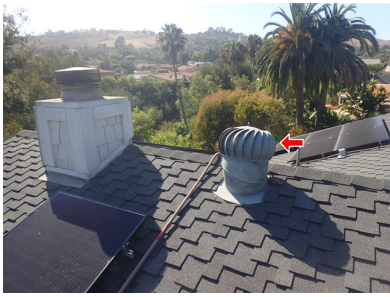
Item 13 - Item 1 (Picture)

13. One or more of the turbine vent(s) on the roof are noisy and no longer turn freely. We recommend a qualified technician repair or replace all non working vents.

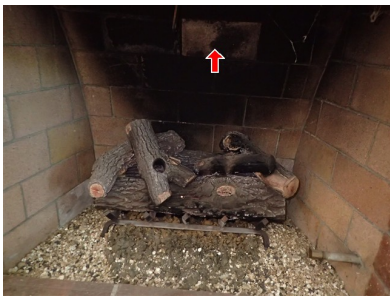
Item 14 - Item 1 (Picture)

14. (3) The gas log fireplace is not equipped with a damper clamp that stops the damper from fully closing. - A proper metal C clamp or damper clamp should be installed to ensure toxic gases go up the chimney, instead of escaping to the interior.

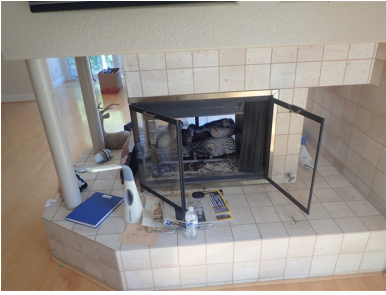
Item 15 - Item 1 (Picture)

15. The Master Bedroom fireplace and/or chimney had a buildup of soot. This can be a fire hazard if the buildup is allowed to continue. - A qualified chimney sweep should clean the flue.

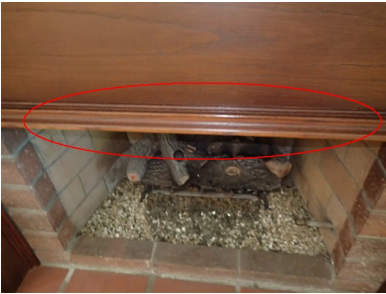
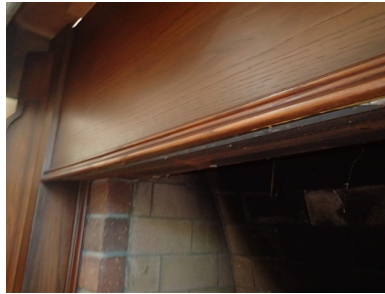
16. (1) The mantle is too close to the firebox opening by current standards (12" minimum clearance). -No damage was noted at this time, however we recommend modifying the mantel for improved fire safety.

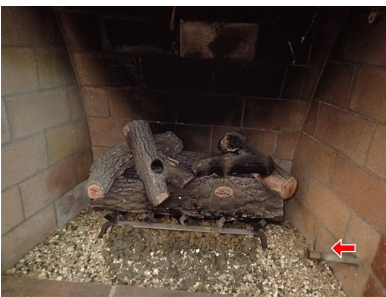
Item 17 - Item 1 (Picture)

17. (2) The fireplace gas connector is rigid aluminum tubing. Aluminum tubing was approved at the time of this installation. However exposure to the elements deteriorates the tubing and makes it more likely to rupture during seismic activity.
- For an increased margin of safety, a connector meeting industry standards should be installed.

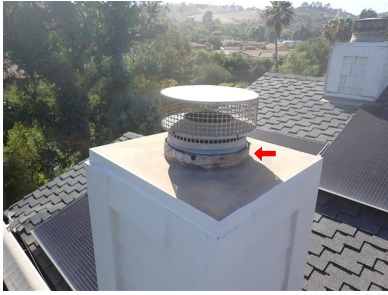
Item 18 - Item 1 (Picture)

18. (1) The sheet metal cap(s) at the top of the chimney is not watertight. Driven rain could leak at the cap.
- A qualified technician should repair the cap as needed.

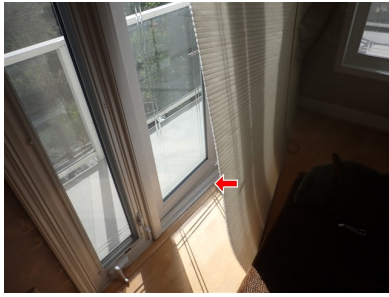
Item 21 - Item 1 (Picture)

21. (1) A exterior door at the Master Bedroom binds on the jamb or threshold. - Have a qualified technician adjust the door to restore proper operation.

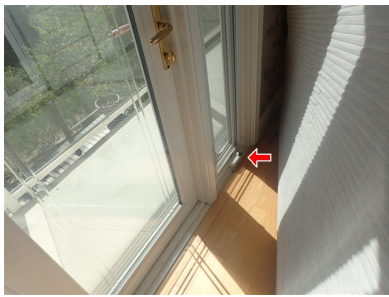
Item 22 - Item 1 (Picture)

22. There is one or more missing crank handles at the windows in the some locations. -The handles should be replaced where needed. (Such windows cannot be easily used for an exit in an emergency.)

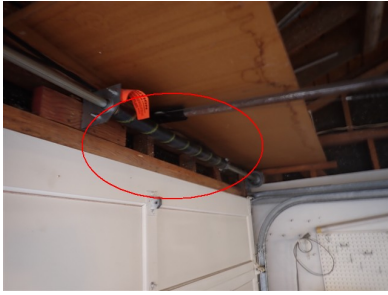
Item 23 - Item 1 (Picture)

23. The counter balance mechanism (spring) for the Left Side garage door is out of adjustment and does not adequately compensate for the weight of the door. -A qualified garage door mechanic should make the necessary repairs and/or adjustments.

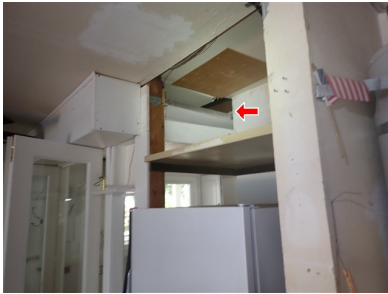
Item 24 - Item 1 (Picture)

24. There are gaps/holes in the fire-resistive barrier between the garage and interior. This condition can allow more rapid spread of smoke and flames in the event of a fire. - All voids should be repaired for improved fire safety.

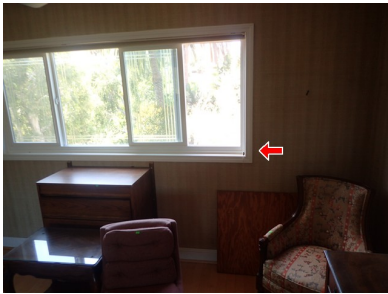
Item 26 - Item 1 (Picture)

26. One or more of the bedroom window sills are more than forty-four inches above the floor. This was likely allowed at the time of construction but no longer meets current standards for fire safety. -Although no upgrading is required, we recommend modifying the windows to meet present safety standards.

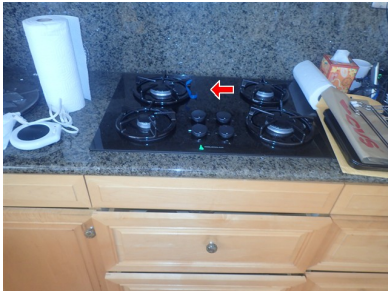
Item 27 - Item 1 (Picture)

27. One or more cooktop burners did not ignite. - A qualified technician should make any needed repairs so that the burners and ignition system are functional

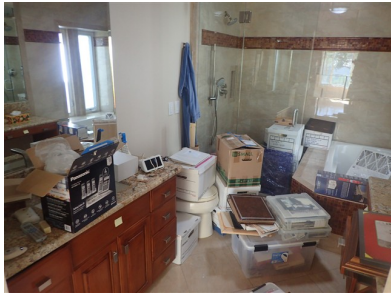
Item 29 - Item 1 (Picture)

29. (2) Personal items were stored in the Master Bathroom at the time of this inspection. The fixtures and drains could not be tested. Stored items should be removed and the fixtures and drains tested by a qualified technician.

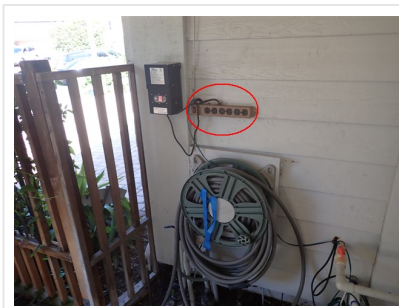
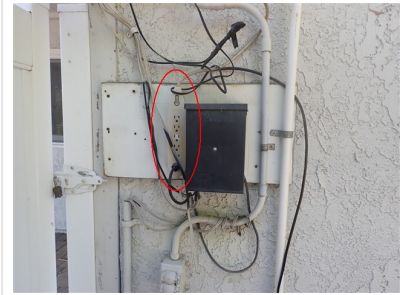
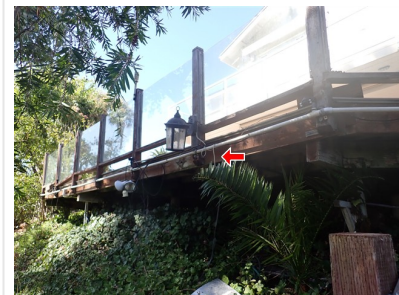
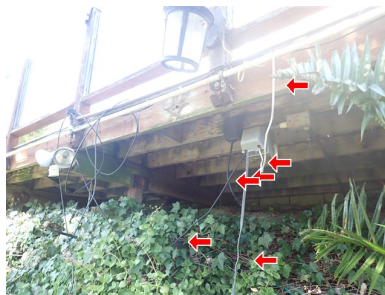
31. (1) Extension cords are being used as permanent wiring at the exterior. Extension cords are not appropriate for use in permanent installations, are easy to overload, and are easily damaged, which can create a shock or fire hazard. Removal of all permanently installed extension cords and replacement with appropriate, permanent wiring is recommended. A licensed electrician should install all permanent wiring.

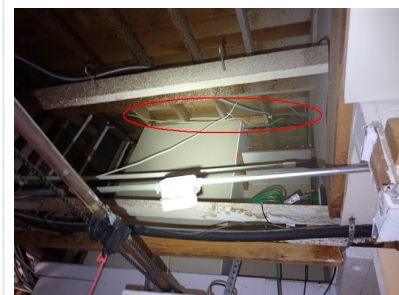
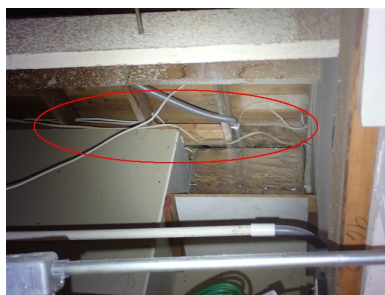
32. (2) There is exposed wiring (Romex) at the garage. The wiring is susceptible to physical damage and not well protected. - A qualified electrician should properly install any exposed wiring.

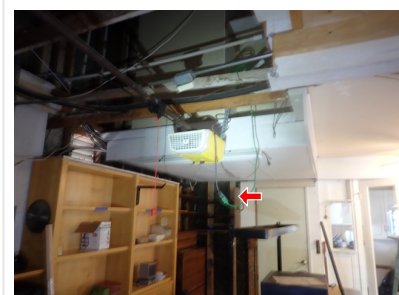
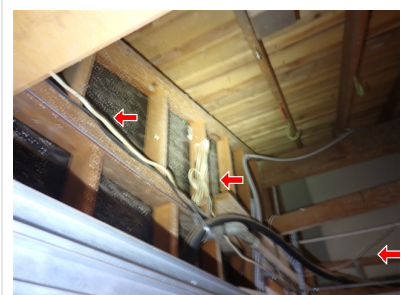
33. (3) Extension cords are being used for permanent power to the garage door opener. This type of wiring is not appropriate for use in permanent installations, is easy to overload, and is easily damaged. - Removal of all permanently installed extension cords and replacement with appropriate, permanently installed wiring is recommended. A qualified technician should do the work.

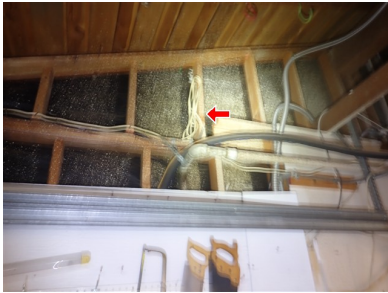
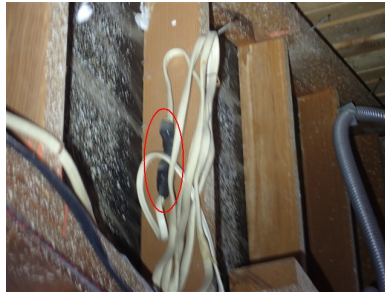
34. (4) There are one or more open wire splices at the Garage. Open splices can be a shock or fire hazard.  
- A qualified technician should properly splice all wiring inside covered junction boxes.

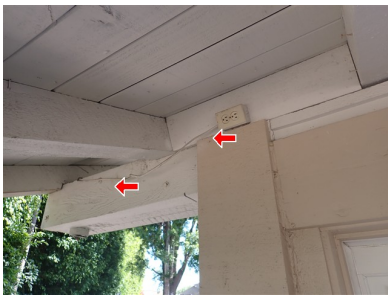
Item 35 - Item 1 (Picture)

35. (5) There is exposed wiring (Romex) at the exterior. The wiring is susceptible to physical damage and not well protected. - A qualified electrician should properly install any exposed wiring.

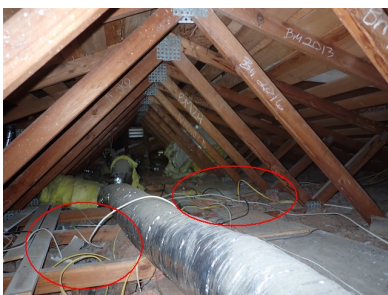
Item 36 - Item 1 (Picture)

36. (6) There is unsecured wiring exposed to physical damage in the attic. Wiring should be secured to prevent damage to the wiring. - A qualified electrician should make repairs as necessary.

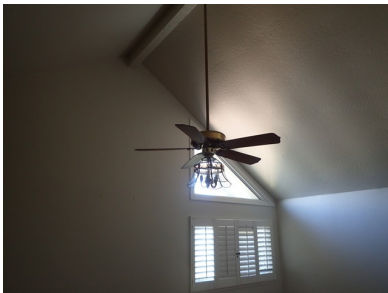
Item 41 - Item 1 (Picture)

41. Some ceiling fans had no visible remote control. The ceiling fan could not be tested or the speed could not be changed. - We recommend having the seller demonstrate the operation of the fan. The fan should be tested at the highest speed to verify it does not wobble excessively.

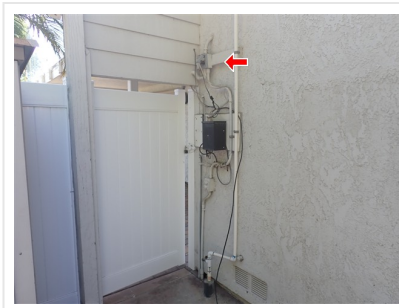
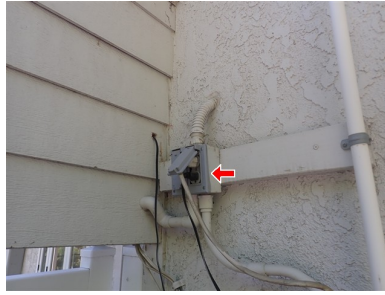
42. (1) There is one or more permanently installed extension or appliance cords at the exterior of the building. All permanently installed cords should have a cover that allows the plug to be installed and still maintain a weather-tight enclosure. -An approved in-use cover should be installed as an upgrade.

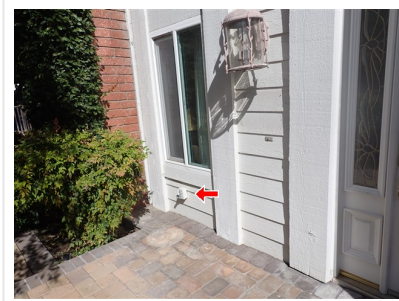
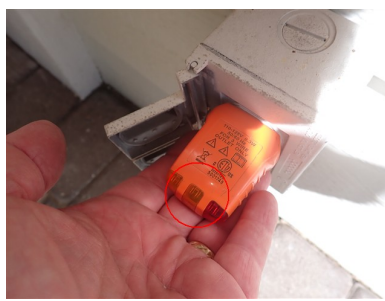
43. (3) The outlet at the right side exterior had no power when tested. No switch or tripped GFCI was located for the outlet. - We recommend further review and repair by a qualified electrician.

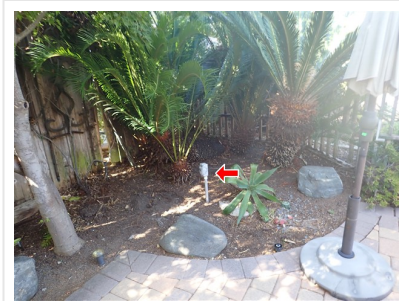
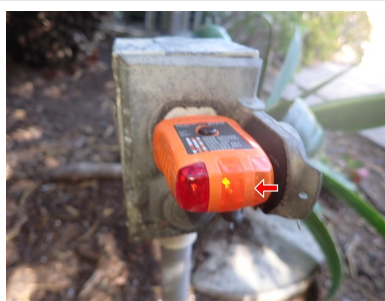
44. (4) There is an ungrounded receptacle in the rear exterior. Three-pronged receptacles should be grounded. The ground is a safety feature.  
- A qualified electrician should make repairs or modifications as necessary to any ungrounded receptacle.

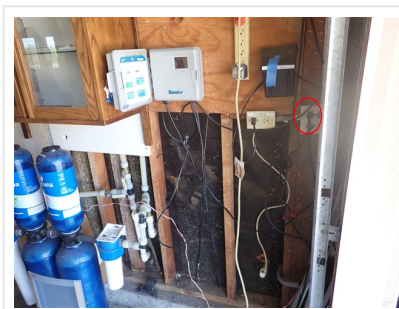
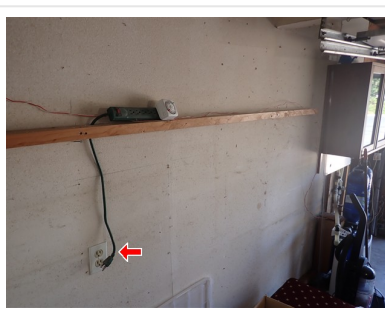
46. (1) Ground Fault Circuit Interrupter (GFCI) protection is installed for some, but not all, of the Garage receptacles where this type of protection is presently required.
- A qualified electrician should make repairs as needed so that all garage receptacles meet current standards.

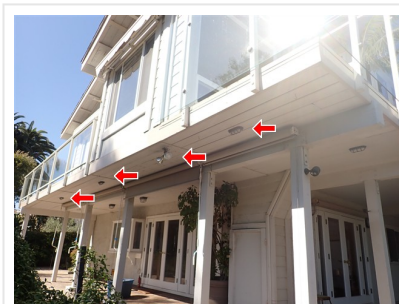
Item 48 - Item 1 (Picture)

48. (2) One or more lights were not verified to be operational. We didn't locate a switch or otherwise did not verify the operation of the lights. - We recommend having the seller demonstrate the operation of the lights.

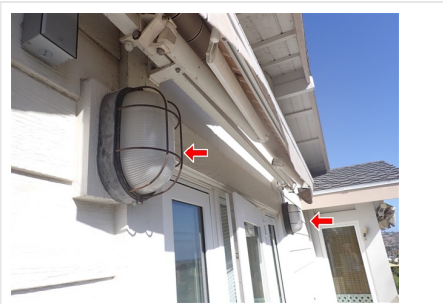
Item 49 - Item 1 (Picture)

49. (6) One or more lights are not functional at the exterior. The bulbs may have burned out. Try replacing the bulbs and testing the fixtures. If new bulbs do not correct the problem, a qualified electrician should make repairs or modifications as necessary.

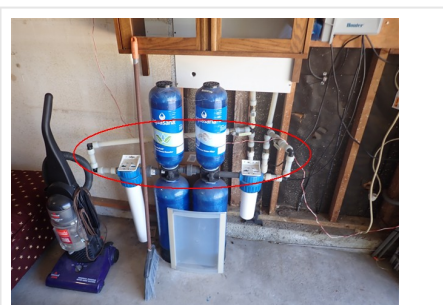
Item 51 - Item 1 (Picture)

51. There is exposed PEX plastic piping at the garage. The piping is exposed to physical damage as well as damage from ultraviolet rays. - All exposed PEX piping should be properly protected in accordance with current plumbing standards.

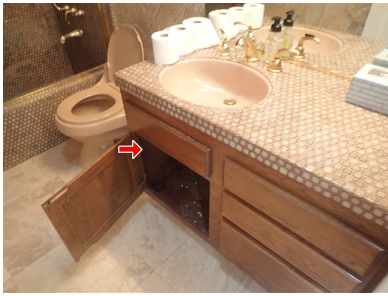
Item 52 - Item 1 (Picture)

52. Some of the sink water supply shutoff valves were noticeably corroded, but were not leaking at this time. - We recommend monitoring the valves for leaks and replacing any valve when a leak is discovered. Be prepared for a valve to leak whenever it is used.

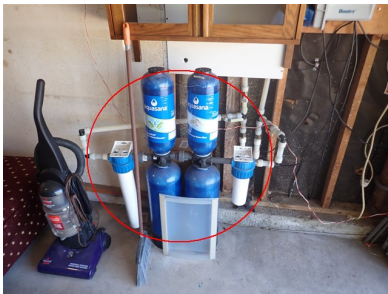
Item 53 - Item 1 (Picture)

53. Water softening/conditioning equipment has been added to the water supply system for this house. Evaluation of this equipment is outside the scope of this inspection.
- We recommend asking the seller for information about this equipment. Sometimes this equipment is leased from, and serviced by, a service provider.

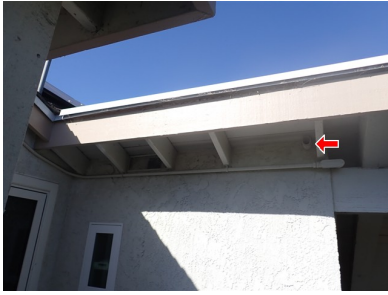
Item 54 - Item 1 (Picture)

54. There is an open pipe at the left rear. The purpose of the pipe was not determined. - We recommend review by a qualified technician to determine the purpose of the pipe.

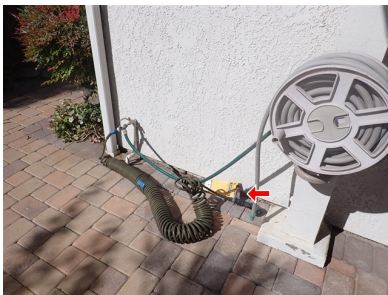
Item 55 - Item 1 (Picture)

55. (1) The gas piping material for the rear exterior was not verified to be approved for underground installation by current standards. The pipe is subject to corrosion and leakage if it is not the proper pipe.  
 - Consult a qualified plumbing contractor for evaluation of this condition and any required repairs.

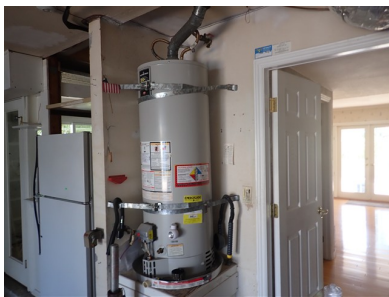
Item 58 - Item 1 (Picture)

58. (1) The water heater is at or beyond the end of its anticipated service life (unit is 12 years old). This type of water heater averages 10-15 years of service life. -Although it is still operating, you should budget to replace it in the not too distant future.

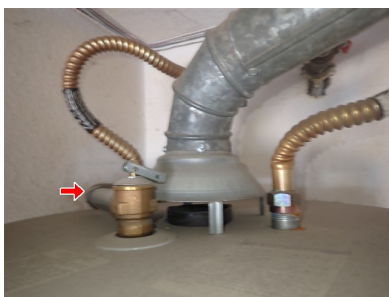
Item 59 - Item 1 (Picture)

59. (2) The flexible and plastic discharge pipe on the water heater's temperature-and-pressure (T&P) valve is not an approved material for this installation.  
- A qualified plumber should install a discharge pipe that complies with the valve manufacturer's specifications.

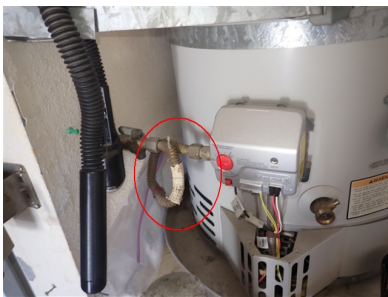
Item 62 - Item 1 (Picture)

62. The water heater gas connector is flexible brass. Flexible brass connectors are no longer an acceptable device for use in a natural gas supply. -A connector meeting present standards should be installed as an upgrade.

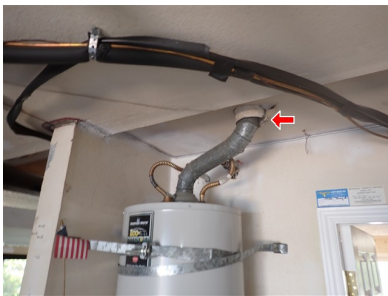
Item 63 - Item 1 (Picture)

63. The water heater vent is not connected with an appropriate transition fitting connector. - A qualified technician should repair with an approved fitting.
