# Inspection Report

**Tiffany Deborde**  
**1340 Bay Oaks Drive**  
**Los Osos, CA 93402**

Report Date: 7/9/2026

Customer File # **21802**

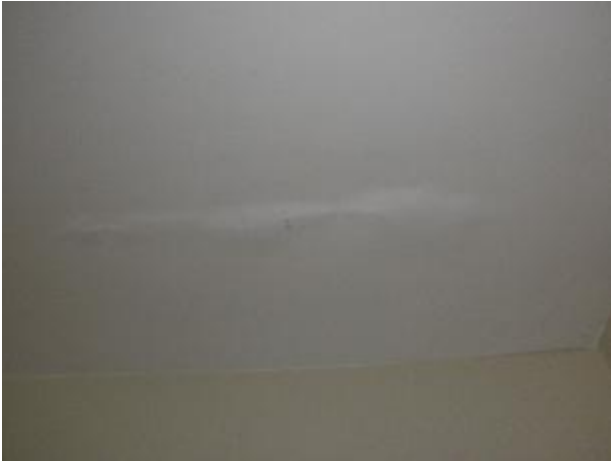
- 1.) There is a water stain at the ceiling above the front entry area with bubbling paint. This area was moisture probe tested and found to be dry during the time of inspection however, this area should be monitored during future rain events.

Water stain and bubbling paint above the front entry door.

**Repaired see Mold Dr contract , certification and invoice dated 7/15/26 Repaired see Estero Roofing Invoice dated 7/30/26**

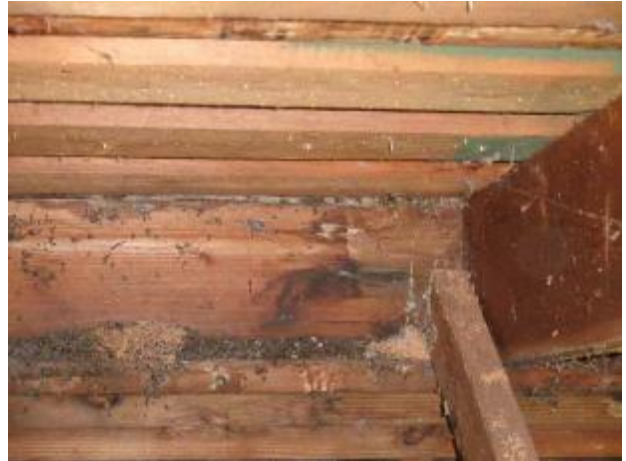
Water stain below the chimney flashing.

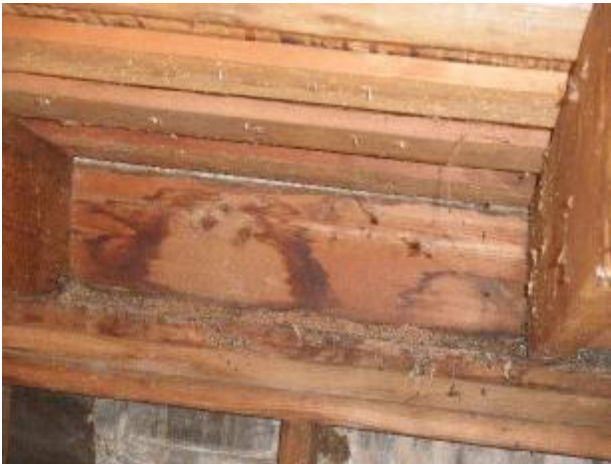
Water stain below the chimney flashing.

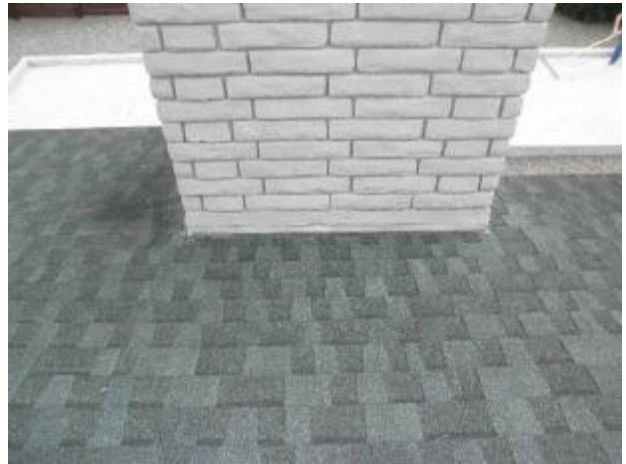
- 18 **Maintenance Note:** There is no "cricket" flashing behind the chimney enclosure. This is installed so water can drain around the chimney. Without a proper cricket the flashing area may be prone to leaks. (Note: There were water stains observed below the chimney flashing as seen from inside the attic space.)

Missing cricket flashing behind the chimney.

**Maintenance Note:** There is no "cricket" flashing behind the chimney enclosure. This is installed so water can drain around the chimney. Without a proper cricket the flashing area may be prone to leaks. (Note: There were water stains observed below the chimney flashing as seen from inside the attic space.) **Repaired by Estero Roofing see invoice dated 7/30/26**

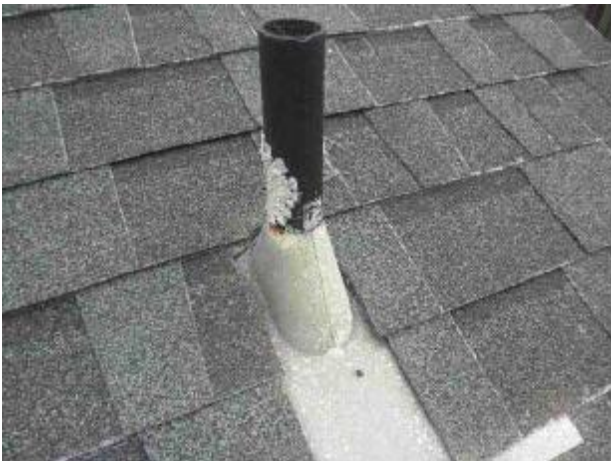
**Maintenance Note:** The sealant at the flashings has become cracked and deteriorated from exposure to the sun. Recommend resealing the flashings to prevent water intrusion.

Reseal all of the flashings.

Recommend resealing the flashings to prevent water intrusion. **Repaired see Estero Roofing Invoice dated 7/30/26**

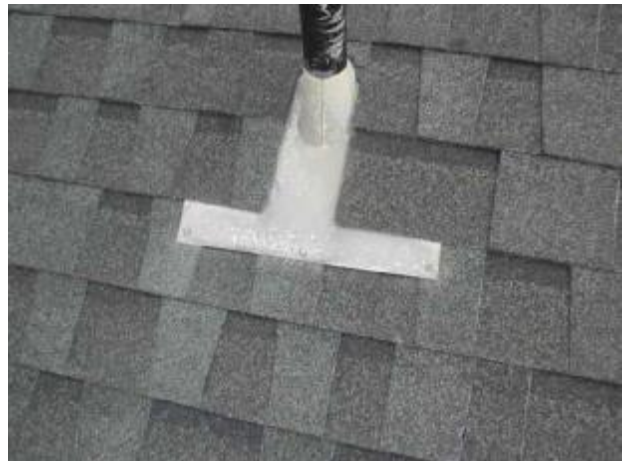
- 2.) Seal the nails at the base of the flashings to prevent rusting and potential water intrusion.

Seal the nails at the base of the flashings.

2.) Seal the nails at the base of the flashings to prevent rusting and potential water intrusion. **Repaired see Estero Roofing Invoice dated 7/30/26**

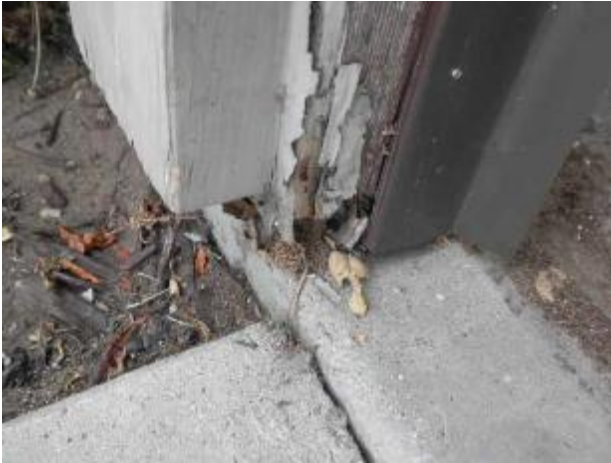
2.) There is evidence of drywood termite damage and infestation at the garage vehicle door jamb. Recommend further evaluation by a qualified and licensed Pest Control Inspector prior to the close of escrow.

Termite damage to the garage vehicle door jamb.

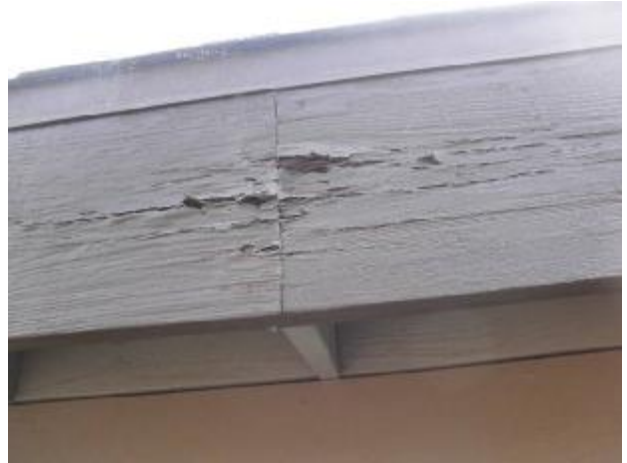
Moisture damage to the south fascia.

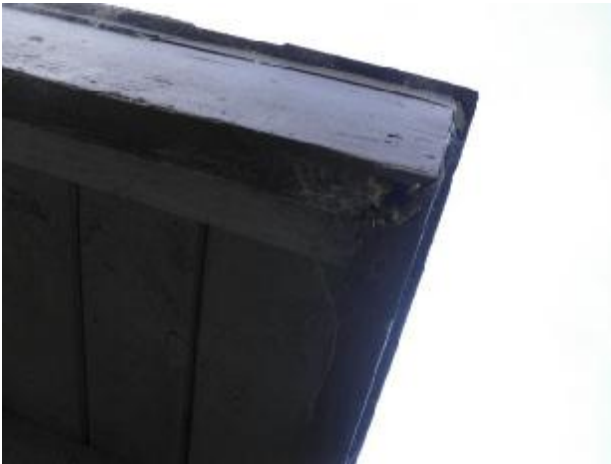
Moisture damage to the SW fascia.

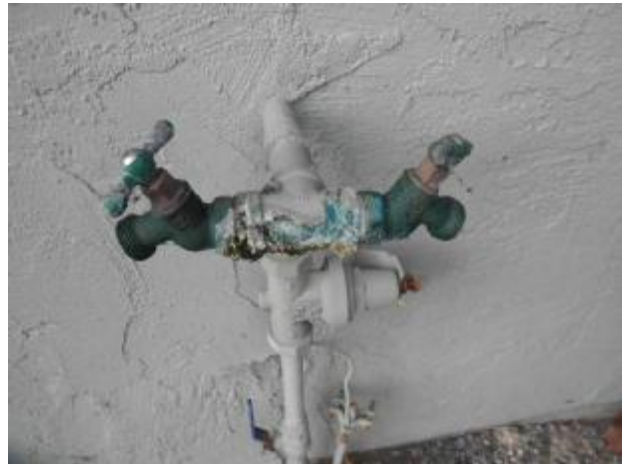
3.) There is a leak at the hose bib on the SW wall.

Leak at the hose bib on the SW wall.

3.) There is a leak at the hose bib on the SW wall. **Repaired see invoice dated 7/23/26**

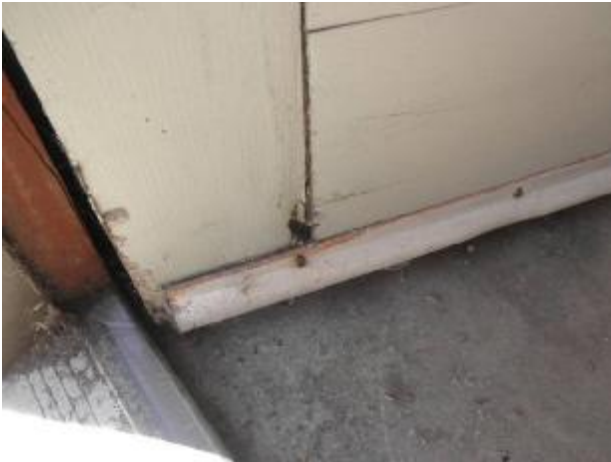
Moisture damage to the base of the garage side door.

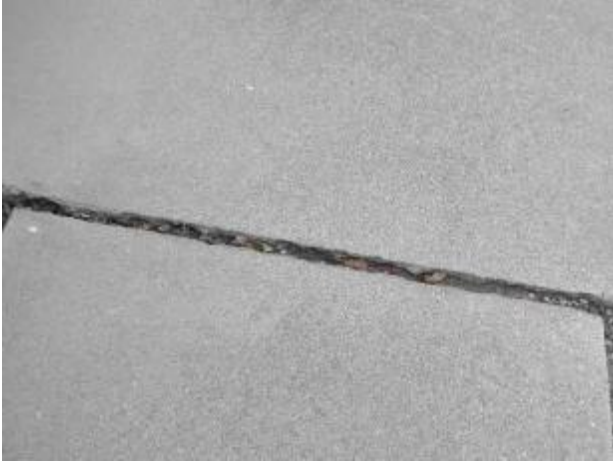
Uplifting at the concrete walkway.

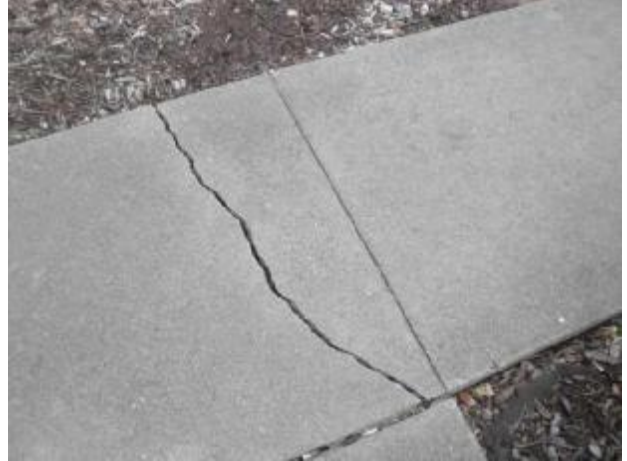
Example of general cracks in the concrete walkways.

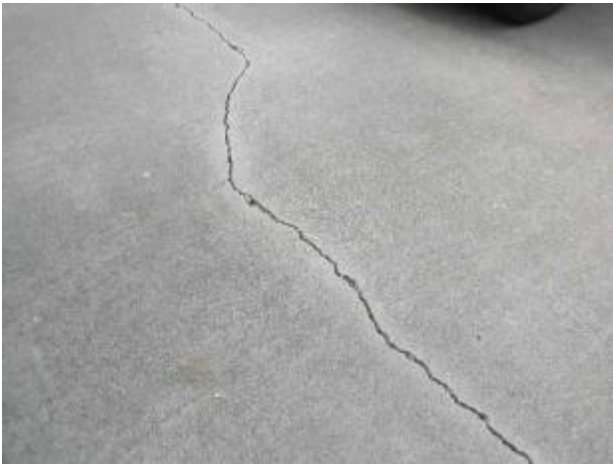
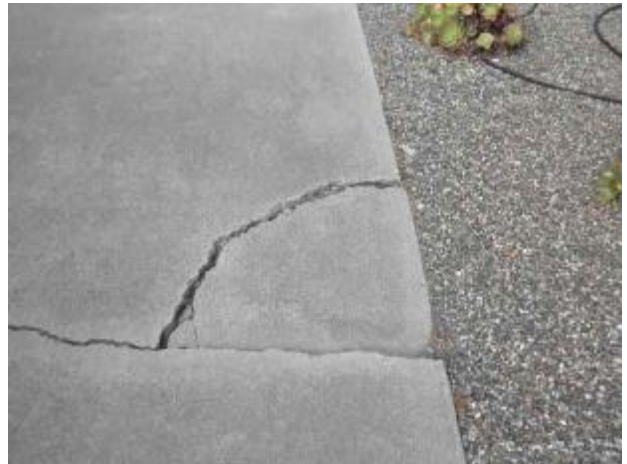
General cracks in the concrete driveway.

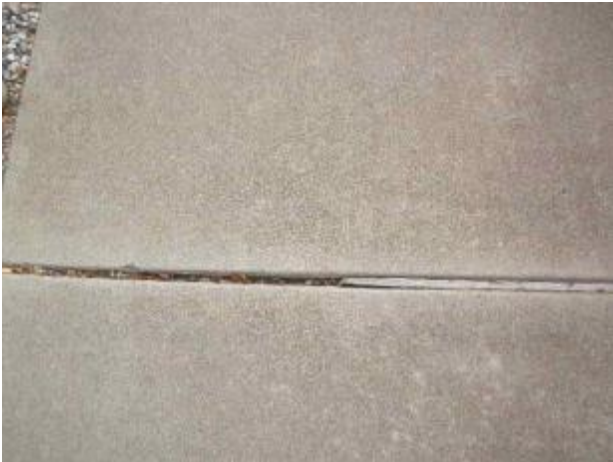
Damaged wood spacer in the driveway.

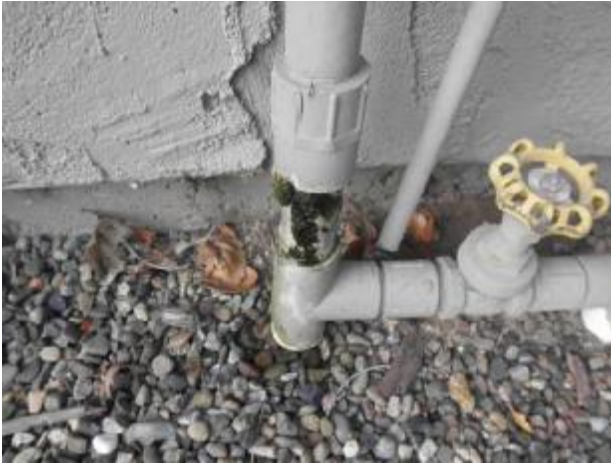
2.) There is an active leak at the main water riser on the SW corner of the home.

Leak at the main water riser.

2.) There is an active leak at the main water riser on the SW corner of the home. **Repaired See Invoice dated 7/23/26**

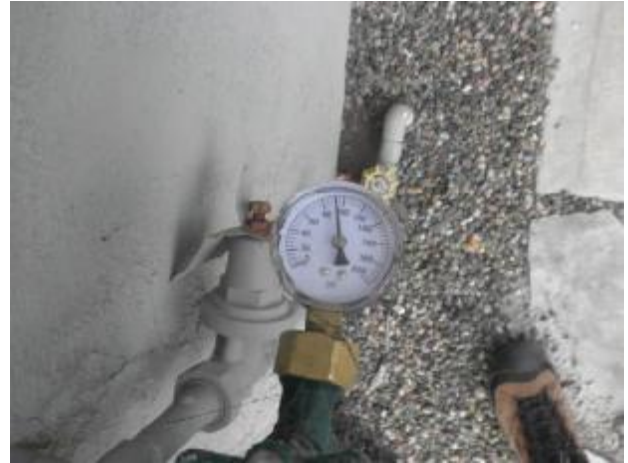
1.) The water pressure was measured at 95 psi. This exceeds the maximum allowable pressure of 80 psi. Recommend adjustment, rebuilding or replacement of the pressure regulator as needed to prevent a possible rupturing of a water line and flooding the home.

Water pressure was greater than the maximum allowable of 80 psi.

1.) The water pressure was measured at 95 psi. This exceeds the maximum allowable pressure of 80 psi. Recommend adjustment, rebuilding or replacement of the pressure regulator as needed to prevent a possible rupturing of a water line and flooding the home. **Pressure Regulator replaced see invoice dated 7/23/26**

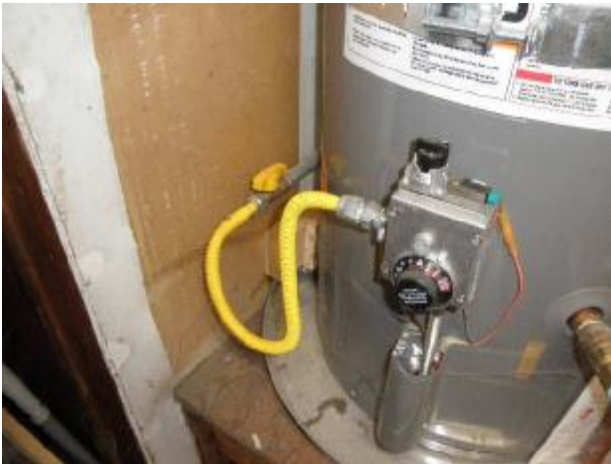
3.) The sediment trap is missing at the gas line connection to the water heater.

Missing sediment trap at the water heater gas line.

3.) The sediment trap is missing at the gas line connection to the water heater. **Installed see invoice dated 7/23/26**

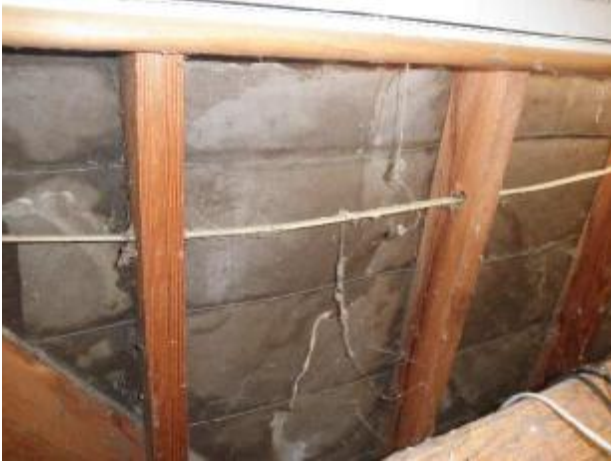
**Safety Hazard Note:** There is horizontal wiring installed in the garage which is less than seven feet off the ground. This is required to be installed in conduit or have a wall surface installed over it for physical protection.

Horizontal Romex wiring less than seven feet off the ground in the garage.

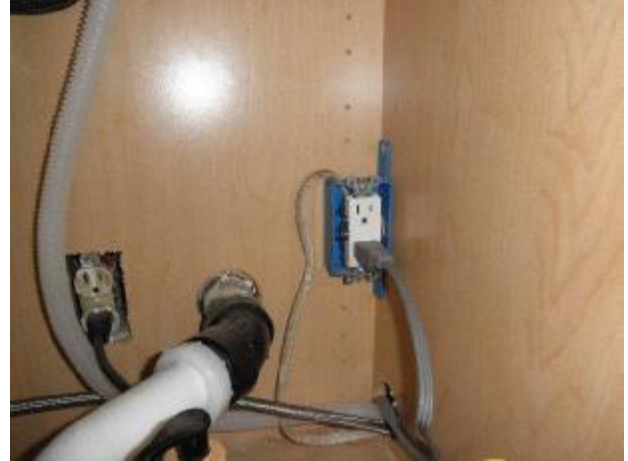
**Safety Hazard Note:** There is surface mounted wiring installed in the kitchen sink cabinet. This is required to be installed in conduit or have a wall surface installed over it for physical protection.

Exposed Romex wiring and missing cover plates below the kitchen sink.

Safety Hazard Note: There is surface mounted wiring installed in the kitchen sink cabinet. This is required to be installed in conduit or have a wall surface installed over it for physical protection. **Repaired see Invoice dated 7/23/26**

1.) There are missing cover plates for the outlets in the kitchen sink cabinet. **Repaired see Invoice dated 7/23/26**

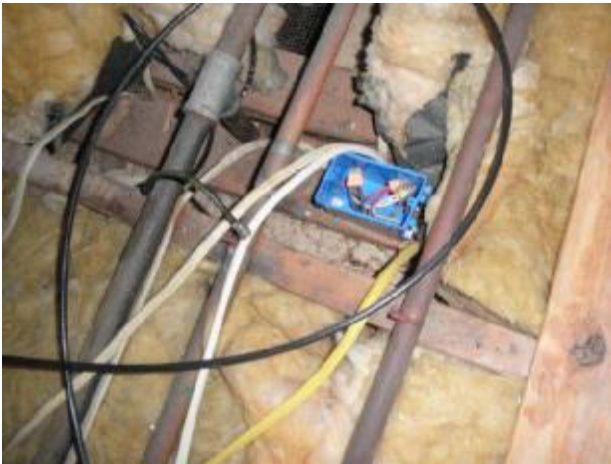
Example of missing cover plates at junction boxes in the attic.

2.) There are a few electrical junction boxes in the attic space that are missing cover plates **Repaired see invoice**

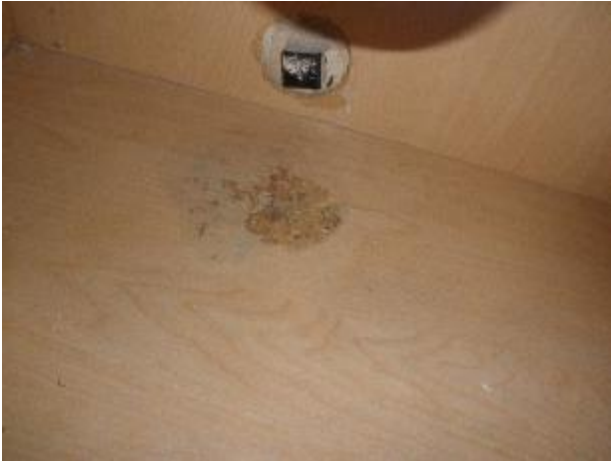
- 1.) There is moisture damage to the base of the sink cabinet in the master bathroom.

**Moisture damage to the base of the master bathroom sink cabinet.**

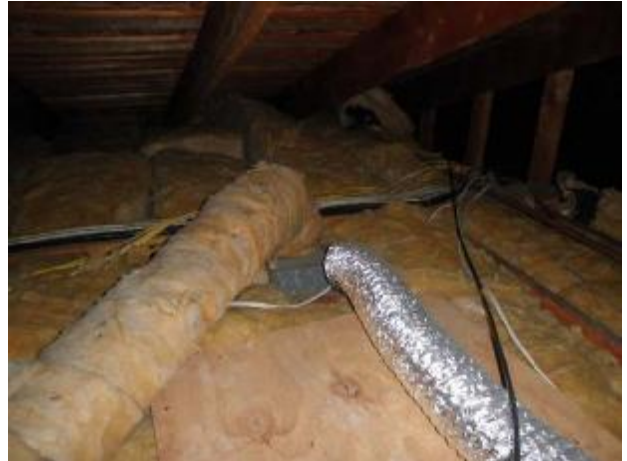
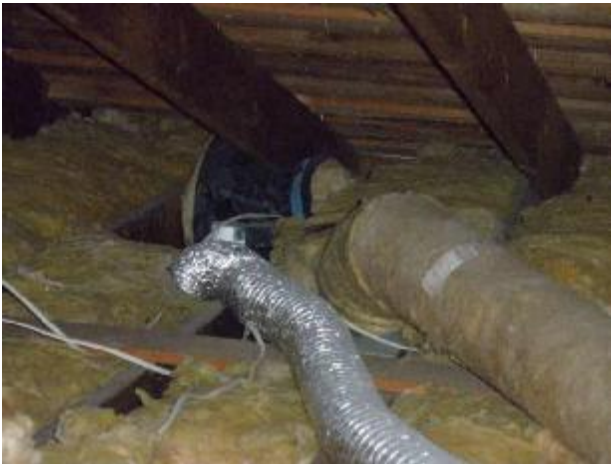
**Repair Note:** The ceiling exhaust fans in both bathrooms vent directly into the attic. This is required to be plumbed to vent to the exterior of the building.

**Bathroom exhaust fans vent directly into the attic.**

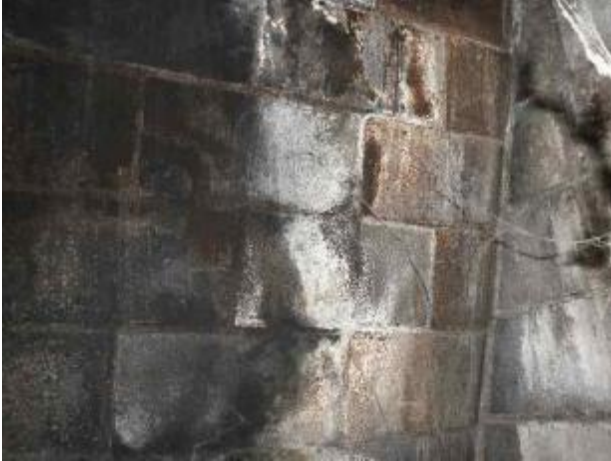
Evidence of water intrusion inside the fireplace.

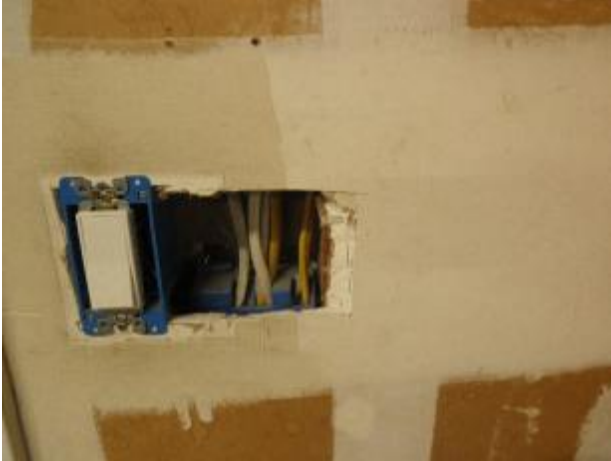
**Fire Safety Hazard Note:** The hole in the drywall next to the light switch in the garage compromises the firewall assembly required between the garage and the house. Recommend sealing the opening with a 5/8" Type X drywall.

Opening in the firewall between the garage and the home.

**Fire Safety Hazard Note:** The hole in the drywall next to the light switch in the garage compromises the firewall assembly required between the garage and the house. Recommend sealing the opening with a 5/8" Type X drywall. **Repaired see invoice dated 7/23/2026**

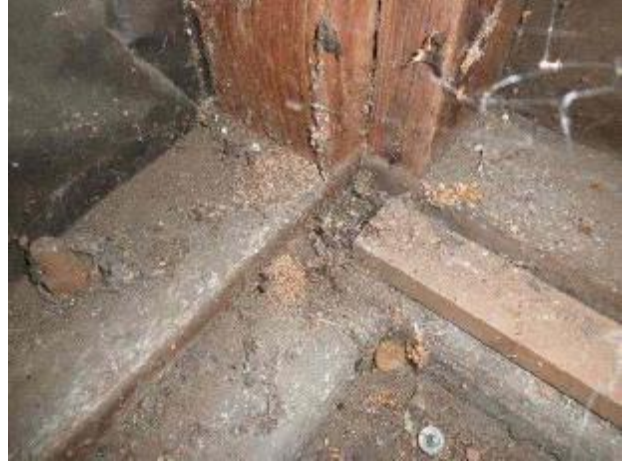
**Information Note:** There is evidence of possible termite infestation in the garage. Recommend further evaluation by a qualified and licensed Pest Control inspector prior to close of escrow.

Evidence of termite infestation in the garage.

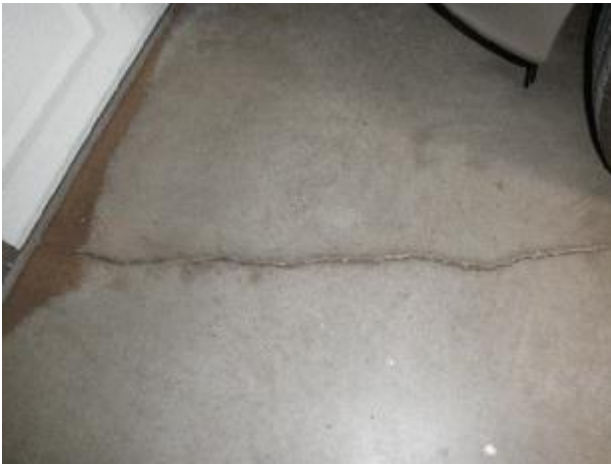
1.) There is a general settlement crack in the garage concrete slab.

Settlement crack in the garage slab.

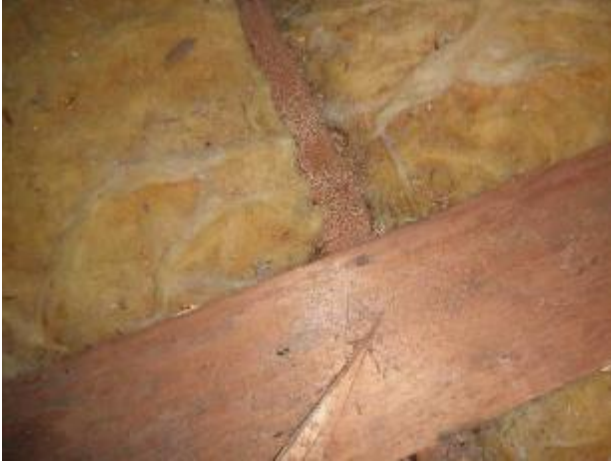
- 17 **Information Note:** There is evidence of possible termite infestation in the attic. Recommend further evaluation by a qualified and licensed Pest Control inspector prior to close of escrow.

Evidence of termites in the attic space.
