# PROPERTY INSPECTION REPORT

**738 Orchard Dr**

**Date of Inspection: 8/4/2026**

**Year Built: 1985 Size: 1712**

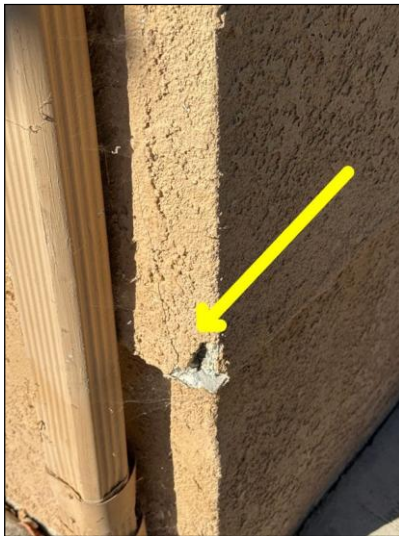
**Maintenance:** All gaps and holes in the stucco surface should be sealed to keep unwanted moisture out.

**Maintenance:** All gaps and holes in the stucco surface should be sealed to keep unwanted moisture out. Recommend having these areas sealed and painted. Continue to monitored as part of annual maintenance.

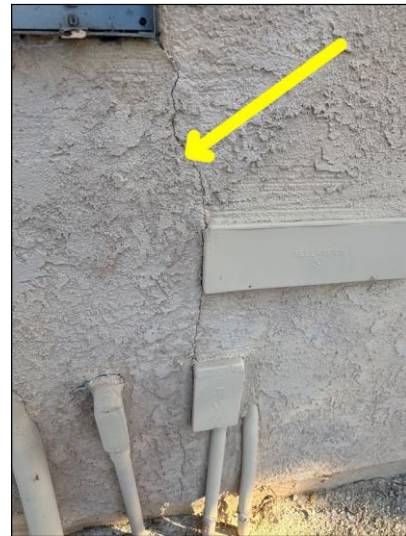
**Monitor:** Normal cracking was visible in stucco covering exterior walls of the home at the time of the inspection.

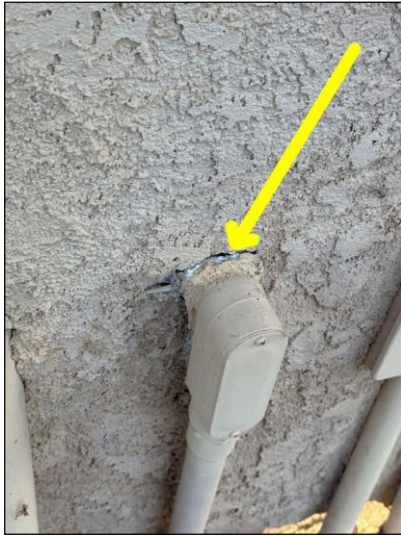
Maintenance: All gaps and holes in the stucco surface should be sealed to keep unwanted moisture out.

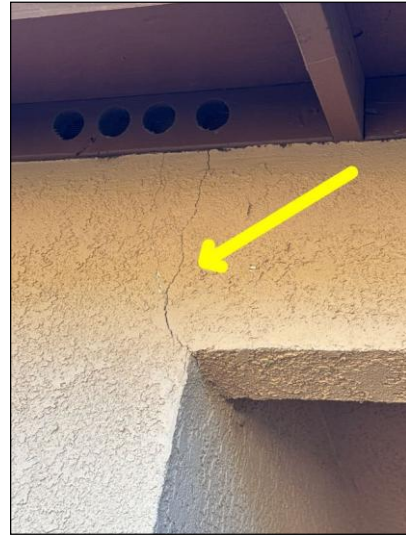
Monitor: Normal cracking was visible in stucco covering exterior walls of the home at the time of the inspection.

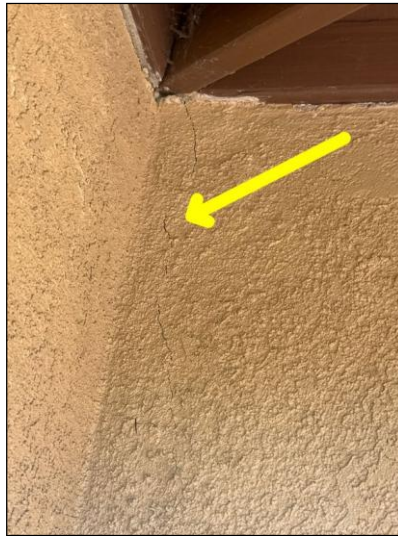
Monitor: Normal cracking was visible in stucco covering exterior walls of the home at the time of the inspection.

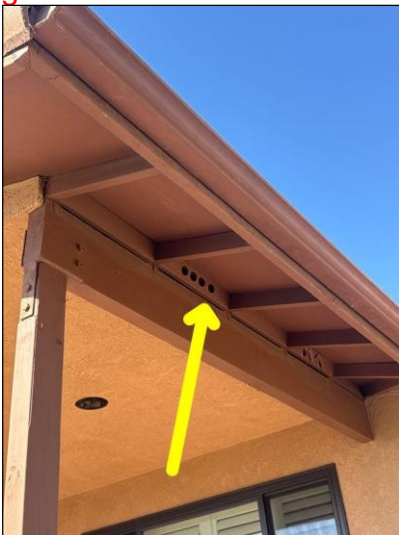
Monitor: The soffit was not sealed above the covered patio area(s) at the time of the inspection. The Inspector recommends repair by a qualified contractor to prevent pests from entering the soffit space.

Monitor: The soffit was not sealed above the covered patio area(s) at the time of the

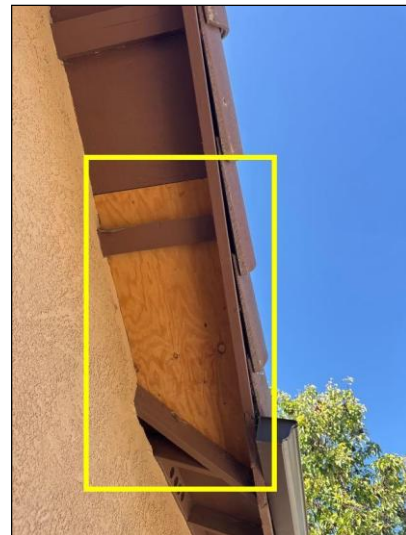
Maintenance Needed: Repaired Soffit had no paint and needed maintenance. All work should be performed by a qualified contractor.

Maintenance Needed: Repaired Soffit had no paint and needed maintenance. inspection.

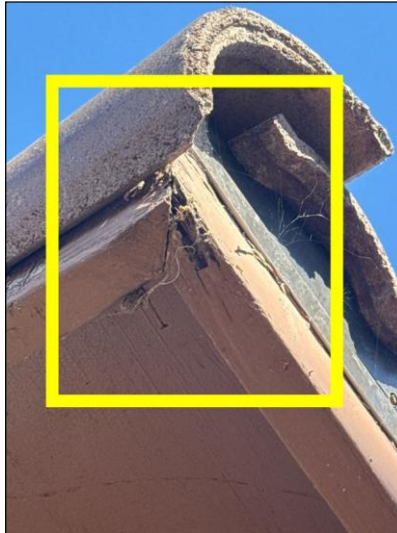
| Exterior Areas | | | |
|---|---|---|---|
| | Page 13 Item: 3 | Soffits & Fascia | Moisture damage, wood rot, observed. Refer to pest report for further details and repair damage as needed. |

Moisture damage, wood rot, observed. Refer to pest report for further details and repair damage as needed.

Moisture damage, wood rot, observed.

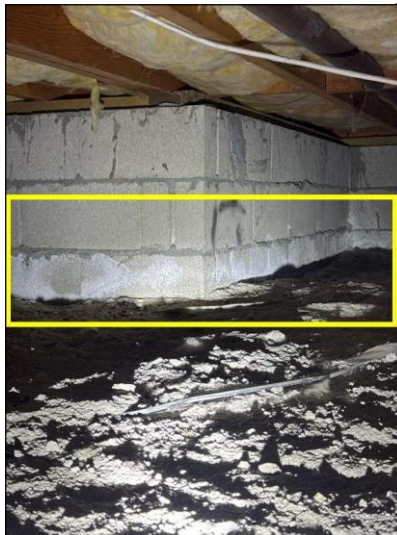
**Monitor:** In the crawlspace, moderate amounts of efflorescence was visible at some of the interior surfaces of the foundation walls. Efflorescence is a white, powdery residue left by moisture seeping through the foundation wall and its presence indicates high moisture levels in soil near the foundation. Excessively high moisture levels in soil supporting the foundation can cause various structural problems related to soil movement if not corrected. The source of moisture should be identified and the condition corrected by a qualified contractor.

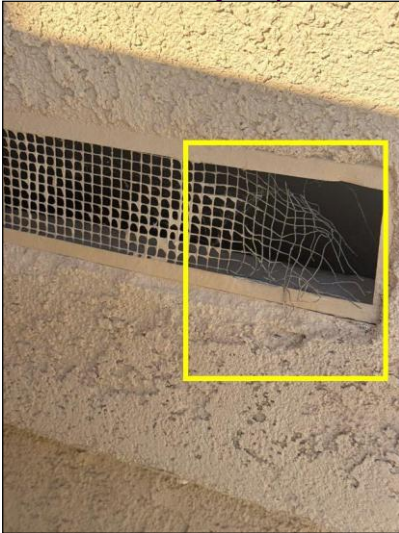
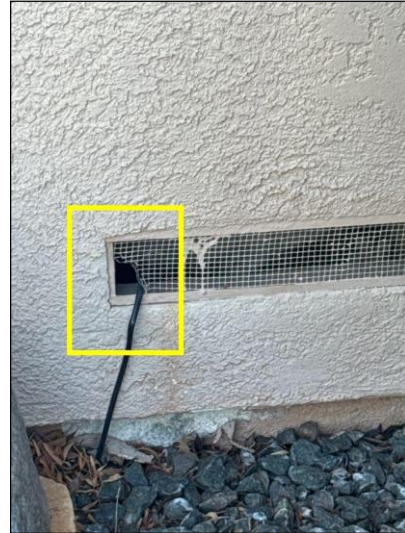
**Maintenance Needed:** Vent screens are damaged or missing, suggest repairing or replacing screens as necessary to prevent entry of unwanted pests.

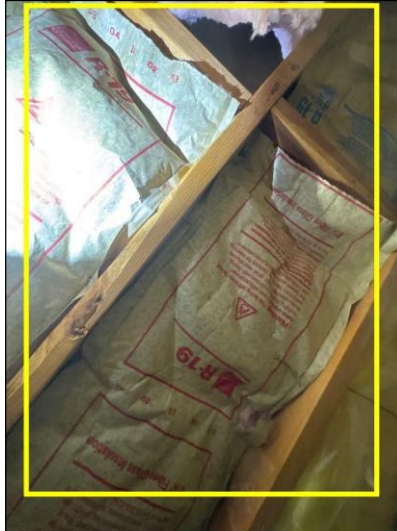
- Some of the thermal insulation was installed upside down and or missing. Thermal insulationshould always be installed with the backing toward the warm side. Installing insulation with the backing toward the cold side can cause problems from excessive condensation.

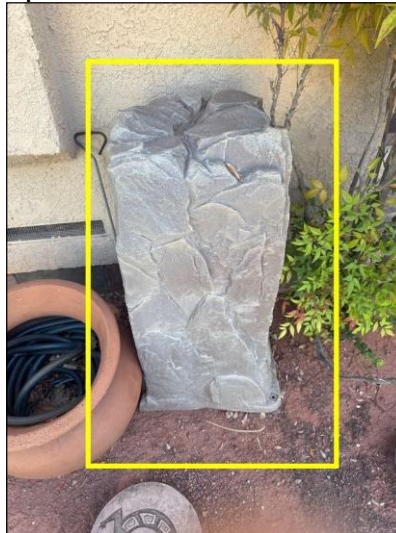
**Safety Improvement:** The main water supply shut-off valve was difficult to access.

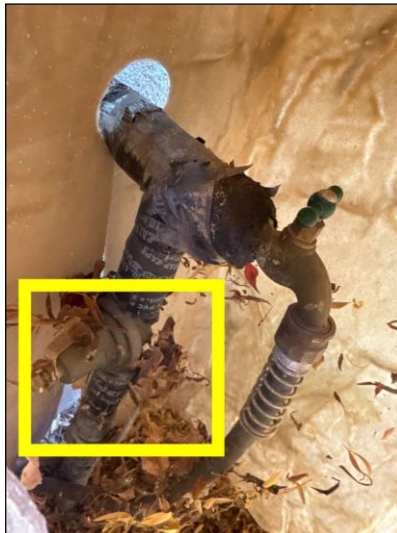
| Exterior Areas | | | |
|---|---|---|---|
| | Page 21 Item: 5 | Pressure Regulator | • The pressure regulator appears to not be functioning due to water pressure over 75 PSI when tested. A pressure regulator is designed to regulate water pressure from the city water supply to between 25-75 PSI (they are factory set at 50 PSI). Recommend repair/replacement by licensed plumber. |

• The pressure regulator appears to not be functioning due to water pressure over 75 PSI when tested. A pressure regulator is designed to regulate water pressure from the city water supply to between 25-75 PSI (they are factory set at 50 PSI). Recommend repair/replacement by licensed plumber.

The pressure regulator appears to not be functioning due to water pressure over 75 PSI when tested.

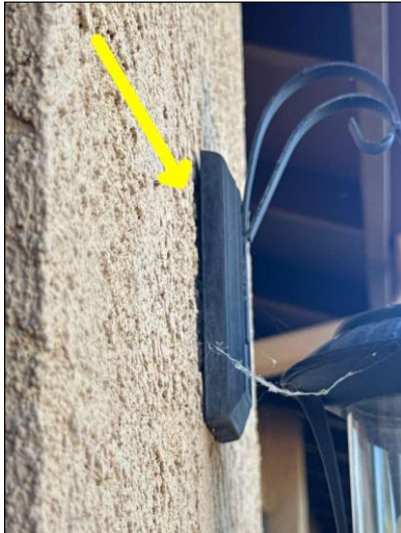
| Exterior Areas | | | |
|---|---|---|---|
| | Page 22 Item: 7 | Exterior Lighting | Some exterior lighting was loose to the wall and could expose electrical components to moisture intrusion. The inspector recommends all fixtures are properly fastened and sealed to the wall by a qualified electrical contractor. |

Some exterior lighting was loose to the wall and could expose electrical components to moisture intrusion. The inspector recommends all fixtures are properly fastened and sealed to the wall by a qualified electrical contractor.

Exterior lighting was loose/not flush to the wall and could expose electrical components to moisture intrusion. front door

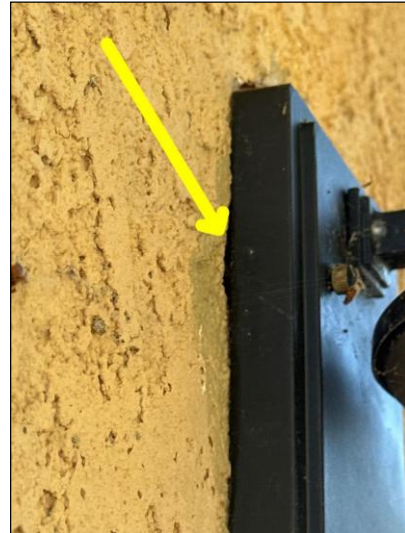
Exterior lighting was loose/not flush to the wall and could expose electrical components to moisture intrusion. front of garage

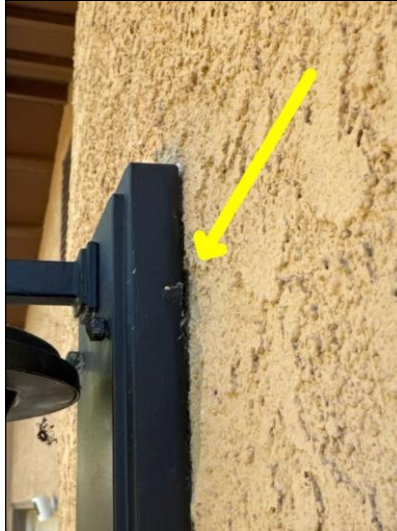
Exterior lighting was loose/not flush to the wall and could expose electrical components to moisture intrusion. front of garage

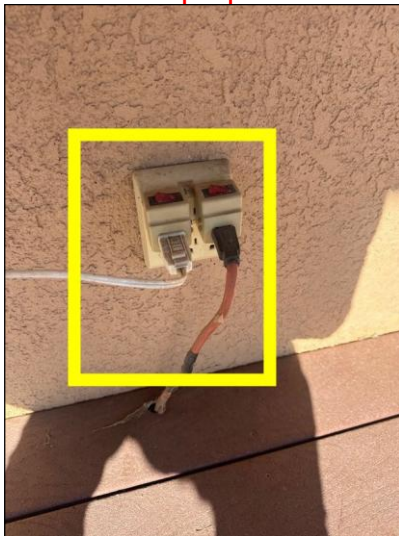
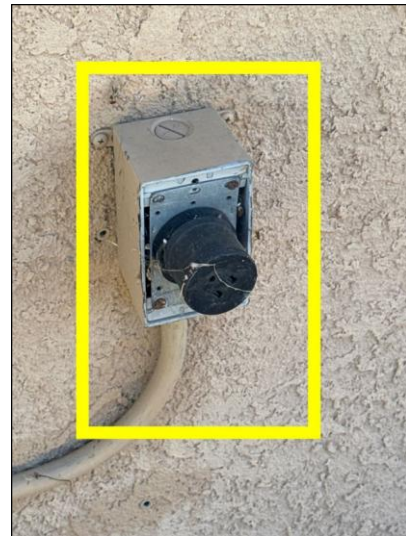
| Exterior Areas | | | |
|---|---|---|---|
| | Page 23 Item: 8 | Exterior Outlets/GFCI | Multiple exterior outlets at the home were not protected from weather. Recommend upgrading all outlets to have proper weather protection. |

Multiple exterior outlets at the home were not protected from weather. Recommend upgrading all outlets to have proper weather protection.

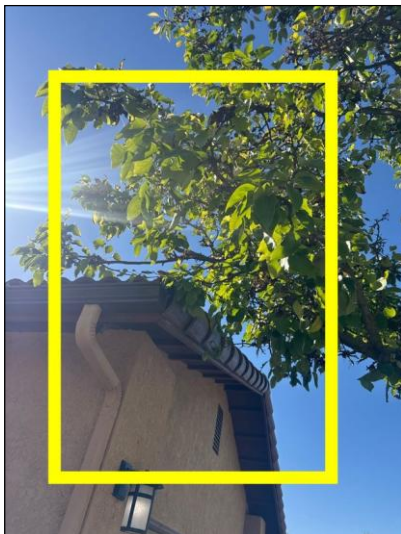
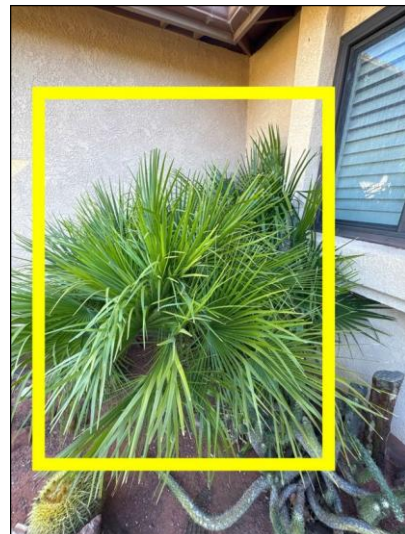
- Monitor: Trim trees that are in contact or proximity to home, as branches can abrade roofing or siding. Branches should be cut back to avoid contact with the home.

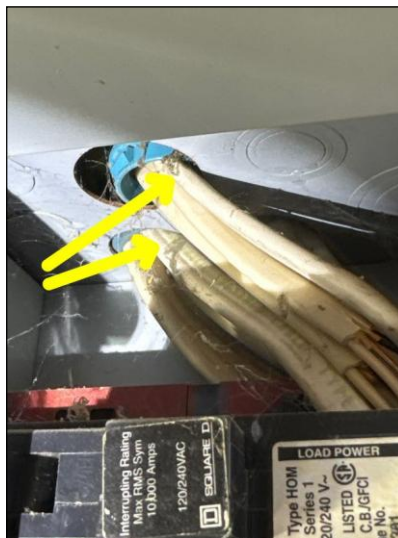
| Exterior Areas | | | |
|---|---|---|---|
| | Page 29 Item: 2 | Electrical Panel | Non-metallic conductors had loose clamps installed where they passed through knock-outs in the electrical service panel. This condition can result in damage to the conductor from contact with the sharp edges of the metal cabinet, or can result in conductors being pulled loose from connections inside the panel; a potential a shock/electrocution or fire hazard. The Inspector recommends that appropriate devices approved for this purpose be installed by a qualified electrical contractor. |

Non-metallic conductors had loose clamps installed where they passed through knock-outs in the electrical service panel.

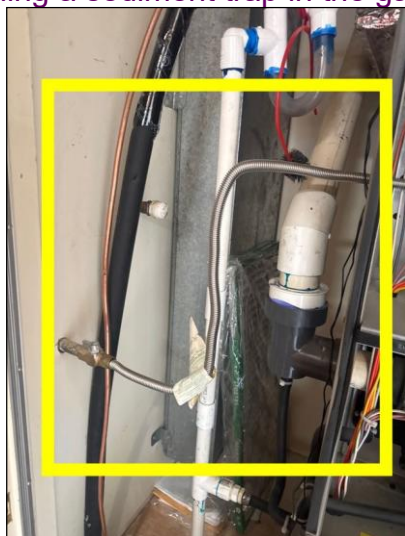
**Recommended Improvement:** The gas supply pipe contained no sediment trap. A sediment trap is generally recommended but not always required, depending on the local Authority Having Jurisdiction (AHJ). The purpose of a sediment trap is to prevent sediment or debris particulates from entering and clogging the heaters gas valve, which can cause the heater to shut down. You may wish to consult with local contractor concerning the advisability of installing a sediment trap in the gas line.

**Improvement:** The gas supply pipe contained no sediment trap.

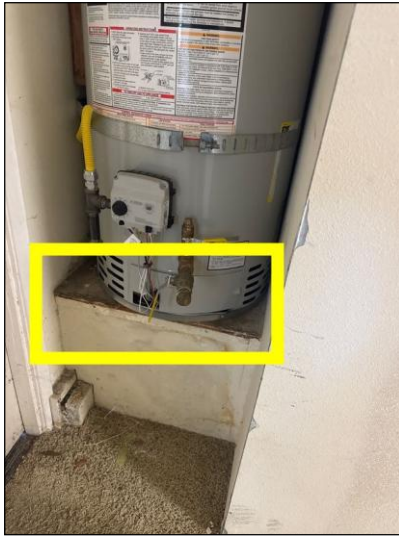
Improvement: no drip pan was installed.

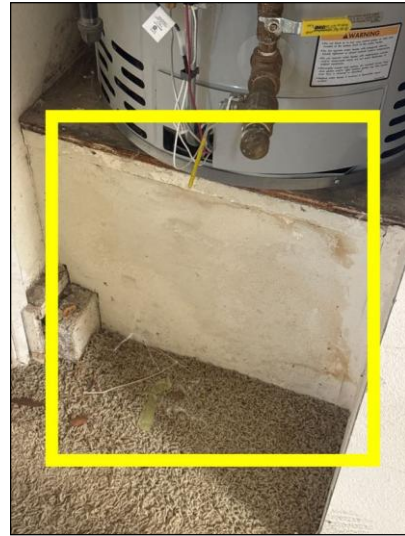
Monitor: Stains and damage to the drywall water heater pedestal was visible at the time of the inspection.

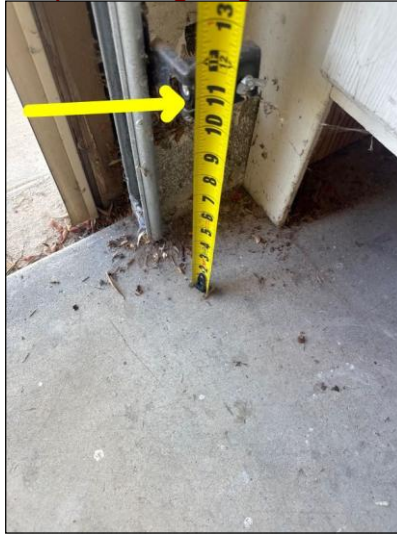
**Safety:** An overhead garage door photo sensor was installed at a height greater than 6 inches above the floor. Photoelectric sensors are devices installed to prevent injury by raising the vehicle door if the sensor detects a person in a position in which they may be injured by the descending door. Installation of photo sensors in new homes has been required by generally accepted safety standards since 1993. Safety standards designed to protect small children limit the maximum mounting height for garage door photo sensors to 6 inches. The Inspector recommends correction by a qualified garage door contractor.

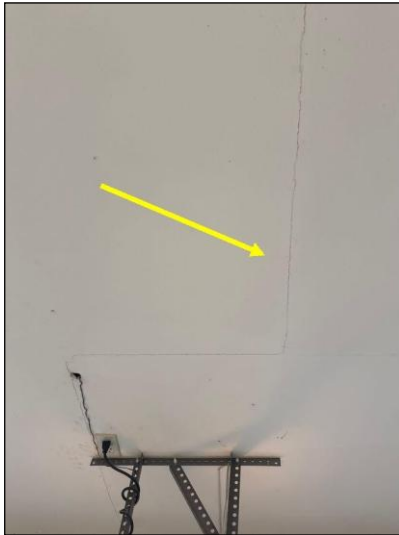
**Monitor:** Normal settlement cracking was visible in interior walls of the home at the time of the inspection.

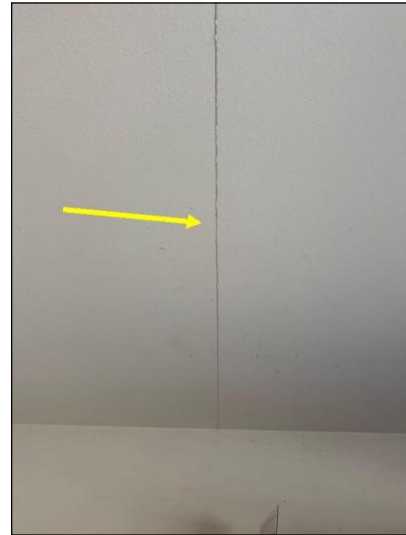
**Monitor:** Normal settlement cracking was visible in interior walls of the home at the time of the inspection.

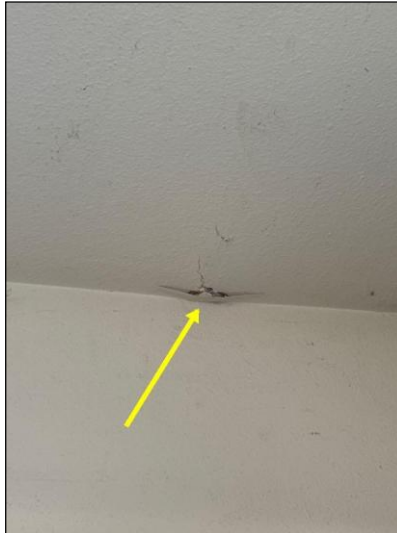
Monitor: Normal settlement nail pop was visible in interior walls of the home at the time of the inspection.

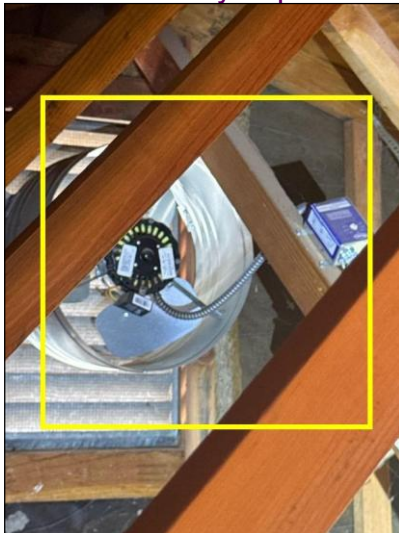
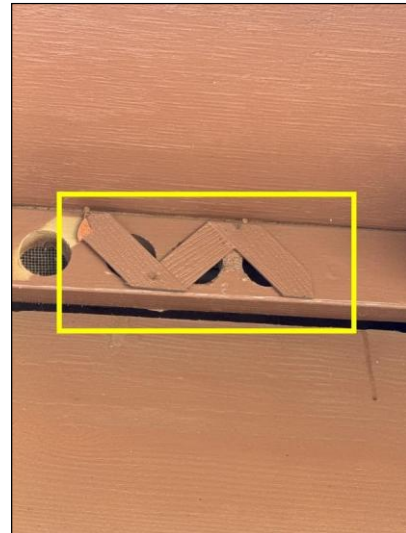
**Maintenance Needed:** Vent screens are damaged or missing, suggest repairing or replacing screens as necessary to prevent entry of unwanted pests.

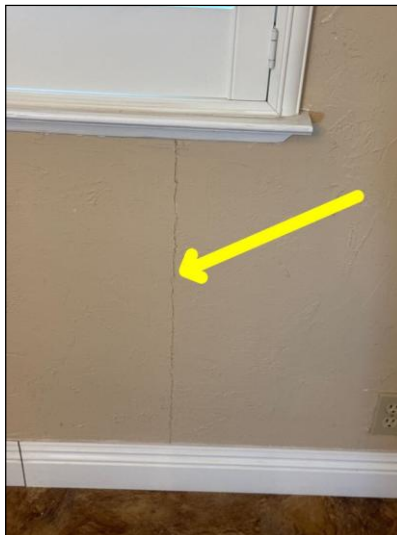
**Monitor:** Normal settlement cracking was visible in interior walls of the home at the time of the inspection.

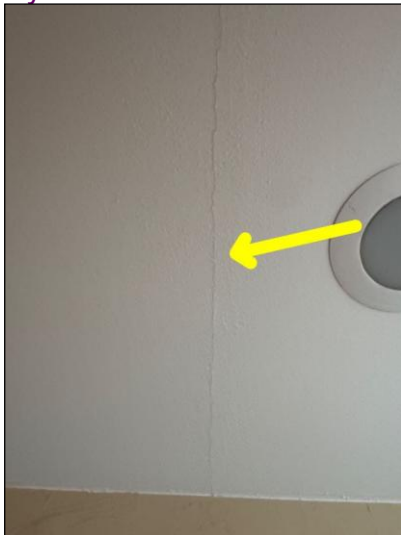
**Monitor:** Normal settlement cracking was visible in interior ceiling of the home at the time of the inspection.

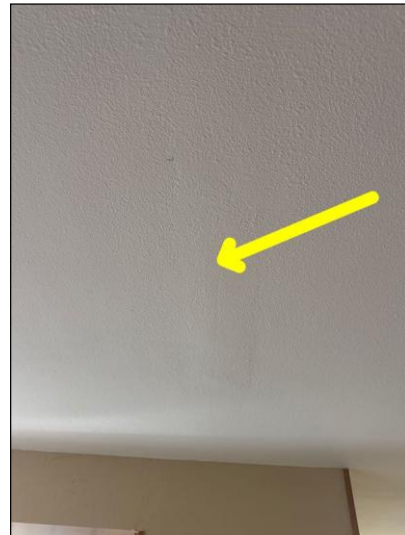
**Monitor:** Normal settlement cracking was visible in interior ceiling of the home at the time of the inspection.

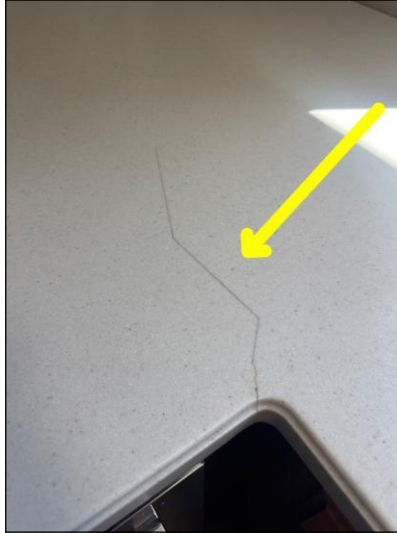
The kitchen countertops had minor damage. The Inspector recommends that before the expiration of your Inspection Objection Deadline you consult with a qualified contractor to discuss options and costs for repair.

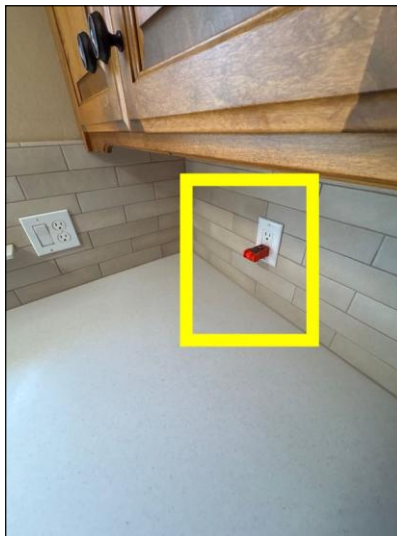
| | Page 52 Item: 3 | Electrical | An electrical receptacle in the kitchen had hot and neutral wires reversed. This condition should be corrected by a qualified electrical contractor. |

An electrical receptacle in the kitchen had hot and neutral wires reversed. This condition should be corrected by a qualified electrical contractor.

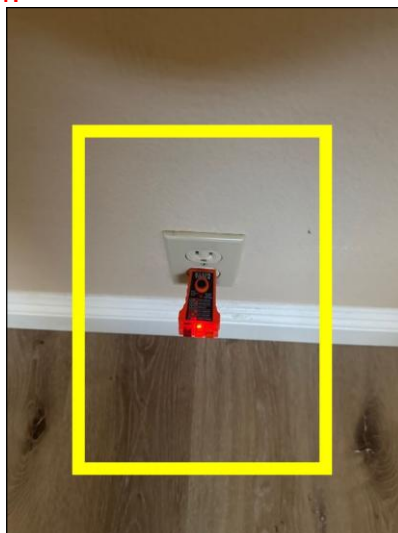
An electrical receptacle in this bedroom had an open ground. This outlet should be corrected by qualified electrical contractor.

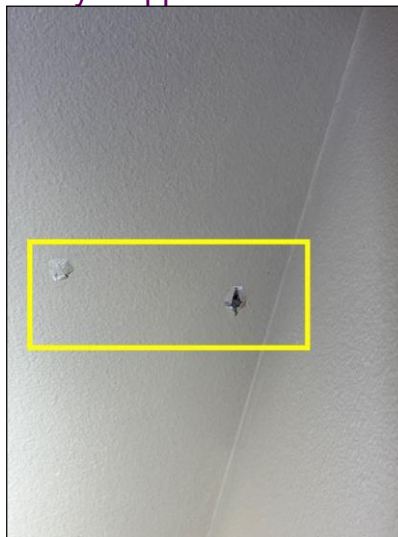
**Monitor:** Normal settlement nail pops were visible in interior ceiling of the bedroom at the time of the inspection.
