## Harmony Inspectors

## Property Inspection Report

Property address: **250 N Monte Vista St # 3  
La Habra CA 90631-4541**

Inspection date: **Tuesday, May 12, 2026**

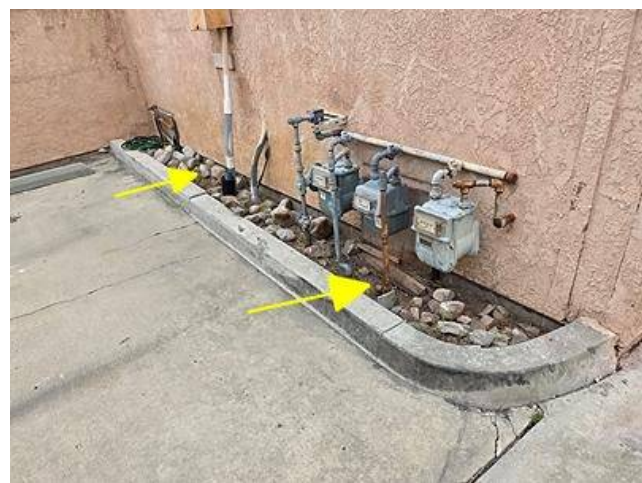
Photo 3-1

Evidence of past accumulated water were found at one or more locations in the yard or landscaped areas, and no drain was visible. If evidence of past water was found (e.g. silt accumulation or staining), monitor these areas in the future during periods of heavy rain. If standing water exists, recommend that a qualified person repair as necessary. For example, installing one or more drains, or grading soil.

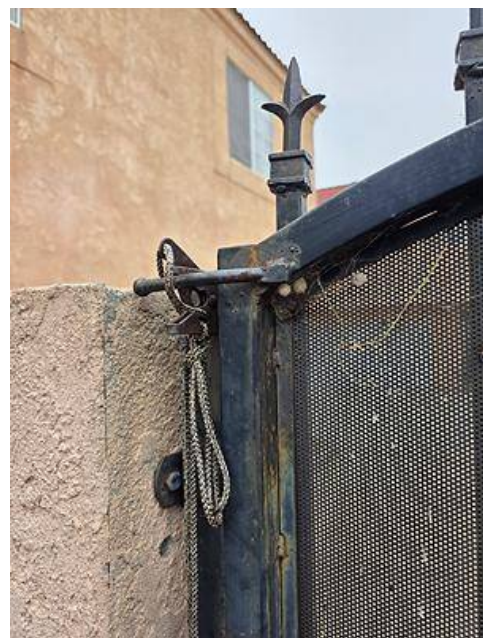
Photo 4-1

One or more gates were difficult to latch and need repair.

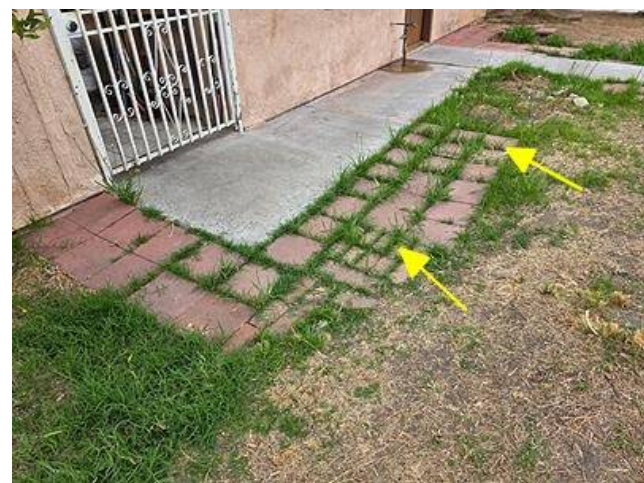
Photo 5-1

Cracks, holes, settlement, heaving and/or deterioration were found in sidewalks and/or patios. Recommend that qualified contractor repair as necessary.

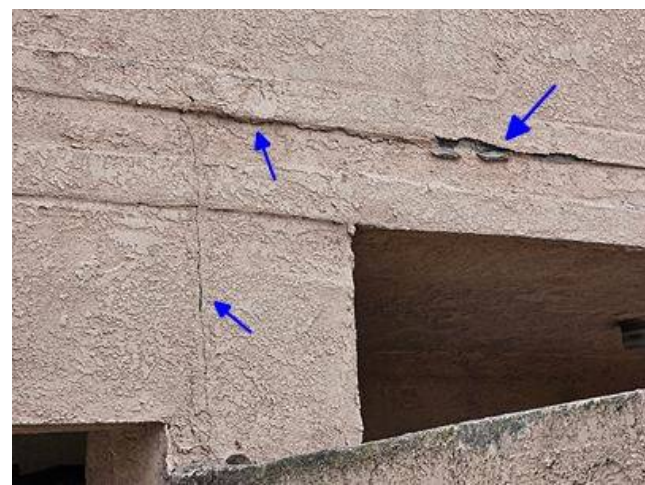
Photo 8-1

8) 🛠️💧 Cracks, deterioration and/or damage were found in one or more areas of the exterior stucco finish. In damp climates, moisture may enter cracks or damaged areas and further deteriorate the stucco. Also the wall behind the stucco may become damaged from moisture. Note that areas behind the stucco are inaccessible and excluded from this inspection. Recommend that a qualified contractor repair or replace stucco as necessary.

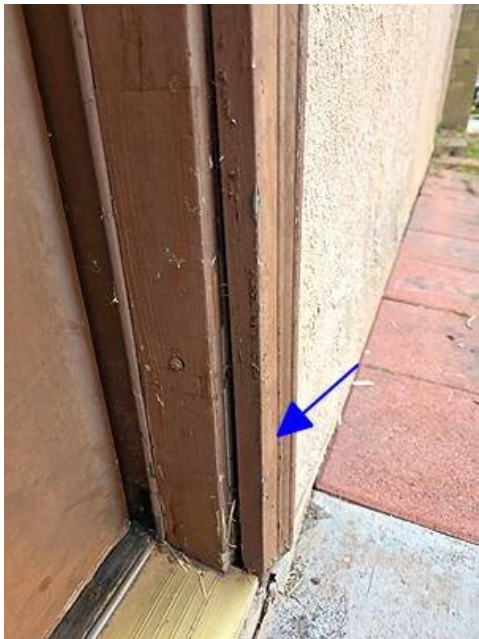
Photo 9-1

Some sections of siding and/or trim were loose. Recommend that a qualified person repair, replace or install siding or trim as necessary.

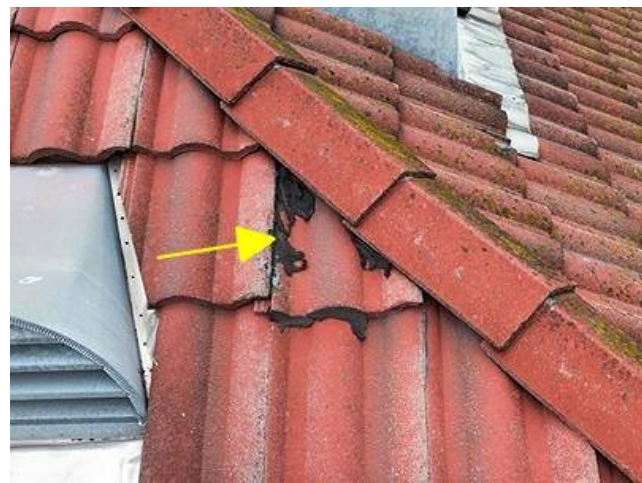
Photo 12-1

12) 🔧🔍 Substandard repairs were found at one or more locations on the concrete tile roof. Sealant was used to repair some sections of the roof and/or around flashing. Sealants may fail to adhere to dirty or wet tiles, trap moisture causing further damage, or degrade under UV exposure, lasting only 5–15 years. For significant damage, replacing tiles is better than sealing, and underlying issues like damaged underlayment must be fixed. Recommend that a qualified contractor evaluate and repair per standard building practices.

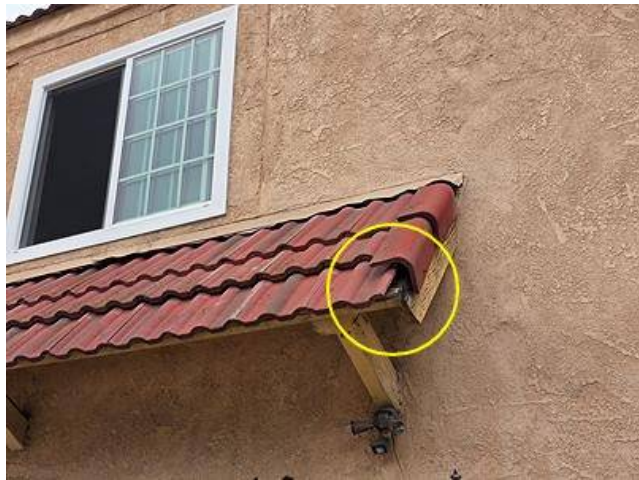
Photo 14-1

Many concrete roof tiles were broken, chipped, missing and/or loose. Leaks may occur as a result. This is a conducive condition for wood-destroying organisms. Recommend that a qualified person replace tiles or make repairs as necessary.

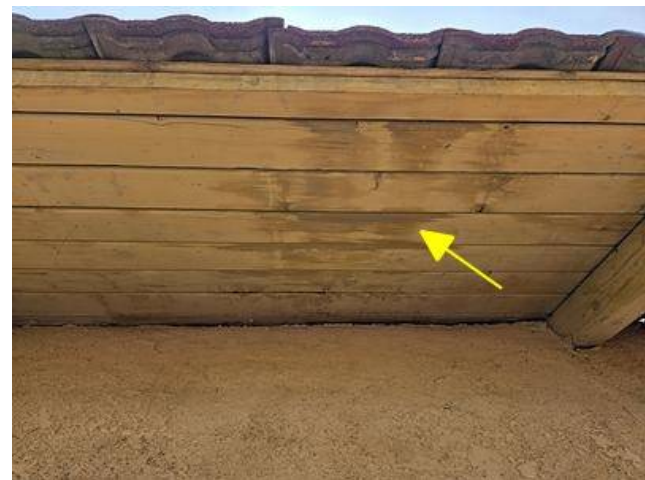
Photo 18-1

What appeared to be past water stains were visible at one or more soffit areas. The stains may have been caused by a past leak. Recommend asking the property owner about past leaks. Monitor these areas in the future, especially after heavy rains to determine if active leaks exist. If leaks are found, recommend that a qualified contractor evaluate and repair as necessary.

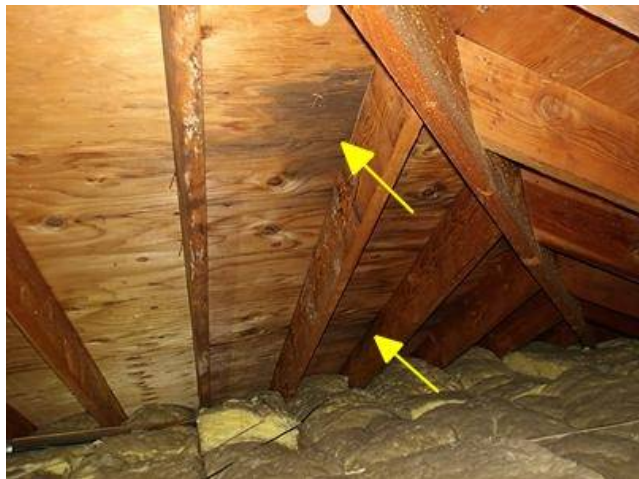
Photo 21-1

What appeared to be past water stains were visible on the roof structure at one or more locations in the attic. However, no elevated levels of moisture were found at these stains during the inspection. The stains may have been caused by a past leak. Recommend asking the property owner about past leaks. Monitor these areas in the future, especially after heavy rains to determine if active leaks exist. If leaks are found, recommend that a qualified contractor evaluate and repair as necessary.

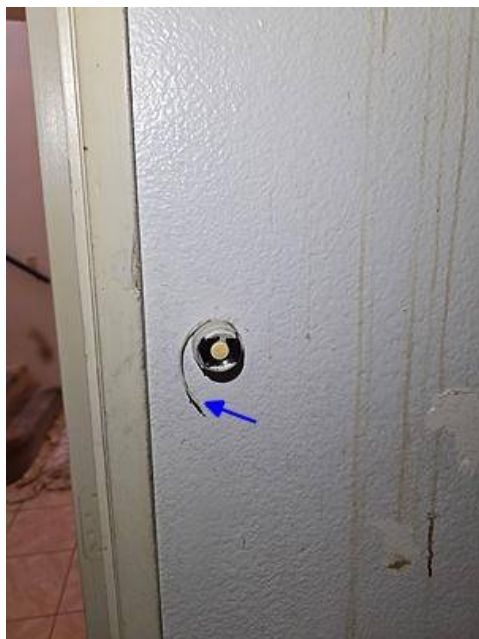
Photo 27-1

The control button for operating one or more automatic garage vehicle door openers was disconnected. A qualified person should repair as necessary so the opener could be controlled with the control button.

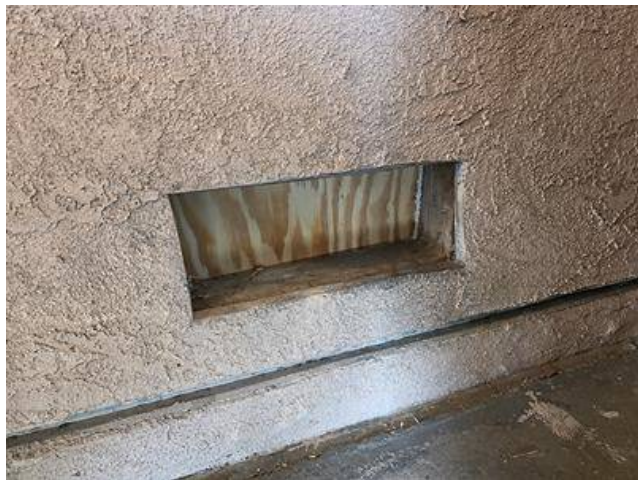
Photo 28-1

The screens for one or more garage vents were missing. Vermin or pets can enter the garage as a result. Recommend that a qualified person install or replace screens where necessary.

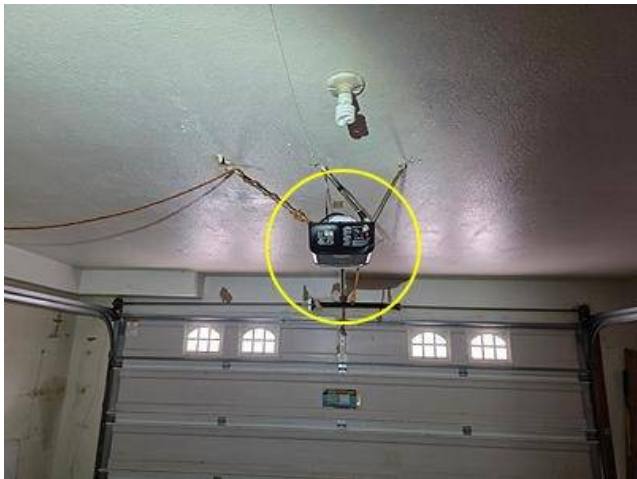
Photo 30-1

One or more automatic door openers were not plugged in or had no power. The inspector was unable to fully evaluate the automatic opener(s).

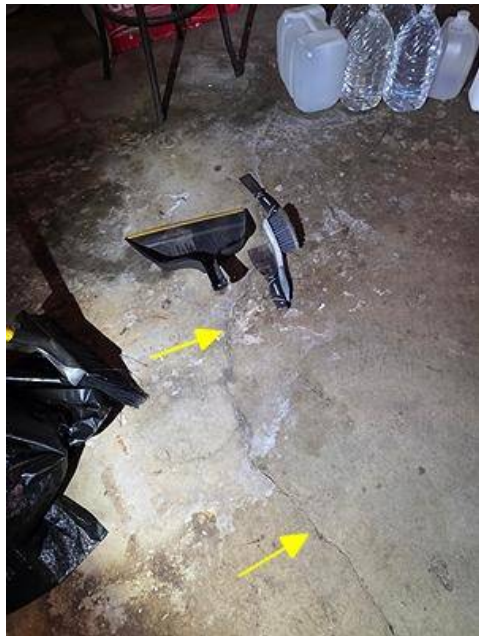
Photo 31-1

31) ⓘ Minor cracks were found in the concrete slab floor. These are common and appeared to be only a cosmetic issue.

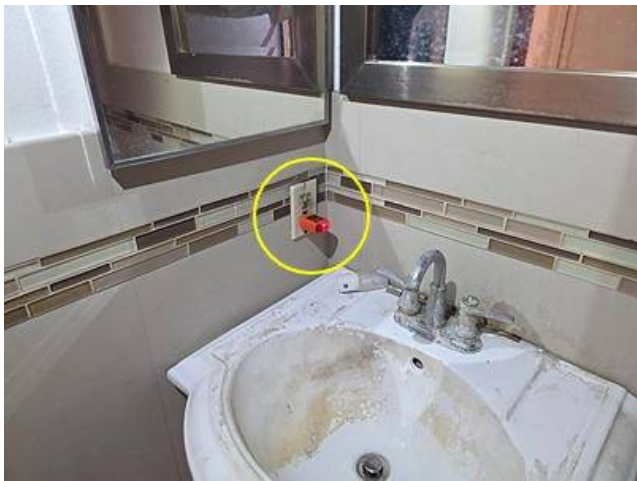
Photo 43-1

One or more ground fault circuit interrupter (GFCI) receptacles or circuit breakers were defective. Because of this, the inspector was unable to determine if all electric receptacles that should be protected by GFCI devices, were protected. After defective GFCI devices have been replaced or repaired, recommend that a qualified electrician verify that receptacles throughout the house have GFCI protection per standard building practices, and make repairs if necessary.

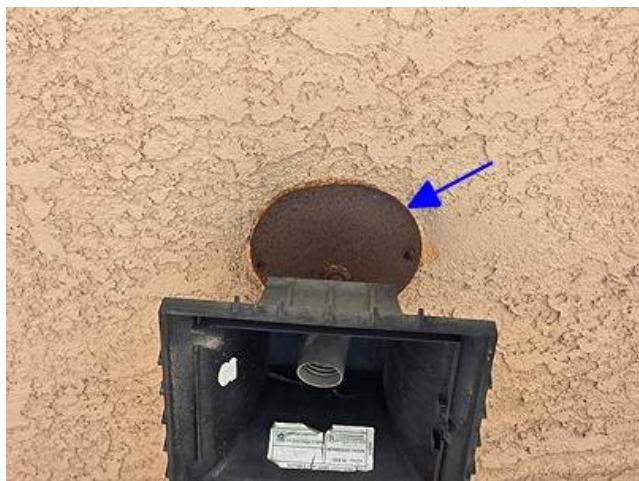
Photo 45-1

One or more light fixtures were loose and/or corroded. Recommend that a qualified electrician repair or replace light fixtures as necessary.

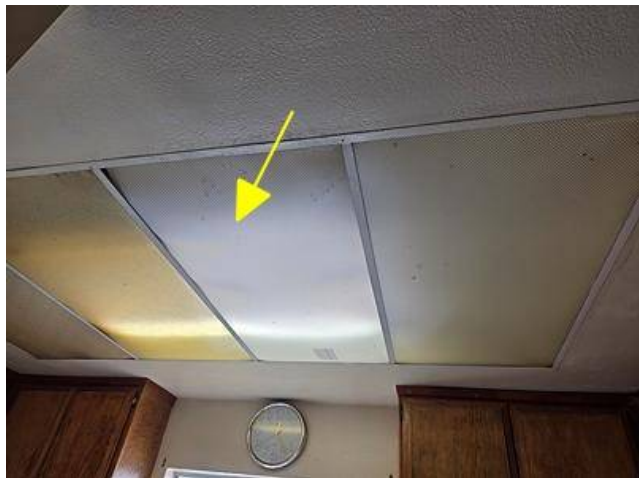
Photo 46-1 Kitchen

One or more fluorescent light fixtures were observed to be operating at a significantly dimmed capacity. The condition is typically caused by failing ballast mechanisms, degraded lamps near the end of their operational lifespan, or low voltage supply issues within the circuit. Recommend further evaluation by replacing bulbs and/or consulting with the property owner. If replacing bulbs doesn't work and/or no other switch(es) can be found, then recommend that a qualified electrician evaluate and repair or replace light fixtures as necessary.

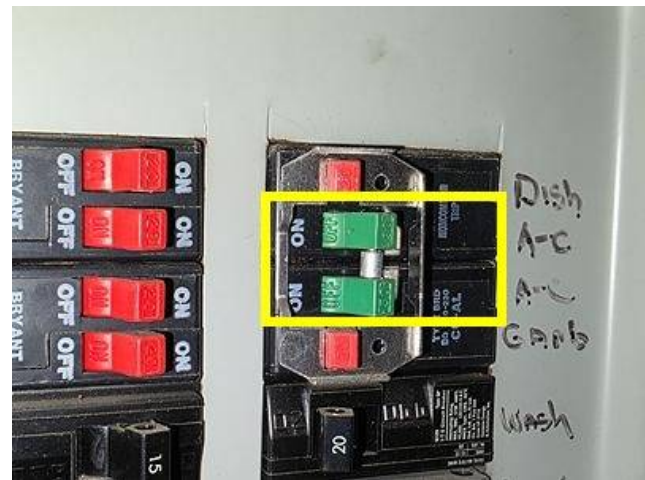
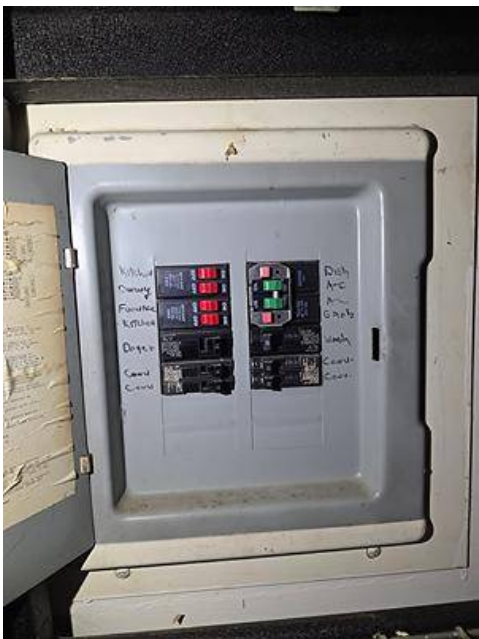
47) One or more circuit breakers in panel(s) #A were in the off position. Consult with the property owner to determine why breakers were tripped or off, and that a qualified electrician evaluate and repair if necessary. Note that the inspector does not operate circuit breakers.

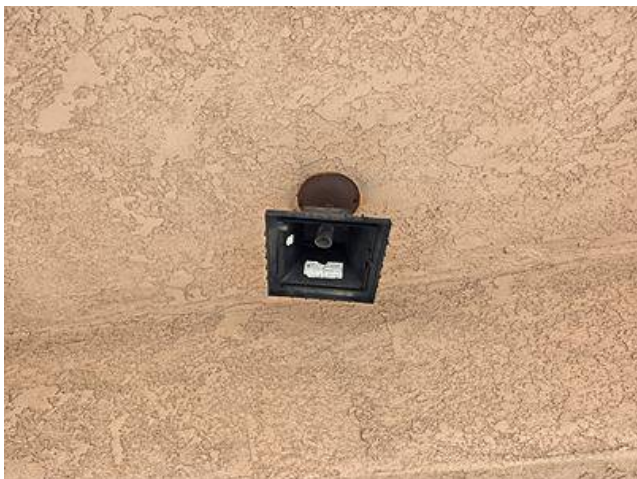
Photo 49-1

49) 🔍 Bulbs in one or more light fixtures were missing or broken. These light fixtures couldn't be fully evaluated. If replacement bulbs are inoperable, then recommend that a qualified electrician evaluate and repair or replace light fixtures as necessary.

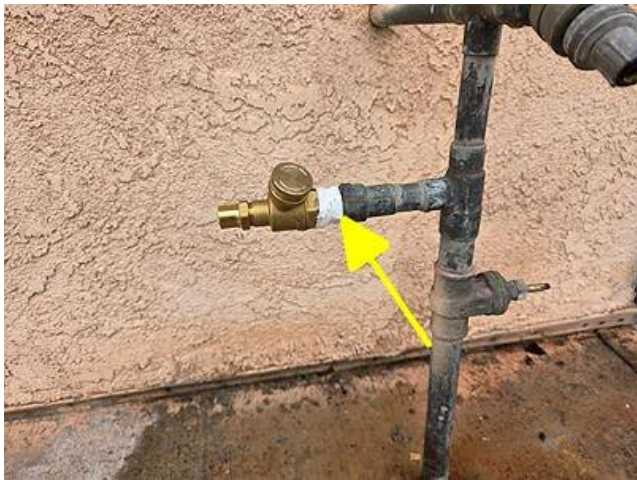
Photo 52-1

One or more leaks were found in water supply pipes or fittings. A qualified plumber should evaluate and repair as necessary.

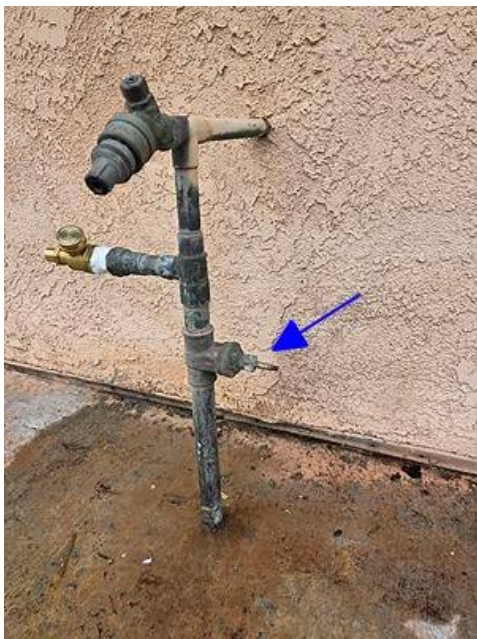
Photo 53-1

The main water shut-off valve handle was missing or damaged. It is especially important to be able to reliably operate the main water shut-off valve in an emergency, such as when a supply pipe bursts. Recommend that a qualified plumber repair as necessary.

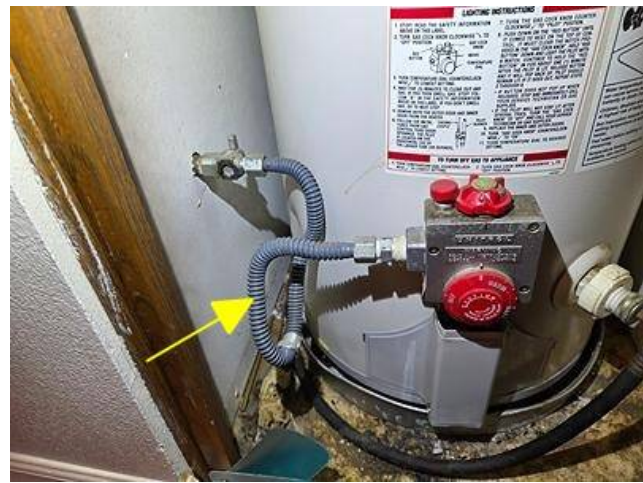
Photo 59-1

No sediment trap was installed in the gas supply line at the water heater. Sediment traps prevent damage to gas-fired appliances by trapping oil, scale, water condensation and/or debris. Recommend that a qualified contractor install a sediment trap per standard building practices.

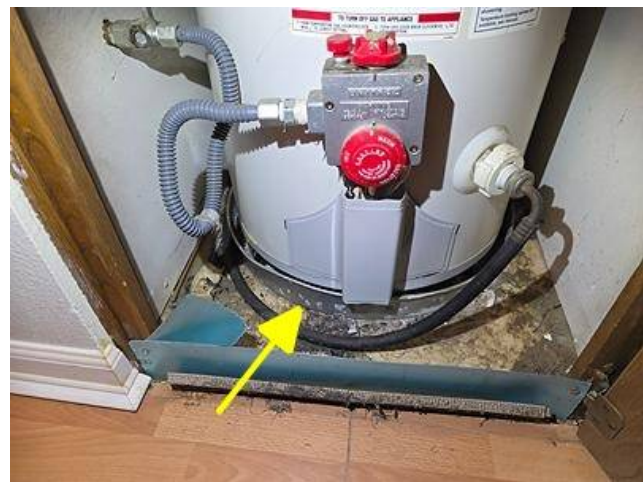
Photo 60-1

A catch pan was installed below the water heater, but no drain line was visible. Typically such catch pans hold only a gallon or two of water. If the water heater fails and leaks significantly, nearby flooring and wall materials, or finished spaces below (if any) may be get water-damaged. Normally, a drain line is installed at the catch pan to route any accumulated water outside the structure. Consider having a qualified contractor install a drain line per standard building practices.

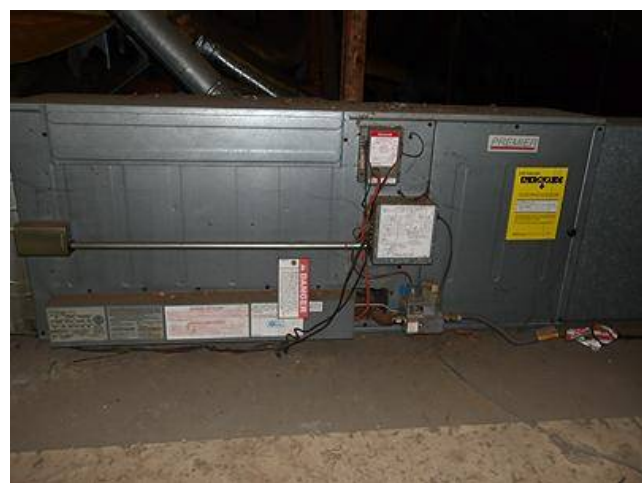
Photo 62-1

The estimated useful life for most forced air furnaces is 15-20 years. This furnace appeared to be beyond this age and/or its useful lifespan and may need replacing or significant repairs at any time. Recommend budgeting for a replacement in the near future.

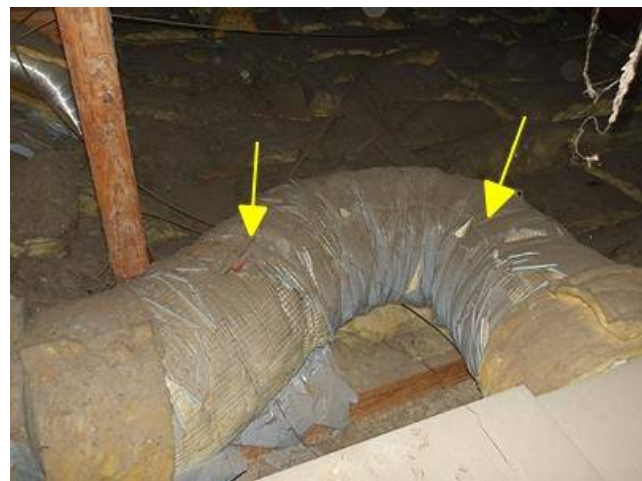
Photo 63-1

The gray plastic outer layer of many flexible ducts was deteriorated. This can result in air leakage, reduced energy efficiency and higher heating/cooling operating costs. The fiberglass insulation that becomes exposed usually also deteriorates, resulting in further reduced energy efficiency or fiberglass particles entering living spaces. In some cases, air can leak in through the deteriorated ducts or mold can grow due to condensation, both resulting in reduced indoor air quality. Recommend that a qualified contractor evaluate further and replace ducts as necessary.

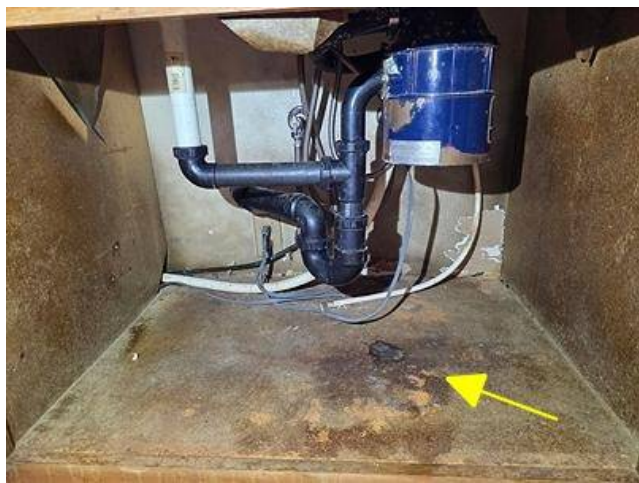
Photo 74-1

Stains were found in the shelving or cabinets below the sink. Plumbing leaks may have occurred in the past. Consult with the property owner about this, and if necessary a qualified person evaluate and repair.

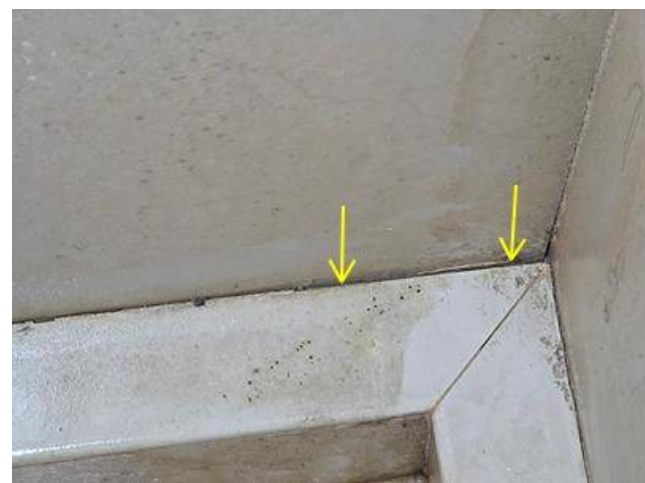
Photo 82-1

82) 🛠️💧 Tile, caulk and/or grout in the shower enclosure at location(s) #A were deteriorated (e.g. loose or cracked tiles, missing grout) or substandard. Water may leak through gaps and damage the wall or floor structure as a result. Recommend that a qualified contractor repair as necessary. Note that the condition of the structure behind and below the shower enclosure is unknown due to it being concealed.

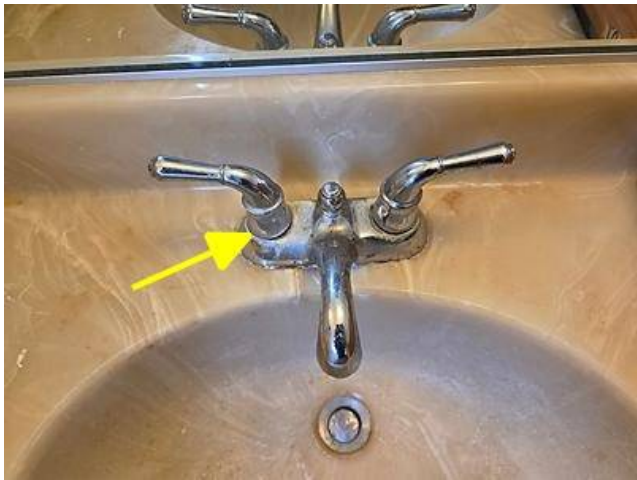
Photo 83-1

Water was leaking at the sink faucet base or handles at location(s) #C. Recommend that a qualified plumber repair as necessary.

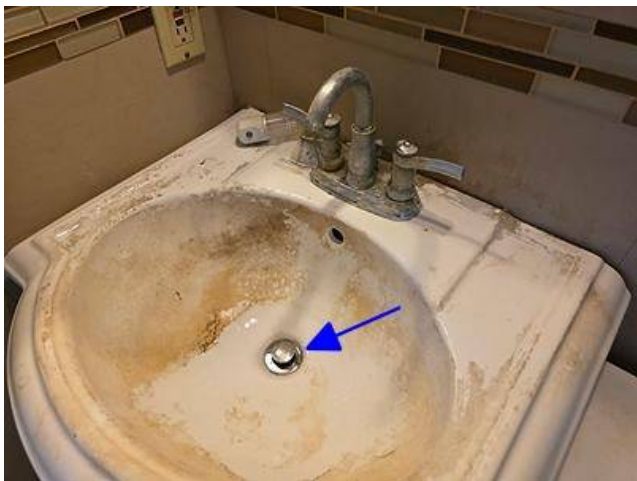
Photo 84-1

The sink drain stopper mechanism at location(s) #A was difficult to operate. Recommend that a qualified person repair or replace as necessary.

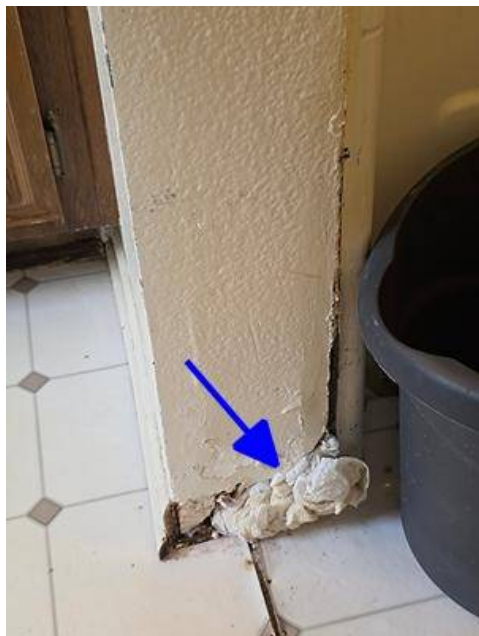
Photo 85-1

The wall by the bathtub at location(s) #C was water-damaged. Recommend that a qualified person repair as necessary.

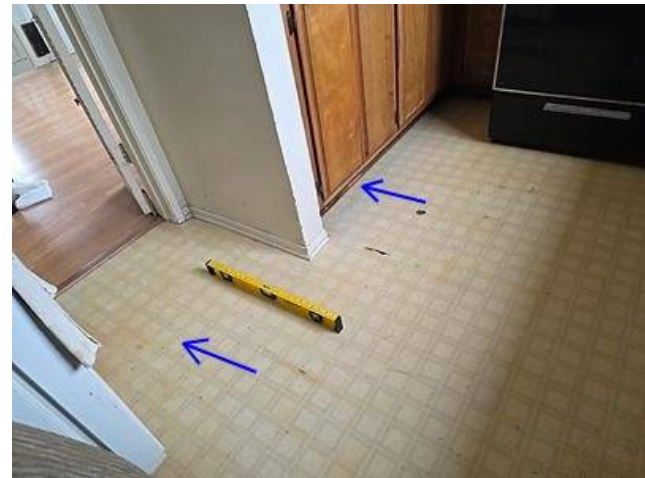
Photo 87-1 Kitchen

Floors in one or more areas were not level. This can stem from foundation settlement, sagging or damaged floor joists, load-bearing wall issues, moisture-induced wood warping, or poor construction practices. Recommend that a qualified contractor and/or engineer evaluate further. Repairs should be performed by a qualified contractor.

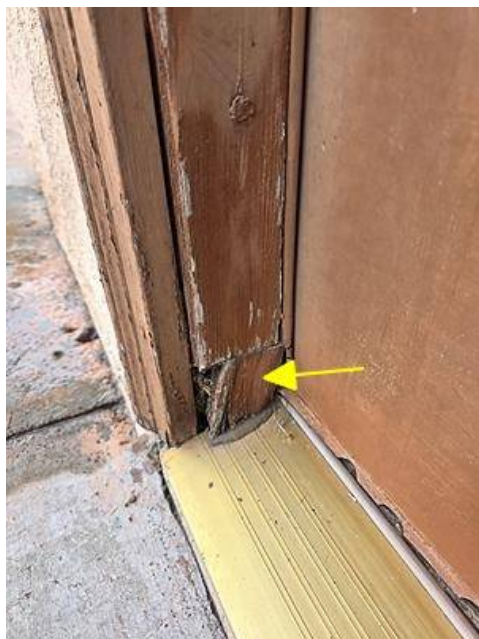
Photo 88-1

Fungal rot was found at one or more exterior door jambs. Recommend that a qualified person repair as necessary. All rotten wood should be replaced.

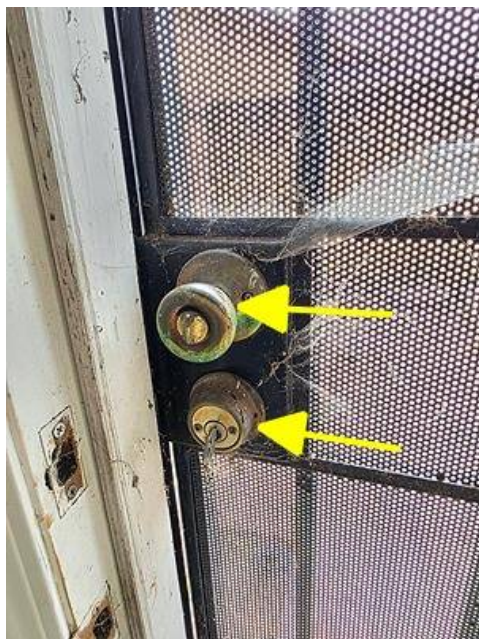
Photo 90-1

Some exterior door hardware, including locksets and and/or deadbolts were difficult to operate. Recommend that a qualified person repair or replace as necessary.

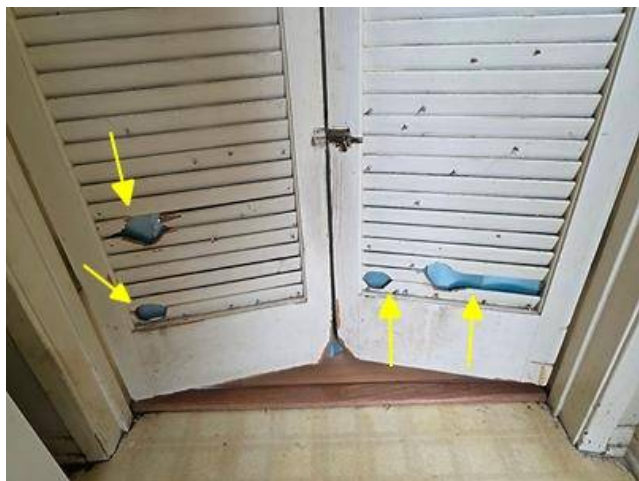
Photo 91-1

One or more interior doors were damaged. Recommend that a qualified person replace or repair doors as necessary.

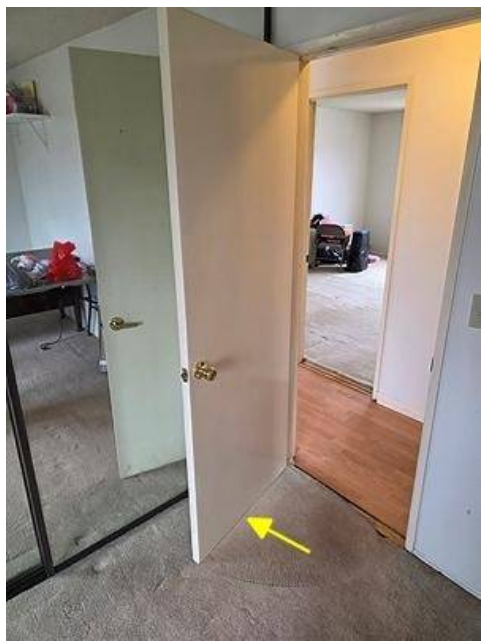
Photo 92-1 Bedroom, 2nd floor

One or more doors dragged on the carpet below and were difficult to open and close. Recommend that a qualified person repair as necessary. For example, by trimming bottoms of doors.

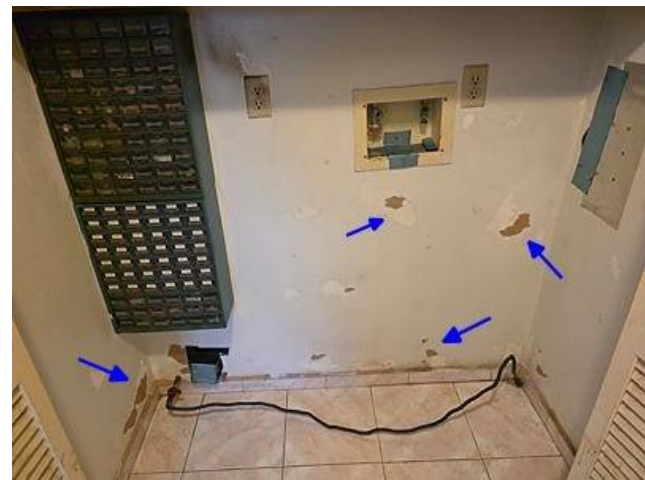
Photo 93-1

One or more walls and/or ceilings were damaged and/or were cracked. Recommend that a qualified person repair as necessary.

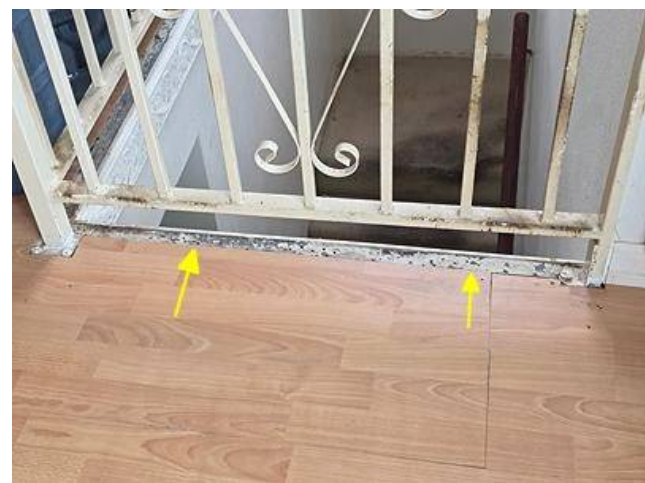
Photo 95-1

The flooring was missing or incomplete in one or more areas. Recommend that a qualified contractor replace or repair flooring as necessary.

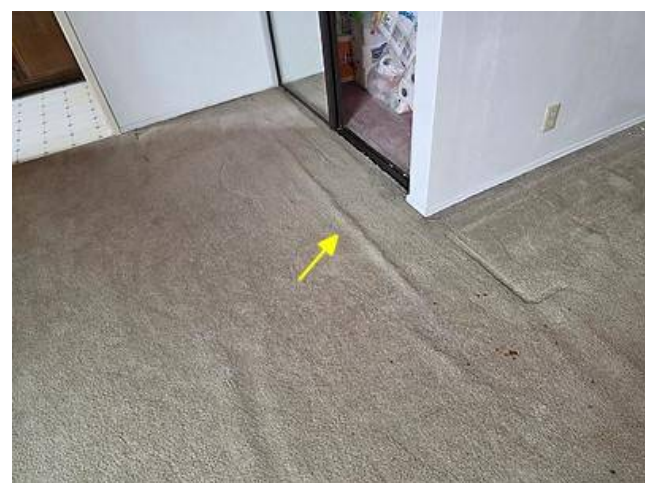
Photo 96-1 Bedroom, 2nd floor

Carpeting in one or more areas was loose. Recommend that a qualified contractor repair as necessary. For example, by stretching or replacing carpeting.

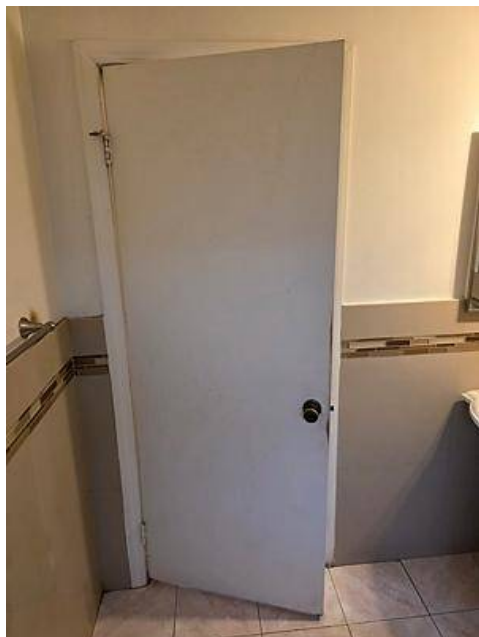
Photo 97-1 Bathroom, 1st floor

The interior door would not remain open and closed by itself. A door may close by itself due to a misalignment in the door or frame, usually caused by loose or improperly installed hinges, an uneven floor, or a slightly tilted door frame, which creates an imbalance causing the door to naturally swing closed due to gravity. Recommend that a qualified contractor repair as necessary.

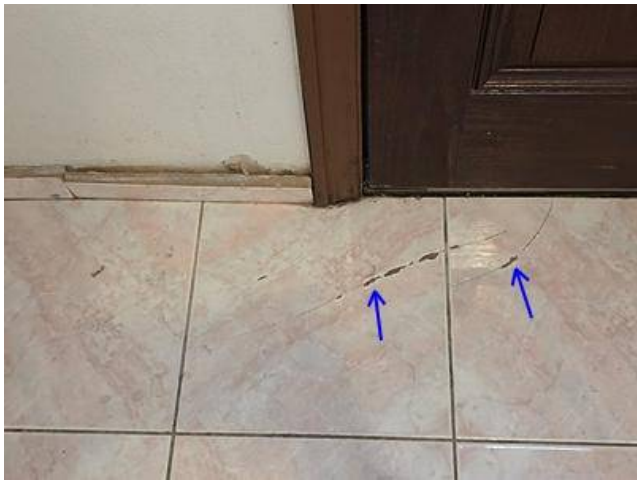
Photo 99-1

Tile, stone and/or grout in the flooring in one or more areas was deteriorated (e.g. loose or cracked tiles, missing grout) or substandard. If in a wet area, water can damage the sub-floor. Recommend that a qualified contractor repair as necessary.

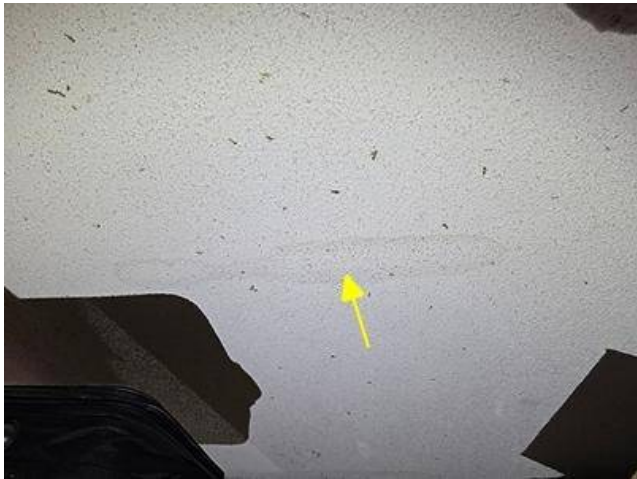
Photo 103-1 Bedroom, 1st floor

Stains were found in one or more ceiling areas. However, no elevated levels of moisture were found. The stain(s) may be due to past roof and/or plumbing leaks. Consult with the property owner and monitor the stained area(s) in the future, especially after heavy or prolonged rain. If elevated moisture is found in the future, then recommend that a qualified contractor evaluate and repair as necessary.

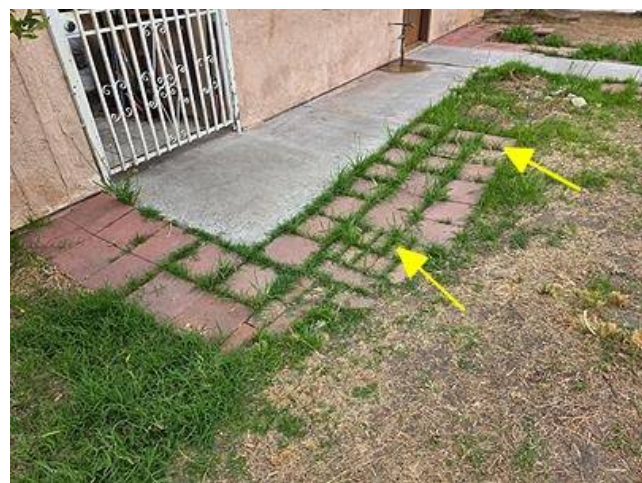
Photo 5-1

Cracks, holes, settlement, heaving and/or deterioration were found in sidewalks and/or patios. Recommend that qualified contractor repair as necessary.

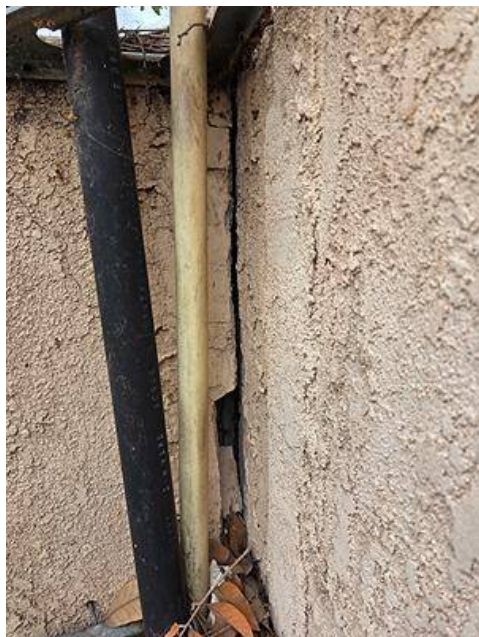
Photo 7-1

One or more holes or gaps were found in siding or trim. Vermin, insects or water may enter the structure. Recommend that a qualified person repair as necessary.

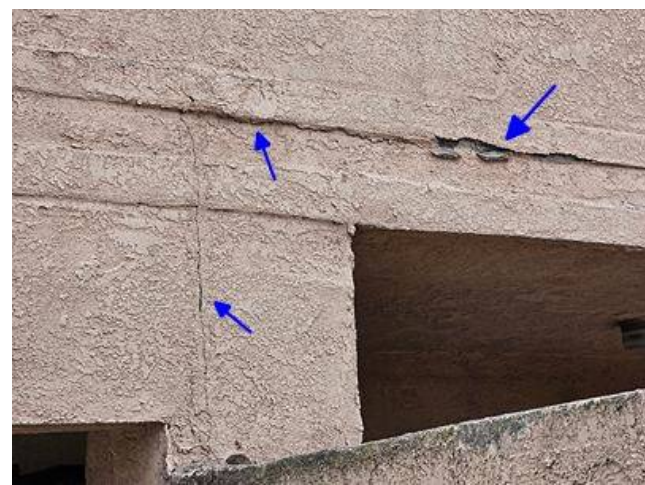
Photo 8-1

8) 🛠️💧 Cracks, deterioration and/or damage were found in one or more areas of the exterior stucco finish. In damp climates, moisture may enter cracks or damaged areas and further deteriorate the stucco. Also the wall behind the stucco may become damaged from moisture. Note that areas behind the stucco are inaccessible and excluded from this inspection. Recommend that a qualified contractor repair or replace stucco as necessary.

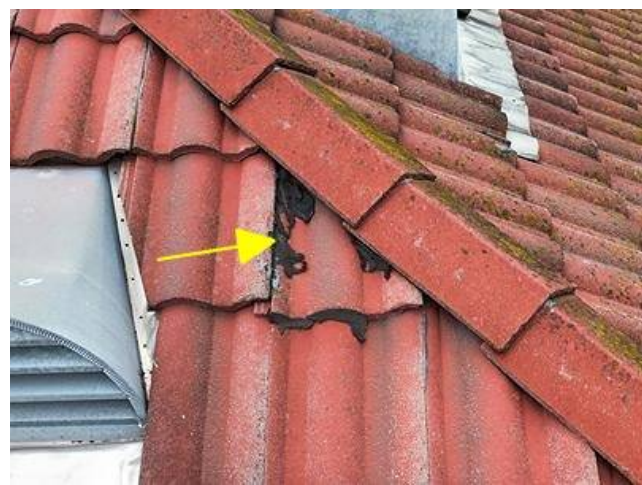
Photo 12-1

12) 🔧🔍 Substandard repairs were found at one or more locations on the concrete tile roof. Sealant was used to repair some sections of the roof and/or around flashing. Sealants may fail to adhere to dirty or wet tiles, trap moisture causing further damage, or degrade under UV exposure, lasting only 5–15 years. For significant damage, replacing tiles is better than sealing, and underlying issues like damaged underlayment must be fixed. Recommend that a qualified contractor evaluate and repair per standard building practices.

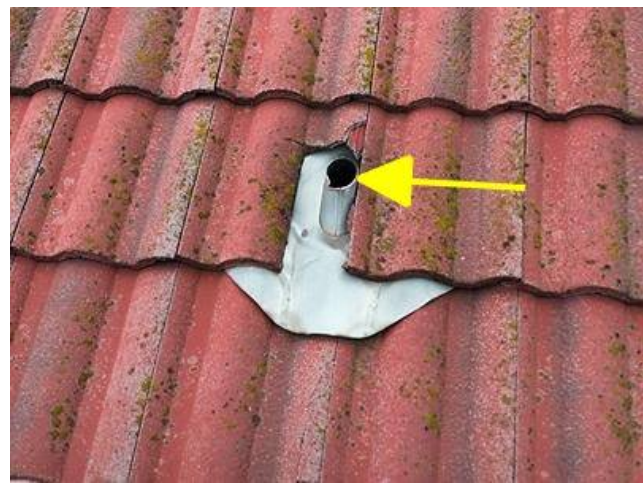
Photo 13-1

One or more roof pipe flashings were observed to be open with no vent pipe penetrating through the collar. These abandoned flashings create a direct opening in the roofing system that allows water to enter the attic space. This defect can lead to localized roof deck rot, damaged insulation, and interior ceiling stains. A qualified roofing contractor should be contacted to remove the empty flashings and properly patch the roof or install a permanent cap over the openings to ensure a watertight seal.

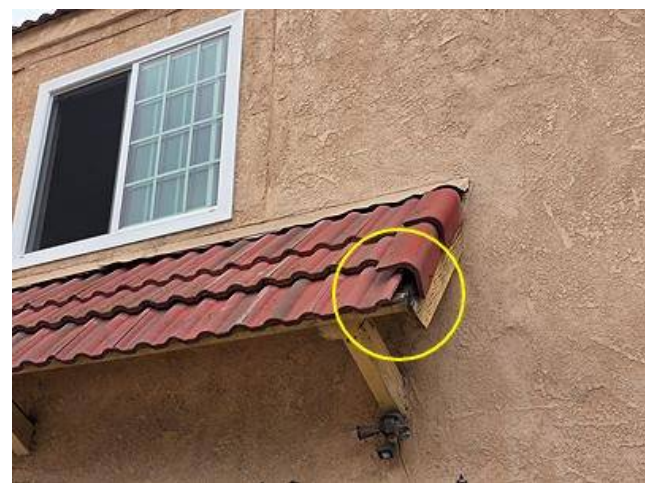
Photo 14-1

14) 🛠️💧 Many concrete roof tiles were broken, chipped, missing and/or loose. Leaks may occur as a result. This is a conducive condition for wood-destroying organisms. Recommend that a qualified person replace tiles or make repairs as necessary.

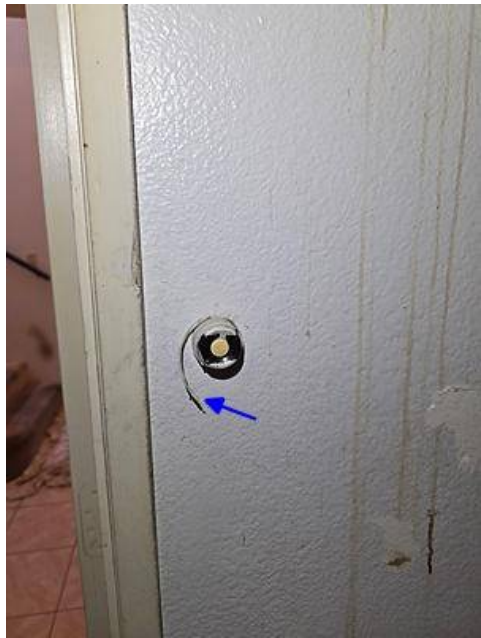
Photo 27-1

The control button for operating one or more automatic garage vehicle door openers was disconnected. A qualified person should repair as necessary so the opener could be controlled with the control button.

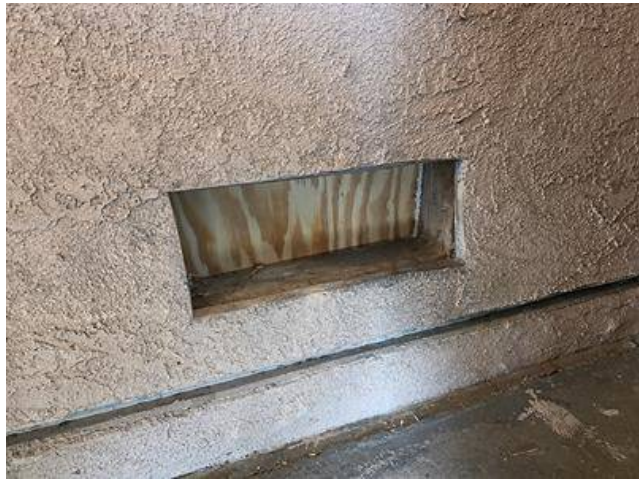
Photo 28-1

The screens for one or more garage vents were missing. Vermin or pets can enter the garage as a result. Recommend that a qualified person install or replace screens where necessary.

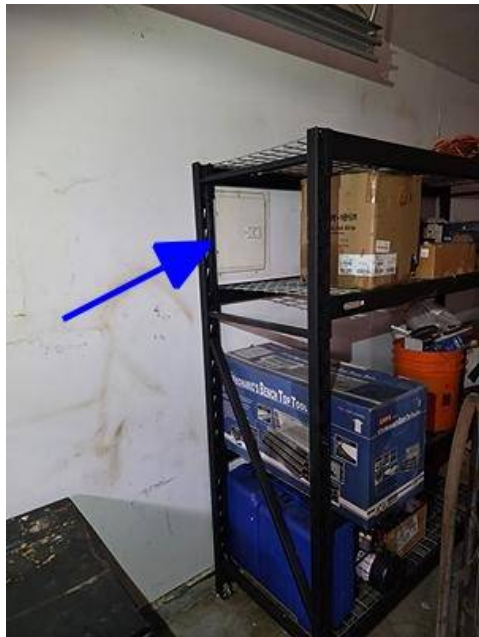
Photo 44-1

The inspector was unable to open and evaluate panel(s) #C because items were blocking access. The condition of these panel(s) is unknown and they are excluded from this inspection. Repairs may be needed. Recommend that a qualified person correct conditions, or that a qualified contractor make repairs if necessary so panels can be opened, and that a qualified person fully evaluate panel(s).
