## ROOF REPORT

| Date | Roof Report No. |
|---|---|
| 04/16/26 | 6599 |

| Project Address |
|---|
| 112 Jimno Ave<br>Pittsburg, CA 94565 |

Roof Inspection Date: April 15th, 2026

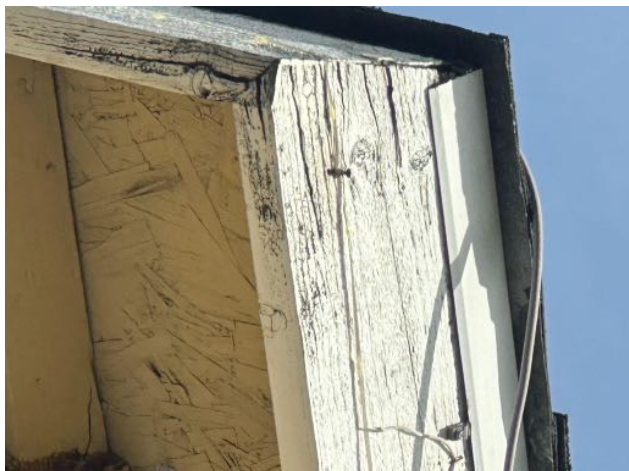
5c.

5. There is no drip edge metal or gutters installed at the eaves, which has contributed to dry rot due to unprotected fascia boards. It is recommended that the visibly dry-rotted plywood and fascia along the second-story eaves be repaired or replaced as needed, that any removed shingles be replaced, and that drip edge metal be installed. Alternatively, gutters may be installed in lieu of drip edge; please see Estimate #6600 for details and pricing.
