*Aldis Enterprises*  
Property Inspection Report

6 Nancy Ln, Chico, CA 95926  
Inspection prepared for: Anderson RJ  
Date of Inspection: 8/10/2026 Time: 9AM  
Age of Home: 1978 Size: 1,532 sqft  
Weather: Warm, Dry

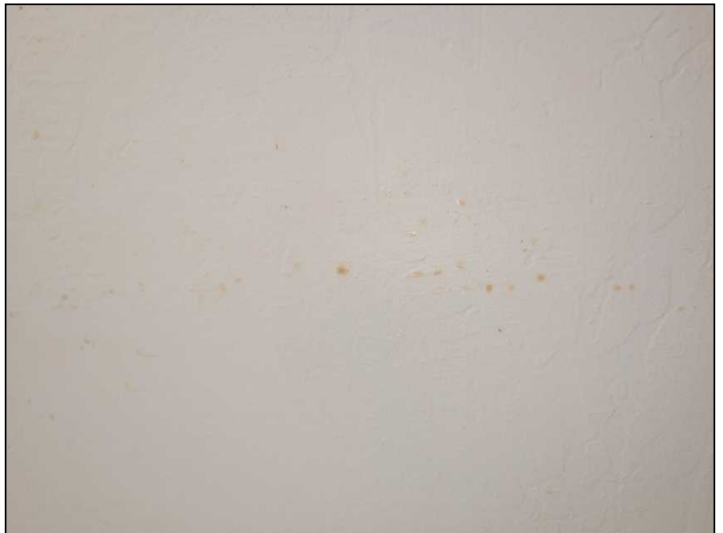
- Appeared satisfactory for age and wear.
- Common cosmetic defects/imperfections observed.
- Evidence of some past repairs/modifications noted. Consult seller for any information regarding these areas.
- Some gaps were observed at the main living area beam trim work.

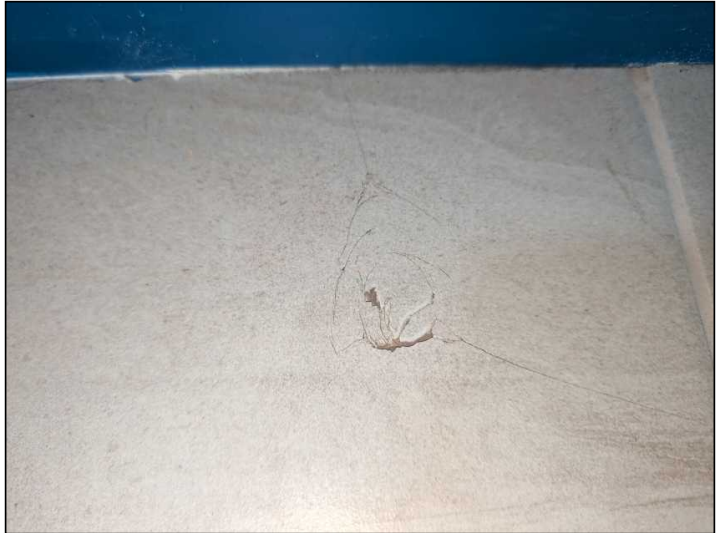
- Appeared satisfactory for age and wear.
- Some damaged flooring observed.
- Recommend having the carpets stretched/repared as needed.

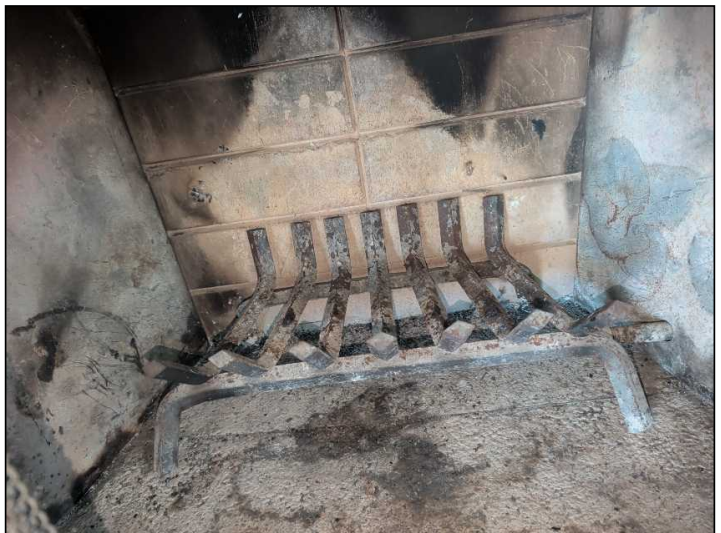
Disconnected screen at the fireplace, left side.

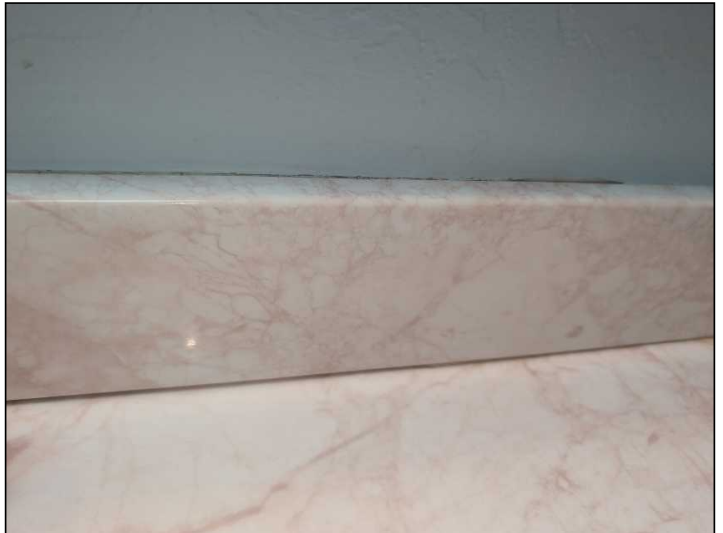
- Appeared satisfactory.
- Consider adding a back splash where missing.
- Caulking/grout maintenance recommended.

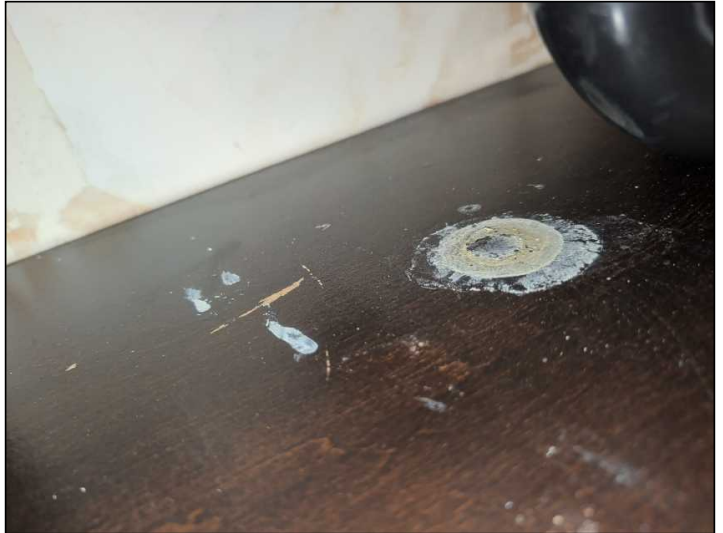
- Functional at inspection, no active leaking detected.
- Moisture stains noted, evidence of possible past leaking observed. Consult seller about all known leaking.

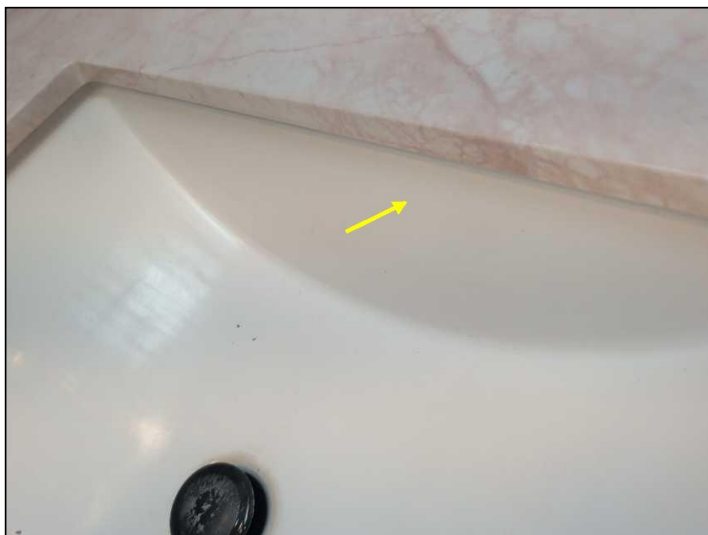
- Appeared satisfactory for age and wear.
- Sink stopper did not operate normally when tested at the guest bath.
- Sinks with no built-in overflow drains should not have mechanical stoppers installed.

No overflow.

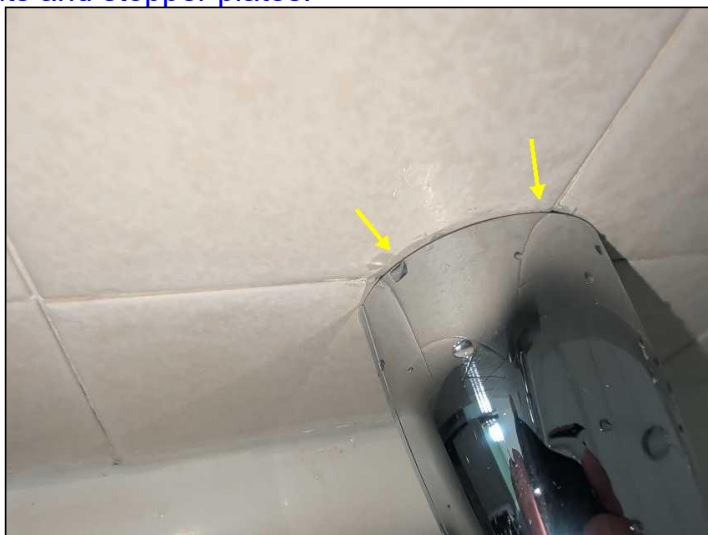
- Functional at inspection.
- Caulking is recommended as needed at tub spouts and stopper plates.

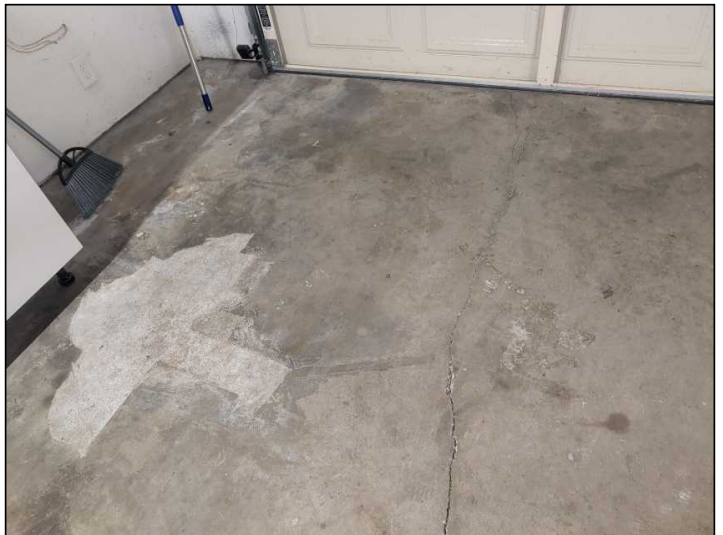
- Concrete cracking noted.
- Common stains and normal wear and tear observed.
- Consider having the garage concrete floor further evaluated and addressed as needed by a licensed concrete contractor.

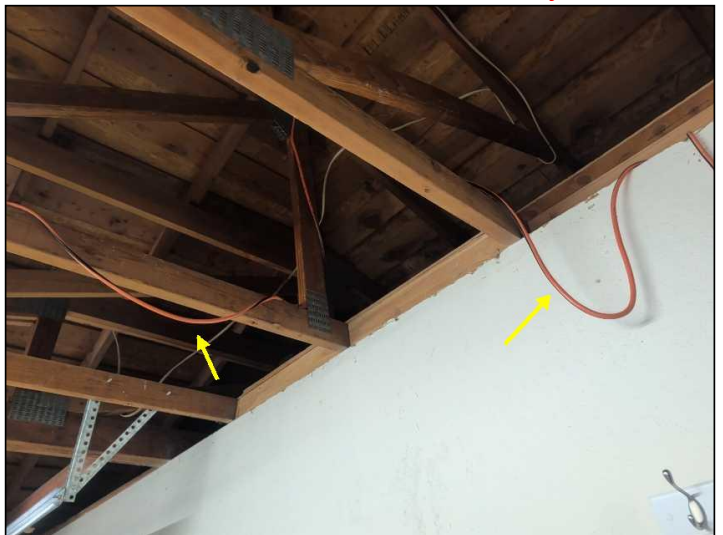
| Interior Areas | | |
|---|---|---|
| Page 28 Item: 3 | Electrical | • Worn/damaged outlets noted; these can cause loose connections and potential arcing, should be replaced as needed.<br>• Missing cover plates observed, potential fire/shock hazard, should be installed for safety. |

- Improper/unprofessional wiring practices observed.
- Improper use of extension cord observed. Extension cords should not be used as permanent or long term power sources.
- Recommend further evaluation with corrections as needed by a licensed electrical contractor.
- Worn/damaged outlets noted; these can cause loose connections and potential arcing, should be replaced as needed.
- Missing cover plates observed, potential fire/shock hazard, should be installed for safety.

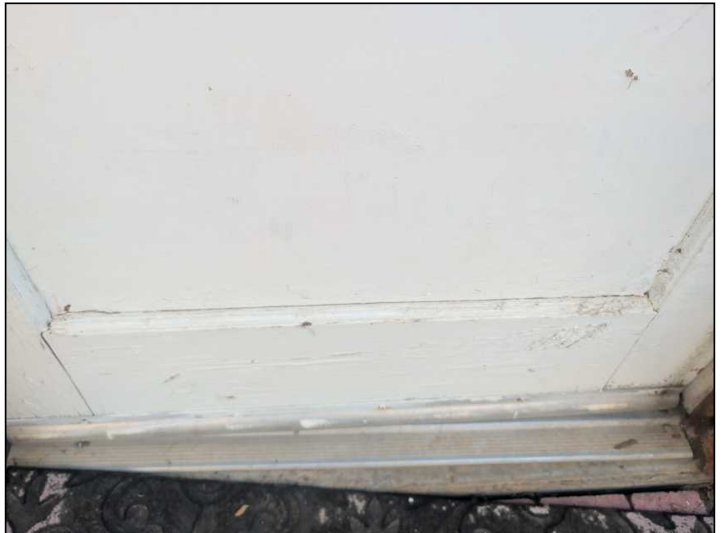
- Functional at inspection.
- Weatherization should be improved at exterior door.
- Damage observed at exterior door frame/jamb.
- Exterior doors/jambs/trim should be kept painted/stained/sealed to protect from elements.
- Consider updating the garage exterior door.

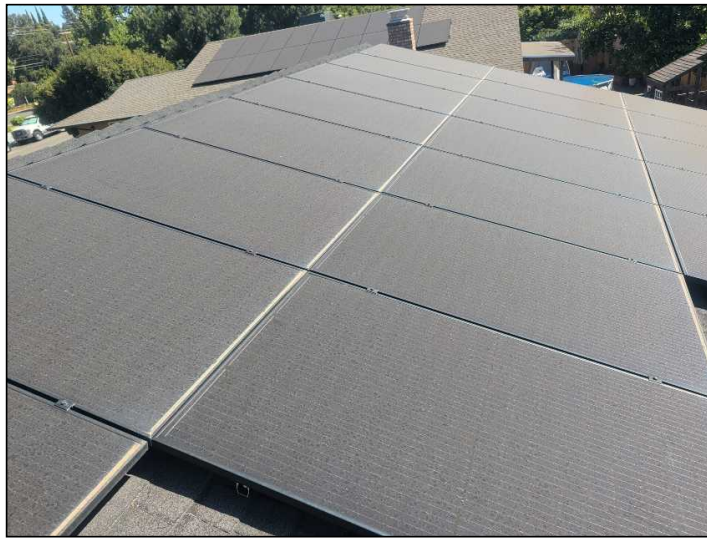
| Interior Areas | | |
|---|---|---|
| Page 32 Item: 1 | Electrical Panel Condition | • Home has a Zinsco/GTE Sylvania brand panel. These are widely considered obsolete, unreliable, and potentially unsafe. This panel should be evaluated by a licensed electrical contractor and updated/replaced as needed. |

- Modifications to panel noted.
- Home has a solar system installed. Appeared satisfactory and functional at inspection, but fully evaluating these systems is beyond the scope of a general home inspection. Consult seller for operation and maintenance information, and recommend evaluation of system and all components by a licensed solar specialist.
- Home has a Zinsco/GTE Sylvania brand panel. These are widely considered obsolete, unreliable, and potentially unsafe. This panel should be evaluated by a licensed electrical contractor and updated/replaced as needed.

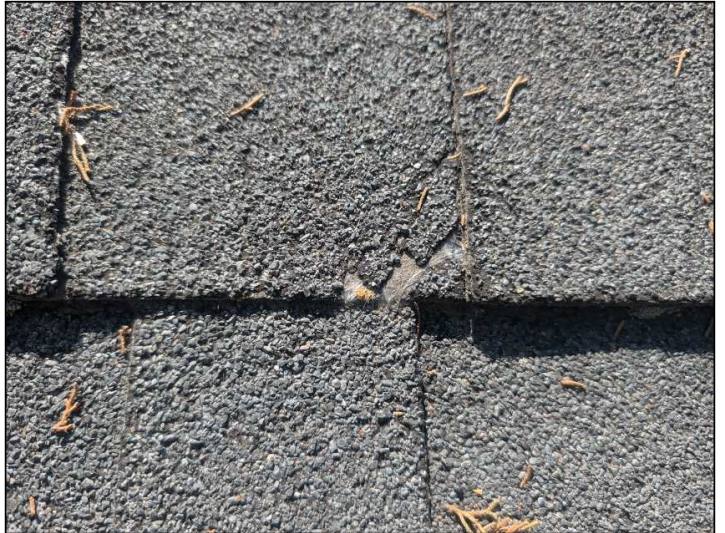
| Interior Areas | | |
|---|---|---|
| Page 34 Item: 1 | Roof Condition | • Based on the age/overall condition of the roof, it is recommended having the roof fully evaluated with corrections as needed by a licensed roofing contractor, and having the remaining useful life determined, which may be limited. |

- Typical wear and tear noted for an aging roof.
- Organic growth/moss observed on roofing materials.
- Exposed fasteners observed, these should be sealed as needed.
- Damaged shingles observed.
- Evidence of past repairs observed at the rear porch roof. Consult seller.
- Satellite dish/antenna installed directly through roof shingles; these should be checked for leaking periodically and sealed as needed.
- Consult seller for exact age of roof if known.
- Based on the age/overall condition of the roof, it is recommended having the roof fully evaluated with corrections as needed by a licensed roofing contractor, and having the remaining useful life determined, which may be limited.

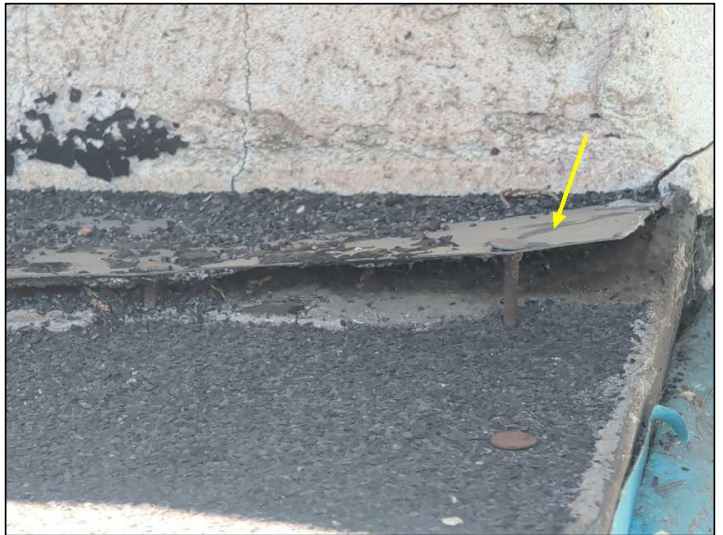
- Loose/lifting flashing observed at the rear porch roof; should be secured properly as needed.

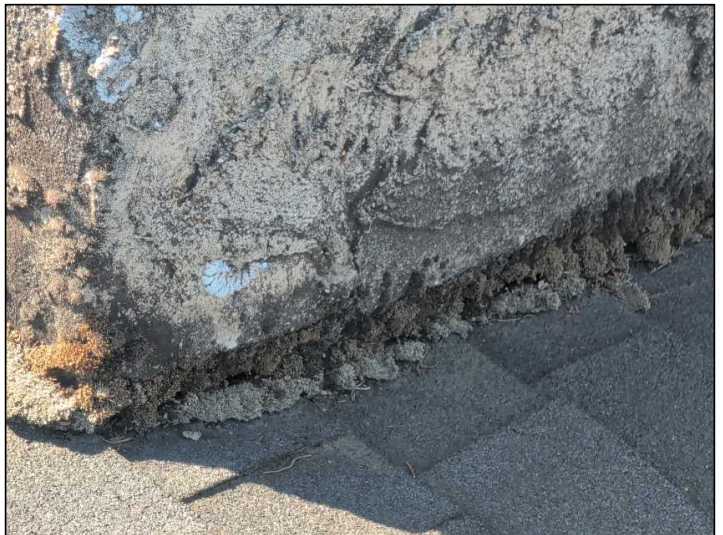
- Maintenance/repairs needed.
- Organic growth observed at the chimney cladding.
- Loose/lifting flashing observed at chimney.
- Additional sealing may be needed at chimney cap.
- Rust observed at the chimney cap metal.
- Chimneys, flues, fireplaces and stoves should always be professionally inspected and serviced as needed by a licensed specialist/chimney sweep, and certified for safety prior to use, and then again every year thereafter for safety and efficiency.
- Recommend further evaluation with corrections as needed by a licensed contractor/chimney specialist.
- **Flashing at chimney base needs to be cleaned and kept clear for proper drainage.**

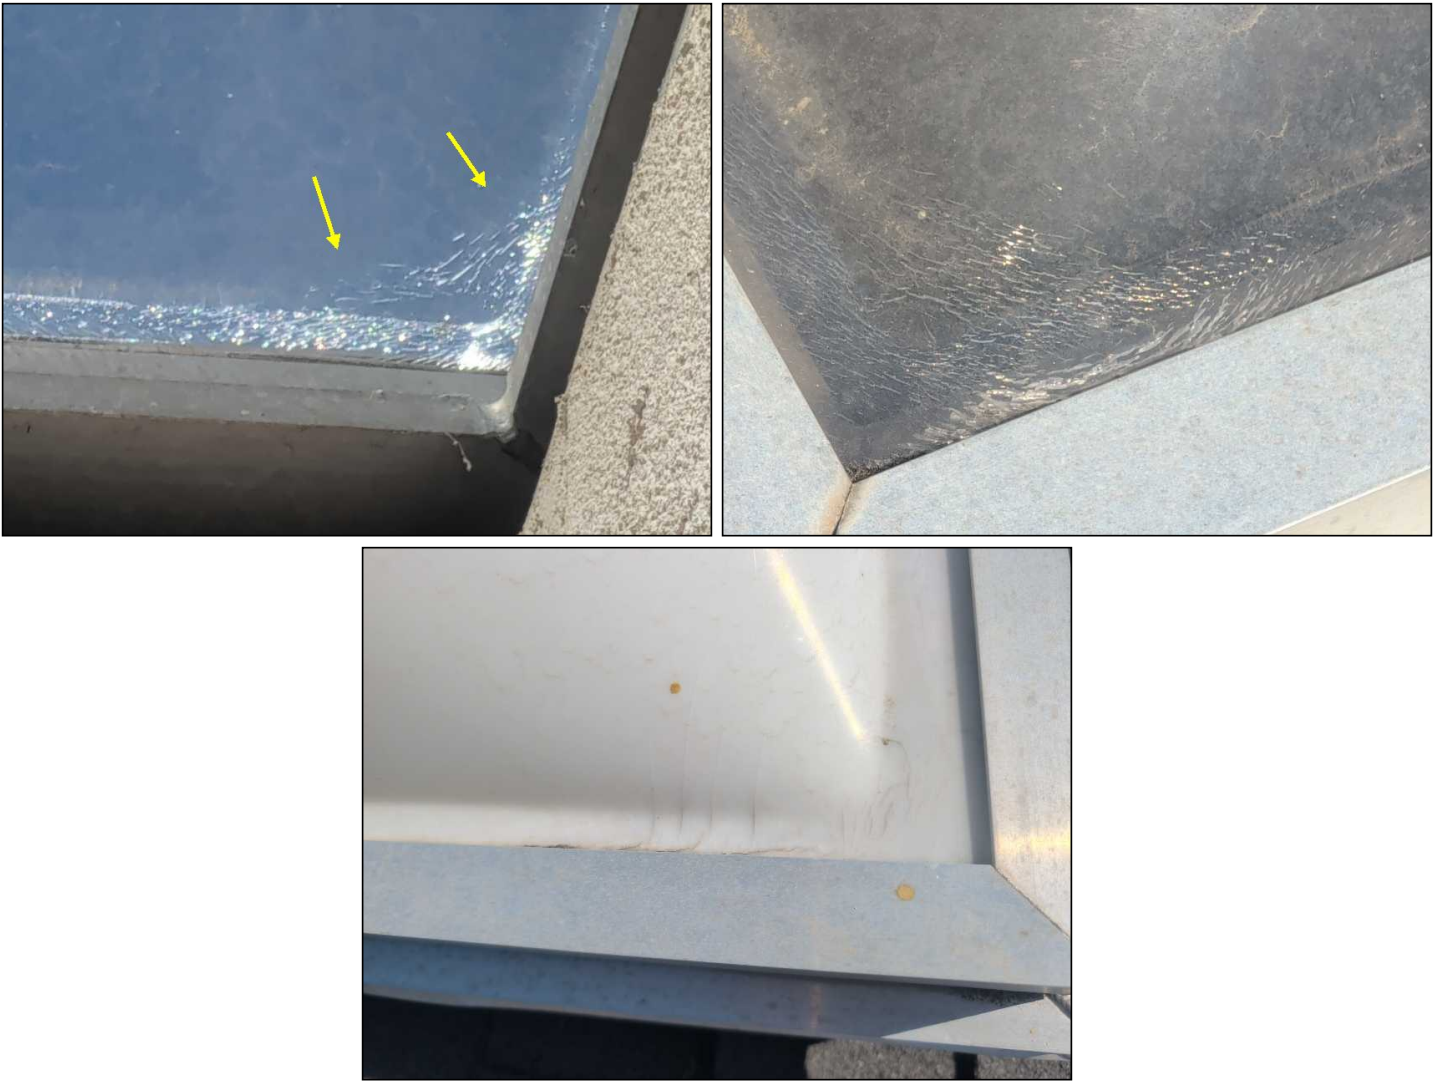
- Some cracking noted at the skylight lenses.
- Skylights are a common source of roof leaking; these should be inspected periodically by a licensed roofing contractor or otherwise qualified person.
- Recommend further evaluation with corrections as needed by licensed roofing contractor.

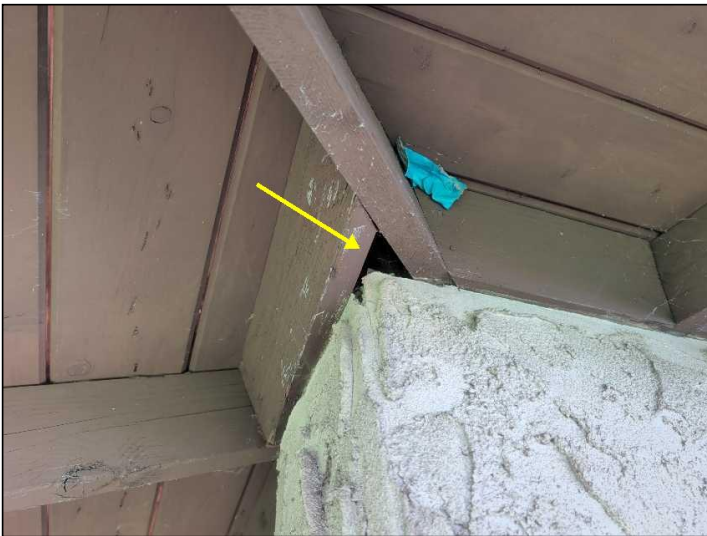
- Maintenance/repairs needed at sections.
- Evidence of past repairs/modifications noted. Consult seller for any information regarding these areas.
- Cracked/chipped stucco observed.
- All gaps/cracks/openings at siding should be repaired/sealed to prevent moisture/pest intrusion.
- Wasp/bee nests observed, these should be removed as needed.
- Recommend further evaluation of siding/eaves with corrections as needed by a licensed contractor/pest control.

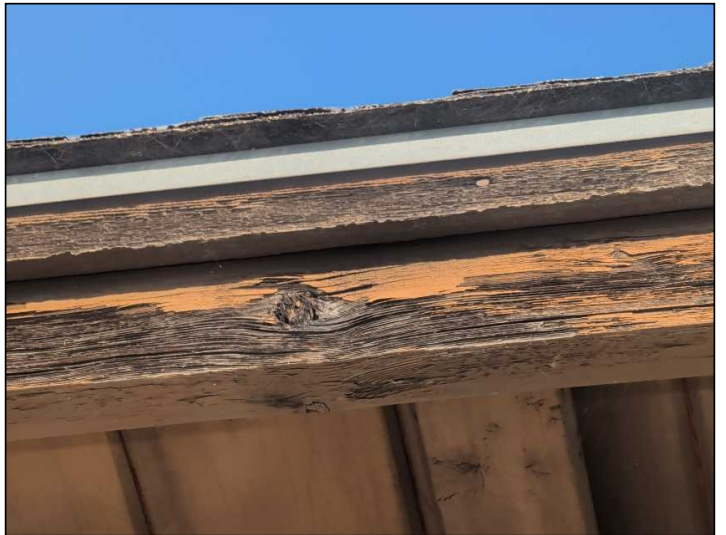
- Recommend full exterior prep and paint soon.

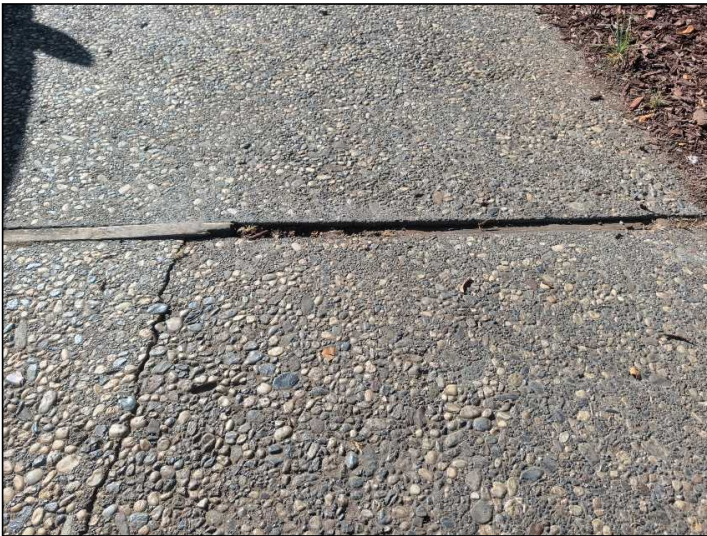
- Cracked concrete observed.
- Uneven surfaces around the home should be improved to eliminate potential trip hazards.

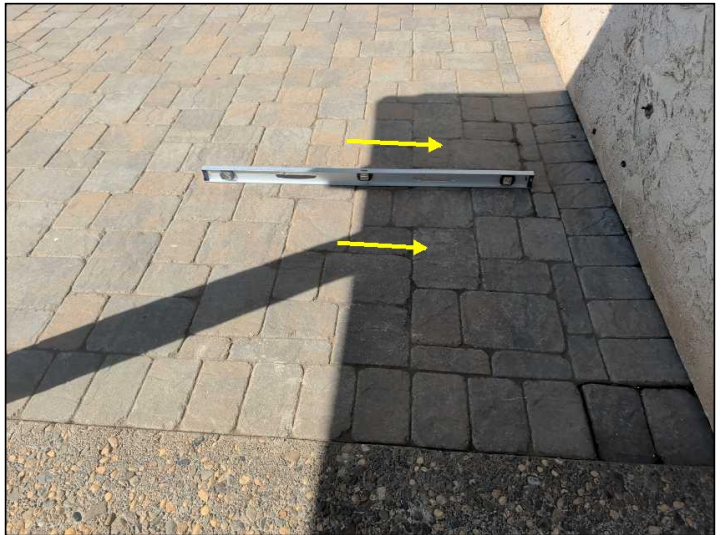
- Some negative grade observed at rear of home. Grading should slope away from structure.
- Planters next to home foundations are not ideal as they can potentially trap excessive moisture next to the foundation perimeter.
- Recommend adding landscape rock at bare soil around home perimeter as needed to help control drainage and erosion.
- Landscape rock is preferable to mulch/bark at home perimeter for better drainage and erosion control. Mulch and bark may also attract pests to the home perimeter.
- Recommend monitoring the grading/drainage at structure perimeter and improving as needed.

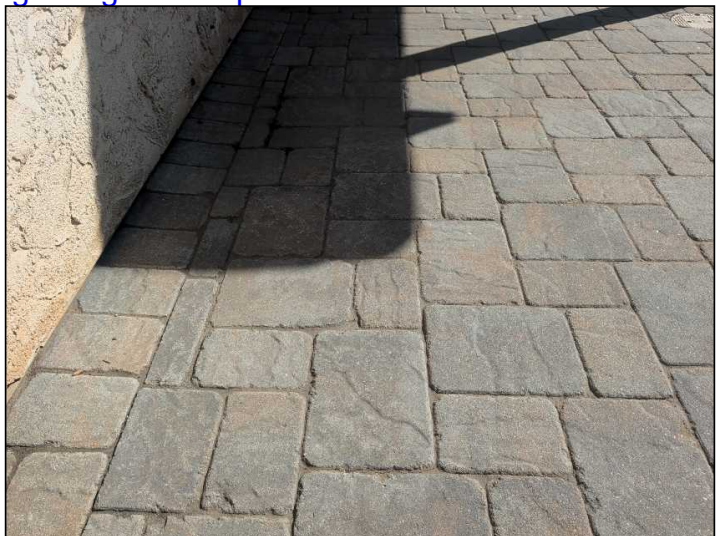
- Appeared satisfactory for age and wear.
- Cracked concrete noted.
- A couple of the rear pavers have sunken creating a pocket where water can collect. See also Grading/Drainage section of report, as there is a slight negative slope in this area.

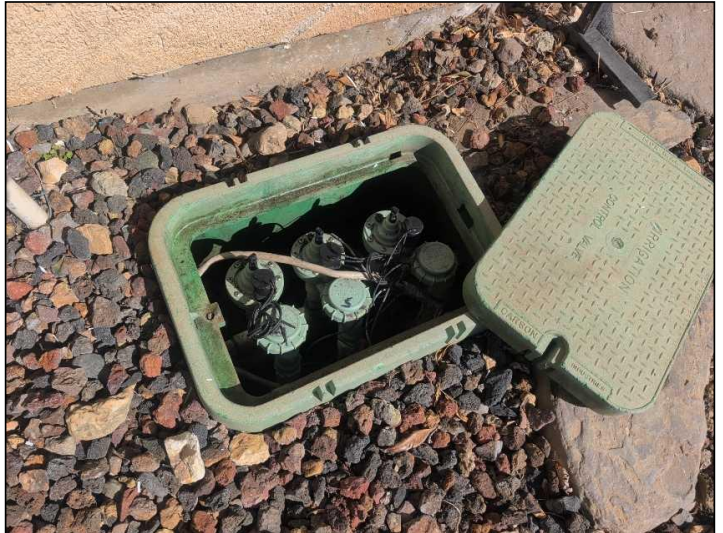
- Visible portions of irrigation system appeared to be in serviceable condition. Testing and fully evaluating sprinkler systems is beyond the scope of a general home inspection.
- Irrigation control valves located at front and rear of home.
- Irrigation isolation valve located at rear of home.
- Automatic sprinkler system noted, control clock located at the garage.
- The rear irrigation appears to be non-functional at this time.

Rear irrigation control valves.

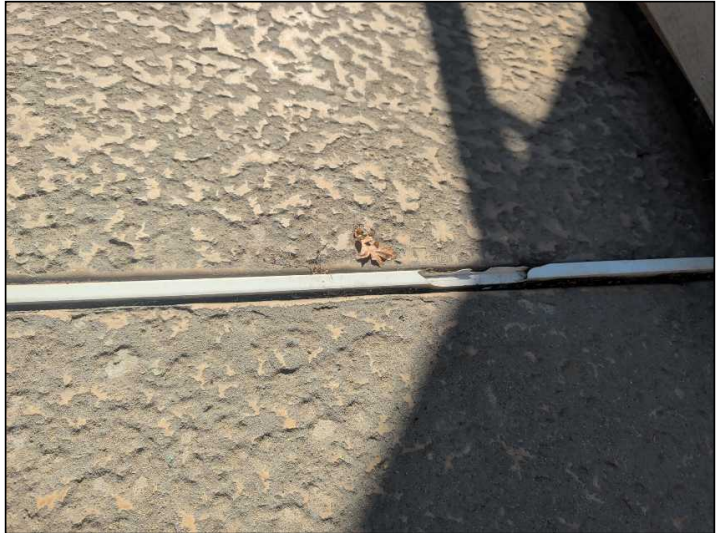
- Concrete cracking noted.

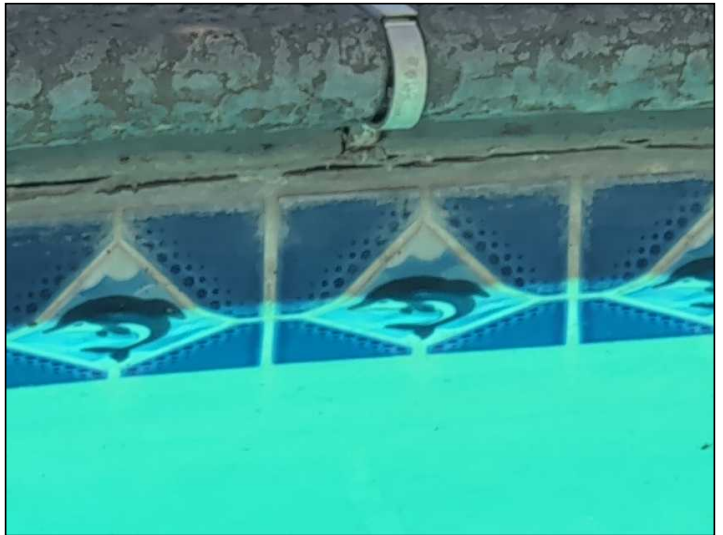
- Satisfactory condition for age and wear.
- Some surface chipping observed.
- General maintenance needed at the tile.
